National Property Inspections

Property Location

9375 Burt Street

1. Executive Summary

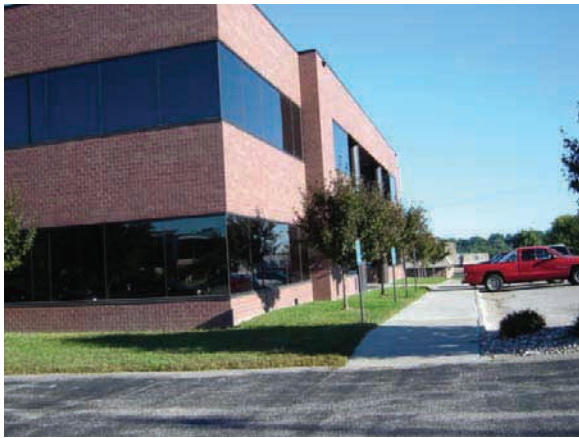
Grade and landscaping

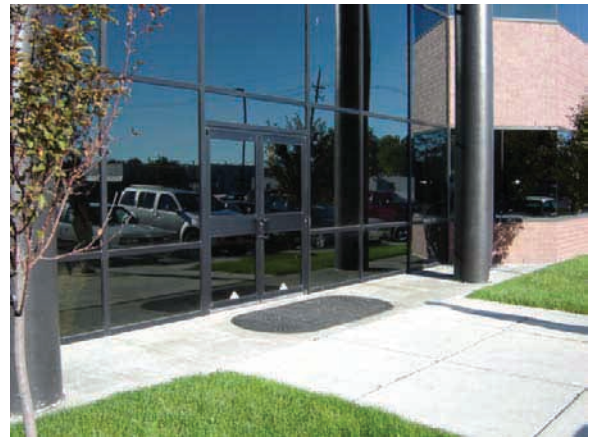
Front Entry Egress

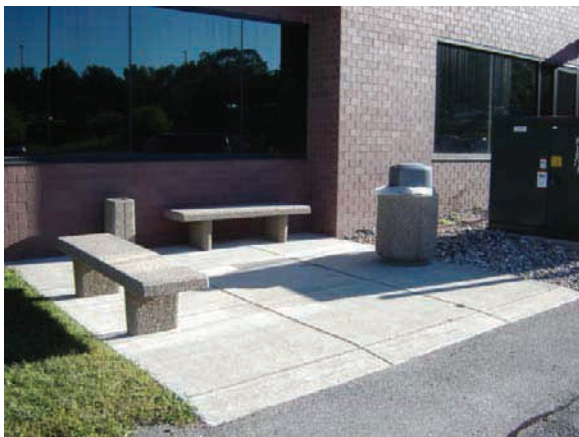
Patio/Flatwork

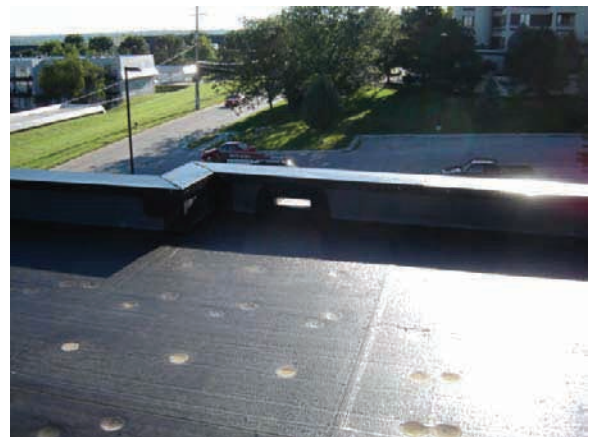
Parapet wall and Scuppers
