PROPERTY INSPECTION REPORT

National Property Inspections**6310 Millwood Court****Arlington, TX 76016****Office 817-492-0161****Fax 817-451-0233****Mobile 469-964-4414****www.npidfw.com****service@npidfw.com****Inspected By: Eric Evans TREC #7077****Inspection Date: 4/27/2006****Client**

Town Home Row

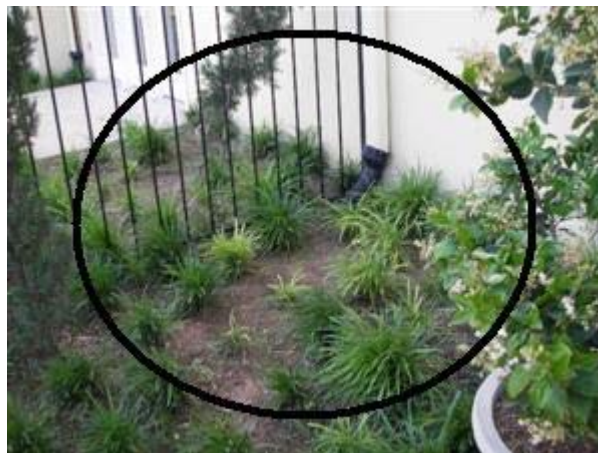
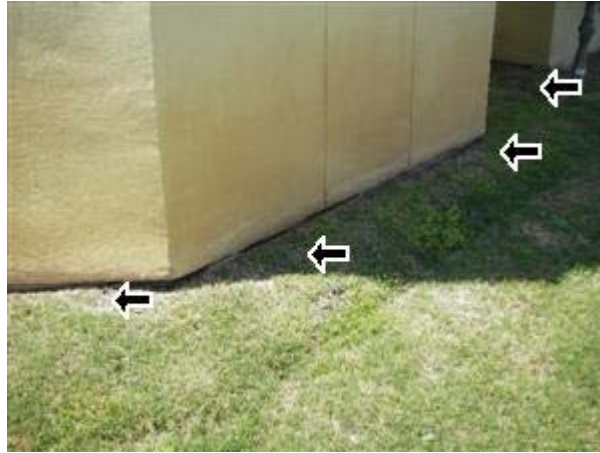
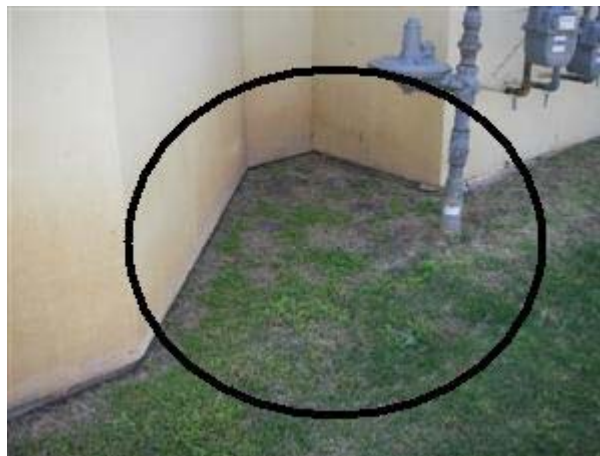
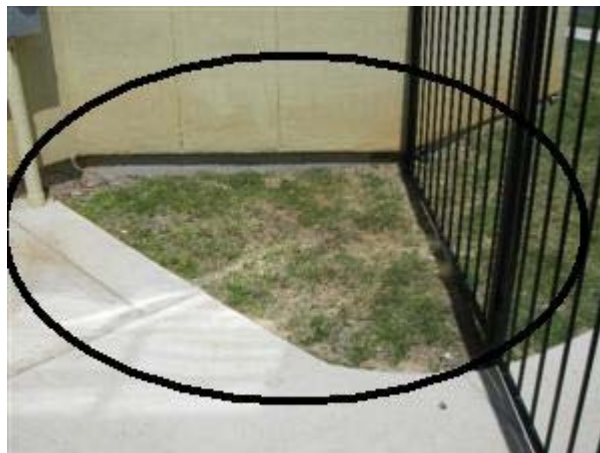
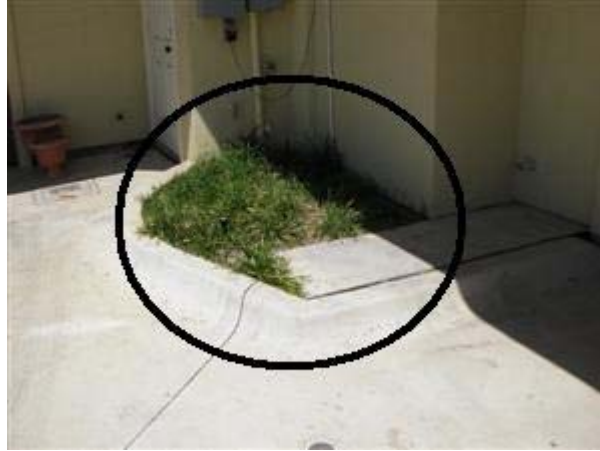
Comments: Overall grading appears to be performing as designed at time of inspection. Noted some minor negative sloping towards structure and low spots on property where water will stand after rain. These areas do not appear to properly drain water from property and need landscaping and drainage corrected. Recommend qualified contractor evaluate and repair.

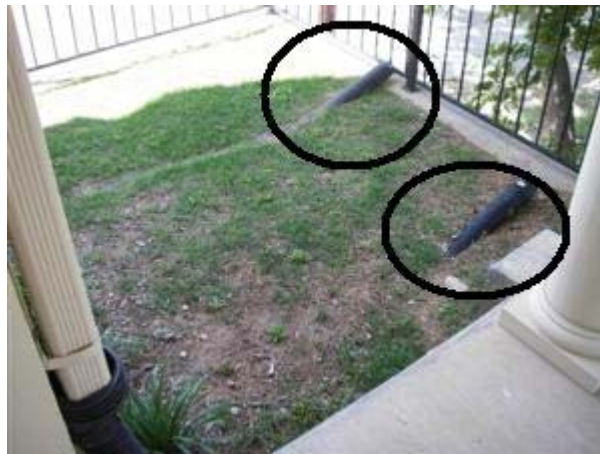
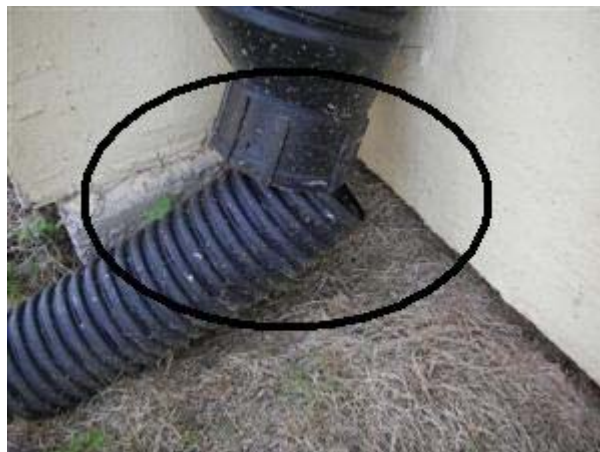
Noted gutter system in need of installation completion or repair at various points around structure. Recommend qualified contractor evaluate and repair.

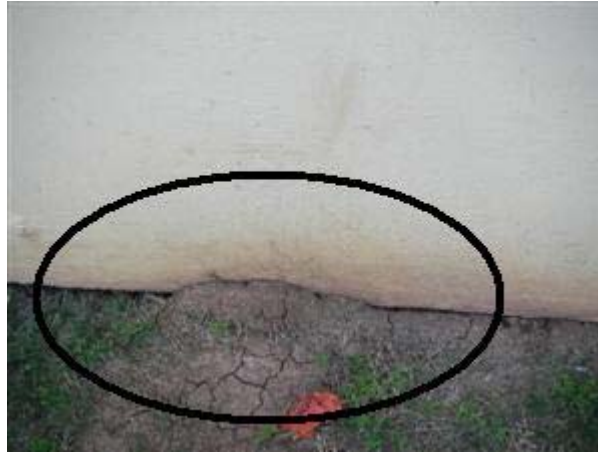
B. Picture 8

Noted soil too high at points around structure. Recommend maintaining a minimum of 4 to 6 inches of exposed foundation wall around structures perimeter. This is a moisture retention issue and WDI (wood destroying insect-termite) issue. Recommend qualified contractor evaluate and repair.

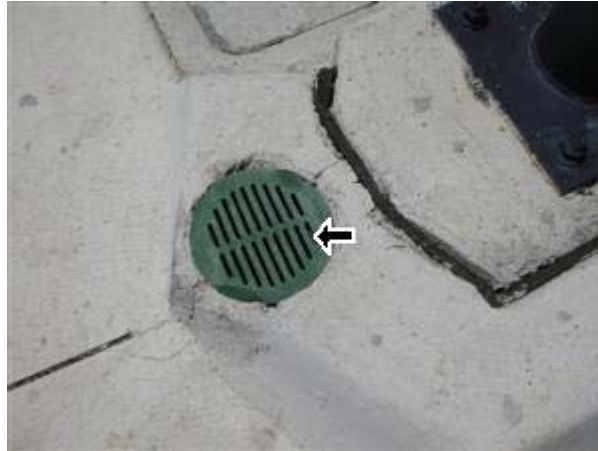
B. Picture 9

Surface drains will need periodical cleaning and maintenance. Recommend future monitoring to maintain their effectiveness.

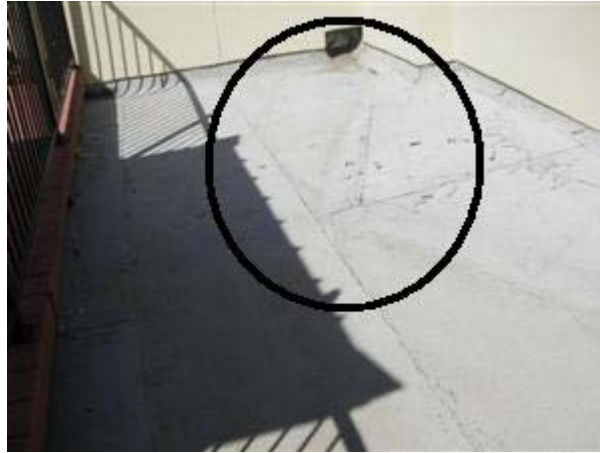
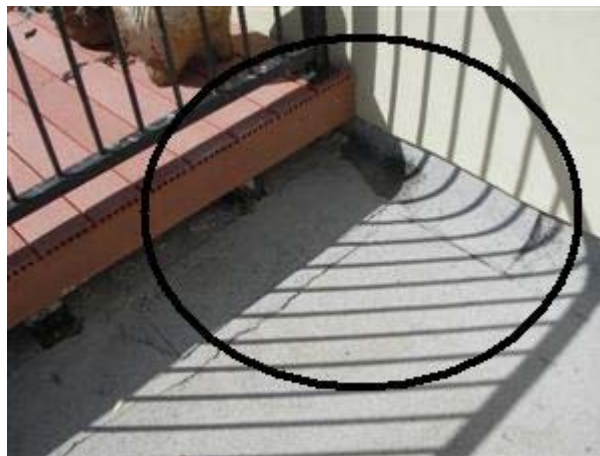
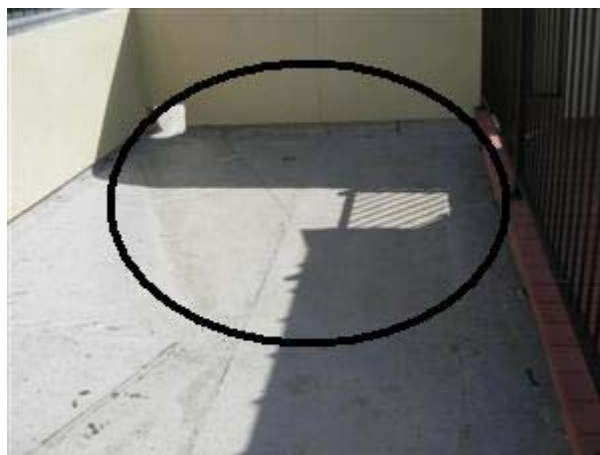
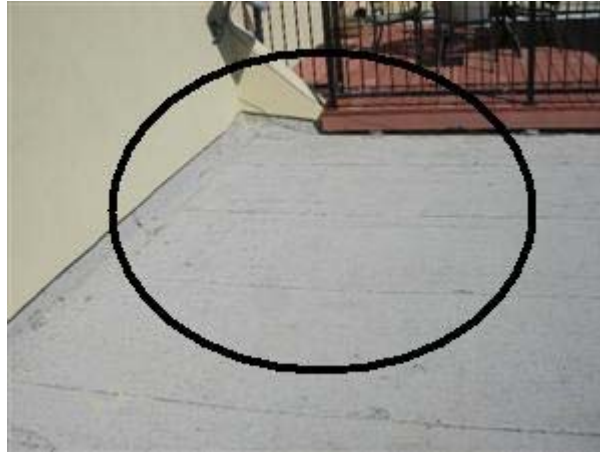
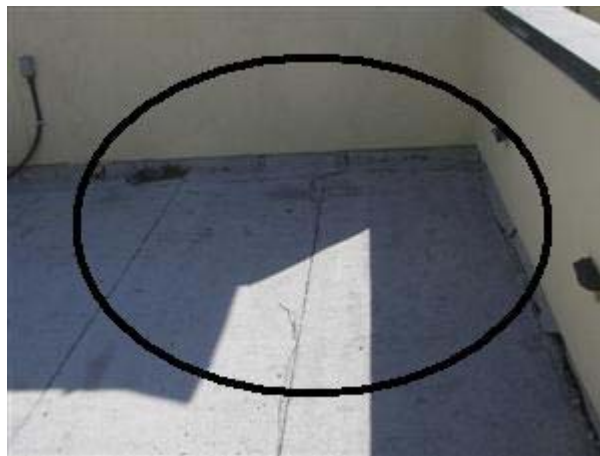
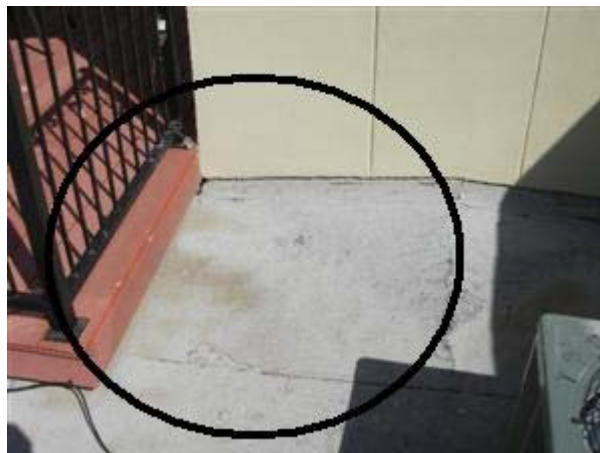
Comments: Noted several instances of standing water or evidence of standing water on roof due to poor design or initial construction. Recommend qualified contractor evaluate and repair.

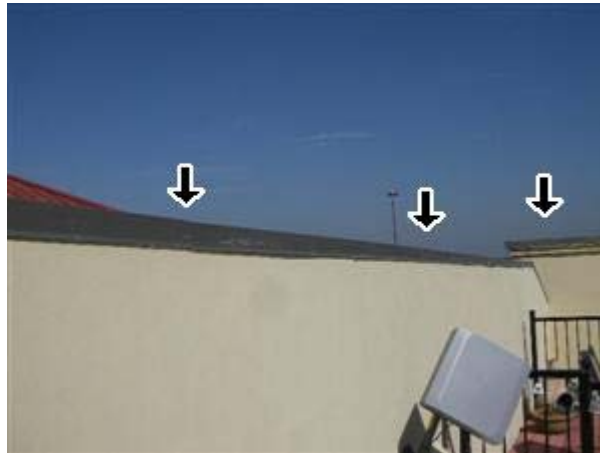
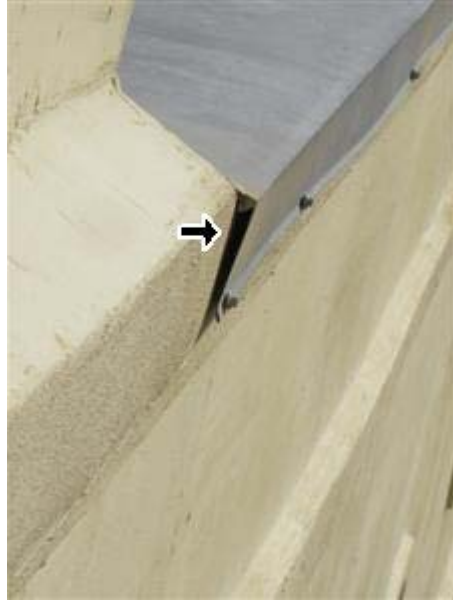
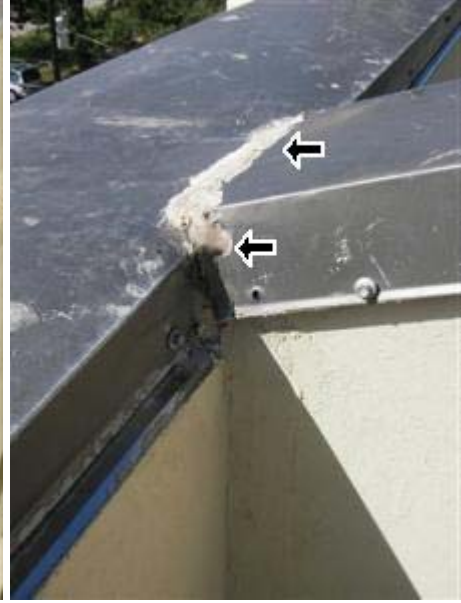
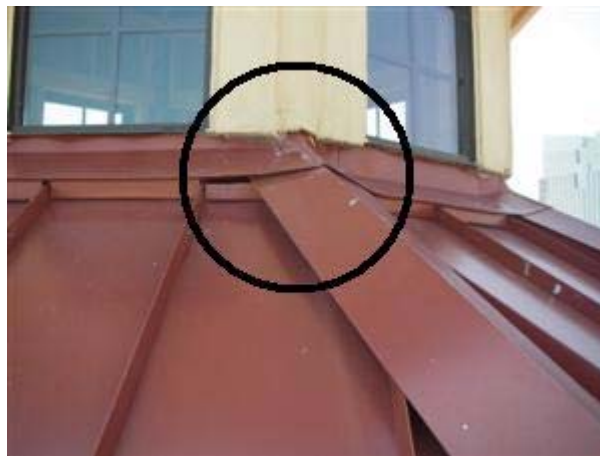
Noted ridge cap and metal roof flashing is unconventionally installed and improperly sealed at most points. Recommend qualified contractor evaluate and repair.

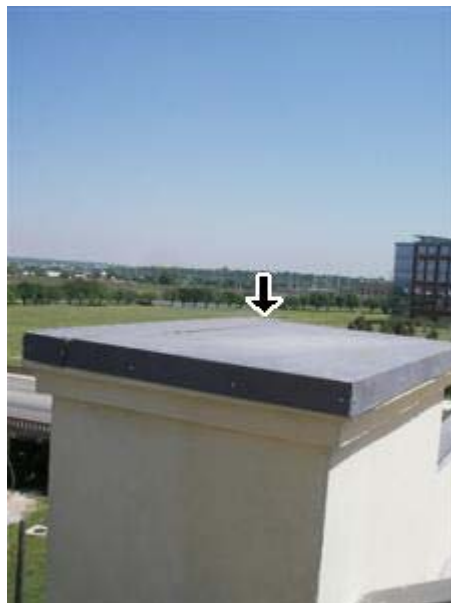
C. Picture 25

Noted points on decorative column caps where metal flash cap is improperly pitched and sealed. This will allow moisture retention and penetration. Recommend qualified contractor evaluate and repair.

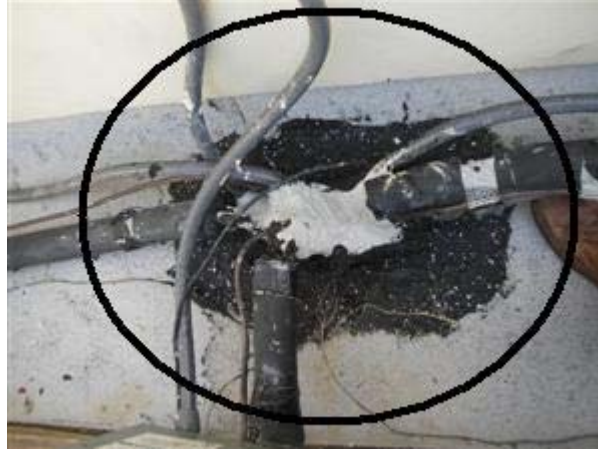
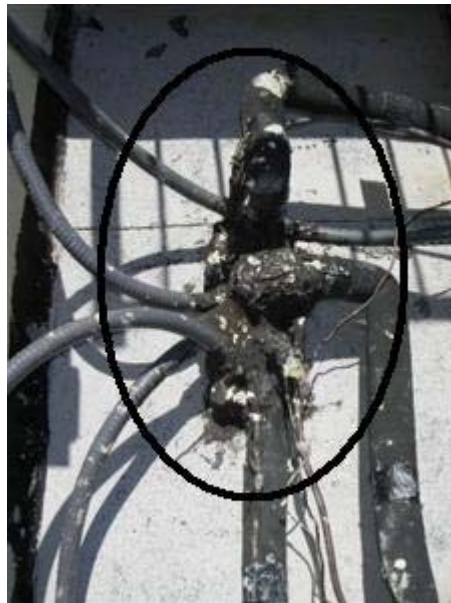
Noted additional conventional sealing required at roof mounted compressor equipment service line structure entrance. Recommend qualified contractor evaluate and repair.

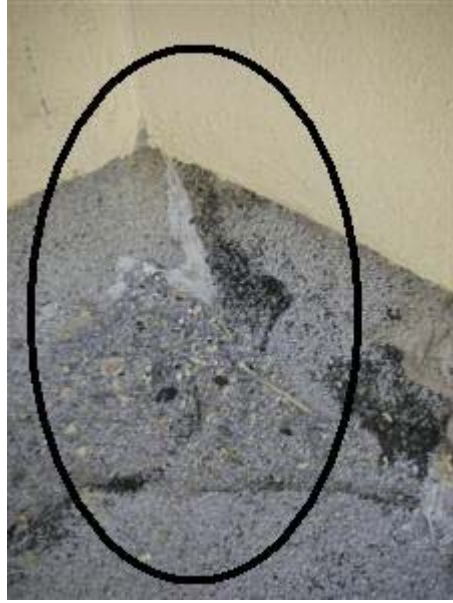
C. Picture 28

Noted points where roofing material seams are separated. Recommend qualified contractor evaluate and repair.

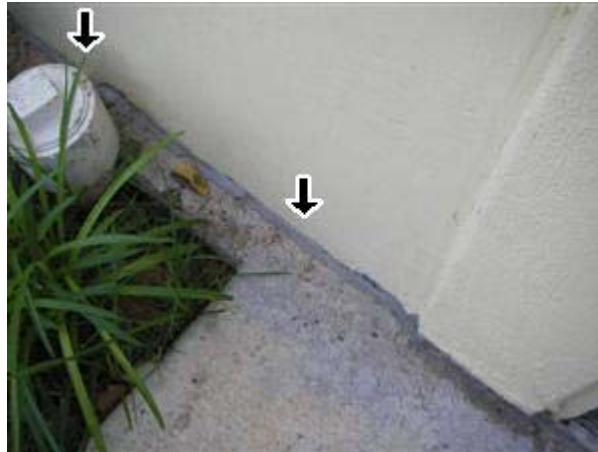
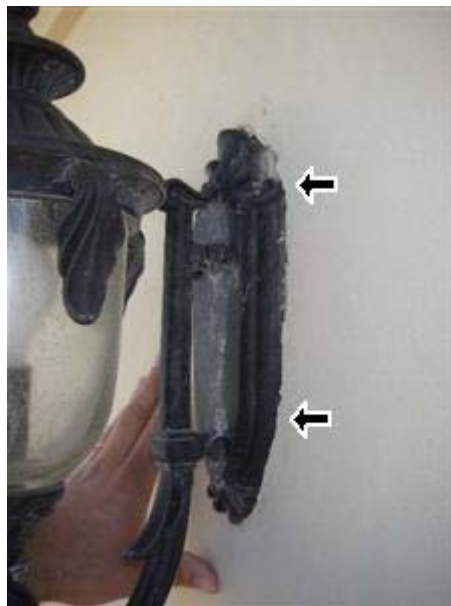
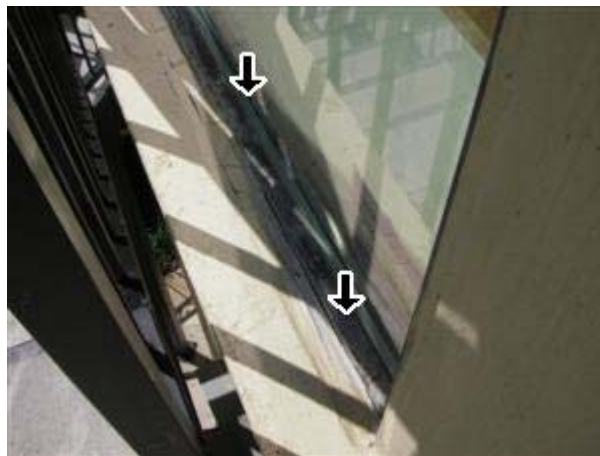
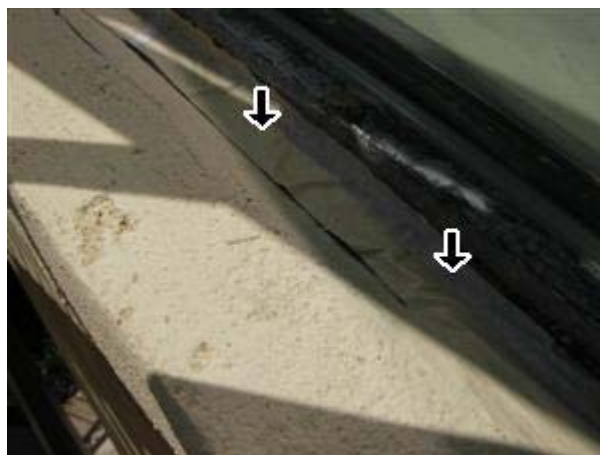
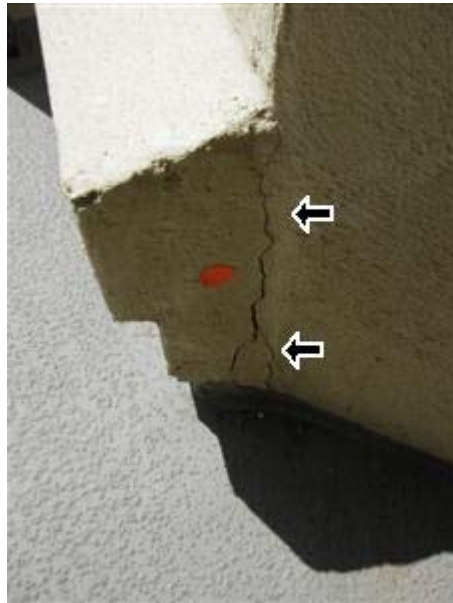
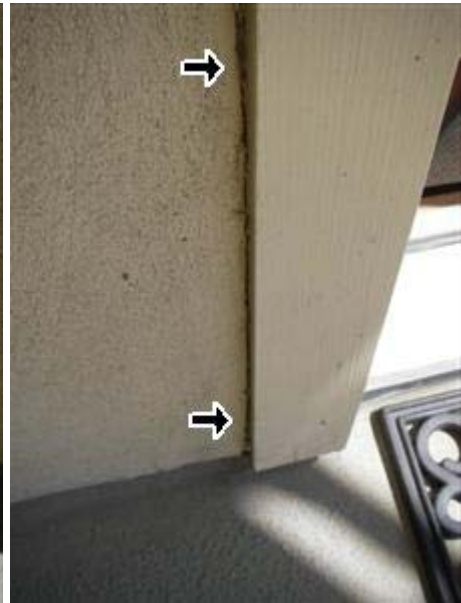
Comments: Noted stucco is unconventional installed and sealed at several points around the structure. Unconventional installation of other building materials (flashing, fixtures, handrails, etc.) noted at several points which has compromised moisture resistance of siding. Noted several points around structure where evidence of water intrusion was present. Stucco siding requires routine maintenance and inspection to prevent issues and realize potential life expectancy. Recommend qualified contractor further evaluate and make necessary repairs.

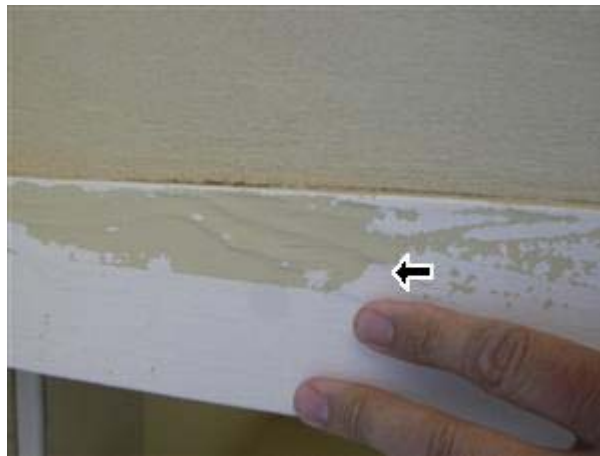
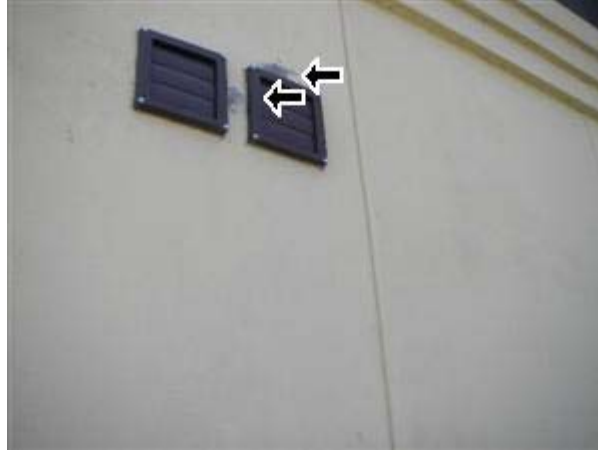
Noted paint on stucco is failing at several points around structure. Recommend qualified contractor evaluate and repair.

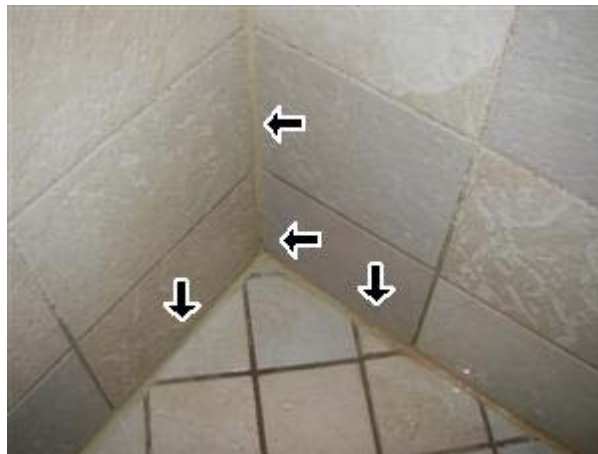
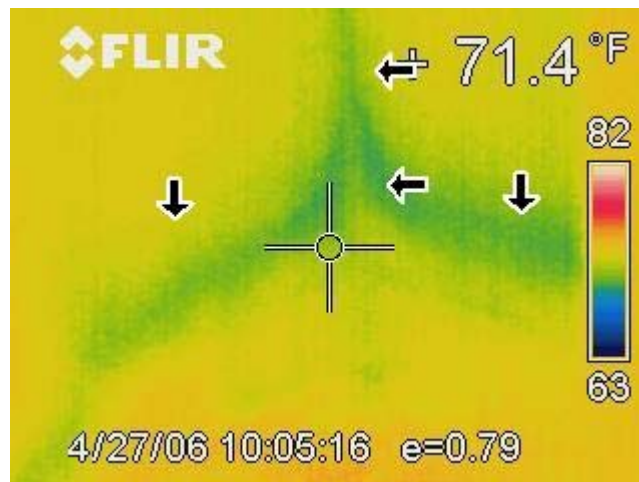
Noted grout at tile surround at master bathroom shower wall is deteriorated and needs repair or replace. Confirmed moisture intrusion to wall behind tiles of at least one foot to all sides of corner crack via thermal imaging. Recommend qualified contractor evaluate and repair.

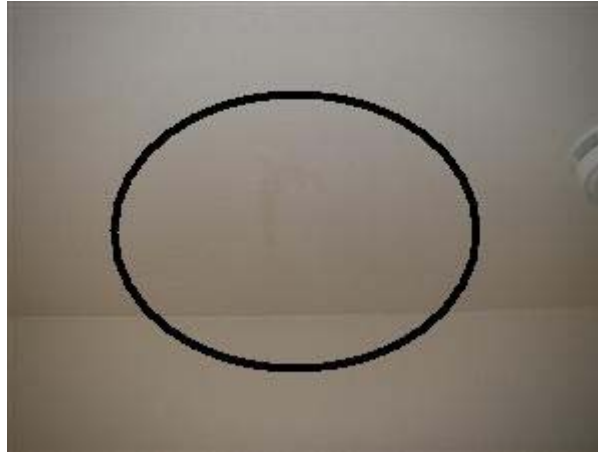
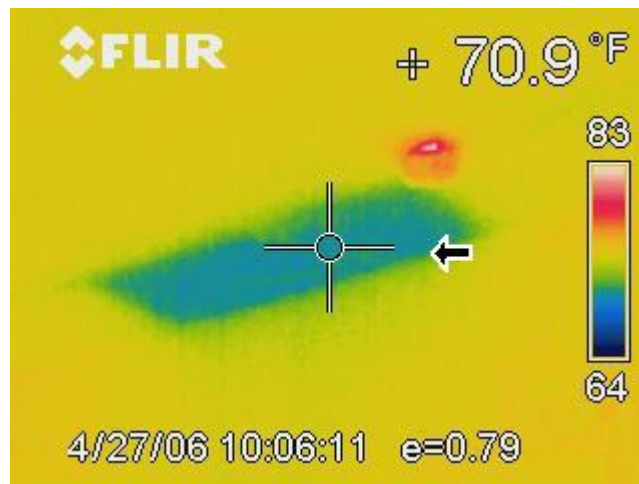
Comments: Moisture stains noted at point on ceiling at top of stair landing at the master bedroom area. Evidence of moisture intrusion confined via thermal imaging to cover approximately 4 X 5 foot area surrounding visual drywall evidence. Recommend qualified contractor evaluate and repair leaks and cosmetic issues.

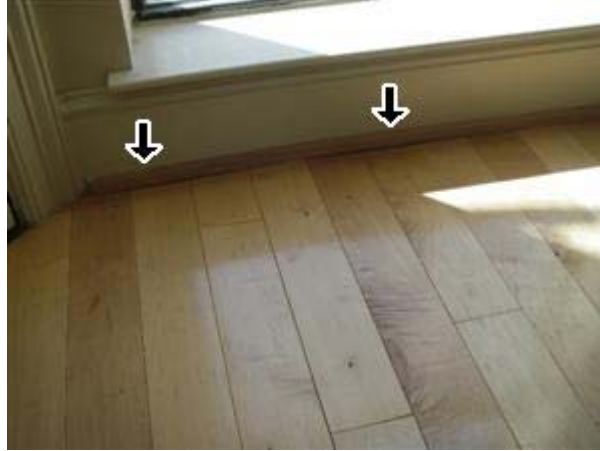
E. Picture 3

Noted unconventional rise in flooring at front entry area due to original construction. Recommend qualified contractor evaluate and repair.

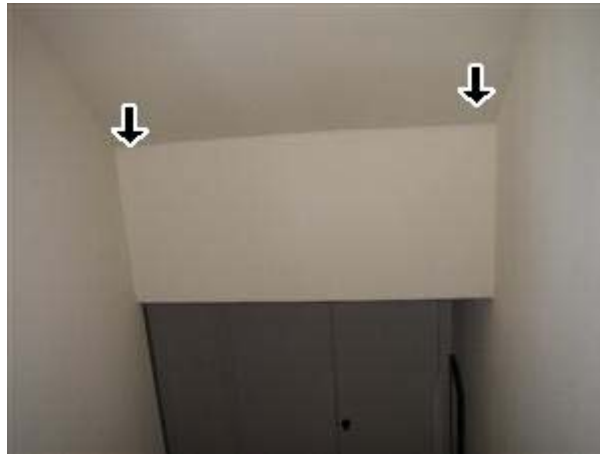
E. Picture 4

Noted unconventional tolerances of header over first to second floor stair case. Recommend qualified contractor evaluate and repair.

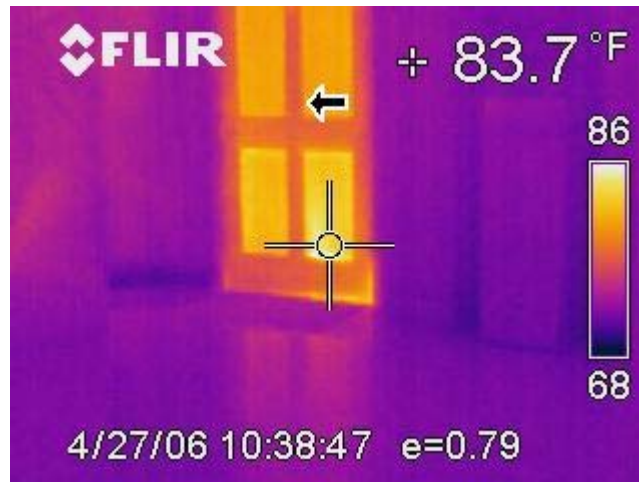
G. Picture 1

Comments: Noted main front door entrance inadequately insulated. Confirmed excessive loss via thermal imaging. Recommend qualified contractor evaluate and repair.

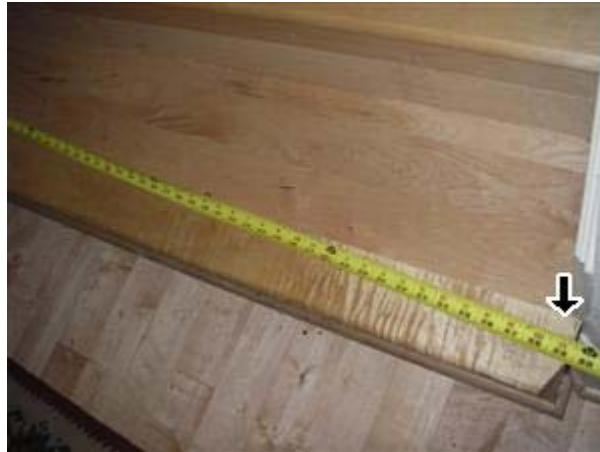
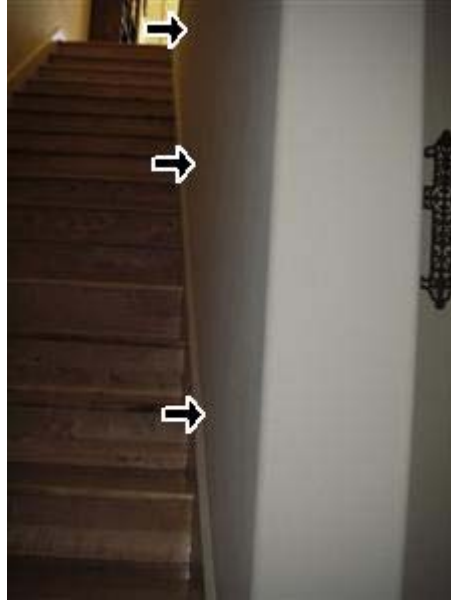
Comments: Handrails should be present on both sides of stairwells where stairs are 44 inches wide or wider. Recommend qualified contractor evaluate and repair.

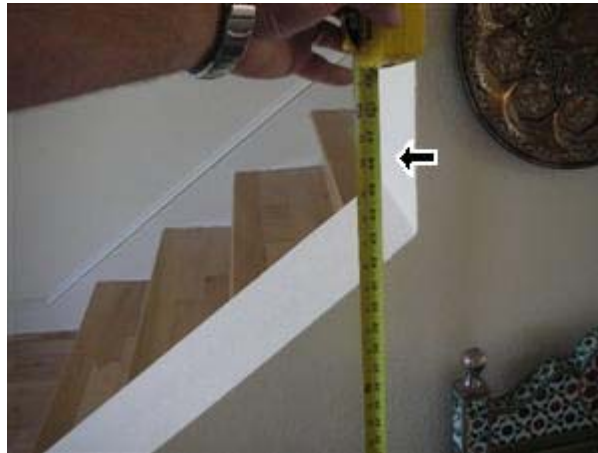
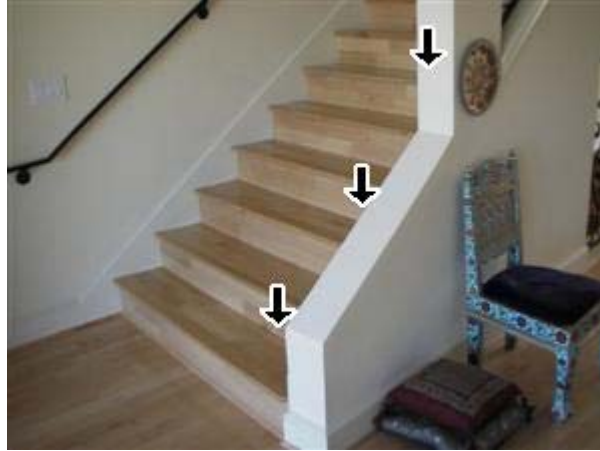
Guardrails should be present where elevations are higher than 30 inches from surface below. Guardrails should be a minimum of 36 inches high from floor. Openings (spindles, both horizontal and vertical) can be a maximum of 4 inches in diameter. These are safety issues by today's standards. Recommend qualified contractor evaluate and repair.

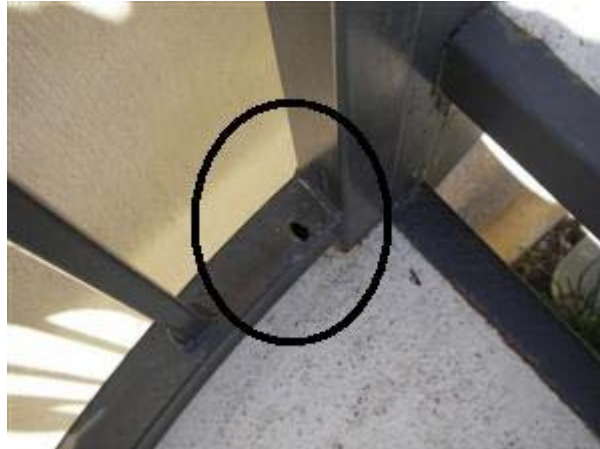
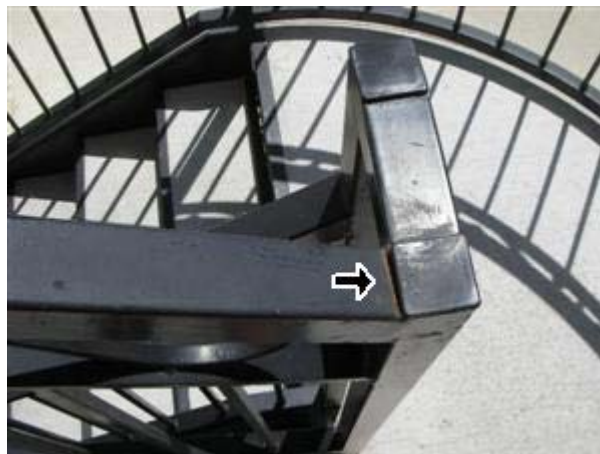
Noted several points where public iron guard/handrails seams are deteriorated which will allow element intrusion and premature failure. Recommend qualified contractor evaluate and repair.

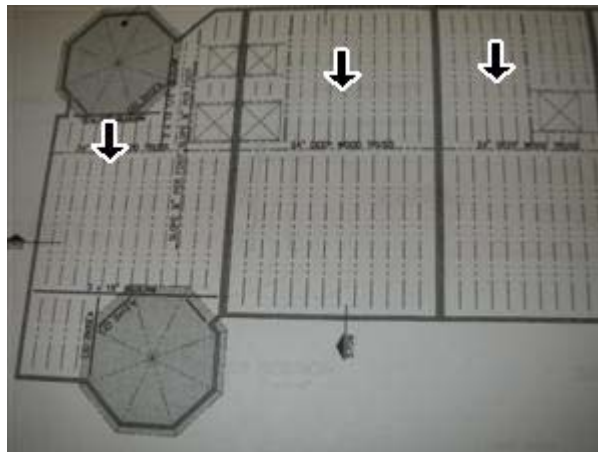
J. Picture 1

Comments: Per the architectural plans it appears that the roof mounted decks have been installed in an unconventional manner. It appears that the beam supports for the deck systems have been installed parallel to the roof truss system which would be considered unconventional to standard building practices. Recommend further evaluation by qualified contractor of structural integrity of roof mounted deck systems and there related effects on the roofing materials and the roof structure of the building.

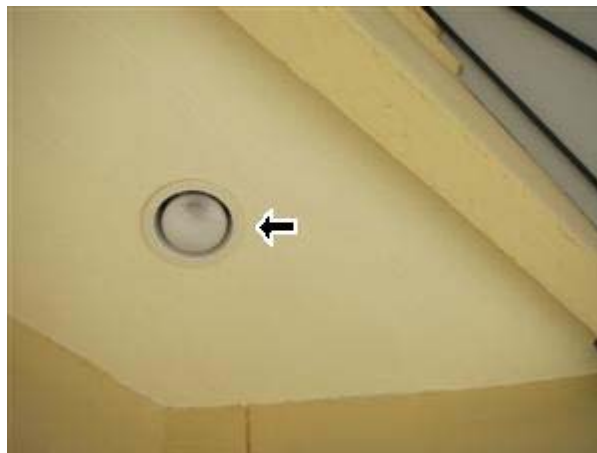
B. Picture 1

<i>Comments: Noted front porch light inoperable at time of inspection. Recommend licensed electrician evaluate and repair.</i> |

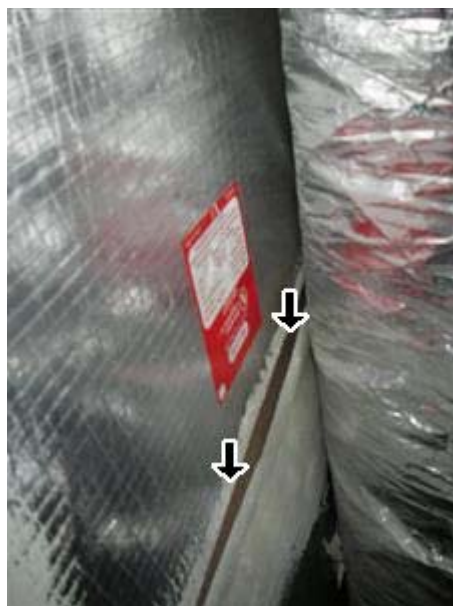
B. Picture 1

I	NI	NP	R	Inspection Items
III. HEATING, VENTILATION, AND AIR CONDITIONING SYSTEMS				
<input checked="" type="checkbox"/>	<input type="checkbox"/>	<input type="checkbox"/>	<input type="checkbox"/>	A. HEATING EQUIPMENT HEAT TYPE: FORCED AIR ENERGY SOURCE: ELECTRIC NUMBER OF HEAT SYSTEMS (excluding wood): THREE COOLING EQUIPMENT TYPE: AIR CONDITIONER UNIT COOLING EQUIPMENT ENERGY SOURCE: ELECTRICITY NUMBER OF A/C UNITS: THREE DUCTWORK: INSULATED FILTER TYPE: DISPOSABLE <i>Comments:</i>
<input checked="" type="checkbox"/>	<input type="checkbox"/>	<input type="checkbox"/>	<input checked="" type="checkbox"/>	B. COOLING EQUIPMENT <i>Comments: Noted plenum in need of additional sealing to ground floor (garage mounted) HVAC unit. Recommend qualified HVAC technician evaluate and repair.</i>

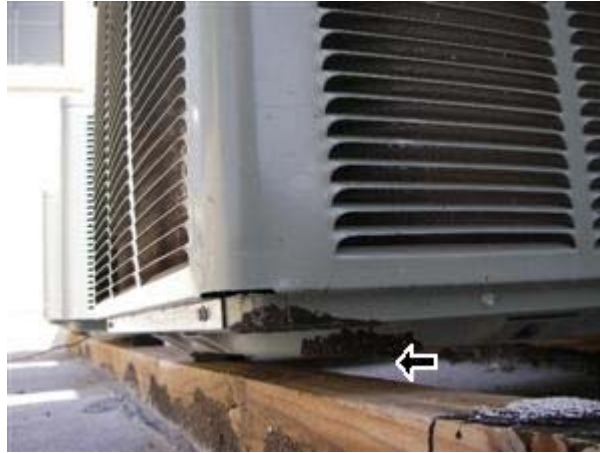
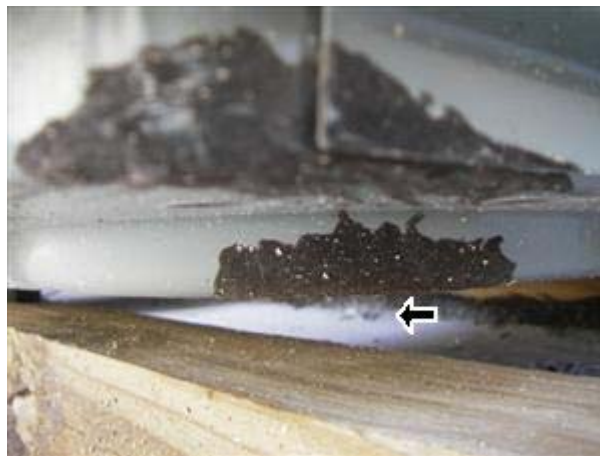
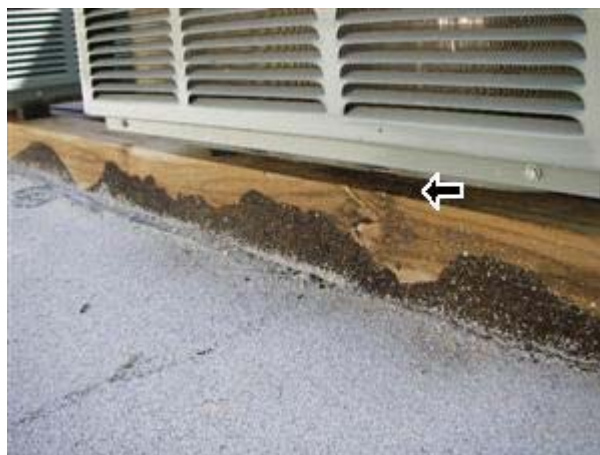
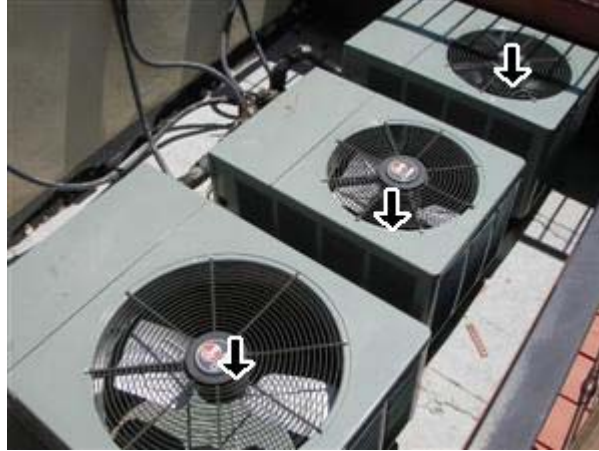
Noted roof mounted compressors excessively noisy at time of inspection. This appears to be due to rubber spacers missing due to unit vibration and lack of securing to pedestal boards and compressor units. Recommend qualified HVAC technician evaluate and repair.

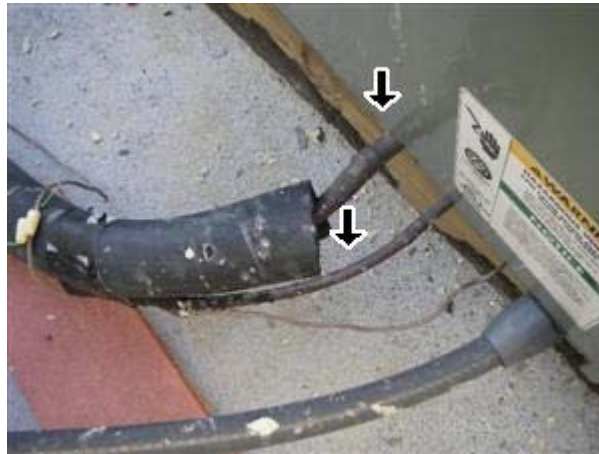
B. Picture 6

Noted compressor line insulation deteriorated or missing at several points. Recommend qualified HVAC technician evaluate and repair.

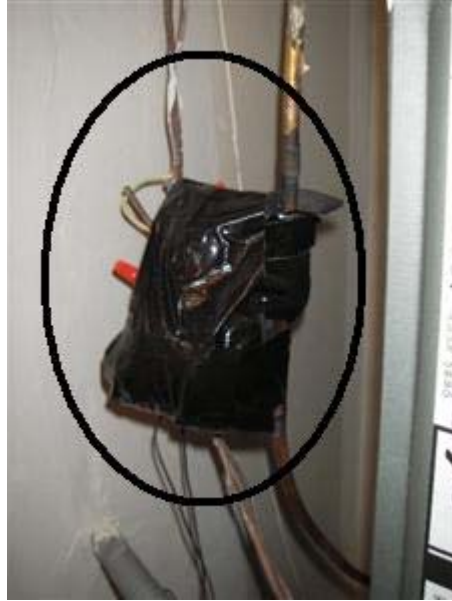
B. Picture 7

Noted unconventional and abandoned apparatus installed at second floor HVAC equipment which is still energized and needs to be permanently removed. Recommend qualified HVAC technician evaluate and repair.

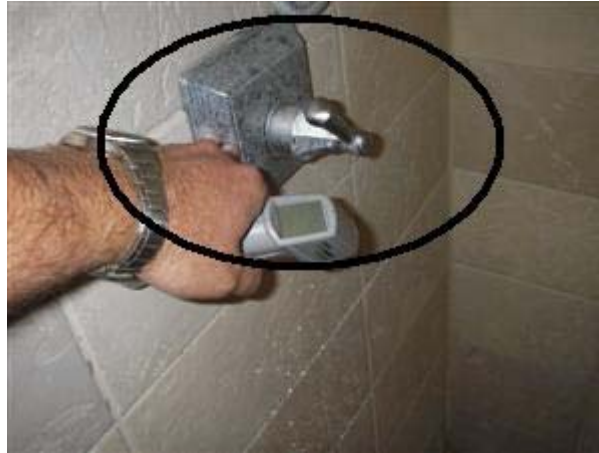
A. Picture 1

Comments: Noted hot and cold reversed per indicators (none) at master bedroom shower fixture. Recommend licensed plumber evaluate and repair.

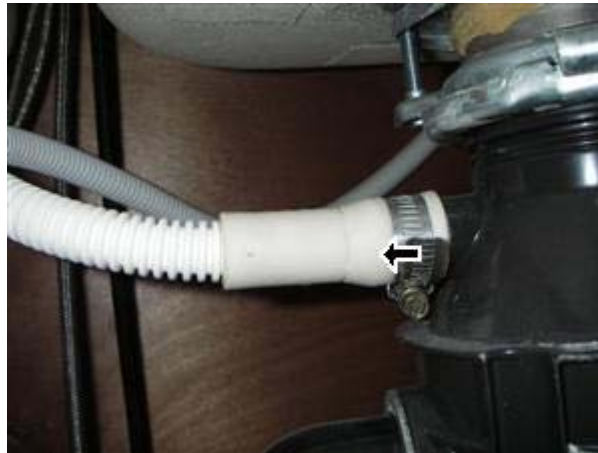
A. Picture 1

Comments: Noted lack of visible anti back-flow device. This is a concern by today's standards. Recommend qualified service technician evaluate and repair.

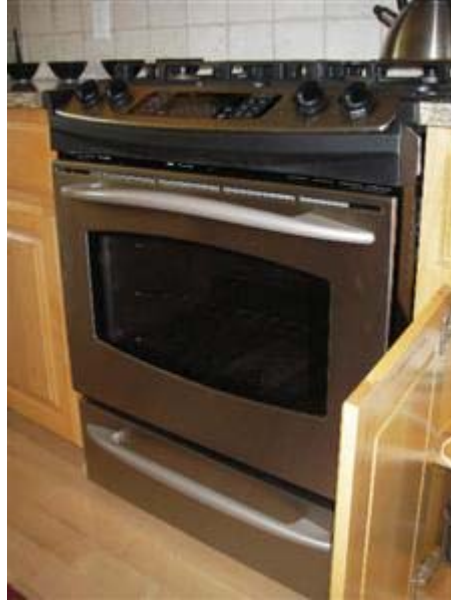
D. Picture 1

Comments: Gas shut-off valve difficult to get to. This is a concern in the event of an emergency and the need for quick access to turn off supply. Recommend qualified service technician evaluate and repair.

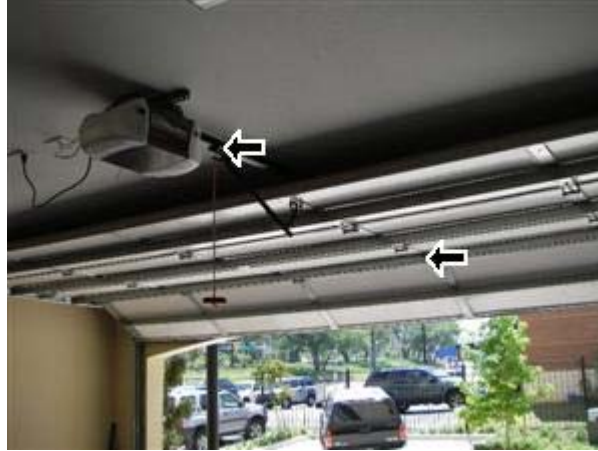
H. Picture 1

Comments: Garage door opener track appears to be inadequately supported (bowing and rubbing ceiling). Opener unit appears to be undersized for weight and size of garage door. Recommend qualified contractor evaluate and repair.
