# Inspection Report

**Property Address:**  
123 Your Street  
Anywhere Tx 00000

# PROPERTY INSPECTION REPORT

**By:** Ralph "Pat" Standefer TREC # 10500 / National Property Inspections 12/7/2011  
\_\_\_\_\_  
(Name and License Number of Inspector) (Date)  
\_\_\_\_\_  
(Name, License Number and Signature of Sponsoring Inspector, if required)

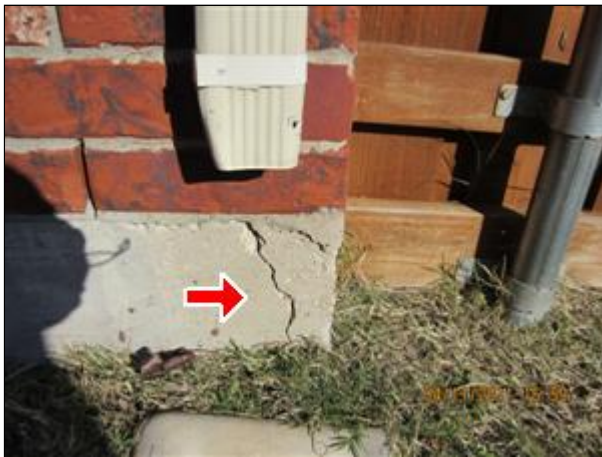
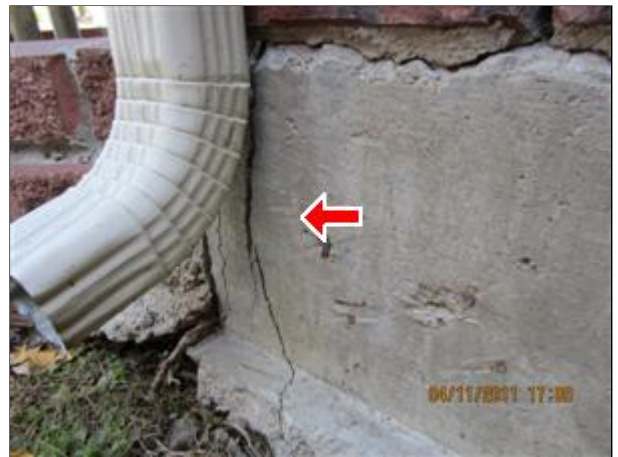
A. Picture 1 Corner Crack

A. Picture 4 Corner crack

The foundation appears in good condition and functioning as intended at the time of the inspection. I did find two common corner cracks at the front right corner and the back right corner. Corner cracks are common, usually only cosmetic in nature and usually does not affect the foundation structure of the house. Corner cracks occur from the inability to reinforce the corners of the slab as well as the rest of the foundation. The corner cracks can be repaired if desired by filling the cracks with a concrete patch.

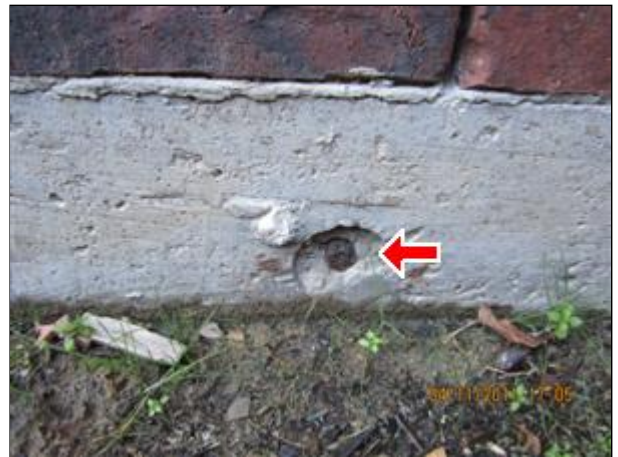
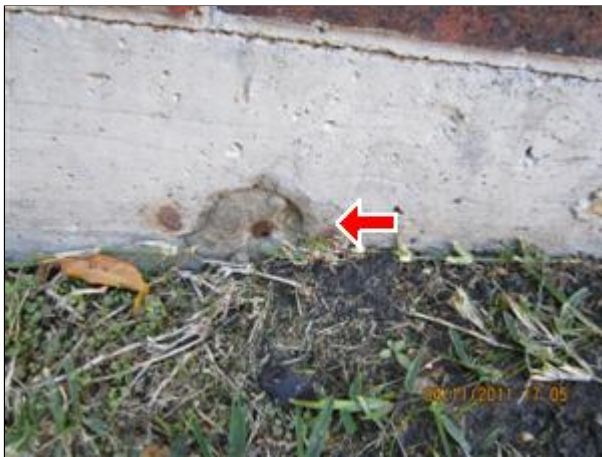
A. Picture 2 Cable end exposed

A. Picture 3 Cable end exposed

I found exposed cable ends around the foundation on the left side and front side of the house. Post tension cables are used as reinforcing material for the foundation. The exposed ends of the cables are usually patched with concrete after the foundation is poured to keep the cable ends from rusting. Several cable end were left exposed and should be patched with a concrete patch to keep cable ends from rusting.

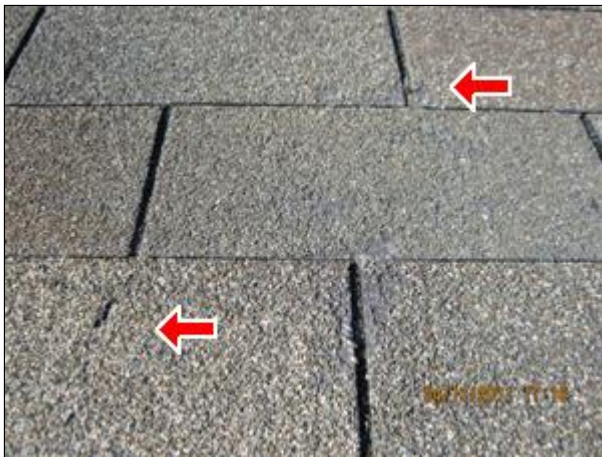
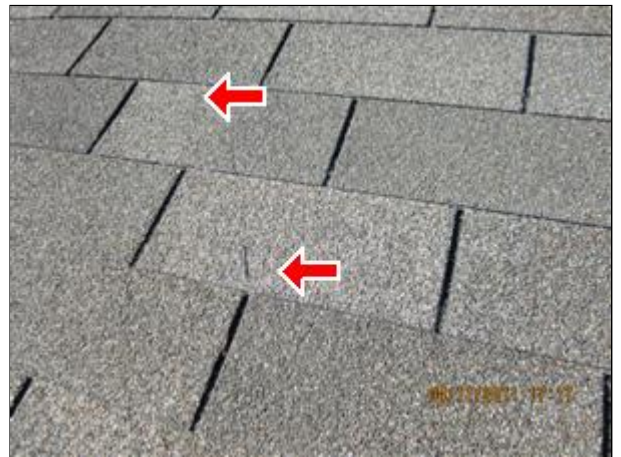
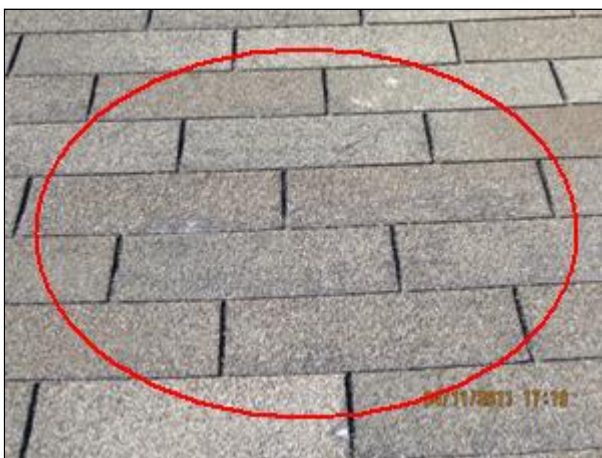
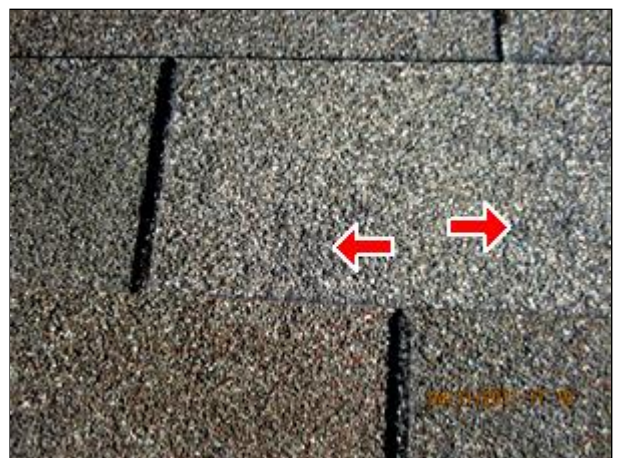
C. Picture 1 Light hail damage

C. Picture 2 Granules have come off at the edges

C. Picture 3 Hail damage and lost granules

C. Picture 4 Light hail damage

The roof covering is the original roof covering when the house was built in 2001. The roof covering is ten years old and shows signs of wear from exposure to the elements. There appears to be some light hail damage to the roof and the granules are starting to come off around the edges of the shingles. I would

The roof covering is the original roof covering when the house was built in 2001. The roof covering is ten years old and shows signs of wear from exposure to the elements. There appears to be some light hail damage to the roof and the granules are starting to come off around the edges of the shingles. I would recommend further evaluation from a qualified roofing contractor or insurance adjuster on the damage on the roof covering.

recommend further evaluation from a qualified roofing contractor or insurance adjuster on the damage on the roof covering.

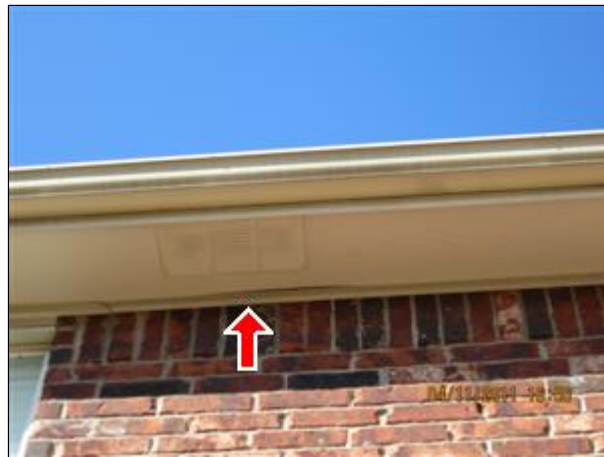
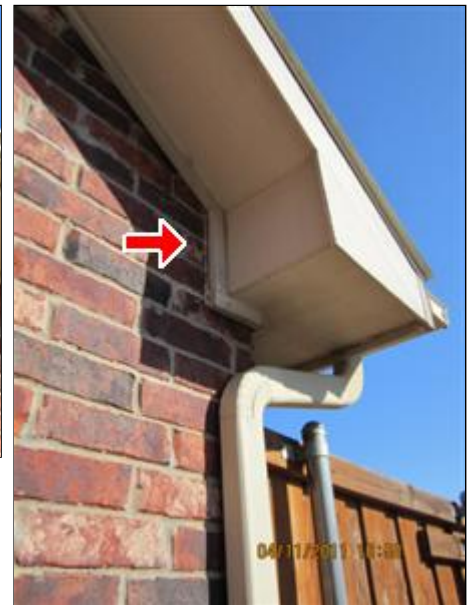
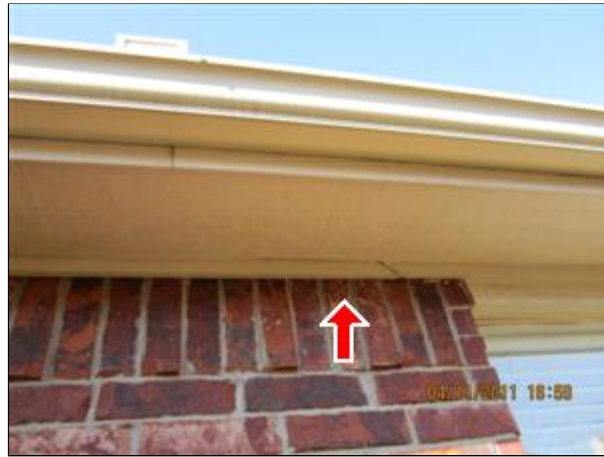
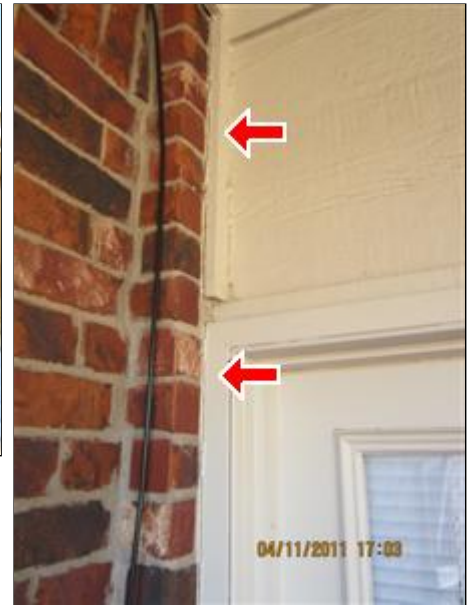
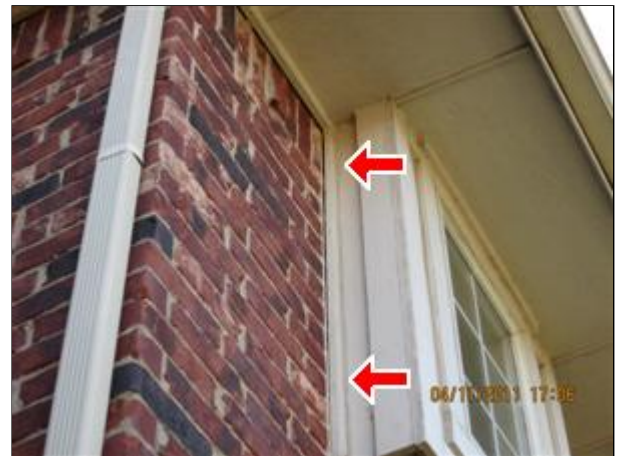
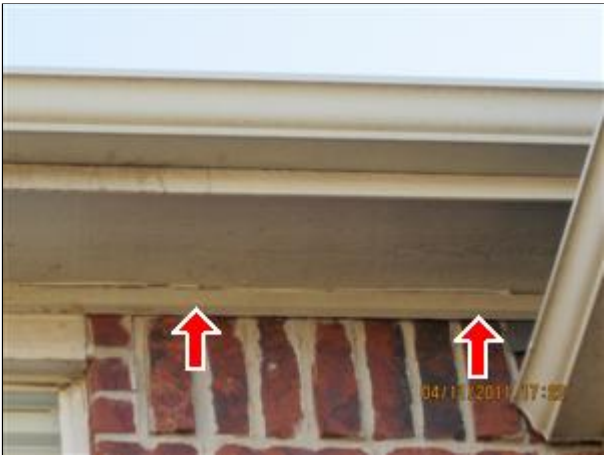
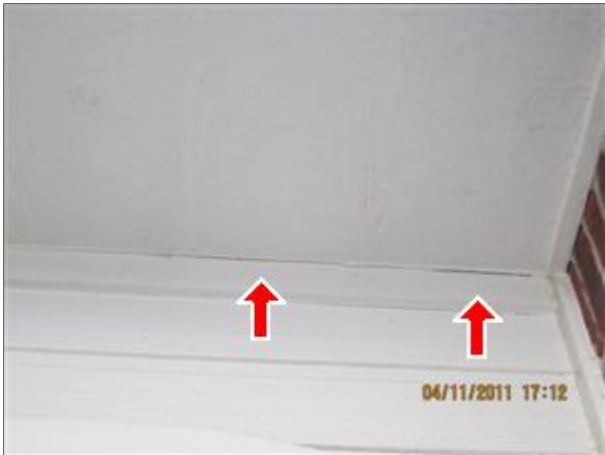
E. Picture 1 Sealant separation

E. Picture 2 Sealant separation

E. Picture 3 Sealant separation

E. Picture 4 Sealant separation

E. Picture 6 Sealant separation

E. Picture 7 Sealant separation

E. Picture 8 Sealant separation

Several areas around the exterior of the house where I found sealant separation at the joints in the siding and trim. It is important to seal the joints in the siding and trim, around windows and exterior doors, to prevent moisture penetration and damage from moisture. I would recommend applying new sealant to fill the cracks at the joints in the siding and trim where necessary around the exterior of the house to prevent moisture from penetrating.

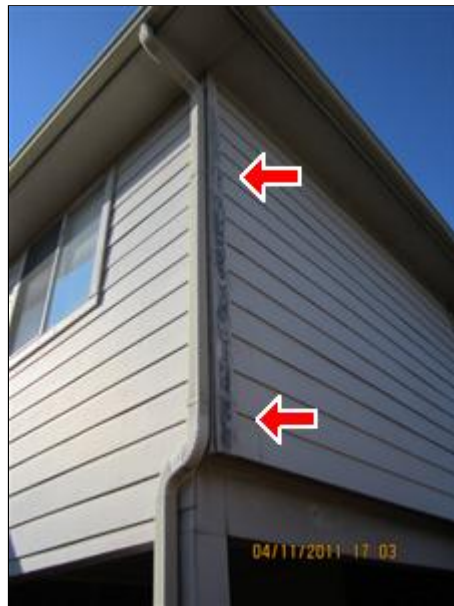
E. Picture 5 Paint peeling and sealant separation

I noticed paint peeling on trim around the chimney, along the vertical trim at the back left corner, and around windows in front of the house. It is important to keep trim sealed and painted as routine maintenance of the home to prevent damage to siding and trim.

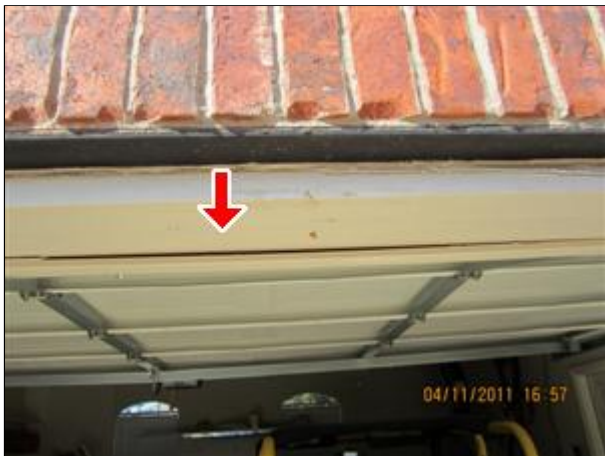
E. Picture 9 Wood trim coming loose

Wood trim at the top of the garage door frame is coming loose. I would recommend re-nailing the loose trim at the top of the garage door.

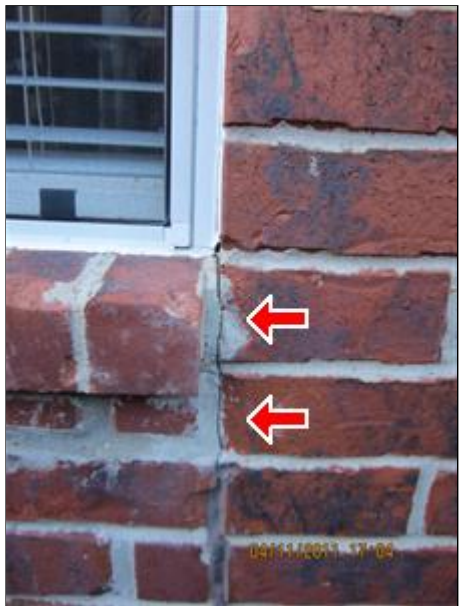
E. Picture 10 Hairline crack above expansion joint

There is a hairline crack in the brick mortar on the right side of the window ledge on the right side of the house. The expansion joint in the brick is just below the crack in the mortar. The crack is possibly caused from slight movement in the brick from expanding or settlement. I would recommend sealing the crack with a sealant similar to what was used in the expansion joint in the bricks.

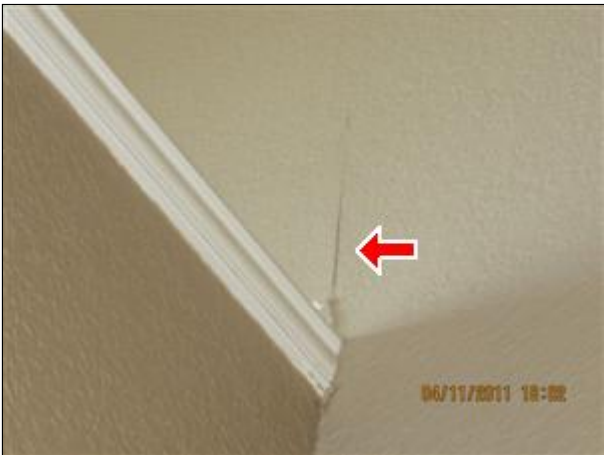
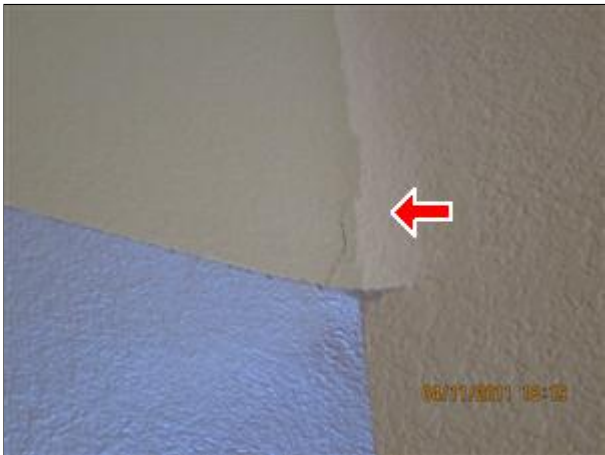
E. Picture 11 Crack in wall above front entry

E. Picture 12 Crack in wall at kitchen/living room

Inside the house I noticed two cracks in the walls. There is a crack in the wall above the front entrance, and a crack in the wall in the living room by the kitchen. The cracks in the walls are possibly caused from settling in the upstairs portion of the house. I would recommend repairs to the cracks by a qualified contractor.

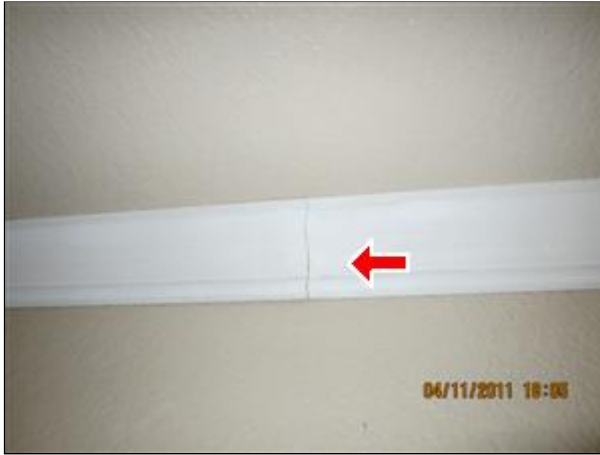
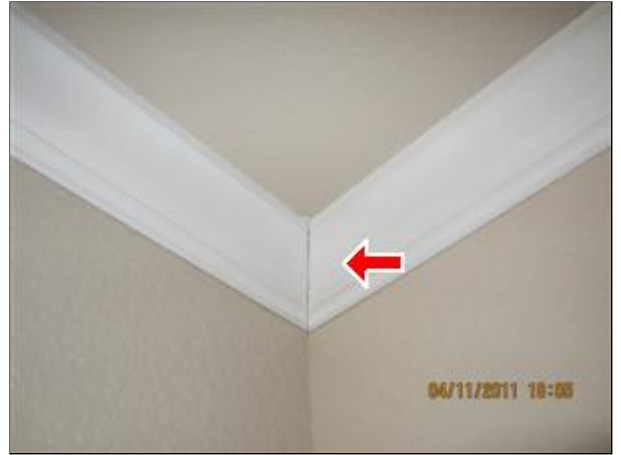
E. Picture 13 Sealant separation at joints in crown mold

E. Picture 14 Sealant separation at corner joints in crown mold

In the formal dining room there is sealant separation in the joints of the crown molding. I would recommend applying new sealant to the cracks in the joints of the crown molding.

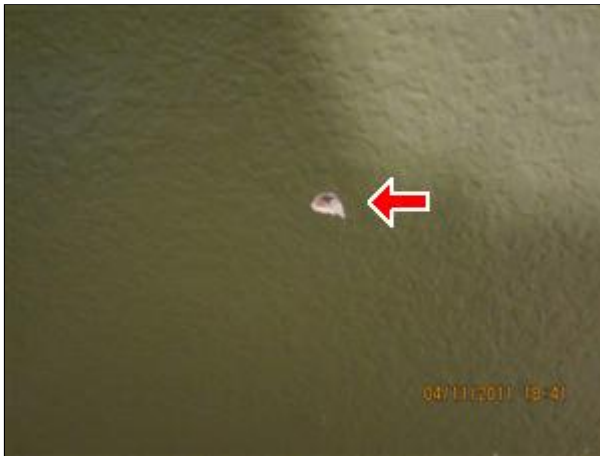
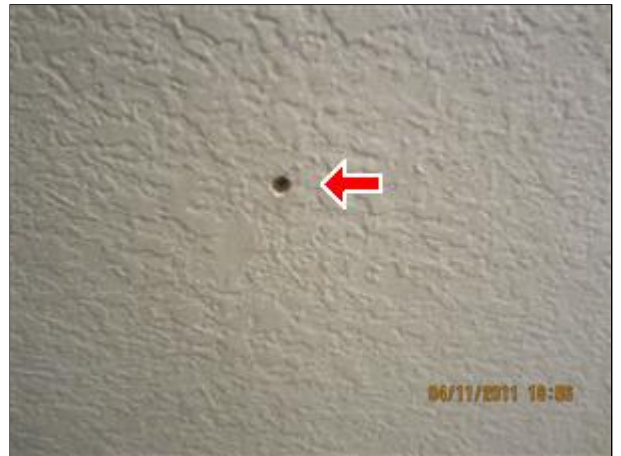
E. Picture 15 Hole in wall

E. Picture 16 Nail pop at stair well

I noticed a nail pop in the wall in the stairwell and a hole in the wall in the green bedroom upstairs. I recommend repairs to the nail pop and hole in the green bedroom.

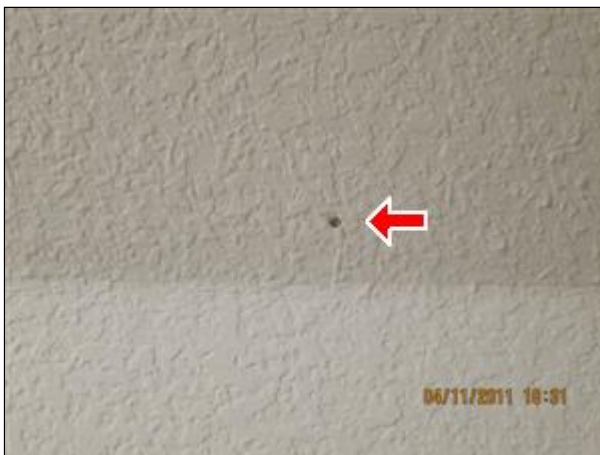
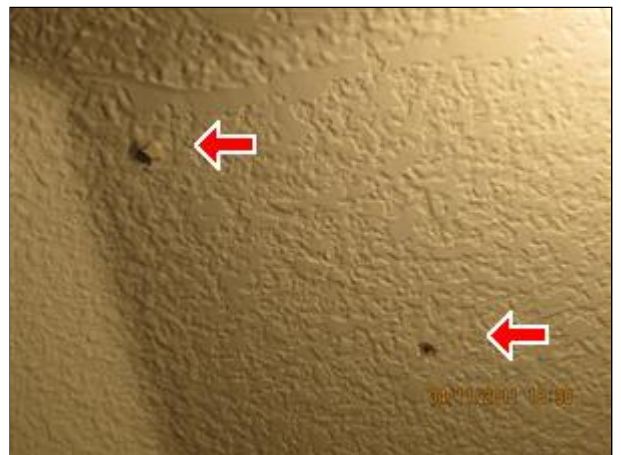
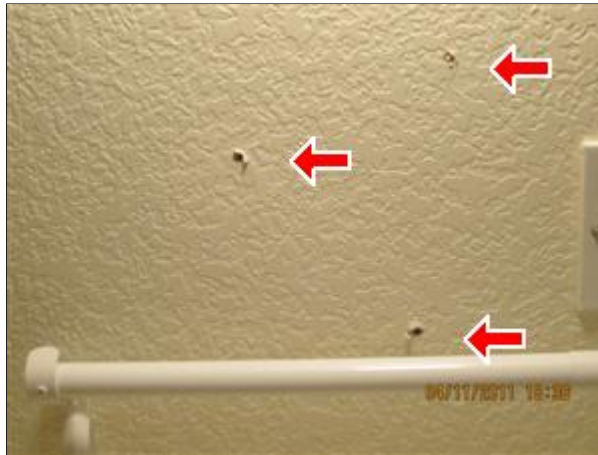
F. Picture 1 Nail pop in ceiling master bedroom

F. Picture 2 Nail pops in master closet

F. Picture 3 Nail pops in master closet

I found nail pops in the ceiling of the master bedroom and the master closet ceiling. I would recommend repairs to the nail pops in the ceilings.

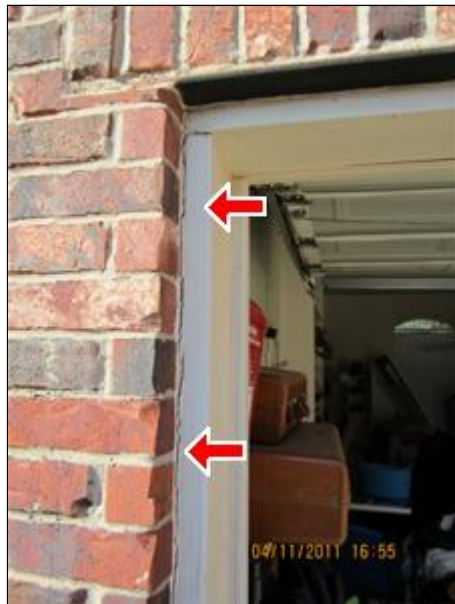
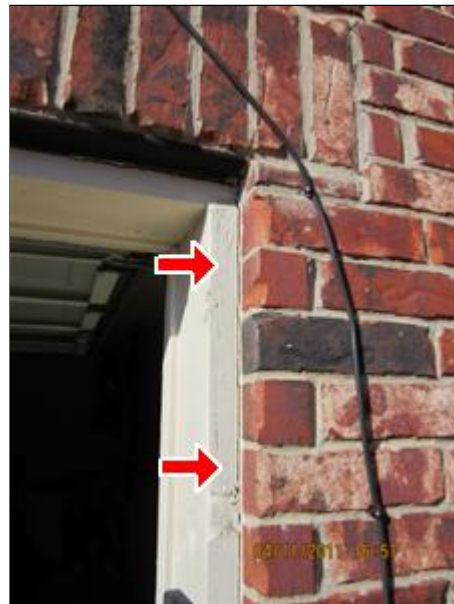
G. Picture 1 Sealant separation

G. Picture 2 Sealant separation

Sealant is cracked or separated around the garage door frame along the sides next to the brick. I would recommend filling the cracks with new sealant to prevent moisture from penetrating and causing damage to the wood door frame of the garage.

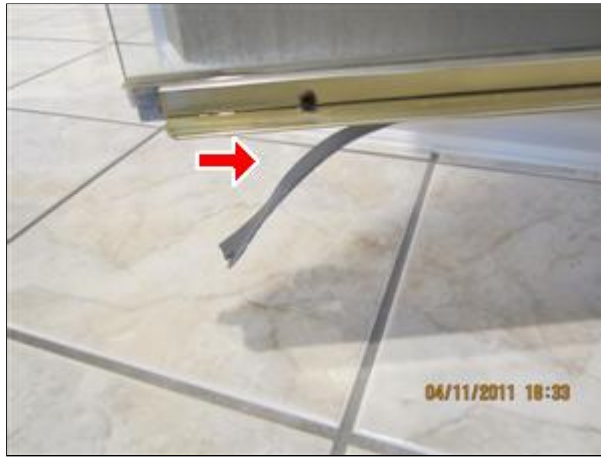
G. Picture 3 Rubber gasket torn on master shower door

I noticed the rubber gasket under the shower door in the master bedroom is torn. I would recommend repairs or replacing the rubber gasket to prevent leaking around the bottom of the shower door.

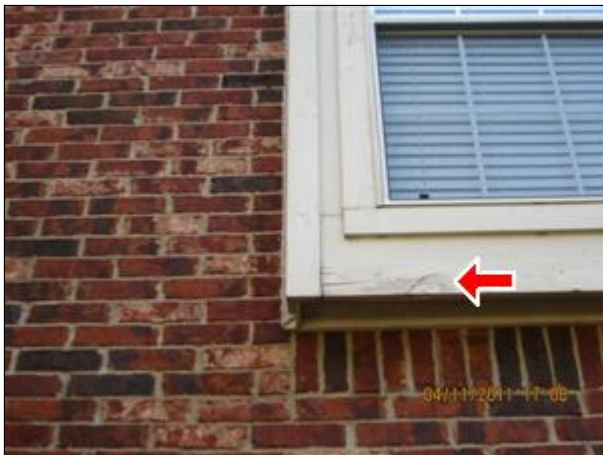
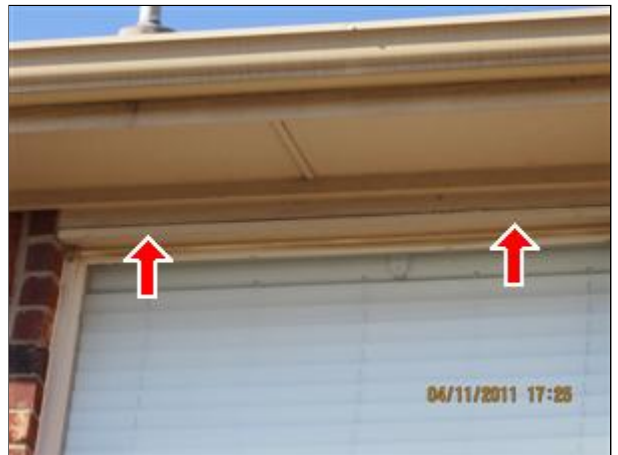
H. Picture 1 Paint peeling and sealant separation

H. Picture 2 Sealant separation

I noticed sealant separation and paint peeling on trim around windows in front of the house. Sealant has separated at the top of windows in the back of the house as well. Moisture can penetrate through cracks in the siding and trim and cause damage if not sealed properly. I would recommend applying new sealant to cracks in the trim around windows where it is necessary to prevent moisture penetration.

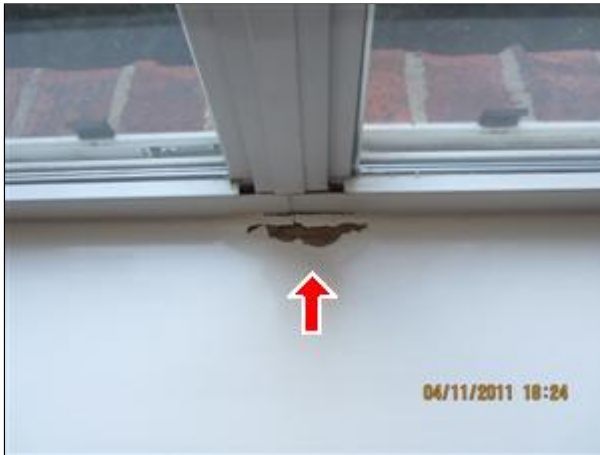
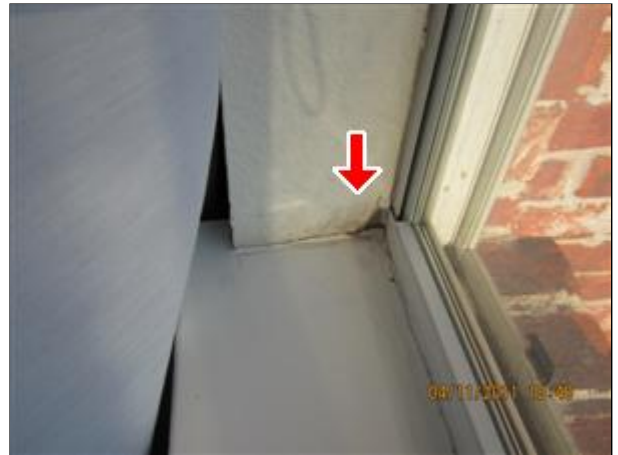
H. Picture 3 Moisture damage to window sill

H. Picture 4 Moisture damage to inside window

I found moisture damage to the window sill in the formal dining room. The paint is peeling on top of the window sill due to condensation moisture from the windows. I would recommend repairs to the damage to the window sill. I noticed slight moisture damage to the left side of the window in the master bedroom possibly caused from condensation of the windows. I would recommend repairs to this area as well.

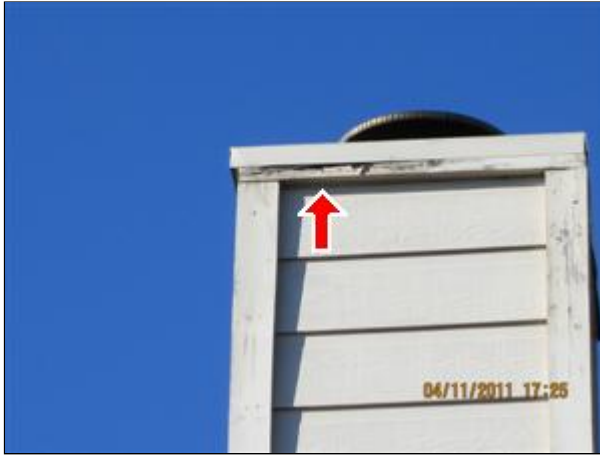
J. Picture 1 Paint peeling on wood trim

The paint is peeling on wood trim around the chimney. The wood trim should be kept sealed and painted to prevent damage from moisture and weather. I would recommend repairs/re-paint the wood trim around the chimney.

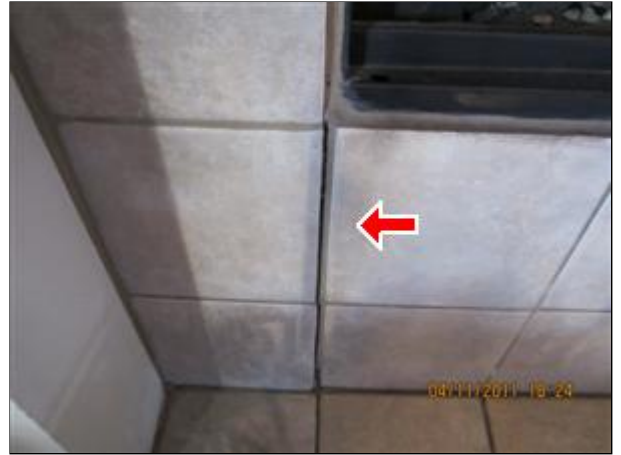
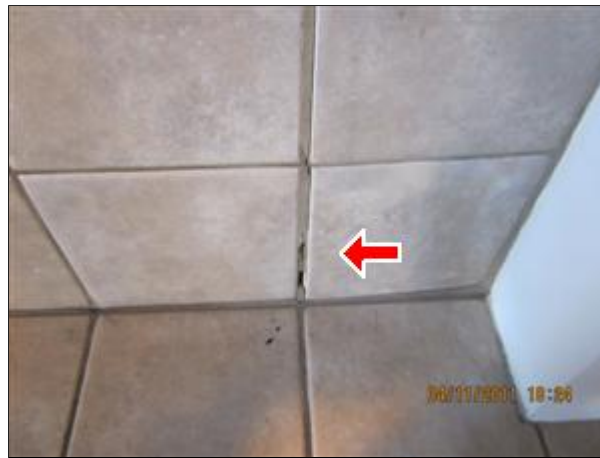
J. Picture 2 Grout cracking in tile

J. Picture 3 Grout cracking in tile

Inside the house I noticed cracks in the grout in the tiles around the fireplace. I would recommend filling the cracks in the grout with new grout.

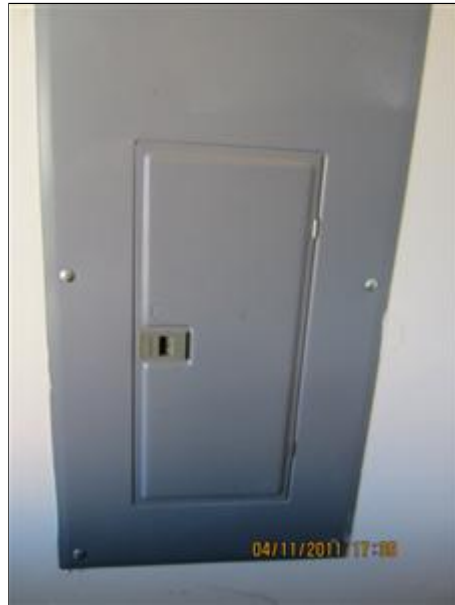
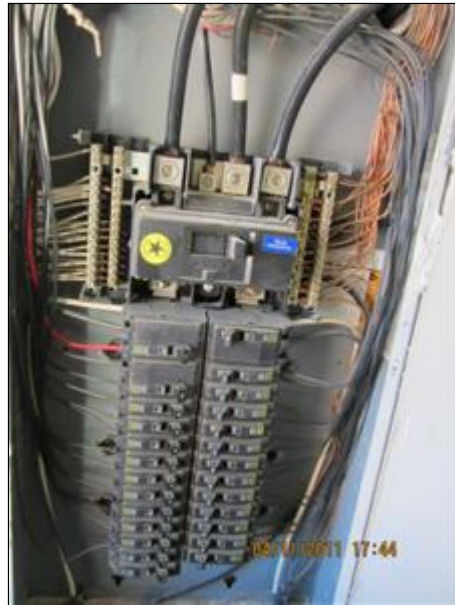
A. Picture 1 Electrical panel

A. Picture 2 Electrical panel

The electrical panel appears in good condition and functioning as intended at the time of the inspection.

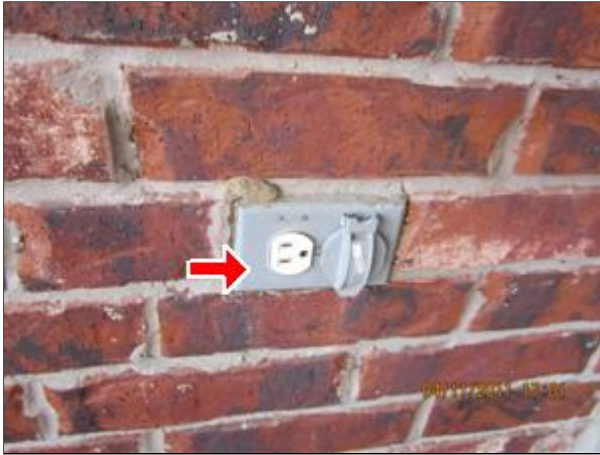
B. Picture 1 Exterior outlet missing cover

The exterior electrical outlet on the back porch is missing the weather proof cover on one side of the outlet. I would recommend repairs or replace the cover to the outlet.

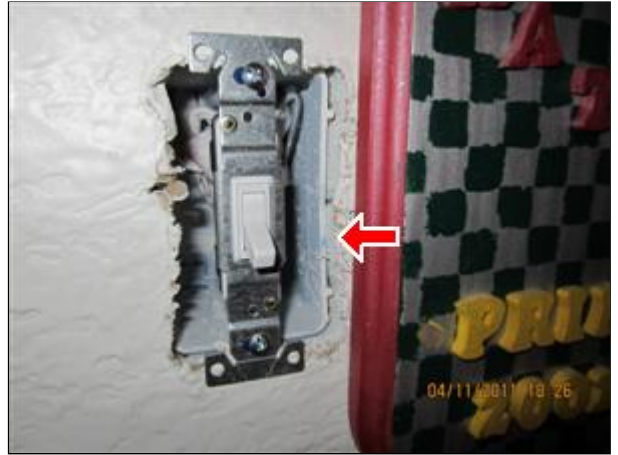
B. Picture 2 Switch cover plate missing

The light switch to the closet under the stairs is missing the switch cover plate. I would recommend replacing the switch cover plate.

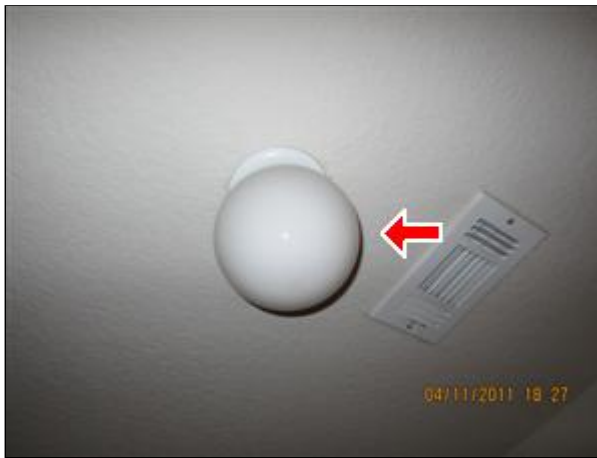
B. Picture 3 Fixture not working

Several light fixtures did not work during the inspection. The light fixtures at the front porch and in the laundry room did not work. I believe the bulbs could be burned out at the fixtures.

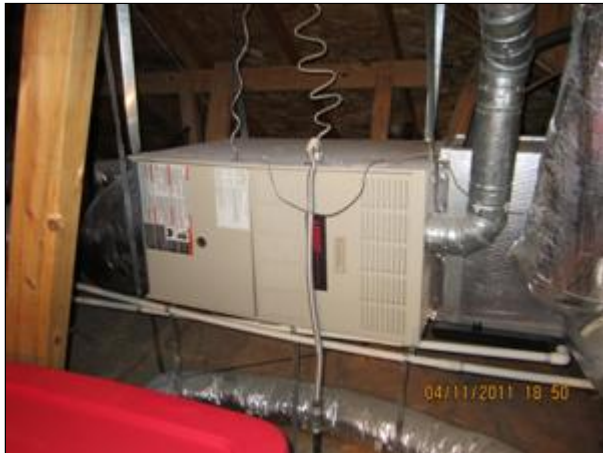
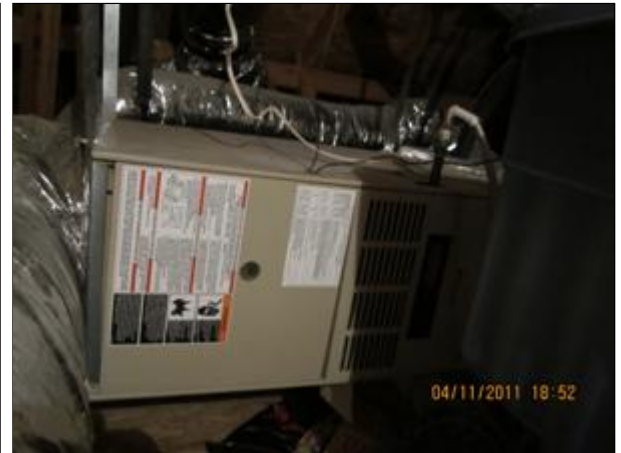
A. Picture 1 Heating equipment

A. Picture 2 Heating equipment

The heating equipment appears in good condition and functioning as intended at the time of the inspection.

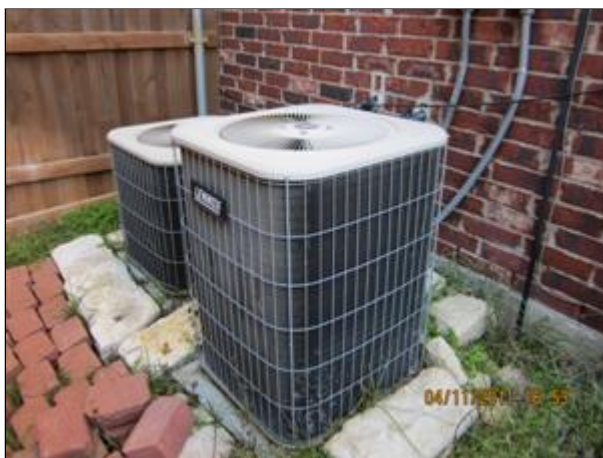
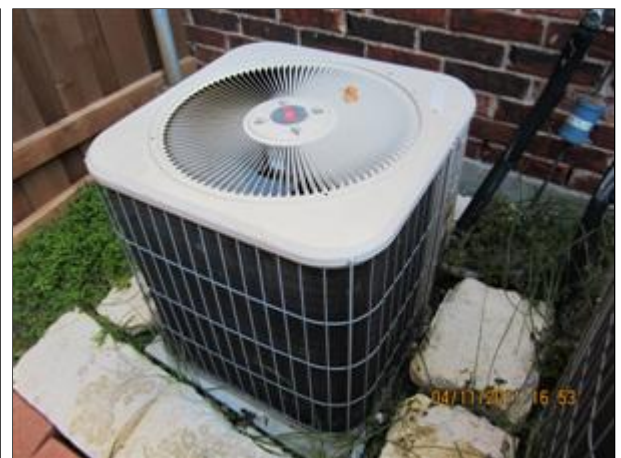
B. Picture 1 Condensing units

B. Picture 2 Condensing units

The cooling equipment was visually inspected but not tested during the inspection because the outside temperature was below 65 degrees.

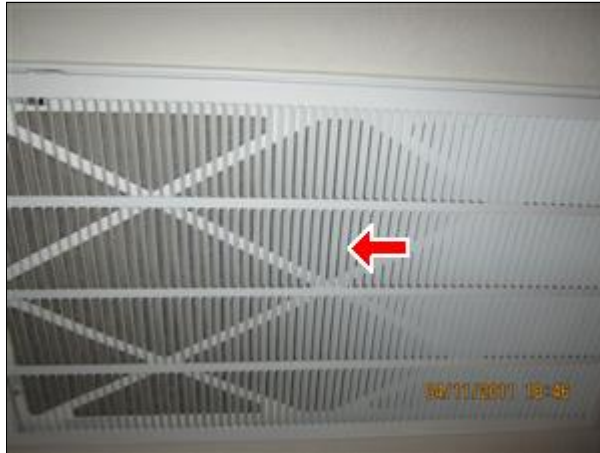
C. Picture 1 Filter extremely dirty

The filter in the return air for the upstairs unit is extremely dirty. I would recommend replacing the filter to the upstairs HVAC.

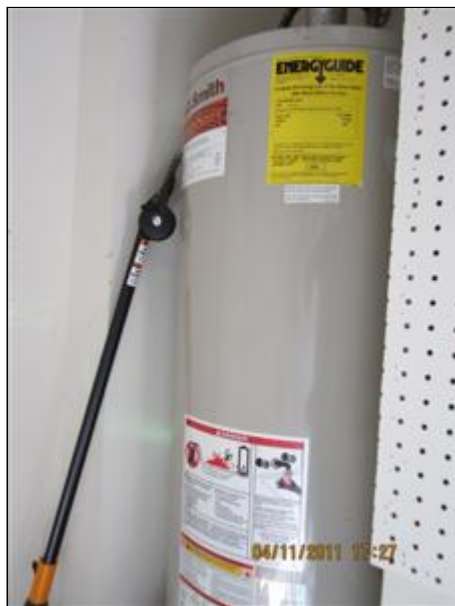
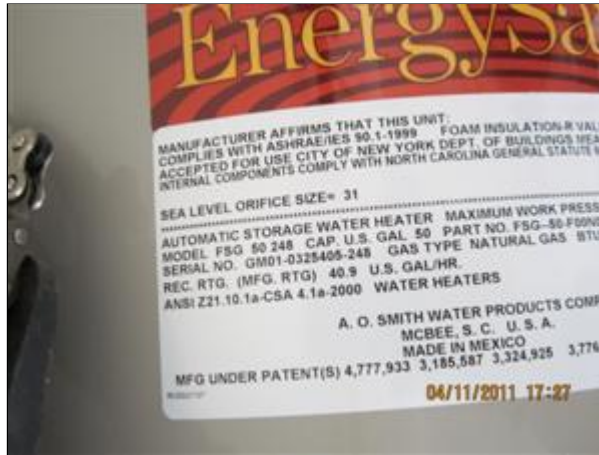
C. Picture 1 Water heater

C. Picture 3 Manufactured in 2001

The water heater appears in good condition and functioning as intended at the time of the inspection. The water heater was manufactured in 2001.

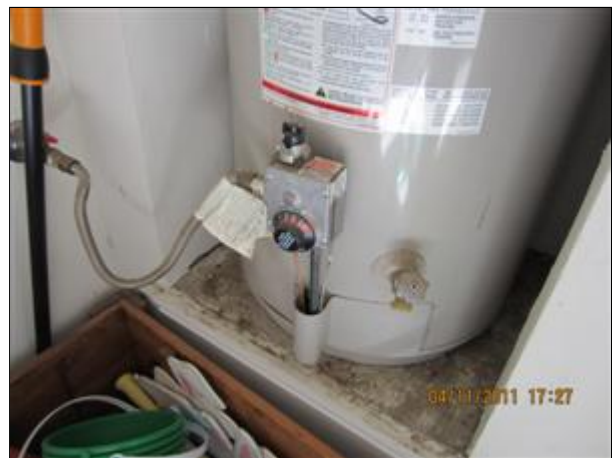
C. Picture 2 No pan under the tank

The water heater does not have a pan under the tank. Today's building standards and city code may require a pan with a drain to the outside under the tank of the water heater to meet code when the water heater has to be replaced. When this water heater was installed in 2001, it did not require a pan under the tank as long as the unit was mounted in the garage and not inside the living area of the house.

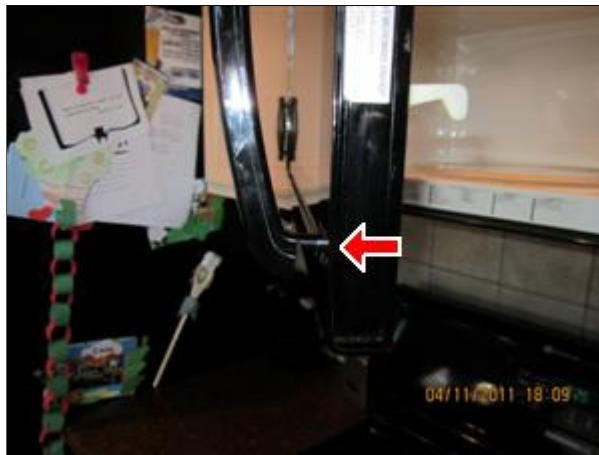
E. Picture 1 Handle broken on microwave

The handle is broken on the microwave. I would recommend repairs or replace the handle to the microwave.

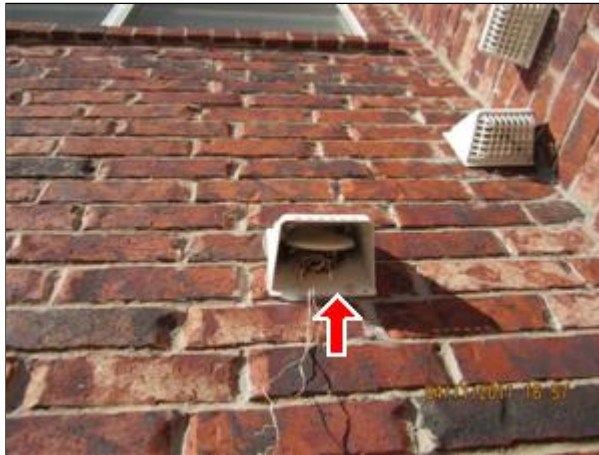
J. Picture 1 Dryer vent has birds nest inside

The dryer vent has a birds nest inside the vent. I would recommend removing the birds nest and cleaning out the vent to where the dryer can vent properly to the outside of the house.
