PROPERTY CONDITION REPORT

Client(s): Client of NPI
Property Address: Goodyear, AZ
Realtor: Keller Williams
Date: 10/02/06
Inspector: Peter Zipp III
Report #: P100203-06BW

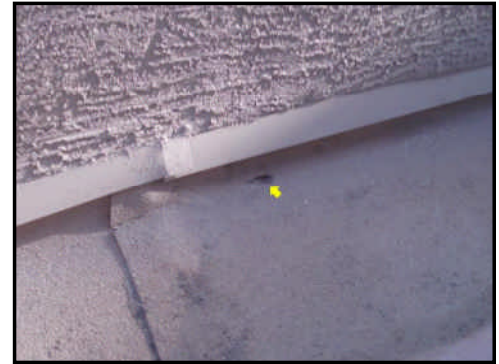
Repair: The membrane of the roll roofing over the patio is punctured.

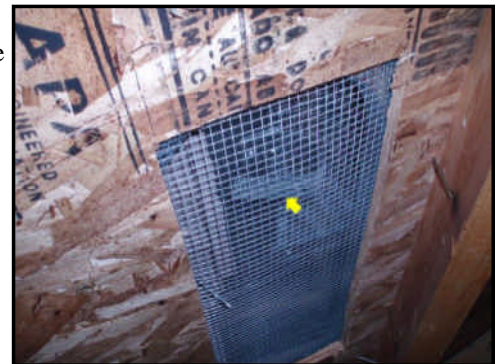
Repair: One or more of the attic roof vents are not installed according to the manufacturers specs. Specifically, the wind clip was either never bent under the preceding course of tiles or the clip was bent, but it is not under the preceding course of tiles, but on top of the tile. The installation of all of the roof vents should be evaluated and the necessary corrections made.

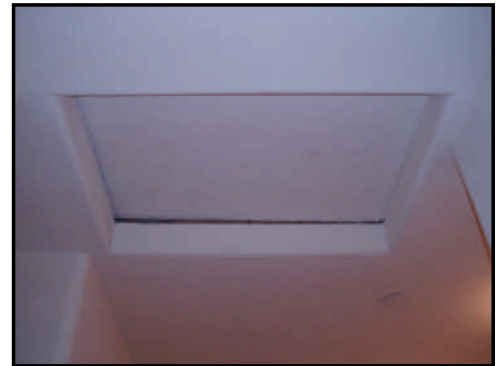
Repair: The access cover at the master bedroom closet does not fit flush.

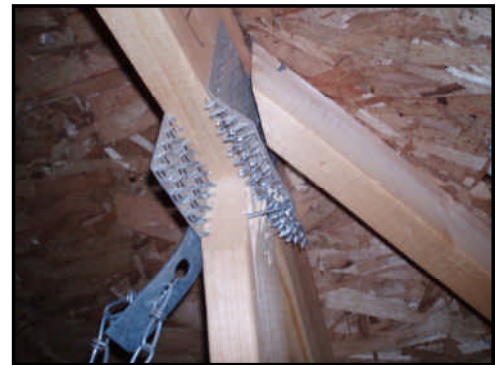
Further Review: The gusset plate (connection plates) on one of trusses over the back furnace is pulling away from the truss due to mechanical damage. We are not able to say with any certainty if this has or will create a structural problem. However, the builder should evaluate the truss system and make the necessary corrections and certify any modifications.

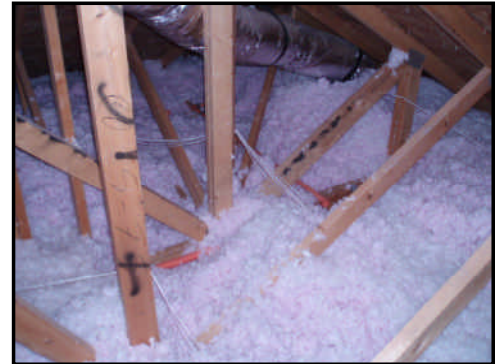
Repair: The insulation is unevenly distributed or displaced in several areas effectively reducing the coverage and R-value. This should be corrected to restore R-value.

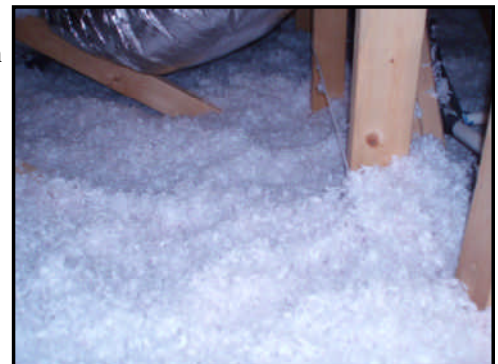
Repair: There were no markers in the attic to verify depth for R-value. However, 14½" is required for an R-value of 38. There needs to be no less than an R-value of 38 or what the insulation certificate states.

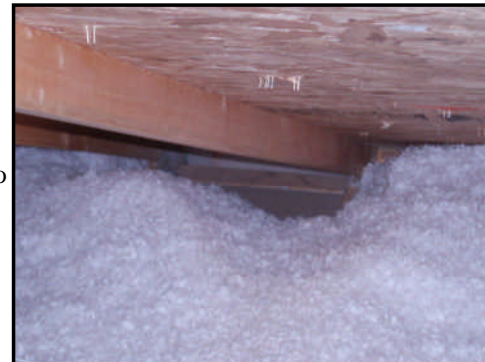
Repair: Insulation should be held back at the eaves with baffles to allow a minimum of 1" of air space for adequate ventilation and to adequately insulate the eaves. No baffles were installed in some areas and the baffles that were installed were installed incorrectly, so there are areas at the eave with no insulation and/or very little insulation or less insulation than required. This should be corrected to reduce thermal loss between the home and the attic and to adequately move air for ventilation.

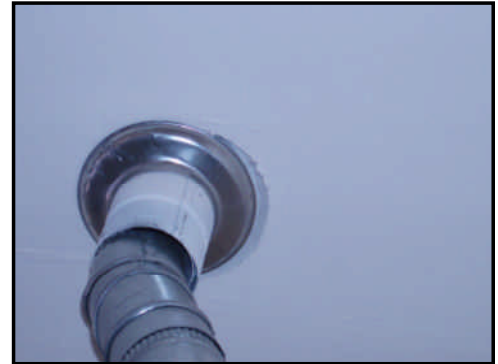
Safety Concern: We found voids (holes or other deficiencies) in the required fire resistive barrier between the garage and the living area in the ceiling around the water heater flue.

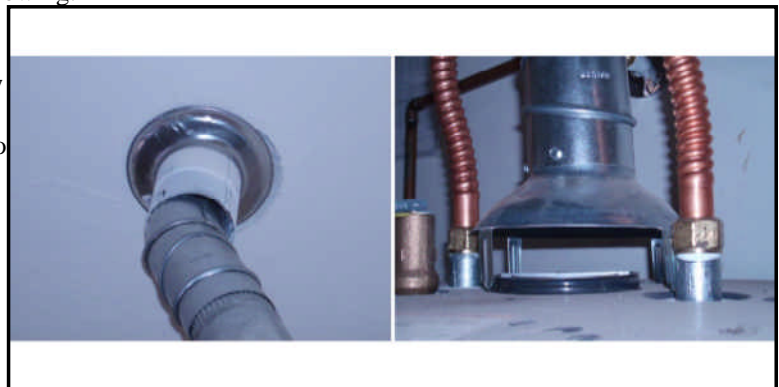
Safety Concern: Even though the flue pipe is fully connected, one or more of the flue pipe connections needs to be fastened with some sort of machine screw to avoid the possibility of it becoming loose and discharging combustion gases (carbon monoxide) into the garage. There should be three fasteners at each gas flue connection and at the draft hood.

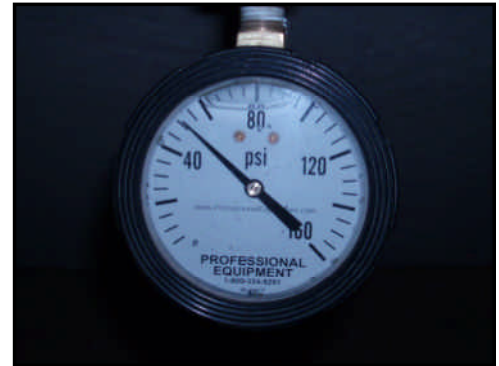
The water supply for the building, measured at an outside hose bibb was 50-55.

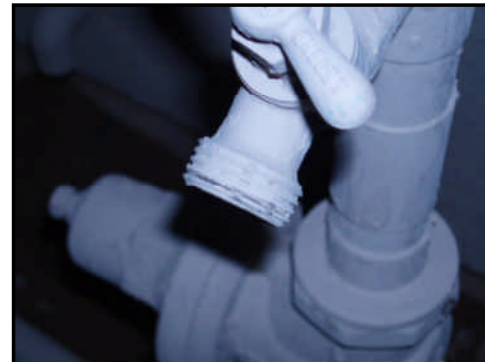
Safety Concern: One or more of the hose bibbs lacks a vacuum breaker (anti-siphon valves). A vacuum breaker can be screwed onto any faucet that has a hose-bibb. These inexpensive valves are needed to prevent the possible contamination of the potable water supply in the home.

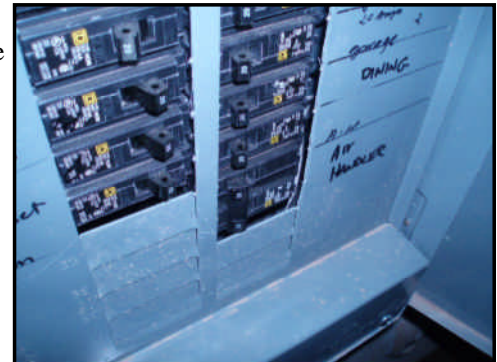
Repair: The inner cover of the panel does not adequately fit and could potentially damage some of the wiring coming into the panel because the bundle of wires extends out too far and was not properly routed into the panel. The wires need to be correctly routed so the inner cover does not damage any wires and will fit flush.

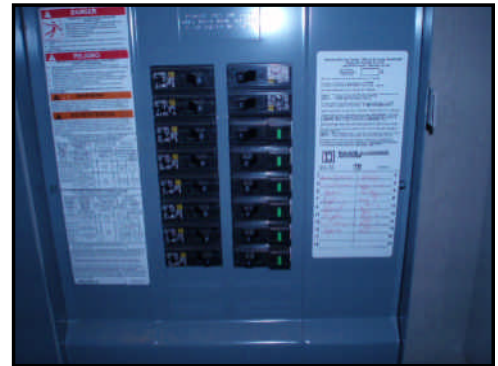
Safety Concern: There are more than 4 AFCI breakers together. Generally, the manufacturer states that there should be no more than four (4) AFCI's breakers in a row together due to how hot the breakers run.

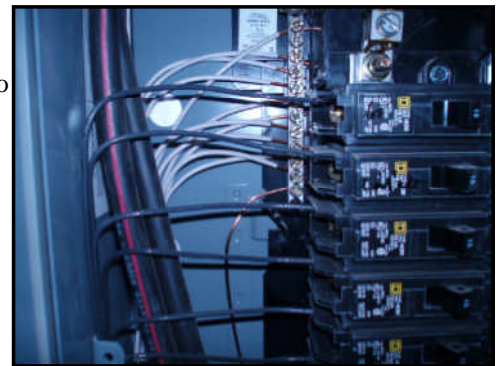
Safety Concern: The panel is not properly wired. The ground wires and the neutral wires are on separate buses, but are both grounded to the panel. The grounding bus needs to be bonded to the panel itself and the neutral bus needs to be "floating." The ground wire connecting the two buses needs to be removed.

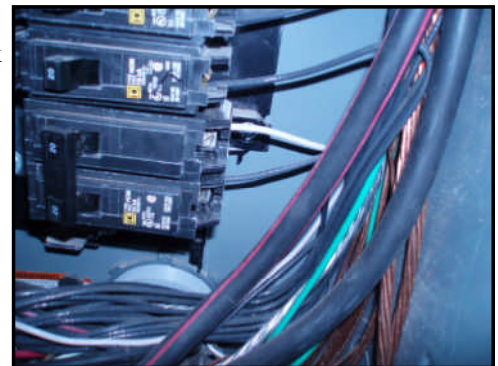
Safety Concern: A white wire is used for power to one of the circuit breakers. For safety, the wires should be designated as powered by adding a strip of black electricians tape.

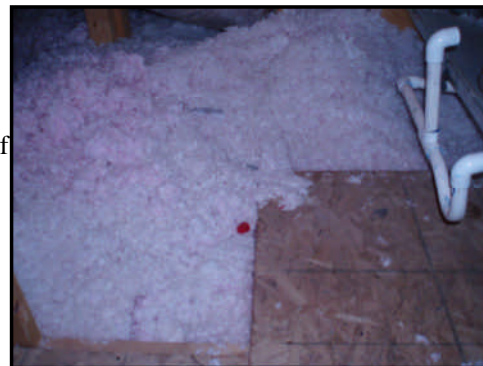
Safety Concern: A section of the furnace platform in the attic has less than the required clearance in front and does not fully extend across the front of the unit. Gas furnaces or any other serviceable HVAC system needs to have 30" of clearance in front of it for safe servicing, especially when they are installed in attic cavities. Also, the platform needs to be effectively across the entire front of the furnace.

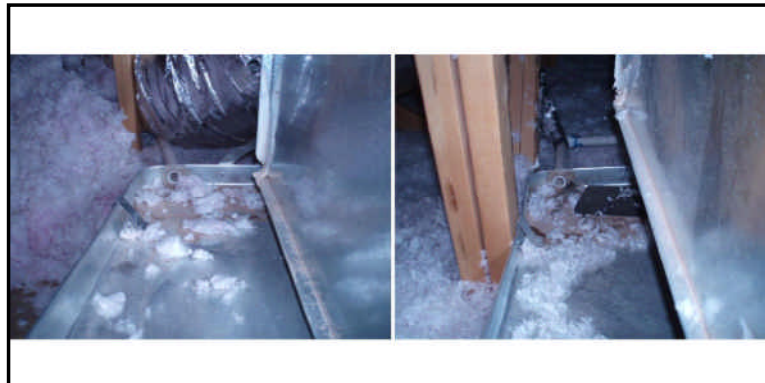
Repair: There is insulation in the safety catch pan (secondary drain pan that sits under the evaporative unit that is designed to catch water from the primary condensation pan if there is a problem) that could easily cause the drain line off of the pan to clog. The insulation and any other obstructions need to be cleaned out to ensure proper drainage.

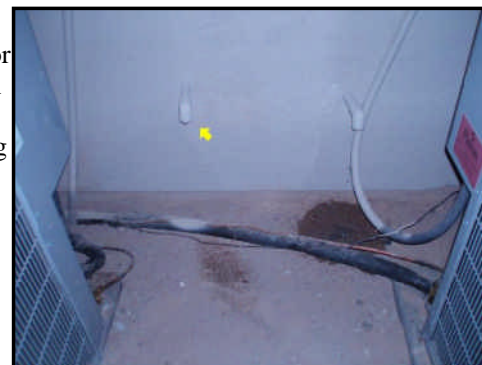
Further Review: There was no condensation dripping from either the primary or secondary condensate drain lines during the entire course of the inspection for one of the units, which was run the entire course of the inspection or from when it was repaired. Most likely the unit is dripping condensation, it must be determined where it is going. It is possible the line sags a bit and water is sitting in the line.

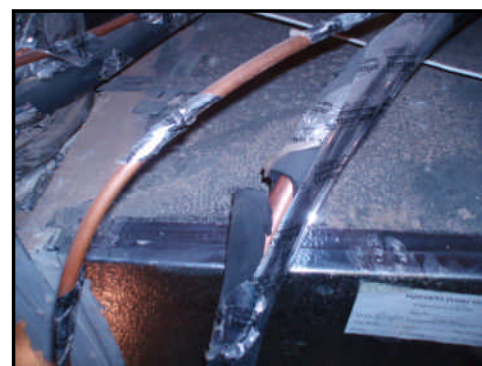
Repair: The refrigerant line is exposed in the attic. This line needs to be properly wrapped and taped to prevent water from dripping down on the platform and/or on the insulation and drywall. This condensation occurs as the line "sweats."

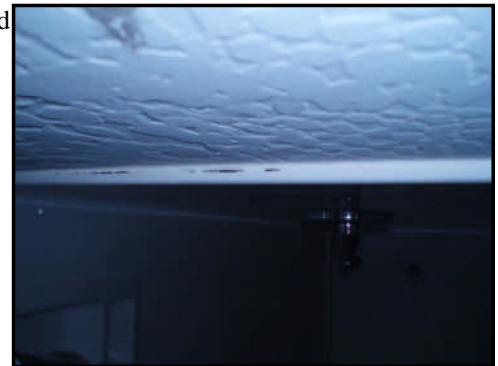
Repair: The gap along the top of the shower enclosure in the guest quarters and at the top of the master bathroom shower surround needs to be caulked to prevent water intrusion and unnecessary damage.

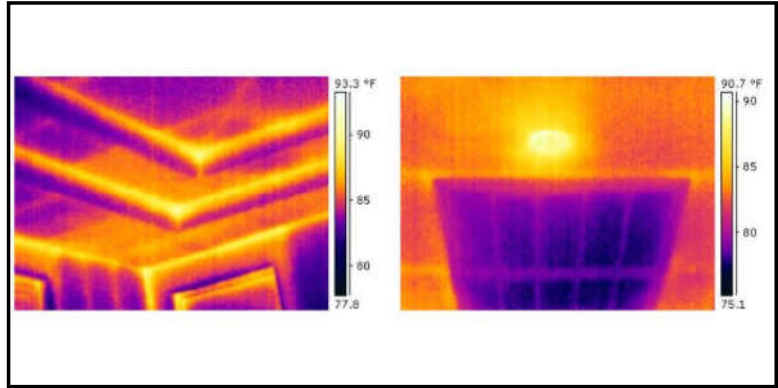
Repair: There are areas in the ceiling with no insulation and/or very little insulation as seen from the IR camera (see the full report). This should be corrected to reduce thermal loss between the home and the attic.

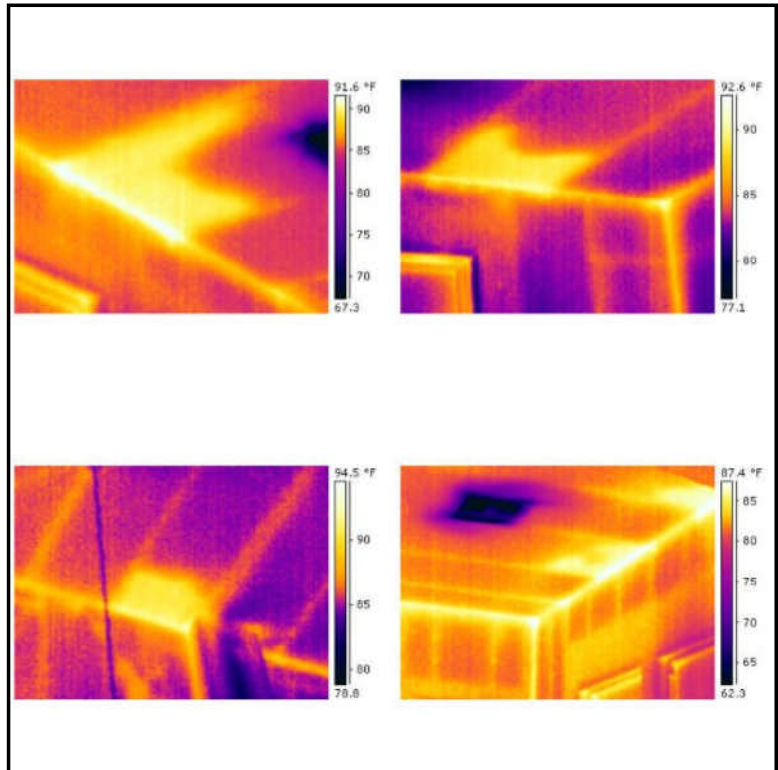
Repair: There are areas at the eave with no insulation and/or very little insulation as seen from the IR camera (see the full report) and is most likely due to there being no baffles in some areas and/or installed incorrectly. This should be corrected to reduce thermal loss between the home and the attic. There are companies out there to evaluate thermal loss and it is recommended the builder have them evaluate where there is thermal loss and make recommendations for correction.

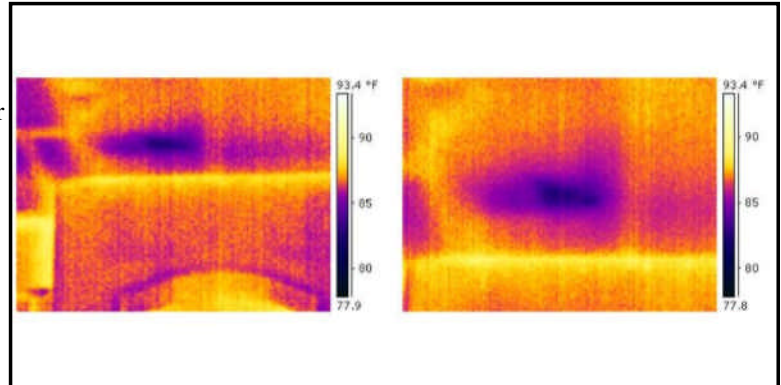
Further Review: There is evidence of a leak seen with the IR camera (see the full report) on the ceiling in the kitchen at the entrance. Our visual inspection cannot determine the actual source of moisture and/or the extent of any damage that may exist. However, moisture meter readings indicate elevated moisture levels at the time of the inspection.
