PROPERTY CONDITION REPORT

Client(s): Client of NPI
Property Address: GoodYear, AZ
Realtor: Keller Williams
Date: 12/12/05
Inspector: Peter Zipp III
Report #: P121205-05FD

Foundation - Slab Inspection

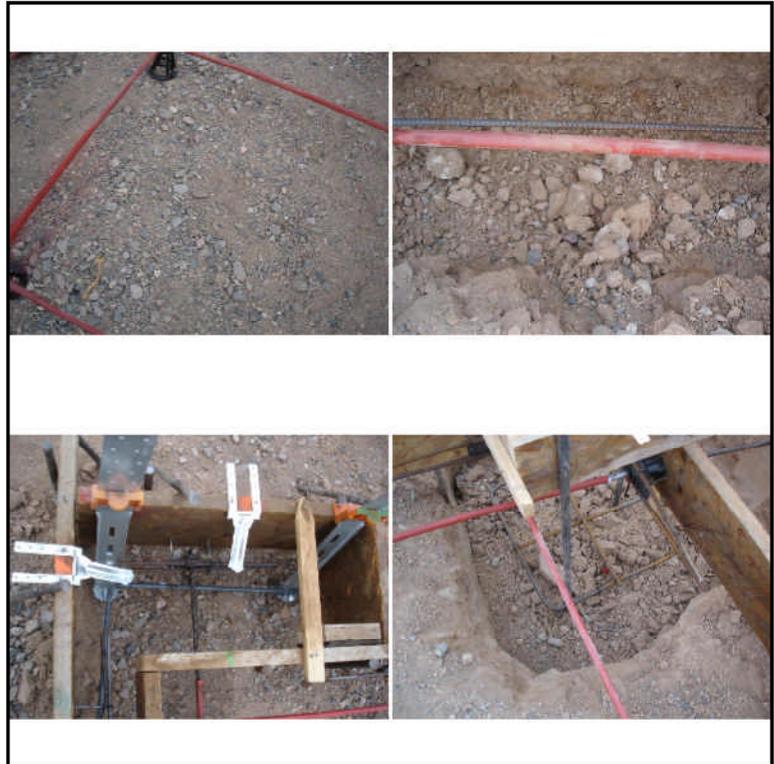
1. The base soil and aggregate is not compacted as required.
2. Debris and larger chunks of dirt/rocks are present and should be removed, especially in the footers.
3. The base soil appears high in several areas, which brings the tension wires closer to the surface.

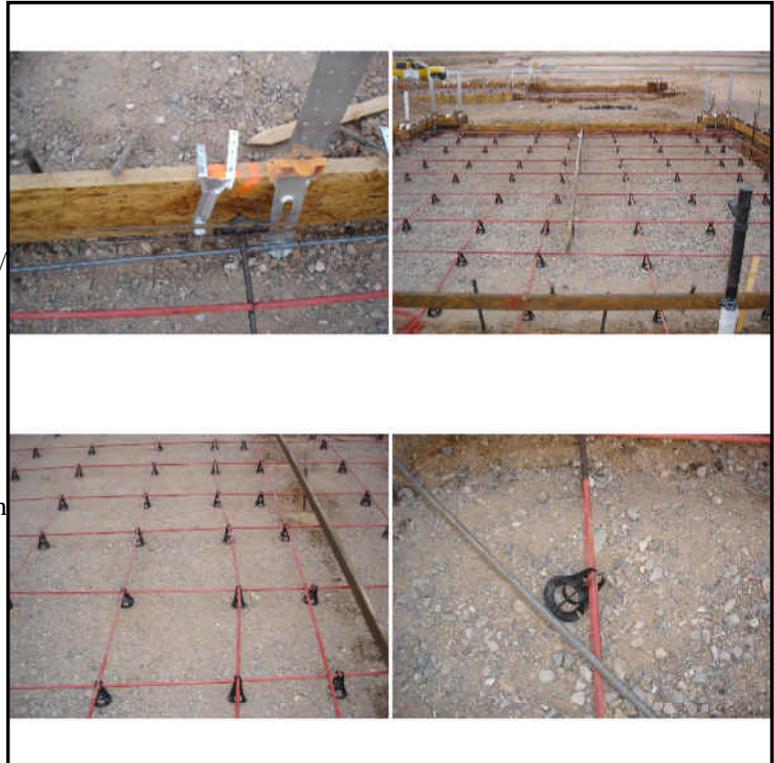
1. Some of the anchor straps were either missing and/or not set correctly.
2. Some of the tension cable supports are missing and/or incorrectly placed.
3. There is at least one area where the rebar and/or the tension cables are not tied. Rebar should be tied where it is in contact and/or passes over or under each other.
4. The plans should be checked because one or more of the tension cables appear to be high on the form.
5. The plans should be checked to ensure a bollard is not required to protect the water heater.
6. Some of the tension cables are not square or set evenly apart.
7. All holdowns and post locations need to be verified prior to pouring.

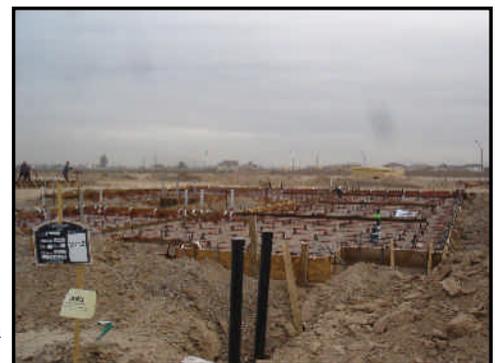
1. None of the plumbing is protected. The plans should be checked to ensure that the architect did not call for the plumbing to be protected. This information is usually found on the holddown schedule.
