## PROPERTY INSPECTION REPORT

Prepared For: Stephen F. Austin  
(Name of Client)

Concerning: 1836 Early Days of Texas, Austin, TX 78745  
(Address or Other Identification of Inspected Property)

By: James Chris Quoyeser, Lic #TREC License #21071 08/05/2014  
(Name and License Number of Inspector) (Date)

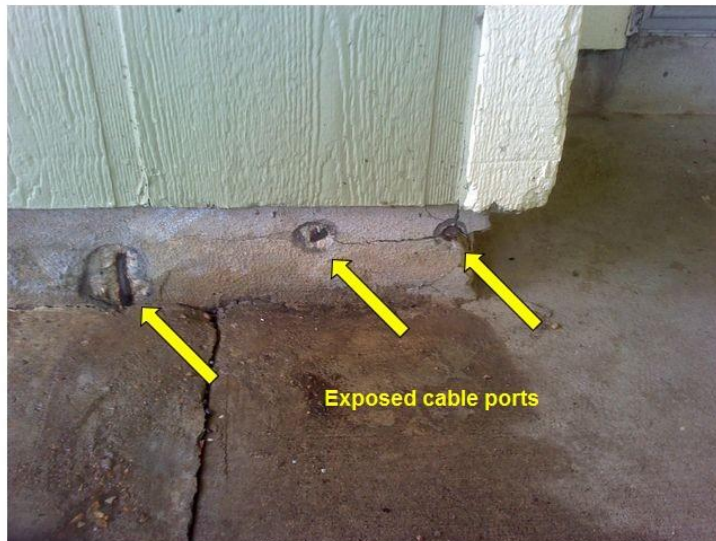
Cable ports on the patio are exposed and should be covered with mortar to prevent further oxidation and deterioration to the concrete.

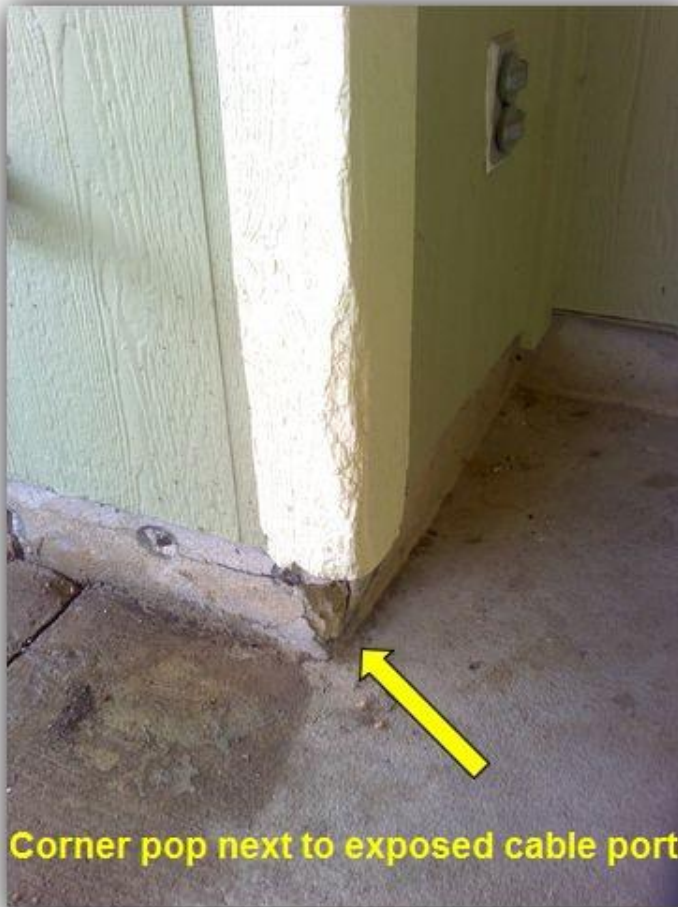
A foundation perimeter beam corner was observed to be cracked (corner pop). This is a common condition in slab on grade foundations. This condition rarely affects the performance of the foundation and is typically cosmetic in nature. Recommend monitoring it over time for further cracking/breaking.

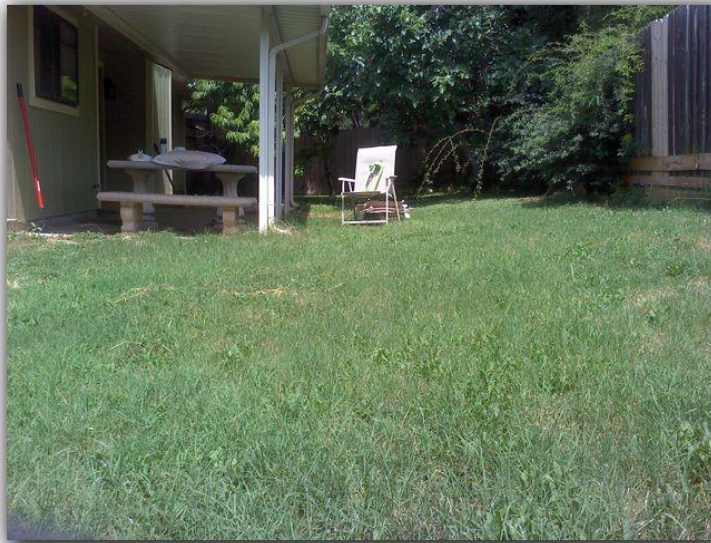
The ground slopes toward the house in the backyard causing water to pool next to the house and at patio. Grading should be a minimum of a 6 inch slope away from the foundation for the first 10 feet. The existing underground drainage system does not appear to be effective in preventing water from pooling next to the foundation. Uneven moisture conditions around the house could result in structural foundation issues.

Backyard slope toward foundation.

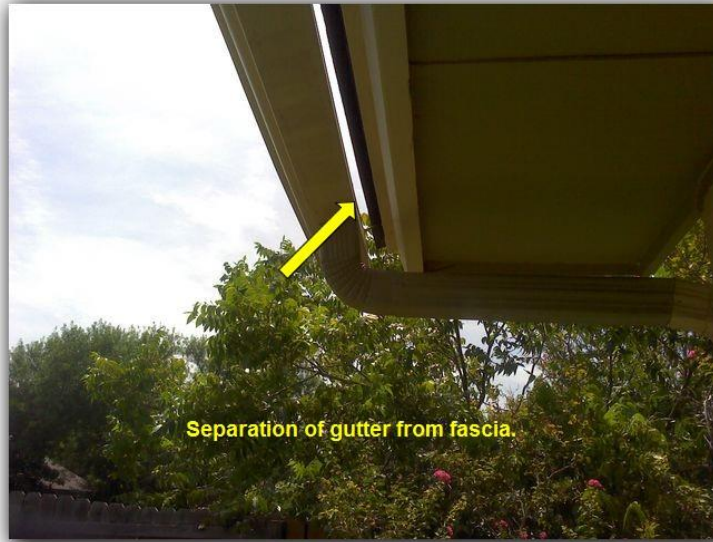
The gutter at the northeast corner of the house has separated from the fascia and should be repaired. Failure to do so could result in water intrusion into the attic and/or wood rot to the fascia.

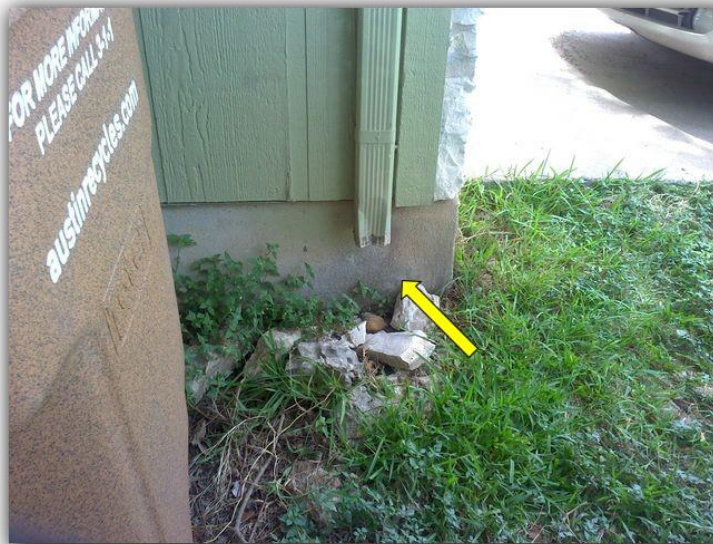
The down spouts on the southwest and northeast corners of the house empty water next to the foundation. Downspouts should channel water 3 to 4 feet away from the structure. Recommend downspout extensions be added and routine cleaning and maintenance of gutter system to prevent future problems.

The down spouts on the southwest and northeast corners of the house empty water next to the foundation. Downspouts should channel water 3 to 4 feet away from the structure. Recommend downspout extensions be added and and routine cleaning and maintenance of gutter system to prevent future problems.

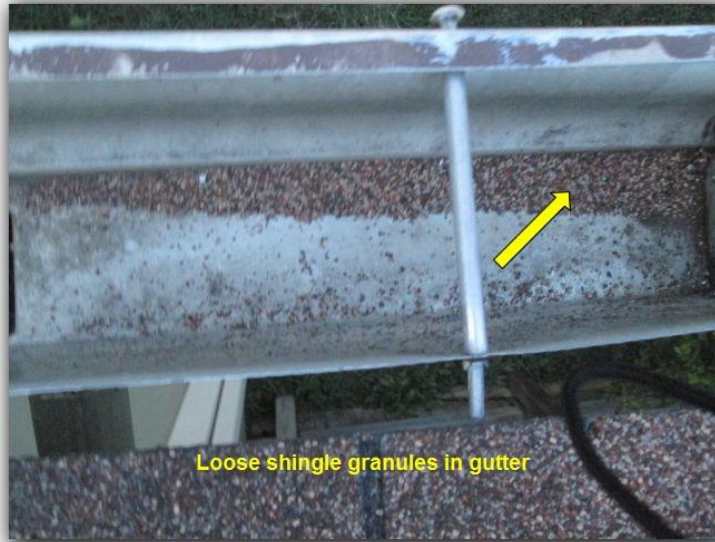
Some shingles are beginning to loose granules which could be an indication that they are nearing the end of their useful life.

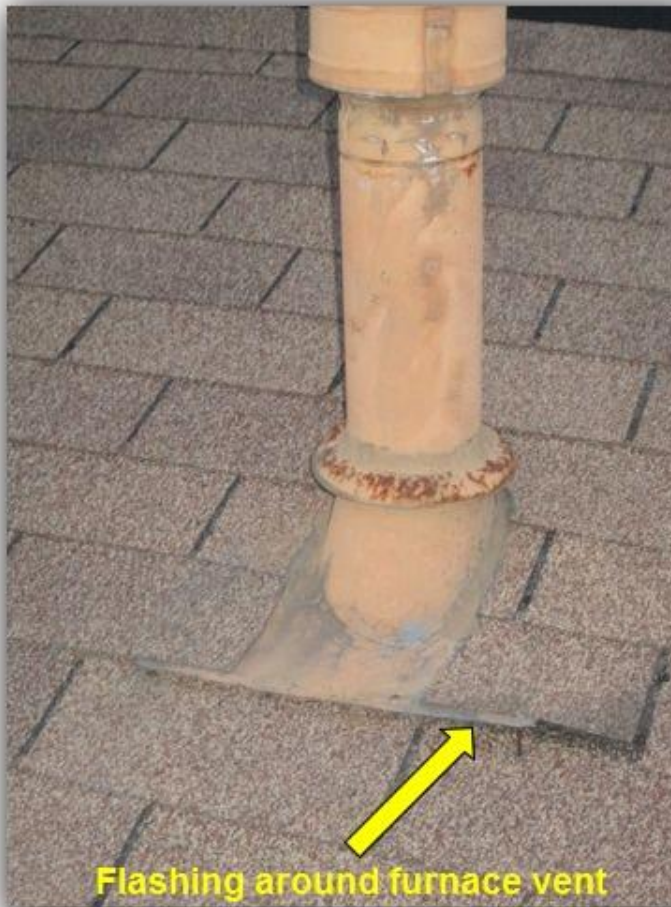
The flashing around the furnace vent is pulled up on the low side and needs repair.

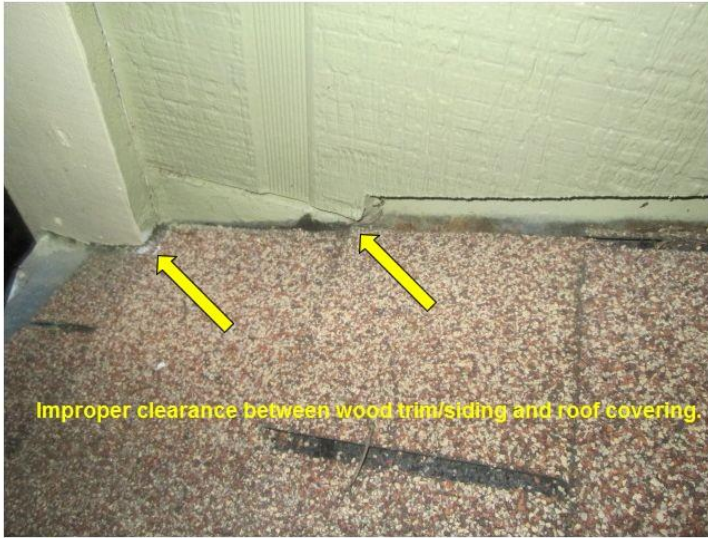
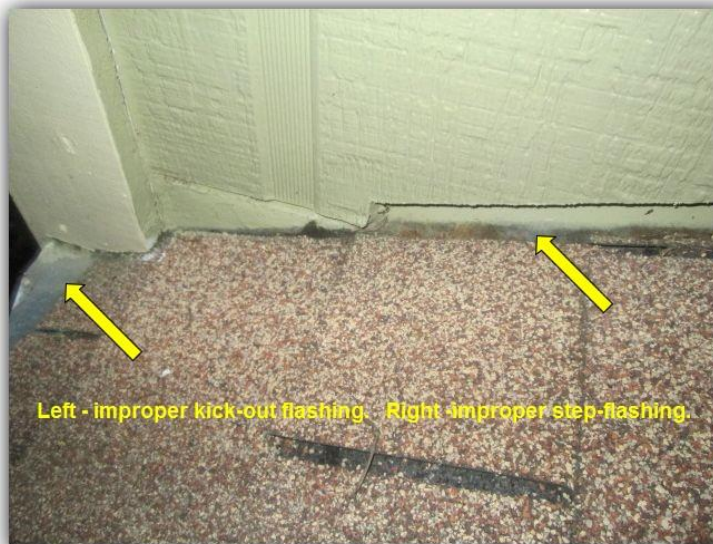
The siding material and wood trim on the chimney was found to be in contact with the roofing material on both sides. Current standards require 2" clearance between siding/trim materials and the roof to prevent deterioration. Also, the sides of the chimney are not properly **step-flashed**, but instead have one continuous piece of metal flashing. This could result in water intrusion into the attic. Finally, the west side of the chimney does not have proper **kick-out flashing** which could result in wood rot on the trim and siding below.

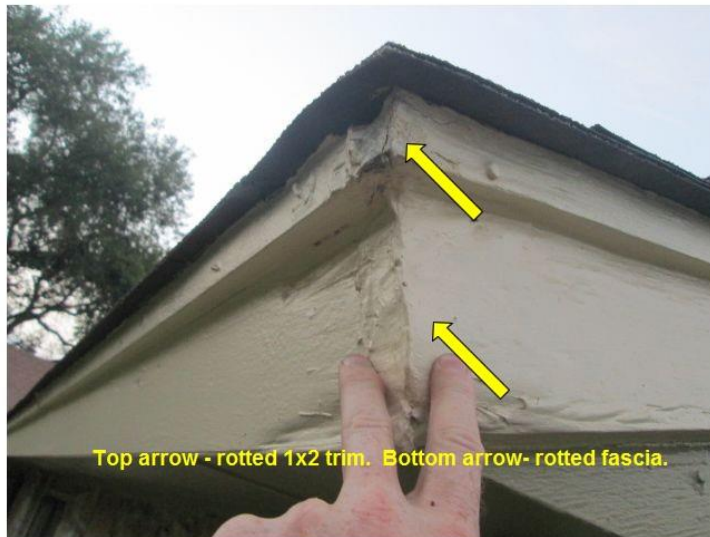
Wood rot was detected on the fascia and 1 x 2 trim under the edge of the roof covering at the southeast corner of the house.

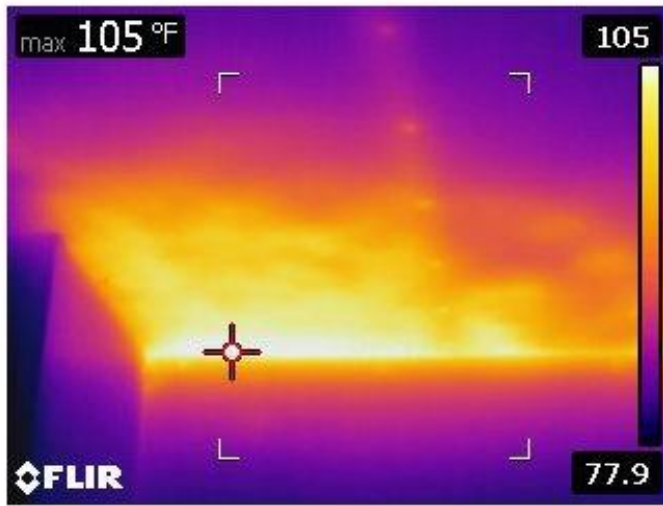
Two areas with **possible** missing/disturbed/compressed insulation in ceiling were detected using infrared thermography. Unable to verify due to inadequate headroom and accessibility in attic. Insulation observed from accessible attic decked space appeared to be adequate.

Breakfast Area - northwest corner of ceiling, approximately 2.5' x 5'

Two areas with **possible** missing/disturbed/compressed insulation in ceiling were detected using infrared thermography. Unable to verify due to inadequate headroom and accessibility in attic. Insulation observed from

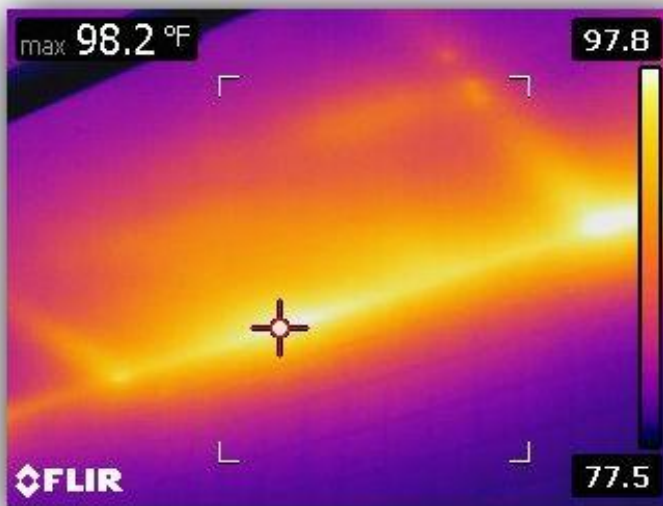
Master Bedroom Bath (above shower surround) - approximately 1' x 3'

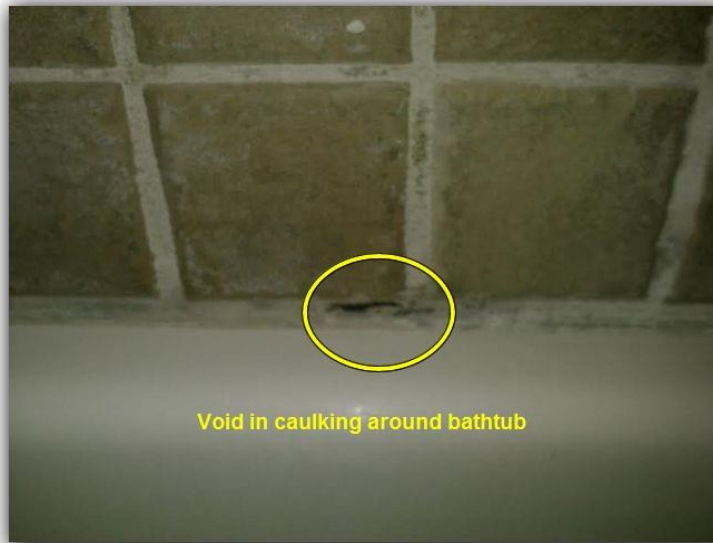
Caulking around bathtub recommended.

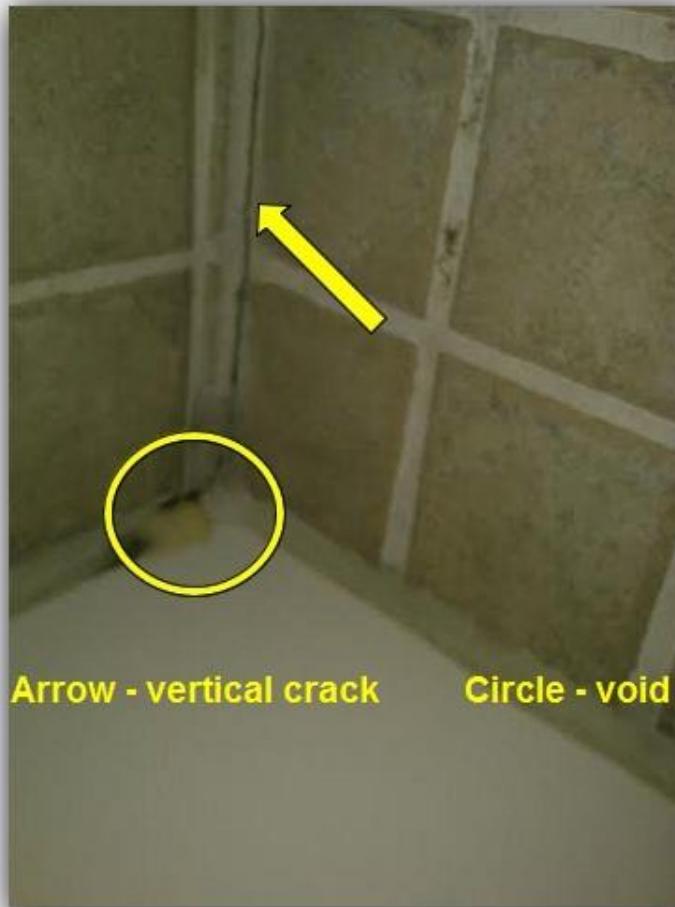
Arrow - vertical crack

Circle - void

The stone veneer has some minor cracks and voids in the mortar and some of the stones are loose. Recommend new mortar be applied and continued monitoring of cracks.

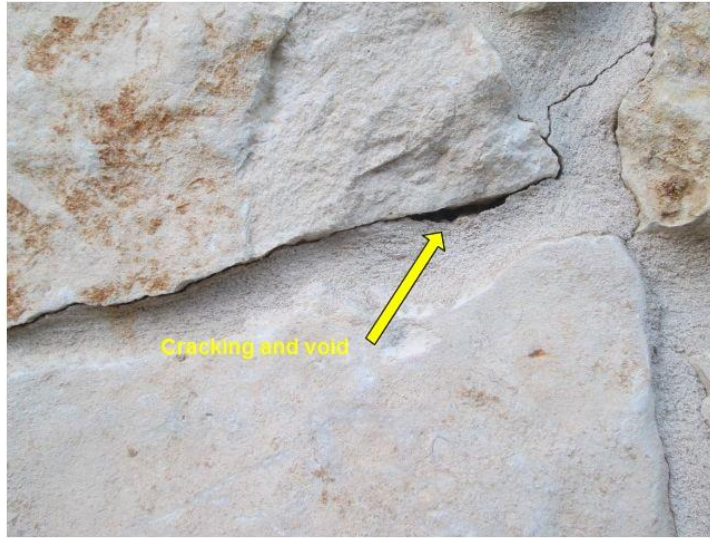
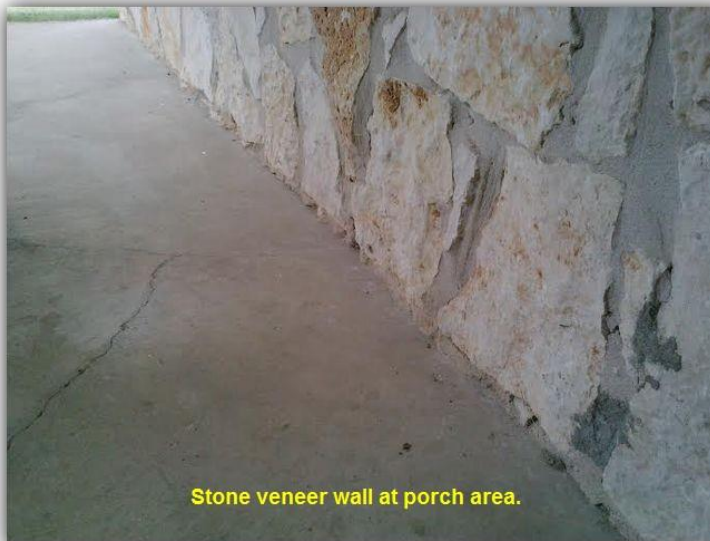
Incorrect weep hole spacing was noted in the porch area and the stone veneer wall to the right of the dining room window. Weep holes allow for any moisture behind the stone veneer to escape, thus keeping the inside wall dry. Spacing should be no more than 33 inches apart. The approximately 12 foot stone veneer wall in the porch area had 1 weep hole and the approximately 12 foot stone veneer to the right of the dining room window had 2 weep holes. (The porch area is protected by the roof.) Recommend additional weep holes be added for wall ventilation.

Correct weep hole spacing was noted in the porch area and the stone veneer wall to the right of the dining room window. Weep holes allow for any moisture behind the stone veneer to escape, thus keeping the inside wall dry. Spacing should be no more than 33 inches apart. The approximately 12 foot stone veneer wall in the porch area had 1 weep hole and the approximately 12 foot stone veneer to the right of the dining room window had 2 weep holes. (The porch area is protected by the roof.) Recommend additional weep holes be added for wall ventilation. Evidence of wood rot and water damage were observed in the composite board.

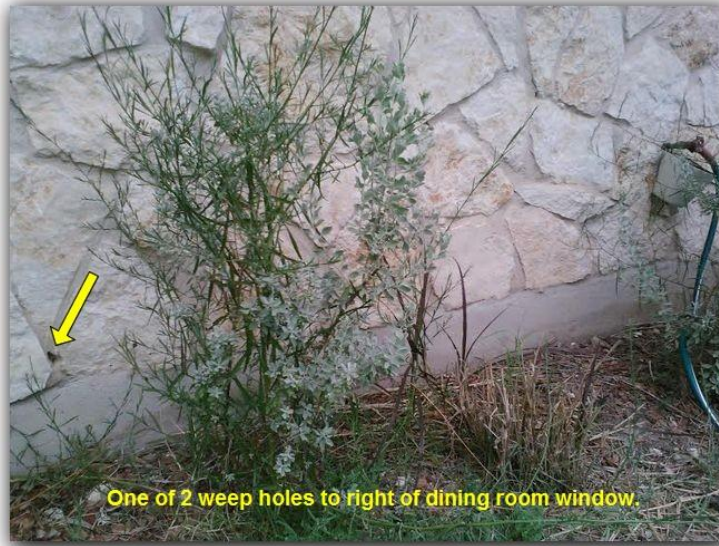
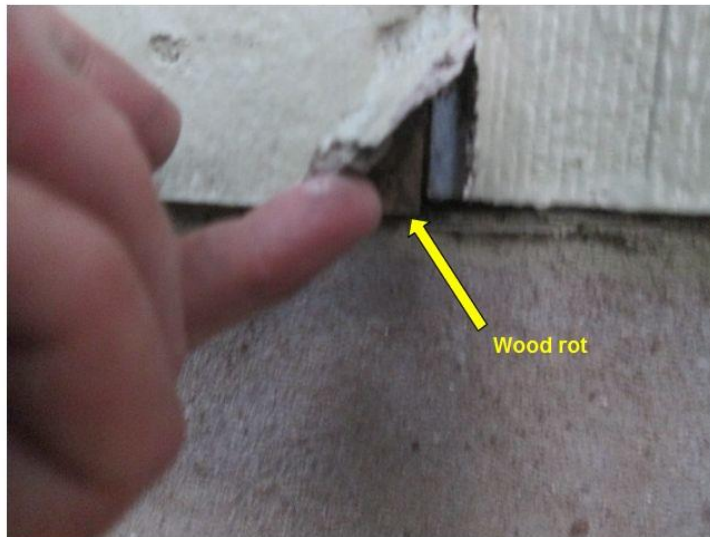
Evidence of wood rot and water damage were observed in the composite board.

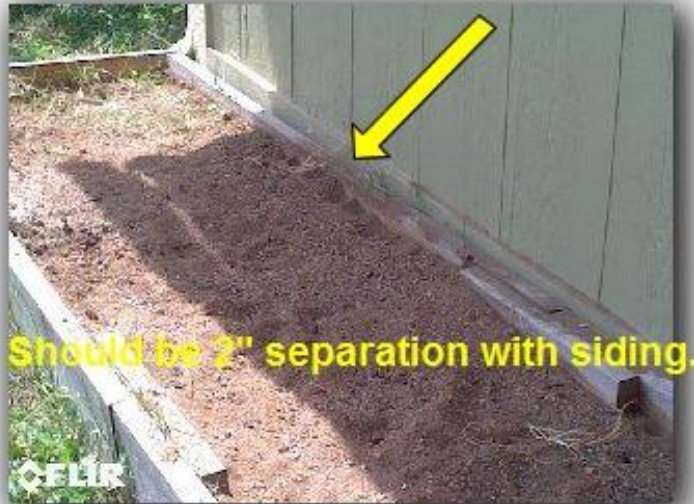
The raised bed (planter box) in the backyard puts soil in contact with composite siding. Recommend that it be moved at least 2" from the house to avoid possible wood rot and problems with wood destroying insects.

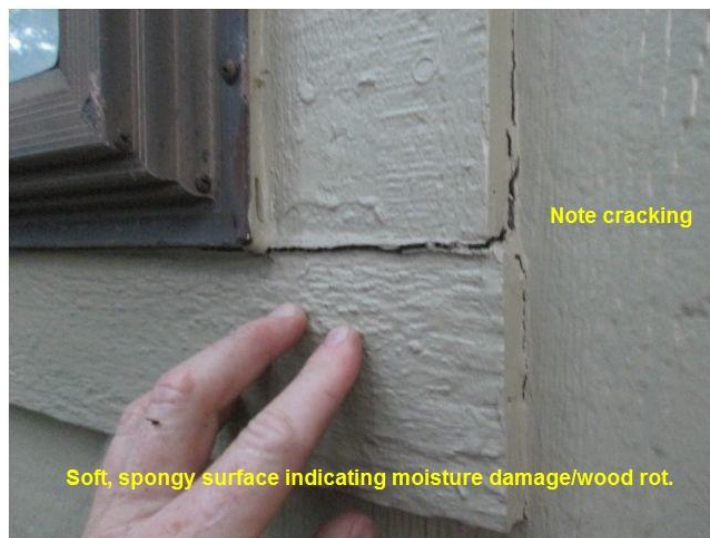
Cracking was observed on window casings around the window on the west side of the house. Recommend caulking open cracks.

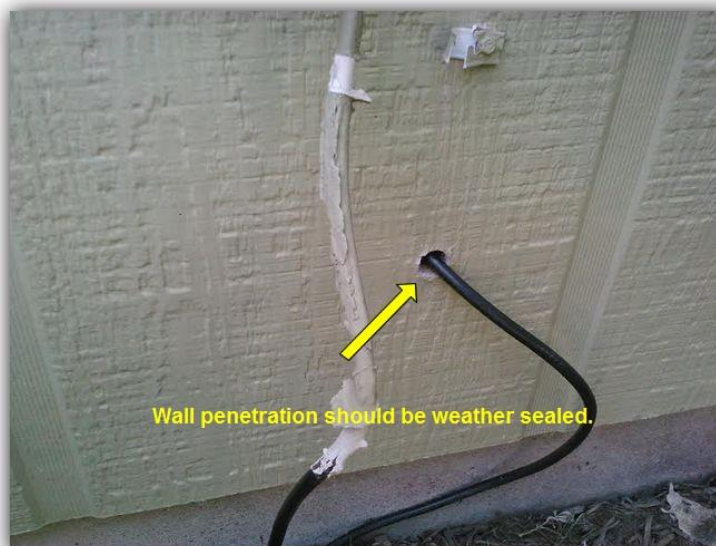
All exterior wall penetrations should be maintained with a good weather seal. Recommend sealing wall on east side of house.

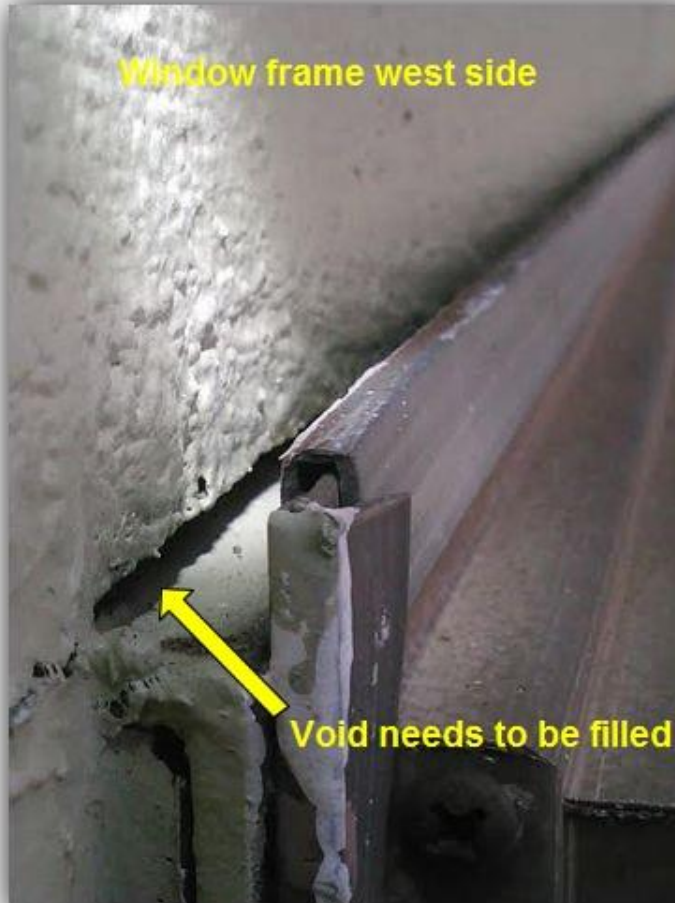
The exterior window frame on the west side of the house appears to be incorrectly installed or has pulled away from house. The open void across the top needs to be weather sealed and some sort of cap flashing should be installed to prevent water intrusion.

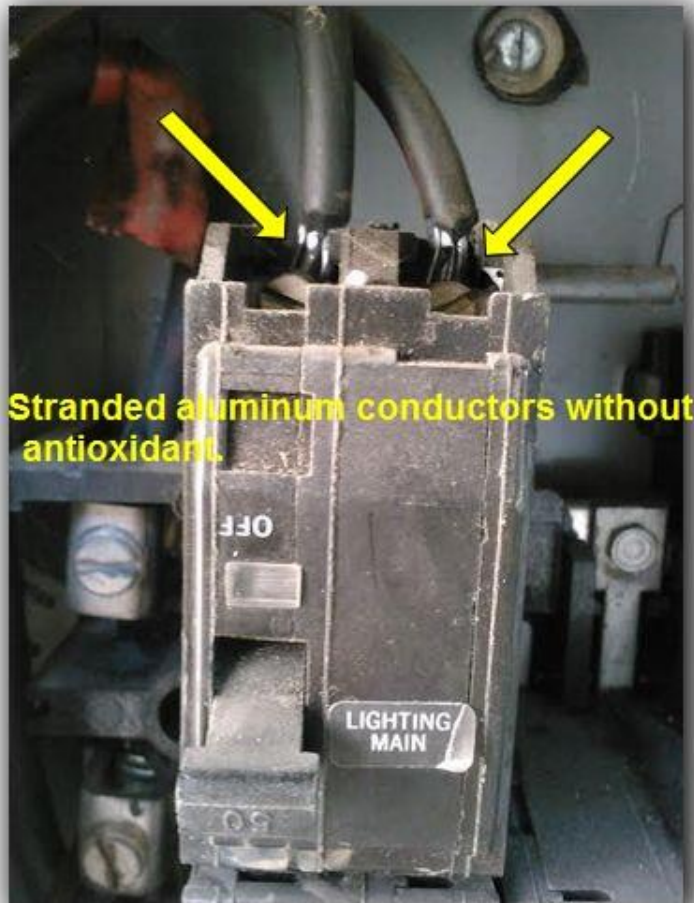
The stranded aluminum service conductors do not have protective antioxidant at connections nor does the stranded aluminum wires connected to the 50 amp, 220 volt breaker and leading to the sub-panel. Aluminum wires are prone to oxidation which can **cause overheating and possible fire hazard**. Recommend repair.

The stranded aluminum service conductors do not have protective antioxidant at connections nor does the stranded aluminum wires connected to the 50 amp, 220 volt breaker and leading to the sub-panel. Aluminum wires are prone to oxidation which can **cause overheating and possible fire hazard**. Recommend repair. Neither the 20 amp, 220 volt breaker or the 50 amp, 220 volt breaker show an AL or CUAL designation, indicating approval for use with aluminum wiring. Recommend evaluation by licensed electrician.

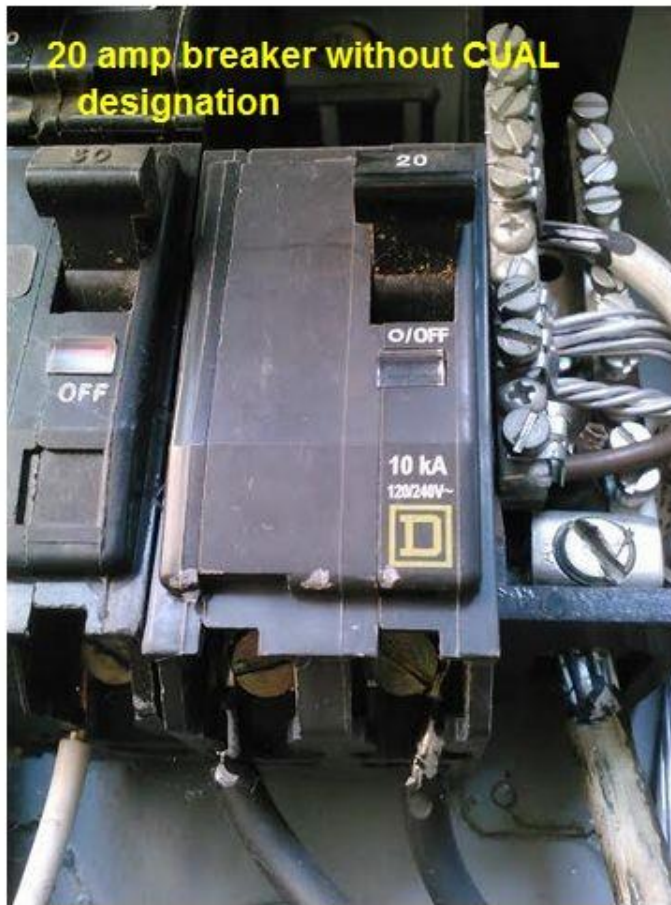
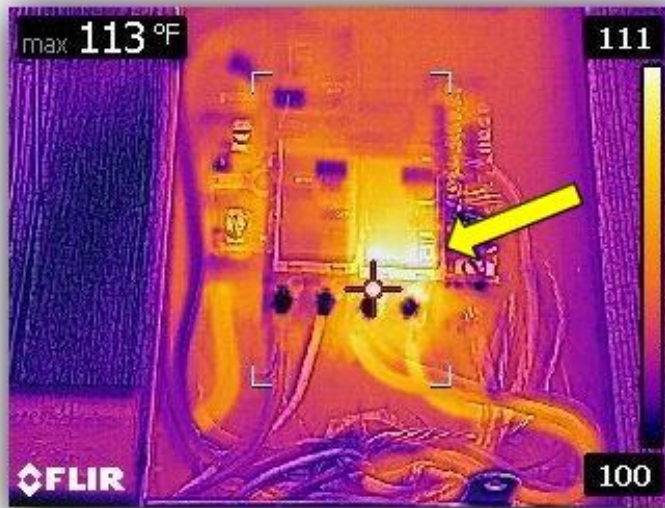
The infrared image below shows an elevated temperature in the 20 amp, 220 volt breaker. Breakers can get hot when they supply power at near peak amperage over long periods and may begin to breakdown internally. Other factors that can elevate the temperature include loose connectors, improperly size conductors, and wrong type of breaker. Recommend review by a licensed electrician.

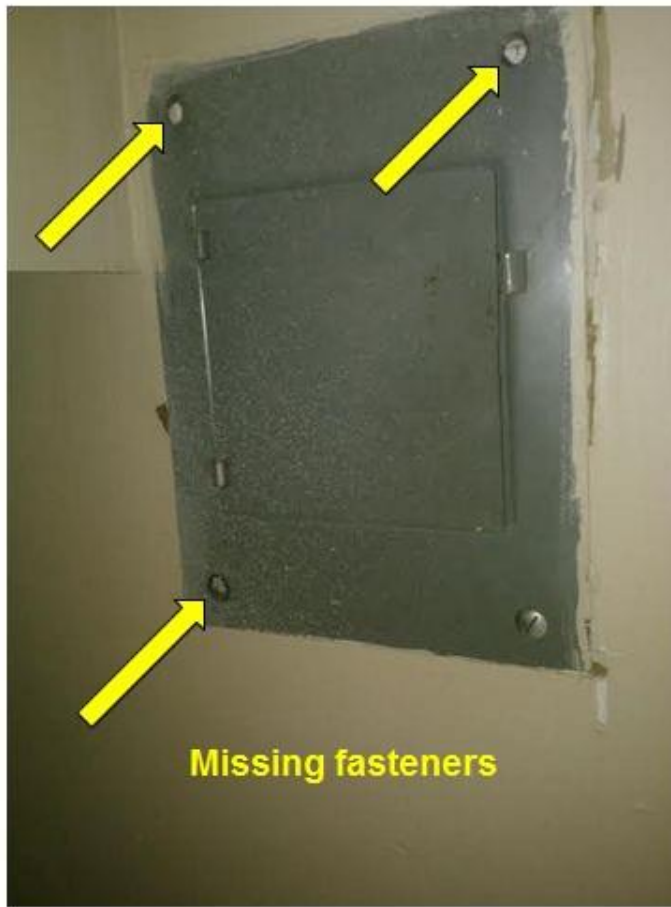
Three out of four fastener screws that connect the subpanel cover to the wall are missing. Recommend repair.

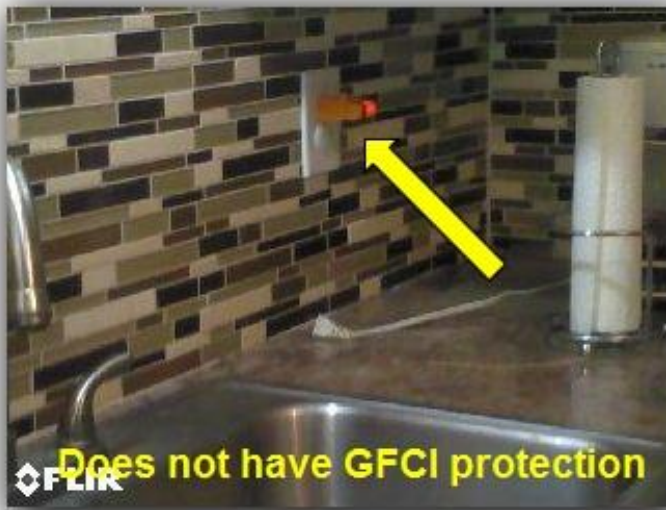
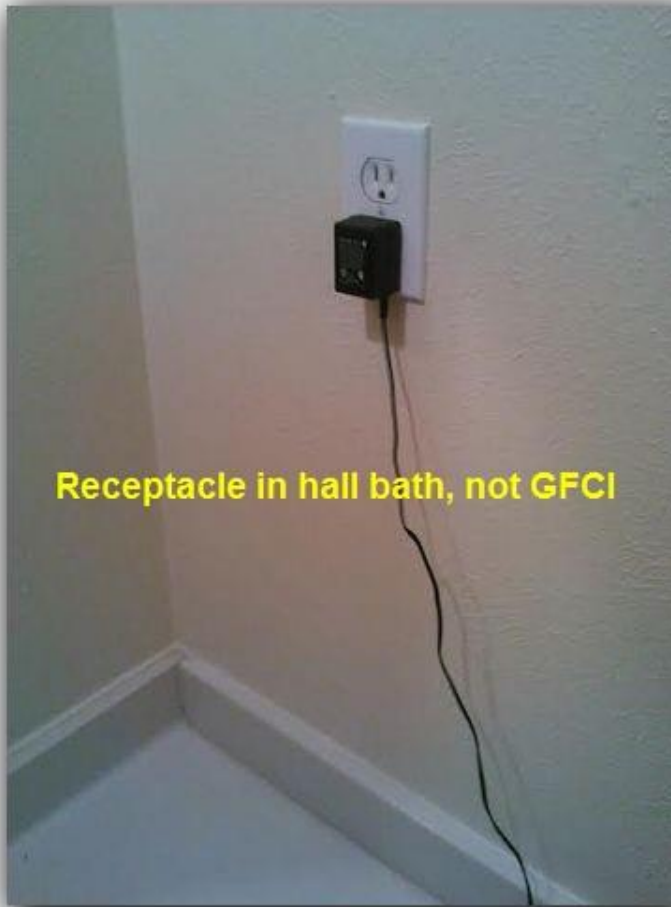
The receptacles above the kitchen countertop, the one in the hall bathroom, and the one in the garage on the east wall do not have GFCI protection. This is a safety issue and required by today's standards. All outlets within 6 feet of water, outlets in unfinished areas (garage) and all kitchen countertop outlets should be GFCI protected. Recommend repair by a licensed electrician.

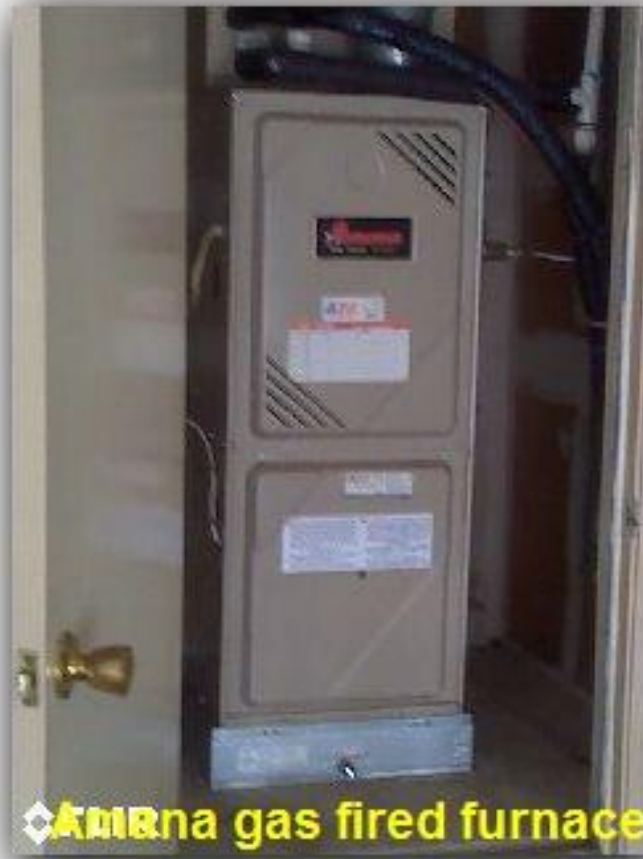
The Amana unit does not have a sediment trap on the gas line. A sediment trap prevents moisture and small particles from clogging small orifices within the gas valve assembly and burners. Not having a sediment trap could void the warranty. However, since the unit is 12 years old the warranty may not be an issue.

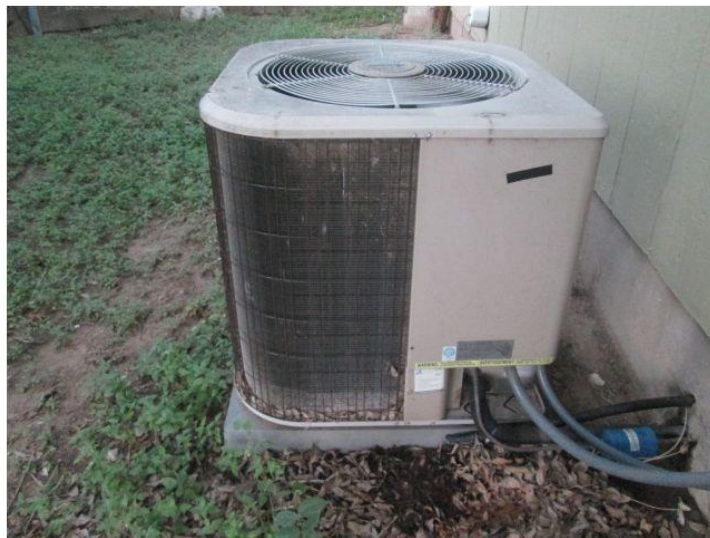
The unit has some minor damage to the condenser fins.

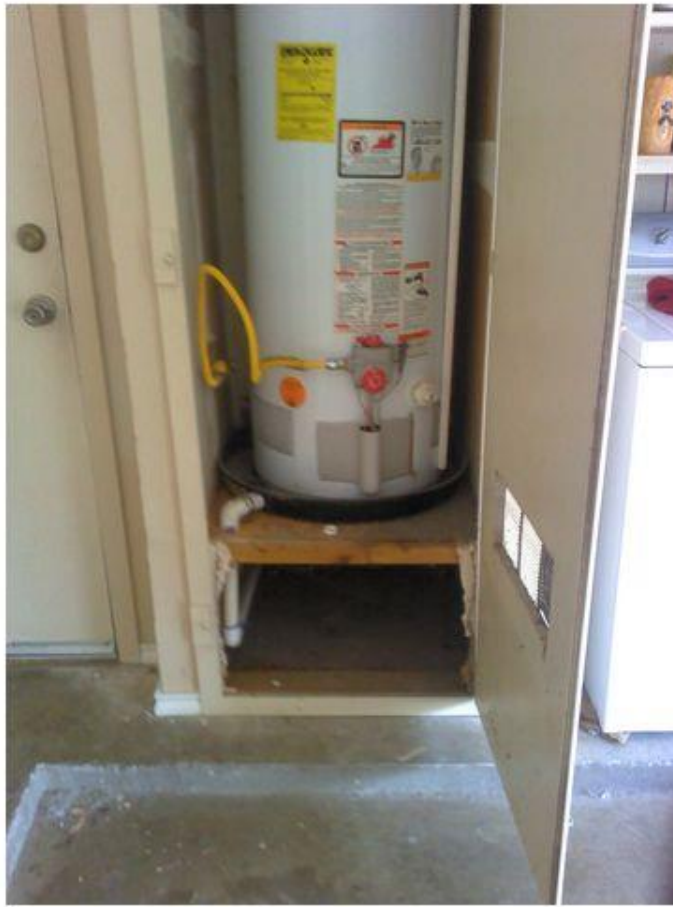
This unit does not have a sediment trap on the gas line. The sediment prevents moisture and small particles from clogging the small orifices in the gas valve assembly and burners. Not having a sediment trap could void the warranty. Since the unit is 9 years old, the warranty may not be an issue.
