# National Property Inspections

Mr. John Doe, 20 Ocean Blvd , Holden Beach, NC, 28462

Inspection Date:  
06/30/2018

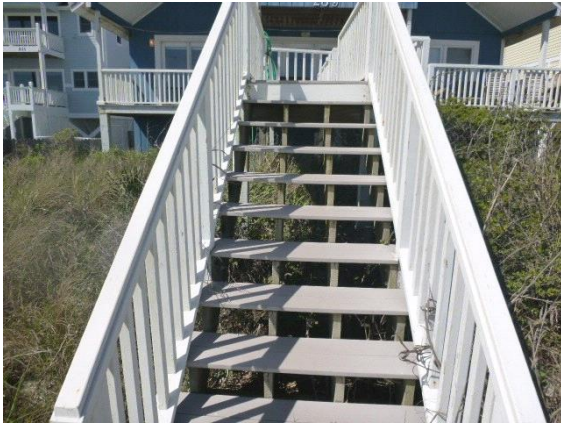
Walks / Steps: Overall view of rear steps

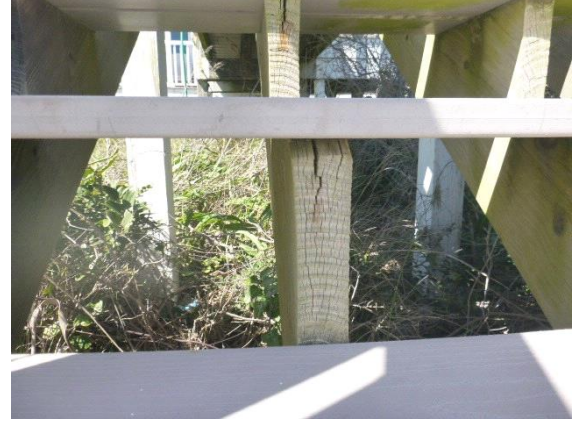
Walks / Steps: View of one location of cracked staircase stringers

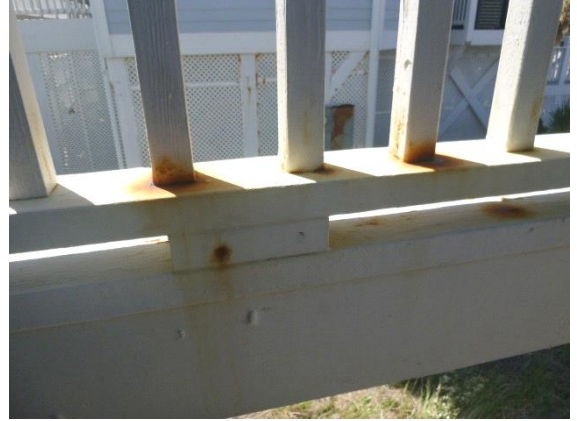
3. There are many rusted fasteners present throughout the deck. See photos. Evidence suggests the rusted hardware has potentially weakened the structure of the deck and that this condition has created a safety hazard.

Decks - 1st Floor - Front : View of one location of rusted fasteners on front deck

\*\*Recommend a licensed general contractor evaluate items 1, 2, and 3, all exterior wood decks, determine the cause and extent of any damage, and make the necessary repairs.

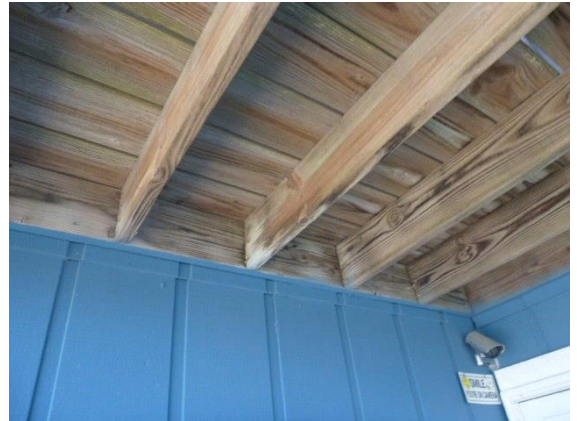
2. All decks are required to have either metal joist hangers or wood ledger strips for proper end-support for all decking floor joists. The front deck does not have either type of joist supports present, and evidence suggests this condition creates a safety hazard. See photos.

Decks - 1st Floor - Front : View of missing joist hangers or ledger strips at the ends of the floor joists

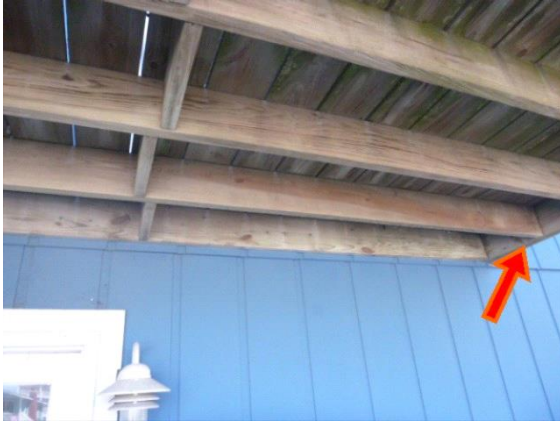
2. All decks are required to have either metal joist hangers or wood ledger strips for proper end-support for all decking floor joists. The front deck does not have either type of joist supports present, and evidence suggests this condition creates a safety hazard. See photos.

Decks - 2nd Floor - Front : View of missing joist hangers or ledger strips located at the ends of the floor joists

\*\*Recommend a licensed general contractor evaluate items 1, 2, and 3, all exterior wood decks, determine the cause and extent of any damage, and make the necessary repairs.

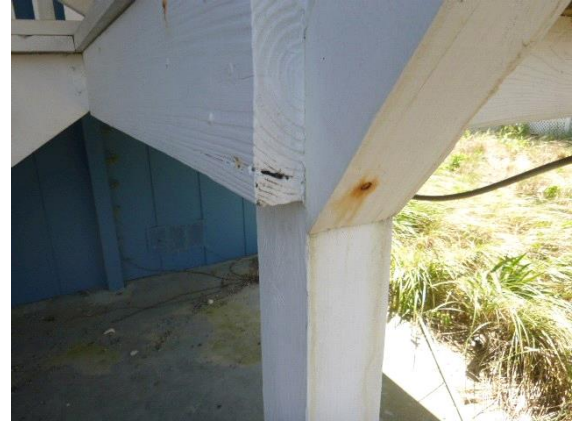
3. There are many rusted fasteners present throughout the deck. See photos. Evidence suggests the rusted hardware has potentially weakened the structure of the deck and that this condition has created a safety hazard.

Decks - 2nd Floor - Front : View of one location of rusted fasteners on front decks

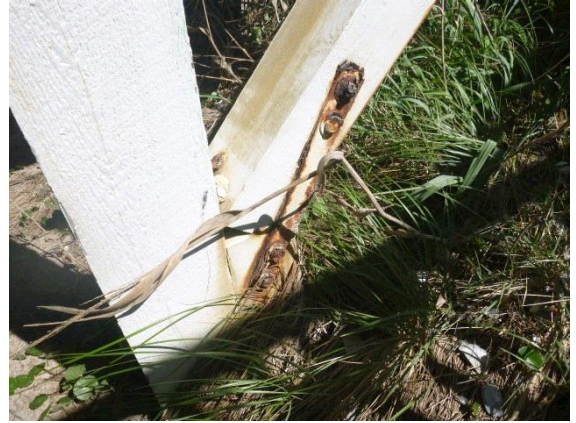
3. There are many rusted fasteners present throughout the deck. See photos. Evidence suggests the rusted hardware has potentially weakened the structure of the deck and that this condition has created a safety hazard. \*\*Recommend a licensed general contractor evaluate items 1, 2, and 3, all exterior wood decks, determine the cause and extent of any damage, and make the necessary repairs.

Decks - 1st Floor - Rear : View of one location of rusted fasteners on rear deck

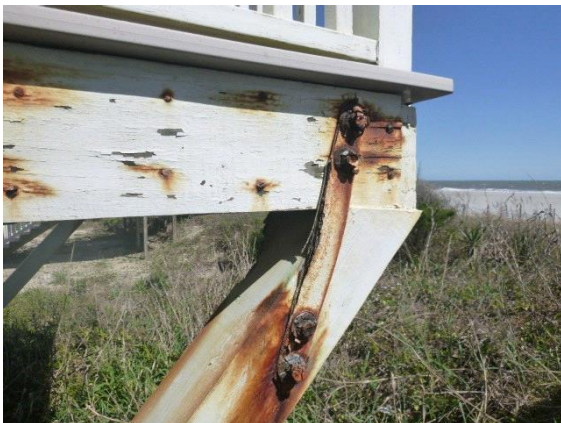
Decks - 1st Floor - Rear : View of one location of rusted fasteners on rear deck

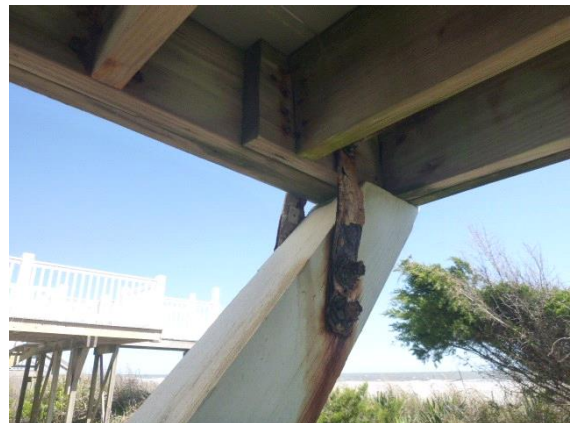
Decks - 1st Floor - Rear : View of one location of rusted fasteners on rear deck

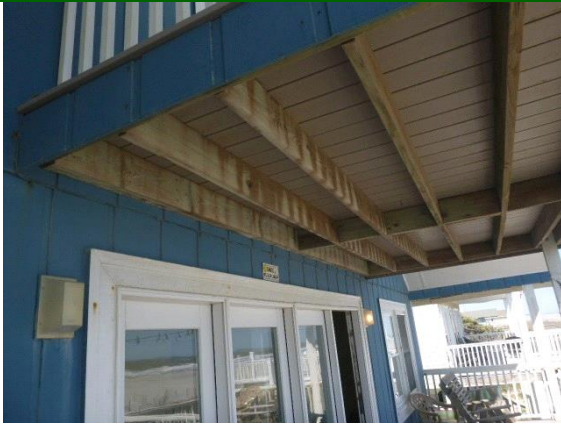
2. All decks are required to have either metal joist hangers or wood ledger strips for proper end-support for all decking floor joists. The rear deck does not have either type of joist supports present, and evidence suggests this condition creates a safety hazard. See photos.

Decks - 2nd Floor - Rear : View of missing joist hangers or ledger strips located at the ends of the floor joists

\*\*Recommend a licensed general contractor evaluate items 1, 2, and 3, all exterior wood decks, determine the cause and extent of any damage, and make the necessary repairs.

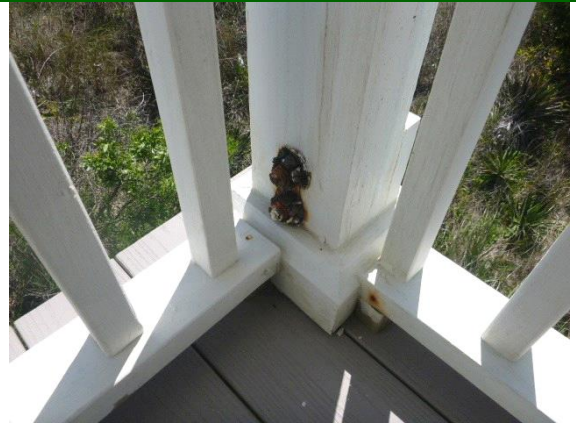
3. There are many rusted fasteners present throughout the deck. See photos. Evidence suggests the rusted hardware has potentially weakened the structure of the deck and that this condition has created a safety hazard.

Decks - 2nd Floor - Rear : View of one location of rusted fasteners on rear deck

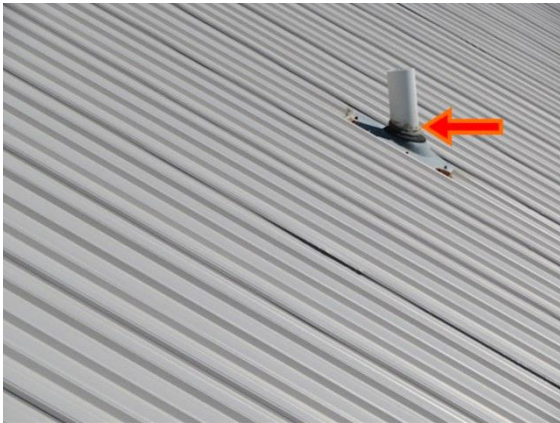
There is evidence of previous repairs to the plumbing vent pipe flashings located on the roof. See photos. Evidence suggests that repairs were made to stop prior leaks in these areas. Recommend asking the current owner for disclosure regarding previous repairs. If no repair history is available, recommend a qualified roofing contractor fully evaluate, determine the cause and extent of any damage, and make the necessary repairs.

Flashing/Valleys: View of one location of previous repairs to flashings

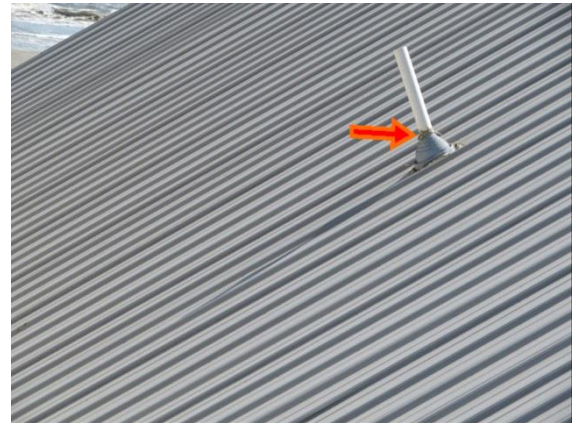
Flashing/Valleys: View of one location of previous repairs to flashings

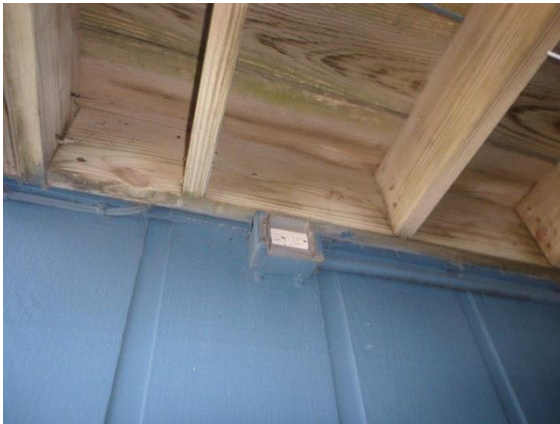
Exterior Surface: View of receptacle with no cover present

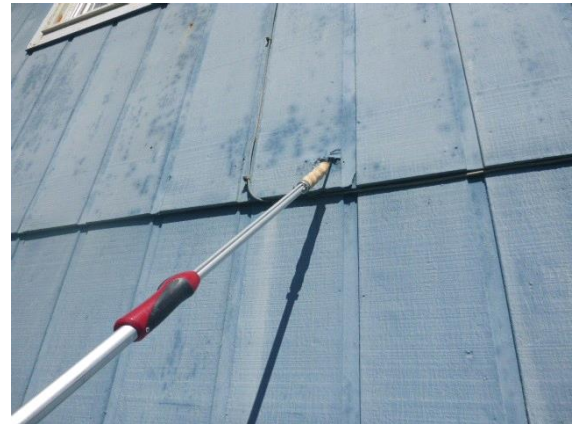
1. There are several areas of soft, deteriorated wood present on the wood siding and trim located throughout the exterior. See Photos. Evidence suggests this condition has weakened the wood siding and that there has been water intrusion into these areas.

Exterior Surface: View of one location of soft deteriorated wood siding

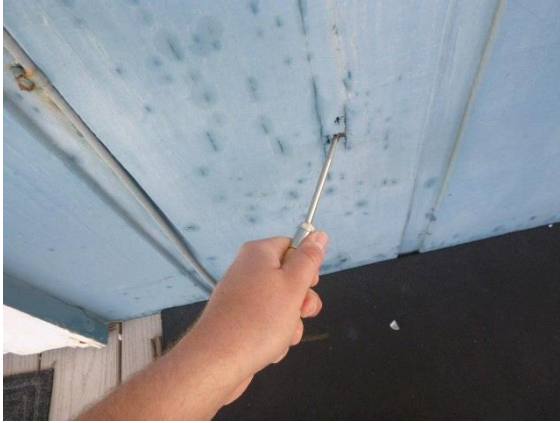
Exterior Surface: View of one location of soft deteriorated wood siding

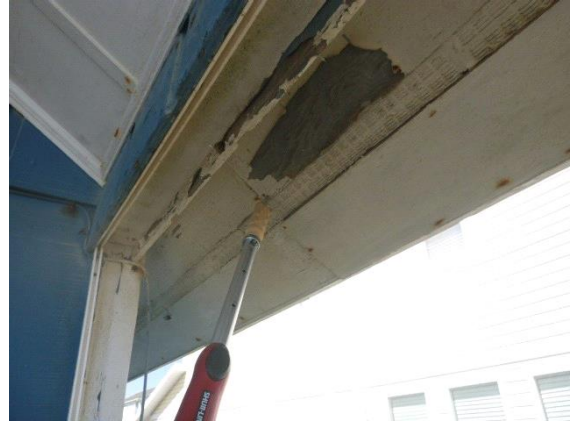
2. There are several areas of soft, deteriorated wood present on the wood soffit and fascia located throughout the exterior. See Photos. Evidence suggests this condition has weakened the wood soffit and fascia and that there has been water intrusion into these areas.  
\*\*Recommend a qualified siding contractor fully evaluate items 1 and 2, all exterior wood siding and trim, determine the cause and extent of damage, and make the necessary repairs.

Exterior Surface: View of one location of soft deteriorated wood soffit and fascia

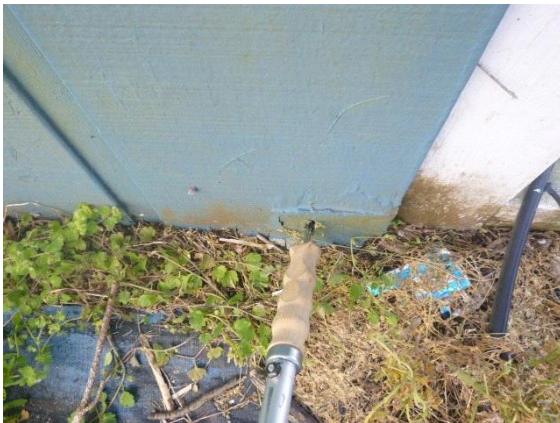
Exterior Surface: View of one location of soft deteriorated wood siding

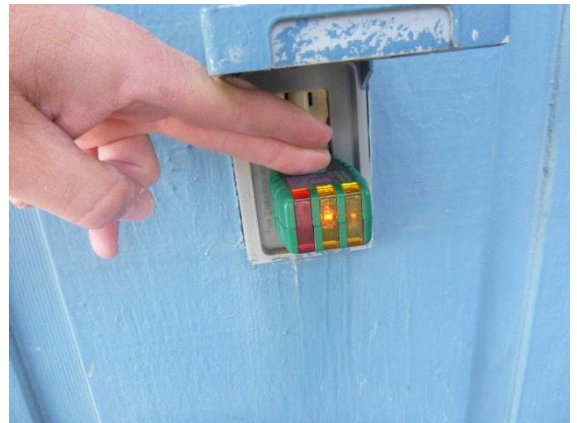
4. The exterior wall receptacle, located ground floor at the rear, is not GFCI-protected. See photo. All exterior receptacles have been required to be GFCI-protected since 1973. Evidence suggests the receptacle does not function as intended. Recommend a licensed electrician evaluate and make the necessary repairs.

Exterior Surface: View of exterior wall receptacle that is not GFCI protected

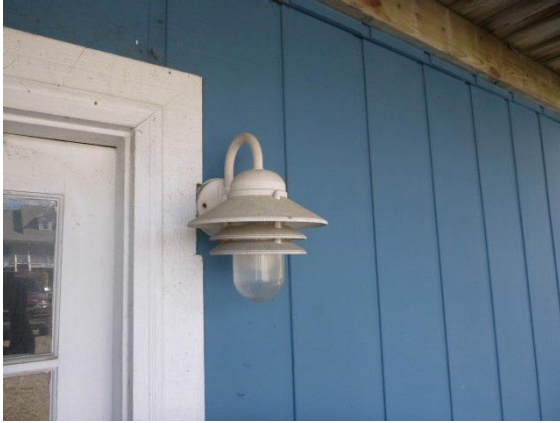
3. There are many exterior wall light fixtures that do not light when turning on the corresponding wall switches. See photos. Recommend changing bulb(s) first.

Exterior Surface: View of one location of defective exterior light fixtures

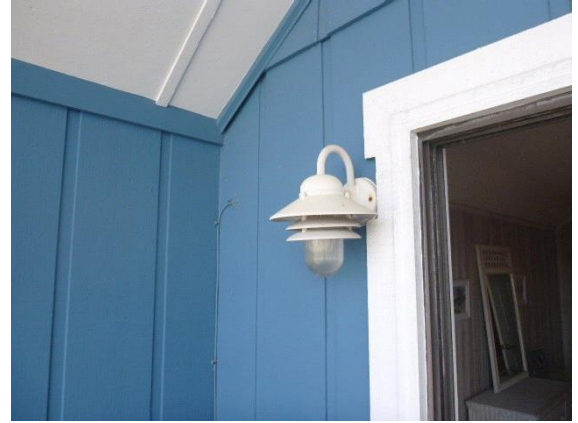
Exterior Surface: View of one location of defective exterior light fixtures

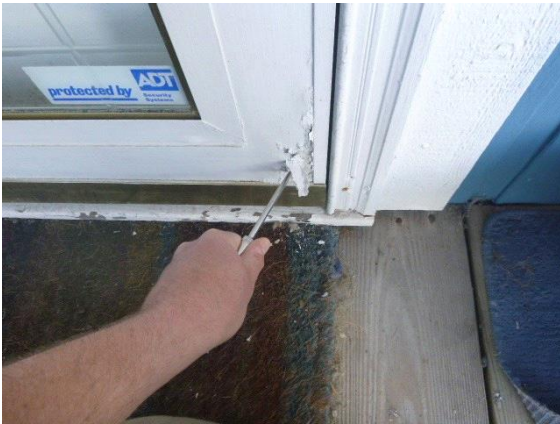
1. The metal storm door, located at the front entry, has excessive corrosion present at the bottom right corner. See photo. Evidence suggests this condition has weakened the structure of the door.

Exterior Doors: View of corrosion present on front storm door

\*\*Recommend a qualified contractor evaluate items 1, 2, 3, 4, 5, 6, 7, 8, 9, and 10, determine the cause and extent of any damage, and make the necessary repairs.

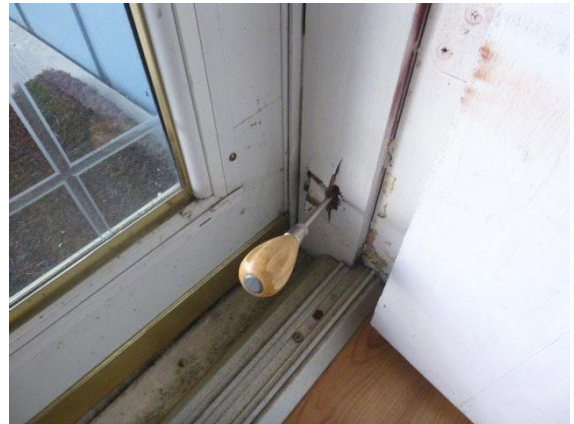
Exterior Doors: View of one location of soft wood present at front entry door

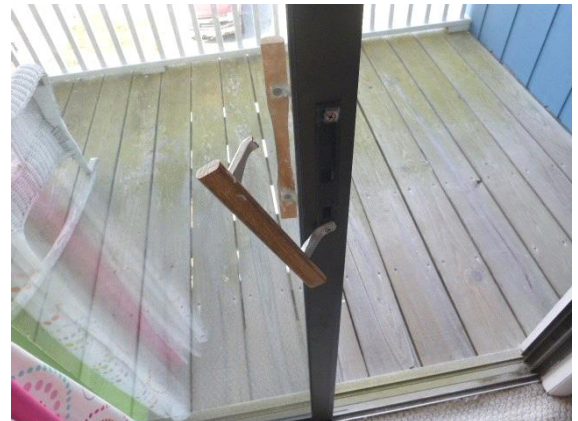
6. The 2nd floor front sliding glass door handle is broken. See Photo. Evidence suggests the door hardware is not operating as intended.
7. The 2nd floor front sliding glass door lock and latch are missing from the door. See Photo. Evidence suggests the door hardware is not operating as intended.

Exterior Doors: View of 2nd floor entry door with broken handle and latch missing

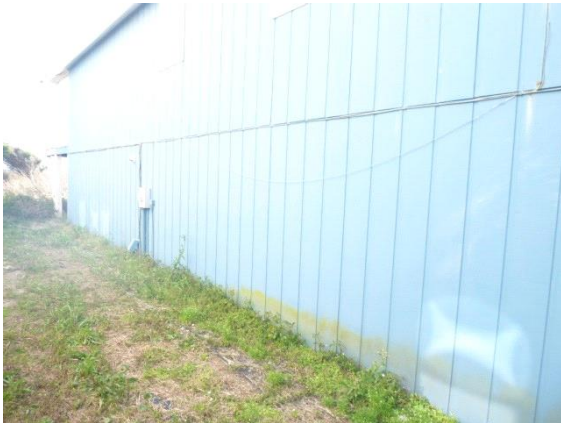
**LIMITATION:** The under-floor framing and support pilings cannot be inspected because the front and rear entry doors to the ground level were locked and the key provided did not access them. Recommend a qualified contractor access and fully evaluate all areas and systems present on the ground floor prior to settlement on the property. The exterior of the support pilings could not be inspected due to the finished exterior walls that have been installed on the ground floor. See Photos.

Under Floor Framing & Support: View of exterior finished walls obstructing support pilings

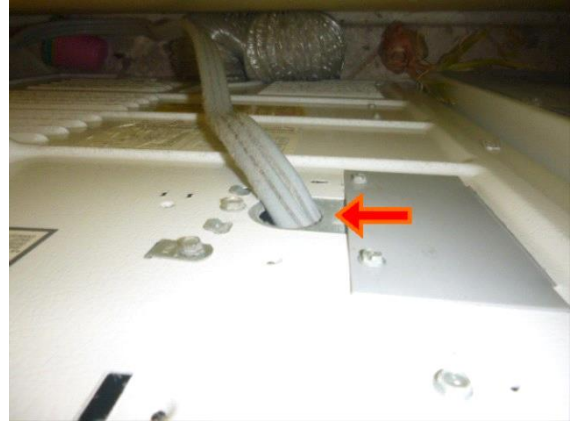
The clothes dryer electric cord does not have the strain relief connector installed. See Photo. This is needed to secure the cord from pulling out of the enclosure, and to prevent the cord insulation from chaffing against the metal housing. Recommend a licensed electrician evaluate and make the necessary repairs.

Laundry Facilities: View of missing strain relief connector on the dryer cord

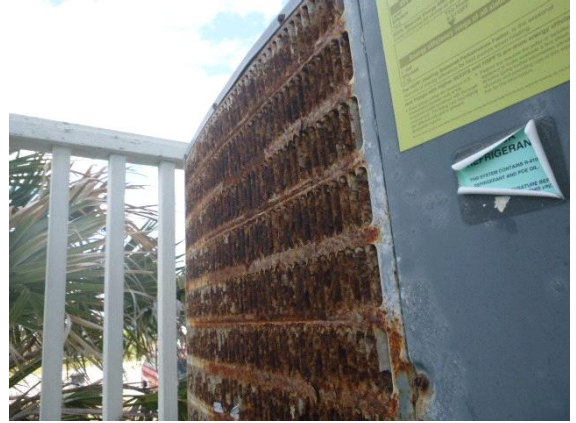
1. There is excessive rust and corrosion present on the HVAC outside condenser unit. See Photos. Evidence suggests this condition will reduce the efficiency of the HVAC system, and that the system may not operate as intended.

Heating: View of one location of excessive corrosion present on the outside condenser unit

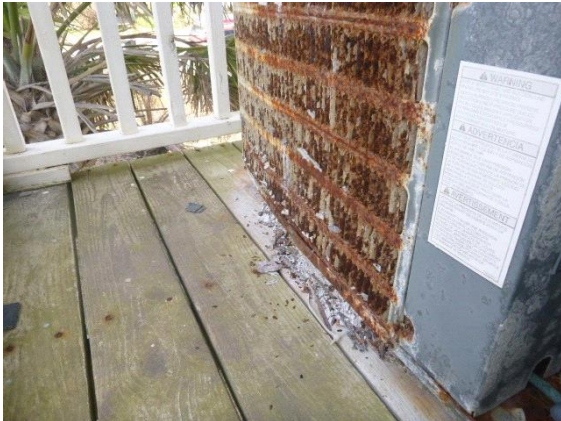
Heating: View of one location of excessive corrosion present on the outside condenser unit

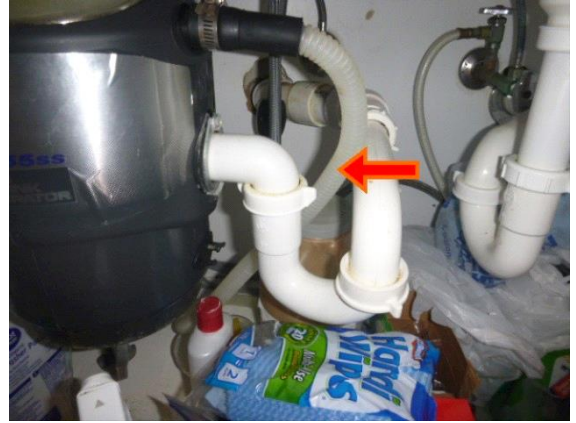
Kitchen: View of dishwasher drain hose with missing anti siphon loop located under the kitchen sink

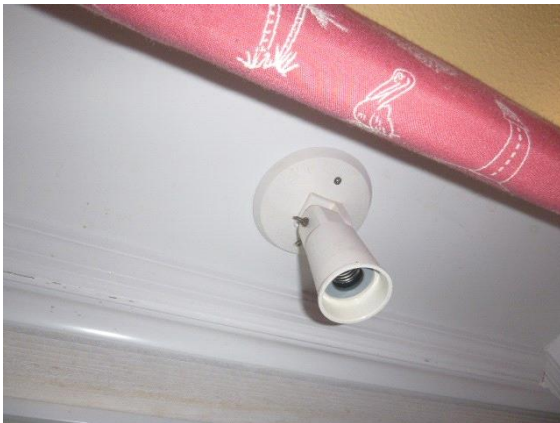
Kitchen: View of bulb missing from kitchen fixture

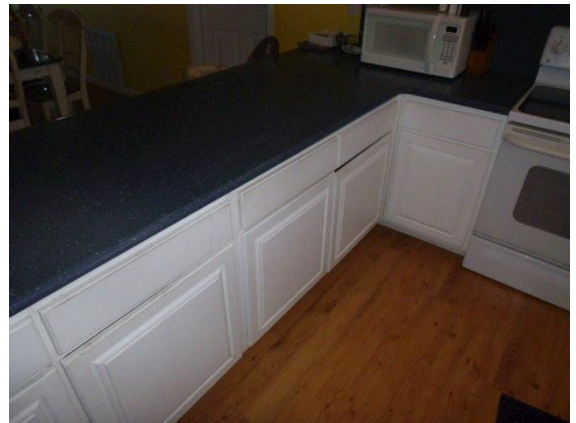
Kitchen: View of kitchen cabinets with no handles present on the doors

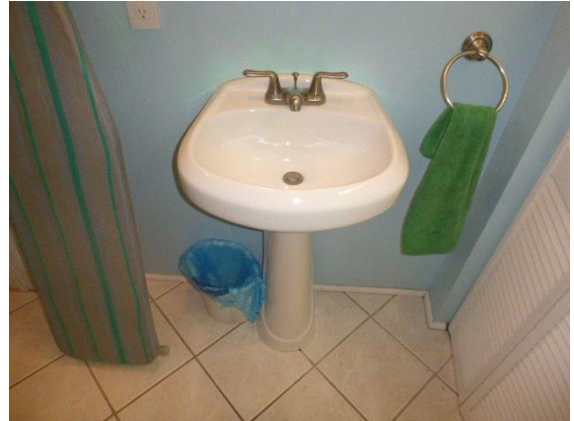
1. The bathroom pedestal sink is loose from the adjacent wall. See Photo. Evidence suggests this condition creates a safety hazard. Recommend a licensed plumber evaluate and make the necessary repairs.
2. The recessed light, located over the shower, does not light when the wall switch is turned on. See photo. Recommend replacing the light bulb, and if it still does not work, recommend a licensed electrician evaluate and make the necessary repairs.

Bathroom #1 -1st Floor Middle : View of pedestal sink loose from wall

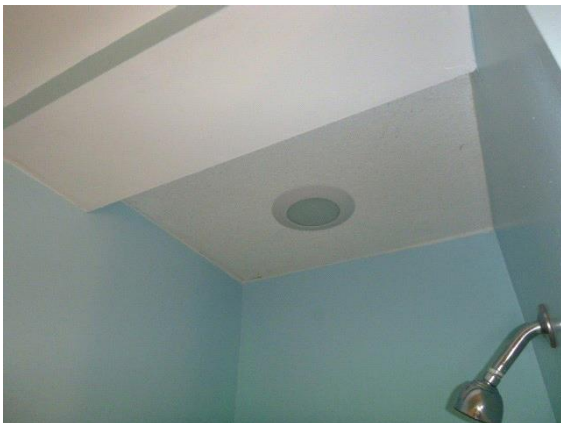
Bathroom #1 -1st Floor Middle : View showing defective recessed light located above shower

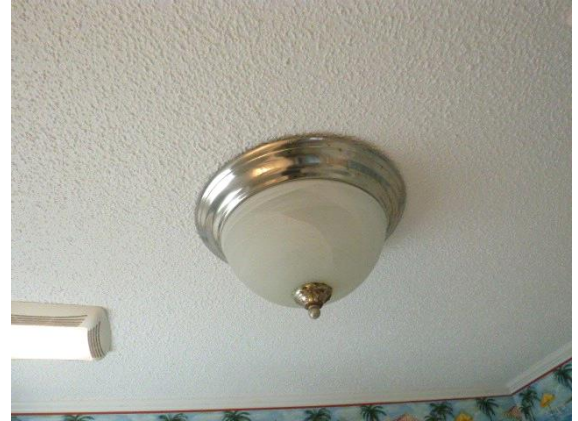
Bathroom #2 - 1st Floor Right: View showing defective bathroom light fixture

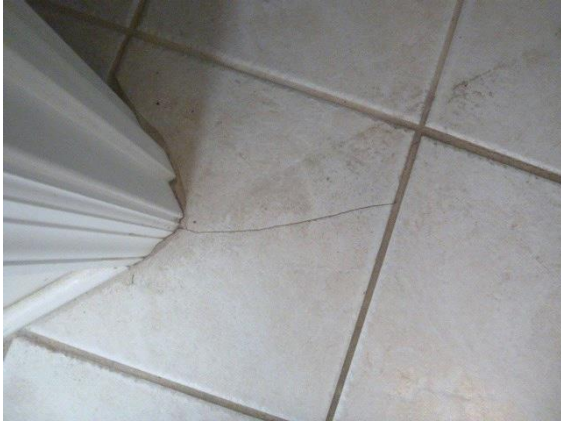
Bathroom #2 - 1st Floor Right: View of cracked bathroom ceramic floor tiles

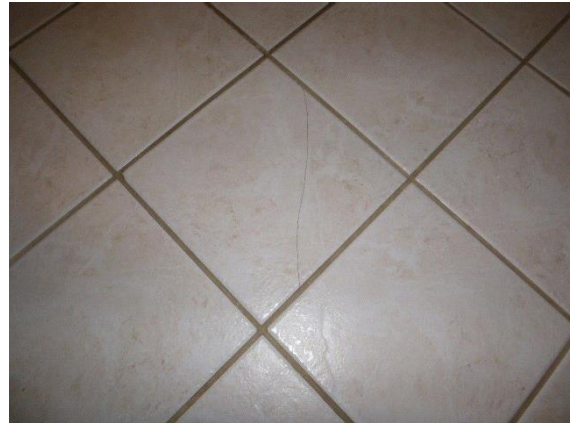
Bathroom #3 - 2nd Floor : View of one location of cracked bathroom ceramic floor tiles

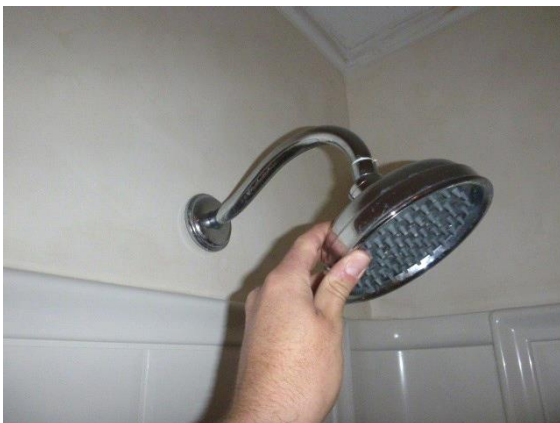
Bathroom #3 - 2nd Floor : View of loose shower faucet

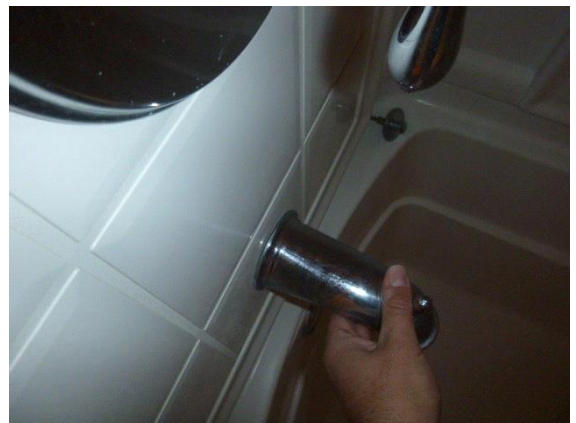
Bathroom #3 - 2nd Floor : View of loose bath tub faucet

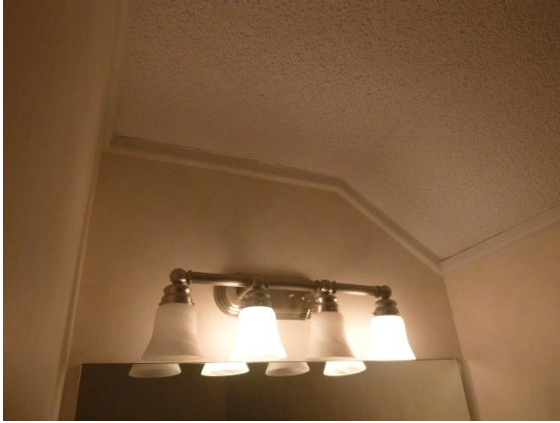
1. Two bulbs in the light fixture, located over the bathroom sink, did not light when the wall switch was turned on. See photo. Recommend changing the light bulbs first, and if the light still does not work, have a licensed electrician evaluate and make the necessary repairs.
  2. The bathtub faucet is loose from the tub enclosure. See photo. Evidence suggests this condition creates an avenue for water intrusion behind the tub enclosure.
  3. The shower body and faucet is loose behind the shower enclosure wall. Evidence suggests this condition will over time result in water leaks, if they are not already present.
  4. The bathroom sink is missing the drain stopper. See photo. The stopper is needed to use the sink in the soak-mode and to prevent items from accidentally going down the drain.
- \*\*Recommend a licensed plumber evaluate items 2, 3, and 4, and make the necessary repairs.

Bathroom #3 - 2nd Floor : View showing defective bathroom light fixture

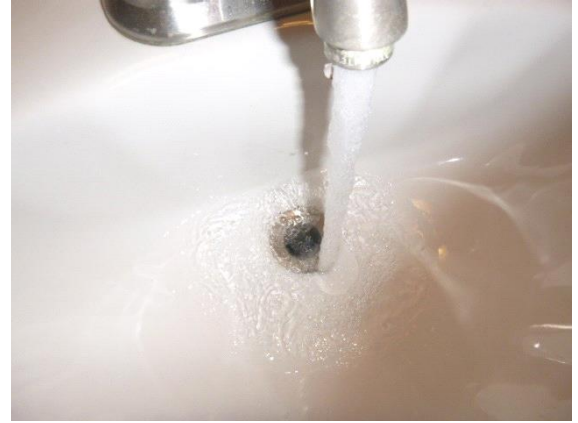
Bathroom #3 - 2nd Floor : View of missing stopper located in the bathroom sink

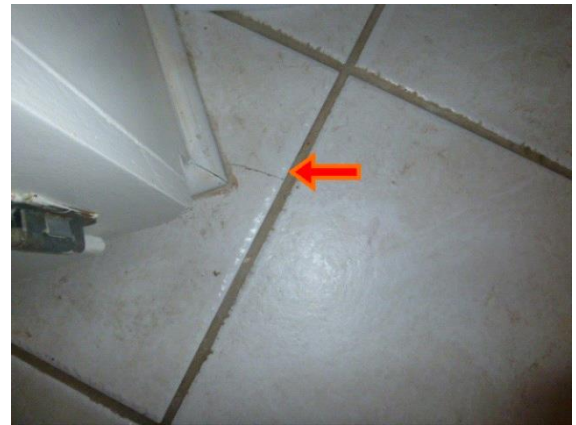
Bathroom #4 -1st Floor Left: View of cracked bathroom ceramic floor tiles

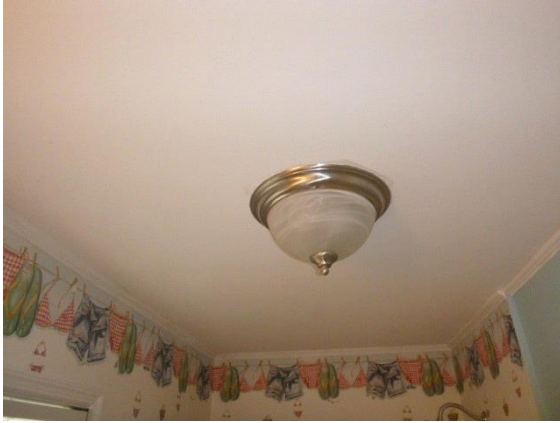
Bathroom #4 -1st Floor Left: View showing defective bathroom light fixture

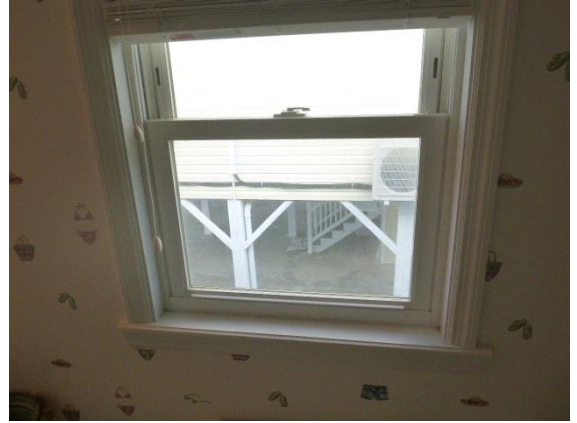
Bathroom #4 -1st Floor Left: View of window that slams shut when operating

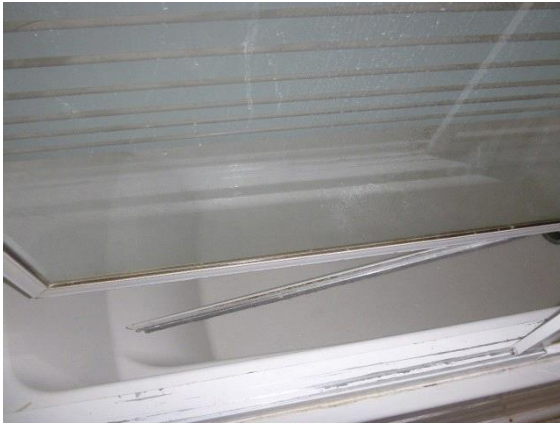
4. The shower enclosure door is damaged at the base and is loose from the operating track. See Photo. Evidence suggests the doors do not operate as intended. Recommend a qualified contractor evaluate and make the necessary repairs.

Bathroom #4 -1st Floor Left: View of damaged shower enclosure door

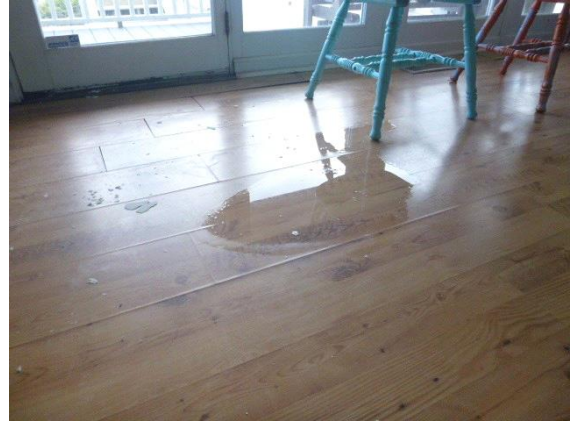
Living Room: View of water noted on living room floor at the time of inspection

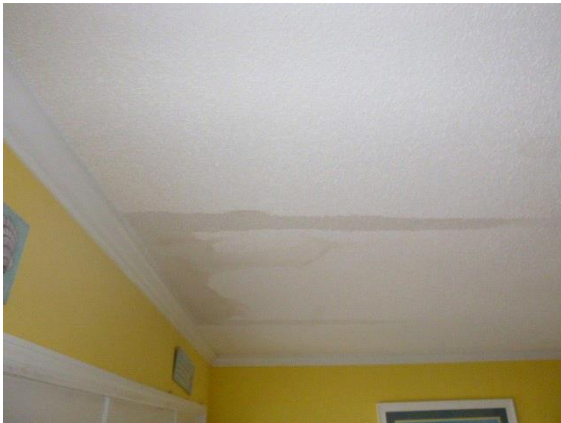
Living Room: View of water stain located on the living room ceiling

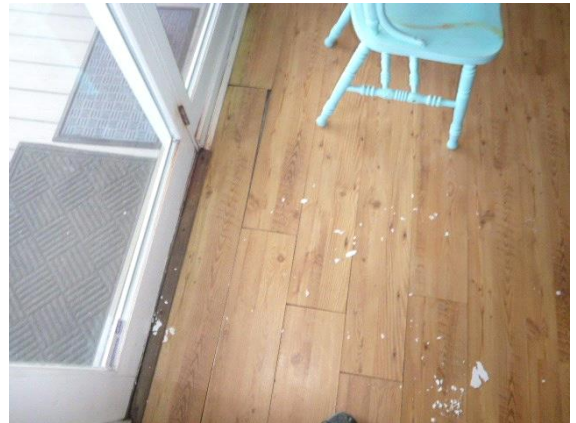
Living Room: View of damaged flooring at rear of living room

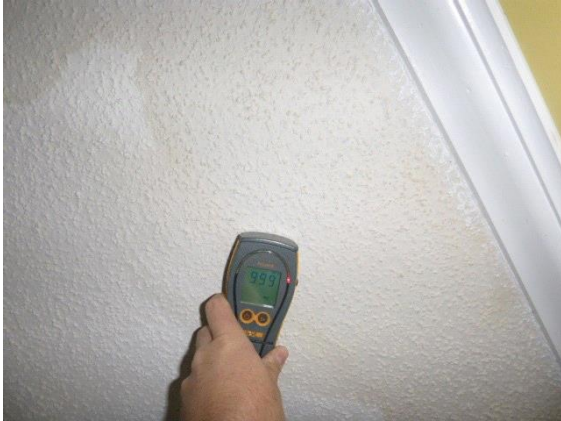
Living Room: View of moisture meter indicating ceiling stains are wet

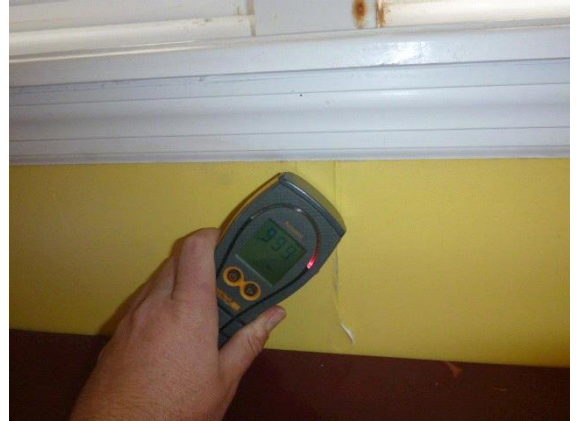
Living Room: View of moisture meter indicating wall stains are wet

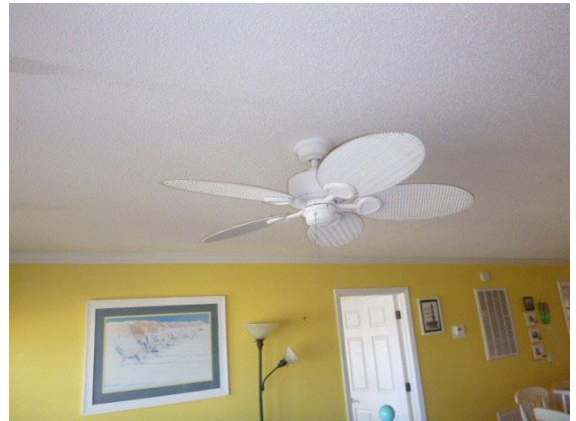
Living Room: View of one location of fan that did not operate

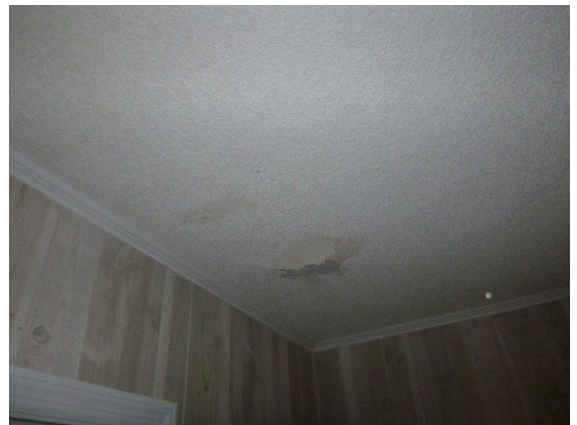
Bedroom #1 - 1st Floor - Front Left : View of one location of water stains present on ceiling

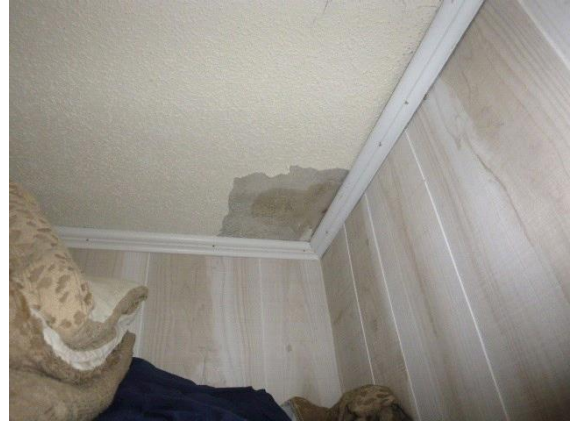
Bedroom #2 - 1st Floor - Front Right : View of water stain located on the bedroom ceiling

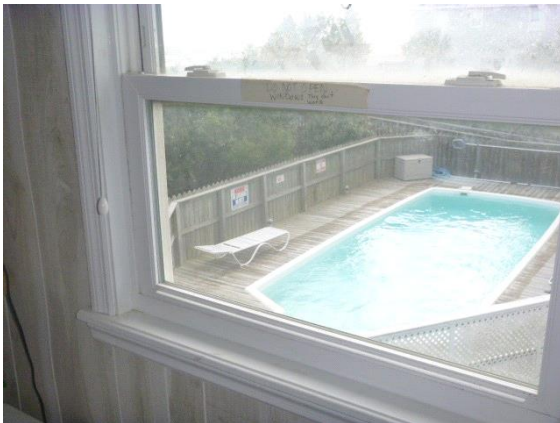
Bedroom #2 - 1st Floor - Front Right : View of window that would not open when using a reasonable amount of force located in the bedroom

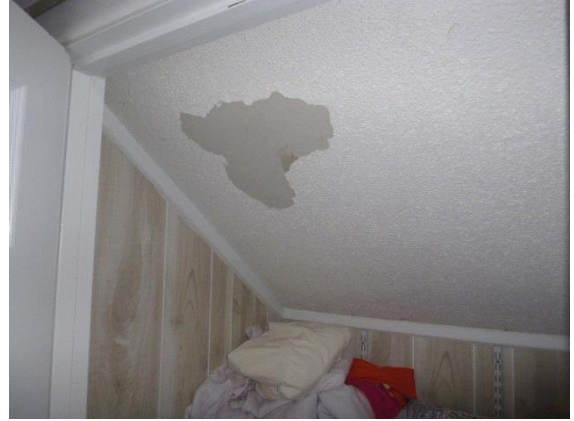
Bedroom #4 - 2nd Floor - Front : View of water stain located on the bedroom ceiling

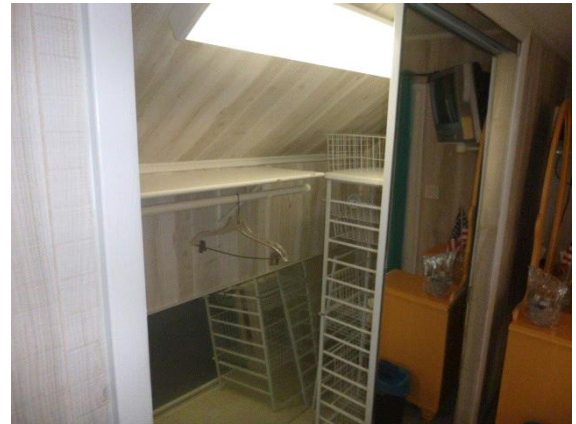
Bedroom #5 - 2nd Floor - Rear : View of one location of missing closet door

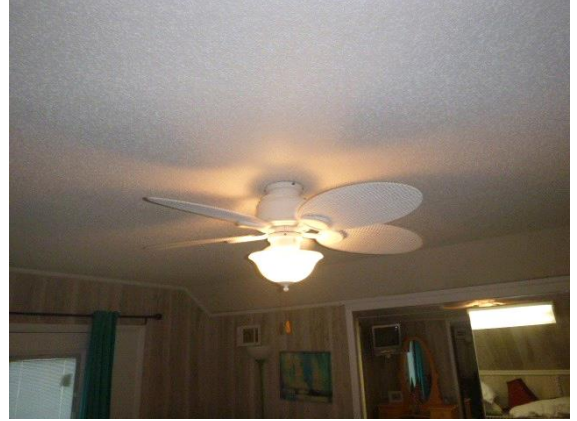
1. The ceiling fan is making excessive noise when running. See Photo. Evidence suggests the fan is not operating as intended. Recommend a licensed electrician evaluate and make the necessary repairs.
2. The left and right side bedroom closets are missing one panel of the closet doors. See Photo. Evidence suggests the closet doors do not operate as intended. Recommend a qualified contractor evaluate and make the necessary repairs.
3. The wall paneling, located throughout the bedroom, was buckled in several areas. See Photo. Evidence suggests the paneling is not operating as intended. Recommend a qualified contractor evaluate this condition, determine the cause and extent of any damage, and make the necessary repairs.

Bedroom #5 - 2nd Floor - Rear : View of noisy bedroom ceiling fan

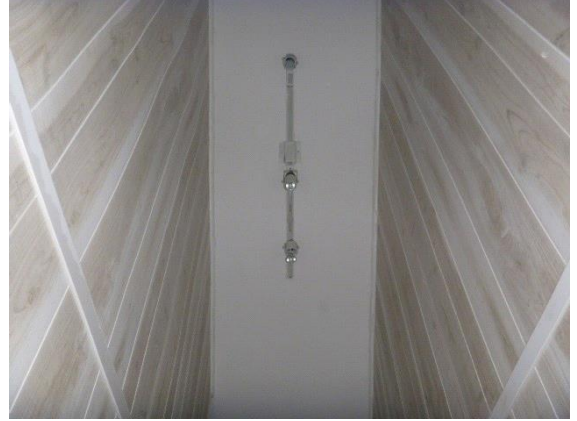
Stairs / Railings: View of defective light fixture located above the stairwell leading up to the 2nd floor
