National Property Inspections

Megan Waesche, 6210 N Ocean Blvd, Myrtle Beach, SC, 29572

Inspection Date:
04/28/2018

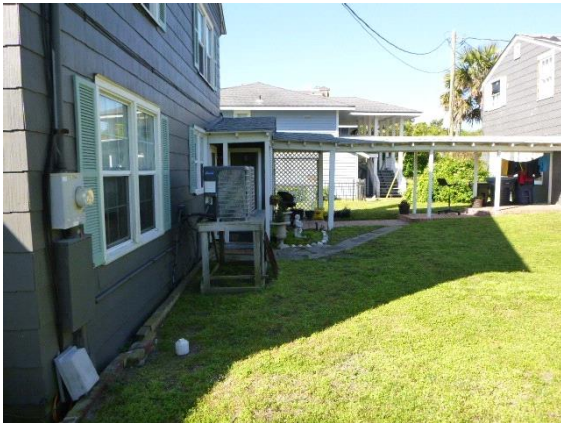
The front and right side of the property have negative slopes. See photos. This means the ground located at the front and right side of the house is pitched toward the foundation. Evidence suggests that during a heavy rain, water is likely to pool up to the foundation walls. Consider having a qualified landscape contractor install additional drainage to prevent any future water damage or water intrusion into the foundation. Recommend a qualified landscape contractor evaluate the grading and make the necessary repairs.

Grading / Drainage: View of front property and grading

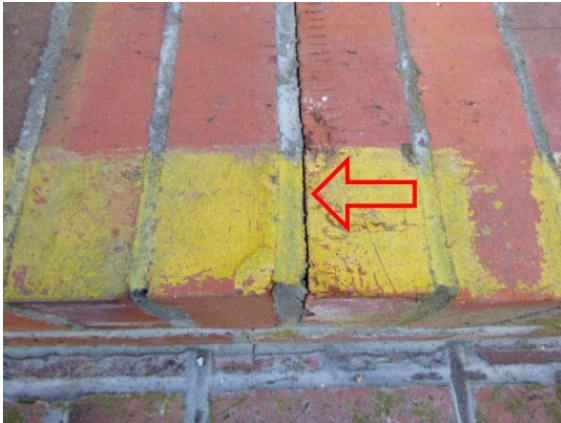
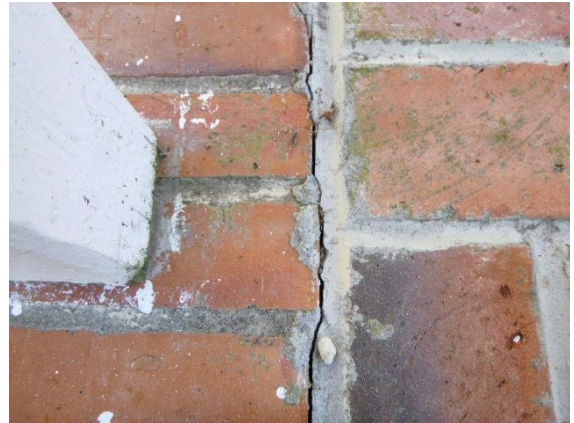
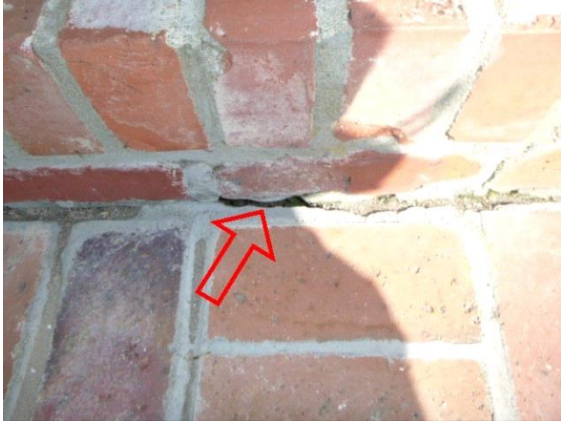
1. The covered brick walkway located in front of the home has several sections with cracked mortar joints. See photos. Evidence suggests this condition has created an avenue for water intrusion. Recommend a qualified masonry contractor evaluate and make the necessary repairs.
2. There is soft, water damaged wood present at the base of the middle left post supporting the roof of the covered brick walkway. See photo. Evidence suggests the damaged wood needs to be replaced to maintain the integrity of the post. Recommend a qualified general contractor to evaluate and make the necessary repairs.

Front Brick Walkway: View of cracked mortar on front brick walkway

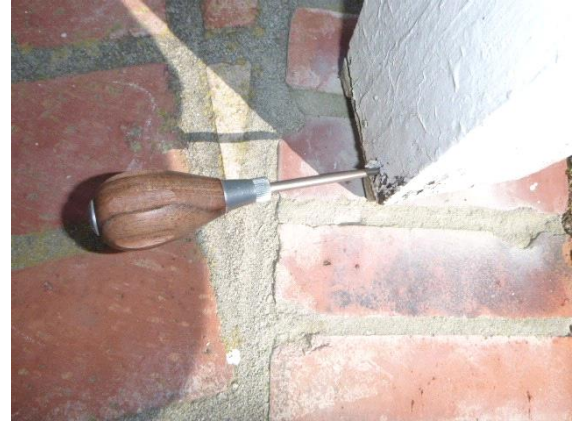
Front Brick Walkway: View of soft water damaged wood at base of support post

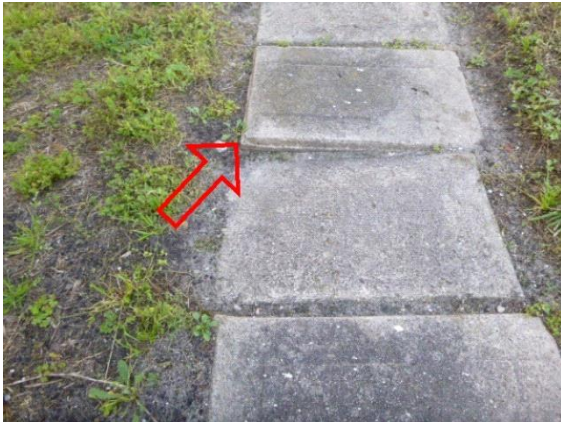
The ground beneath the front paving stone walkway is sunk down and creates an uneven surface. See photo. Recommend a qualified masonry contractor evaluate and make the necessary repairs.

Paver Walkway: View showing height differential of paver walkway

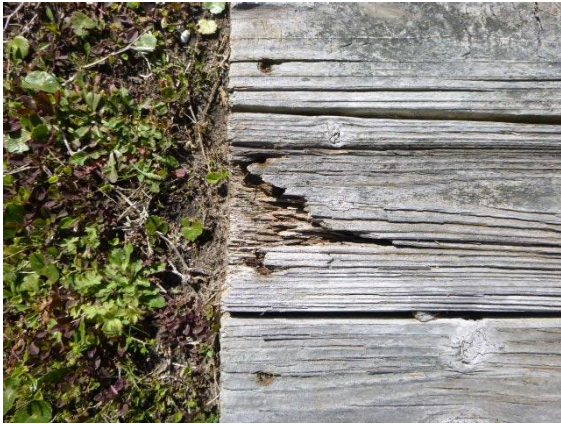
The wooden walkway, located on the left side of the house, has many weathered boards present, several with exposed nails. Several of the boards are bowed creating a trip hazard. See photos. Recommend a qualified general contractor to evaluate and make the necessary repairs.

Rear Wood Walkway: Views of weather boards on rear wooden walkway

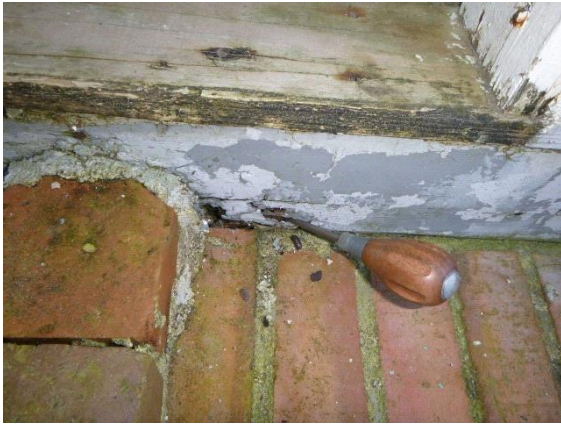
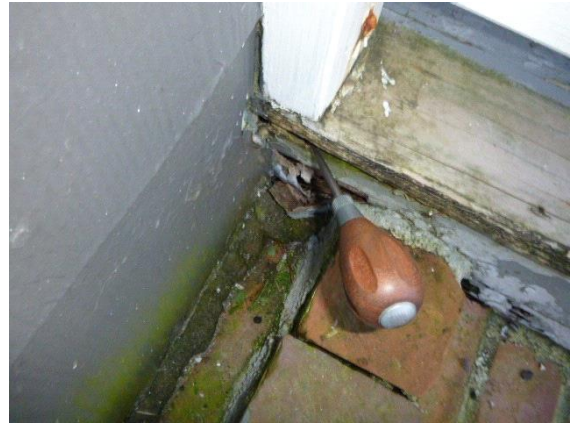
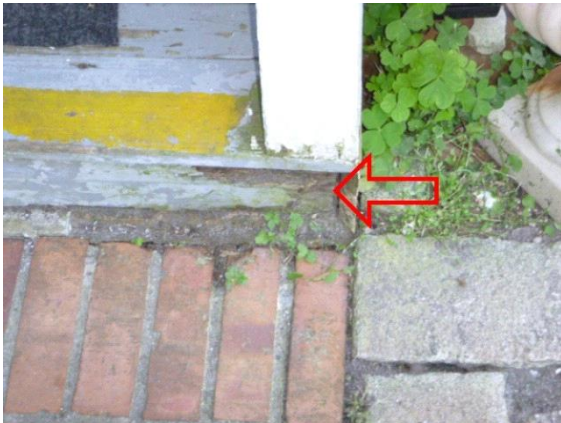
The wooden trim around the base of the decking on the front stoop has soft, water damaged wood present. See photos. Evidence suggests the damaged wood needs to be replaced. Recommend a qualified general contractor to evaluate and make the necessary repairs.

Front Stoop: Views of water damaged wood trim

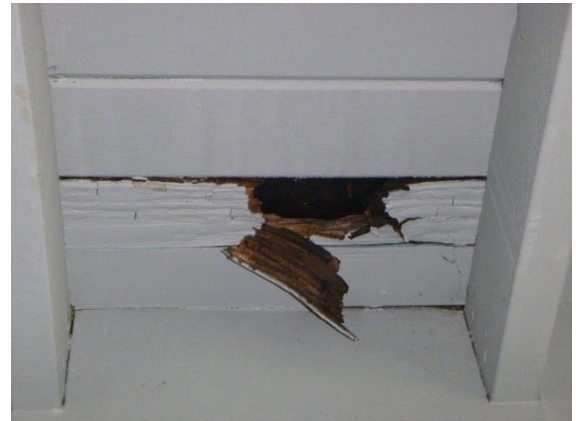
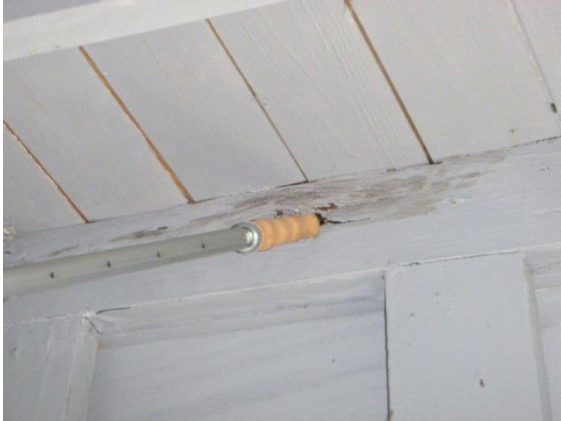
- 1.The ceiling of the enclosed porch has several areas with damaged wood present. See photos. Evidence suggests the damaged wood is a result of water intrusion.

Right Enclosed Porch: Views of soft, water damaged wood present on walls and ceiling of enclosed porch

- ***Recommend a licensed general contractor to evaluate points 1&3 and make the necessary repairs.

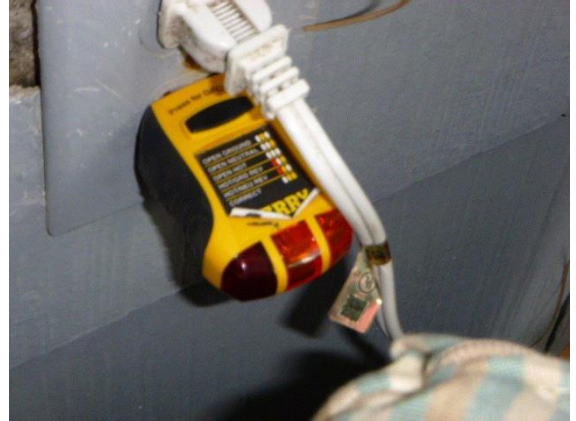
- 5.The wall receptacle, located in the enclosed porch, has no power to it. See photo. The wall receptacle does not function as intended. Recommend a licensed electrician to evaluate and make the necessary repairs.

Right Enclosed Porch: View of wall receptacle with no power

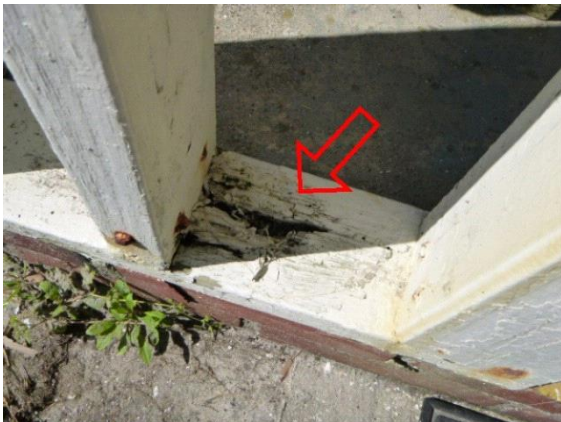
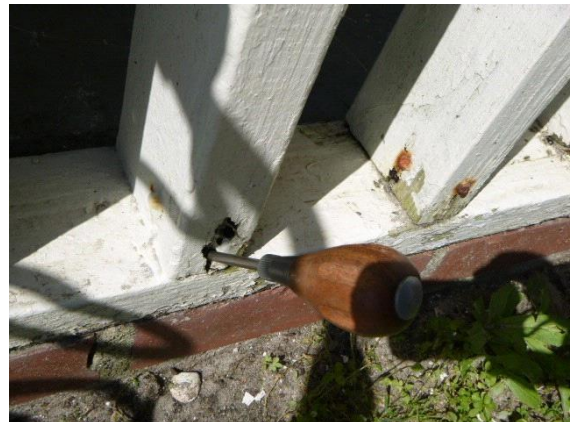
There is soft, water damaged wood present on the wood trim, located on the base of the guardrails, on the covered porch located on the left side of the house. See photos. Evidence suggests the damaged wood needs to be replaced to restore the integrity of the guardrail.

Left Covered Porch: View of soft water damaged wood on base of guardrails

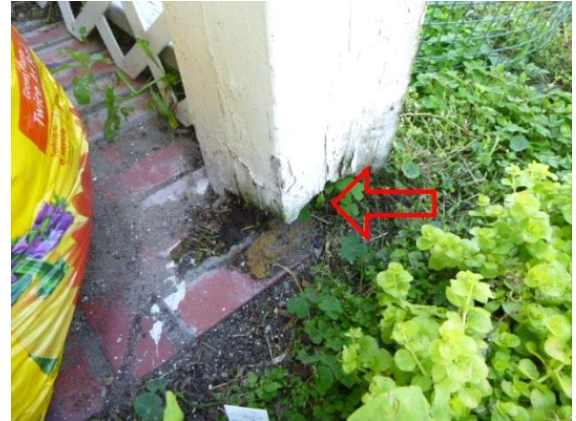
The right and left support posts, for the roof covering the patio, have wood rot present at the bases. See photos. Evidence suggests the damaged wood needs to be replaced to restore integrity of the columns.

Front Brick Patio: Views of water damaged wood at base of columns

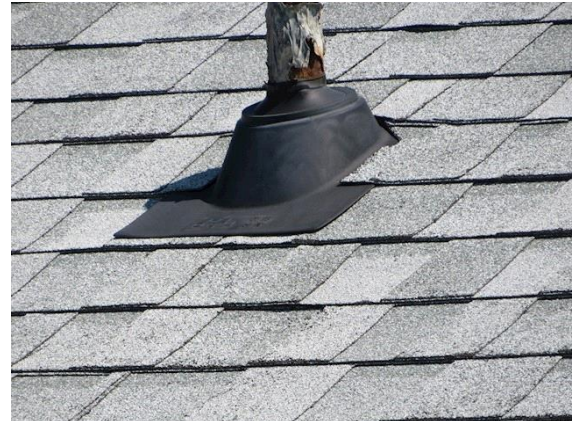
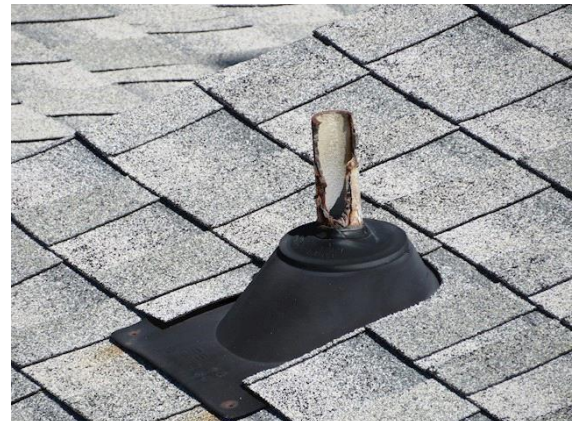
1. The plumbing vent pipes have excessive rust present. See photos. It is difficult to determine when a rusted component may fail.
2. There are exposed nails heads, located at the bottom of the neoprene vent pipe flashings. See photos. Evidence suggests the nail heads need to be sealed with an approved sealant to prevent future leaks.

Flashing/Valleys: Views of heavily corroded plumbing vents

Flashing/Valleys: Views of heavily corroded plumbing vents and flashing with exposed nail heads

***Recommend a qualified roofing contractor evaluate points 1&2 and make the necessary repairs.

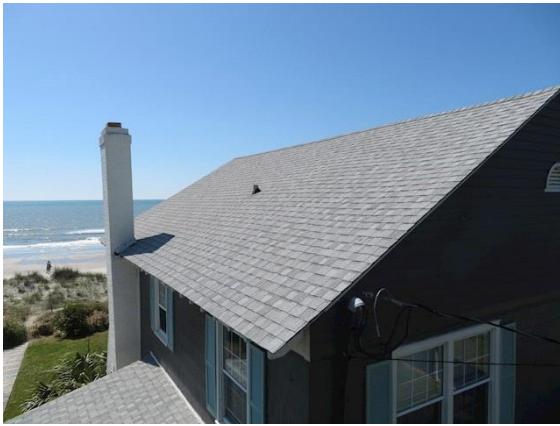
3. The external masonry chimney, located on the left side of the house, appears to be leaning and separating away from the home with cracked mortar present. See photos. This is could be due to inadequate footings or unconventional construction.

Chimney: View of left chimney pulling away from house

***Recommend further evaluation of both chimneys by a qualified masonry contractor or structural engineer to reinstate the structural integrity/stability of the chimneys.

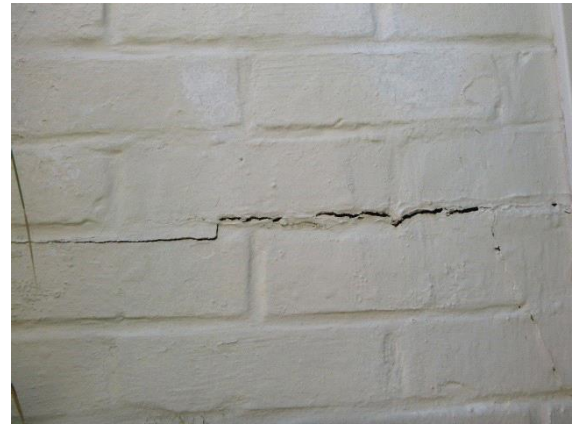
Chimney: View of cracked mortar on left chimney

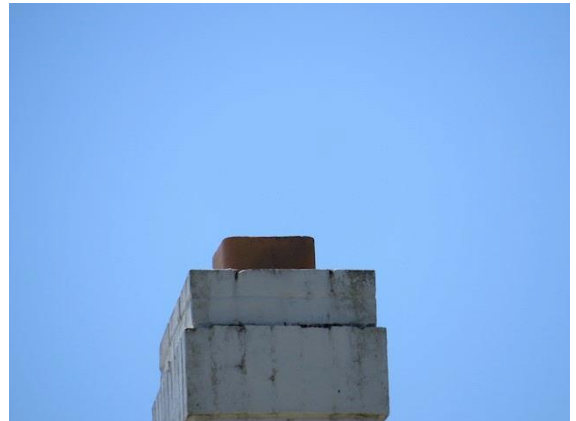
Chimney: View of missing rain cap

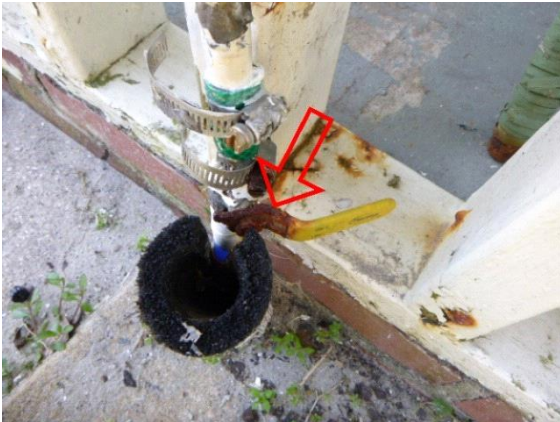
1. The exterior faucet located on the left side of the home has a rusted control valve. See photo. Evidence suggests that the corroded valve could fail and cause a water leak. Recommend a licensed plumber evaluate and make the necessary repairs.

Exterior Surface: View of rusted water valve on exterior water faucet

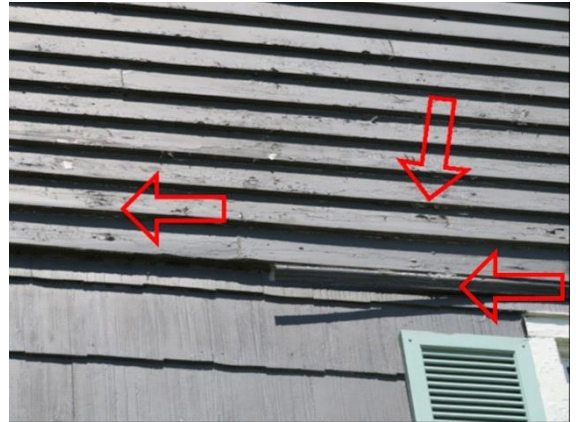
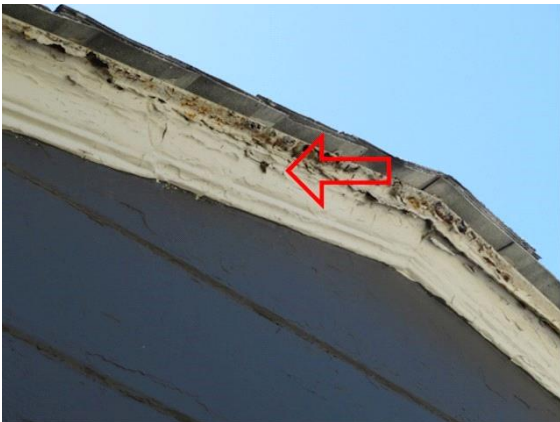
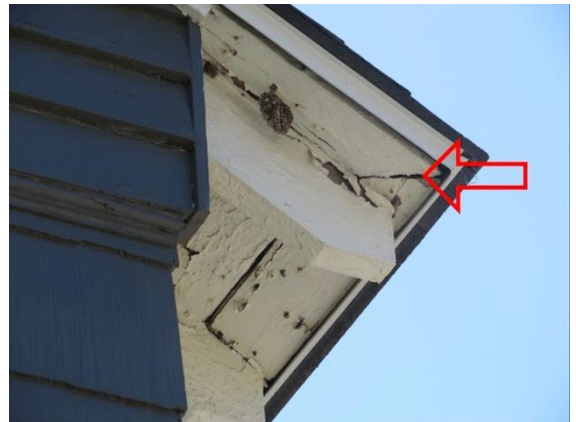
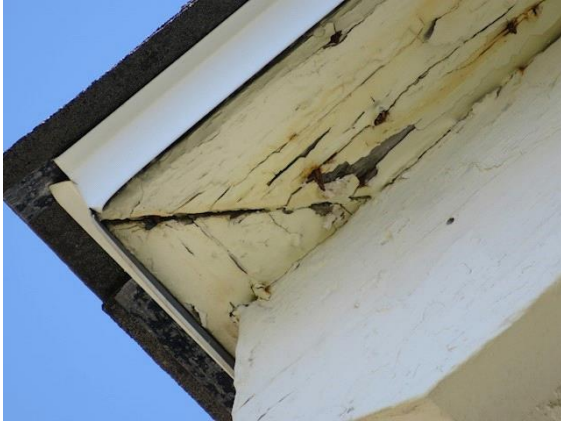
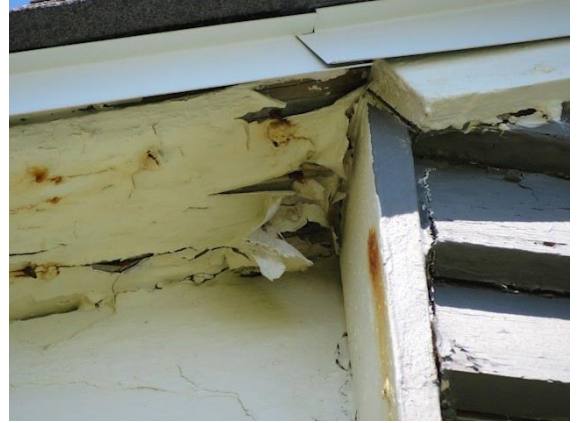
2. There is soft, water damaged wood present on the exterior wood siding located, in the front and rear, above the second floor of the home, and on the eaves around the perimeter of the house. See photos. Evidence suggests the decaying wood has created avenues for water intrusion. Recommend a licensed general contractor to evaluate and make the necessary repairs.

Exterior Surface: Sample view of water damaged wood siding

Exterior Surface: View of water damaged rake board on front of home

Exterior Surface: View of water damaged eaves around home

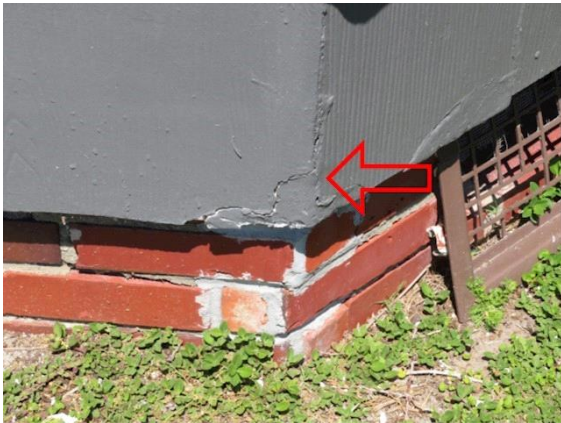
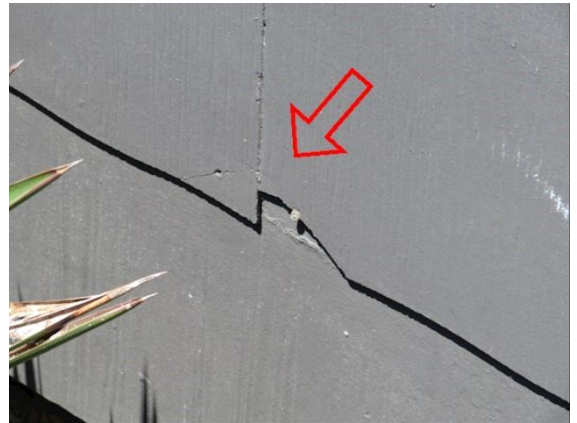
3. The siding on the home appears to be asbestos shingles. Many of the shingles are cracked and have created avenues for water intrusion into the wood framing behind the siding. See photos. Recommend having the shingles tested by an asbestos inspector before having a qualified siding contractor evaluate and make the necessary repairs.

Exterior Surface: Views of cracked composite siding

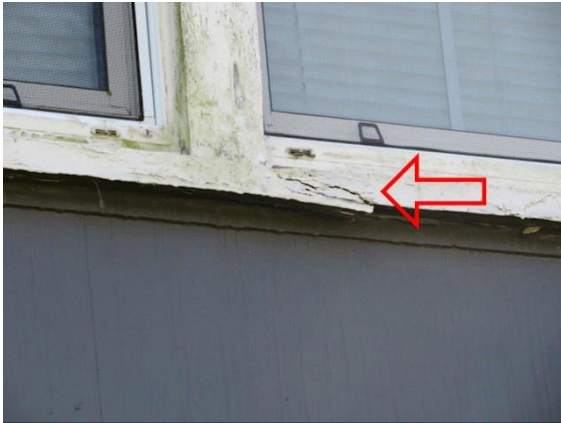
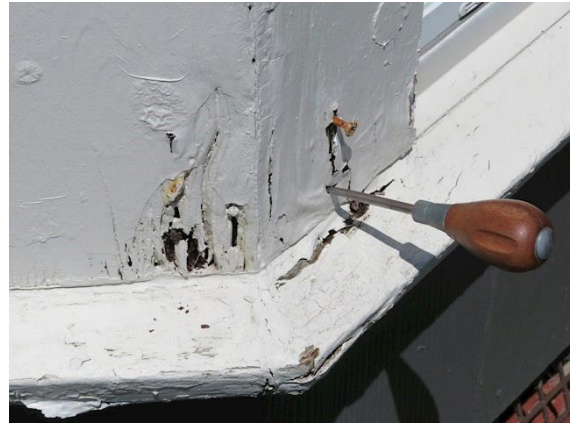
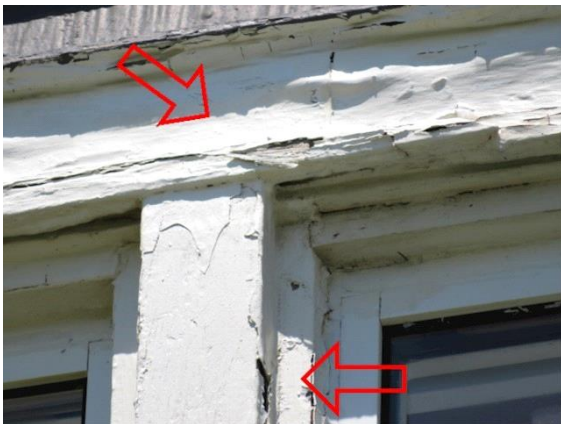
2. There are several windows that have soft wood (water damage) around the window casing, the sill and the window frames. See photos.

Windows: Views of damaged wooden window frames

***Recommend a licensed general contractor to evaluate all windows and make the necessary repairs.

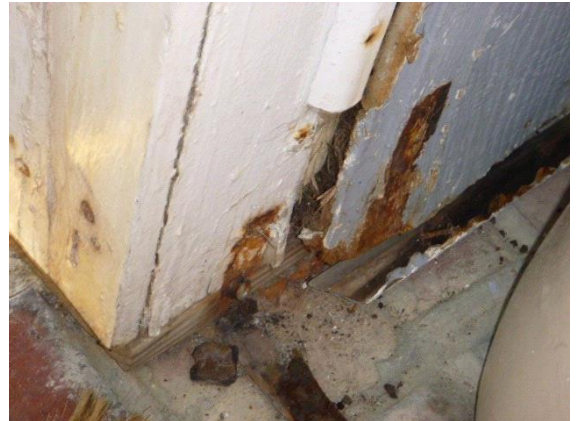
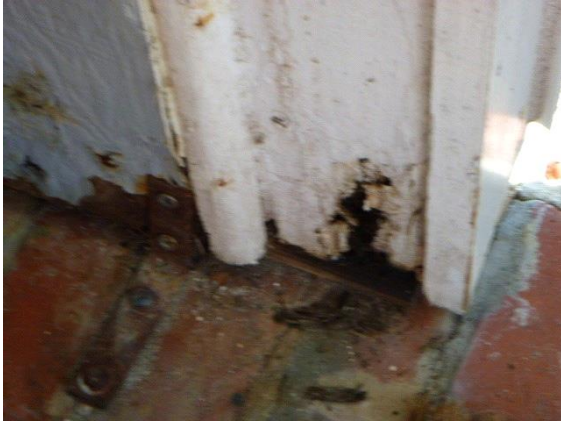
- 1.The rear entry door for the enclosed porch, located on the right side of the home, is hitting the top of the frame when closing and has soft, water damaged wood present at the base of the frame. The door frame itself is cracked on the interior, hinge side of the door. See photos.

Exterior Doors: View of water damaged wood on base of rear door frame

***Recommend a qualified general contractor to evaluate points 1-4 and make the necessary repairs.

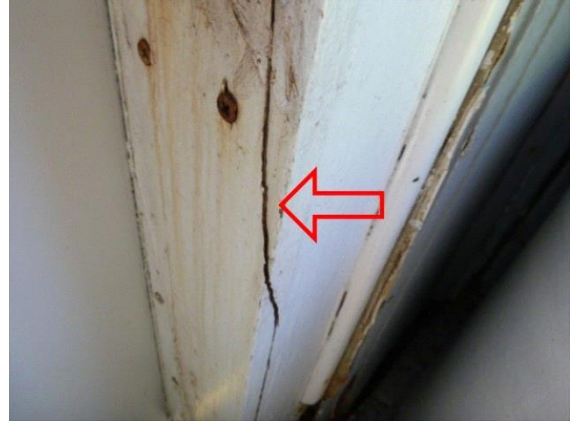
Exterior Doors: View of cracked rear door frame

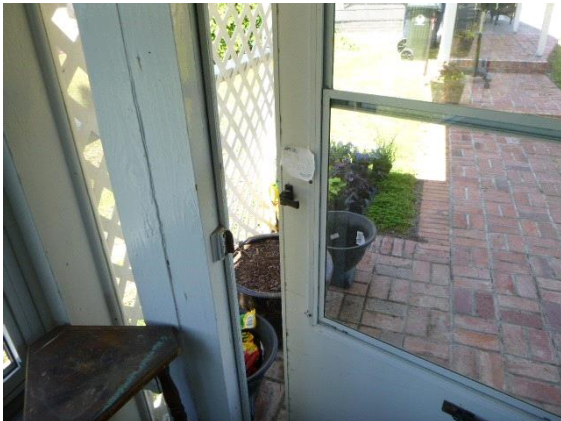
- 2.The front entry storm door for the enclosed porch, located on the right side of the home, does not latch when closing. The wood trim at the top of the door frame is damaged and in need of repair. See photos.

Exterior Doors: View of front storm door not closing properly

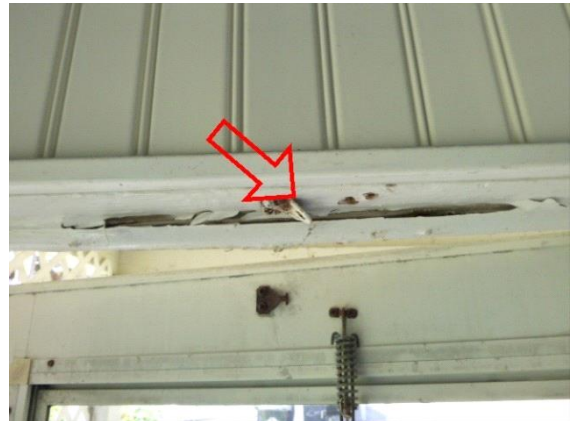
Exterior Doors: View of damaged wood trim on front storm door frame

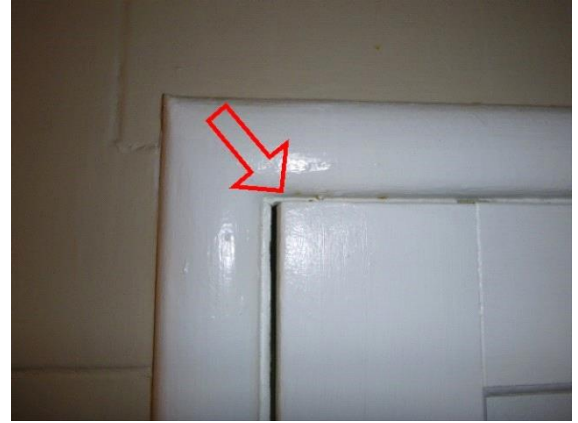
Exterior Doors: View of wooden side entry door hitting top of door frame when closing

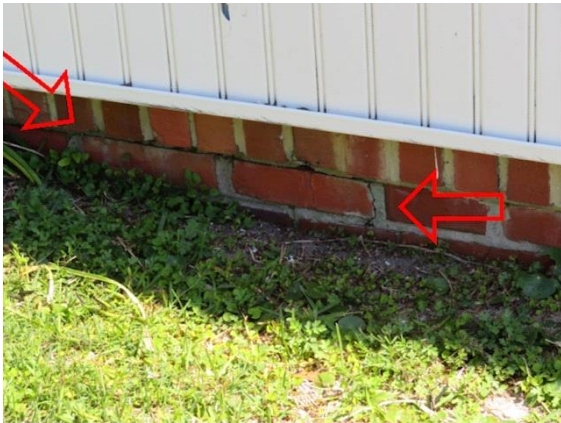
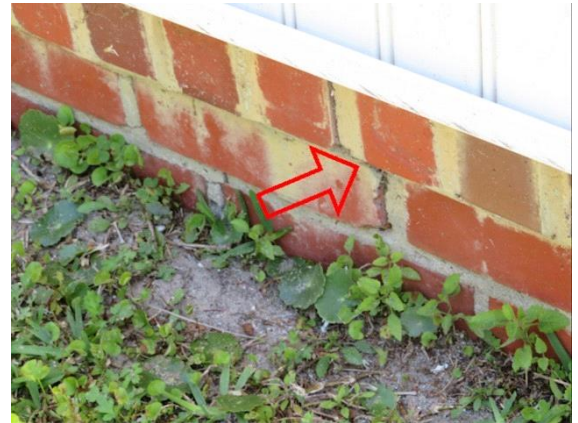
There are cracks present in the brick foundation on the left and right sides of the house. See photos. Evidence suggests this condition is due to ground settlement. Recommend a qualified mason contractor to evaluate the cracks and make the necessary repairs.

Foundation - Slab: Views of cracks in mortar on brick foundation wall

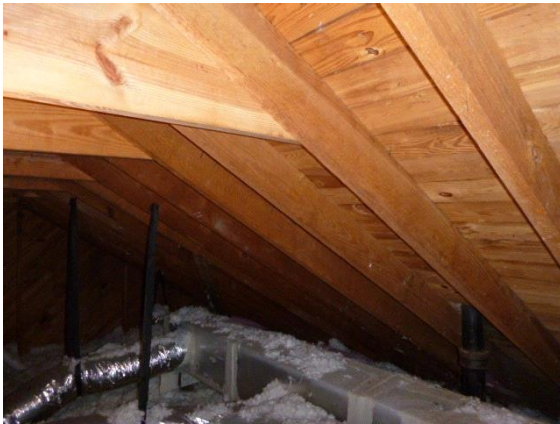
The attic framing consisted of 2" x 6" roof rafters with purlins that are 16 inches on center with tongue and groove sheathing. See photo. The framing and sheathing are in acceptable condition.

Attic Framing/Sheathing: Views of attic framing and sheathing

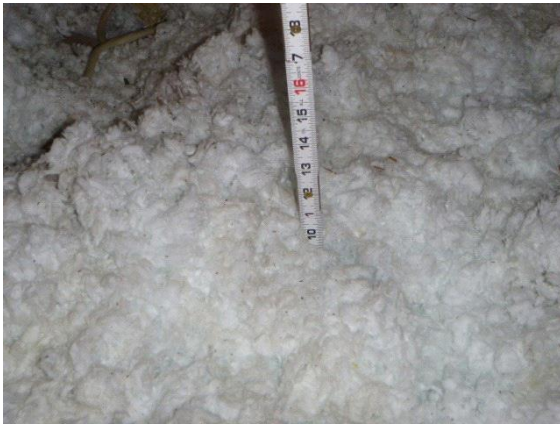
There is 10 to 12 inches of loose fill type fiberglass insulation present in the attic area and it is evenly distributed. The attic insulation has an R value of R30 and is in acceptable condition.

Attic Insulation: View showing the depth of insulation located in the attic

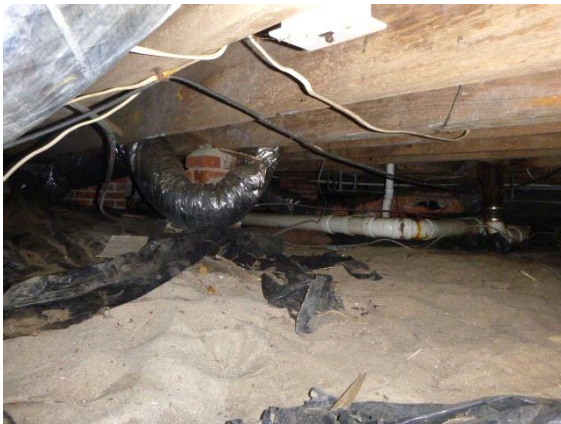
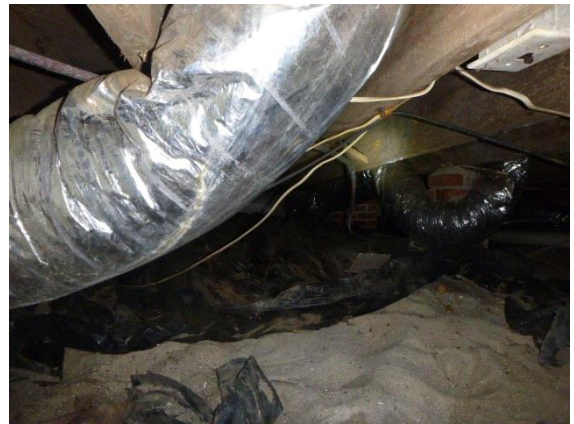
Limitation: Due to ductwork, plumbing and overall height clearance I was unable to inspect the interior foundation, under floor framing and support and the crawl space. See photos.

Interior Foundation: Views showing ductwork, plumbing and ground to joist clearance in crawl space

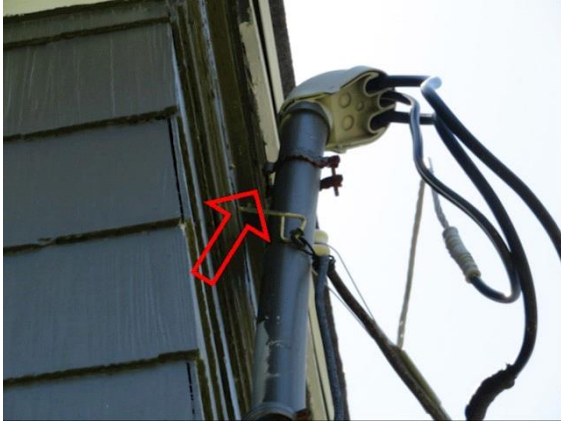
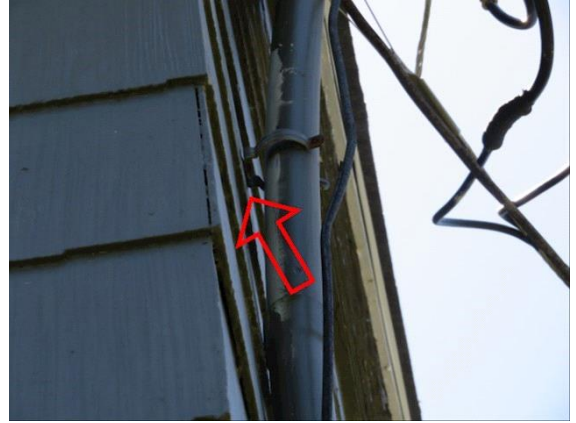
- 1.The metal brackets used to secure the electrical service mast to the home have detached which is causing the mast to lean away from the home. See photos. Evidence suggests the corroded brackets should be replaced for safety purposes.

Electrical: Views of detached/corroded brackets on electrical mast

***Recommend a licensed electrician evaluate points 1-4 and make the necessary repairs.

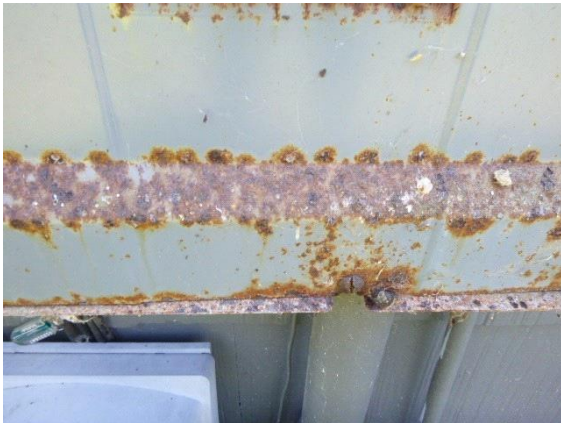
- 2.The main electrical panel, located outside under the electric meter, has excessive rust on the covers and along the backside of the enclosure. See photo. Evidence suggests this condition is preventing access to the main circuit breaker, which has created a safety hazard.

Electrical: View of excessive corrosion on main electrical panel

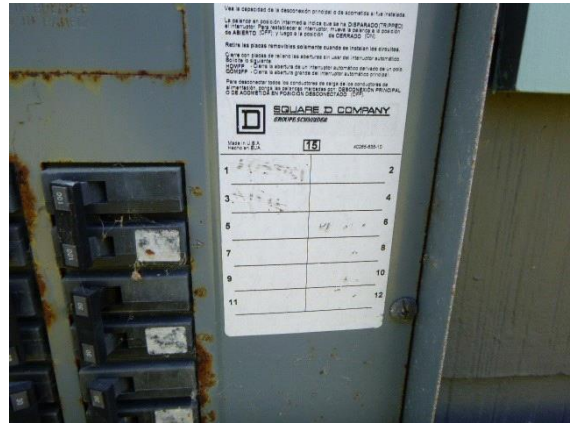
Electrical: View of main panel not labeled

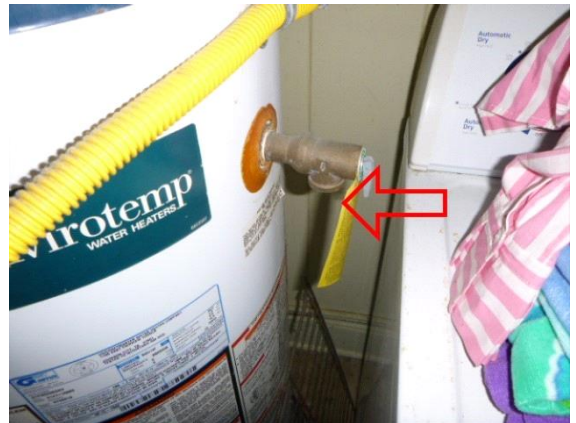
1. The gas exhaust vent located at the top of the water heater is not properly aligned. See photo. Evidence suggests this condition is allowing the exhaust to enter the laundry room.
2. The T/P relief valve located on the side of the water heater is missing the extension tube which is needed to divert the hot water down and away from harm's way in the event the safety valve opens. See photo.
3. There is excessive rust and corrosion present at the hot water copper pipe fitting, located at the top of the water heater. See photo. When there is heavy corrosion present at a plumbing fitting, it is difficult to predict when the joint may fail.

Water Heater: View of missing TPR valve extension pipe on the side of water heater

***Recommend a licensed plumber to evaluate points 1-3 and make the necessary repairs.

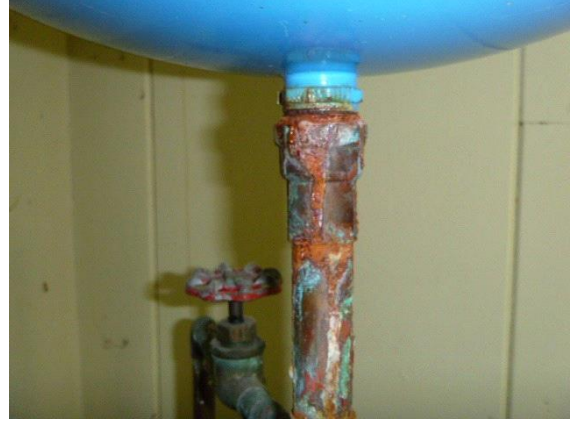
Water Heater: View of excessive corrosion present at base of the fitting located at the top of water heater

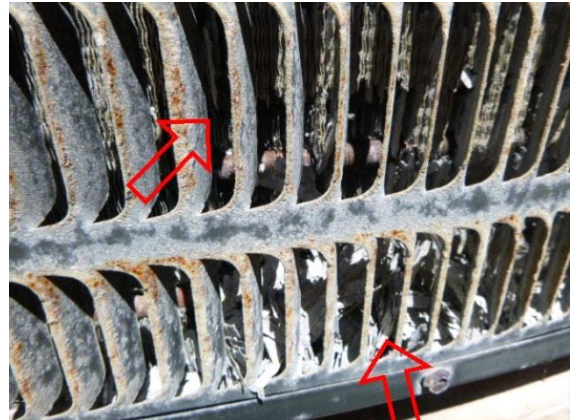
Downstairs Cooling : View of excessive corrosion on HVAC condenser and coils

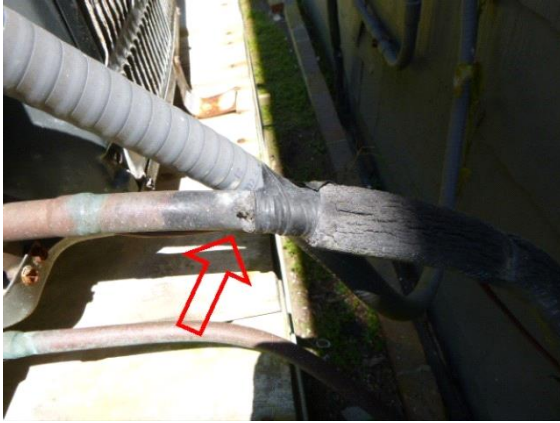
Downstairs Cooling : View showing the deterioration on the foam insulation on low pressure suction line leading into the HVAC condenser

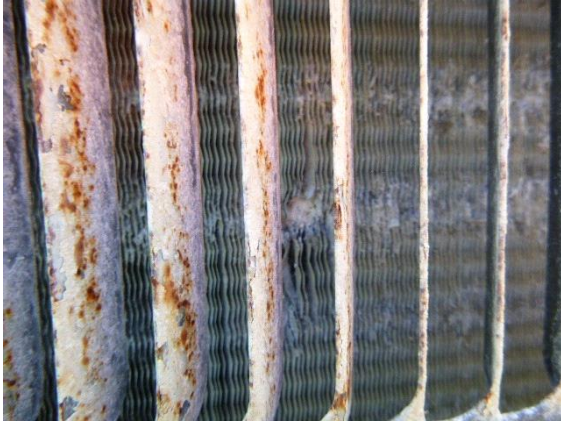
Upstairs Cooling: View of excessive corrosion on HVAC condenser and coils

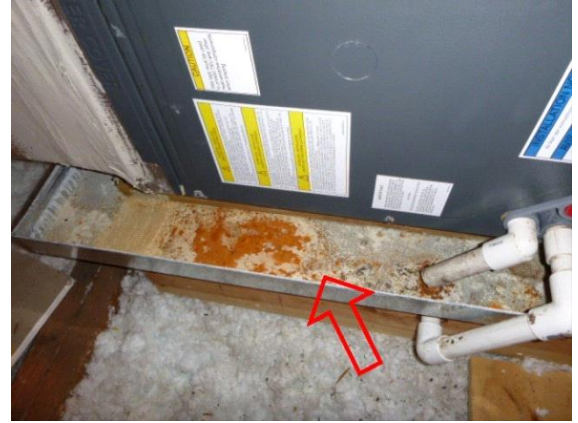
Upstairs Cooling: View of corrosion in catch pan under air handler located in attic

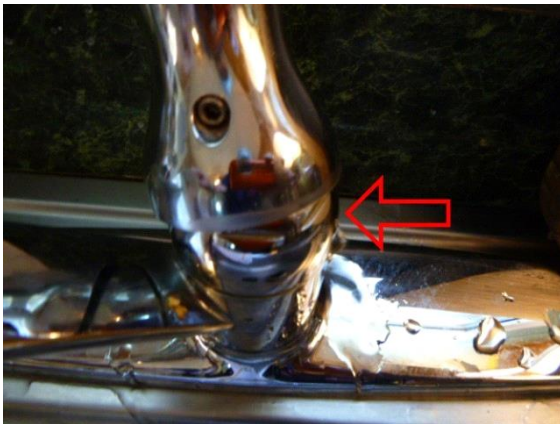
Kitchen: View of kitchen faucet leaking from below handle

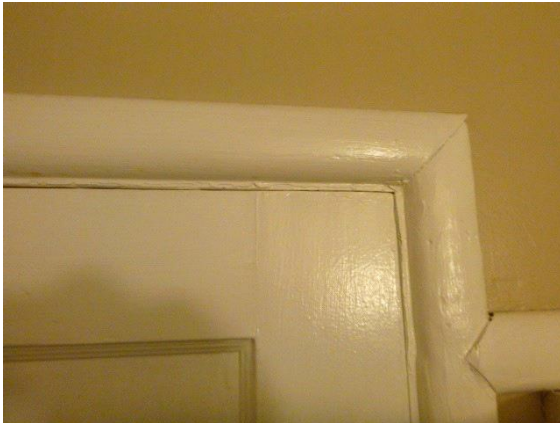
1. The bathroom entry door is hitting the upper door jamb when trying to close the door. See photo. Evidence suggests that the door is not hanging square in the door frame and needs adjustment. Recommend a qualified general contractor evaluate and make the necessary repairs.
2. The bathroom ceiling exhaust fan did not turn on when activating the wall switch. The bathroom exhaust fan does not function as intended. Recommend a licensed electrician evaluate and make the necessary repairs.
3. The light inside of the exhaust fan does not work. See photo. Recommend replacing the light bulb, and if the light still does not work, have a licensed electrician evaluate the light fixture and make the necessary repairs.

Downstairs Bathroom: View of bathroom entry door sticking in door frame

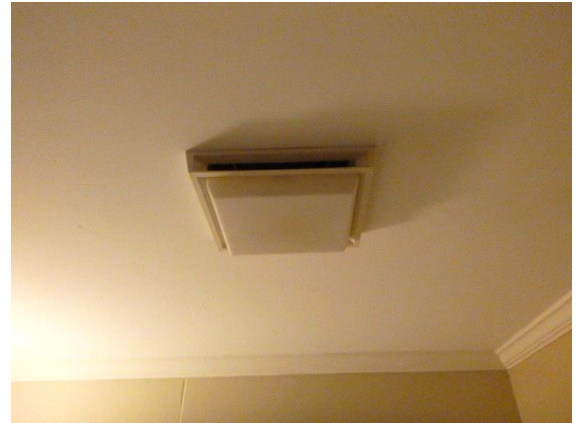
Downstairs Bathroom: View of defective bathroom exhaust fan and ceiling light

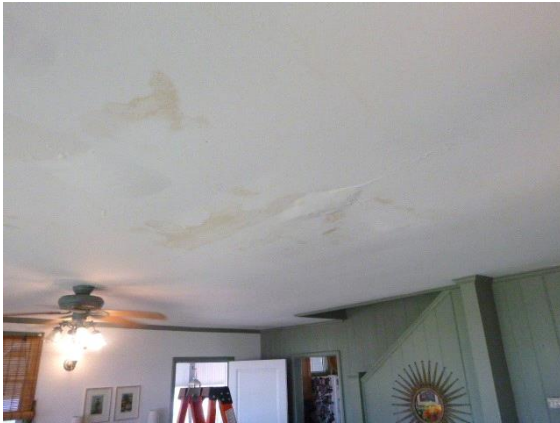
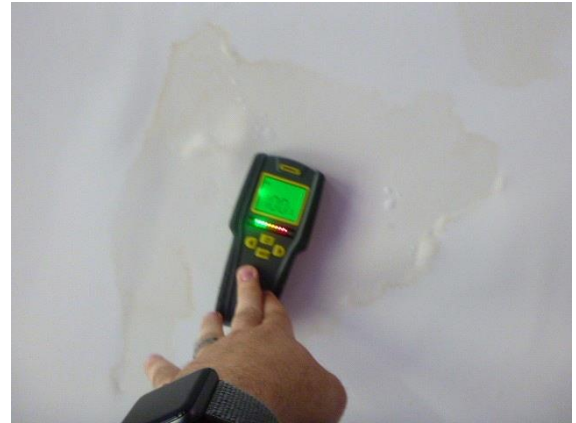
Living Room: Overall view of water stain on living room ceiling

Living Room: Overall view of water stain on living room ceiling with moisture meter

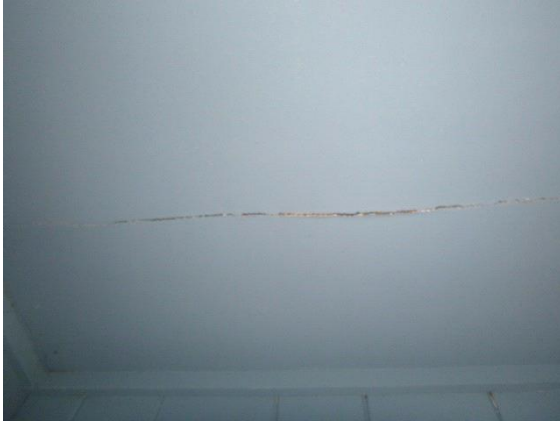
Upstairs Front Right Bedroom: View of cracked ceiling in bedroom closet

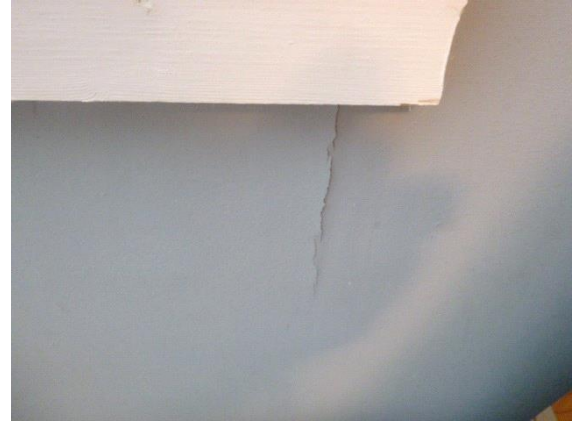
Upstairs Front Right Bedroom: View of wall crack below bedroom window

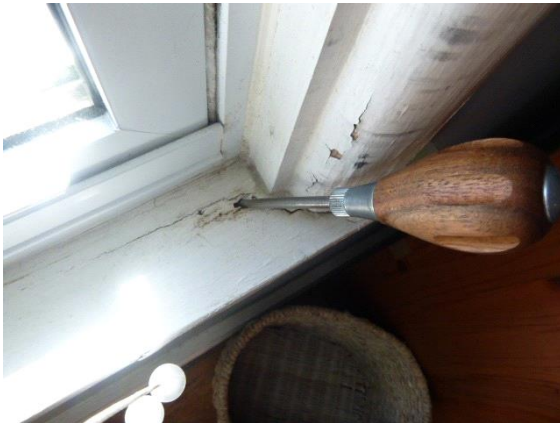
Upstairs Front Right Bedroom: View of water damaged window sill

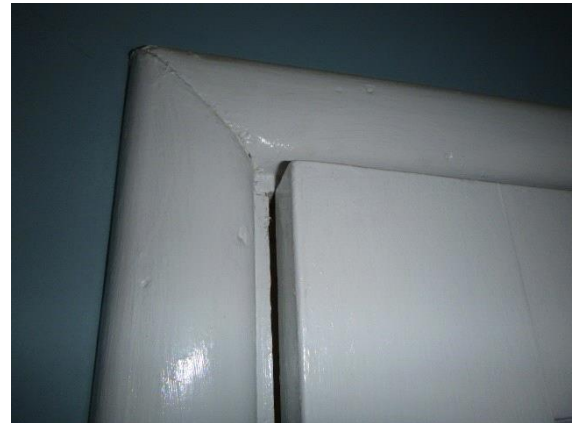
Upstairs Front Right Bedroom: View of bedroom entry door hitting top of door frame

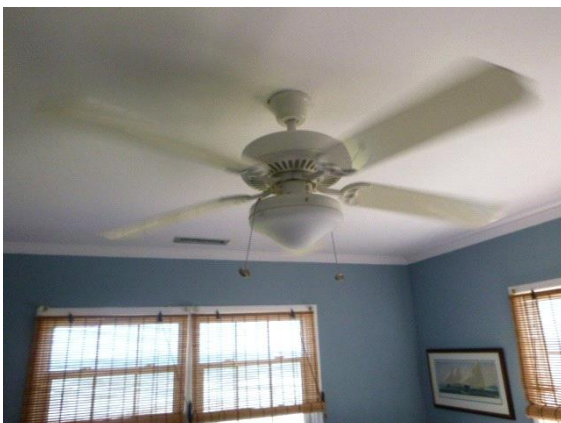
Upstairs Rear Right Bedroom: View of defective fan light in bedroom

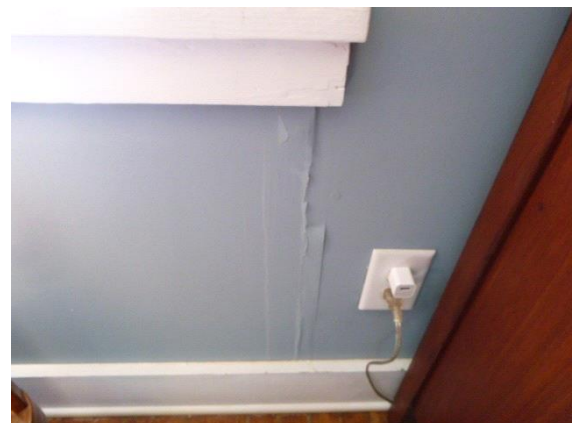
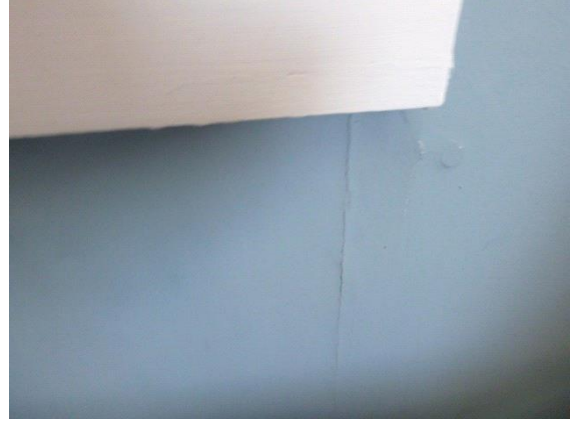
3. There are settlement cracks on the walls located above and below the bedroom windows. See photos. This type of cracking is likely due to settlement in accordance with the age of the home. Recommend a qualified painting contractor evaluate and make the necessary repairs.

Upstairs Rear Right Bedroom: View of settlement cracks in walls above and below windows

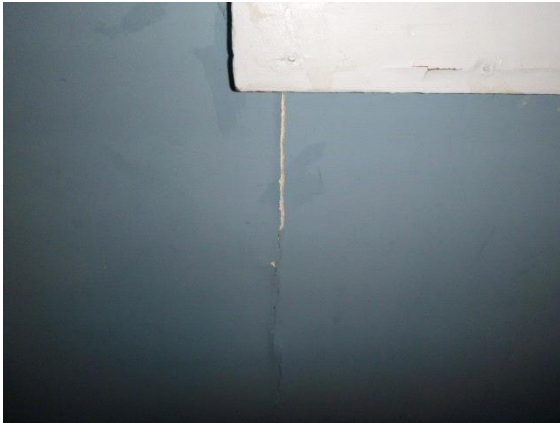
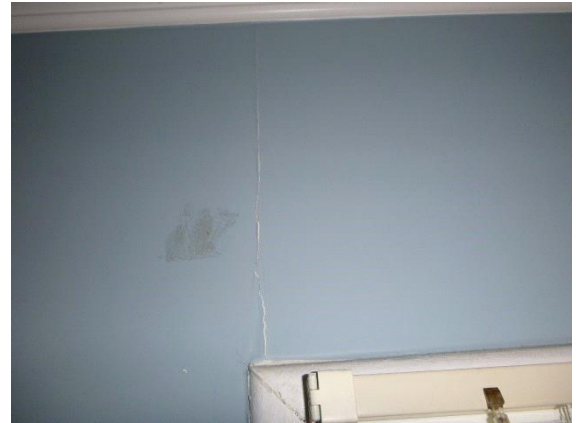
There are settlement cracks on the wall located above and below the bedroom rear window. See photos. This type of cracking is likely due to settlement in accordance with the age of the home. Recommend a qualified painting contractor evaluate and make the necessary repairs.

Upstairs Front Left Bedroom: View of settlement cracks in walls above and below windows

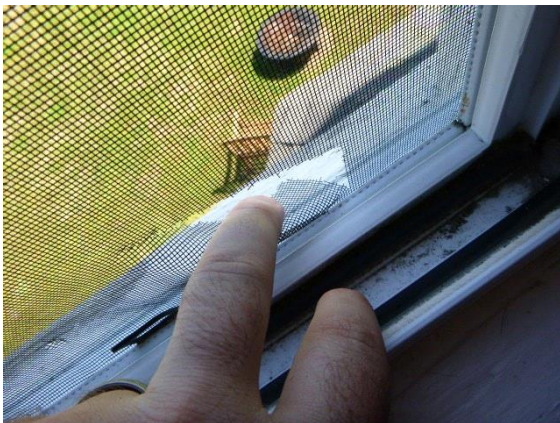
Upstairs Rear Left Bedroom: View of hole in bedroom window screen

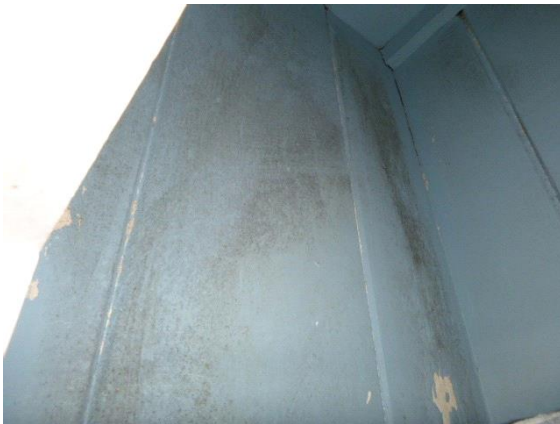
There is microbial growth present on the upstairs hall closet ceiling and walls. See photos. Evidence suggests the growth may have been caused by poor ventilation which has now created a health concern. Recommend a qualified cleaning contractor to evaluate, clean and remove for health purposes.

Upstairs Hall Closet: Views of microbial growth in upstairs hall closet
