Inspection Report

Property Address:
124 new built home
Grand Prarie TX 75054

PROPERTY INSPECTION REPORT

Prepared For:	Sample Report	
	(Name of Client)	
Concerning:	124 new built home, Grand Prairie, TX 75054	
	(Address or Other Identification of Inspected Property)	
By:	Scott Hoenig TREC 21111 / National Property Inspections	1/9/2017
	(Name and License Number of Inspector)	(Date)

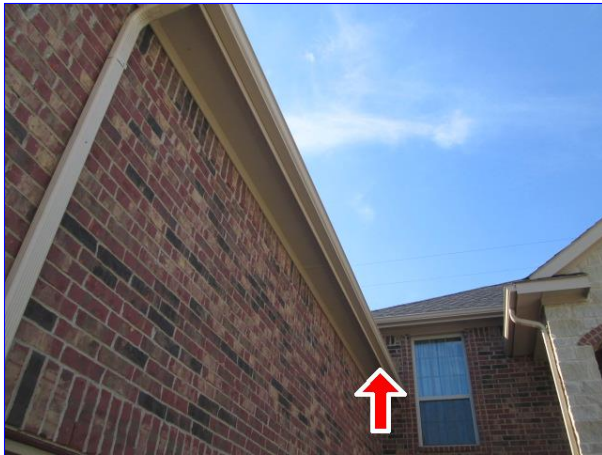
B. Item 1

The grading appeared to be positively sloped away and flat near structure.

However, the gutter above garage is holding over 1inch of water at right end. Gutter should tilt toward drain end.

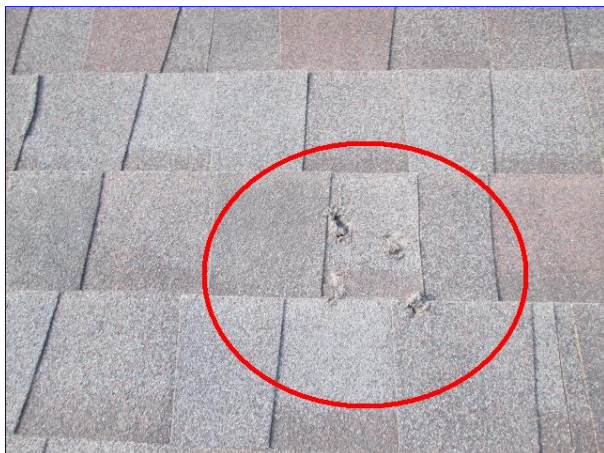
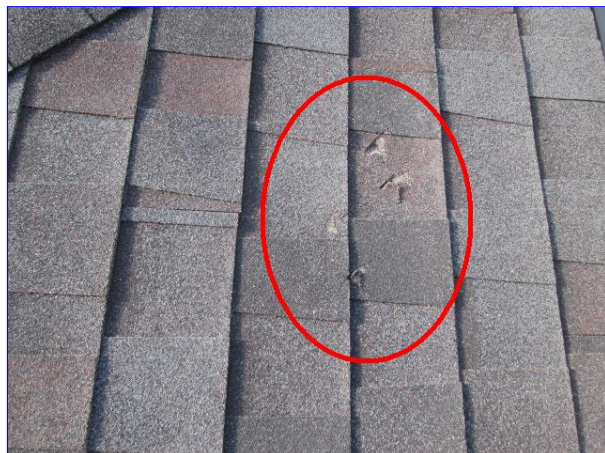
Roof Coverings appeared to be performing as intended at time of inspection, however, one or more deficiencies were observed with examples within this subsection.

A few damaged shingles should be replaced. Found at rear section. ALL roofing should be examined, and replace all found damaged.

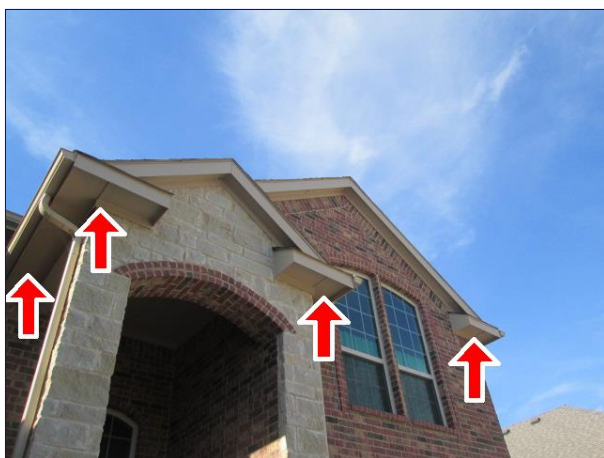
D. Item 1

(1) The Roof Structure was in good overall condition and appeared to be performing as intended.

However, static vents on roof is adequate, but soffit vents are missing at front of home. Not enough intake venting. Recommend a roofing company add vents to meet todays standards, this will improve life of roof shingles and roof deck materials.

However, static vents on roof is adequate, but soffit vents are missing at front of home. Not enough intake venting. Recommend a roofing company add vents to meet today's standards, this will improve life of roof shingles and roof deck materials.

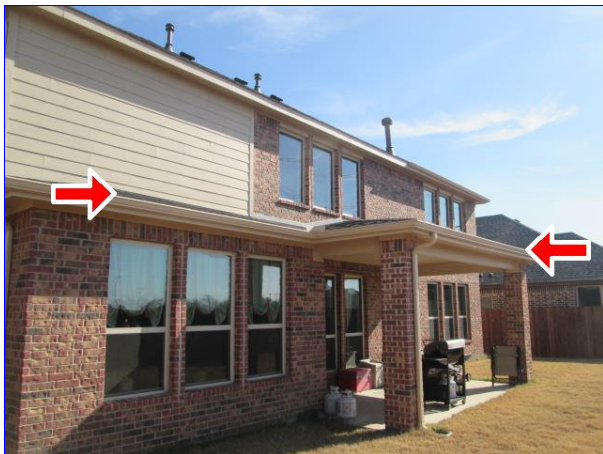
D. Item 2

(2) Small roof area at rear has NO ventilation. Repairs are needed, should add proper venting.

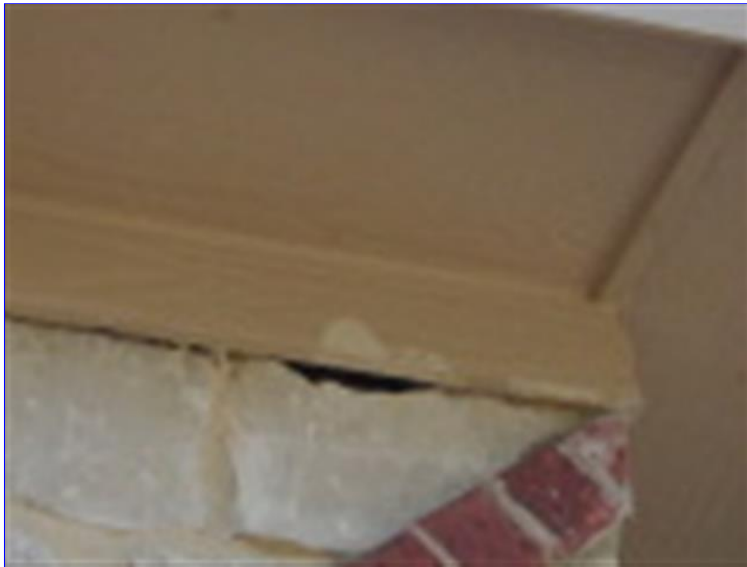
E. Item 2

(2) There are cracks (gaps) in the exterior walls that are considered to be entry point for vermin. Recommend filling with brick and mortar. Front wall.

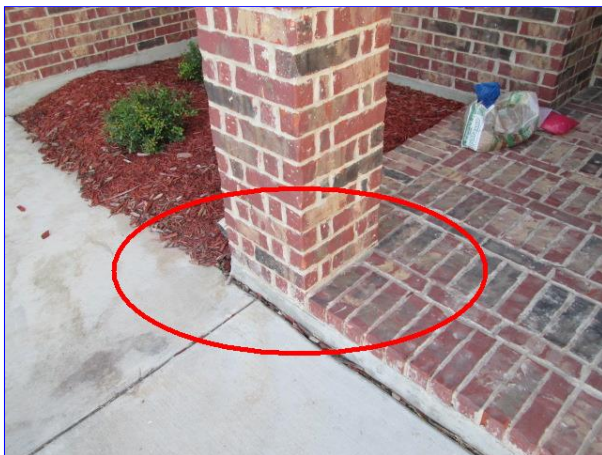
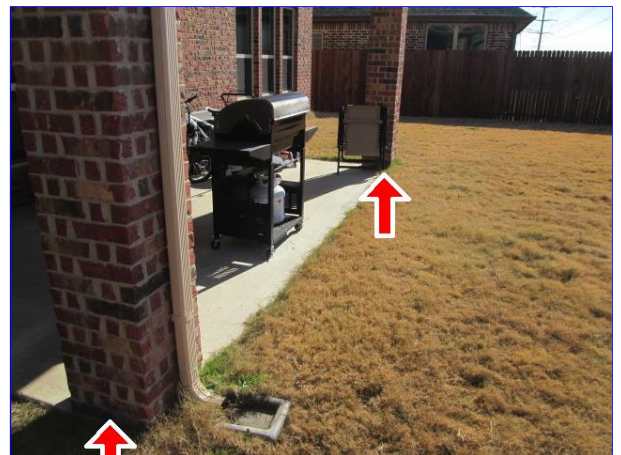
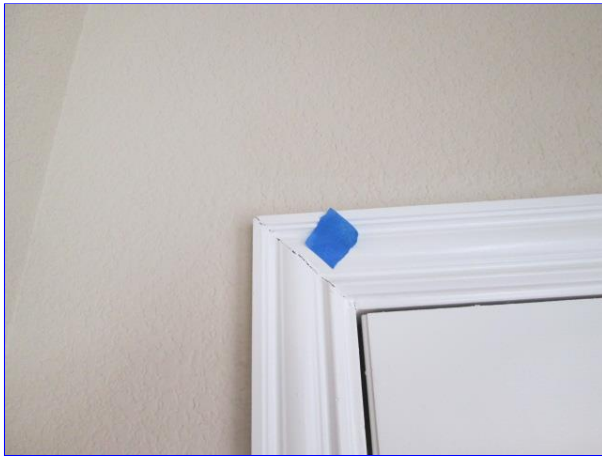
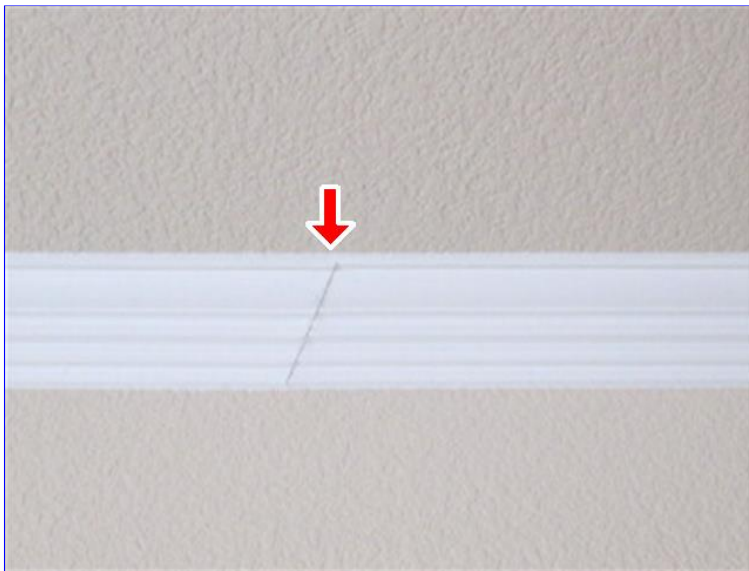
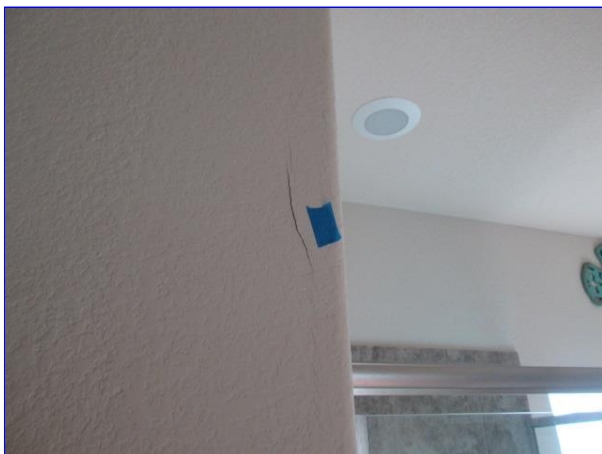
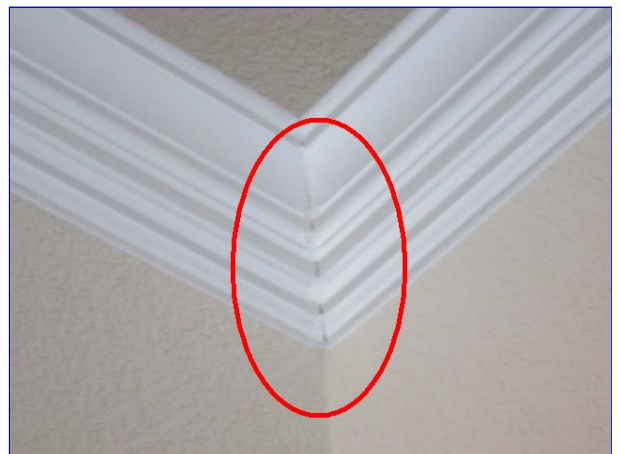
(3) Weep holes are not present at bricks/foundation column base's (THREE). Weep holes can be drilled between bricks/rock every 33 inches apart. These holes allow water to DRAIN and AIR TO CIRCULATE behind veneer rock/brick.

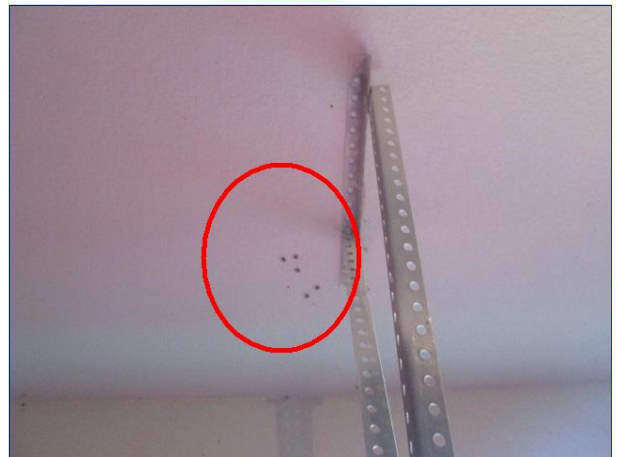
E. Item 11

(6) Holes in garage walls, these represent a fire danger in the home from the garage, where a fire break is required. Recommend a qualified contractor repair.

Hole found next to water heater. Also found at garage door bracket mounts in ceiling.

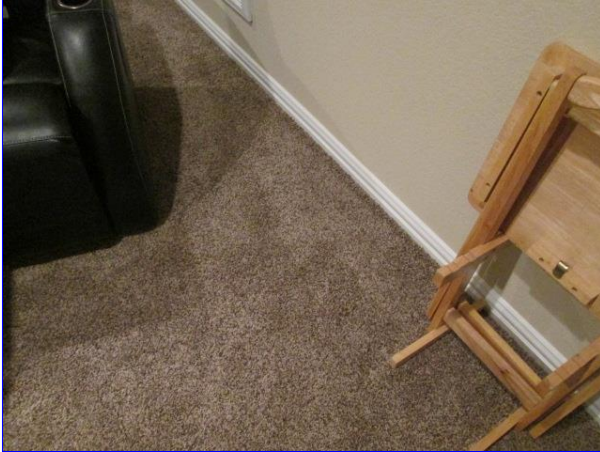
F. Item 1

Areas of upstairs floor squeak loudly, repairs are needed. Home owner will show builder spots found to be unacceptable.

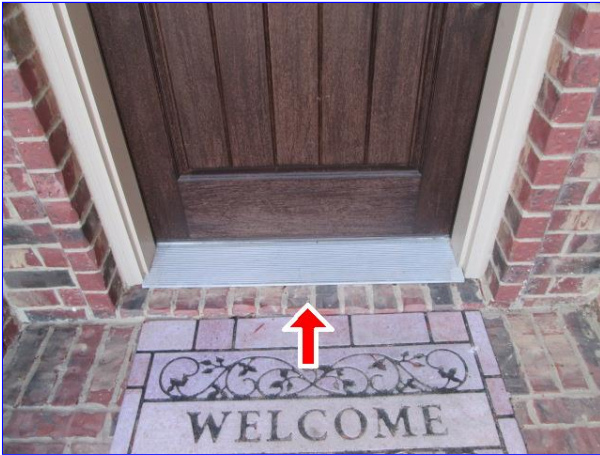
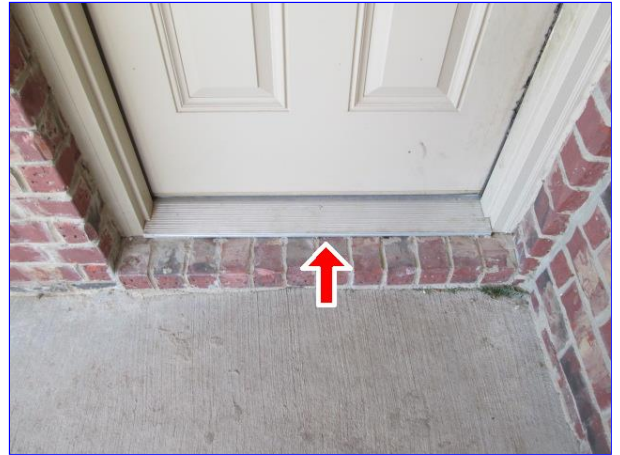
(1) Thresholds at both exterior doors are not properly sealed at front edge. Sealant is needed to stop water intrusion under threshold in blowing rains.

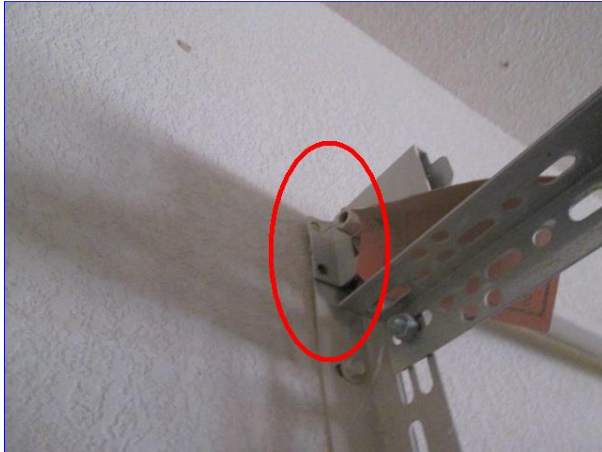
G. Item 3

(2) Garage door brackets are missing screws, these should be installed.

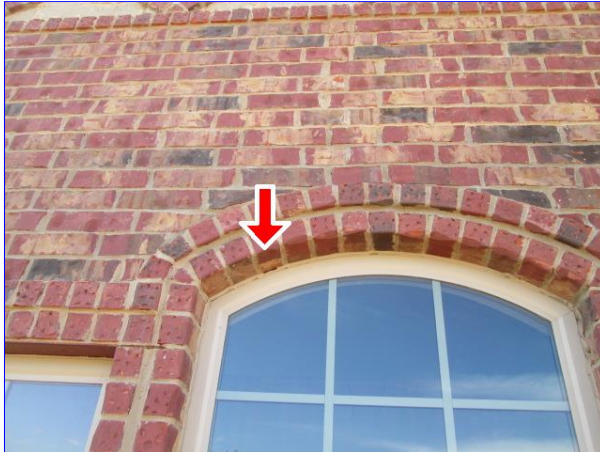
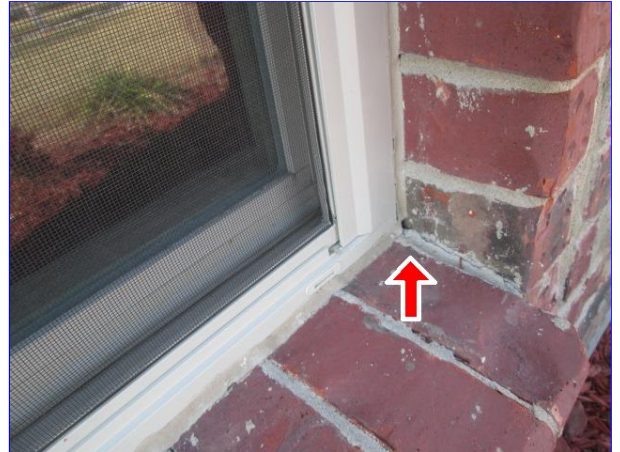
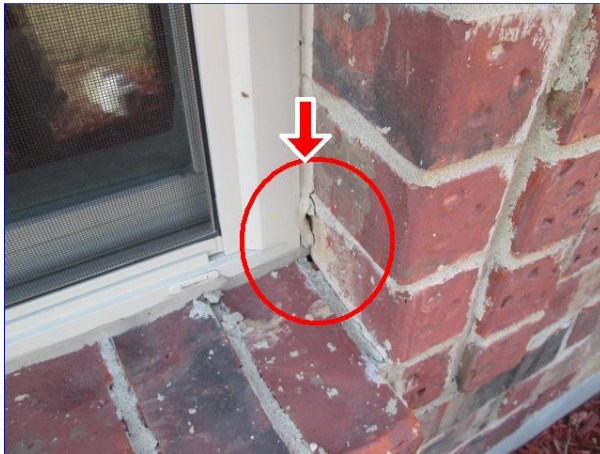
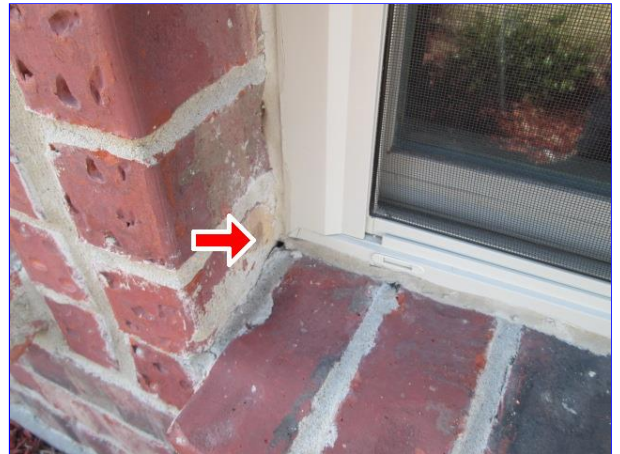
Sealant around some windows is not properly installed, to keep moisture out, these joints need to be resealed with silicone type caulk.

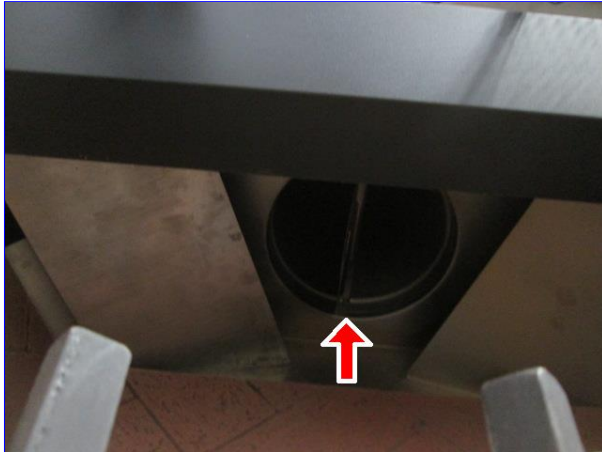
K. Item 1 inside firebox

(1) Damper block was missing at gas log fireplace. A damper block will eliminate any risk of operating the gas log system with a closed damper and dumping (odorless and colorless) combustion gases into the dwelling. Recommend block be installed. I Recommend an approved damper block be installed.

(1) Damper block was missing at gas log fireplace. A damper block will eliminate any risk of operating the gas log system with a closed damper and dumping (odorless and colorless) combustion gases into the dwelling. Recommend block be installed. I recommend an approved damper block be installed.

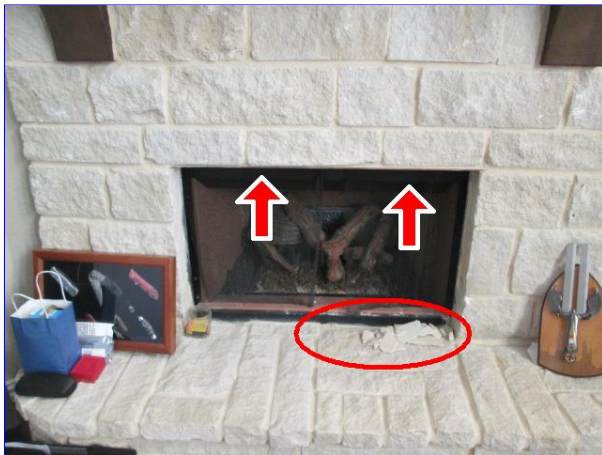
K. Item 2

(2) Mortar at lintel in fireplace has loosened and fallen, Repairs are needed.

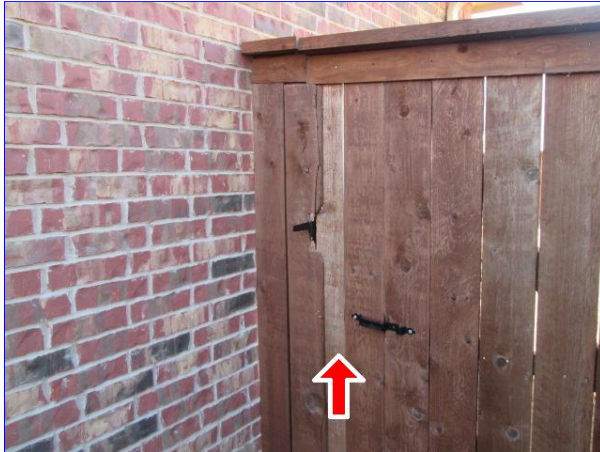
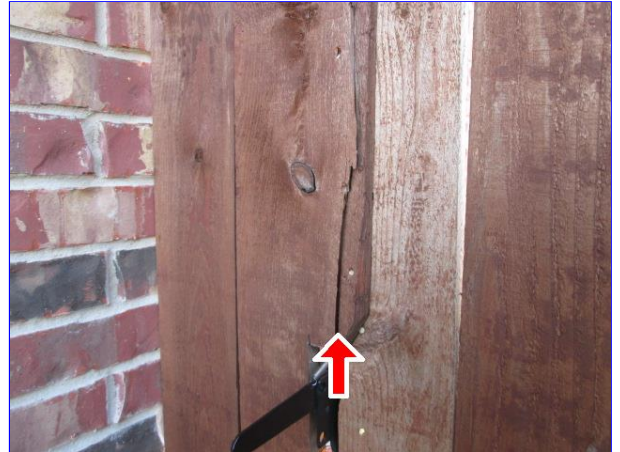
Fence picket at gate latch is split, should be replaced.

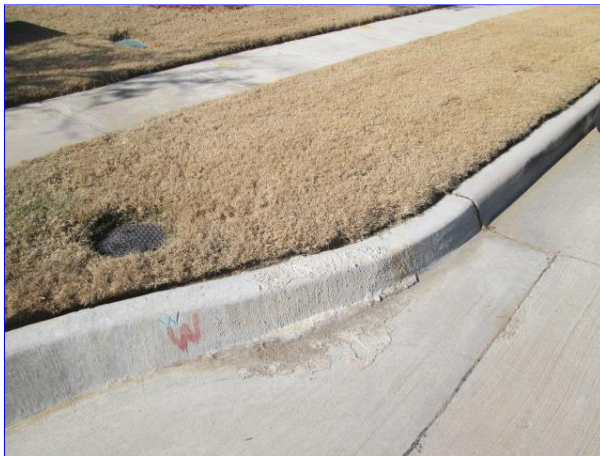
O. Item 1

Concrete spillage at front of home curbside, should be removed.

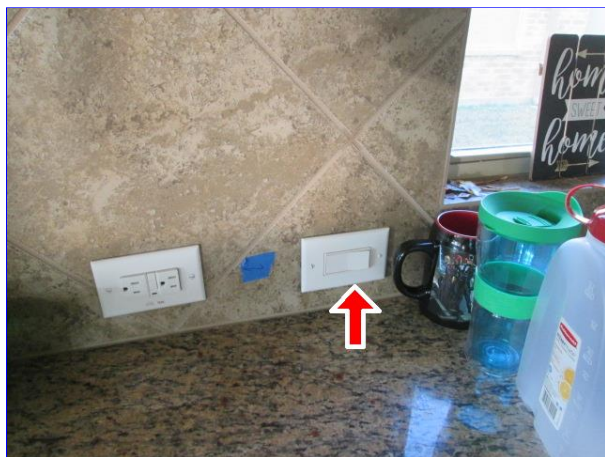
B. Item 1

Switch for disposal is loose mounted, correction needed.
