Inspection Report

Property Address:
123 Your Street
Fort Worth TX

PROPERTY INSPECTION REPORT

By: Scott Hoenig TREC 21111 / National Property Inspections 1/24/2017
(Name and License Number of Inspector) (Date)

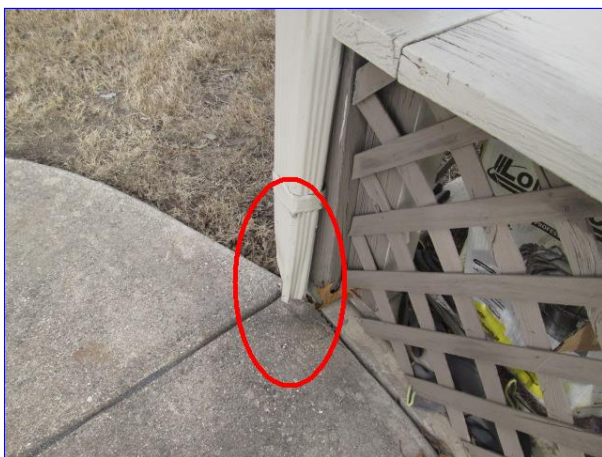
B. Item 2

Gutter system has damaged downspouts, need repairs.

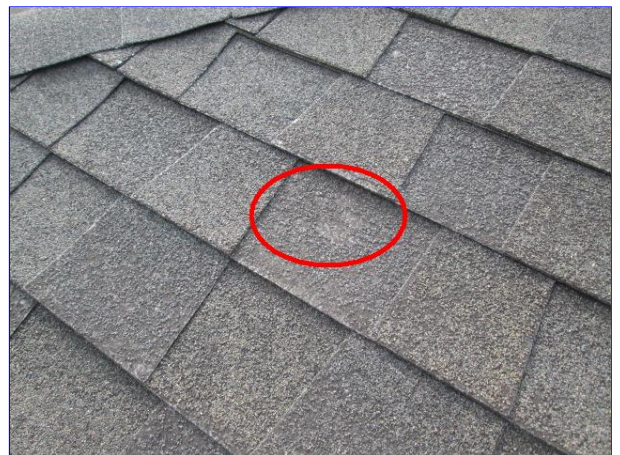
C. Item 5

The roof covering has areas that have very high granule loss, possible due to age and lack of ventilation, Also a **STRONG** possibility of hail damage on those areas. Although no leaks were detected, the roof will need replacement soon. I recommend a roofing contractor evaluate further, Possible the current owner will be able to make an insurance claim.

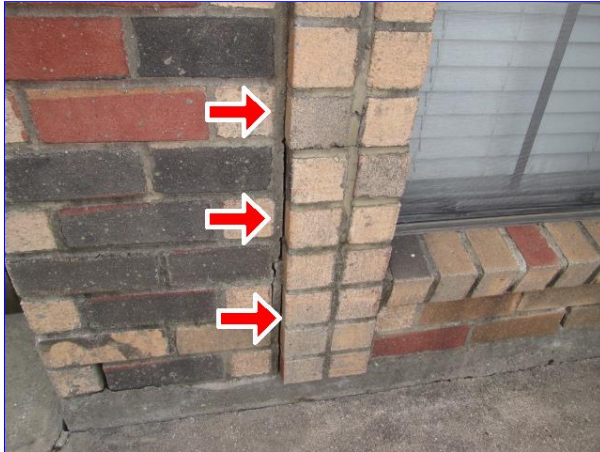
E. Item 1 left front

(1) There are significant cracks in the exterior walls that are considered to be a water intrusion point.. No attempt is made to discover or document an exhaustive list of every crack or anomaly in the exterior. Possible structural wall damage. These deficiencies should be repaired to avoid water intrusion.

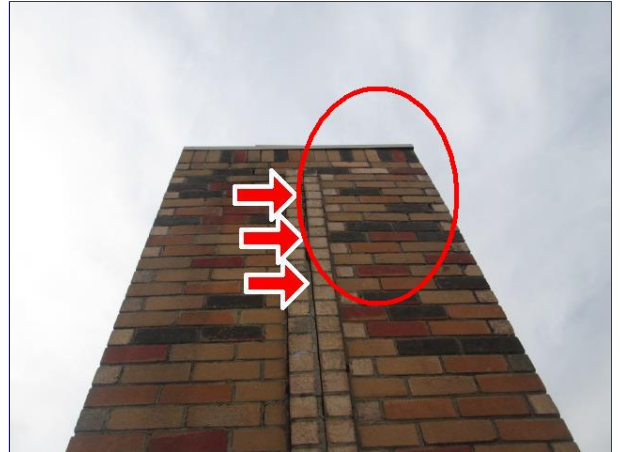
E. Item 2 chimney brick repair needed

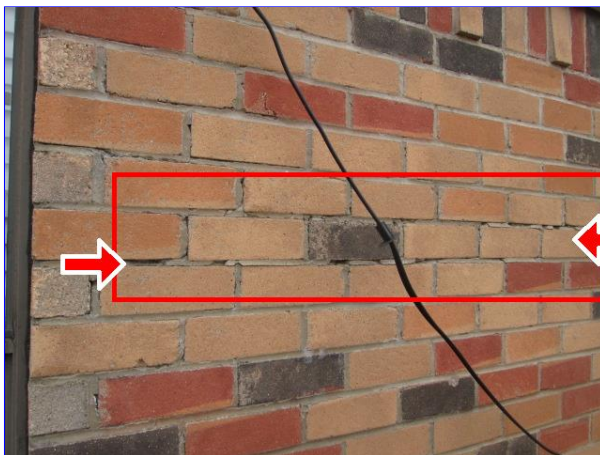
E. Item 5 right side wall damage

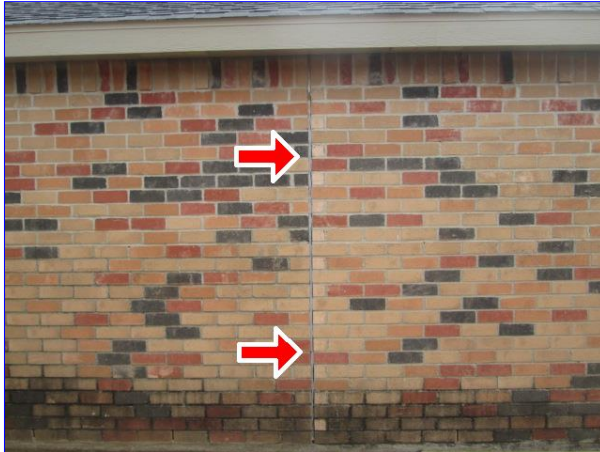
E. Item 6 right side

(2) Brick expansion joint is missing sealant. Recommend filling with silicone type sealant to stop water intrusion.

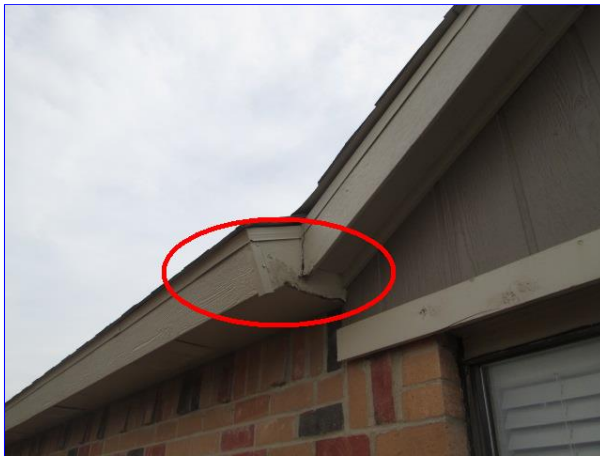
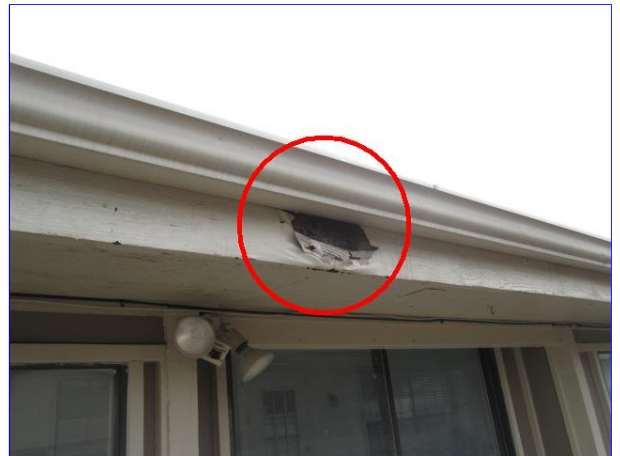
(3) Damaged fascia trim , right and rear area. Repairs are needed.

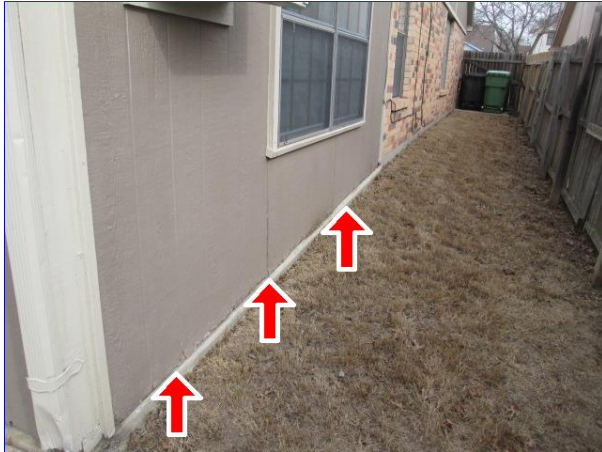
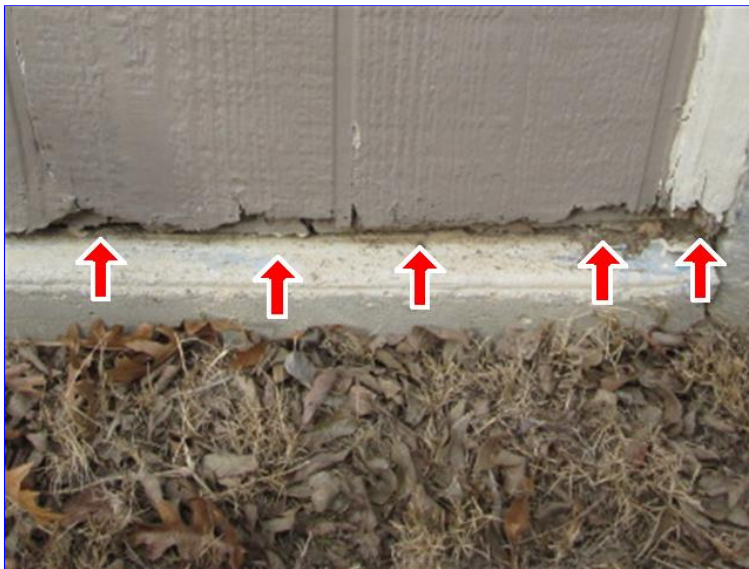
(4) Decay lower edge on siding at left side of home.

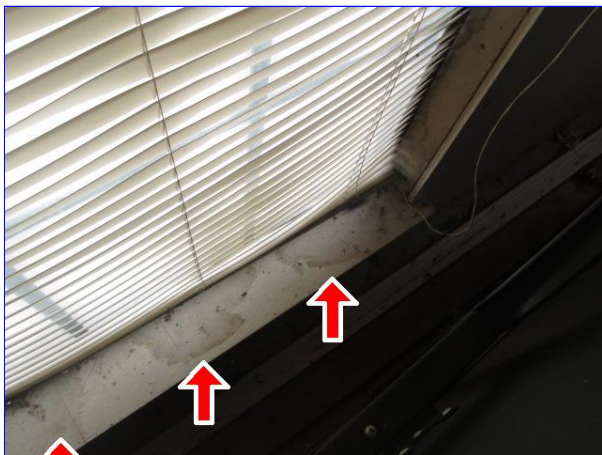
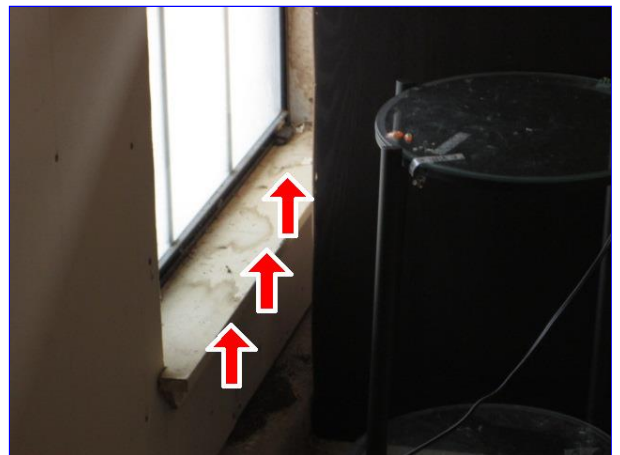
(5) Water stains are found around garage windows and window sills.

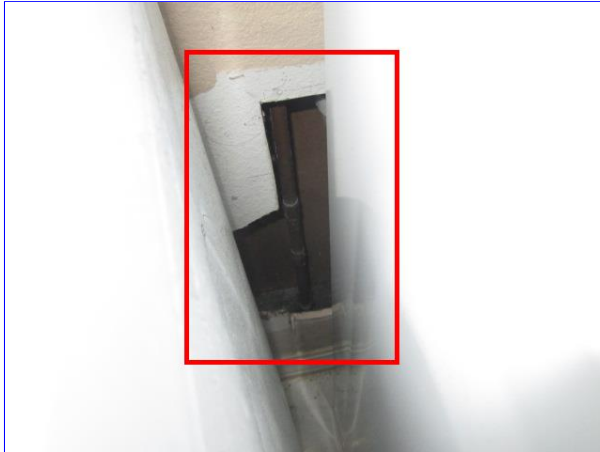
E. Item 15 large hole in wall.

(6) Large hole in wall behind washer/dryer. Repairs are needed.

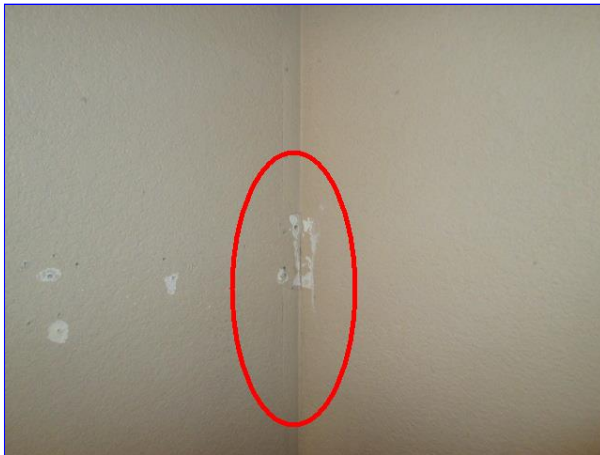
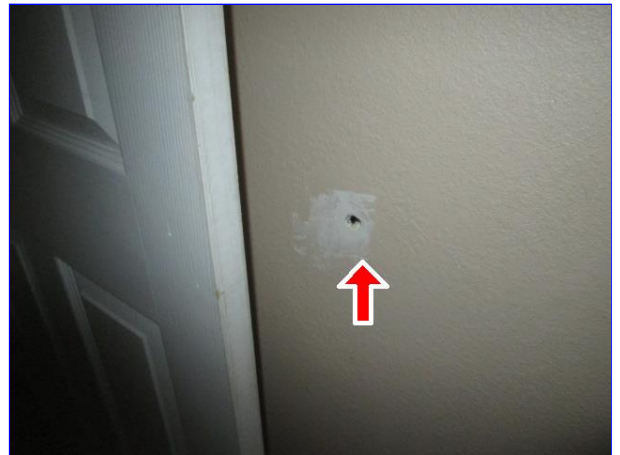
(7) Cracks, and hole, in wall of laundry room, need repairs.

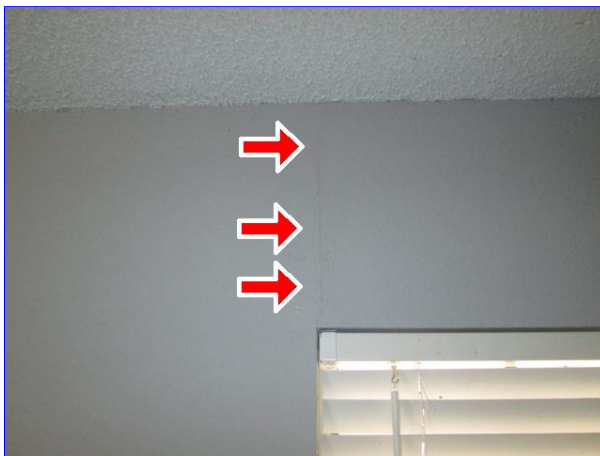
E. Item 18 crack above window, master bed

(8) There are cracks in the interior walls. No attempt is made to discover or document an exhaustive list of every crack or anomaly in the interior walls. Recommend prep and paint.

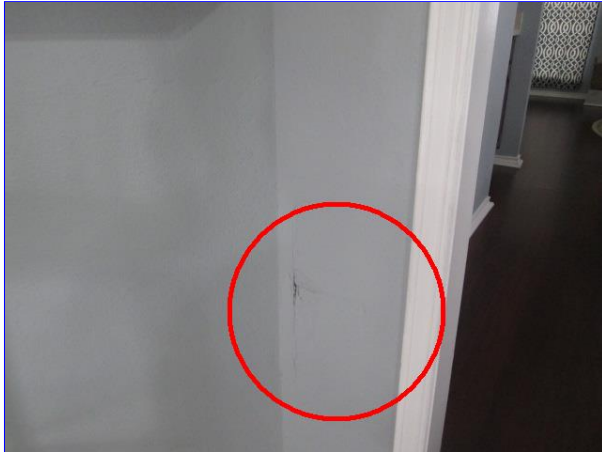
E. Item 19

(9) Damaged wall under kitchen bar area.

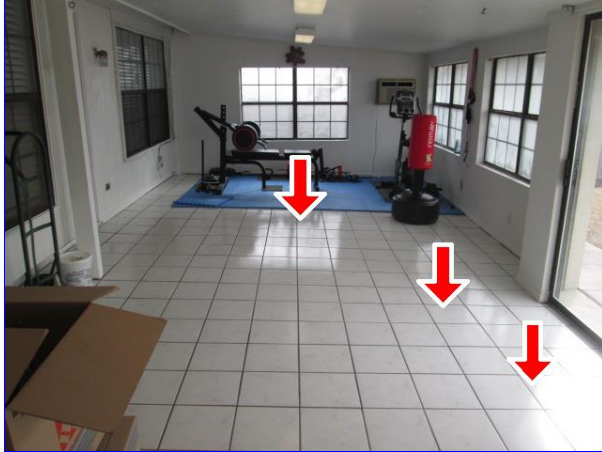
F. Item 2

(2) Rear patio floor ,slopes badly. this appears to be by design, in this area.

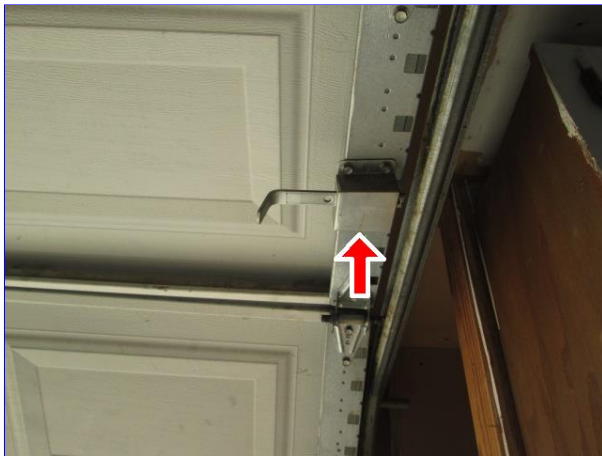
G. Item 1

(1) There were manual door locks present on automatically controlled garage doors. It is recommended that the manual door locks be removed, or disabled when automatic door controls are in use to avoid damage.

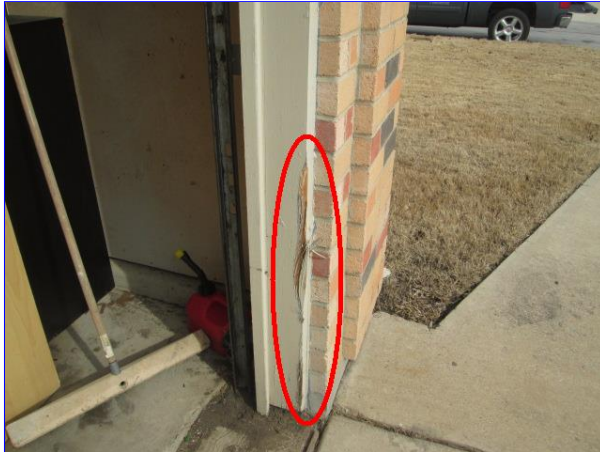
G. Item 2

(2) Wood Damage at garage door frame.

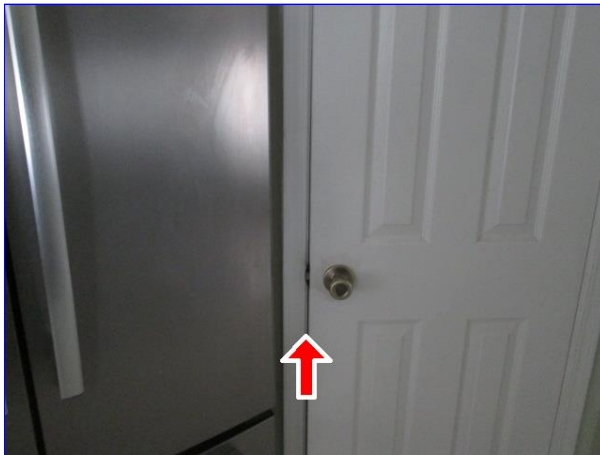
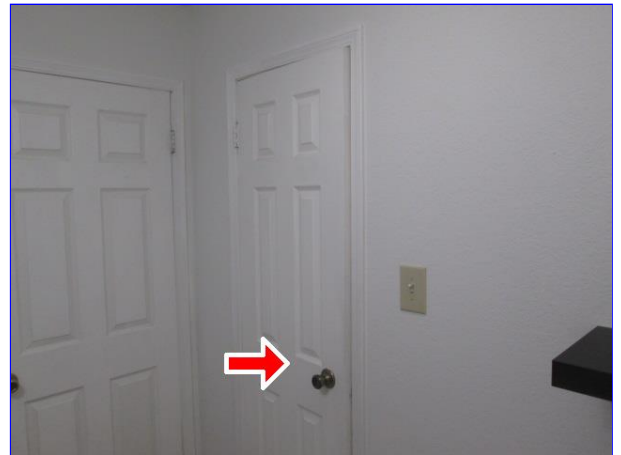
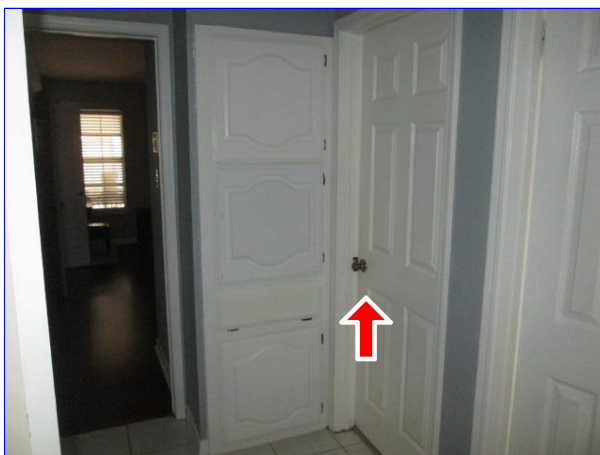
(3) Several doors in home will not close properly, repairs are needed.

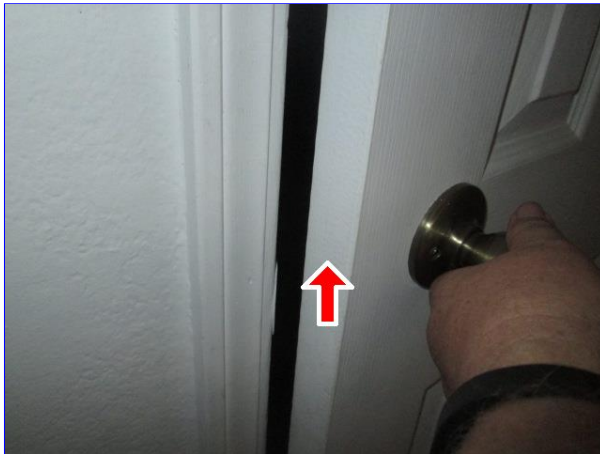
G. Item 8 no latch at bedroom closet

(4) Four doors in home are missing latch/knobs.

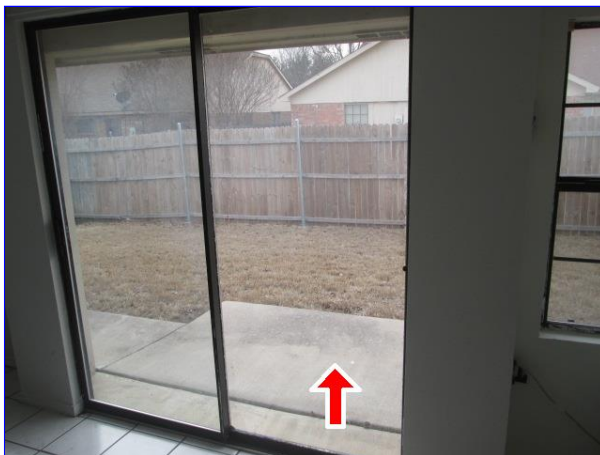
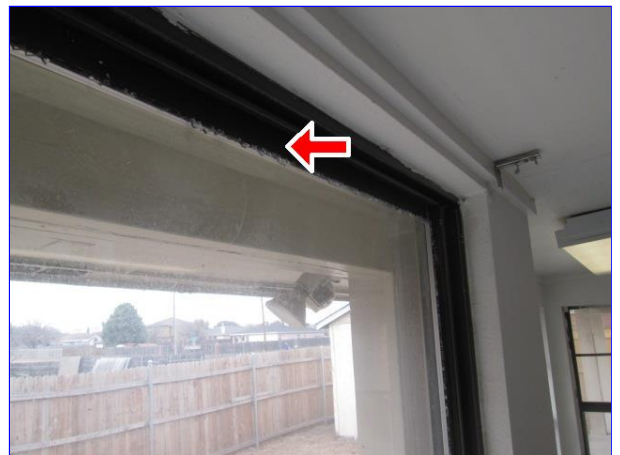
(5) Sliding glass door has broken glass , one pane is intact. one is broken out. repairs are need for safety, broken glass edges are dangerous, replacement glass is recommended.

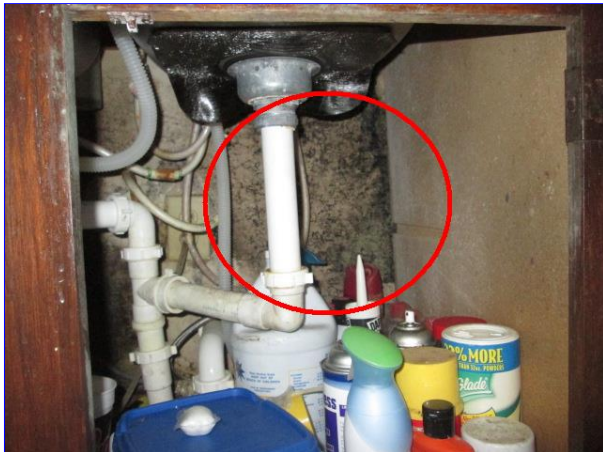
H. Item 1

(1) Badly water stained wall under kitchen sink, unknown cause, repairs will be needed.

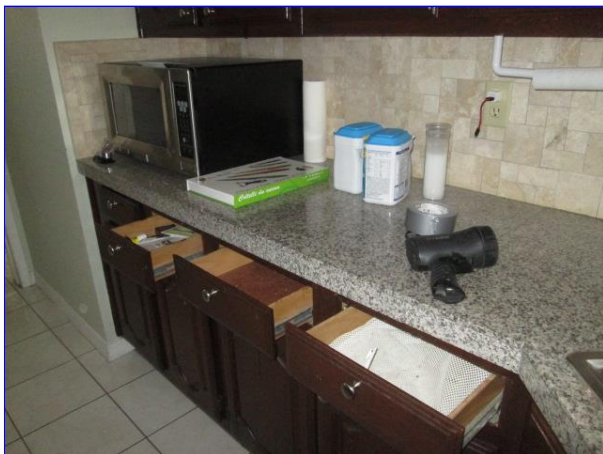
H. Item 2

(2) many cabinet drawers are off track/loose, repairs are needed.

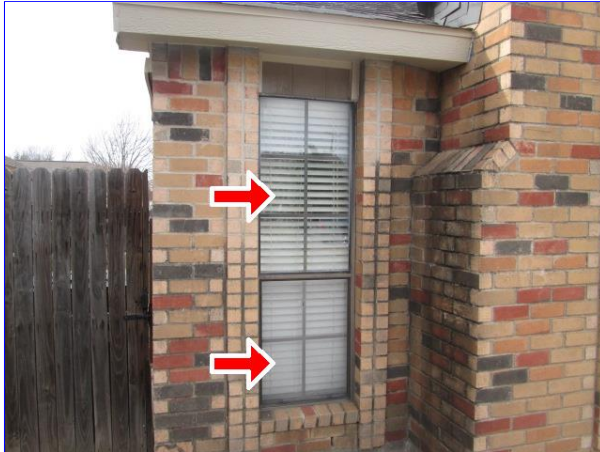
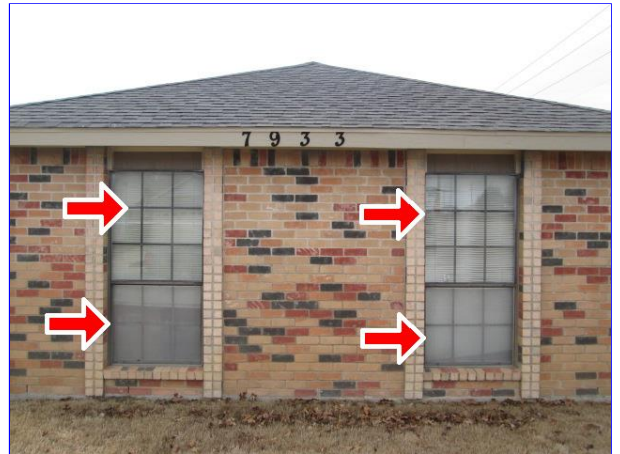
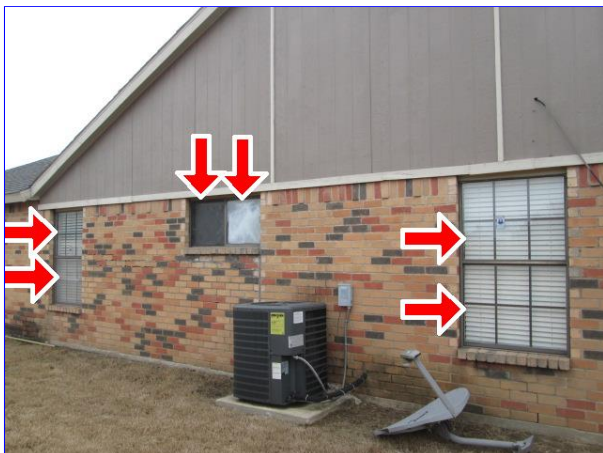
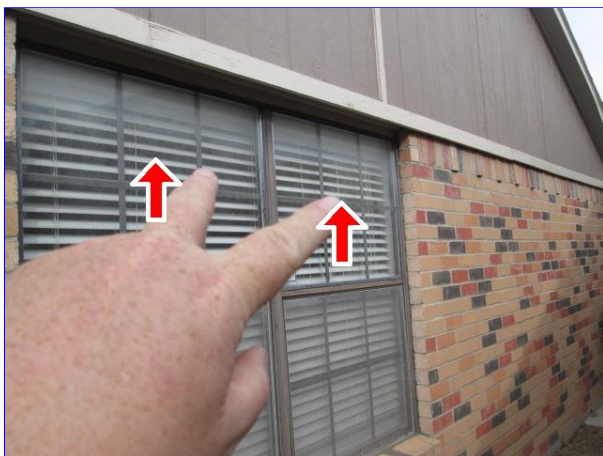
(1) Estimate 19 Thermal pane window(s) have been identified that are Obviously fogged or display other evidence of broken seals. As thermal panes lose their vacuum, moisture may appear and then disappear, depending on the inside and outside temperature, barometric pressure and the humidity level. Windows are listed and observed at the time of inspection only and no warranty is implied.

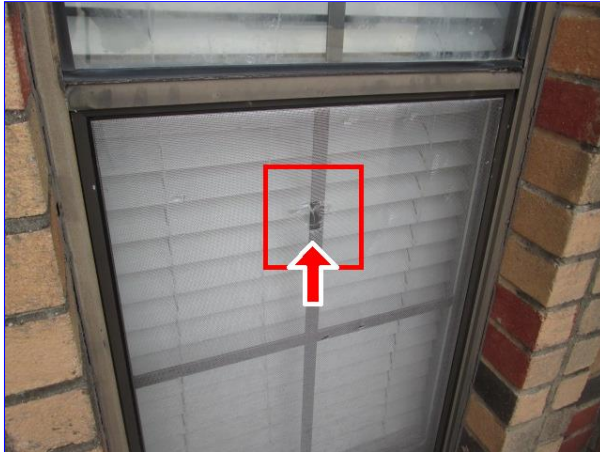
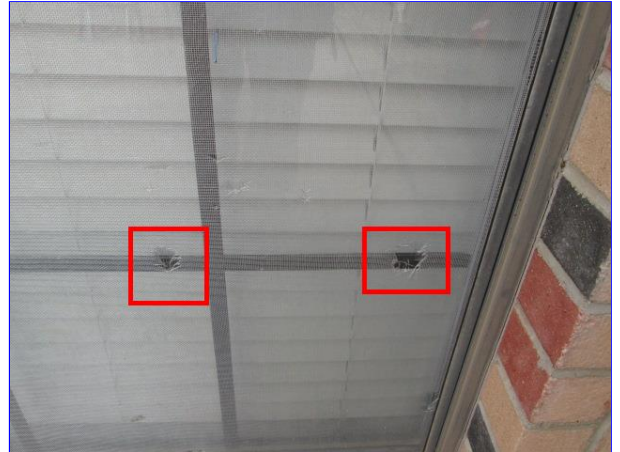
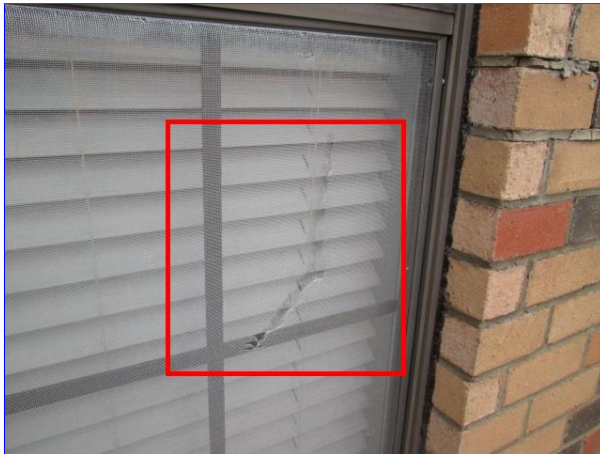
I. Item 8 damaged screens

(2) TEN or more screens were either missing and/or damaged. Recommend screens be repaired or replaced as necessary.

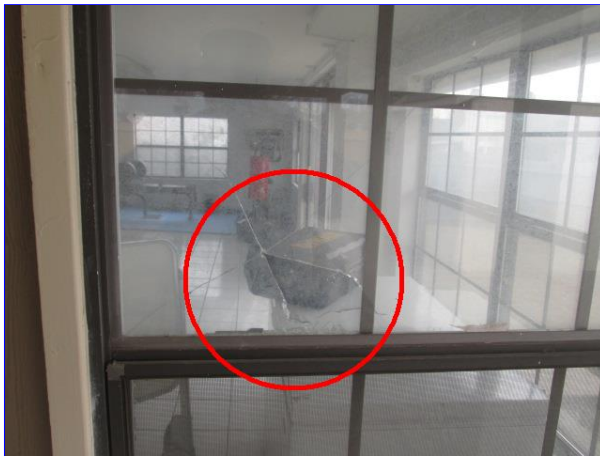
I. Item 11 broken glass, patio

(3) Three window panes are found to have broken glass. Kitchen , living room, patio room.

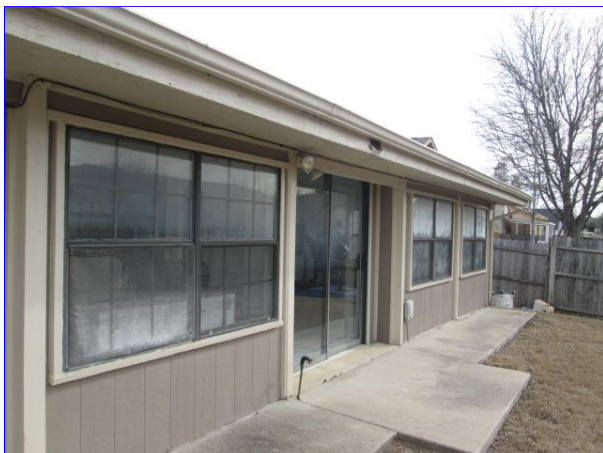
I. Item 12

(4) Many windows have been painted, inspector cannot see to determine if these have broken seals. Unknown if pain can be removed.

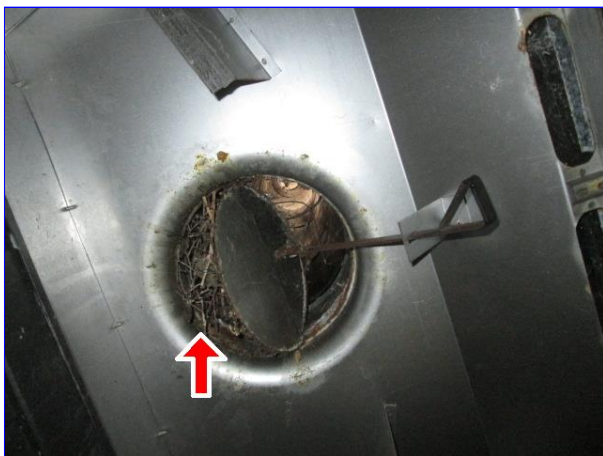
K. Item 1

(1) Fireplace flue pipe is full of debris, bird nesting. Recommend professional cleaning of fireplace.

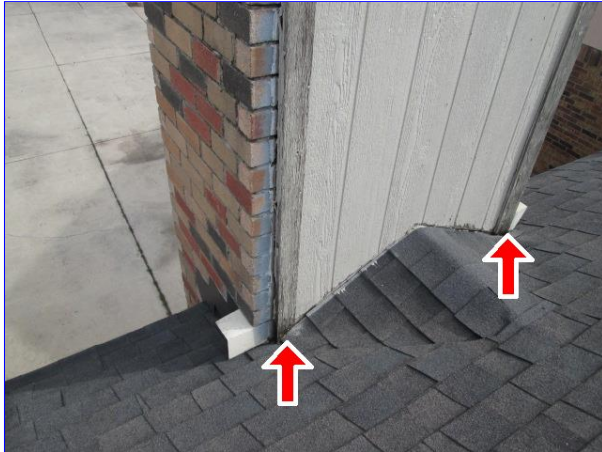
K. Item 2

(2) Much of the wood trim around the chimney is deteriorated, The siding however appears to be in good shape. Recommend replace trim with cement type and repaint.

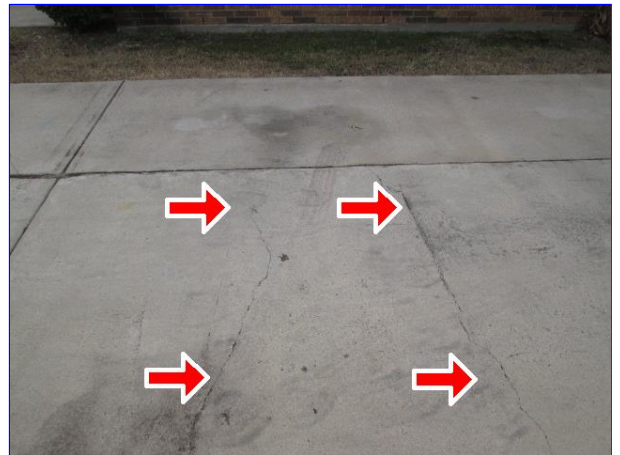
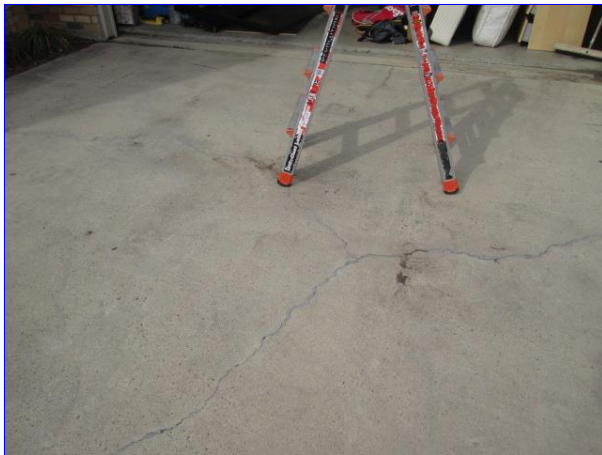
Some cracks were discovered on driveway, These cracks should be sealed to prevent further deterioration.

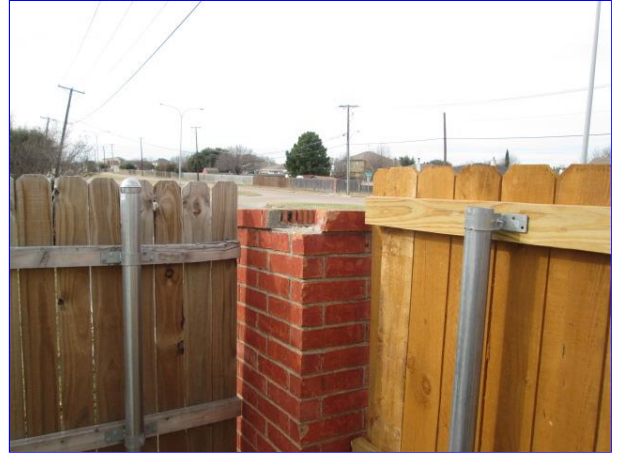
M. Item 2 rear

Brick column at rear is damaged on top and leans.

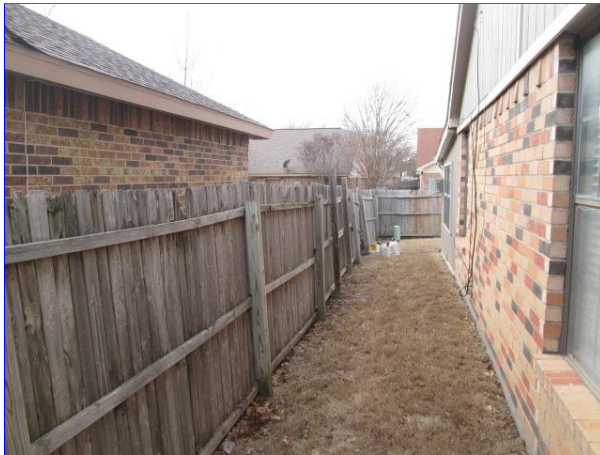
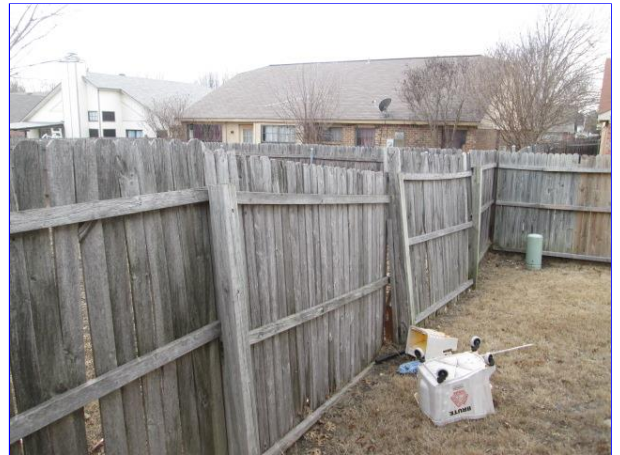
(2) Fence on left side is in bad condition, repairs are needed.

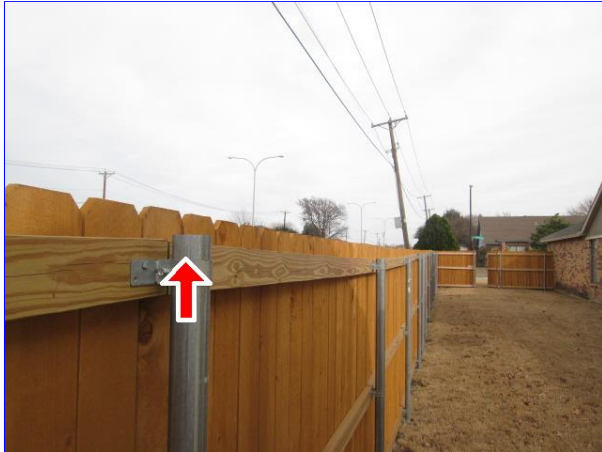
M. Item 5

(3) New fence post on right side are missing metal caps. 15 caps missing.

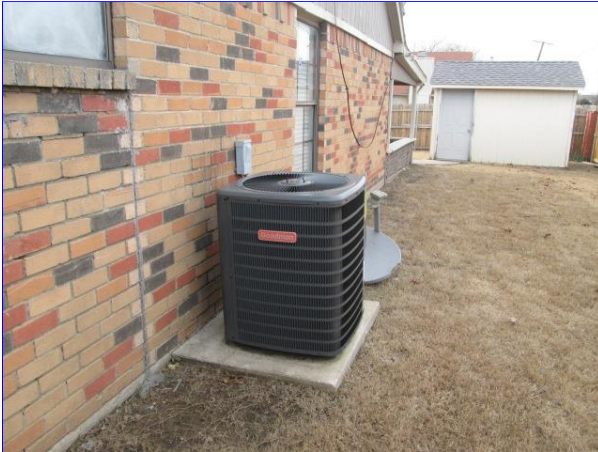
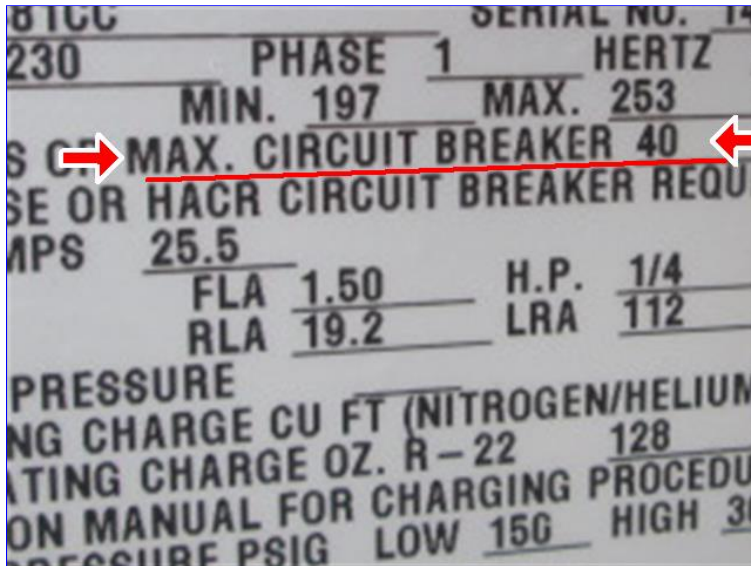
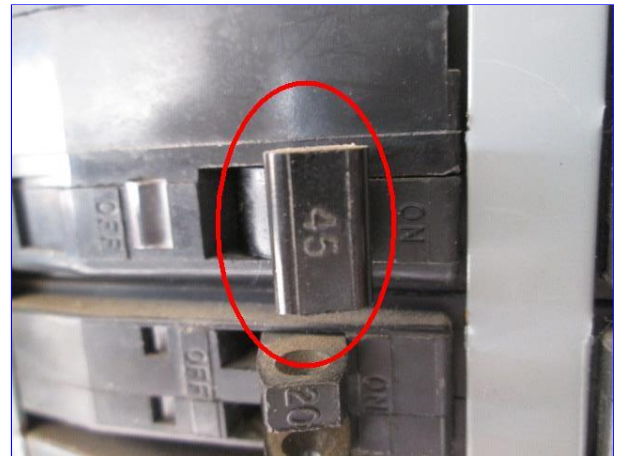
(1) Manufacture of AC unit has maximum of 40 amp breaker. The breaker in panel box for the AC unit is currently 45 amp. Recommend HVAC contractor correct to proper size and type.

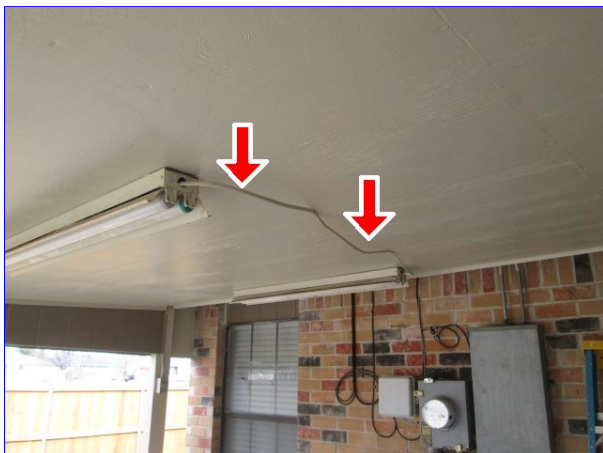
B. Item 5

(2) Exposed electrical wiring on porch lights, should be in conduit pipe.

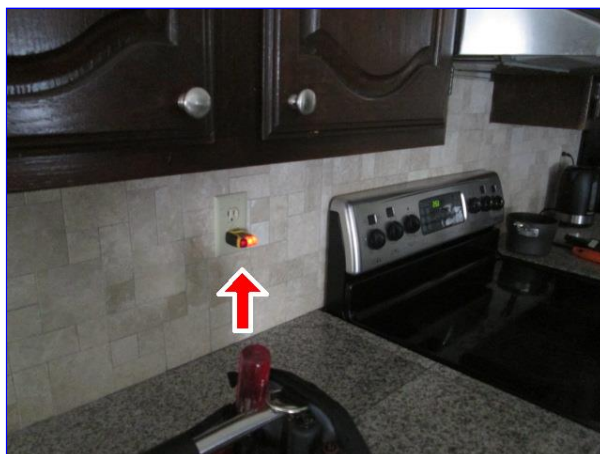
B. Item 7

(3) Ground Fault circuit interrupter (GFCI) receptacles are not present at all recommended locations in this house.

NO GFCI found in kitchen

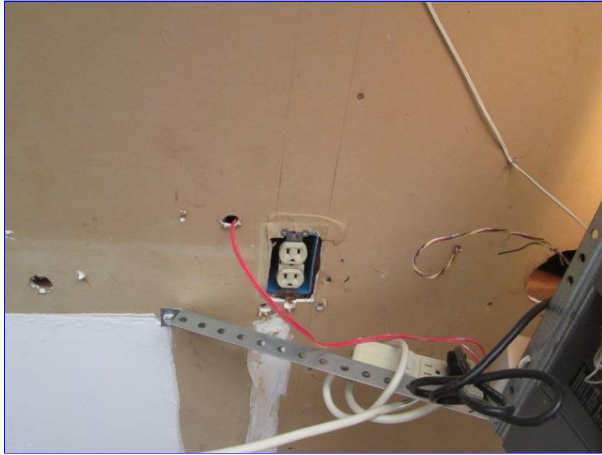
B. Item 8

(5) Missing electrical outlet cover at garage ceiling.

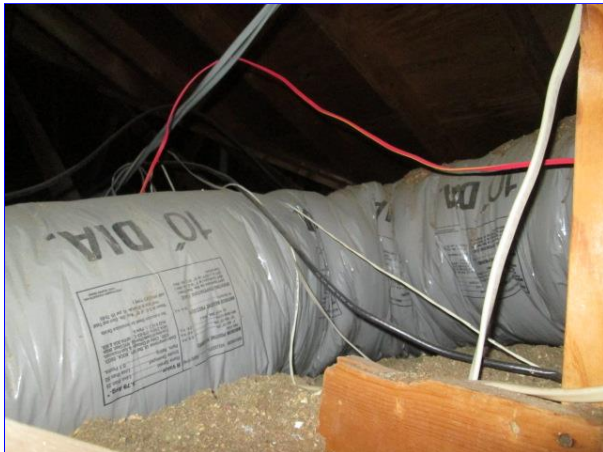
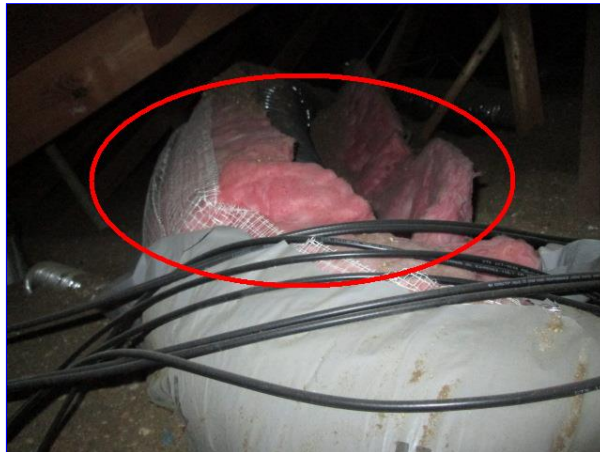
Grey(Goodman) flexible air flow ducts were recalled in the 90's due to their deterioration in attic heat. These ducts are present they should be replaced. [ref: TREC 535.230(d)(1)]

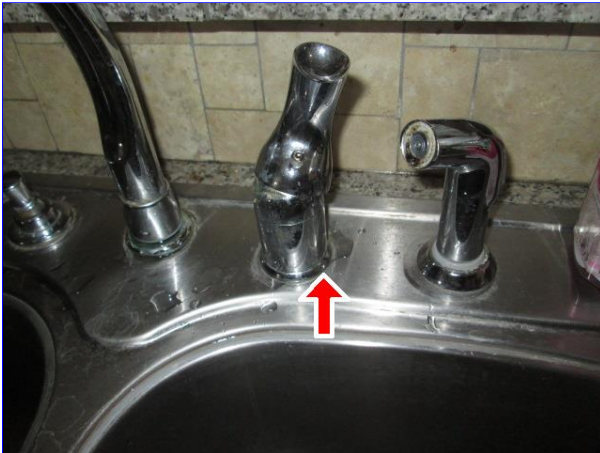
A. Item 2

(2) Kitchen faucet leaks at handle during use. Should be replaced or repaired.

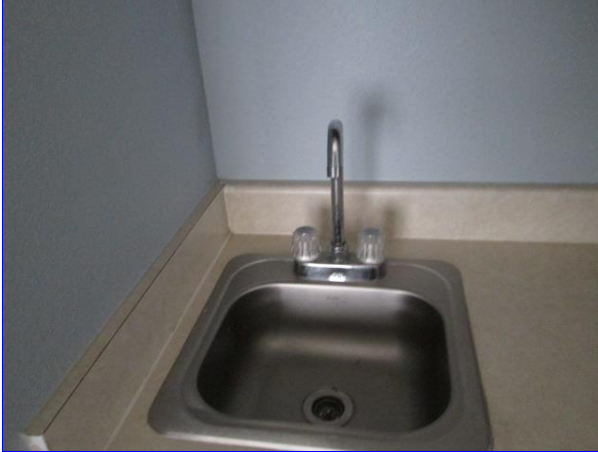
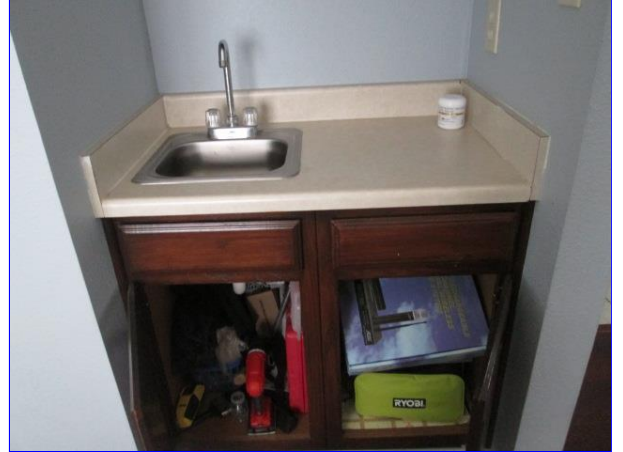
A. Item 3 faucet not operating

(3) Faucet at bar sink is NOT operating. Needs repair.

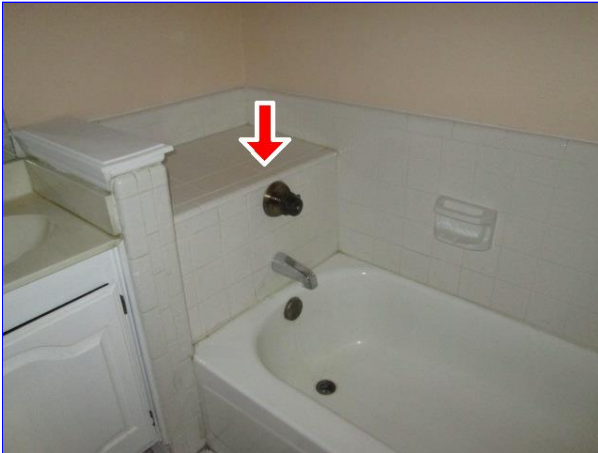
A. Item 5

(4) Master bathroom tub controls do NOT operate. Repairs by plumber is recommended.

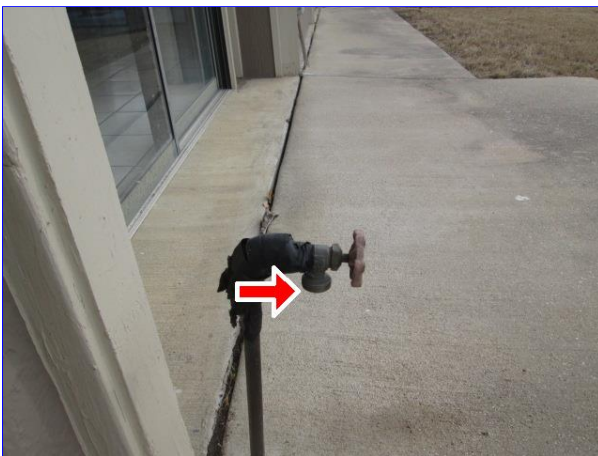
A. Item 6

(5) The hose bibb faucets need an anti-siphoning device installed (vacuum break) to prevent the possibility of backflow to the fresh water supply. These can be purchased and easily installed.

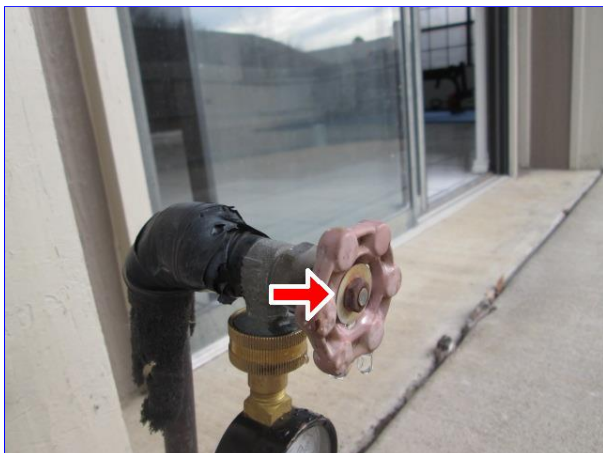
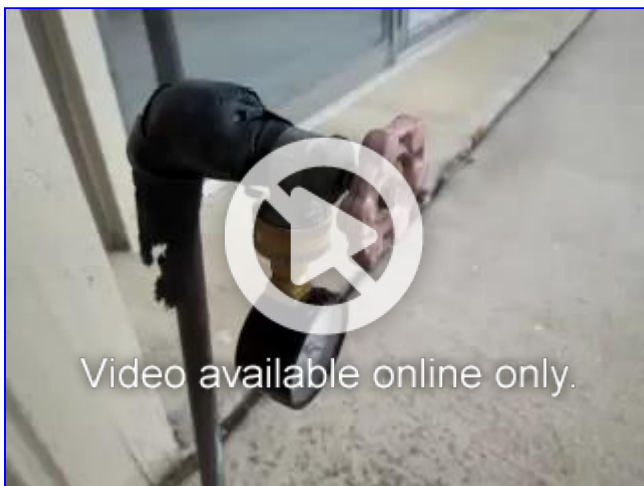
A. Item 7 leaking at handle

(6) Hose faucets at front and rear of home are leaking at handles. Recommend repair.

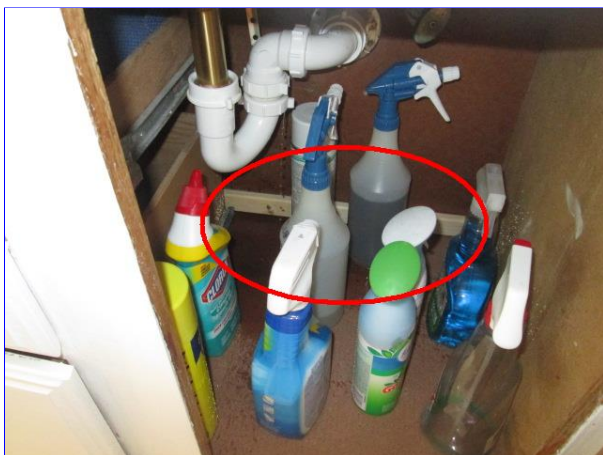
B. Item 1

Drain leak found at guest bathroom sink. Repairs are needed.

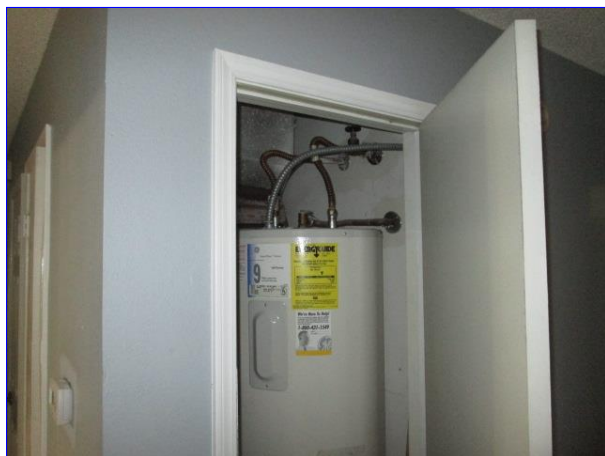
C. Item 1

(1) Although water heater appeared to be operating as intended, due to age considerations, the heater was near the end of its life expectancy. Most water heaters have a life expectancy of approximately 12 to 15 years. Realize that with a change in patrons and water usage habits, water heater failure can occur.

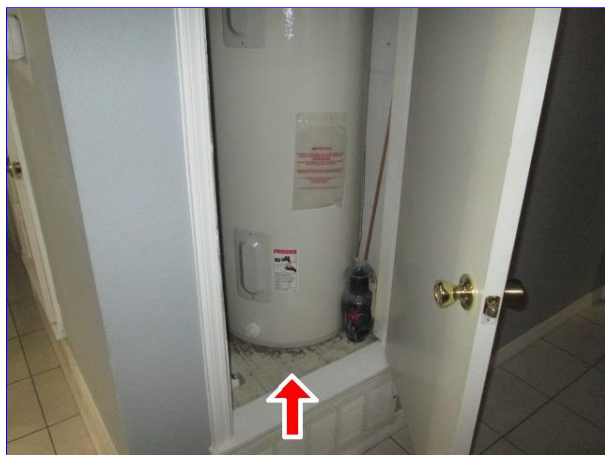
C. Item 2

(2) Water heater drain pan was never installed. Recommend drain line be added to direct the water outside in case of a water heater leak. Note: A sensor is also available to shut down the water supply if water from a leak is sensed in the drain pan.
