Sample Report Newton NH Antique Home, , Newton, NH, 03858

Inspection Date : 10/16/2010

Inspector: Steve Mangekian Inspector Phone: (603)816-1014

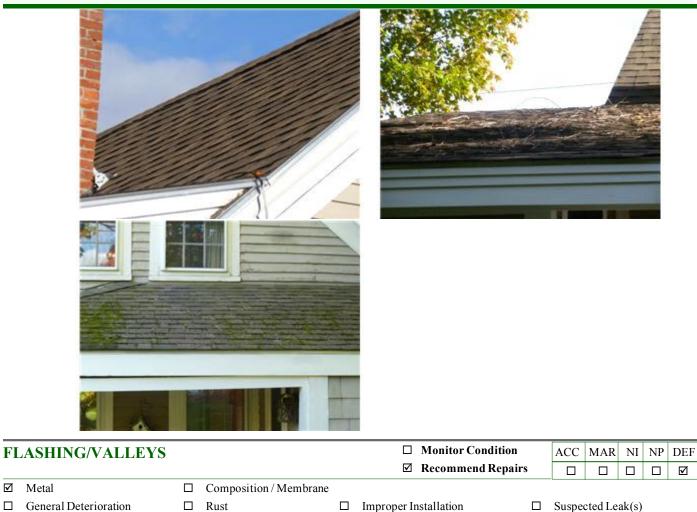
Comments : There is excessive sealant around chimney flashing . Recommend inspection and proper repair by a qualified roofing contractor.

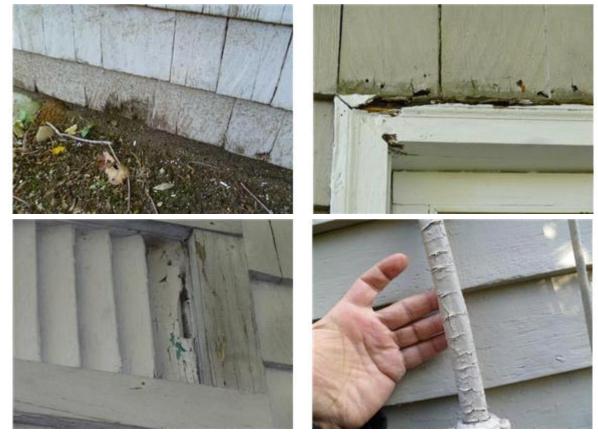
There is damage to lower siding and trim, peeling paint on one section of wall and deteriorated framing around window on right side of building, Recommend further investigation and repairs by a qualified contractor. Electric service entrance cable is frayed, recommend to monitor and have repaired by a licensed electrician as needed.

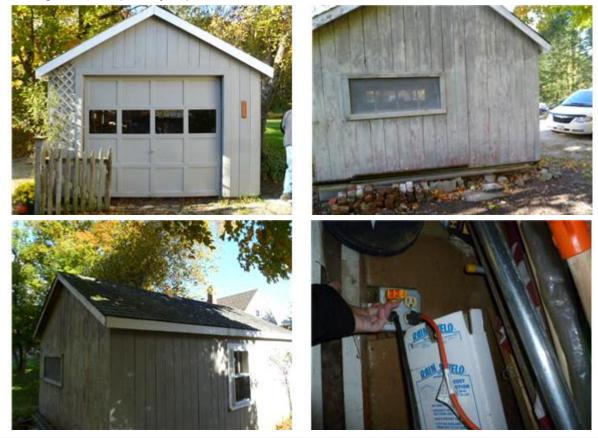
Comments: Limited visibility due to stored items. Outlet is not GFI protected, wall switch does not appear to control anything. Recommend repairs by a licensed electrician. Roof has excessive fungal growth, trees overhanging roof surface, excessive granular loss on shingles. Recommend further investigaton and repairs by a qualified contractor.

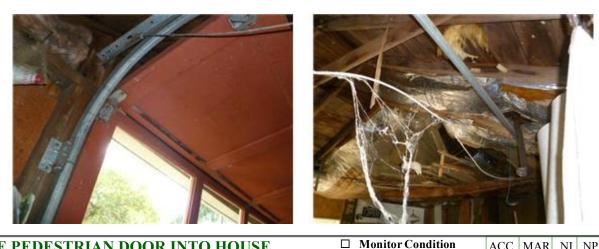
Comments : Damaged hard ware, doors does not open properly. Recommend repair by a qualified over head door company.

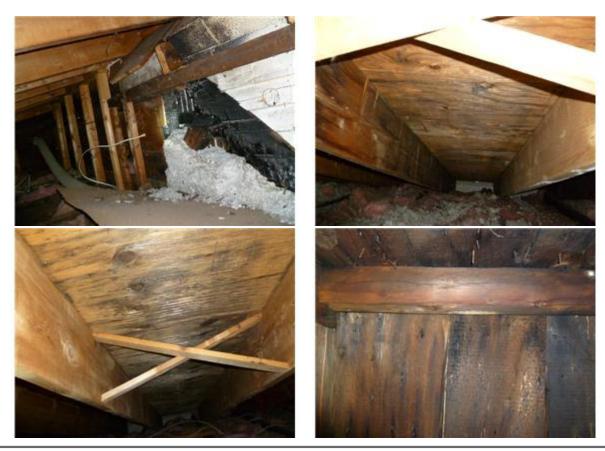
Prior fire damage in one area of new attic, Dark staining on attic sheathing on rear left corner appears to be mold. Recommend further investigation and treatment if needed by a qualified mold mitigation company.

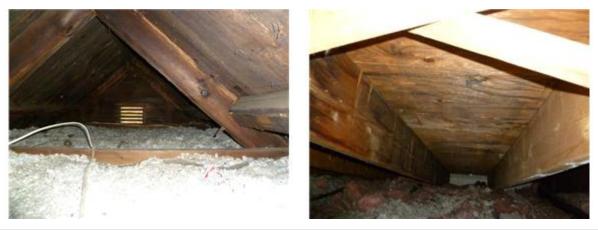
Comments: Due to dark staining on attic sheathing it appears that insufficient ventilation is present. Recommend further evaluation and installation of the correct amount and type of ventilation system to prevent condensation, degradation of the external roofing system and to reduce energy costs.

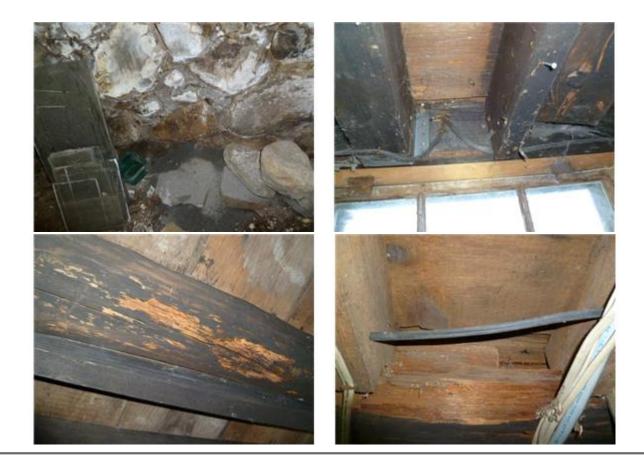
Comments: Evidence of water intrusion, efflorescence, Many areas of improperly supported joists and beams, many areas of insect damage to structural components, Areas of cracking and movement to foundation walls. Dirt floor should be covered with vapor barrier to help prevent moisture, insect and fungal intrusion. Recommend further investigation and repair by a qualified contractor.

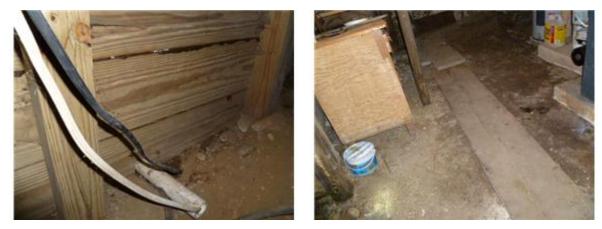
Comments: Dirt slab has covering in many area , . A full vapor barrier should be installed to help to minimize moisture, insect and humidity. Wood construction debris being stored in basement should be removed. Recommend removing any earth to wood contact within 5' of the house to help prevent wood destroying insects.

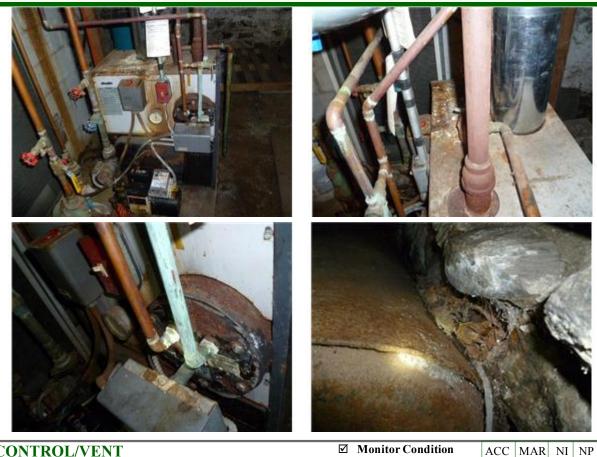
Boiler operating and is providing heat at time of inspection, maintenance records are up to date. Appears to be beyond its life.Temperature / pressure relief valve extension is corroded, there is excessive corrosion on cabinet and fittings. There is corrosion and debris on oil tank. Recommend remove all debris from oil tank. Recommend further investigation and repair as needed by a qualified heating contractor.

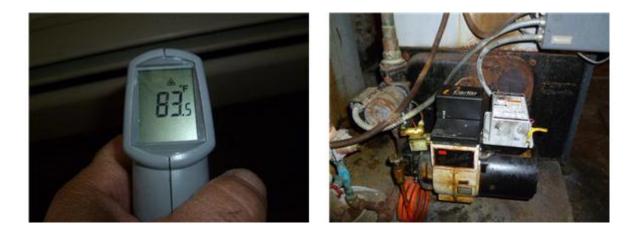
## Comments: Base board heaters were spot tested and were providing heat at time of inspection. Corrosion noted on circulator pump. Recommend monitor for any leaking and repair by a qualified heating contractor if needed.

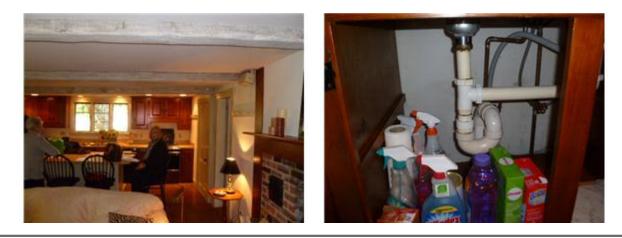
Comments: Window above sink is damaged has rot around framing and does not properly open and close, recommend repair by a qualified tradesman. Drain in kitchen sink has "S" trap, this can cause siphoning allowing sewer gases into the house. Recommend further investigation and repairs by a licensed plumber.

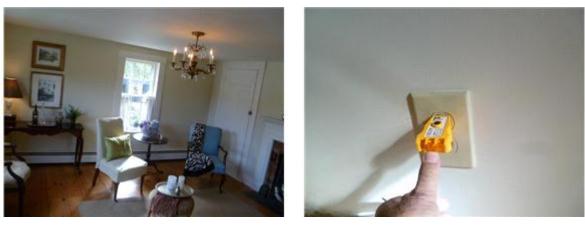
Comments: Ungrounded three prong outlets present. Recommend repair by a licensed electrician. NOTE: To protect sensitive electronics it is recommended that properly grounded outlets are installed.

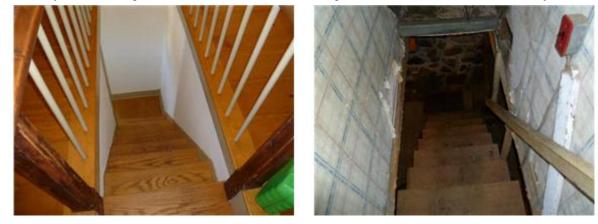
Comments : Stairways are missing hand rails. Recommend installing hand rails where needed for safety.
