PROPERTY INSPECTION REPORT

Concerning: 12345 Residential Property
Any City, TX

Inspected By: National Property Inspections
Joe Inspector

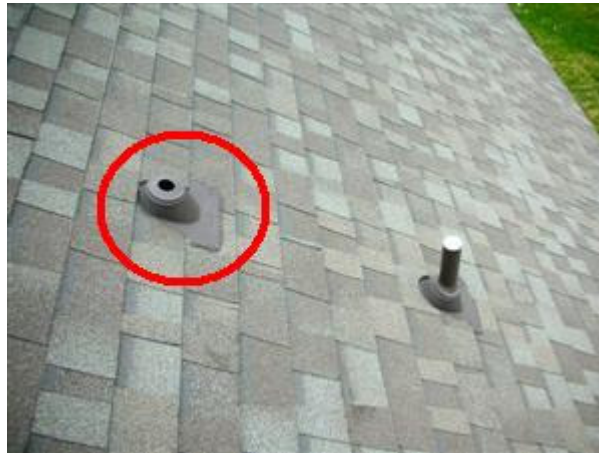
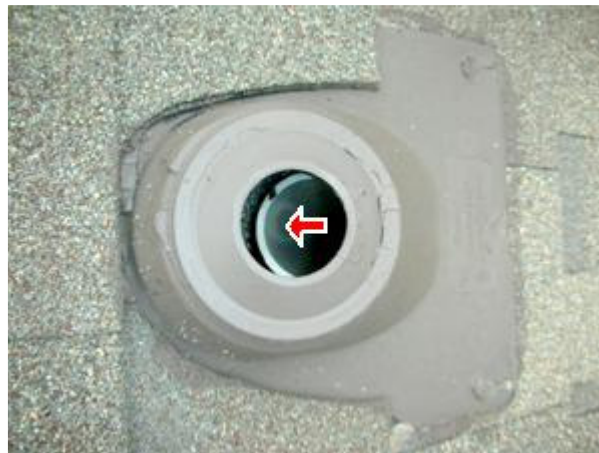
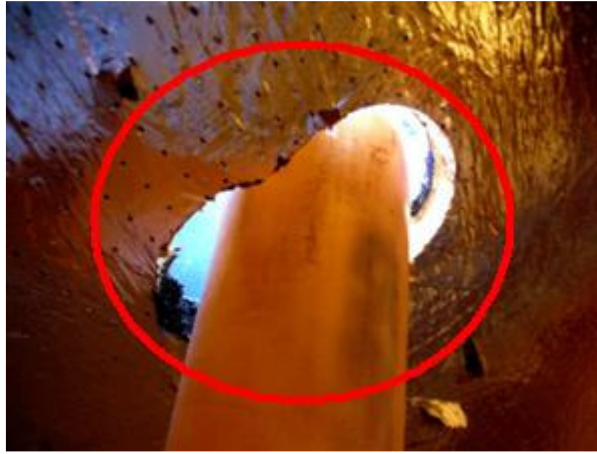
1. South Face: There is a plumbing vent that is too short, and does not extend above the top of the roof jack (pictures #1-3). Recommend a qualified plumber cut & extend the vent no less than 6 inches above the lip of the roof jack to prevent water penetration around the vent pipe.

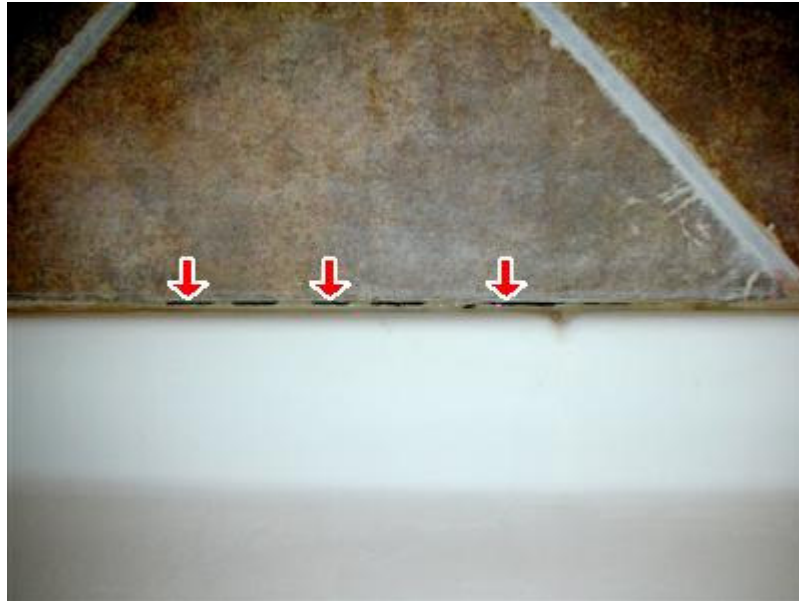
E. Picture 1

1. Master Shower - Right Side: There is deteriorated caulk along the bottom edge of the tile (picture #1). Recommend re-caulking wherever necessary to prevent water penetration.

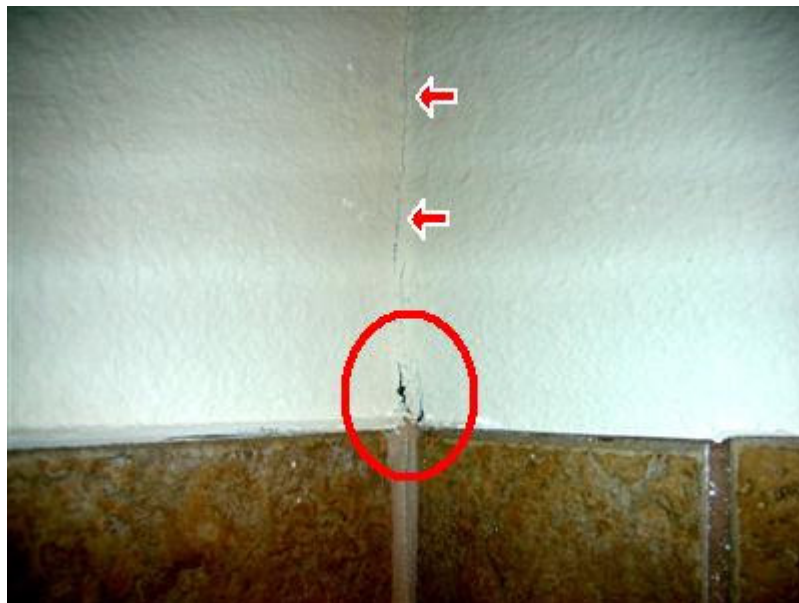
E. Picture 2

2. Upstairs - North Shared Bath - Back Right Corner of Tub/Shower Tile Surround: There is a hole and a sheetrock joint crack above the tile (picture #2). Recommend a qualified tradesperson evaluate and make any necessary repairs to prevent water penetration.

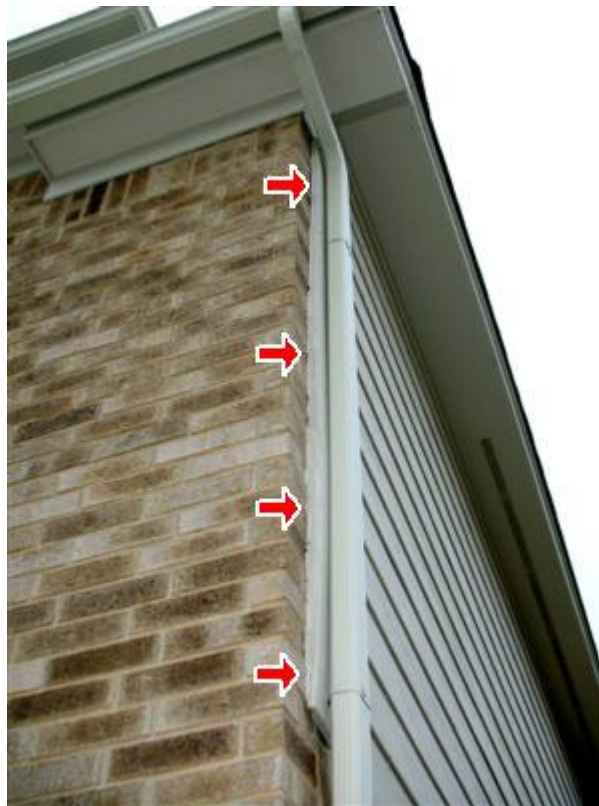
E. Picture 3

1. South-West Corner: There is deteriorated caulk along the interface trim board (picture #3). Recommend re-caulking/re-painting wherever necessary to prevent water penetration.

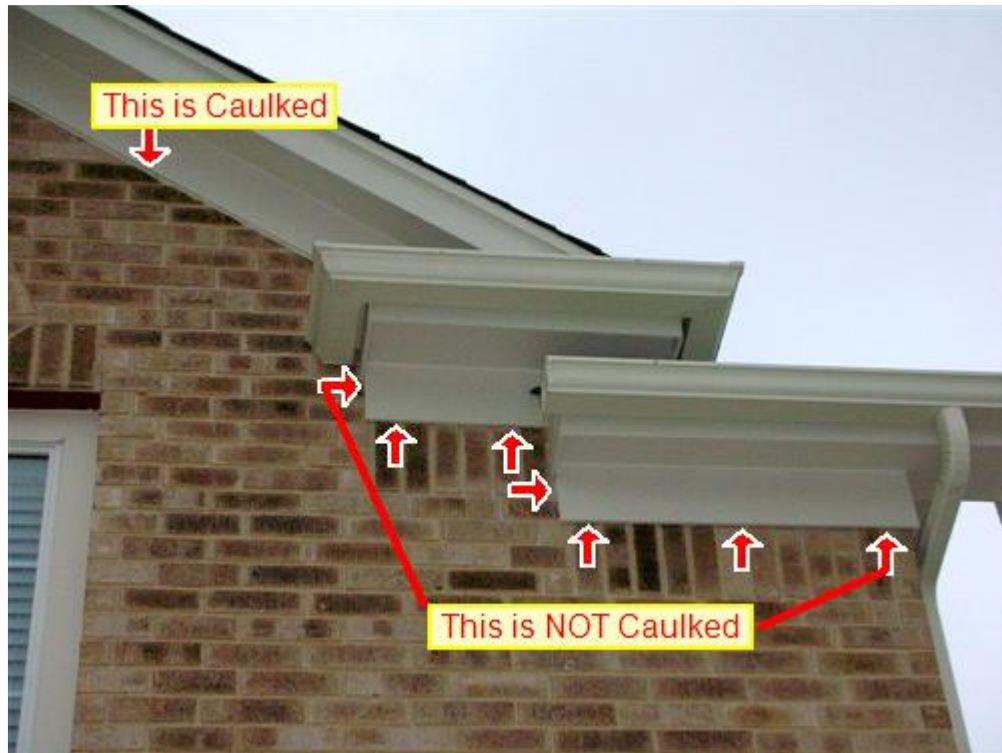
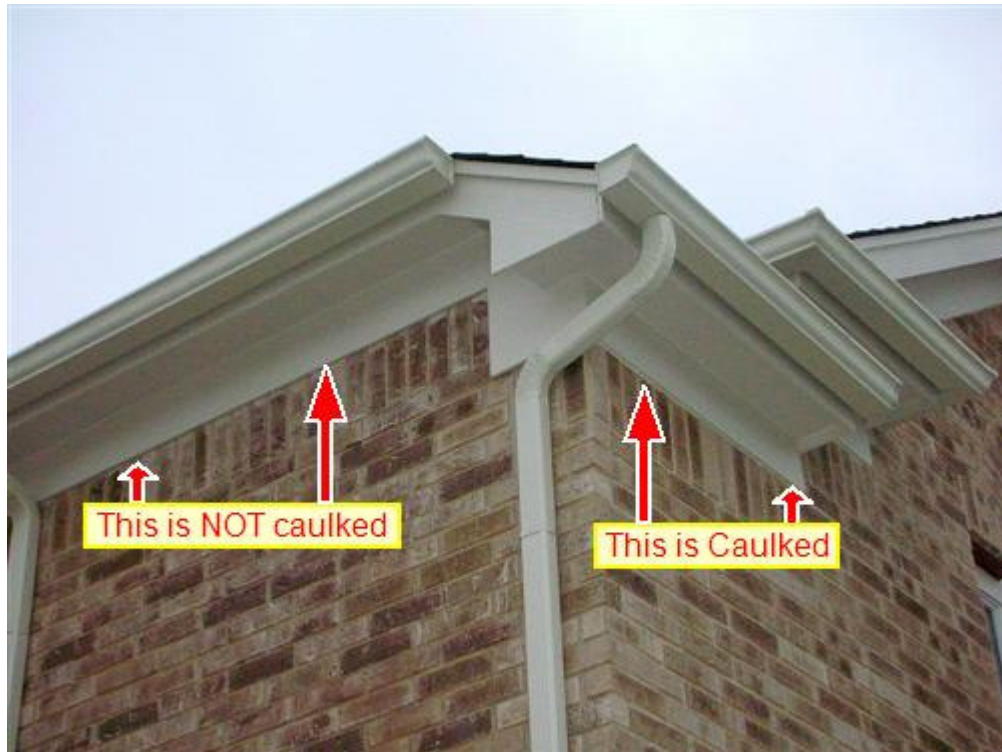
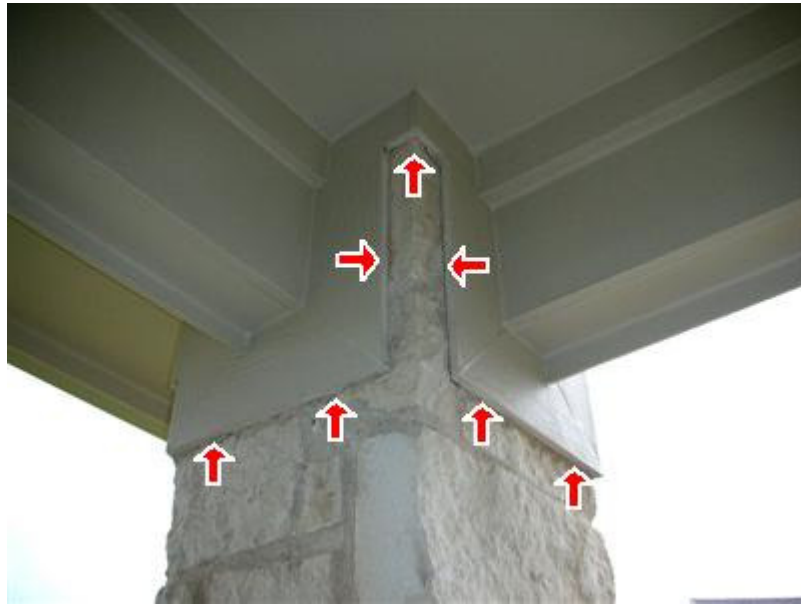
- 2. Frieze Trim - Inconsistent Caulking:** Some frieze trim sections are caulked, and others are not (example pictures #4-6). Recommend caulking ALL of the frieze trim for consistency, and to prevent moisture penetration.

2. Frieze Trim - Inconsistent Caulking: Some frieze trim sections are caulked, and others are not (example pictures #4-6). Recommend caulking ALL of the frieze trim for consistency, and to prevent moisture penetration.

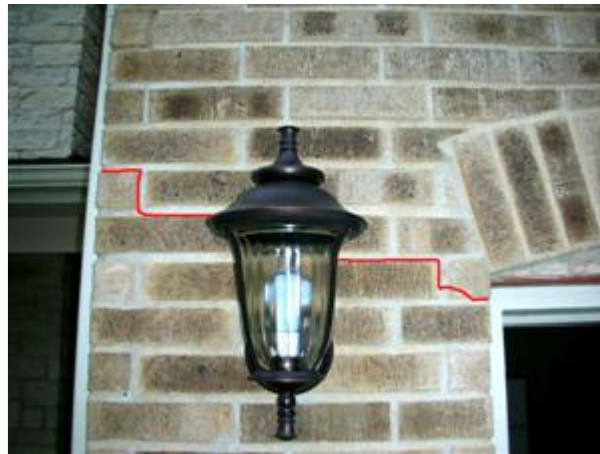
E. Picture 7

- 3. Garage:** There is a typical non-structural crack in the veneer mortar near the north light fixture (picture #7). Recommend a qualified masonry professional evaluate and tuck-point this crack to prevent water penetration.

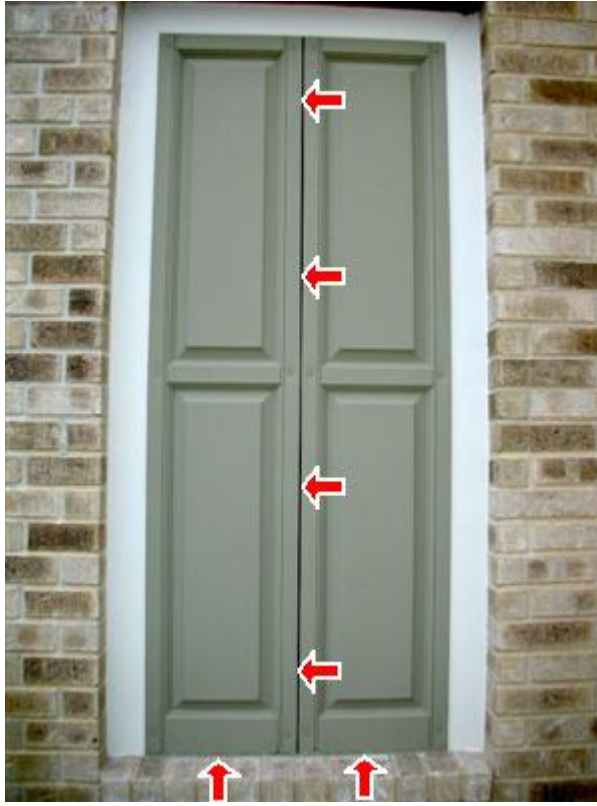
E. Picture 8

- 4. North-West Corner:** The lower deco shutters are not adequately sealed (picture #8). Recommend sealing & painting wherever necessary to prevent water penetration.

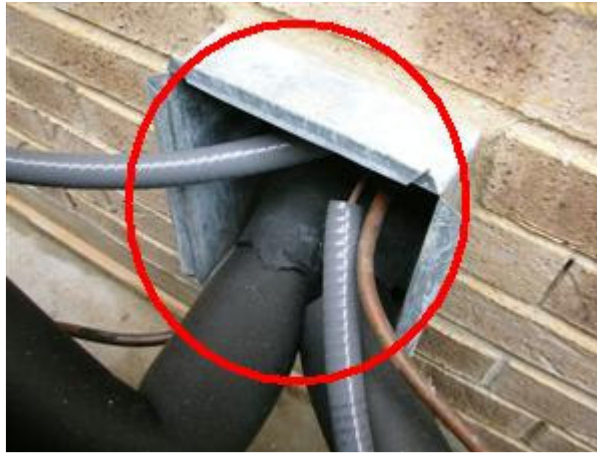
E. Picture 9

- 5. South Side:** The A/C coolant lines are not adequately sealed where they enter the home (picture #9). Recommend a qualified HVAC professional evaluate and properly seal the wall penetration against water penetration. If expansive foam sealant is used, it MUST be listed for exterior exposure and weatherproof.

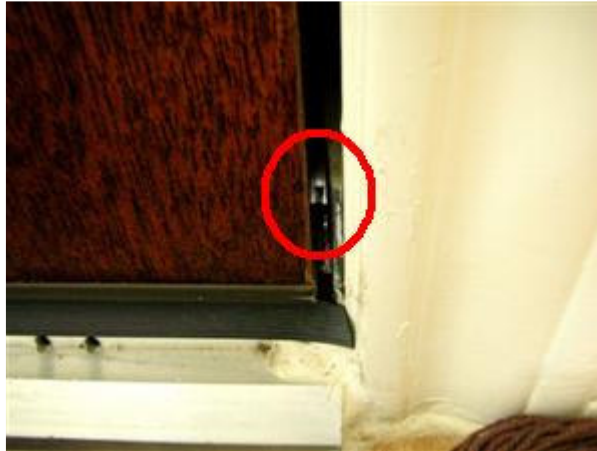
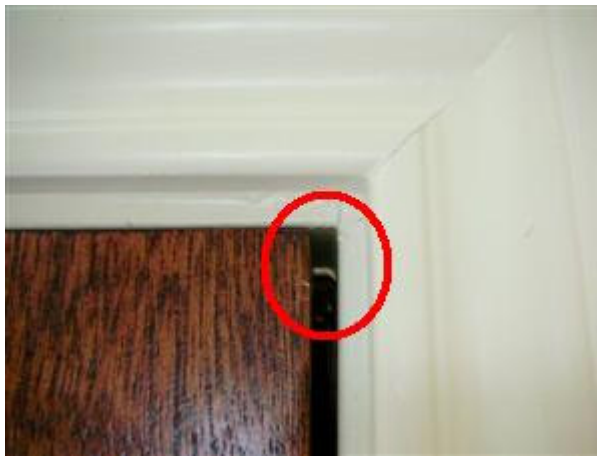
1. Front Door: Daylight is visible at the bottom and top corners on the latch side (pictures #1 & #2). Recommend a qualified door installation professional evaluate and adjust/repair/replace the weather-stripping wherever necessary for energy efficiency.

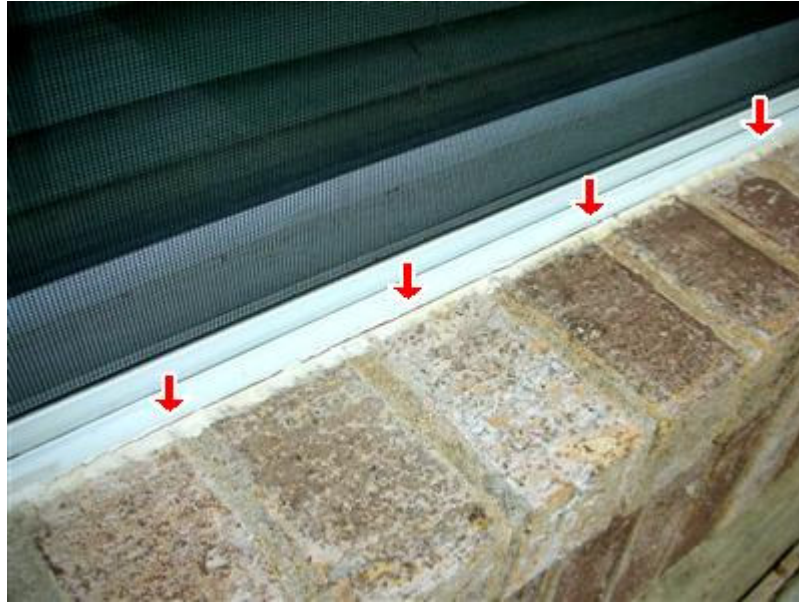
H. Picture 1

1. Not Adequately Sealed: There is deteriorated and/or missing caulk/grout around various exterior window frames and trim joinery (example picture #1). Recommend re-caulking/re-grouting/re-painting wherever necessary to prevent water penetration.

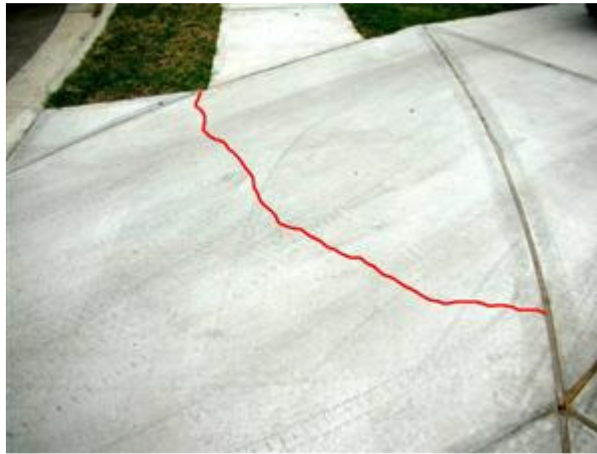
K. Picture 1

1. Driveway: There are cracks in the driveway (example picture #1). Recommend sealing these cracks to prevent water penetration that can corrode the reinforcement steel and cause spalling.

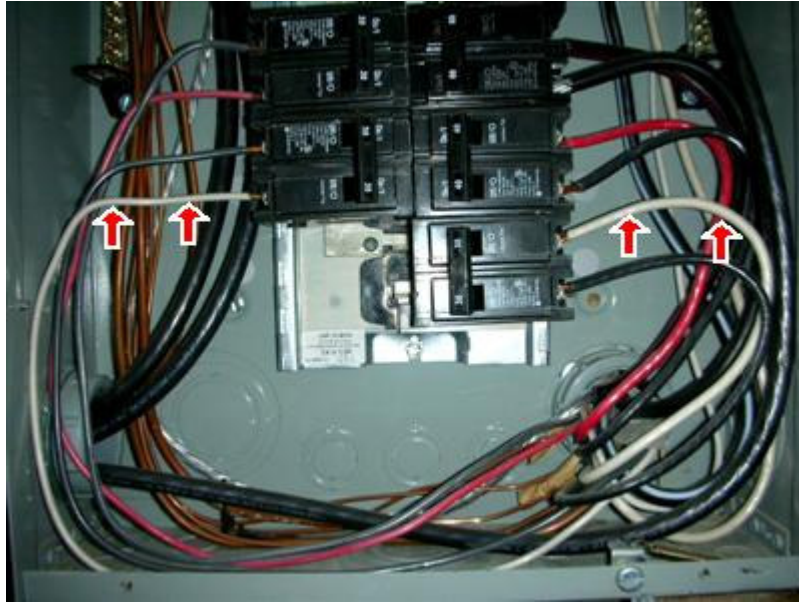
A. Picture 1

1. South-West - Main Exterior Service Panel: There are current-carrying WHITE wires present in this panel (picture #1). Recommend a qualified electrician tape these wires RED for safety.

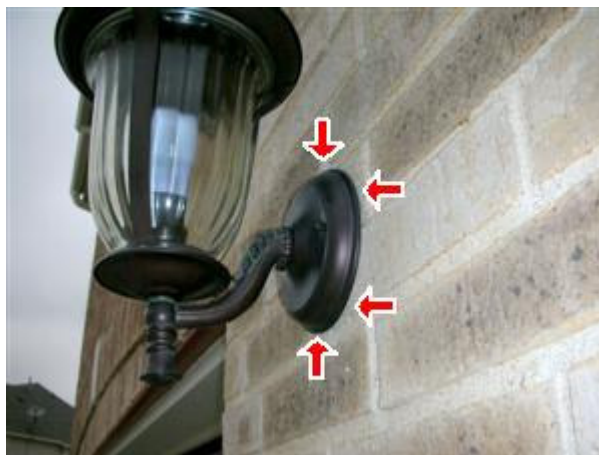
B. Picture 1

- 1. Exterior:** Some of the exterior fixtures are not adequately sealed around at the wall (example picture #1). Recommend sealing around all fixtures to prevent water penetration.
- 2. Upstairs - North Shared Bath:** The bathroom lights are on the GFCI circuit, and lose power when the GFCI protected outlet is tripped (picture #1). Recommend a qualified electrician evaluate and rewire the lights to be on a non-GFCI circuit.

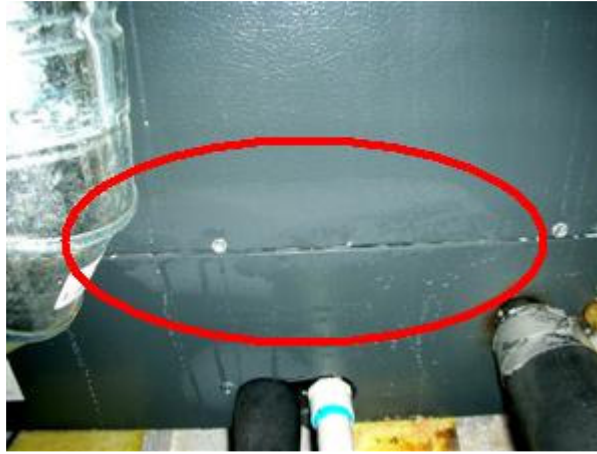
B. Picture 1

2. Attic - West: The downstairs-serving evaporator is leaking cold air and moisture is condensing on the side of the unit (picture #1). Recommend a qualified HVAC professional evaluate and make any necessary repairs.

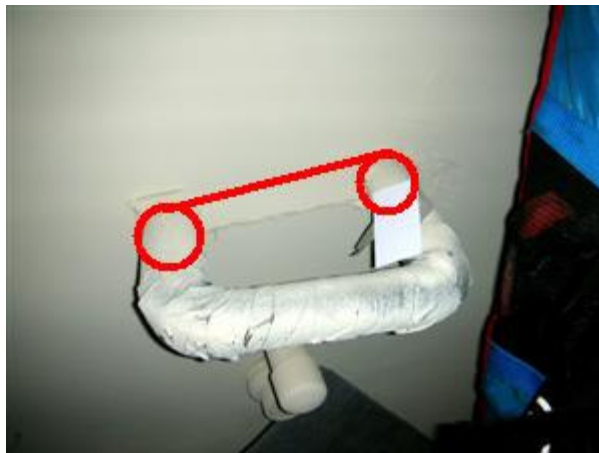
A. Picture 1

1. Garage: The water softener supply loop does not have an electrical bonding jumper installed. This will only become an issue if the homeowner installs a water softener. Since most water softener connections are non-conductive, they interrupt the electrical continuity of the plumbing supply system. Although the plumbing supply system is properly bonded to the main panel, there will be no continuous path for electricity to travel back to the main panel should the plumbing supply system become energized. This represents an electrical safety hazard. If the homeowner installs a water softener, then recommend a qualified electrician install a bonding jumper at the water softener loop to ensure electrical continuity for the plumbing supply system (picture #1).

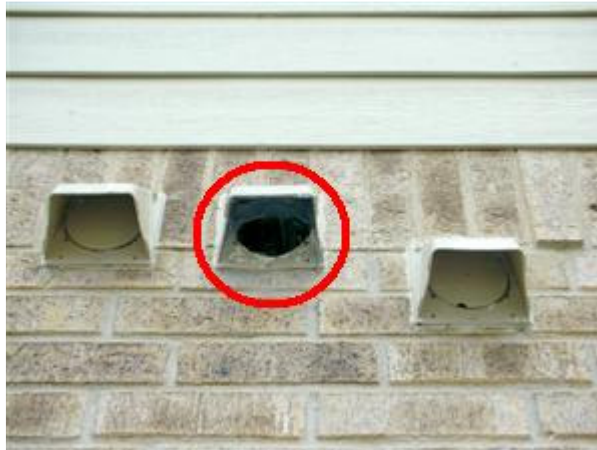
K. Picture 1

- 1. North Side:** There are birds nesting in the dryer vent (picture #1). Recommend a qualified dryer-vent cleaning professional remove the nest to prevent heat build-up. Also, recommend careful repair or replacement of of the vent hood so that the flap closes properly. **DO NOT INSTALL A SCREEN ON THE VENT HOOD.**
