# Inspection Report

**Property Address:**  
111 Sample View Drive  
Mckinney Tx 75069

# PROPERTY INSPECTION REPORT

**By:** Earl Lanning Trec#8669 / National Property Inspections 1/13/2012  
\_\_\_\_\_  
(Name and License Number of Inspector) (Date)

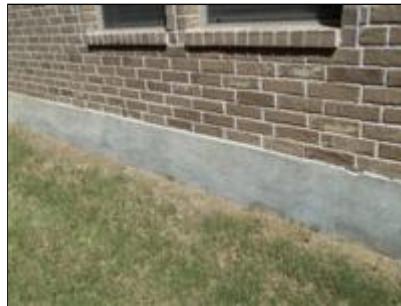
A. Picture 1

In my opinion the foundation appears to be providing adequate support for the structure at the time of this inspection. I did not observe any apparent evidence that would indicate the presence of adverse performance or significant deficiencies in the foundation. The interior and exterior stress indicators showed no affects of adverse conditions and I perceived the foundation to contain no significant un-levelness after walking the 1st level floor.

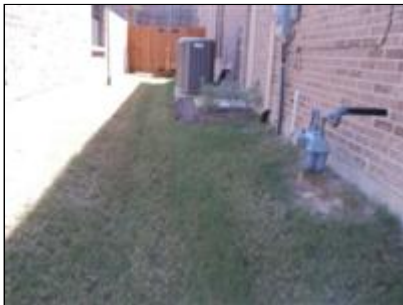
B. Picture 1

Inspected grading and drainage around home, noted excessive standing water at right front planting bed at main water valve area (Possible Leak ?), this condition can cause foundation issues (movement) in future. Recommend further evaluation and repair by qualified contractor.

Recommend to maintain slight positive grading away from foundation for proper drainage approximately 6 inch drop for 10 feet. Recommend to maintain soil line clearance of 4 - 6 inches from top of foundation. Recommend water to drain 3 - 5 feet away from foundation.

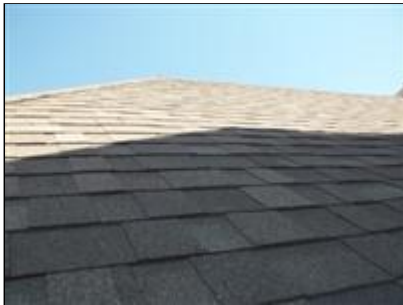
C. Picture 1

(1) Inspected roof at various areas, roof materials appear to be showing normal signs of wear, noted slight puckering of a few shingles at various areas and slight curling of bottom row of shingles, noted no obvious signs of water penetration at time of inspection. Recommend future and yearly monitoring of all roof level vent stack flashing details for proper sealing around the stack, these areas are known for cracking and deteriorating and allowing moisture penetration in future after lengthy service.

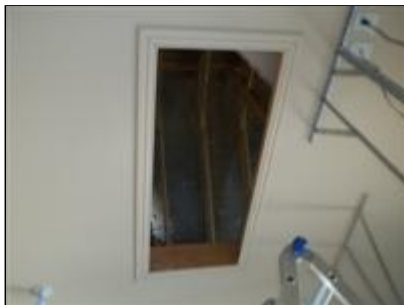
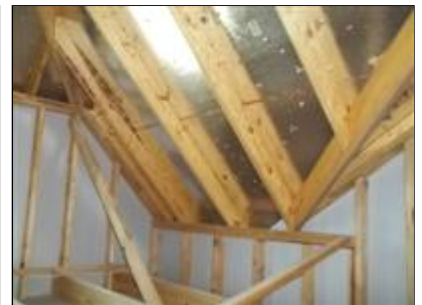
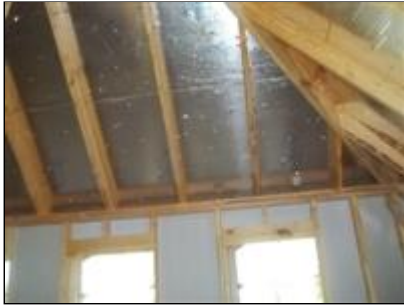
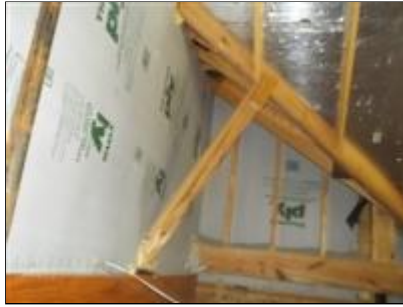
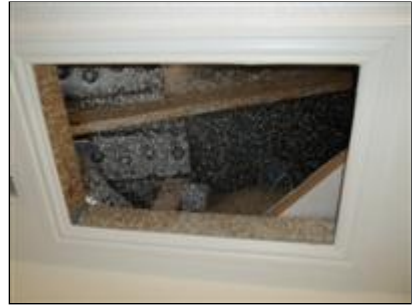
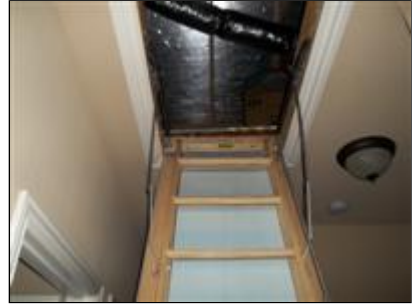
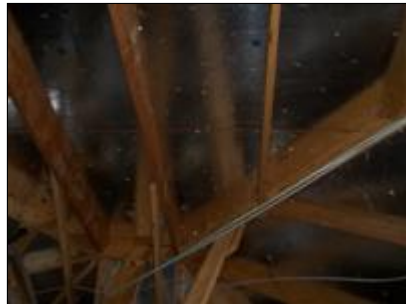
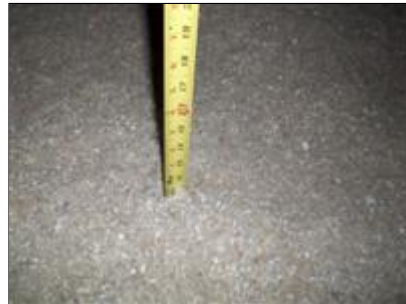
Inspected attic as well as possible from three separate entry accesses approximately 50%, due to lack of access and walking area it was not possible to inspect all areas, due to location and obstructions it is difficult to view all areas of sheathing, vent and stack areas for possible moisture penetration, attic appeared to be performing as designed at time of inspection.

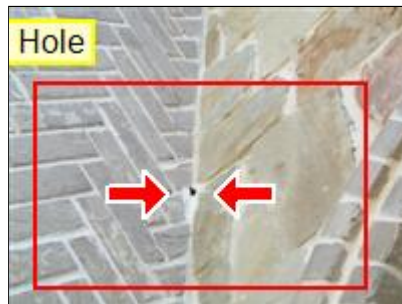
E. Picture 1

(1) Noted hole at stone mortar at middle left side corner area near front entrance. Recommend sealing all open areas.

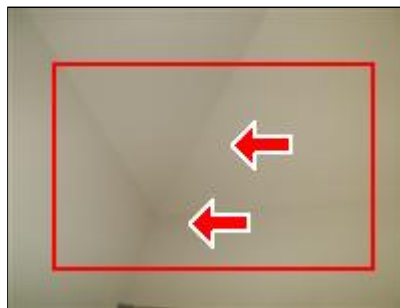
G. Picture 1

Noted texture cracking at attaching screws (nail pops) at left corner of upstairs game room area (These are not structural issues. Recommend repair during paint upgrade.

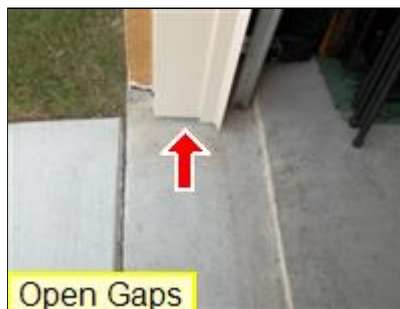
H. Picture 1

(1) Noted open gaps at bottom of garage door frames. Recommend sealing all open areas to eliminate infestation of small animals and insects

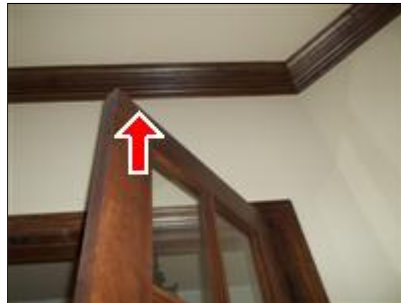
H. Picture 4

(3) Noted left door leading to office hard to latch. Recommend further evaluation and possible adjustment by qualified professional.

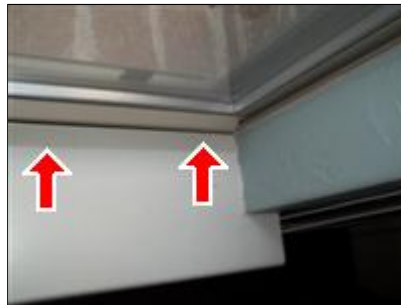
I. Picture 1

(1) Noted signs of moisture and standing water at various window sills through out home, including upstairs bedroom windows. Recommend further evaluation and possible repair by qualified contractor.

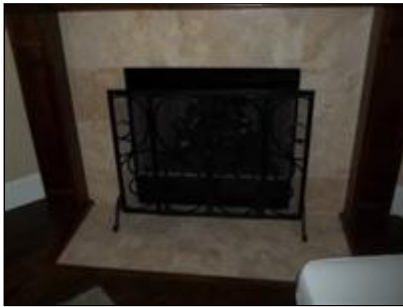
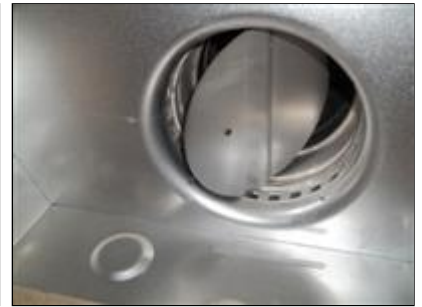
Noted lack of damper clamp, when artificial gas logs are installed in a firebox with a damper, the damper should be permanently blocked open with a damper clamp to prevent accidental spillage of carbon monoxide into the living space. Recommend installing damper clamp assembly. There were gas logs installed in the firebox at the time of this inspection. I was unable to view the floor of the firebox at the time of this inspection. All visual components were found to be in satisfactory condition at time of inspection.

Noted lack of damper clamp,when artificial gas logs are installed in a firebox with a damper,the damper should be permanently blocked open with a damper clamp to prevent accidental spillage of carbon monoxide into the living space.Recommend installing damper clamp assembly.There were gas logs installed in the firebox at the time of this inspection. I was unable to view the floor of the firebox at the time of this inspection. All visual components were found to be in satisfactory condition at time of inspection.

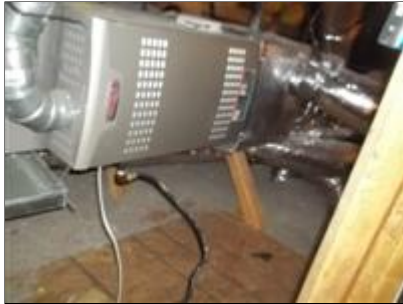
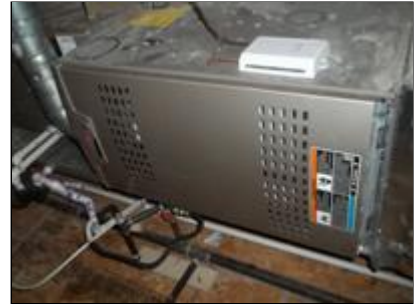
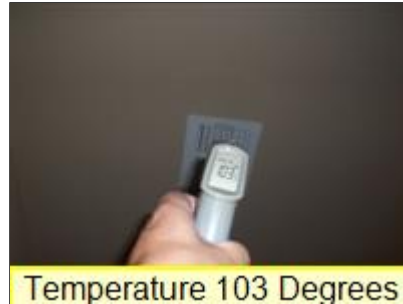
(1) Performance tested upstairs and downstairs heating systems for approximately 20 minutes systems appear to be approximately 1 year old dated 1-15-2011, noted both upstairs and downstairs system appeared to be operating as designed at time of inspection. Recommend yearly maintenance and service by qualified professional to help keep system at optimum operation.

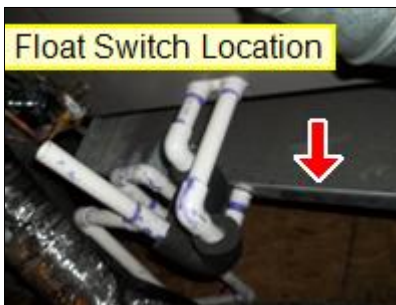
A. Picture 6

(2) Noted lack of condensate drain pan float switch being installed at condensate drain pan assembly, this switch when installed is a safety device shutting system down so drain pan will not overflow in case drain line is plugged or not operating properly and will not allow pan to overflow and cause water damage in attic area. Recommend adding a float switch as a safety precaution. (This is a recommended future upgrade)

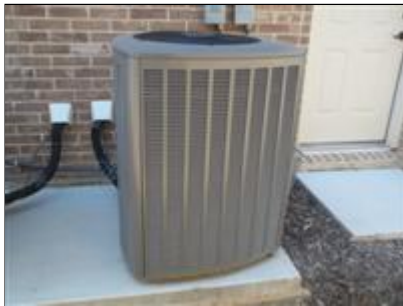
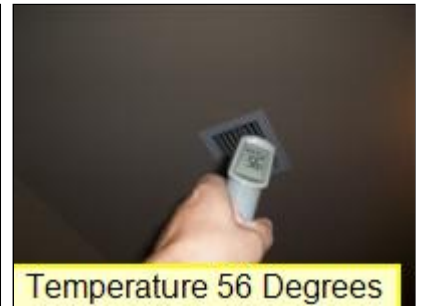
(1) Performance tested and visually inspected two cooling systems for approximately 60 minutes, noted downstairs system (Thermostat located at hallway near master bedroom area and condenser unit located at right side of home) (Rear Unit) appeared to be approximate 16 Seer 3 ton unit dated 1-2011, upstairs system (Thermostat located at hallway area and condenser unit located at right side of home) (Front Unit) appeared to be approximately a 16 Seer 3 ton unit dated 1-2011, both units appear to be operating as designed and had approximately 20 degrees differential between delivered air and return air and within TREC recommendations. Recommend yearly maintenance and service by qualified professional to help keep system at optimum operation.

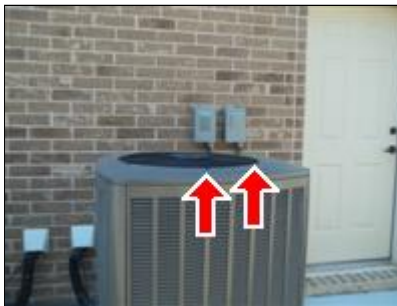
B. Picture 4

(2) Air conditioning emergency shut offs are located directly behind the outside condenser/coil assemblies which does not meet the clearance requirements of the National Electrical Code or the International Residential Code for today's building standards. "This is an as built condition" Recommend further evaluation by qualified professional.

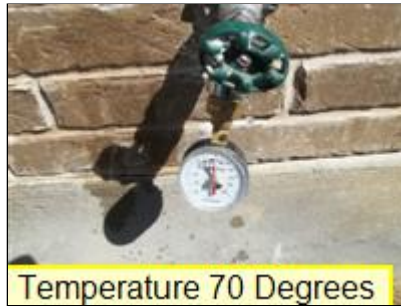
A. Picture 1

(1) Noted water pressure within recommended pressure (Maximum 80) pounds per square inch, actual reading approximately 70 pounds per square inch and within standards.

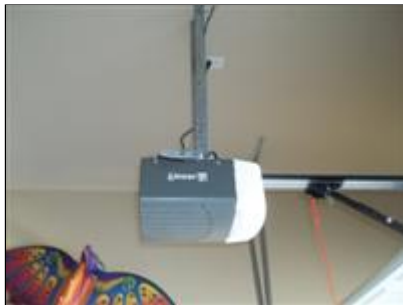
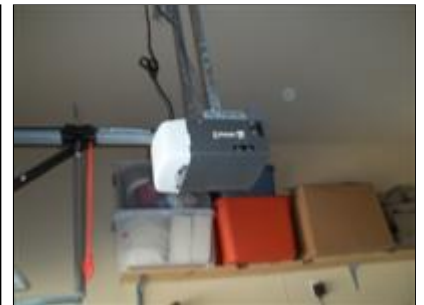
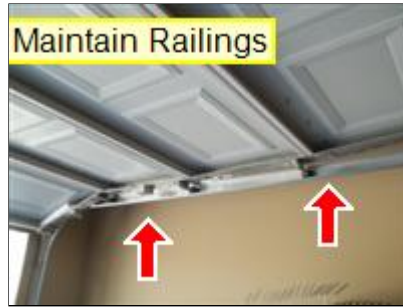
Garage doors appear to operate as designed and will reverse when met with resistance. Sensors are in place and will reverse the door.

Recommend to maintain and lubricate railing and wheel assemblies to help prolong life expectancy and quiet operation.

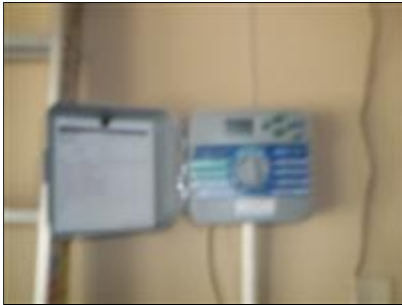
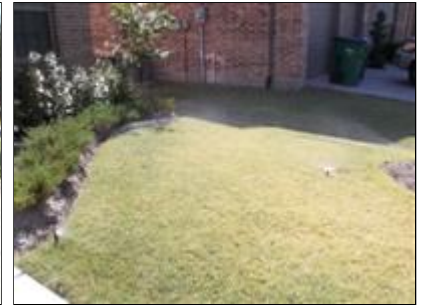
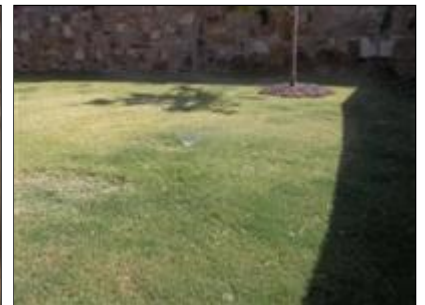
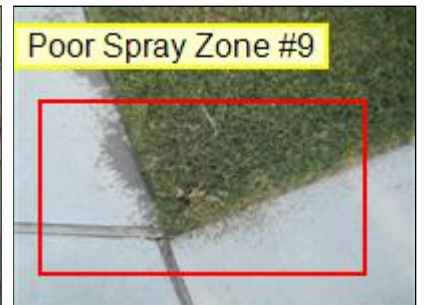
Performance tested sprinkler system, noted poor spray at left front corner of driveway zone #9. Recommend further evaluation and possible cleaning/repair by qualified professional. Also recommend periodic monitoring for complete and consistent coverage and minimal over spray on home exterior areas.

Performance tested sprinkler system,noted poor spray at left front corner of driveway zone #9.Recommend further evaluation and possible cleaning/repair by qualified professional. Also recommend periodic monitoring for complete and consistent coverage and minimal over spray on home exterior areas.

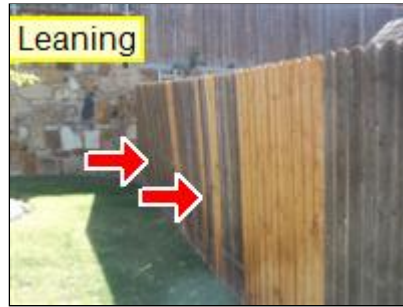
B. Picture 1

Noted right side fence at rear of yard leaning and fence post coming loose. Recommend further evaluation and repair by qualified professional.
