# National Property Inspections

**Richard Bailey, 00000 Burnet Rd, Austin, Tx, 78758**

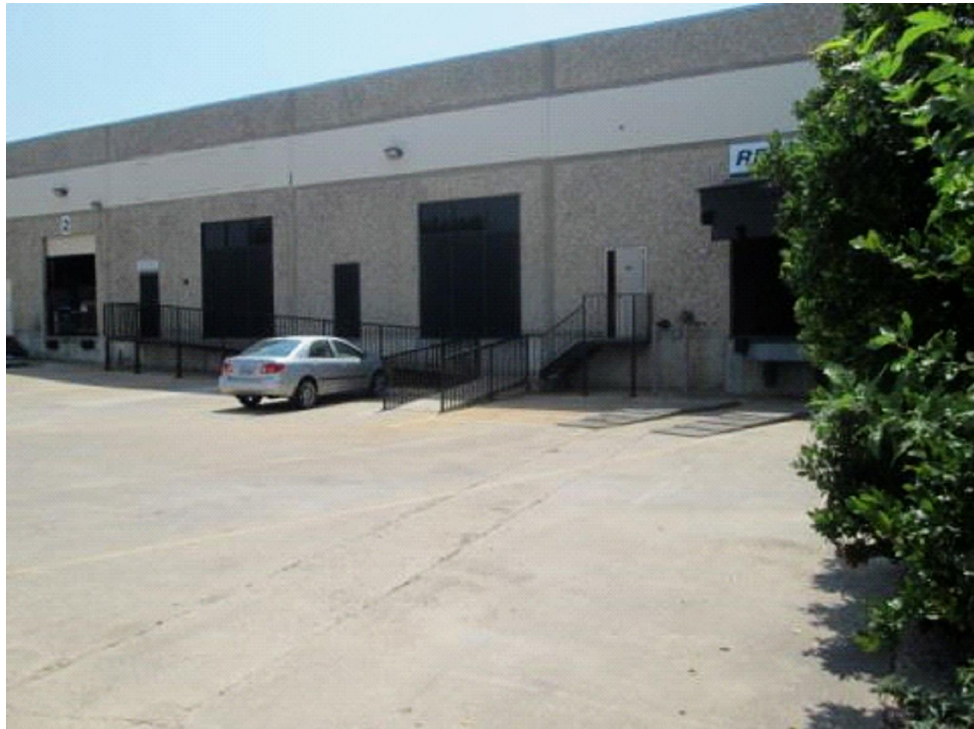
Tuesday, October 15, 2013  
Inspector  
Chris Quoyeser  
281-818-1266  
npi.chrisq@gmail.com  
TREC # 21071

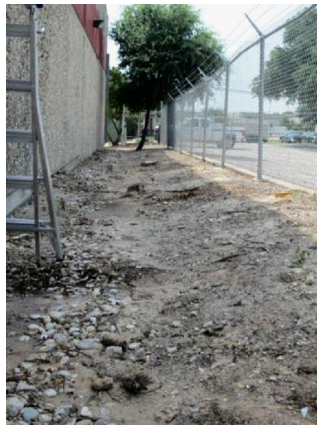
Grading / Drainage: Negative slope on north (left) wall.

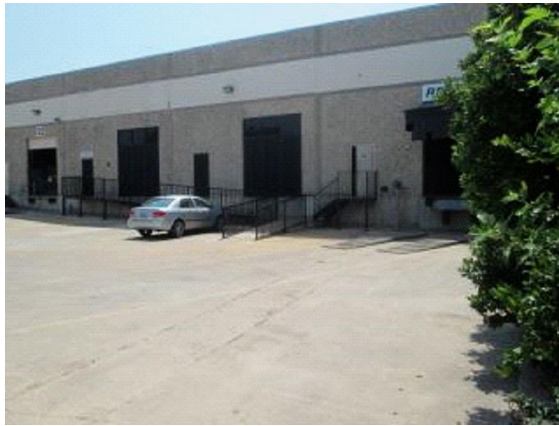
Comments : Parking lot has some cracks consistent with its age. None were detected that appear to be active or are excessively wide. Slope and drainage appear to be satisfactory.

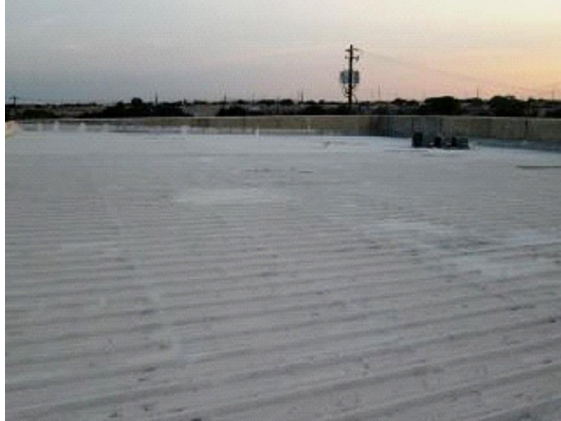
Roofing: Overall view of roof with spray-on elastomeric coating.

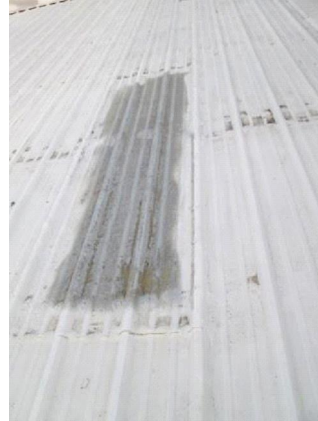
Roofing: Translucent panel cut into roof. Possible safety hazard.

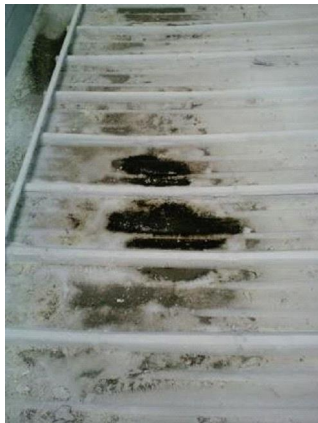
Roofing: Low end (west) where roof meets gutter showing evidence of ponding water.

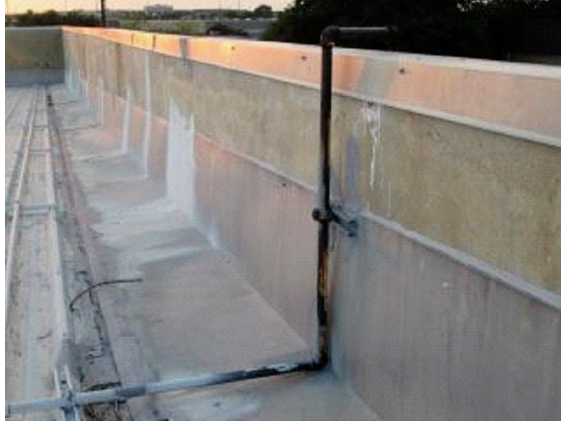
Flashing/Valleys: Cap and side flashing at north parapet wall. Cracking of elastomeric coating where flashing meets roof surface.

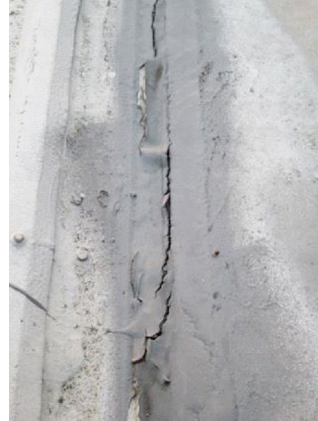
Flashing/Valleys: Cracking of elastomeric coating where flashing meets roof surface.

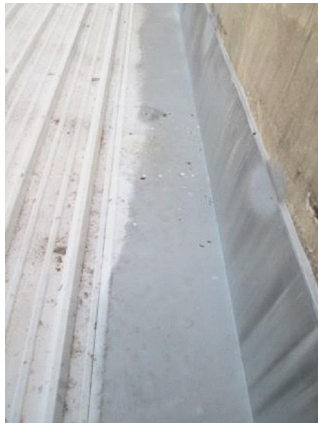
Flashing/Valleys: Side flashing

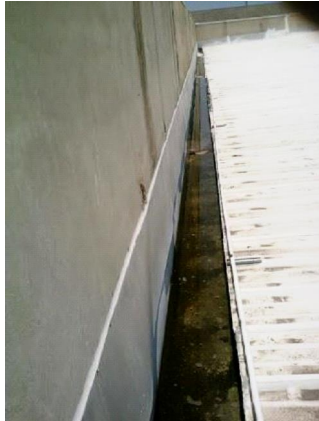
Gutters/Down Spouts: Water ponding observed on July 24, several hours after a light rain.

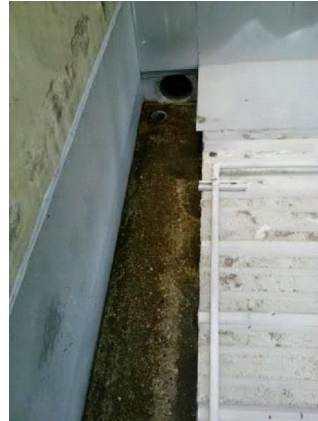
Gutters/Down Spouts: Ponded water near the drains on the north end.

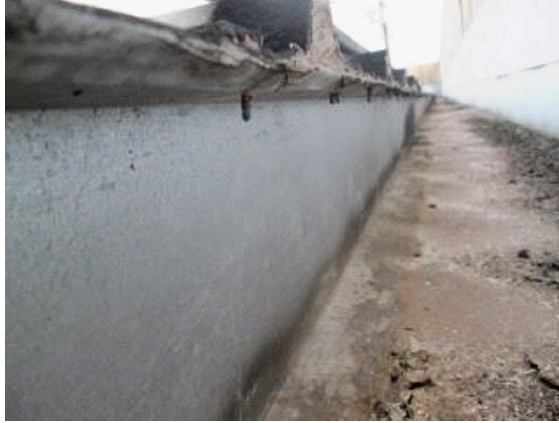
Gutters/Down Spouts: Evidence of water ponding observed on July 22.

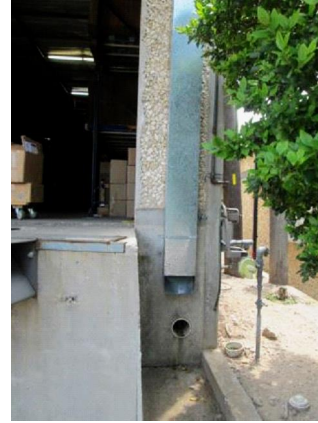
Gutters/Down Spouts: Downspouts and drains on the north and south ends of buildings appear satisfactory.

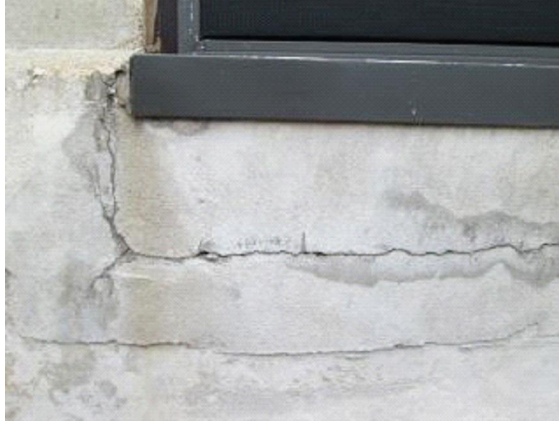
Exterior Surface: Minor crackng under window at west (front) of building.

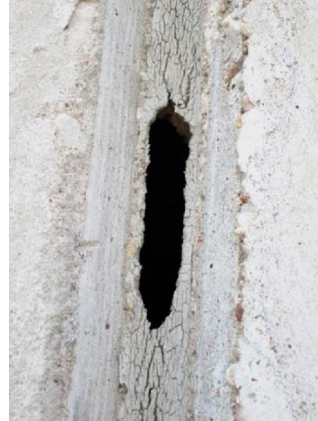
Exterior Surface: Gap and cracking of sealant in expansion joint between wall sections.

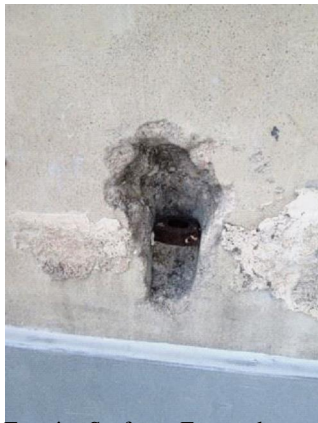
Exterior Surface: Exposed snap tie embedded in concrete inside the west (front) wall above the roof.

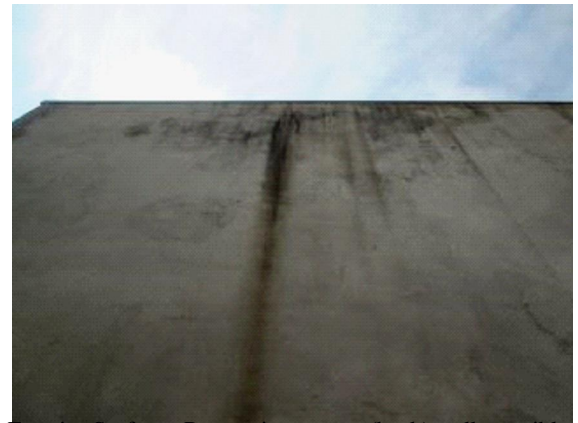
Exterior Surface: Rust stains on east (back) wall, possibly from earlier cap flashing and/or cap fasteners that had rusted out.

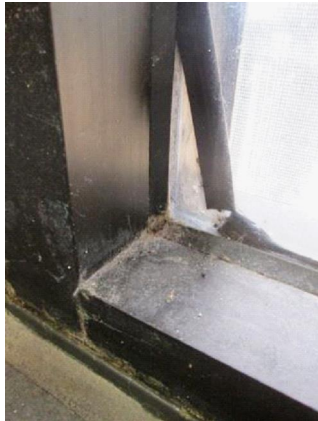
Windows: Loose gasket in window.

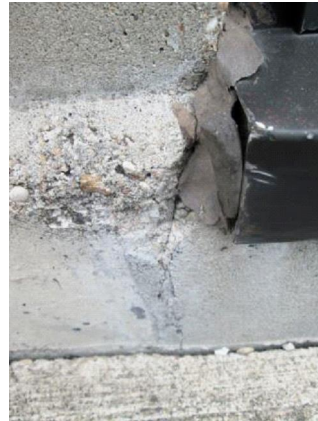
Windows: Open end on window sill.

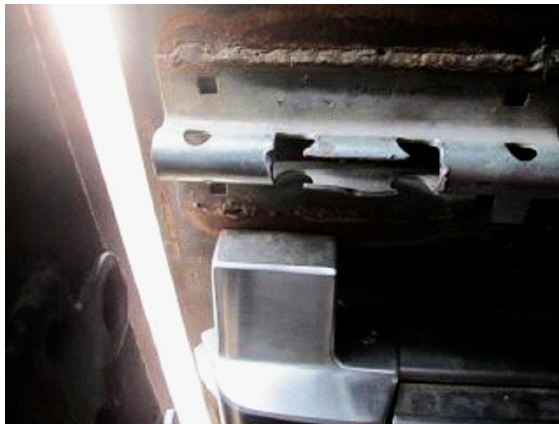
Exterior Doors: Exterior door on back wall at north end does not have functioning hardware. Must be tied after business hours.

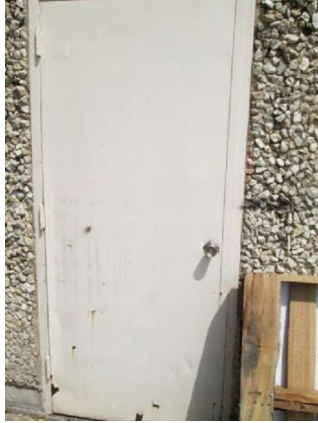
Exterior Doors: Exterior door on front wall at south end next to overhead door. Minor cosmetic damage (typical).

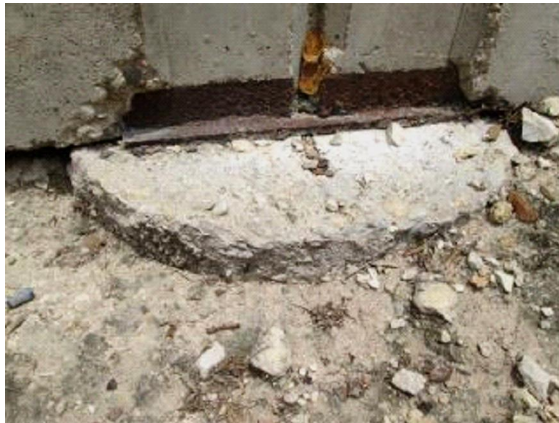
Foundation: Breakage of foundation beam wall over pier.

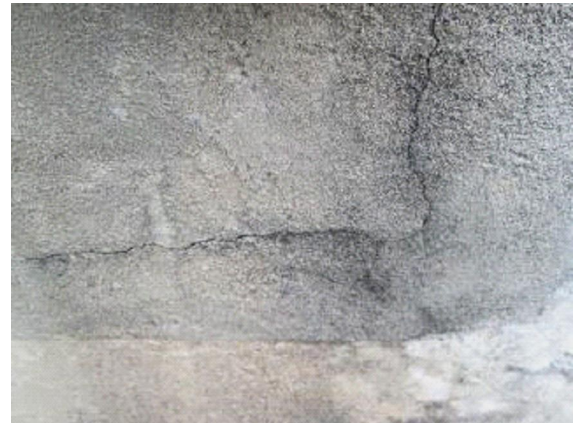
Foundation: Minor cracking.

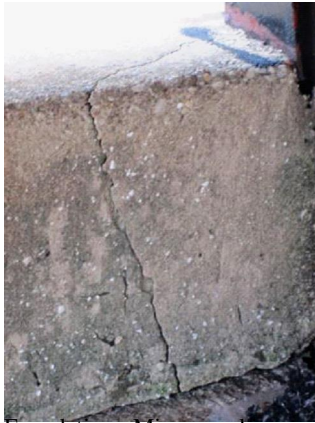
Foundation: Minor cracking.

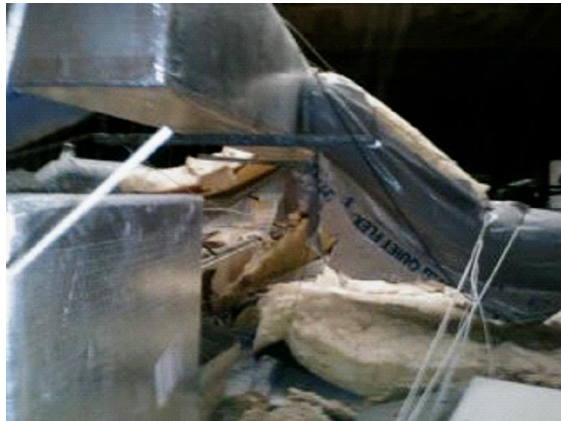
Insulation: Torn insulation on air duct.

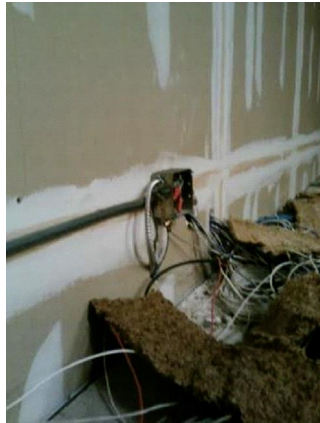
Attic Electrical: Open junction box above ceiling grid.

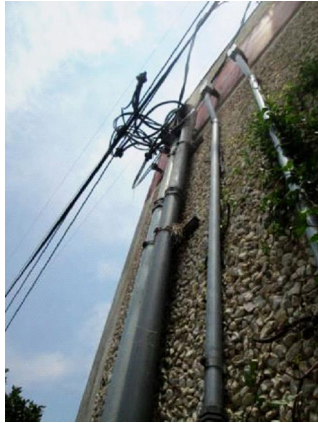
Electrical: Overhead service entrance mast.

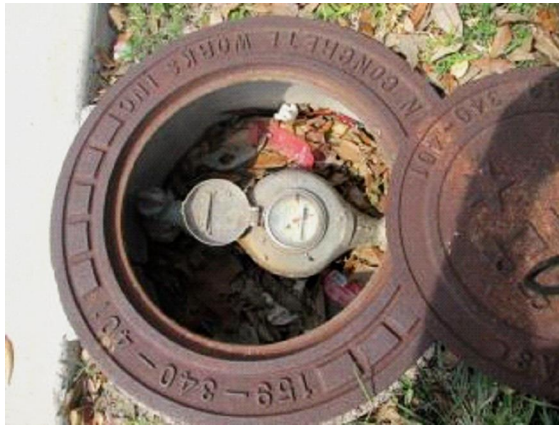
Plumbing: Water meter.

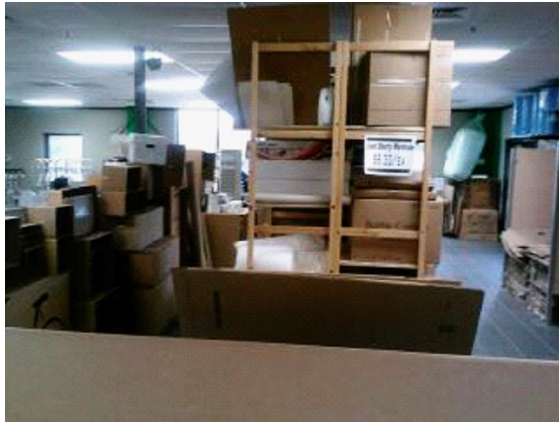
Heating: Obstructions preventing inspection of furnace.

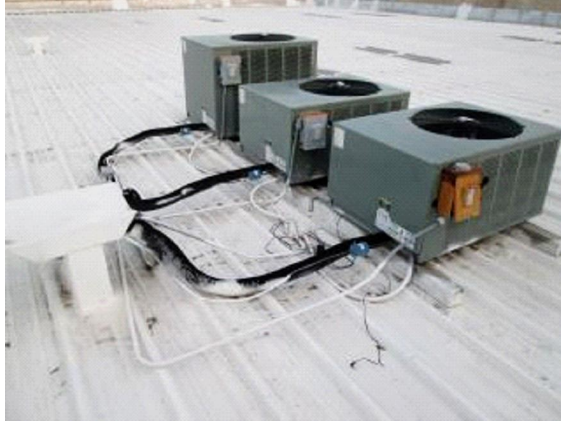
Richard Bailey, 00000 Burnet Rd, Austin, Tx, 78758

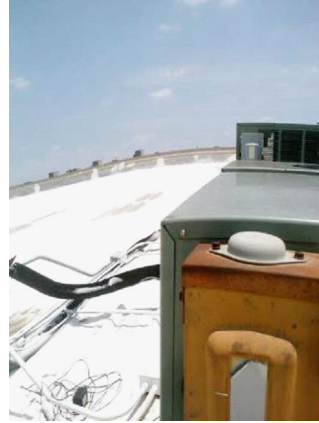
Cooling: Rusted switch box on one of the 3.5 ton units.

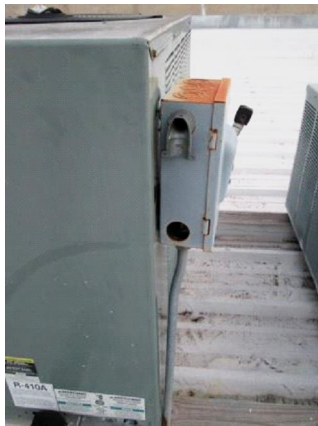
Cooling: Uncovered openings in switch boxes on the 5 ton unit and on one of the 3.5 ton units.

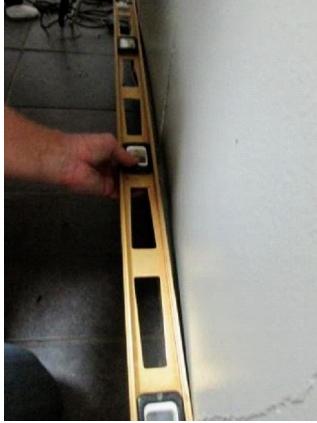
Interior Rooms (showroom, offices, conference room, and restroom.: Level used as straight edge to illustrate bow in wall.

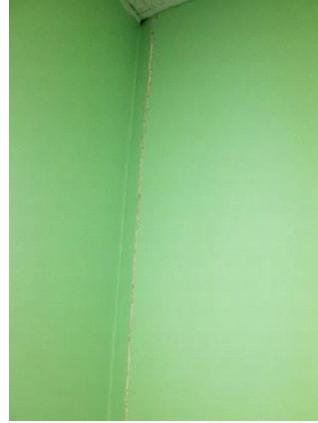
Interior Rooms (showroom, offices, conference room, and restroom.: Vertical crack with displacement on back wall of an office.

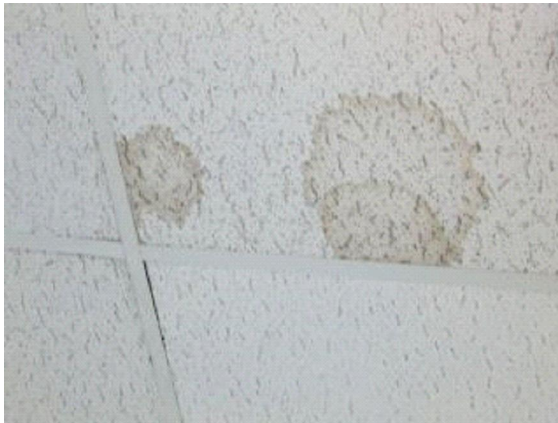
Interior Rooms (showroom, offices, conference room, and restroom.: Typical ceiling stains.

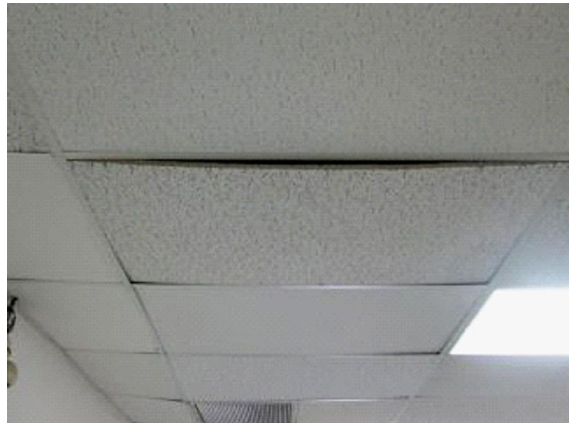
Interior Rooms (showroom, offices, conference room, and restroom.: Bowed ceiling tile.

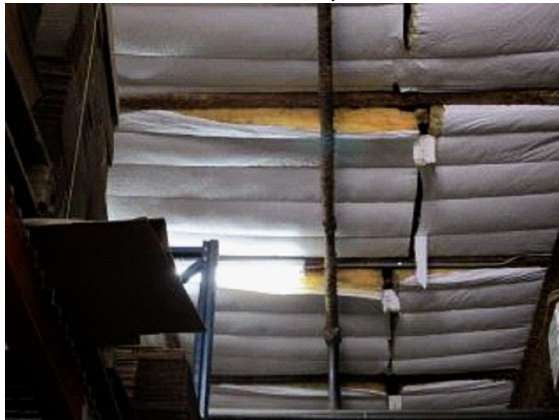
Warehouse Interior: Sagging insulation.

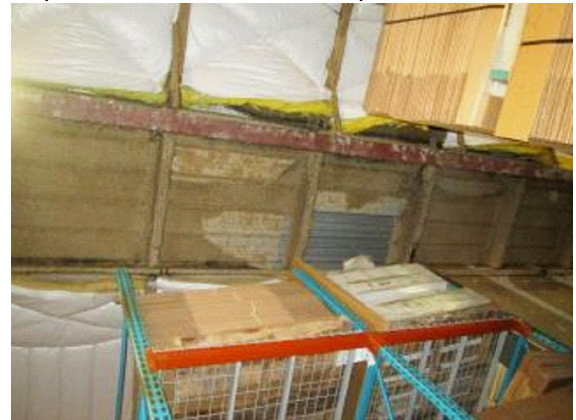
Warehouse Interior: Missing insulation.

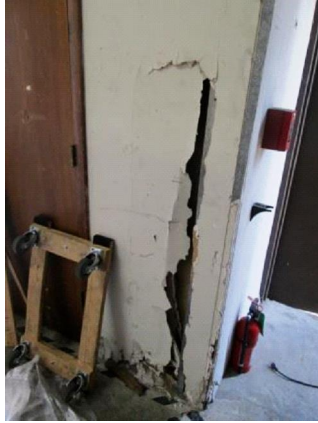
Warehouse Interior: Sheetrock damage.

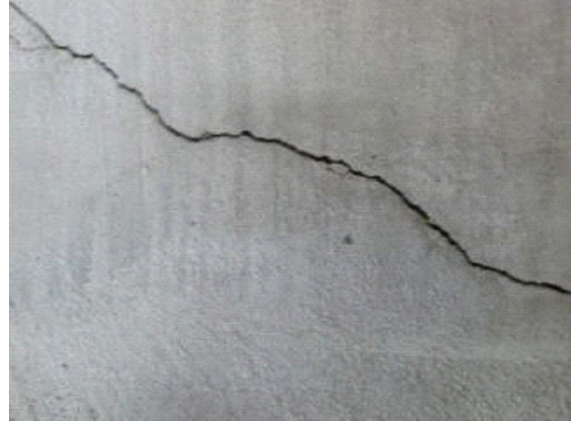
Warehouse Interior: Crack on east (back) wall, extending from northeast corner to 1st exterior door - about 24 ft.

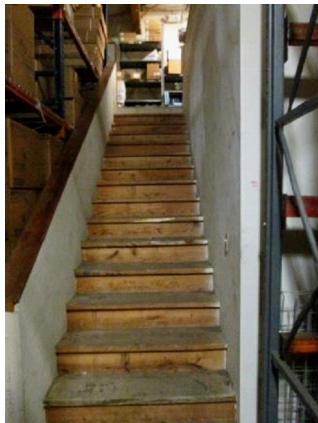
Stairs / Railings: Warehouse stairs to upper level.
