National Property Inspections

Mr. & Ms. Buyer, 245 Lane Way, Kure Beach, NC, 28449

Saturday, June 30, 2018

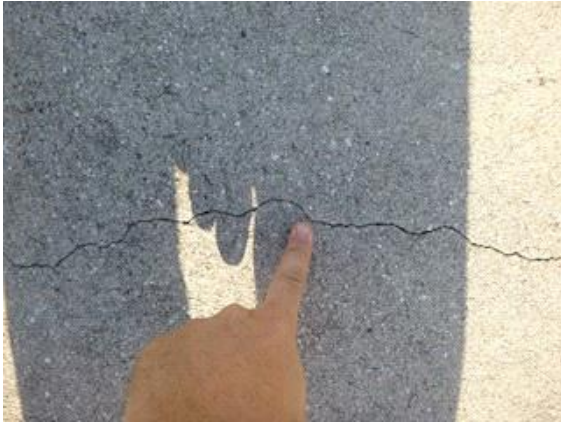
There are minor cracks present located on the left and right sides of the concrete driveway. Evidence suggests that these types of cracks are common and are caused by normal ground settlement. Recommend filling the cracks with an approved concrete filler to avoid future water intrusion.

Driveway: View of minor cracks located in concrete driveway

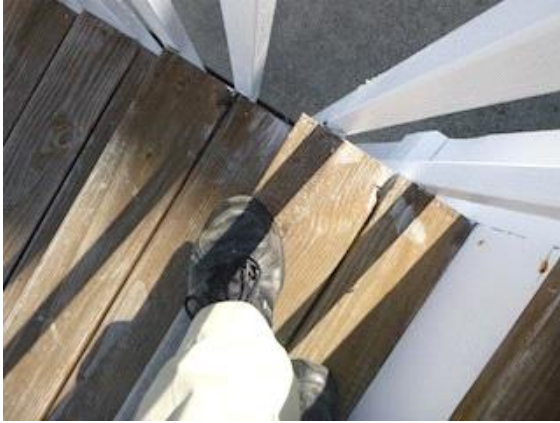
The front wood steps have a loose tread board, located on the 7th step from the bottom. Evidence suggests that this condition could create a potential trip hazard, and the step needs to be secured. Recommend a qualified contractor to evaluate and make the necessary repairs.

Walks / Steps: View showing loose tread board

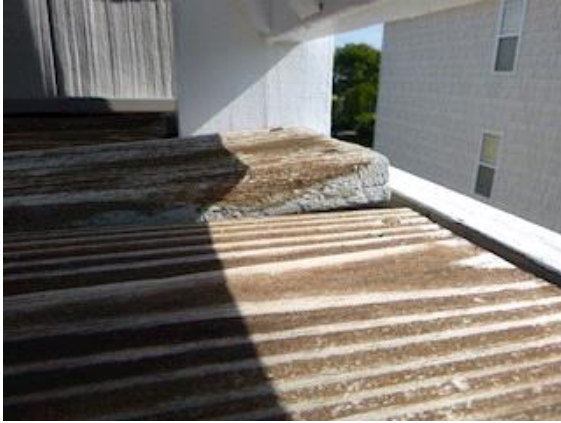
The 2nd floor rear deck has loose deck boards that are curling upward, located on the left and right sides of the deck. This condition has created potential trip hazards and needs to be repaired. Recommend a qualified general contractor to evaluate and make the necessary repairs.

Decks - Rear: View of lifted deck board on rear wood deck

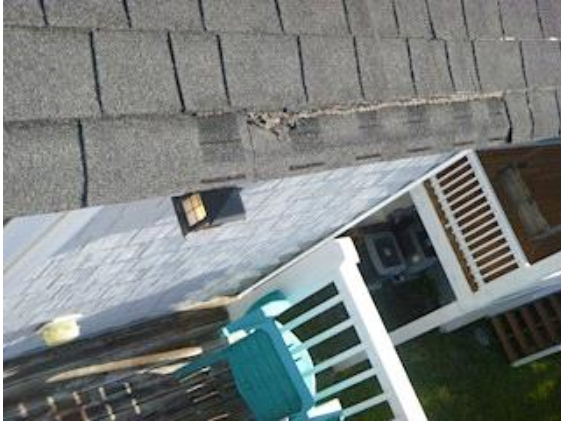
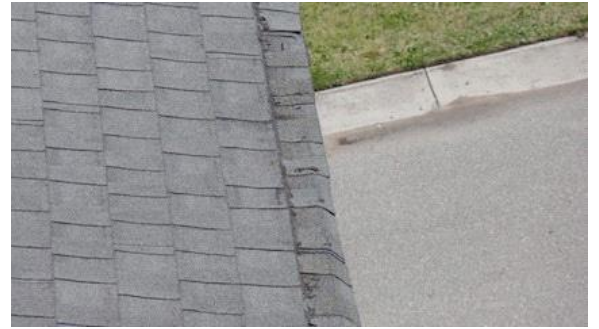
There appears to be multiple missing asphalt roof shingles, located on the front and rear sides of the roof along the drip edges. This condition exposes many roofing nails, creating avenues for water intrusion. Recommend a qualified roofing contractor to evaluate the condition of the roof and make the necessary repairs.

Roofing: Views showing missing shingles

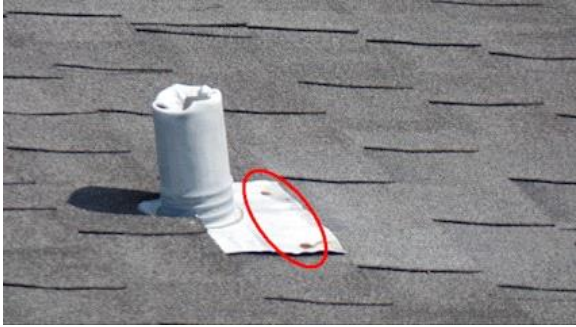
There are exposed nails heads, located at the bottom of the left side lead vent pipe flashing. Evidence suggests that the nail heads need to be sealed with an approved sealant to prevent future leaks. Recommend a qualified roofing contractor to evaluate the condition of the flashing and make the necessary repairs.

Flashing/Valleys: View of exposed nail heads at the base of vent pipe flashing

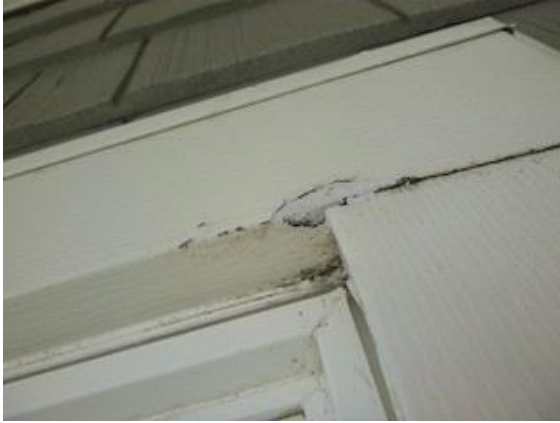
1. There are several corroded sections of aluminum trim pieces around the exterior of the fascia boards, windows and doors. Evidence suggests that the harsh salt air is starting to break down the aluminum trim. Recommend a qualified siding contractor to evaluate and to make any necessary repairs/replacement.

Exterior Surface: View showing corroded trim

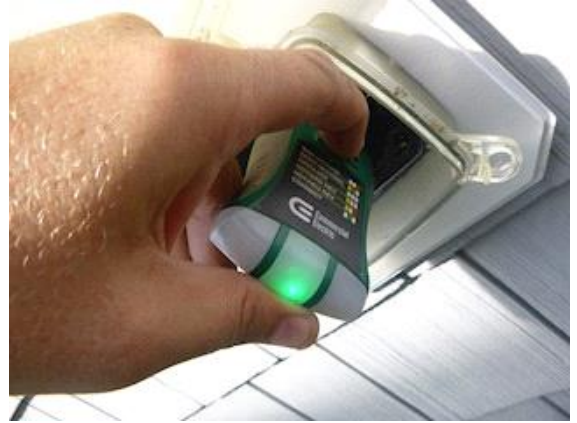
2. Many of the receptacles on the exterior of the house are not GFCI-protected and have been required to be since 1973. The exterior receptacles do not function as intended, and are in need of repair or replacement by a licensed electrical contractor.

Exterior Surface: View of exterior wall receptacle that is not GFCI protected

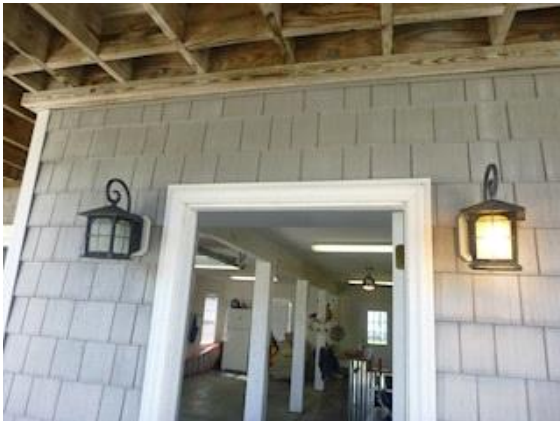
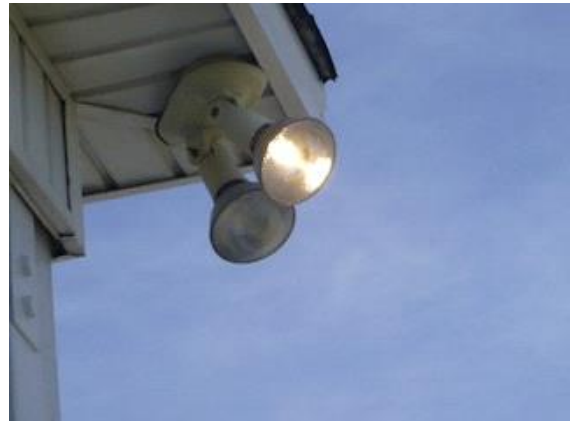
3. The exterior light located next to the garage front entry door and one spotlight at the front right corner of the house, did not come on when the wall switches were activated. Recommend replacing the bulbs first, then if the lights still do not work, recommend a licensed electrical contractor to evaluate the condition of the light fixtures and make the necessary repairs.

Exterior Surface: Views showing defective exterior lights

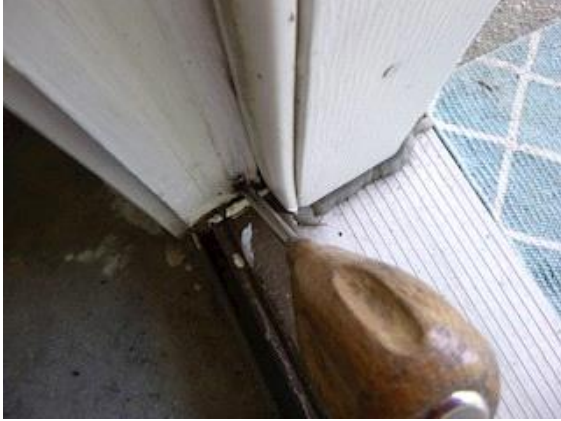
1. There is soft (water-damaged) wood present on the garage rear entry door, located at the base of the lock-side door jamb. Evidence suggests that there is water intrusion at this location, and the damaged wood needs to be replaced to restore the integrity of the door.

Exterior Doors: View showing water-damaged door jamb

** Recommend a licensed general contractor to evaluate the condition of the exterior entry doors, determine the full extent of damage to the areas, and make the necessary repairs to issues #1-5 listed above.

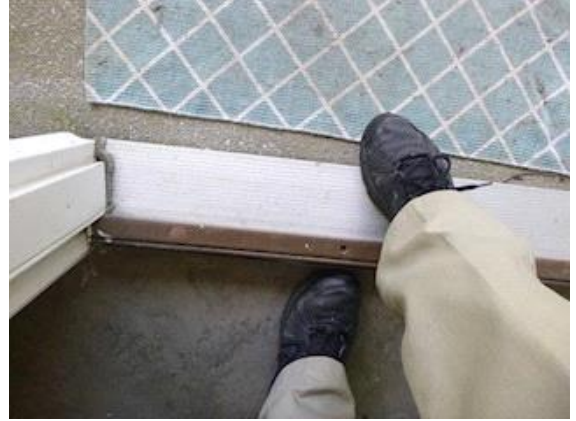
2. The lower threshold is loose, located on the garage rear entry door. Evidence suggests that this condition is creating a potential trip hazard, and is in need of repair.

Exterior Doors: View showing loose threshold

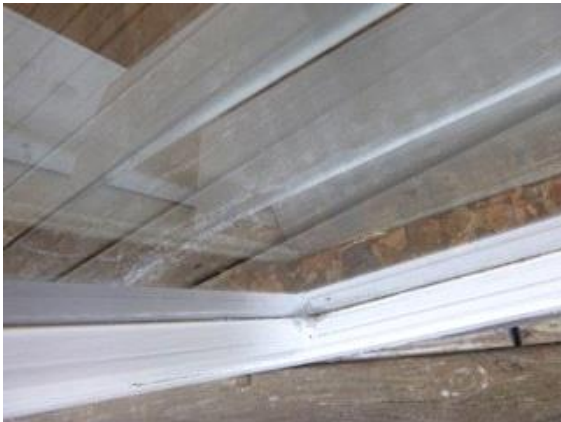
3. The seal between the glass panes appears to have failed, located on the 1st floor rear entry door. Evidence suggests that the desiccant strip designed to absorb moisture from the space between the panes has become saturated and can no longer prevent condensation from forming. In some situations repair is possible, but if irreparable damage has occurred, the door pane assembly will need to be replaced.

Exterior Doors: View showing rust between glass panes

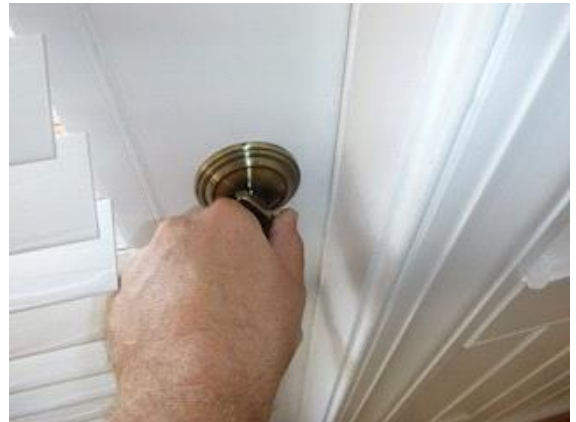
Exterior Doors: View of binding dead bolt

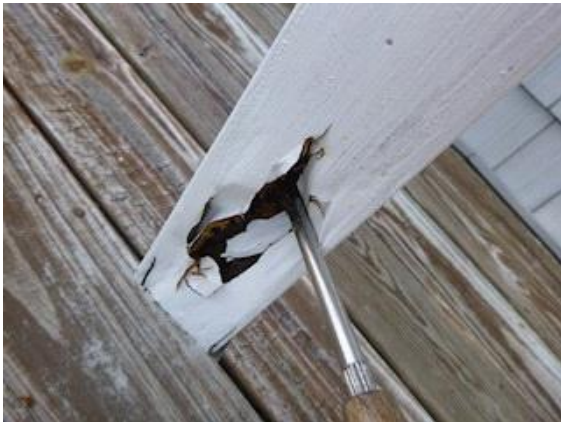
5. There is soft (water-damaged) wood present on all three 2nd level front and rear entry doors, located at the base of the door cores. Evidence suggests that there is water intrusion at these locations, and the damaged wood needs to be replaced to restore the integrity of the doors.

Exterior Doors: View showing water-damaged door core

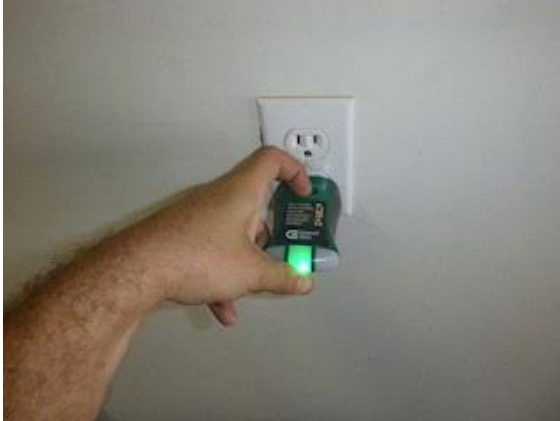
1. The electrical receptacles located on the left and right walls are not GFCI-protected. All receptacles in the garage are required to be GFCI-protected since 1978. The receptacles do not function as intended and are in need of further evaluation by a licensed electrical contractor.

Garage/Under House: View of electrical tester indicating the receptacles are not GFCI protected

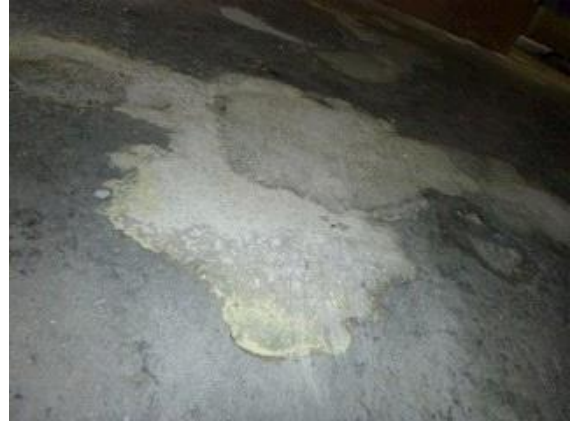
2. There is efflorescence (white chalky substance) present on the garage floor, located at the front right side of the garage. This is an indication of ground water intruding up through the garage floor slab. Recommend a qualified masonry contractor to evaluate and make the necessary repairs.

Garage/Under House: View showing efflorescence on garage concrete floor

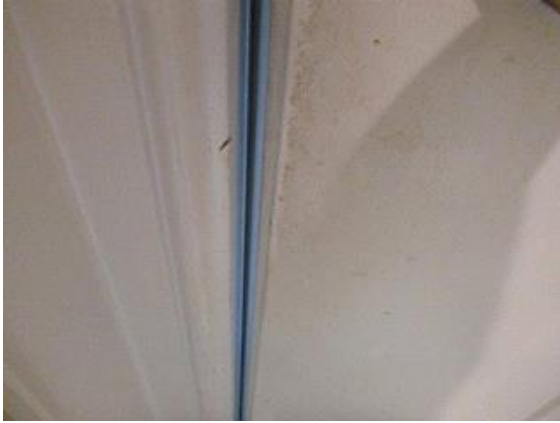
There is a gap along the lock side edge of the weather-stripping on the garage pedestrian door, allowing daylight to shine through the door seal. Evidence suggests that this condition is creating an avenue for energy loss/unwanted air exchange. Recommend a qualified contractor to evaluate and make the necessary repairs.

Garage Pedestrian Door into House: View of daylight shining through the garage pedestrian door

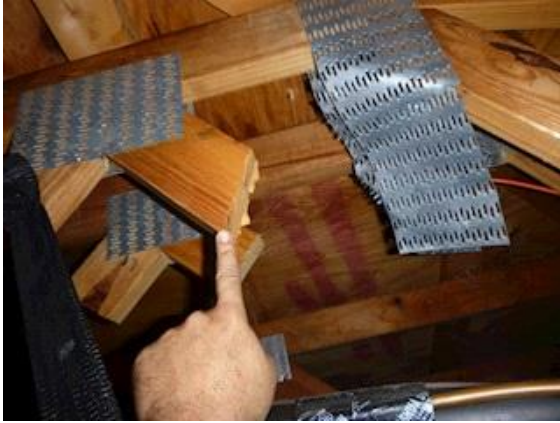
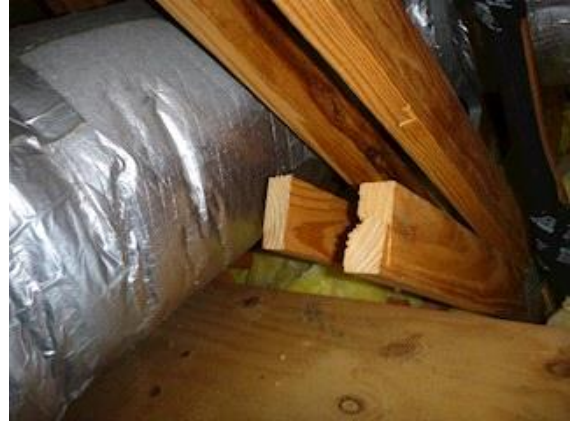
It appears as though four 2" x 4" wood webs used to support the roof truss have been cut in order to fit the air handler in the attic, located in the central area, next to the attic access. The only way a truss is allowed to be cut or altered is with an engineers' approval, and an alternate support system must be in place. A professional engineer must evaluate the cut webs for the truss and then provide documentation describing the proper fix. A qualified contractor is needed to carry out the repairs in accordance with the documentation.

Attic Framing/Sheathing: Views showing cut roof trusses

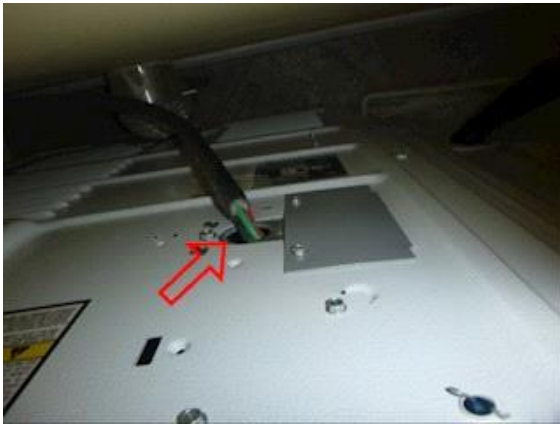
The clothes dryer electric cord does not have the strain relief connector installed. Evidence suggests that this is needed to secure the cord from pulling out of the enclosure, and to prevent the cord insulation from chaffing against the metal housing. Recommend a licensed electrical contractor to install the proper connector for safety purposes.

Laundry Facilities: View of missing strain relief connector on the dryer cord

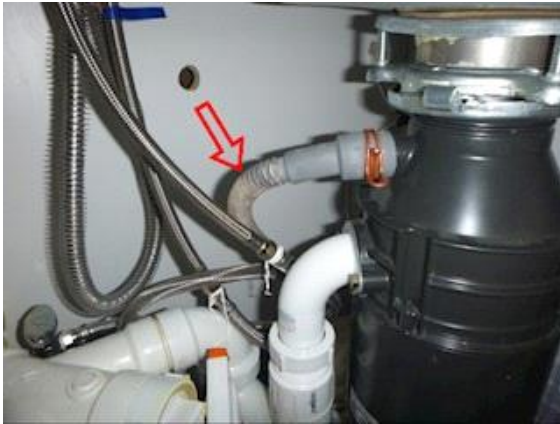
1. The drain hose, used for the dishwasher drain, does not have the proper loop needed to prevent sink water from emptying into the dishwasher. Recommend a licensed plumber to evaluate the condition of the dishwasher and make the necessary repairs.
2. The kitchen stove is missing an anti-tip device required since 1991. An anti-tip device is installed on the floor and locks down one of the stove legs; it prevents the stove from tipping over while pushing down on the oven door while it is open. Recommend a qualified contractor install the missing anti-tip device for safety purposes.
3. When checking the garbage disposal unit located under the sink water was leaking from the side of the unit. The garbage disposal unit is cracked and needs to be replaced. Recommend a licensed plumber to evaluate the condition of the garbage disposal and make the necessary repairs.

Kitchen: View of dishwasher drain hose with missing anti siphon loop located under the kitchen sink

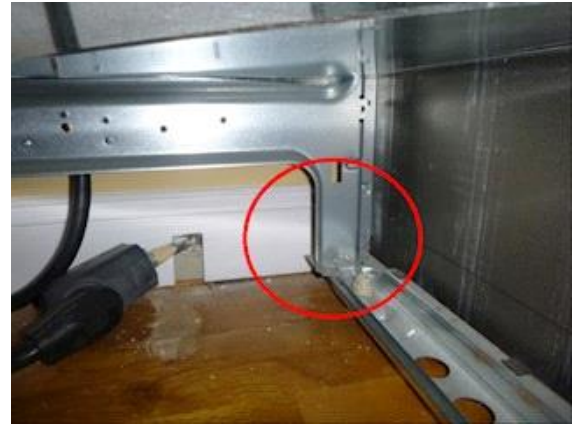
Kitchen: View of missing anti tip device located under the kitchen stove

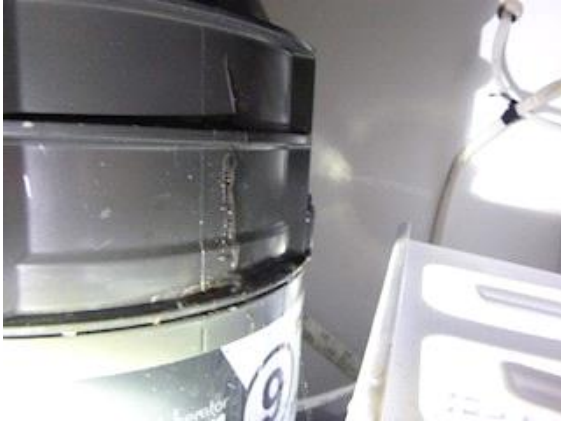
Kitchen: View showing leaking garbage disposal

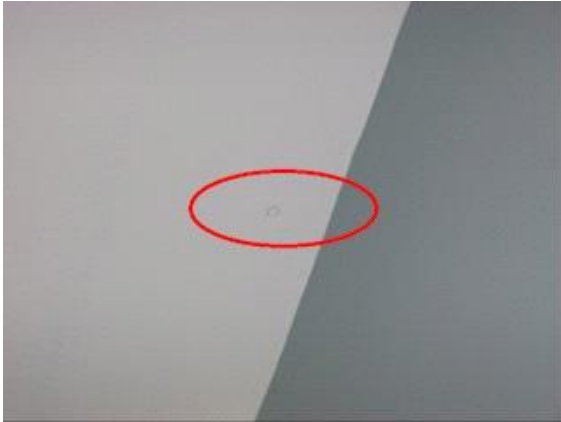
There is a nail pop present on the bathroom ceiling, located over the toilet. It is important to repair nail pops in the bathroom when they appear because the exposed nail heads get rusted and are hard to seal and paint. Recommend a qualified painting contractor to evaluate and make the necessary repairs.

Bathroom #1 - 1st Floor: View of nail pop located on the bathroom ceiling

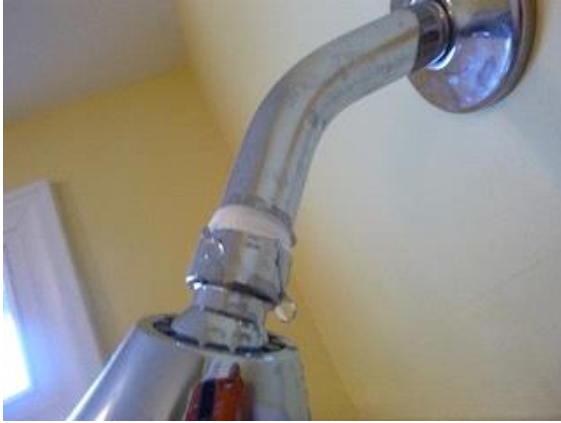
1. When testing the shower, water leaked from the nut located behind the shower head. Evidence suggests that the nut may need tightening. Recommend a licensed plumber to evaluate the condition of the shower head and make the necessary repairs.

Bathroom #2 - 2nd Floor - Guest: View showing leaking shower head

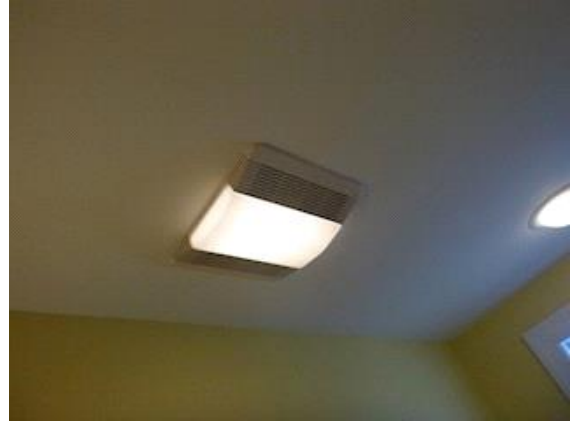
2. When operating the bathroom exhaust fan, it makes excessive noise. Evidence suggests that there could be a bad bearing in the fan motor or the housing is loose. Recommend a licensed electrical contractor to evaluate the condition of the exhaust fan and make the necessary repairs.

Bathroom #2 - 2nd Floor - Guest: View showing noisy exhaust fan

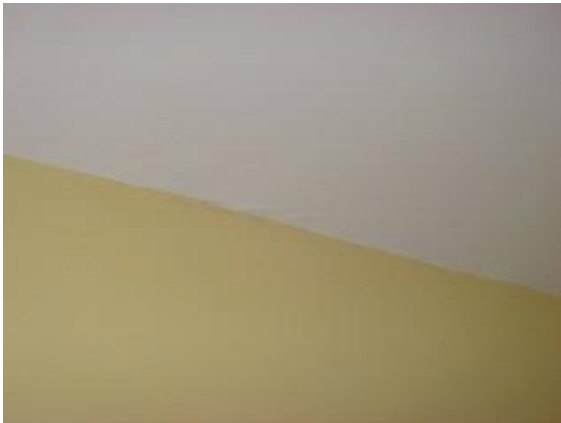
3. The drywall tape, used at the ceiling and wall seams is starting to separate from the drywall. The tape is starting to fail and is pulling away from the drywall.

Bathroom #2 - 2nd Floor - Guest: View showing failing drywall tape

- ** Recommend a qualified painting contractor to evaluate and make the necessary repairs to issues #3-4 listed above.

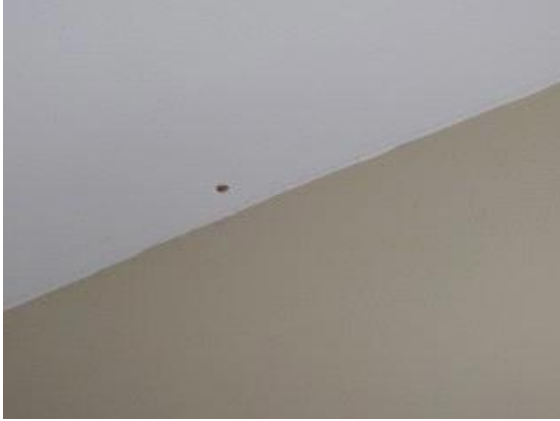
Bathroom #3 - 2nd Floor - Master: View of nail pops located on the bathroom ceiling

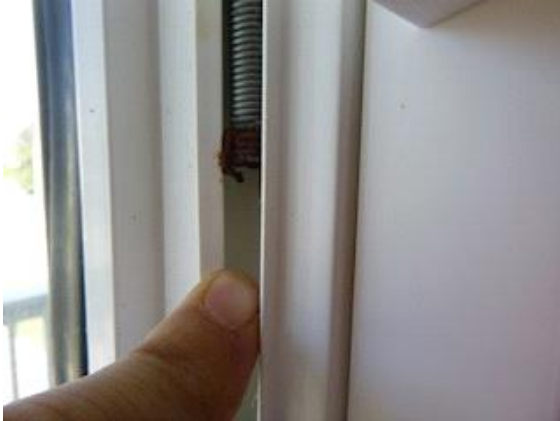
Living Room/Dining Area: View showing broken sash springs

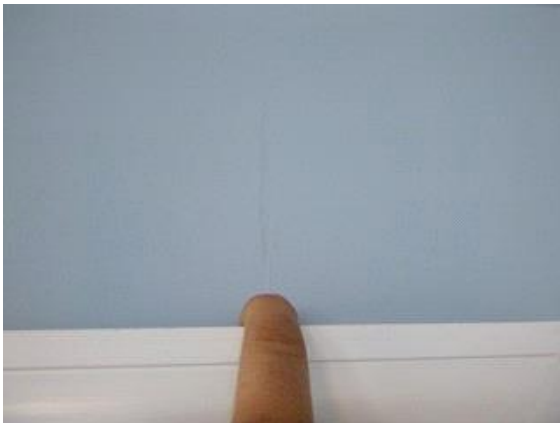
There is a minor drywall crack present, located above the closet entry door. Evidence suggests that this type of crack is common and due to normal settlement. Recommend a qualified painting contractor to evaluate the condition of the drywall and make the necessary repairs.

Bedroom #2 - 2nd Floor - Front - Master: View showing minor drywall crack

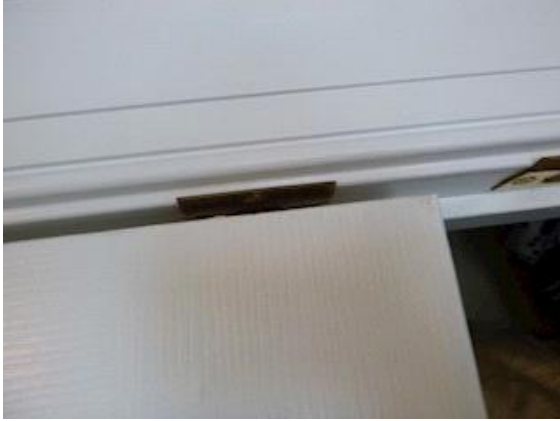
Bedroom #4 - 2nd Floor - Rear/Right: View showing closet door not latching when closed

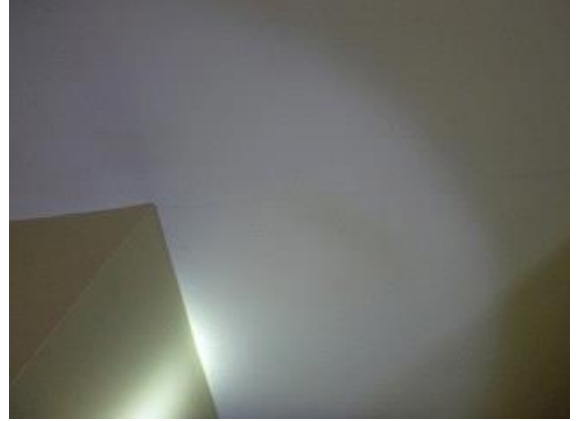
Bedroom #4 - 2nd Floor - Rear/Right: View showing minor drywall crack on ceiling

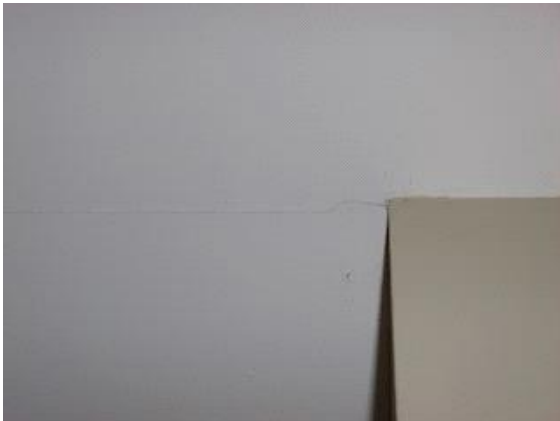
NOTE: There is a minor drywall crack present on the ceiling, located at the top of the stairs leading up to the 2nd floor. Evidence suggests that this type of crack is common and due to normal settlement. Recommend a qualified painting contractor to evaluate the condition of the drywall and make the necessary repairs.

Stairs / Railings: View showing minor drywall crack at the top of the steps

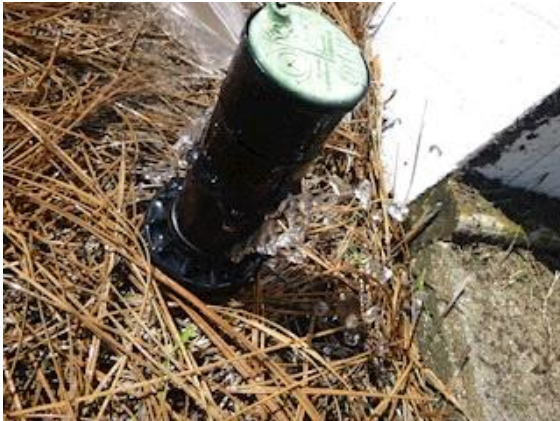
Irrigation System: View showing water leaking from the side of the sprinkler head

** Recommend a qualified irrigation specialist to evaluate the condition of the irrigation system, and make the necessary repairs to issues #1-3 listed above for proper operation.

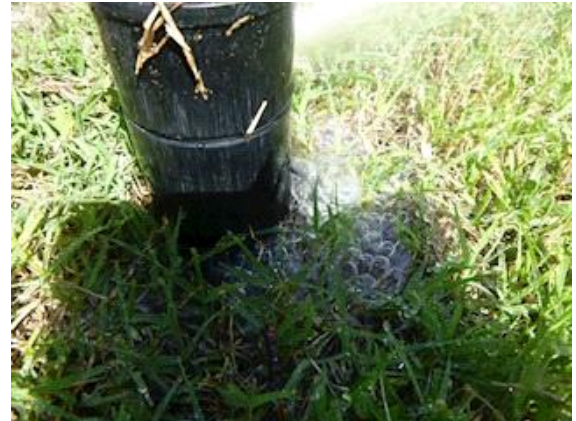
Irrigation System: View of water pooling at the base of the sprinkler head

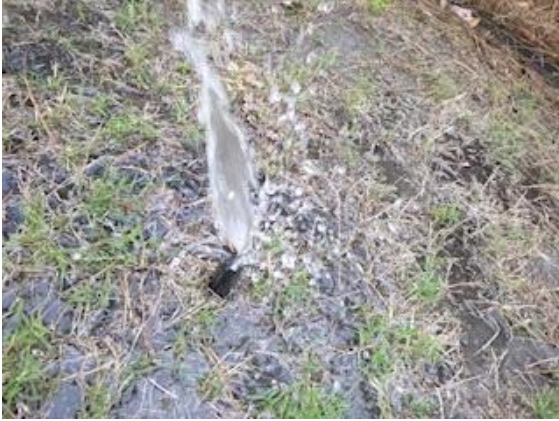
Irrigation System: View showing water spraying from the top of the sprinkler head
