National Property Inspections

Ronald Buyer, 38 Lyndon Dr, Little River, SC, 29566

Inspection Date:
12/31/2018

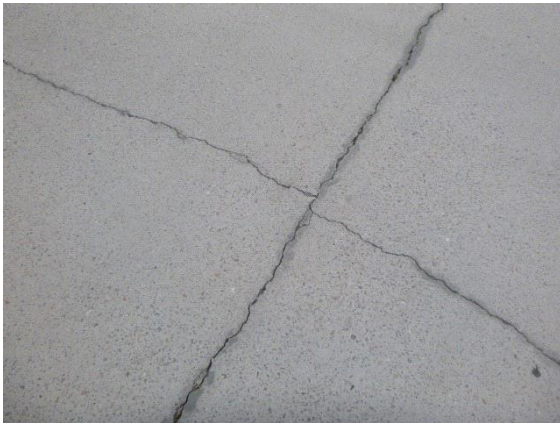
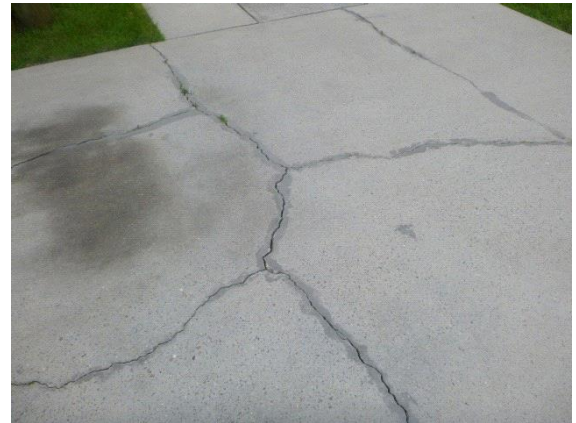
There are several large cracks present in the concrete driveway. See photos. Evidence suggests that cracks this wide are an indication of excessive settlement, and further suggests that repairs are needed. Recommend a qualified masonry contractor to evaluate and make the necessary repairs.

Driveway: View of cracks located in concrete driveway

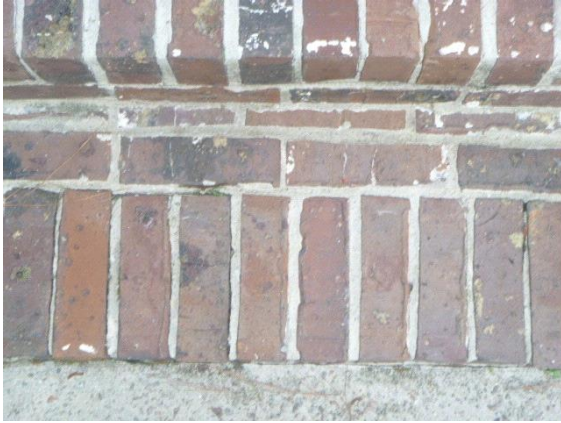
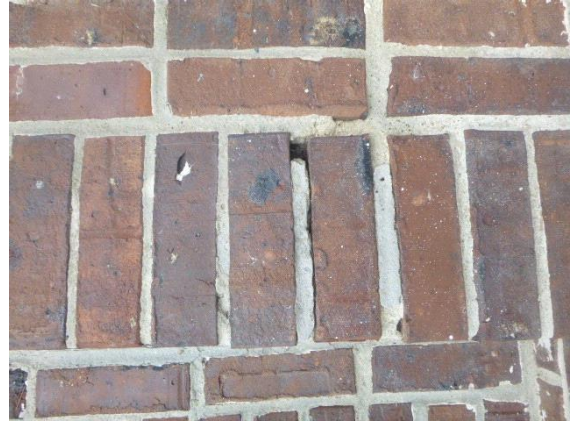
- 1.The brick steps, located at the front and rear of the house, have several cracked mortar joints. See photos. Evidence suggests this condition may create an avenue for water intrusion and may eventually loosen the bricks. Recommend a qualified masonry contractor evaluate and make the necessary repairs.
- 2.The wood handrail on the stairs located behind the home is loose. See photo. Evidence suggests that the handrail post needs to be reinforced for stability. Recommend a qualified general contractor evaluate and make the necessary repairs.
- 3.There is a minor crack present in the rear concrete walkway. See photo. This is common and is caused by normal ground settlement. Recommend filling crack(s) with an approved concrete filler or sealant to prevent further damage due to water intrusion.

Walks / Steps: View showing the deteriorated mortar joints located between bricks on steps

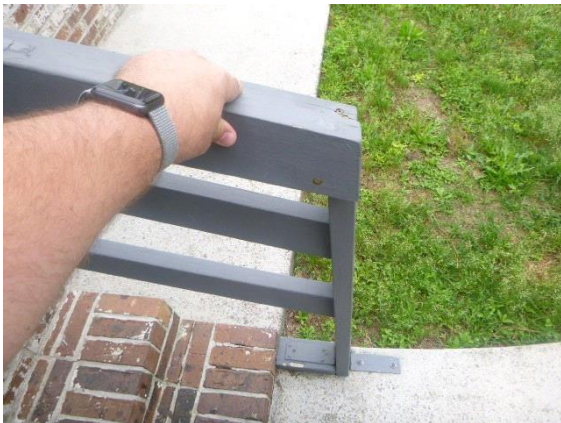
Walks / Steps: View of loose handrail located on the rear steps

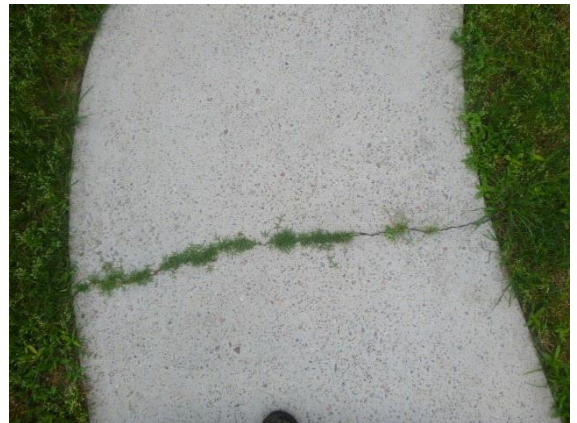
Walks / Steps: View of minor cracking in rear concrete walkway

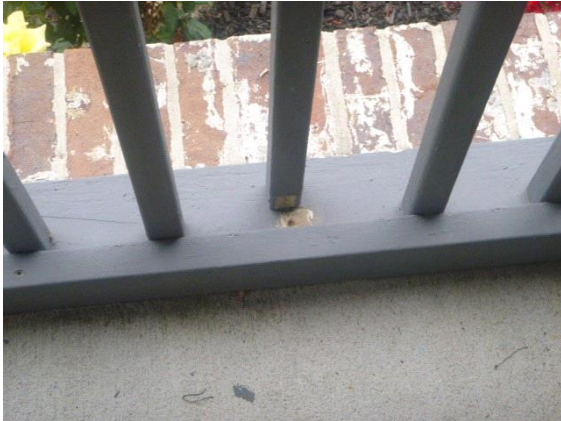
One of the balusters has detached from the base of the guardrail, located on the front concrete porch. See photo. Recommend a qualified contractor evaluate and make the necessary repairs.

Porches / Stoops: View of loose baluster on front porch

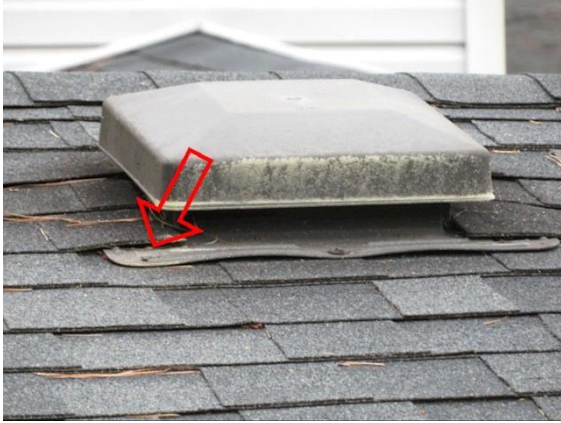
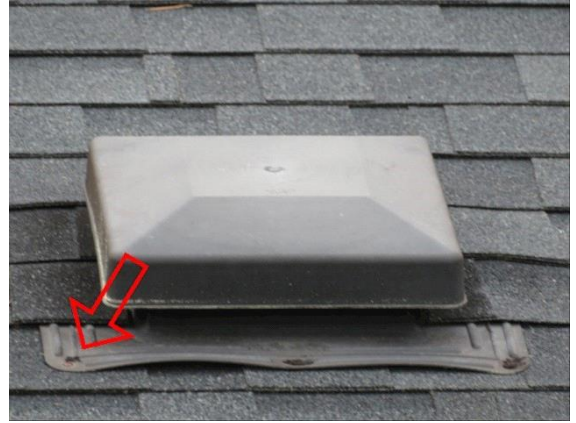
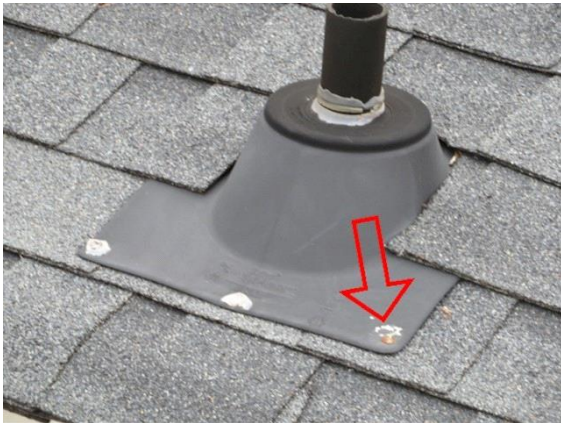
Flashing/Valleys: Views of exposed nail head on vent flashings

1. All metal and neoprene roof flashings were inspected. Several of the metal vent flashings have exposed nail heads present. See photos. Evidence suggests the exposed nail heads have created avenues for water intrusion and that the nail heads need to be properly sealed.
2. Both of the older plumbing vents located on the rear section of the roof have corrosion present on the vent caps. See photos. It is difficult to determine when a rusted component may fail.
***Recommend a qualified roofing contractor evaluate points 1&2 and make the necessary repairs.

***Recommend a qualified roofing contractor evaluate points 1&2 and make the necessary repairs.

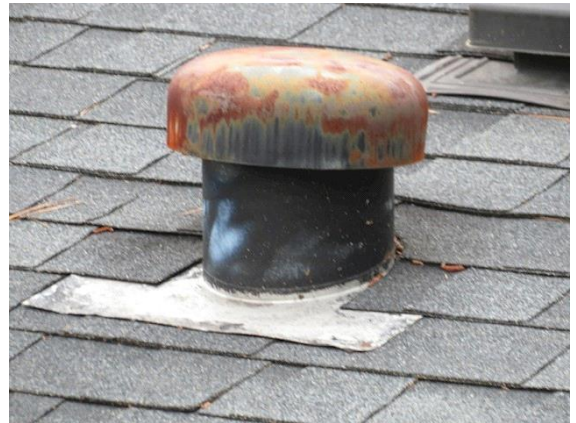
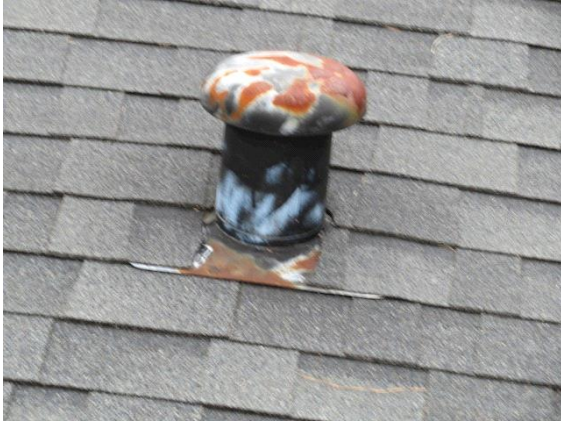
2. Both of the older plumbing vents located on the rear section of the roof have corrosion present on the vent caps. See photos. It is difficult to determine when a rusted component may fail.

Flashing/Valleys: Views of rusted caps/flashing on vents

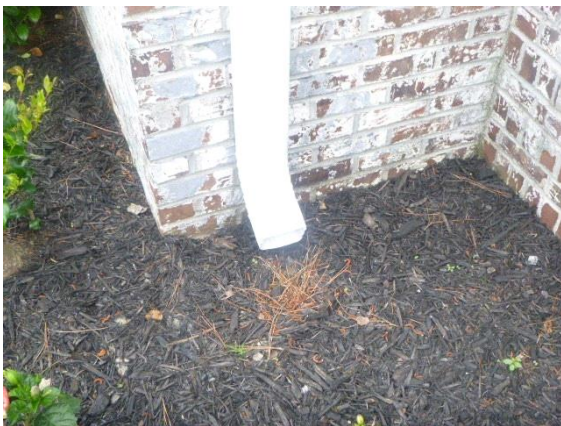
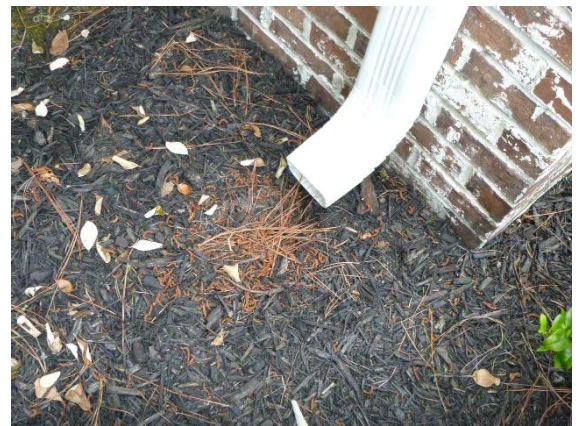
There are no splash blocks or extension hoses present on any of the downspouts. See photos. Small holes are starting to form in the ground at the bottom of the downspouts. Recommend installing splash blocks or downspout extensions to help divert water way from the foundation.

Gutters/Down Spouts: View showing missing splash blocks/extension hoses at the end of downspouts

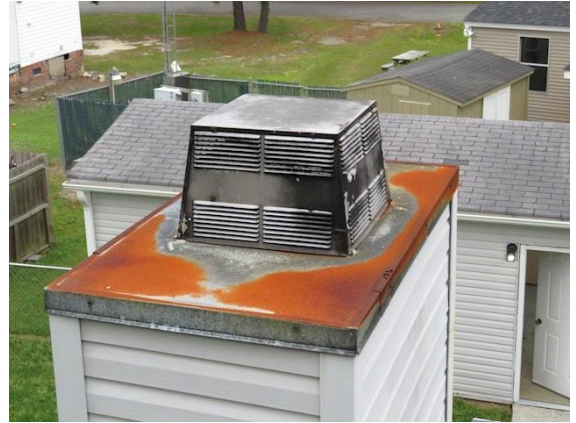
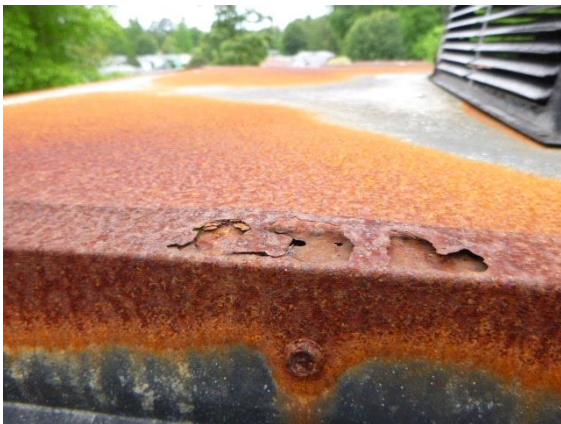
The metal rain cap used to enclose the vinyl chase chimney is rusted. See photo. It is difficult to determine when a rusted component is going to fail and it is recommended to replace the rusted metal cap to ensure years of service. Recommend a qualified roofing contractor to evaluate and make the necessary repairs.

Chimney: View of rusted metal chimney cap

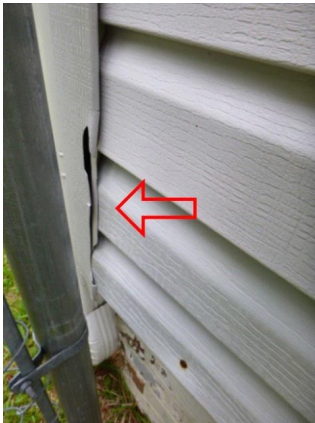
Exterior Surface: View of cracked vinyl trim

***Recommend a qualified contractor evaluate points 1&2 and make the necessary repairs.

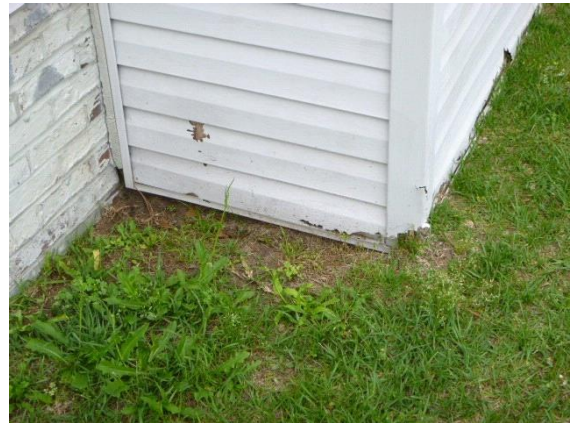
Exterior Surface: View of damaged vinyl siding and trim at base of vinyl chase

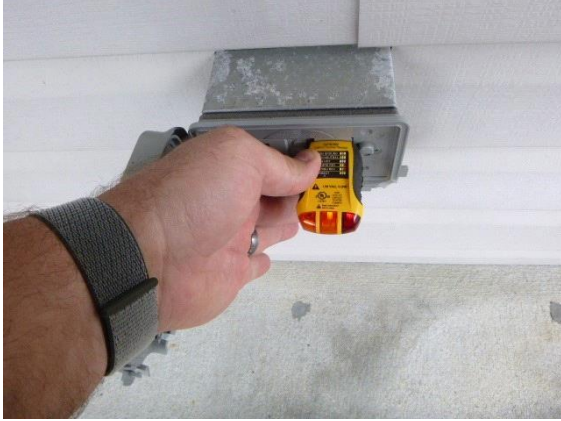
Exterior Surface: View of GFCI receptacle with reversed polarity

***Recommend a licensed electrician evaluate points 3&4 and make the necessary repairs.

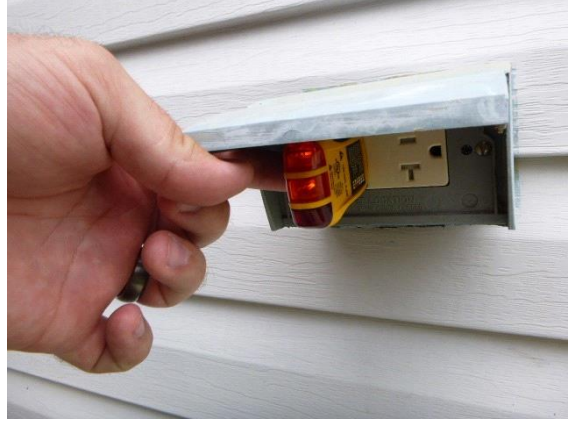
Exterior Surface: View of exterior wall receptacle that is not GFCI protected

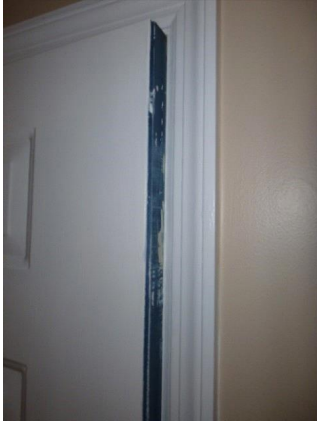
The front entry door is hitting the upper section of the door frame when operating. See photo. Evidence suggests that the door is sagging and is not set square in the door frame. Recommend a qualified contractor to evaluate and make the necessary repairs.

Exterior Doors: View of front entry door hitting frame when closing

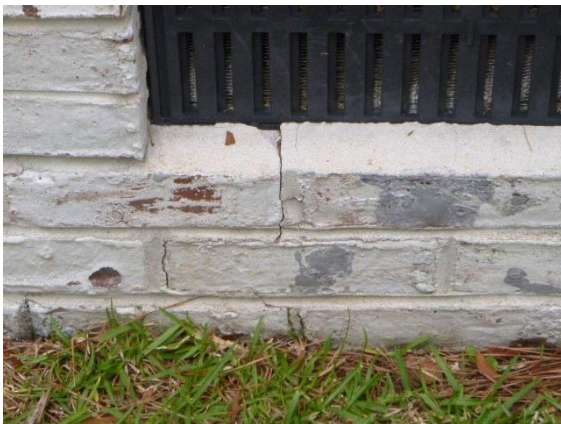
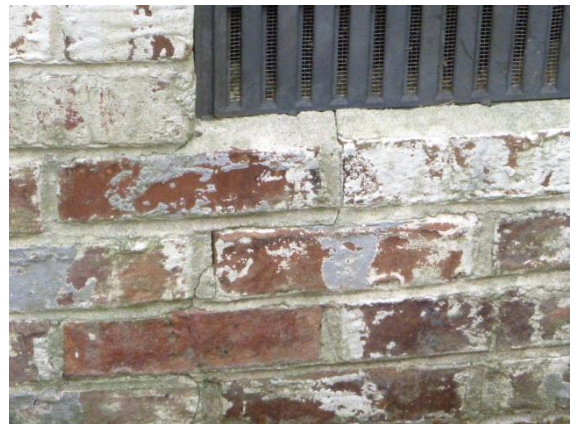
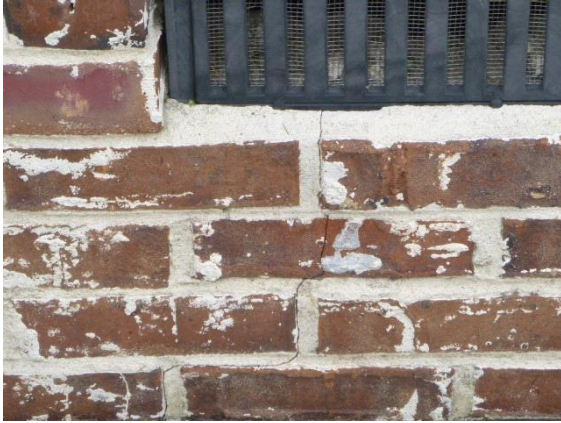
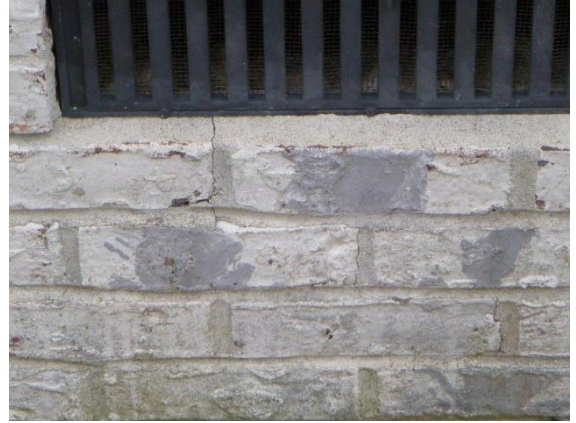
There are several areas below the crawlspace vents that have step cracks in the mortar of the brick foundation walls. See photos. Evidence suggests the cracks are due to normal settlement. Recommend a qualified contractor to evaluate and repair the cracks to prevent future water intrusion.

Foundation - Slab: Views of cracked mortar below crawl space vents

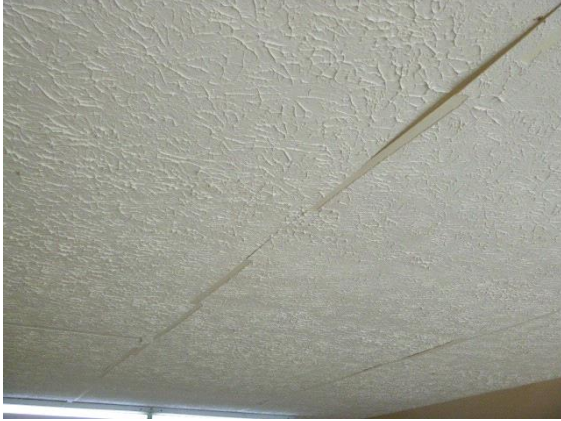
1. There are several drywall ceiling tape seams, where the drywall tape is separating from the drywall ceiling. See photos. Evidence suggests this condition is usually caused by the humid conditions present inside the garage. Recommend a qualified painting contractor to evaluate drywall and make the necessary repairs.

Garage/Carport: View of failing drywall tape on garage ceiling

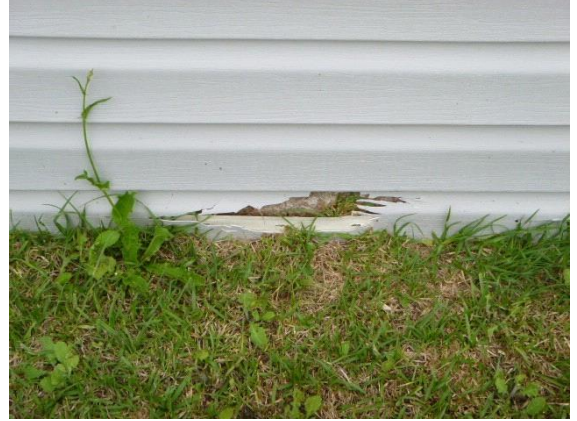
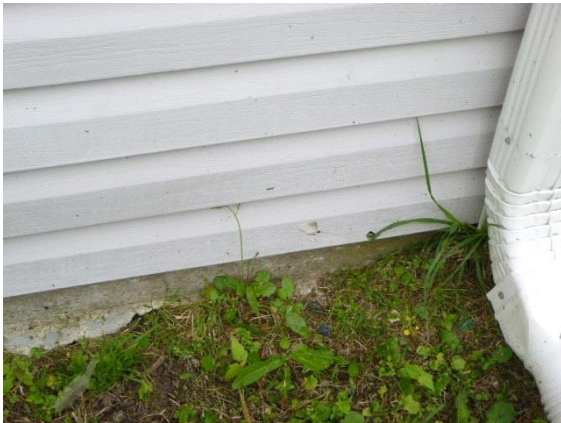
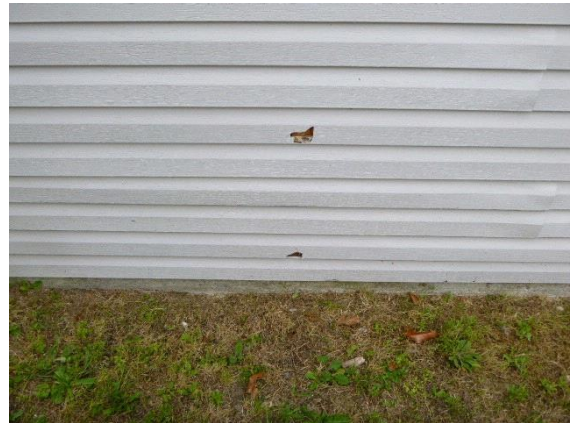
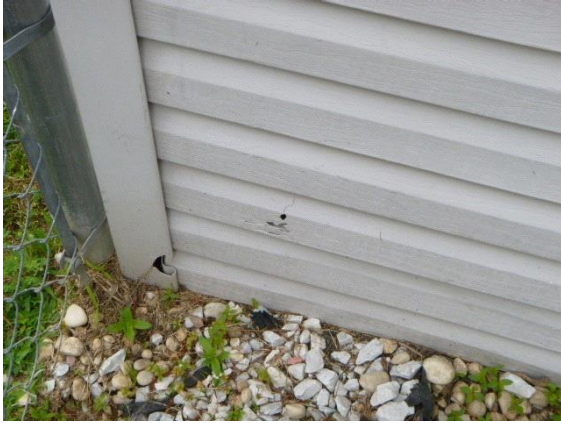
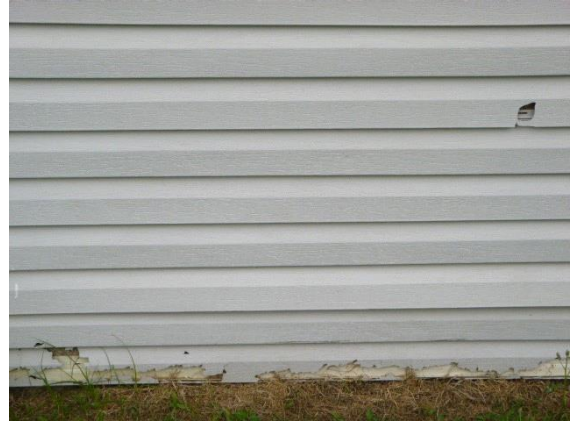
2. There are many sections of damaged vinyl siding and trim located around the perimeter of the garage. See photos. Evidence suggests the damaged siding has created avenues for water intrusion.

Garage/Carport: Views of damaged vinyl siding and trim on garage exterior

***Recommend a qualified contractor evaluate points 2&3 and make the necessary repairs.

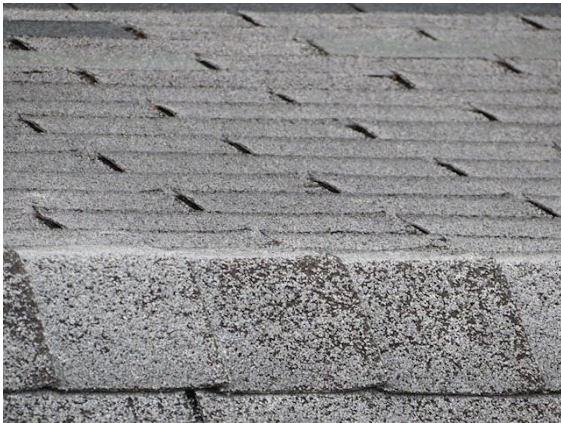
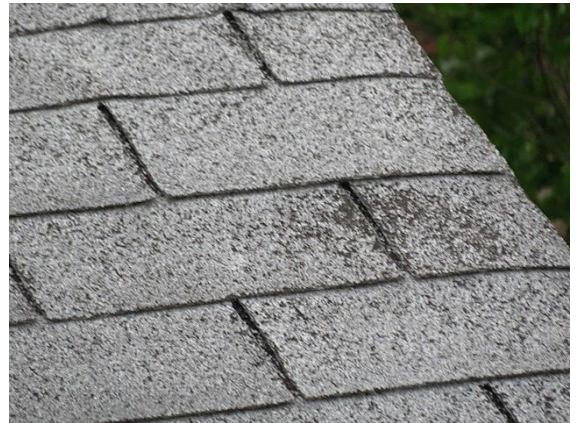
4. The three tab asphalt shingles covering the roof of the detached garage have excessive granular loss. See photos. Evidence suggests the roof may be near the end of its life expectancy. Recommend a qualified roofing contractor evaluate and make necessary repairs.

Garage/Carport: Views of excessive granular loss on garage roof shingles

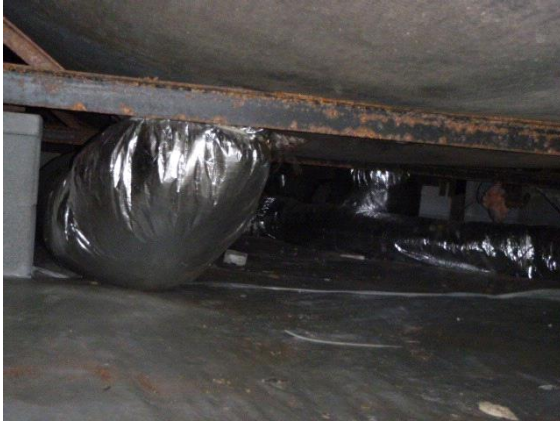
Crawl Space: View of HVAC ductwork laying on the ground

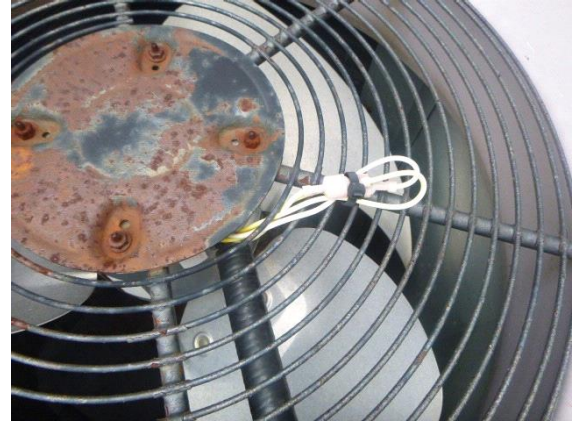
- 1.The wiring for the evaporator fan is not properly secured. See photo. The wiring is currently secured to the cover with a plastic zip tie which could break and allow the wiring to come in contact with the fan blades.
- 2.The outside HVAC cover has excessive corrosion present at the base. See photo. It is difficult to determine when a rusted appliance may fail.

Cooling: View of wiring for evaporator fan not properly secured

***Recommend a licensed HVAC contractor evaluate points 1&2 and make the necessary repairs.

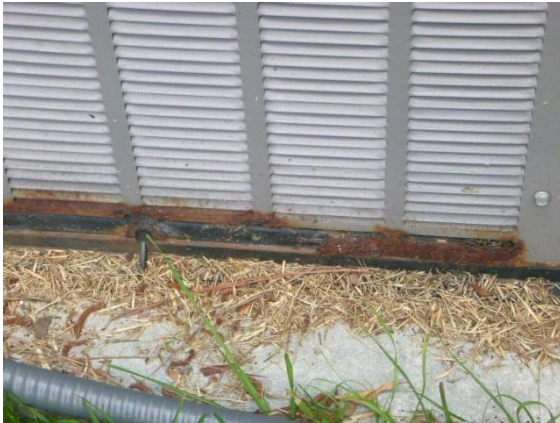
Cooling: View of rust at base of HVAC cover

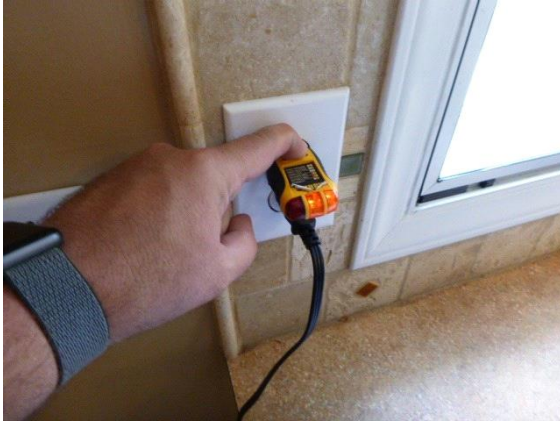
The kitchen counter top receptacle, located left of the sink, is not GFCI-protected. The kitchen counter top receptacles have been required to be GFCI-protected within 6 feet from either side of the kitchen sink since 1987. Recommend a licensed electrician to evaluate and make the necessary repairs.

Kitchen: View of kitchen wall receptacle that is not GFCI protected

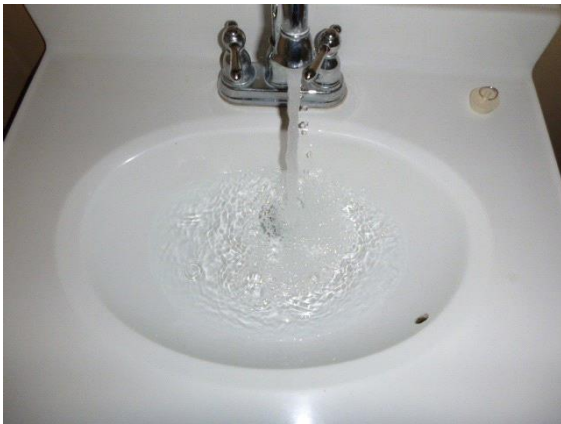
The bathroom sink is draining very slowly. See photo. Evidence suggests that there is a restriction in the drain pipe or trap located under the sink. Recommend a licensed plumber evaluate and make the necessary repairs.

Guest Bathroom: View showing the sink filling up when running the faucet

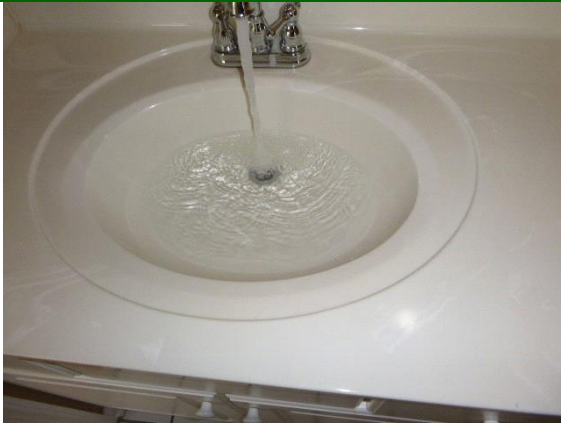
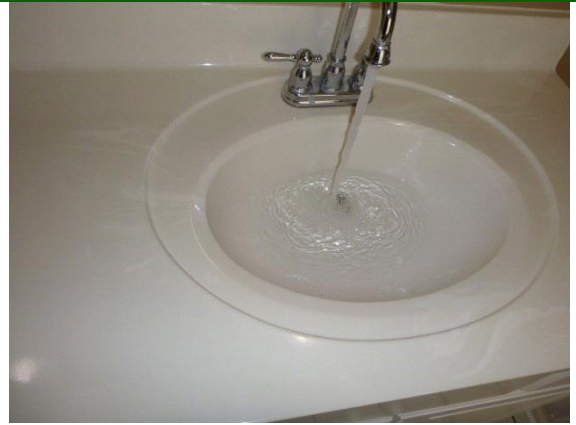
- Both bathroom sinks are draining very slowly. See photos. Evidence suggests that there is a restriction in the drain pipe or traps located under the sinks.
- The toilet is loose at the base with movement from left to right. A loose toilet over time will damage the wax seal located between the toilet and the drain pipe and can create a water leak.

Master Bathroom: View showing the sink filling up when running the faucet

***Recommend a licensed plumber evaluate points 1&2 and make the necessary repairs.

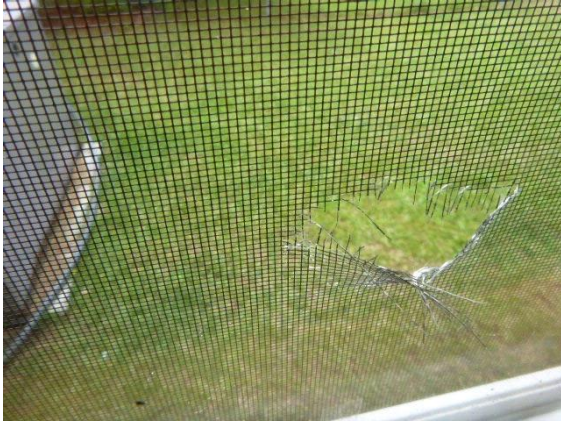
- 1.The side window screen, located in the family room, has a large hole in it. See photo. Evidence suggests this hole creates an avenue for insects to enter the room and then into the house. The window screen does not function as intended and is in need of repair or replacement by a qualified screen repair specialist.
- 2.The bedroom door connecting the family room to the laundry room does not latch shut when closed. The door hardware does not function as intended, and is need of repair or adjustment. Recommend a qualified contractor evaluate and make the necessary repairs.

Family Room: View of hole in family room window screen
