# National Property Inspections

Mr. Buyer , 1121 Congleton Rd, Wilmington, NC, 28409

Inspection Date:  
06/30/2018

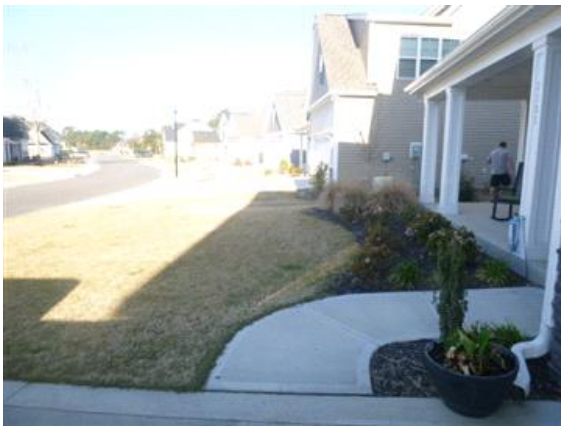
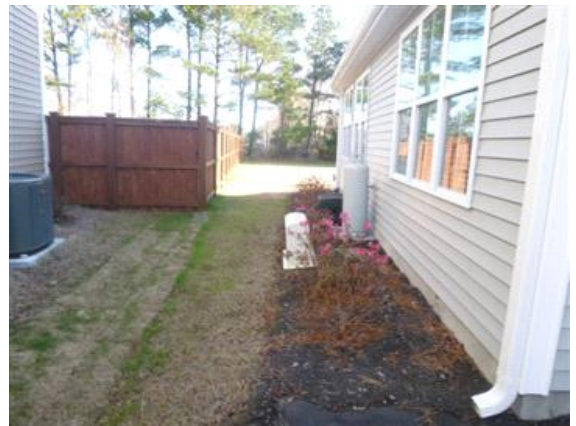
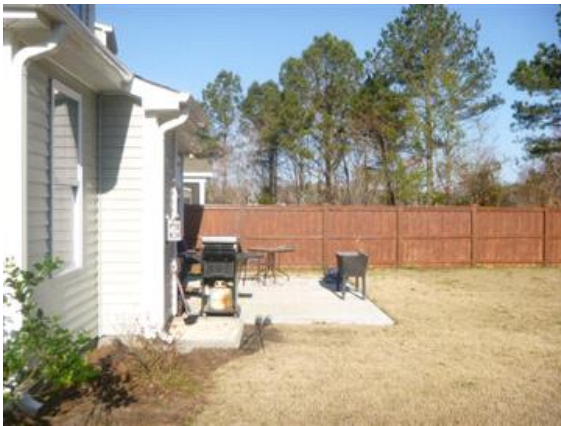
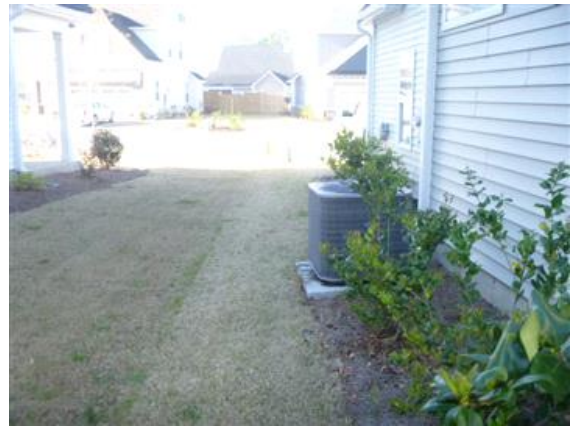
The property consists of positive slopes on all four sides of the house. See photos. This condition is providing drainage away from the foundation.

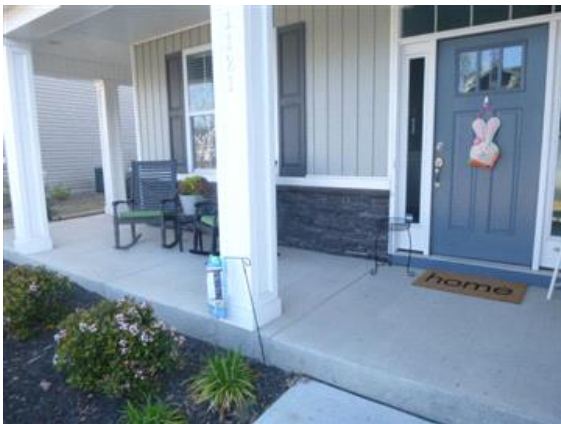
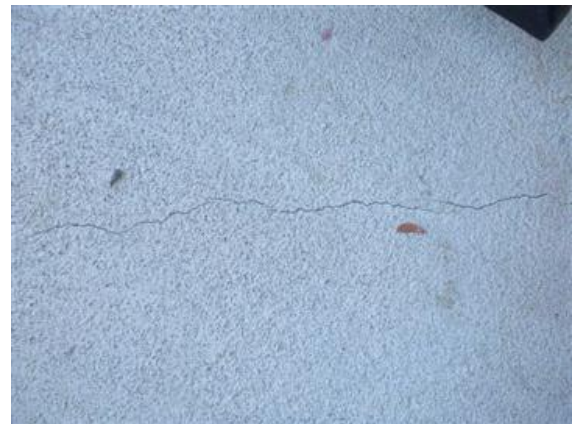
Crack Front Of Porch

The front porch has minor cracking present in the concrete floor, to the left of the front door and on the left side extension of the porch. See photo. This type of cracking is common due to typical ground settlement and/or curing of the concrete and can create an avenue for water intrusion. Recommend a qualified contractor to evaluate and make the necessary sealing repairs.

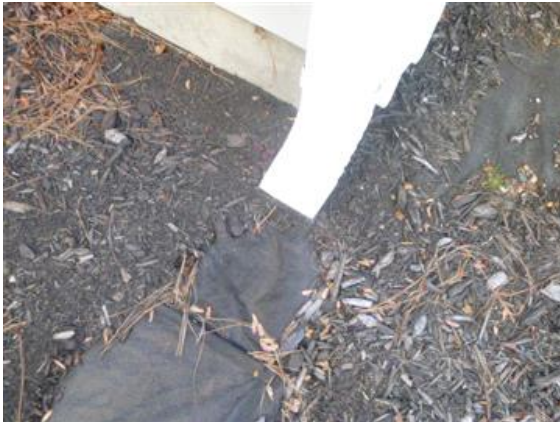
- 1) There are no splash blocks or extension hoses present on any of the downspouts. Soil is washing out and depressions have formed at the bottom of the downspouts, indicating water is collecting near the foundation. See photos. Recommend having splash blocks or downspout extensions installed to help divert water way from the foundation.
- 2) Some of the gutters are starting to build up debris. See photo. Evidence suggests if left as is, the gutters may continue to build up debris that could restrict the water flow through the gutters and downspouts. Recommend a qualified contractor to evaluate and provide cleaning where needed.

Washout Under Downspout

1) There are no splash blocks or extension hoses present on any of the downspouts. Soil is washing out and depressions have formed at the bottom of the downspouts, indicating water is collecting near the foundation. See photos. Recommend having splash blocks or downspout extensions installed to help divert water way from the foundation.

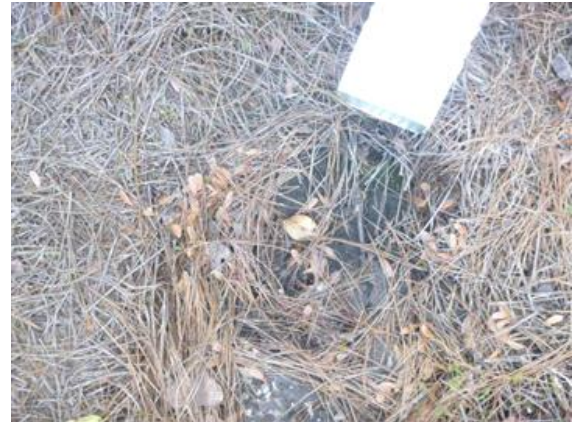
Depression Under Downspout

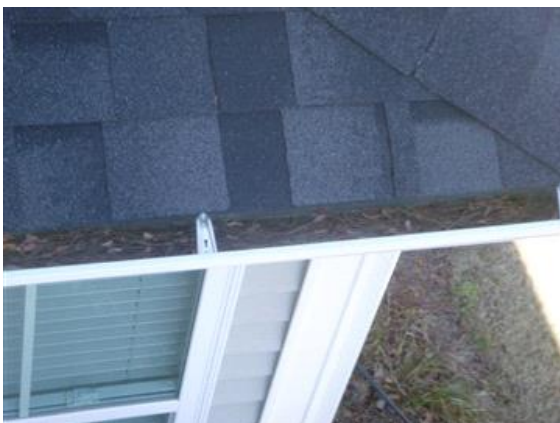
Debris In Gutter

2) Some of the gutters are starting to build up debris. See photo. Evidence suggests if left as is, the gutters may continue to build up debris that could restrict the water flow through the gutters and downspouts. Recommend a qualified contractor to evaluate and provide cleaning where needed.

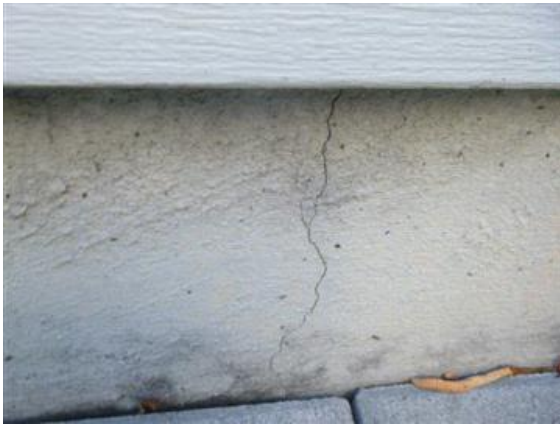
Left Side Crack

The foundation is a concrete slab on grade. There are minor vertical cracks present at several locations around the foundation. See photos. These cracks are common, caused by either ground settlement or curing of the concrete. Evidence suggests this condition can create an avenue for water intrusion. Recommend a qualified contractor to evaluate and make the necessary sealing repairs.

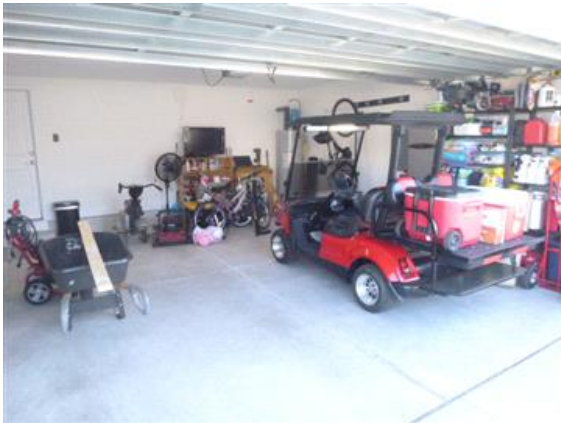
**Limitation:** The garage had limited visibility due to shelves, stored items and a golf cart present. See photo. The visible areas of the garage that are not obscured and all electrical items, were in acceptable condition and functioned as intended.

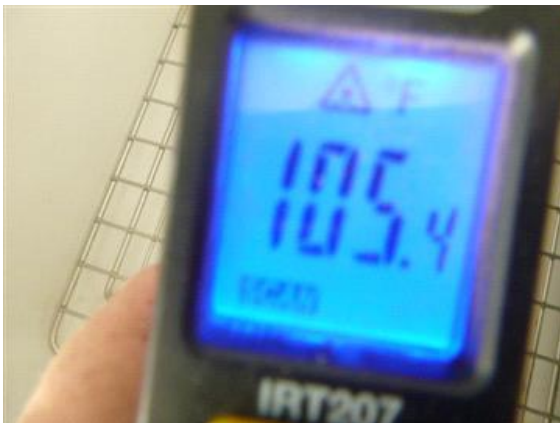
The electric water heater located in the garage, is properly installed and functioning, with the water temperature reading 105 degrees at the kitchen sink. The temperature appears to be set low. Recommend a licensed plumber to evaluate and make the necessary adjustment or repair to set the temperature to the manufacturers recommended setting of 120 degrees.

Hot Water Temperature Kitchen Sink

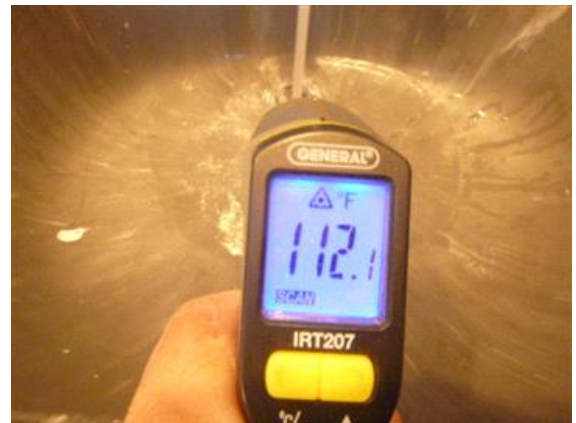
**NOTE:** An additional reading was taken in one of the upstairs bathrooms and produced 112 degrees.

Hot Water Temperature 2nd Floor Bathroom Sink

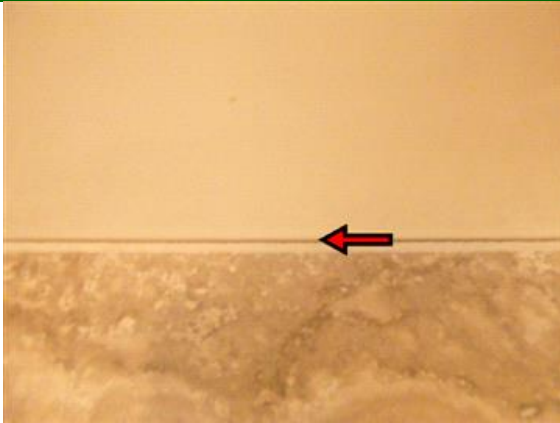
The bathroom tile floor grout seam, located along the bathtub, is open. See photo. Evidence suggests this condition creates an avenue for water intrusion. Recommend a qualified contractor to evaluate and make the necessary repair.

Open Floor Tile Grout Seam At Tub

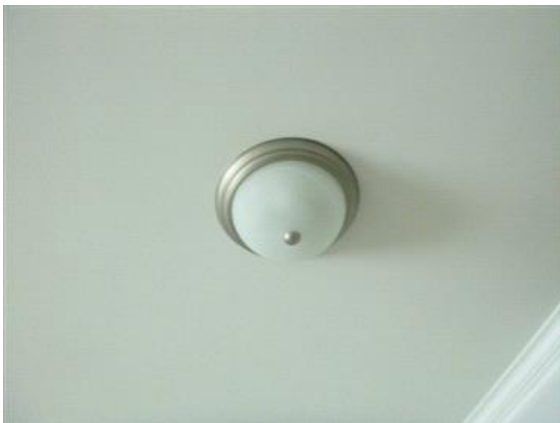
The ceiling light does not turn on when turning on the wall switch. See photo. Suggest replacing the bulb **first**, and if it still does not work, recommend a licensed electrician to evaluate and make the necessary repair.

Ceiling Light Out

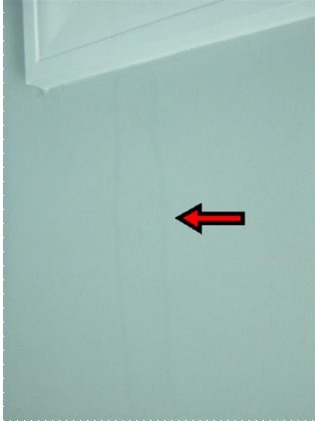
The window above the bottom of the stair case, has a water stain under the left lower corner of the window on the drywall. A moisture meter test produced a normal reading. Evidence suggests this may be from an old leak. Since a leak test with a hose was previously done and did not re create the leak, recommend monitoring this area during future rainy conditions and if the leak appears again, recommend a qualified contractor to perform a more invasive inspection of the window flashing and make any necessary repair.

Drywall Stain.

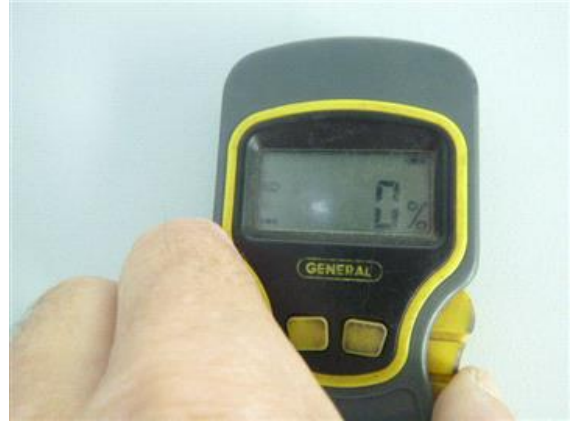
**NOTE:** It is important to note that stain moisture meter results are based on the conditions on the day and time of inspection.

Normal Moisture Reading On And Around The Stain
