# National Property Inspections

Ms. Jane Doe, 4632 Wish Ct, Wilmington, NC, 28405

Saturday, June 30, 2018

Inspection Date:  
06/30/2018

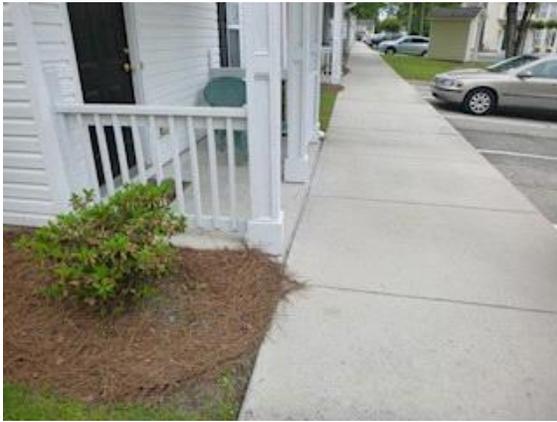
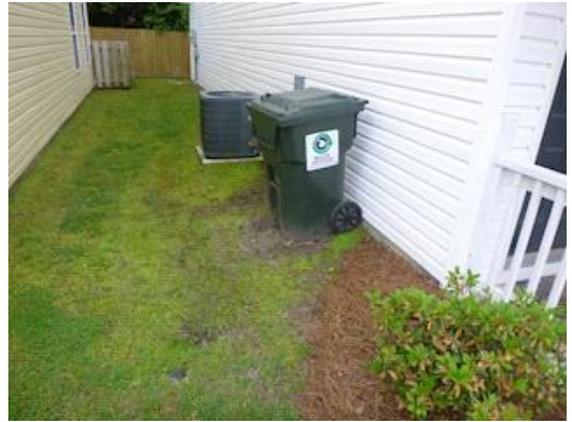
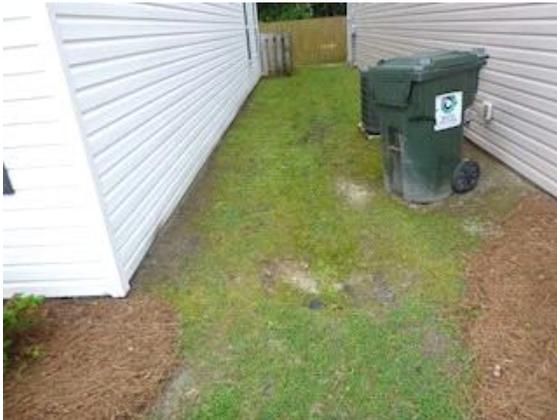
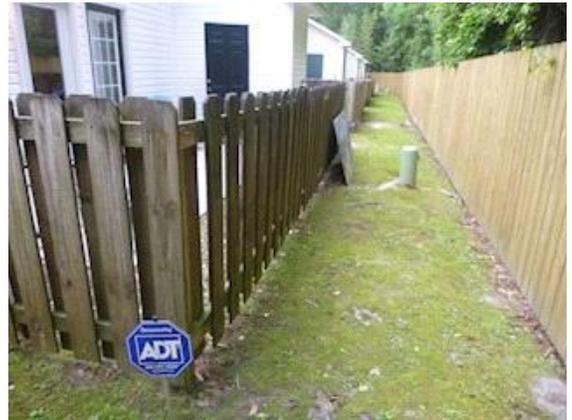
The property consists of positive slopes on all four sides of the house. See photos. This condition is providing good drainage away from the foundation.

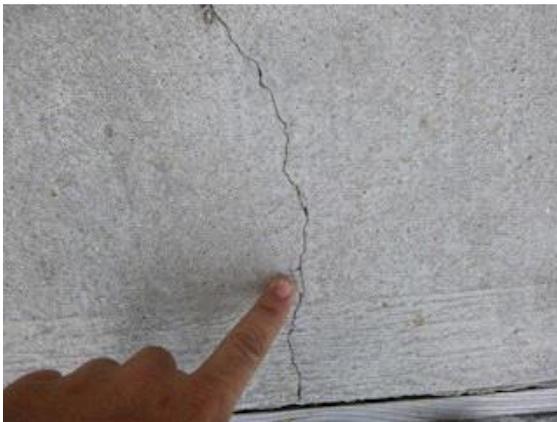
There is an open concrete porch directly in front of the front entry door that has a minor crack present. Evidence suggests that this type of crack is common and caused by normal ground settlement. Recommend filling the crack with an approved concrete filler or sealant to prevent future water damage.

Porches / Stoops: View of minor crack on front porch

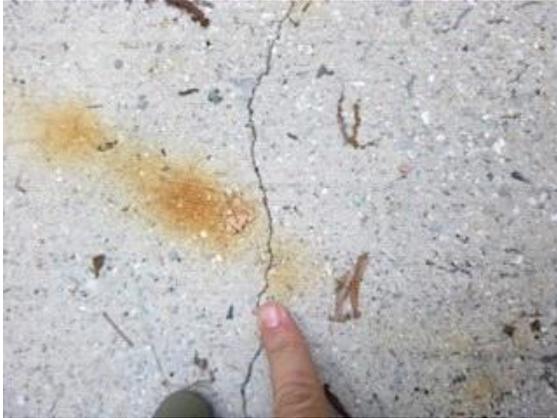
The rear concrete patio has minor cracks, located on the left and right sides of the patio. Evidence suggests that this condition is common due to normal ground settlement. Recommend filling the cracks with an approved concrete filler to prevent any future water damage.

Patio - Rear: View of minor cracking present in concrete patio

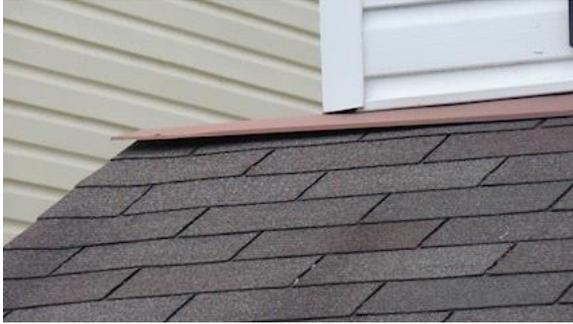
1. The metal flashing located on the front section over the porch, is lifted and is not laying flat against the roof shingles. Evidence suggests that this condition creates an avenue for water intrusion.
2. There are exposed nails heads, located at the bottom of the upper rear side lead vent pipe flashing. Evidence suggests the nail heads need to be sealed with an approved sealant to prevent future leaks.

Flashing/Valleys: View showing lifted flashing

\*\* Recommend a qualified roofing contractor to evaluate the condition of the flashings and make the necessary repairs to issues #1-2 listed above.

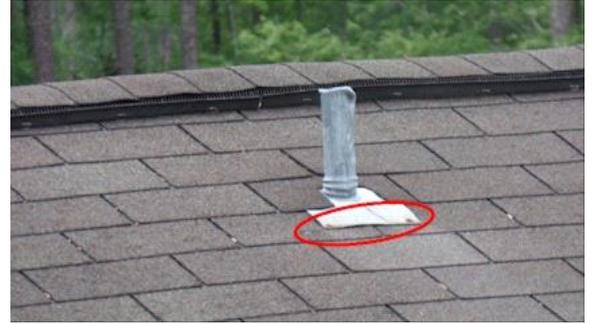
Flashing/Valleys: View of exposed nail heads at the base of vent pipe flashing

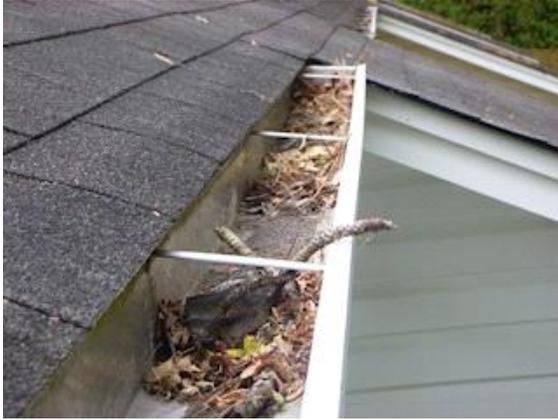
The rear gutter is filled with debris which is inhibiting water draining off the roof, and flowing through the gutter and down spout properly. Evidence suggests that the gutter is not functioning as intended. Recommend cleaning by a qualified contractor.

Gutters/Down Spouts: View of debris inside the roof gutters

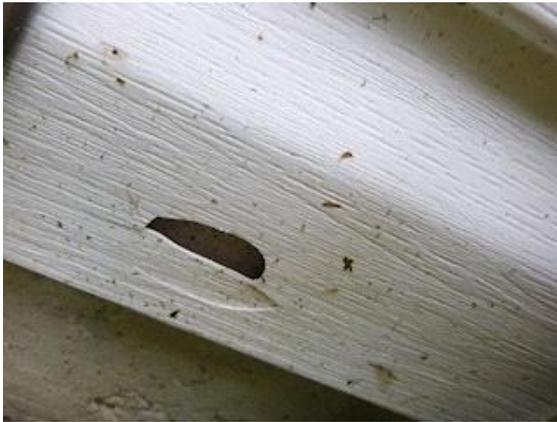
1. The bottom courses of vinyl siding have cracks present, located on the front, left, and right sides of the house. Evidence suggests that the cracks were made by a weed wacker or line trimmer because of the height of the cracks, and this condition may create avenues for water intrusion. Recommend a qualified general siding contractor to evaluate and make the necessary repairs.

Exterior Surface: View showing cracked siding

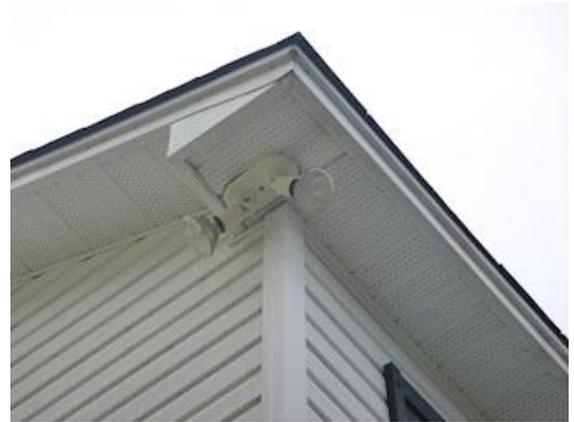
2. The exterior spotlights located on the front and rear corners of the house, do not light when the wall switches are turned on. Recommend replacing the bulbs first, then if they still do not work, recommend a licensed electrical contractor to evaluate the condition of the fixtures and make the necessary repairs.

Exterior Surface: View showing defective spotlights

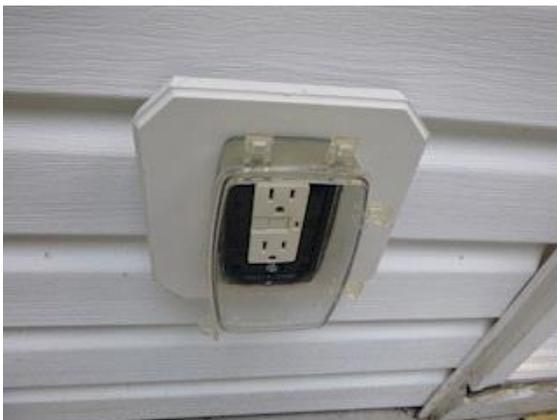
3. The exterior wall receptacle, located on the wall of the rear patio, has a broken or missing weatherproof cover. The weatherproof cover needed for personal protection does not function as intended and is in need of replacement by a qualified contractor.

Exterior Surface: View showing missing receptacle cover

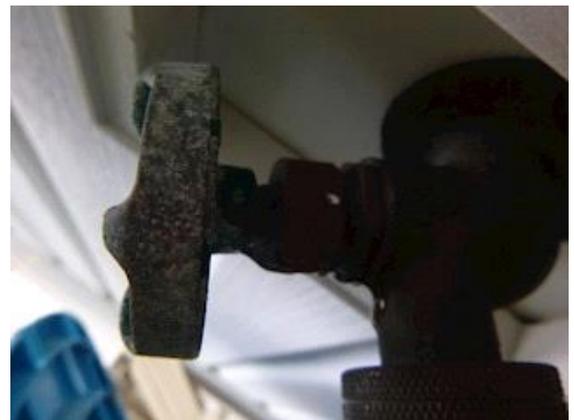
4. The exterior water faucet located at the rear side of the house is leaking around the valve stem when it is turned on. Evidence suggests the packing nut may need to be tightened or the packing needs to be replaced. Recommend a qualified contractor to evaluate the condition of the faucet and make the necessary repairs.

Exterior Surface: View showing leaking faucet

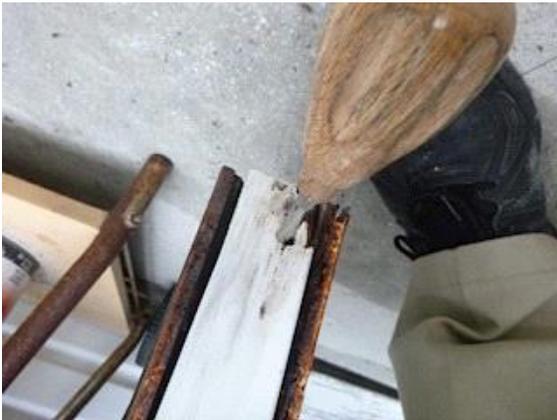
There is soft (water-damaged) wood present on the exterior storage room entry door, located at the base of the door core. Evidence suggests that there is water intrusion at this location, and the damaged wood needs to be replaced to restore the integrity of the door. Recommend a qualified general contractor to evaluate and make the necessary repairs.

Exterior Doors: View showing water-damaged door core

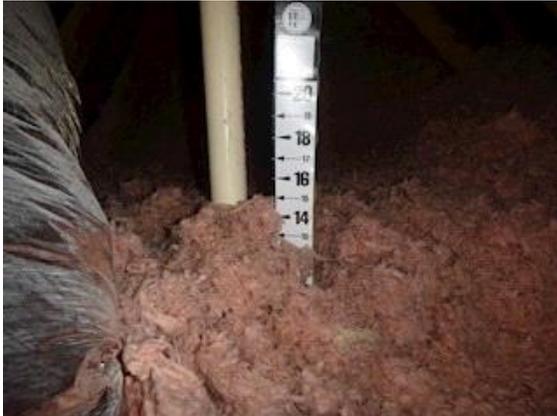
There is approximately 12 inches of loose-fill fiberglass insulation present in the attic area and it is evenly distributed. The attic insulation has an R value of R30 and is in acceptable condition.

Attic Insulation: View showing the depth of insulation located in the attic

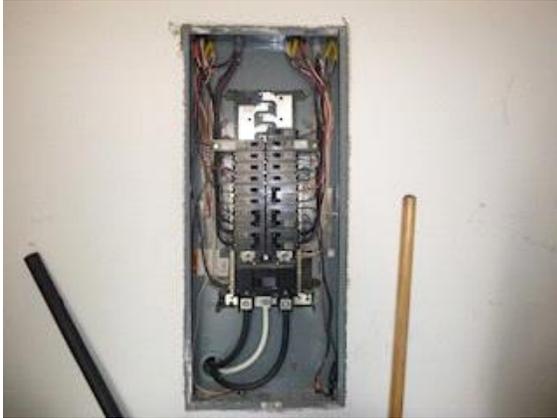
The main electric panel located in the exterior storage room, has been installed very neatly, is well marked, and has been installed in a professional manner.

Electrical: View of main electric panel and circuit breaker located in the storage room

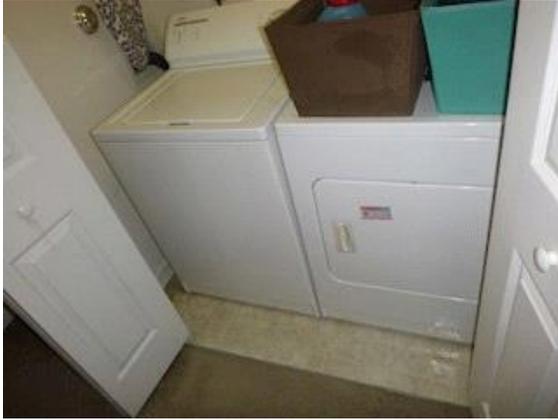
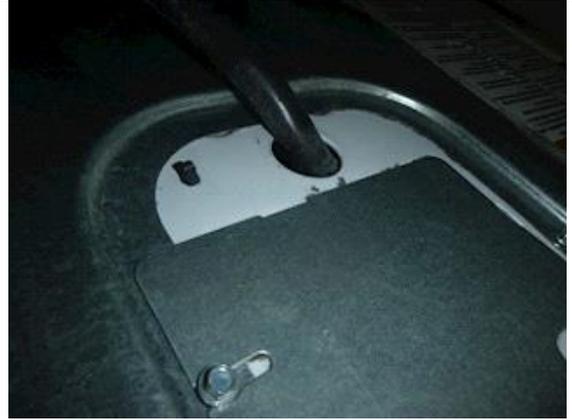
- When a washing machine is being used over a living area, it is required to have a drain pan that is piped to the outside located under the washing machine. A drain pan is not present under the washing machine in this house. Recommend a licensed plumber to install the required drain pan and plumbing.
- The clothes dryer electric cord does not have the strain relief connector installed. Evidence suggests that this is needed to secure the cord from pulling out of the enclosure, and to prevent the cord insulation from chaffing against the metal housing. Recommend a licensed electrical contractor to install the proper connector for safety purposes.

Laundry Facilities: View showing missing drain pan under washing machine

Laundry Facilities: View of missing strain relief connector on the dryer cord

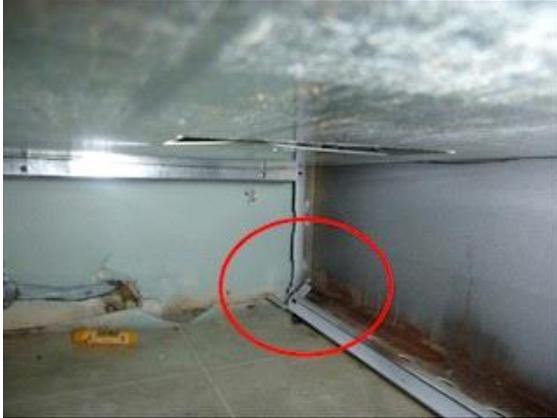
The kitchen stove is missing an anti-tip device required since 1991. An anti-tip device is installed on the floor and locks down one of the stove legs; it prevents the stove from tipping over while pushing down on the oven door while it is open. Recommend a qualified contractor install the missing anti-tip device for safety purposes.

Kitchen: View of missing anti tip device located under the kitchen stove

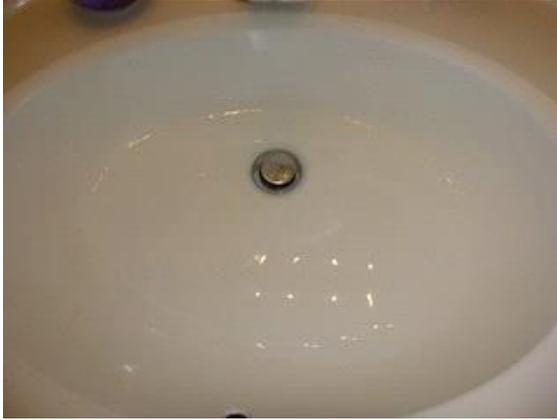
1. The bathroom sink is draining very slowly. Evidence suggests that there is a restriction in the drain pipe or trap located under the sink. Recommend a licensed plumber to evaluate the condition of the sink drain and make the necessary repairs.
2. There are a few nail pops present on the bathroom ceiling and walls, located over the tub enclosure. It is important to repair nail pops in the bathroom when they appear because the exposed nail heads get rusted and are hard to seal and paint. Recommend a qualified painting contractor to evaluate and make the necessary repairs.

Bathroom #2 - 2nd Floor: View showing slow draining sink

Bathroom #2 - 2nd Floor: View showing nail pops

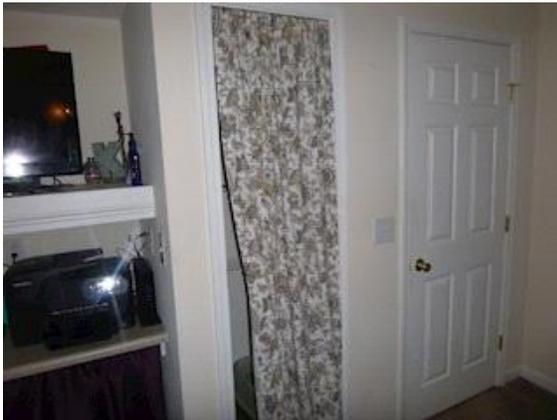
1. The left closet is missing a door. Recommend a qualified contractor to evaluate and make the necessary repairs.
2. One of four lights in the ceiling fan light kit in the bedroom does not light when turning on the wall switch. Recommend replacing the light bulb first, then if the light still does not work, recommend a licensed electrical contractor to evaluate the fixture and make the necessary repairs.

Bedroom #1 - 1st Floor: View showing missing closet door

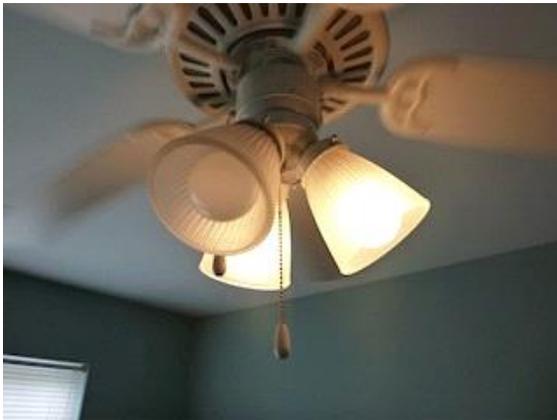
One of three lights in the ceiling fan light kit in the bedroom does not light when turning on the wall switch. Recommend replacing the light bulb first, then if the light still does not work, recommend a licensed electrical contractor to evaluate the fixture and make the necessary repairs.

Bedroom #2 - 2nd Floor - Left: View showing defective ceiling fan light

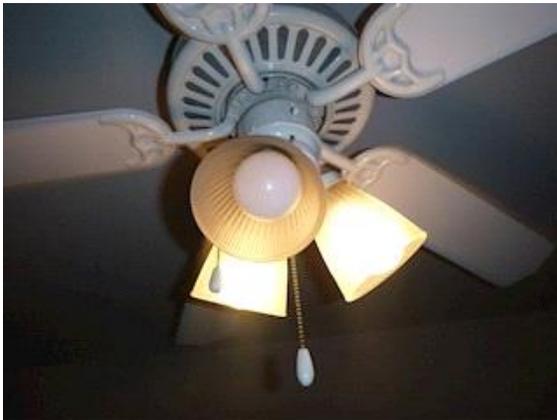
One of three lights in the ceiling fan light kit in the bedroom does not light when turning on the wall switch. Recommend replacing the light bulb first, then if the light still does not work, recommend a licensed electrical contractor to evaluate the fixture and make the necessary repairs.

Bedroom #3 - 2nd Floor - Right: View showing defective ceiling fan light
