Property Inspection Report

Residential Inspection Sample

Property Address:
123 Any Street
Any town TX 00000

By: Sean Green TREC #8266 / National Property Inspections 10/11/2018
(Name and License Number of Inspector) (Date)

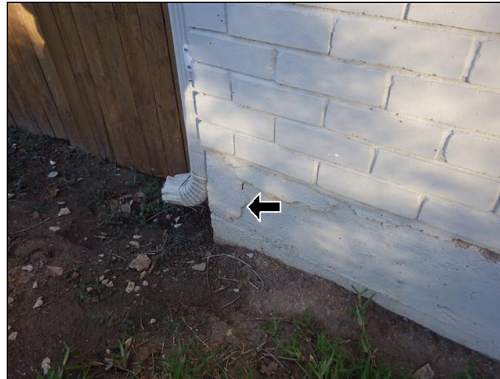
A. Photo 1

(3) Noted cracks at one or more corners of the foundation grade beam. Corner cracks are not structural in nature but cosmetic and caused primarily by expansion of the adjacent veneer when heated by the sun. Although cracks such as these are common and not structurally significant, the client may want to repair a corner crack as the foundation in this area does provide some support for the adjacent wall.

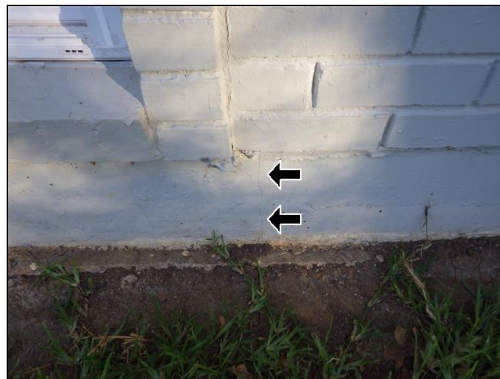
A. Photo 2

(4) There was a hairline vertical crack along the left front of the foundation. This did not appear to be structurally significant.

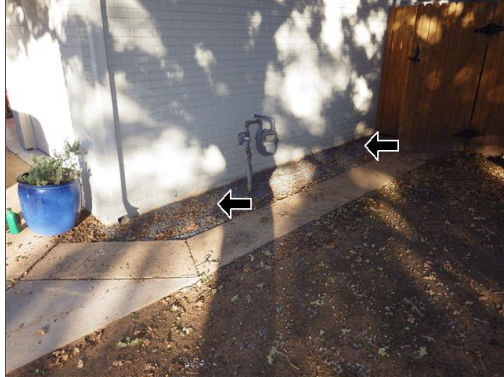
B. Photo 1 Right side

(1) The soil was sloped toward the structure at one or more locations. This condition could affect foundation performance if water were retained near these locations. Today's standards require that grading be positively sloped away from the structure a minimum six inches for every ten feet (5% positive slope). Recommend further evaluation and repair by a qualified contractor.

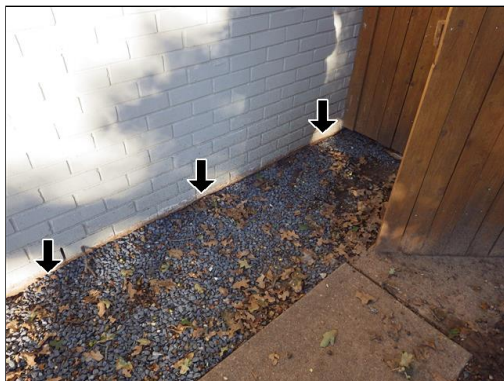
B. Photo 3

(2) Noted soil line was positioned too high at one or more locations along the base of the structure exterior. Any surface water retained in these areas could penetrate the structure if not corrected. A minimum four to six inches of exposed foundation grade beam should be maintained. Recommend repair by a qualified contractor. Note: Care should be taken in correcting the soil line so that a negative grade is not created.

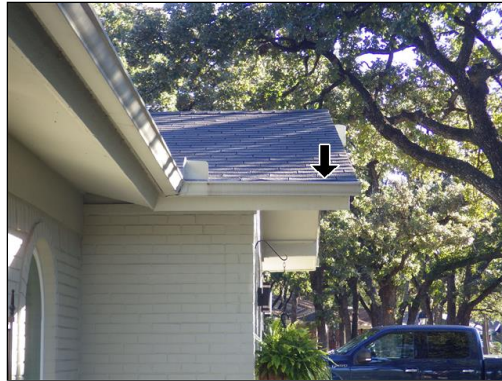
B. Photo 7 Front

(3) One or more gutters were not properly pitched toward the downspouts. Water retained in gutters can prematurely rust them over time and in some cases, can overflow into the adjacent eaves. Recommend repair/adjustment by a qualified contractor.

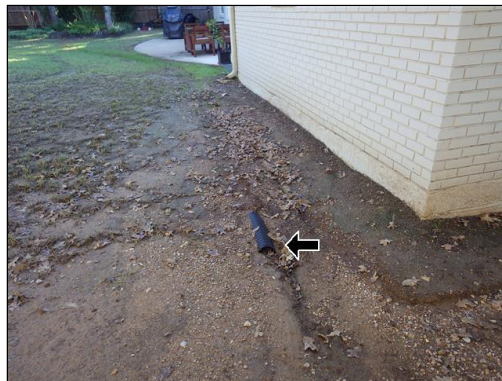
B. Photo 8

(4) There was a underground gutter outlet in the grade at the left rear corner of the structure. The drain inlet was not found.

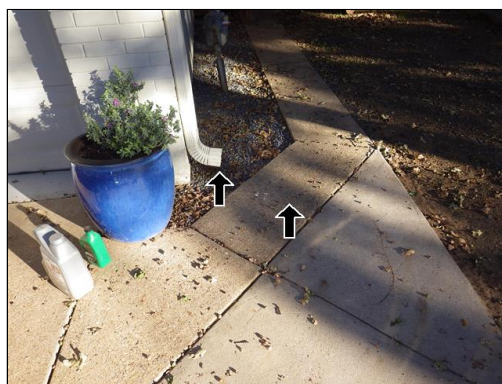
B. Photo 9

(5) One or more gutter downspouts were positioned to discharge rainwater near the foundation. Rainwater ponding near the foundation could affect its performance. Recommend downspout extensions be installed to move water a minimum of three feet away from the foundation.

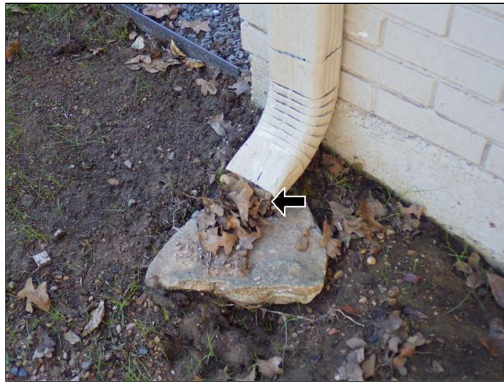
B. Photo 10

(6) Several gutters and/or downspouts were full of debris. Recommend removal for proper rainwater release.

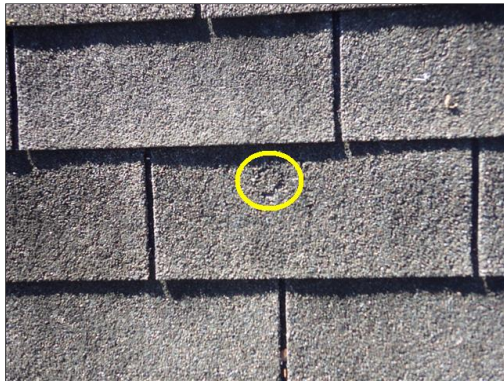
C. Photo 1

(1) The roof covering showed visual signs of impact damage. It was marginal whether there was enough damage to warrant repair and/or an insurance claim. Also, the inspector observed granular loss at several shingles, primarily on the right front roof plane and the left front valley. Recommend further evaluation by a qualified roofing contractor.

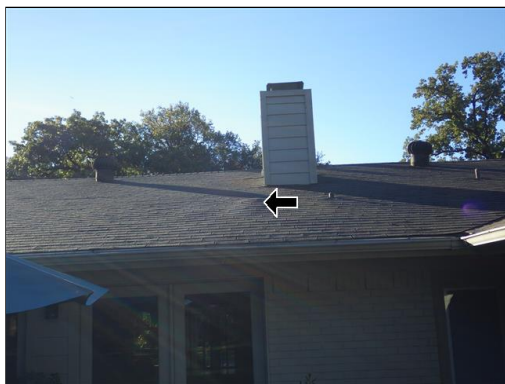
D. Photo 1

(1) There was a deflection in the surface of the rear roof plane (near the chimney). This area was not readily accessible in the attic due to a lack of decking. Also, there was a broken collar tie. Recommend further evaluation and repair by a qualified framing contractor.

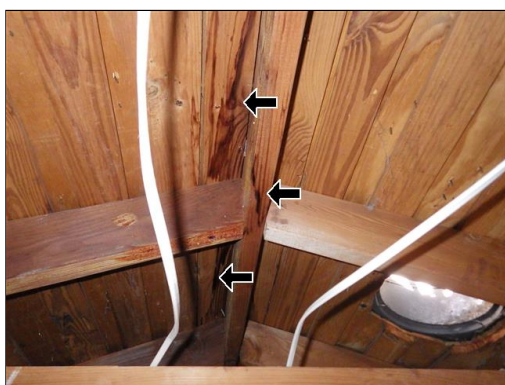
D. Photo 3

(2) There were several apparent water stains along the ridge and rafters at the attic above the garage. These did not appear to be recent or active. Recommend continued monitoring for further developments.

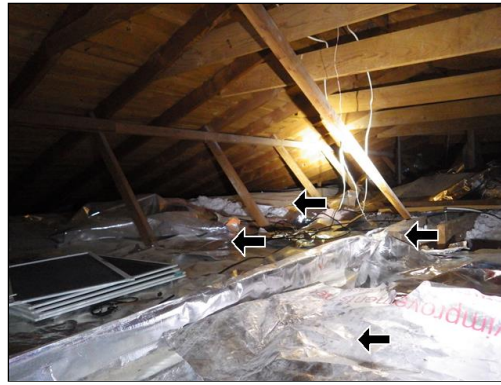
D. Photo 6

(3) The insulation on the attic floor was covered by radiant barrier sheets. Typically, these would be hung from the rafters, not laying on the attic floor. Recommend consulting with an energy efficiency professional to confirm the best way to utilize the radiant barrier present in the attic.

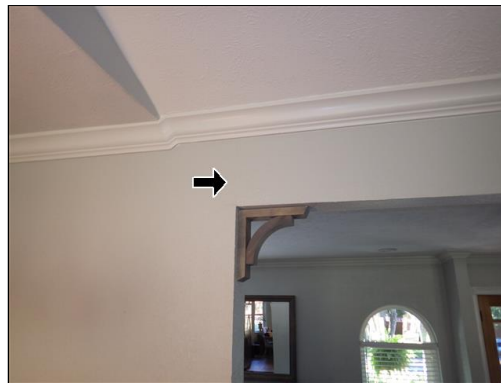
E. Photo 1

(1) There was a hairline crack at the archway between the front living room and the rear living room.

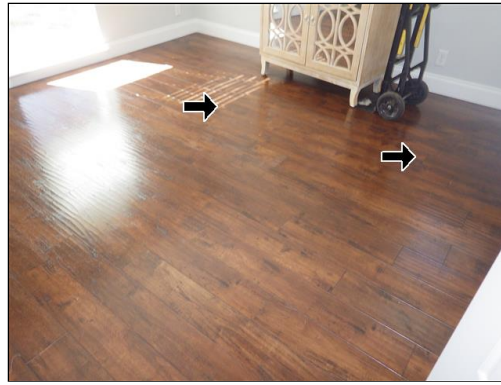
F. Photo 1

At the left front bedroom, the floor was sloping downward toward the left side exterior wall. Based on the age of the home, some sloping of floors can be expected. This did not appear to be structurally significant. Recommend continued monitoring for further developments.

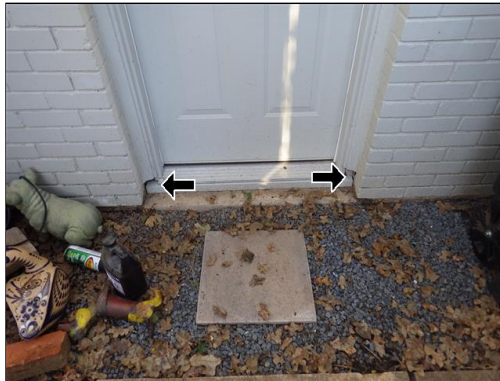
G. Photo 1

(1) At the right side patron door, the trim had been cut short with portions of the wall framing visible. It is possible that some deteriorated wood had been cut off. These are potential entry points for rainwater or rodents. Recommend repair by a qualified contractor. Note: the client mentioned that the seller disclosed that when there is a heavy rain, storm water will run under the door and enter the garage. Recommend client ask the seller additional questions about this condition.

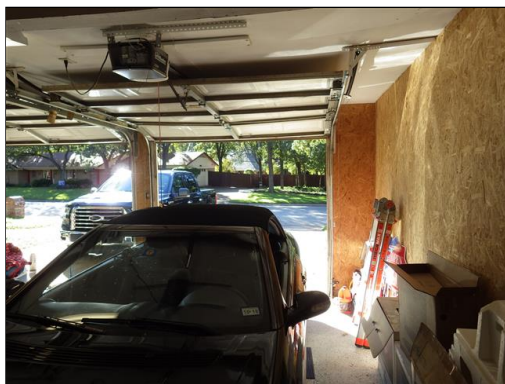
G. Photo 4

(2) The left garage door did not close with the opener in that the door was binding during down travel. Further investigation found that several door panels were cracked and the center supports were no longer glued to the skin of the panels. The door may need to be replaced. Also, one of the rail supports was pulling away from the ceiling. Recommend repair by a qualified contractor.

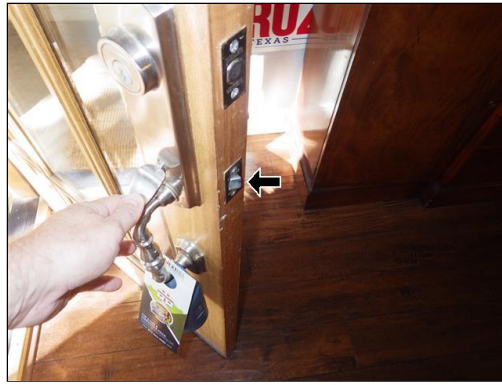
G. Photo 9

(3) The striker at the front exterior door did not fully engage when the button was depressed. The front door was difficult to open. Recommend repair by a qualified contractor.

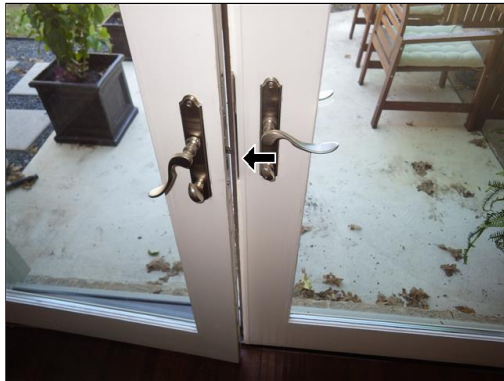
G. Photo 10

(4) One of the rear double doors did not latch closed. It would only latch when the lock was engaged. Also, at another one of the double doors, the upper part of the door did not latch. Recommend repair by a qualified contractor.

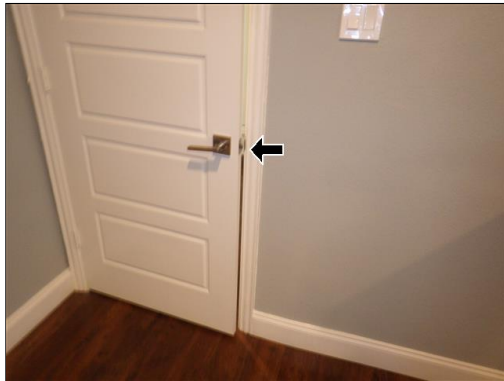
G. Photo 12

(5) The door to the master bedroom did not latch and the door to the left front bedroom was rubbing on the frame. Recommend repair/adjustment by a qualified contractor.

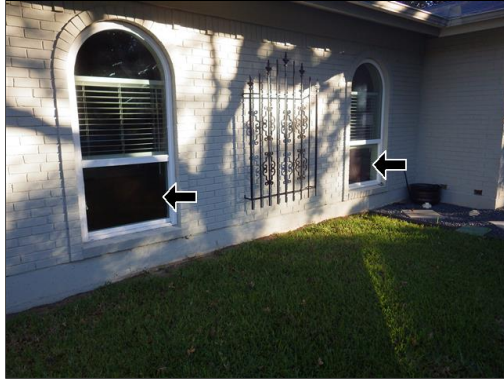
H. Photo 1

(1) There were no screens on the windows at time of inspection. There were numerous screens observed in the attic. They were not inventoried.

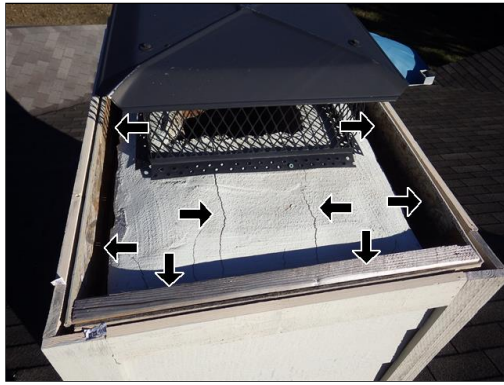
J. Photo 1

The fireplace had numerous deficiencies. The inspector observed that a siding cover was installed over the existing chimney and that there was no cap. The wood framing and the backside of the siding was exposed which will deteriorate it over time. The mortar cap had several cracks which are potential entry points for rainwater. At the firebox, there was a vertical crack at the back wall. Also, the area above the firebox opening had missing mortar and some exposed wood which is combustible. Recommend a full review of the fireplace and chimney be performed by a qualified contractor.

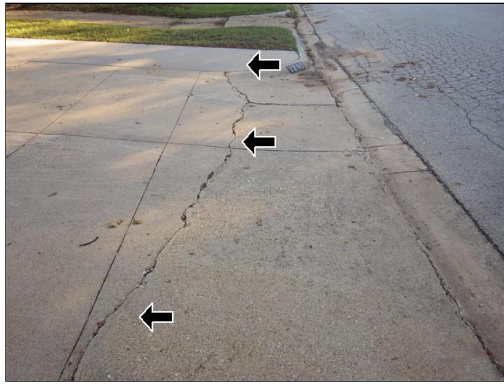
K. Photo 1

There were a few concrete cracks across the driveway and at the rear patio.

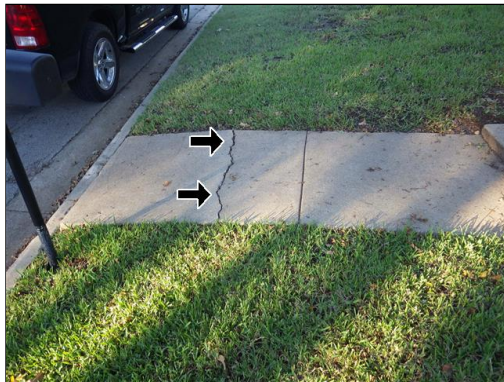
L. Photo 1

(1) There were a few cracks across the sidewalk concrete.

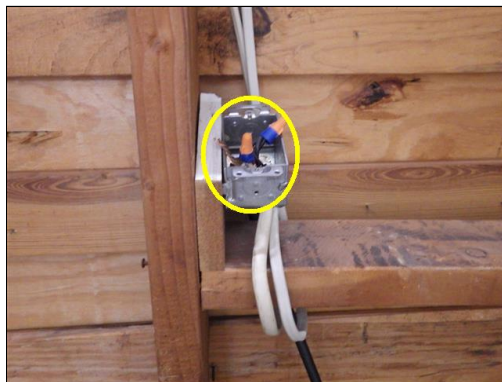
B. Photo 1

(1) In the attic, there was an open junction box. This is a safety concern. The wire connections should be protected from rodents and patrons of the attic. Recommend repair by a qualified contractor.

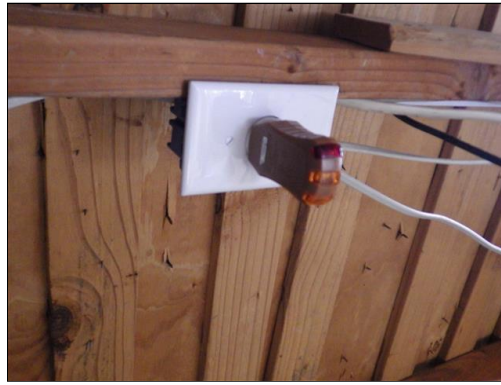
B. Photo 2

(2) Above the attic entry, there was an electrical receptacle that did not have power. Recommend repair by a licensed electrician.

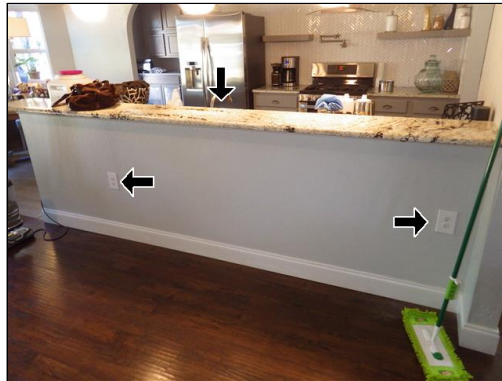
B. Photo 3

(4) Ground Fault Circuit Interrupter (GFCI) protection was not present one or more garage receptacles and at the front exterior receptacle. Also, a couple of receptacles on the wall near the kitchen sink and at a right side bathroom were not GFCI protected. Today's standards require GFCI protection at all **bathroom, garage, outdoor**, crawlspace, unfinished basement, and kitchen countertop receptacles. Also, any receptacle within **six feet of water** are to be GFCI protected. Although the structure may not have been required to have GFCI protection in any or all of these locations at the time of construction, it is considered a life-safety upgrade. The Texas Real Estate Commission (TREC) Standards of Practice requires inspectors to report lack of GFCI protection as deficient.

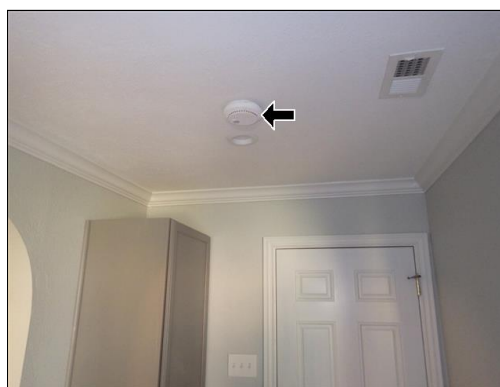
B. Photo 7

(6) At the right side of the interior, a smoke detector did not sound when the test button was depressed. This could be due to a dead battery. Recommend repair by a qualified contractor.

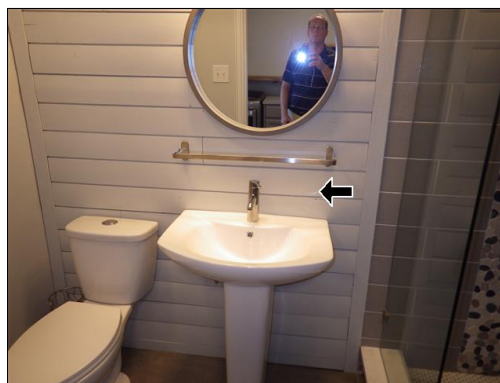
B. Photo 8

(7) There was no receptacle present near the right side bathroom sink. Today's electrical standards require that a GFCI protected receptacle be present within three feet of a bathroom sink to service the sink.

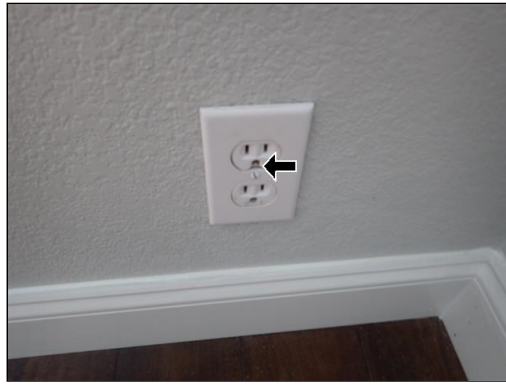
B. Photo 9

(8) At the left front bedroom, one of the receptacles had a grounding pin broken off in it. Also, one of the receptacles was tested to have an "open ground" condition which is a safety concern. Recommend repair by a licensed electrician.

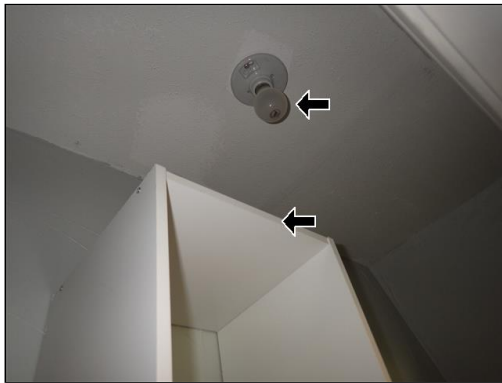
B. Photo 11

(9) Lighting in one or more closets were an open incandescent bulb fixture. This is no longer an acceptable lighting receptacle by today's standards. Recommend replacing with an enclosed incandescent light that is a minimum 12 inches away from shelf storage area or replacing with a recessed incandescent or surface fluorescent that is a minimum 6 inches from shelf storage area. Note: The shelf storage area is measured from the light fixture to a vertical line from shelf to ceiling.

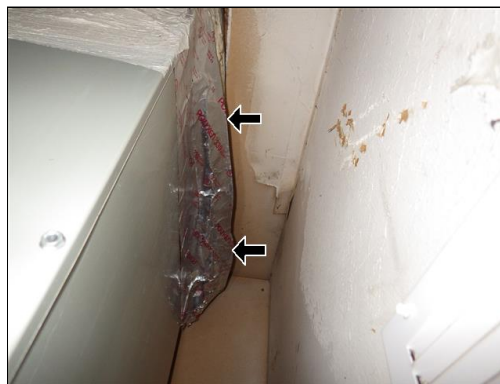
C. Photo 1

(2) On the right side of the supply plenum, there was some loose tape at a seam. Due to the location, it was unclear whether there was an air leak in this area. Recommend area be sealed/taped by a qualified HVAC contractor.

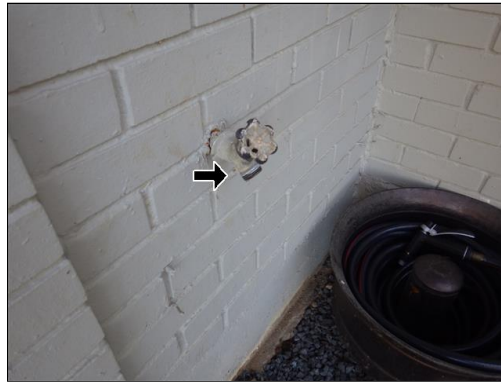
A. Photo 1 An example

(2) Anti-siphon valves were missing at one or more hose bibbs. A backflow preventor (anti-siphon valve), eliminates the possibility of a vacuum and prevents water from backsiphoning into the main water lines. Recommend anti-siphon valves be added.

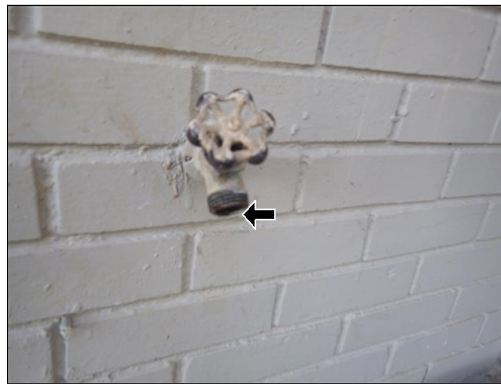
A. Photo 2

(3) At the left front hose bibb, there was a slight drip visible when the valve was fully closed. Recommend repair by a licensed plumber.

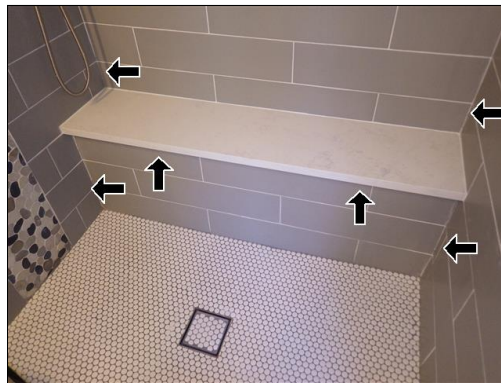
(4) Observed grout and/or sealant separation along shower/tub walls and fixtures. These areas retain moisture that could deteriorate drywall and framing. Recommend new grout/sealant be applied.

A. Photo 3 Master shower

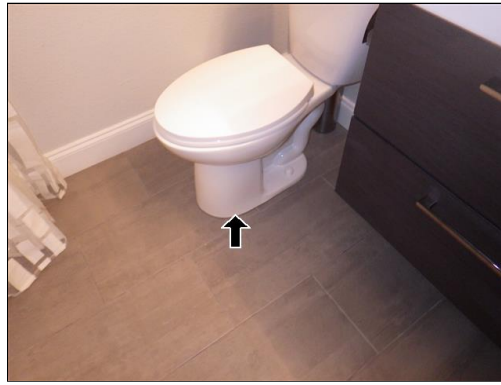
A. Photo 4

(5) The guest bathroom toilet was loose from the floor and may have broken its wax seal and/or flange. Recommend repair by a licensed plumber.

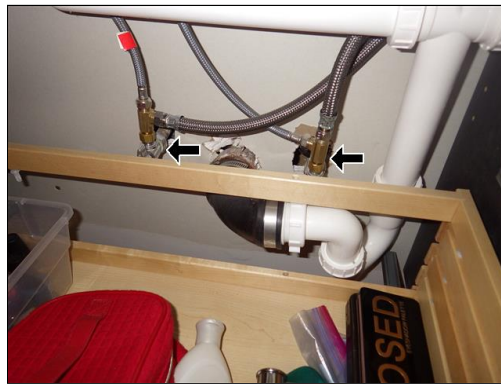
A. Photo 5

(6) At the guest bathroom, the hot and cold water supplies were sharing shut off valves. Today's plumbing standards require that each supply have its own shut off valve. Recommend repair by a licensed plumber.

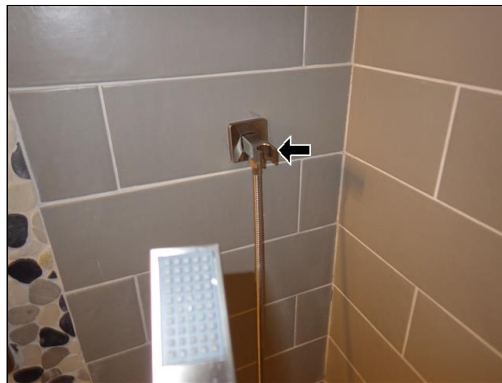
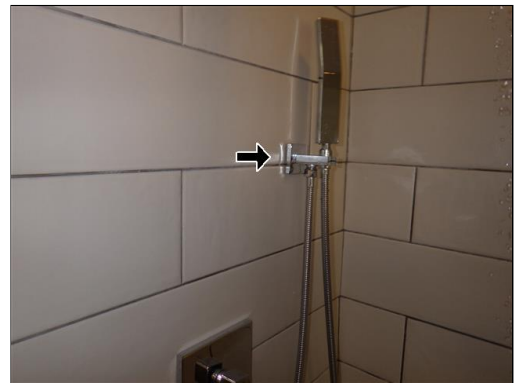
(7) At two of the showers, the mounting brackets for the wands were loosely mounted to the wall. Recommend they be secured.

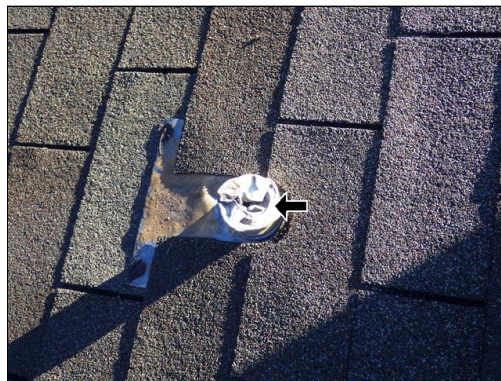
B. Photo 1

(1) At the rear center of the roof, there was a plumbing vent that was partially covered. Due to its location in the attic, it was unclear whether the vent had fallen down and lead boot was bent over it or if this was an attempt to abandon the vent. Recommend repair by a licensed plumber.

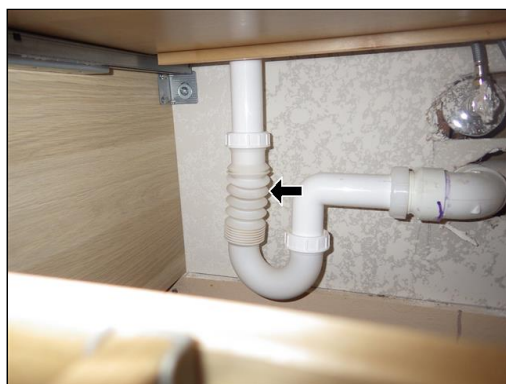
B. Photo 2

(2) The drain lines at the sinks for both master sinks were of a flexible design. This is not an approved material in that the ribbing can retain sediment, hair, etc. that can prematurely clog the drain. Recommend repair by a licensed plumber.

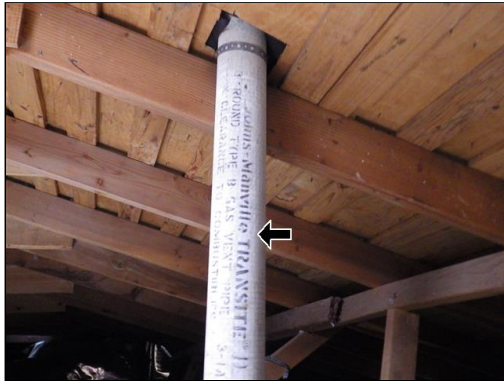
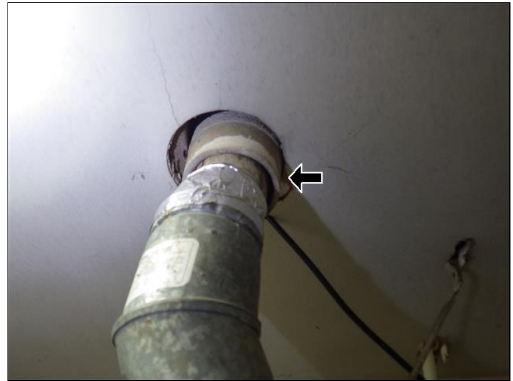
- (1) Water heater(s) appear to be operating as intended at time of inspection. The life expectancy of a water heater is typically eight to thirteen years. Realize that with a change in patrons and water usage habits, water heater failure can occur.
- (2) The exhaust vent appeared to be constructed with an asbestos-like material. This is a potential health concern. Recommend further evaluation by a licensed plumber. A new vent may be warranted.

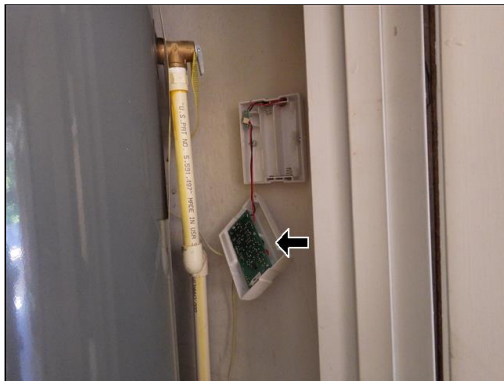
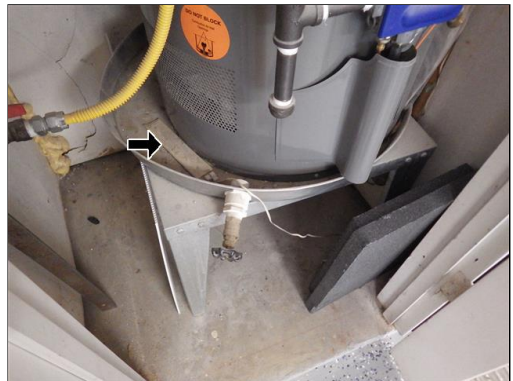
- (3) The water heater had a drain pan but no drain line for the pan. As a work around, there was a sensor installed (flood stop) in the pan that if water was sensed in the pan, it would interrupt the water supply. The controller for the sensor was missing batteries. There was no way to determine whether it would be operational if batteries were added. Recommend further evaluation by a licensed plumber.

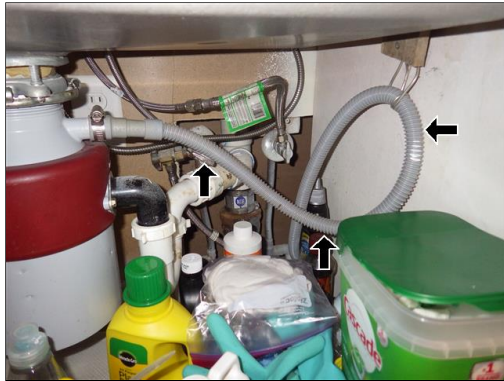
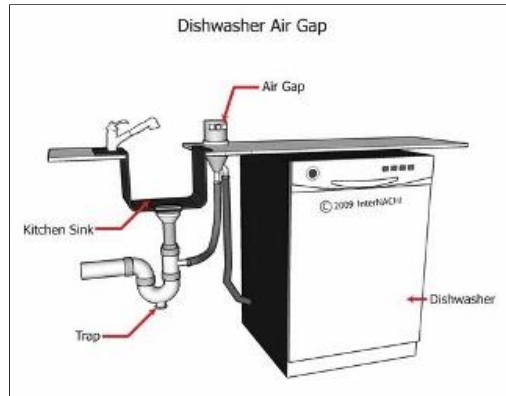
(2) The dishwasher did not appear to have an anti-siphon device installed for the drain line. Anti-siphon devices should be installed to prevent wastewater within the disposer from being siphoned back into the dishwasher and contaminating its contents. Recommend repair by a qualified service technician. Note: In some cases, a high loop of the drain line will provide the same protection. In a high loop installation, the drain line must be secured to the underneath side of the counter. The current loop to the drain is not adequate.

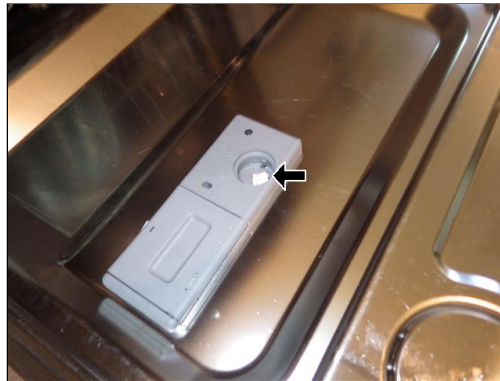
A. Photo 3

(3) The cap for the rinse reservoir was missing.

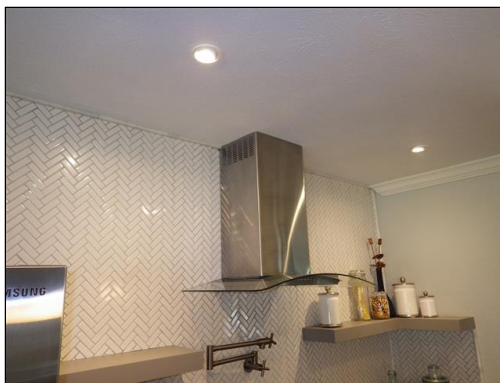
C. Photo 1

(2) The kitchen exhaust fan appeared to be venting into the attic. Today's standards require that exhaust fans terminate to the exterior so that moisture and/or odors will not be retained in the attic. Excessive moisture can contribute to mold growth.

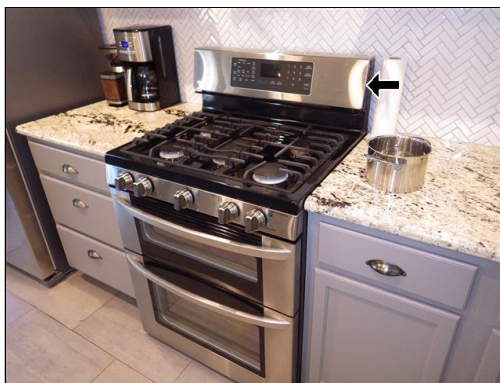
D. Photo 1

(2) Range did not have an "Anti-tip device" installed. Children have been known to stand on an oven door and tip over the appliance. Recommend anti-tip hardware be added.

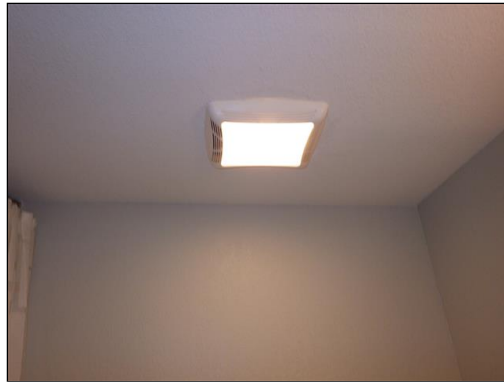
F. Photo 1

Bathroom and/or laundry exhaust fans were venting into the attic. Today's standards require that exhaust fans terminate outside so that moisture and/or odors will not be retained in the attic.

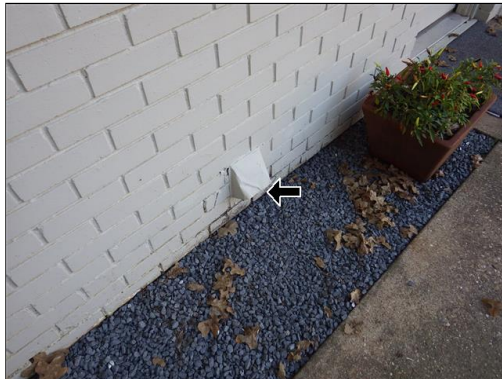
H. Photo 1

The damper for the dryer vent was stuck in the open position. In some cases, this could be due to excessive lint. The condition is a potential entry point for rodents and/or insects. Recommend repair by a qualified contractor.

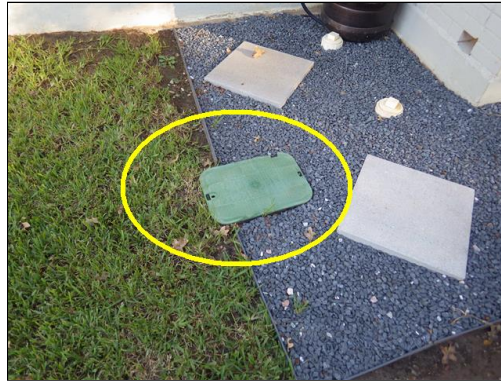
A. Photo 1

independently of the main water supply for servicing of the system and/or of the backflow prevention device.

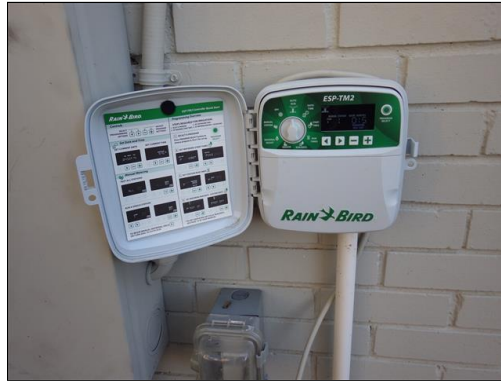
A. Photo 2

(2) The sprinkler system did not have the zones labeled. Recommend zones be labeled for ease of use.

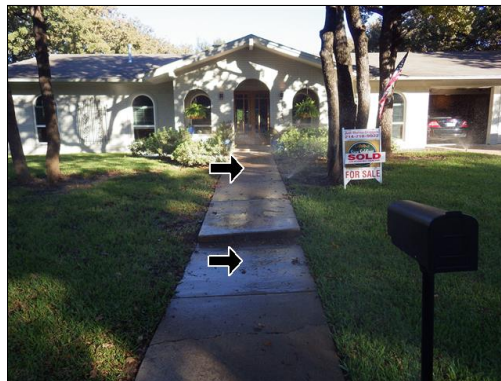
A. Photo 3

(3) Noted one or more sprinkler heads on the property that were adjusted incorrectly and spraying on areas such as but not limited to: the structure, the flatwork (e.g. sidewalk, driveway, decks), street, cooling equipment, gutters, fencing. Recommend head adjustment by a qualified lawn sprinkler contractor.

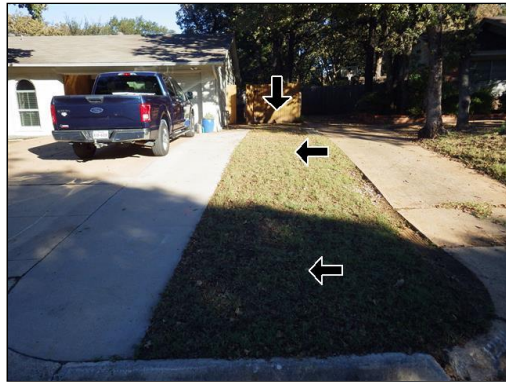
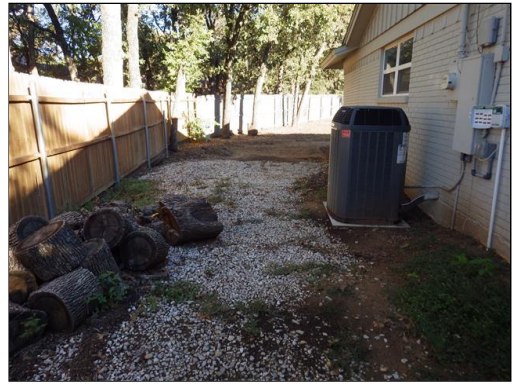
(5) There was no sprinkler coverage to the right of the property, to the right of the home and to the left of the home. Also, there was a single pipe connected to a hose bibb that provided water to heads at the center of the backyard. The backyard configuration was operational but was not checked for coverage.
