# Property Inspection Report

## New Construction w/Thermal- Sample

**Property Address:**  
123 Any Street  
Any City TX 75208

**By:** Sean Green TREC #8266, Westley Green TREC #21480 / National Property Inspections  
\_\_\_\_\_  
1/10/2017  
\_\_\_\_\_  
(Name and License Number of Inspector) (Date)

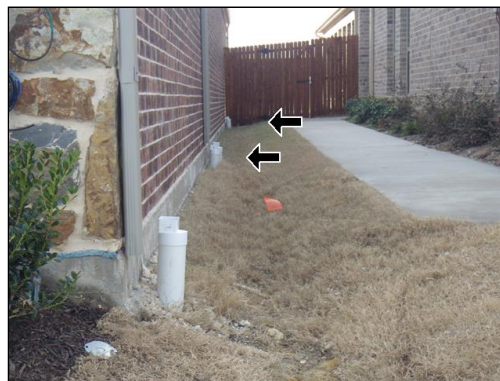
B. Photo 1

(1) The grading appeared to be positively sloped away from the structure to promote drainage with exception to the right side where negative sloping was observed. This could affect foundation performance if water was retained in this area. Today's standards require that the grading be positively sloped away from the structure a minimum six inches for every ten feet (5% positive slope). Recommend repair by a qualified contractor.

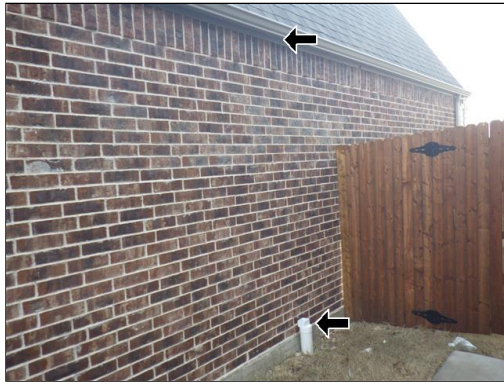
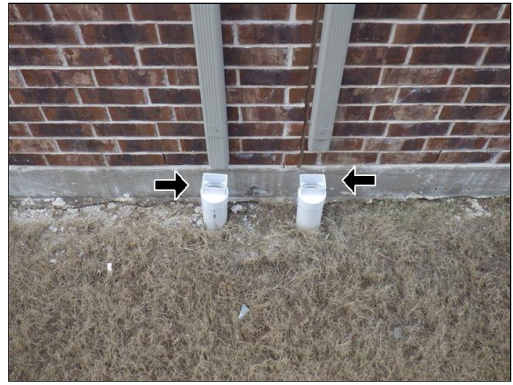
(2) At the right side, it appeared that a gutter downspout was missing. Also, several underground gutters were not yet connected to downspouts with one at the right front corner that was not properly aligned with the downspout. Recommend repair by a qualified contractor.

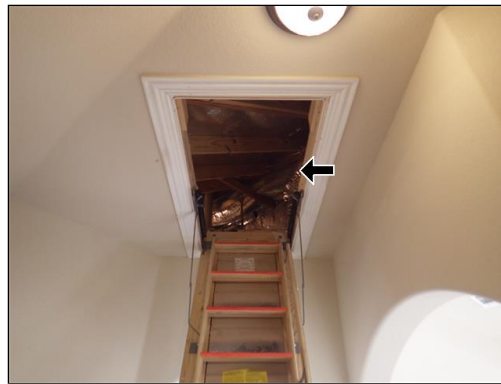
D. Photo 1

(1) The inspector did not observe the presence of an attic stairs insulator for the attic opening. Today's energy conservation standards require that an access door from conditioned spaces to unconditioned spaces be weatherstripped and insulated to a level equivalent to the insulation of the surrounding surfaces. Since this is a prescriptive requirement, most builders will use an insulated cover to achieve an R-10 value at the opening. Recommend repair by a qualified contractor.

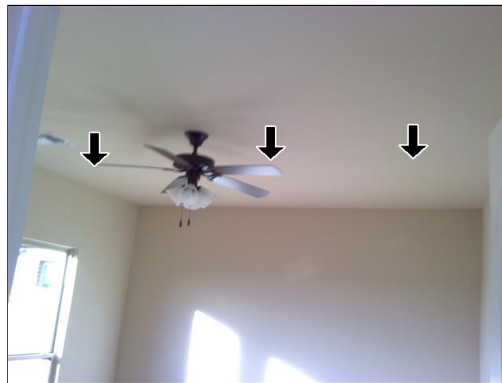
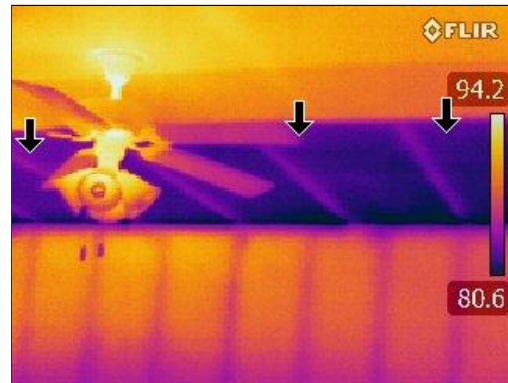
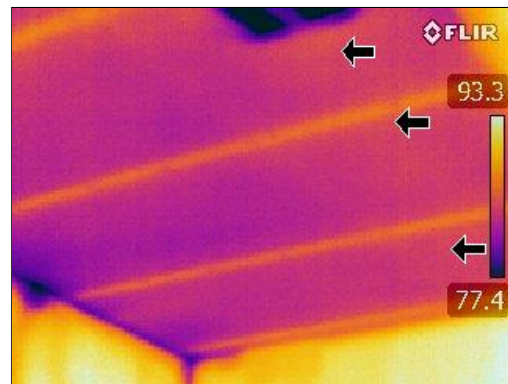
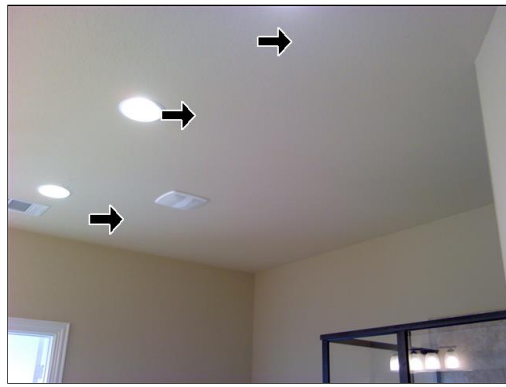
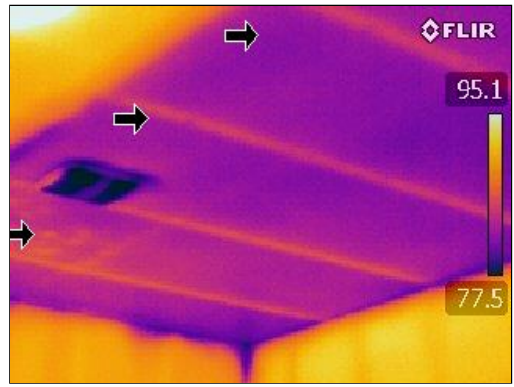
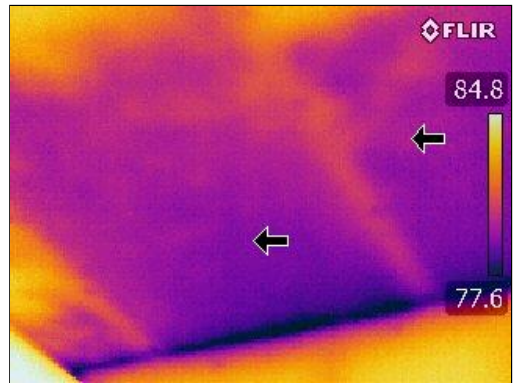
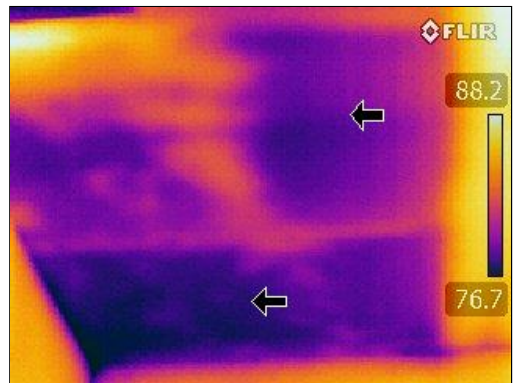
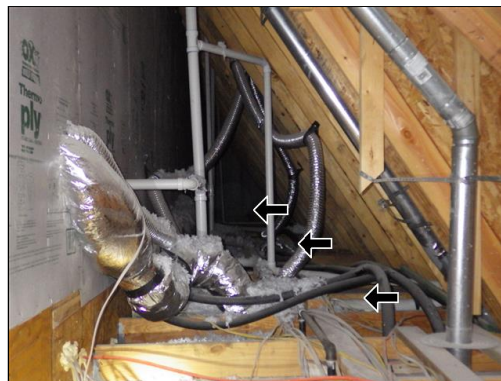
(2) During a thermal imaging scan, there was a decrease in the apparent temperature along about a six foot width down the whole right side of the first floor ceiling. It extended from the laundry room all the way down to the master bedroom. Further evaluation found that the right side first floor attic was not insulated. Ceilings are typically insulated to R-38. Recommend repair by a qualified contractor.

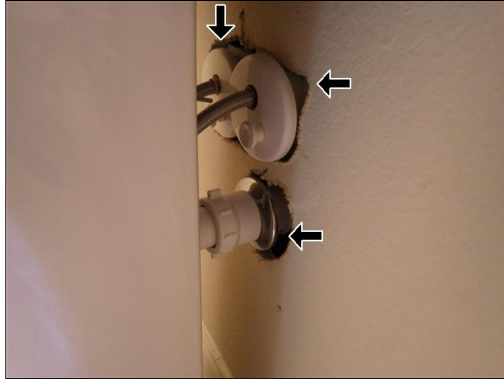
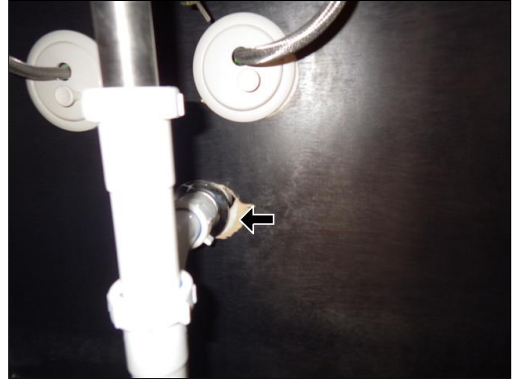
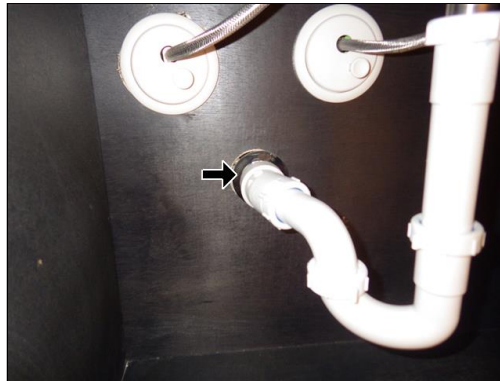
(1) At the half bath and master bath, the walls were cut too large to accommodate the supply and drain plumbing. This is substandard workmanship and a potential entry point to the structure for insects. Recommend repair by a qualified contractor.

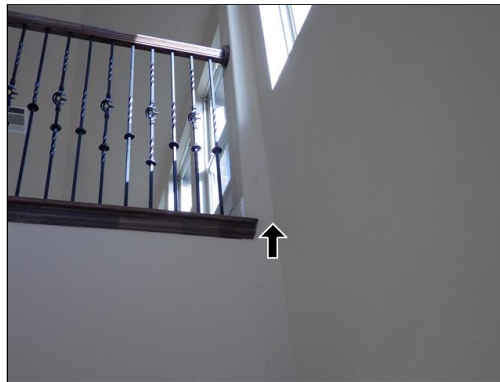
E. Photo 4

(2) At the base of the second floor railing, there was a hairline horizontal crack on the wall.

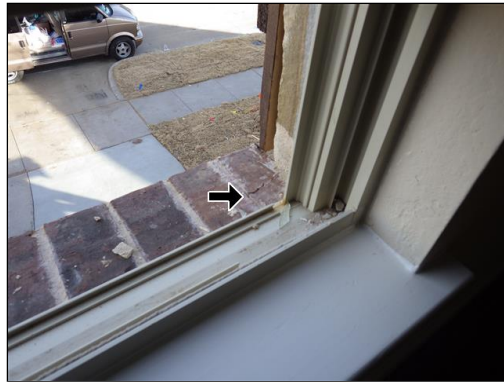
E. Photo 5

(3) There was a broken brick at the ledge near a right front second floor window. Recommend brick be replaced.

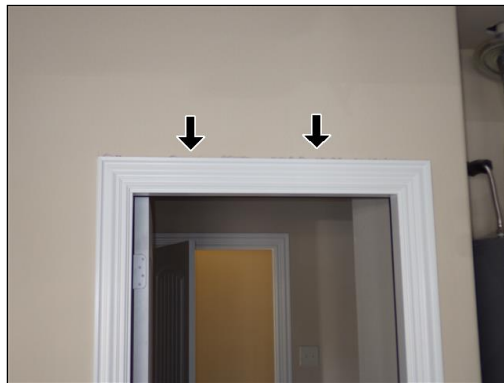
E. Photo 6

(4) Along the upper trim at the door leading to the laundry room, the drywall was damaged.

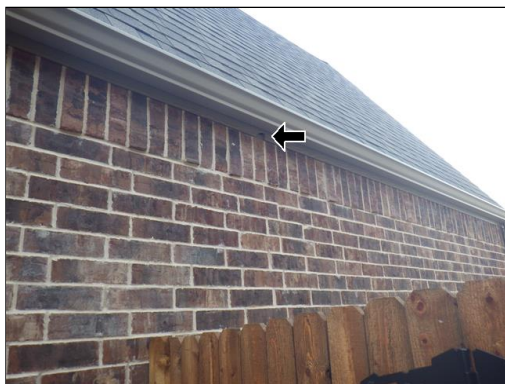
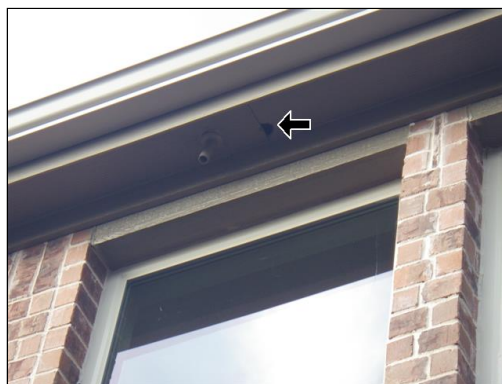
(5) There was a broken piece of frieze board trim at the right side upper wall. There was damage to the fascia at the right front roof/soffit transition and there was a hole in the left side eave. Recommend repair by a qualified contractor.

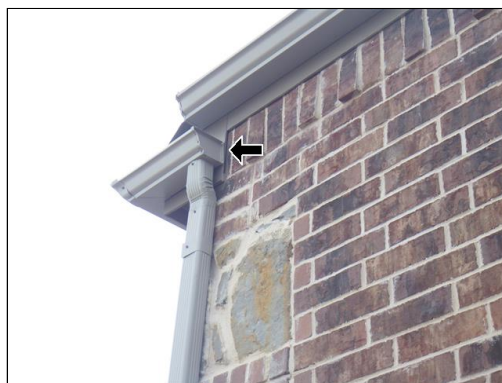
E. Photo 10

(6) At the right front of the structure, there was missing sealant along a piece of vertical trim.

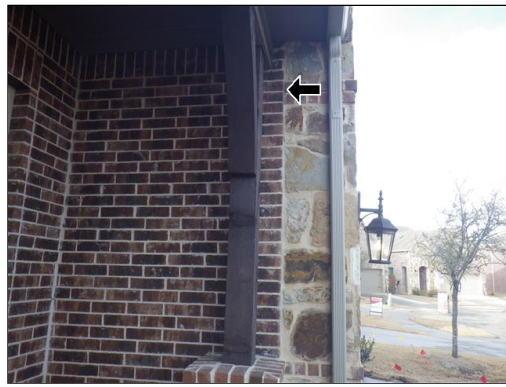
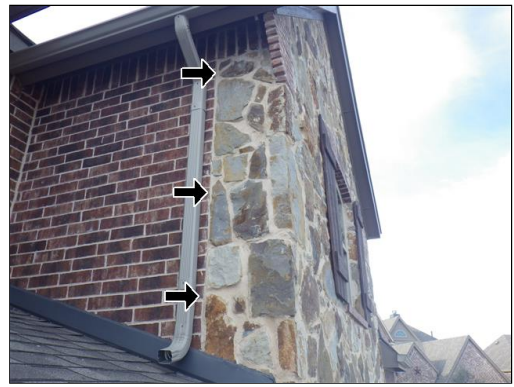
(7) To the right of the front door, there was a hairline vertical mortar crack at the brick/stone transition that extended from the patio to the top of the wall. Recommend repair by a qualified masonry contractor.

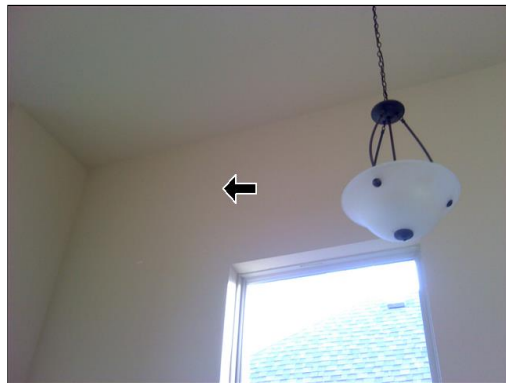
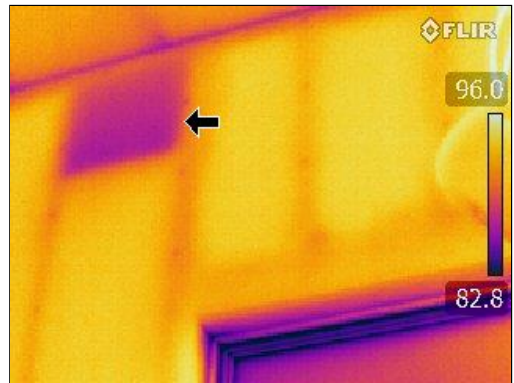
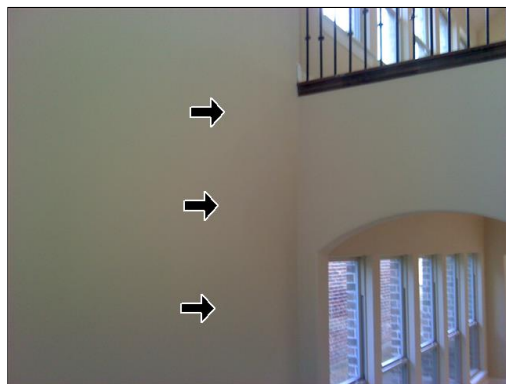
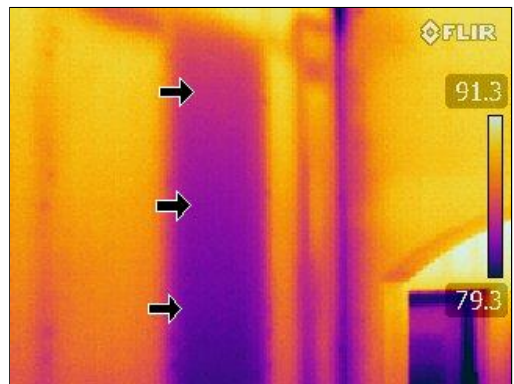
(8) During a thermal imaging scan, the inspector observed decreases in the apparent temperature of one or more interior wall locations. These are most likely due to a lack of insulation, dislodged insulation, or air infiltration from the exterior or attic. Recommend further evaluation and repair by a qualified contractor. Photographs are labeled for locations.

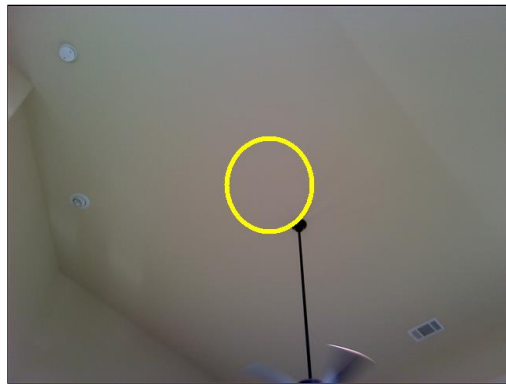
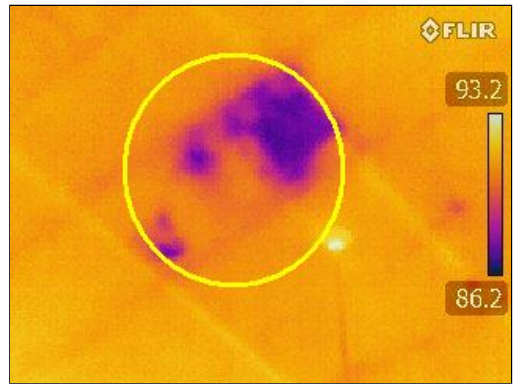
(1) During a thermal imaging scan, the inspector observed decreases in the apparent temperature of one or more ceiling locations within the home. These are most likely due to a lack of insulation, dislodged insulation or air infiltration from the exterior and/or attic. Recommend further evaluation and repair by a qualified contractor. Photographs are labeled for locations.

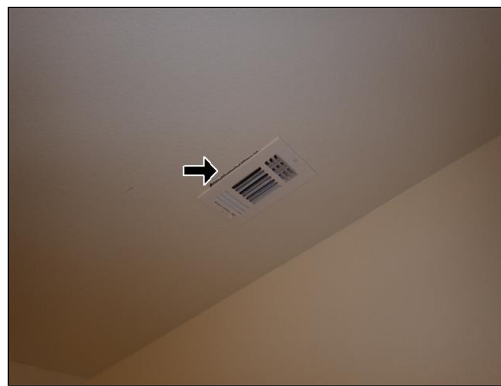
F. Photo 3

(2) In the master closet, the ceiling was cut too large to accommodate the supply register. Recommend repair by a qualified contractor.

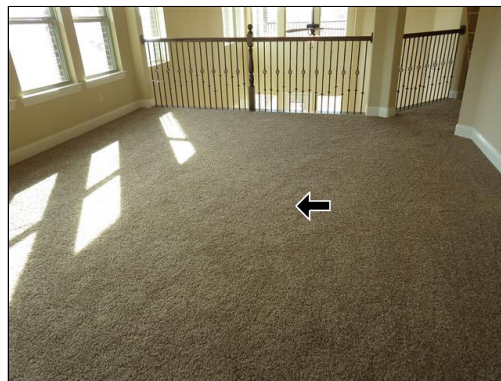
F. Photo 4

(3) A creak was heard while walking along the second story floor at the center of the game room. This may be due to loose fasteners in the floor boards and/or improper spacing of framing joists. Recommend repair by a qualified contractor.

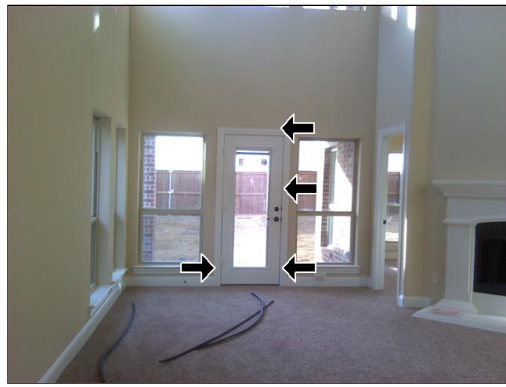
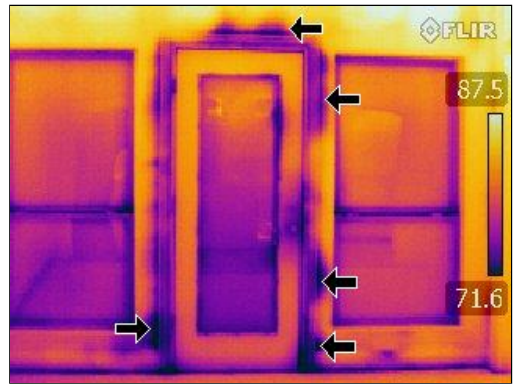
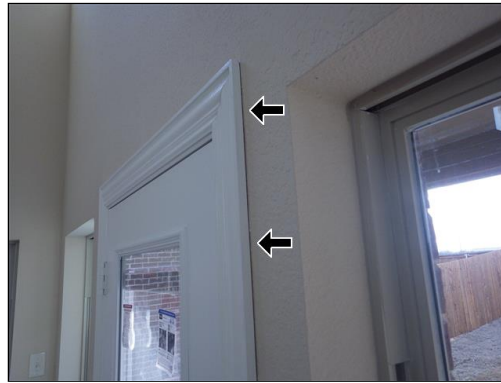
(1) During a thermal imaging scan, the inspector observed decreases in the apparent temperature along the perimeter trim of the rear exterior door. The trim had not yet been sealed to the adjacent wall. Recommend repair by a qualified contractor.

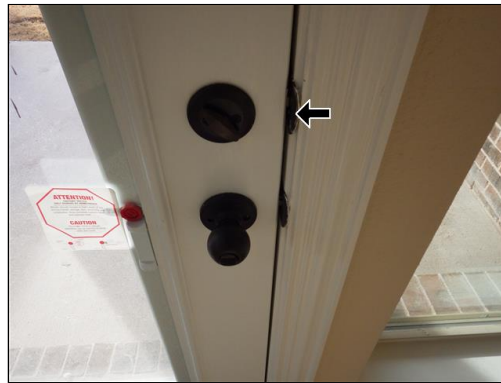
G. Photo 4

(2) When the rear exterior door is fully closed, the striker for the deadbolt lock does not fully engage. Recommend repair/adjustment by a qualified contractor.

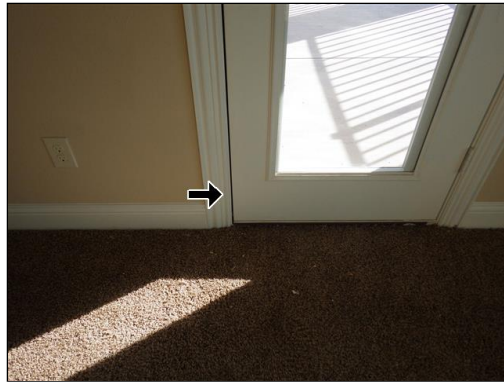
G. Photo 5

(3) There was an air gap on the lower left corner of the door leading to the balcony. Recommend repair/adjustment by a qualified contractor.

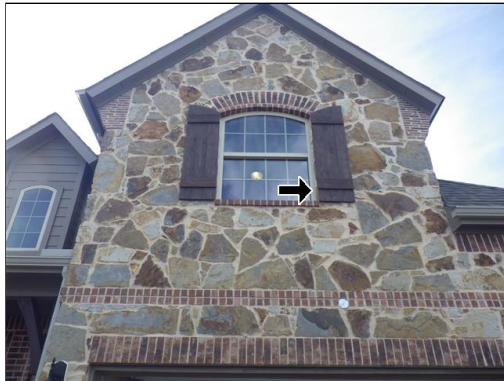
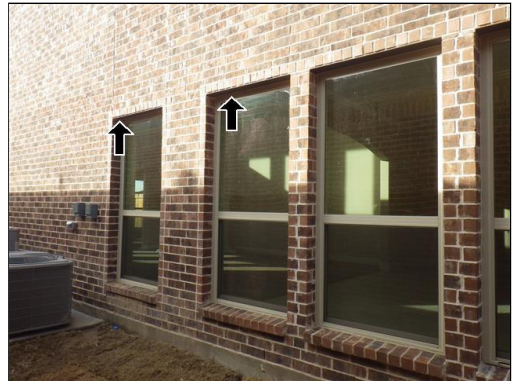
- (1) The window installation was substandard with numerous deficiencies noted within this subsection. Recommend a full review of the windows be performed by a qualified window contractor. Examples can be found within this subsection.
- (2) There was misapplied sealant along a second floor window over the garage and along a couple of left side windows.

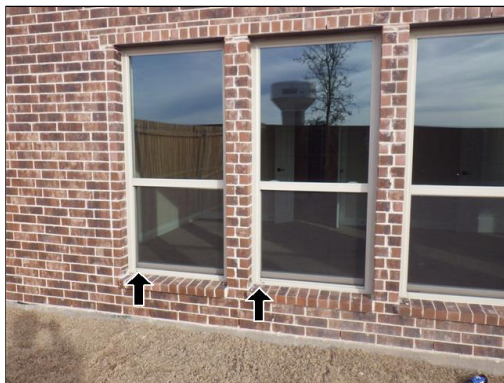
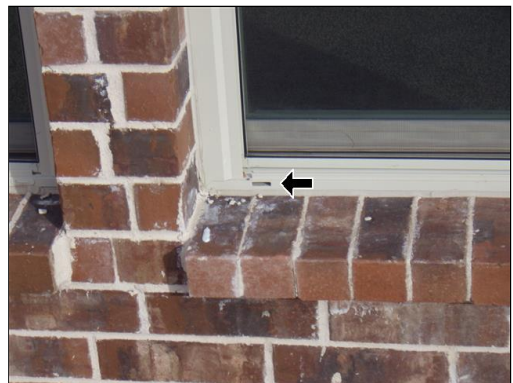
- (3) Weep hole caps were either missing or damaged at the base of one or more window frames. Weep holes allow water to weep out of the frame and the caps were installed (by the window manufacturer) to keep insects from entering the structure.

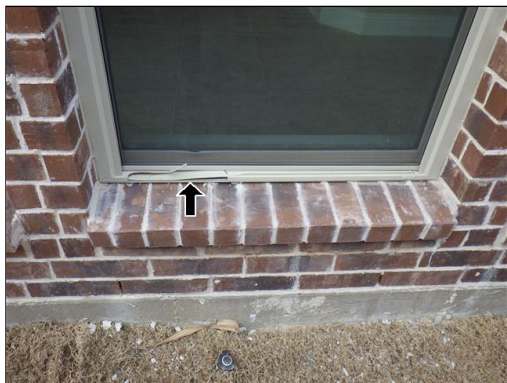
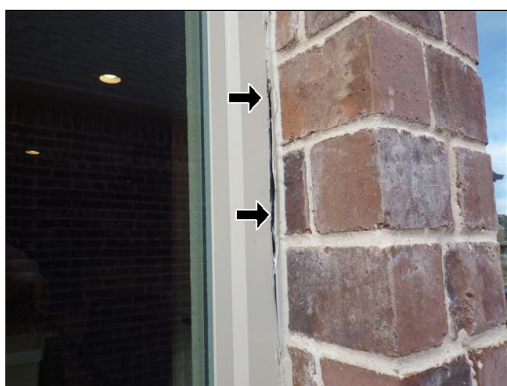
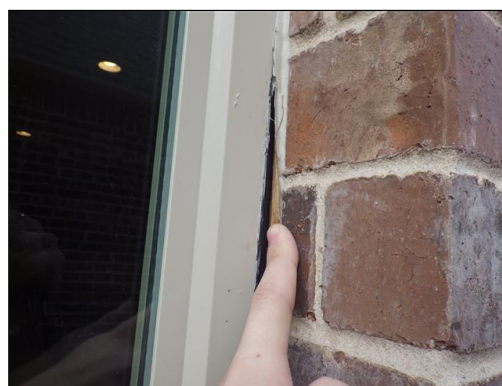
(4) At the left side, one of the windows had a broken frame and several had dislodged/damaged flashing tape. Also, there was considerable staining along some of the frames.

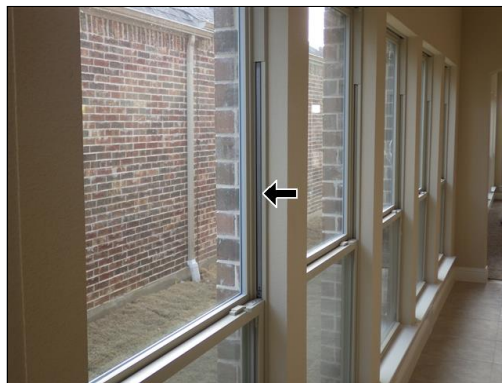
H. Photo 9 Near kitchen

(5) One or more windows had a broken and/or disconnected spring mechanisms. A spring mechanism aids in opening a window and keeping it in the "open" position. This is a potential safety issue. The window would not open.

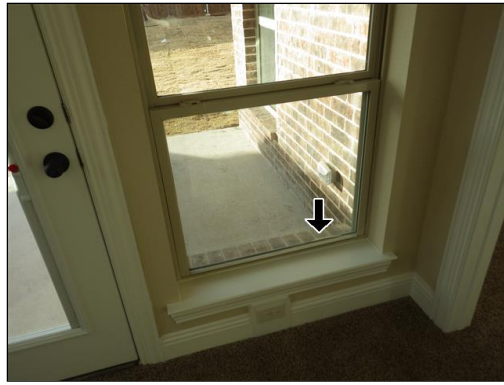
H. Photo 10

(6) To the right of the rear exterior door, there was broken glazing within the lower sash.

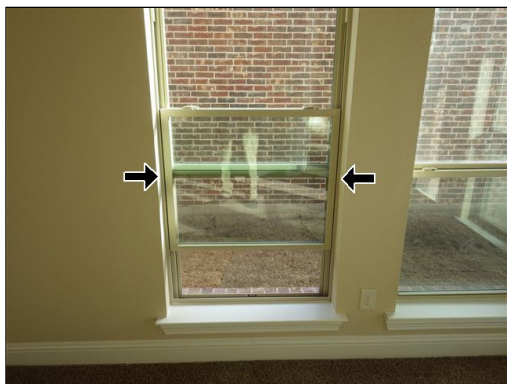
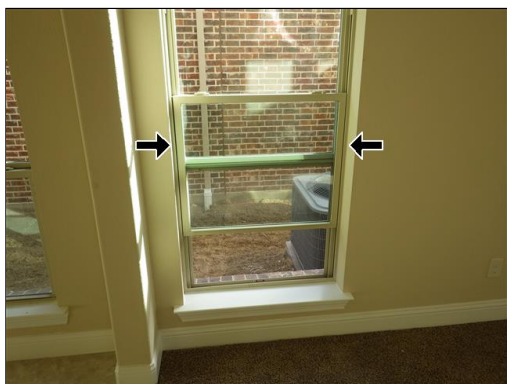
(8) Two of the windows along the left side of the living room had frames that were installed too wide. During testing, the lower sashes fell out of the frames. This is a potential safety issue. The lower sash should have very little side to side movement.

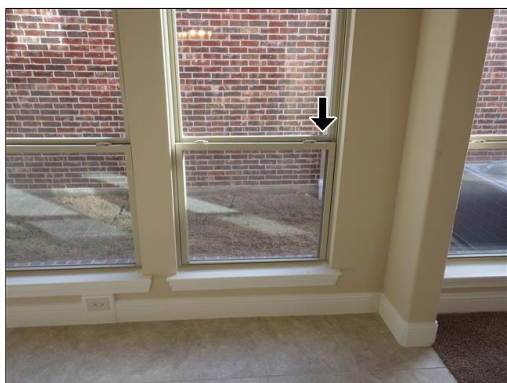
H. Photo 16

(9) At a left side breakfast nook window, the lower sash was not parallel to the frame and so it would not lock down. Also, one of the interior plastic beads was dislodged.

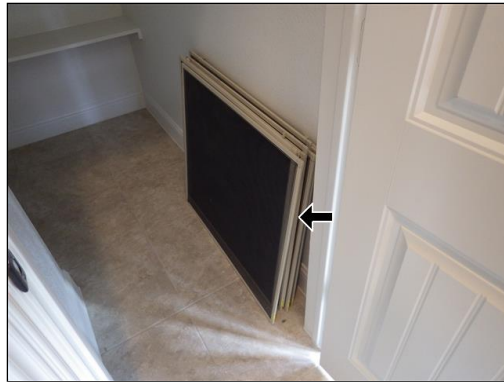
H. Photo 18

(10) Screens were not yet installed.

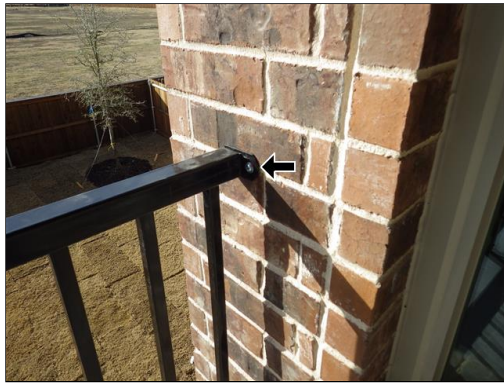
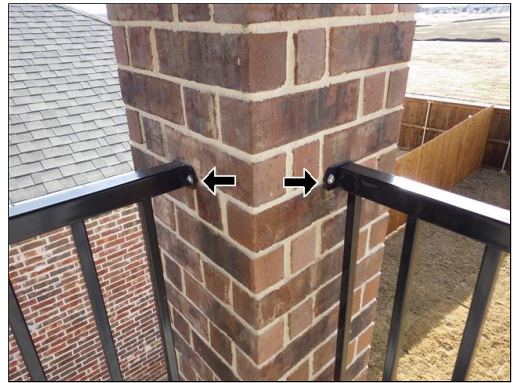
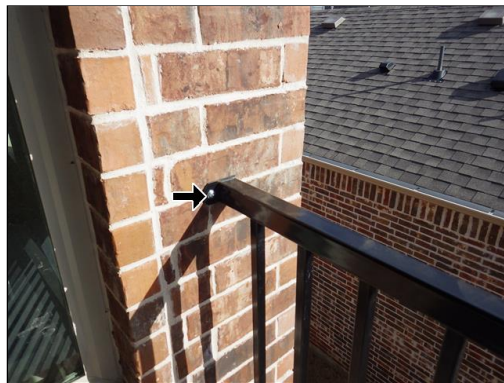
(1) At the balcony, the fasteners for the railings were not sealed. Recommend fasteners be sealed to deter rust.

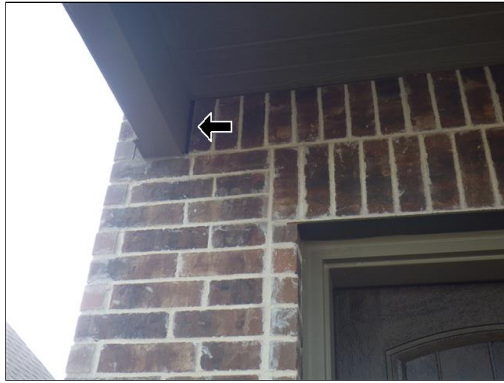
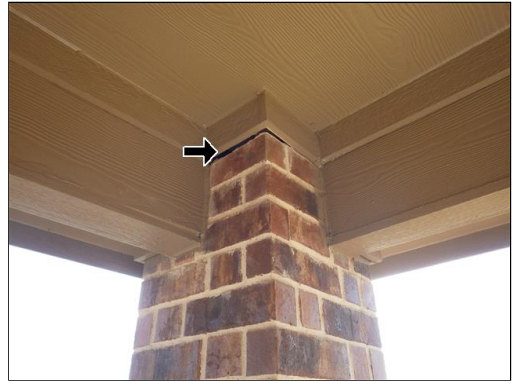
(2) At the front porch area, there was a considerable gap between the brick veneer and the beam. Also, at the balcony, the brick veneer on the post was not built tall enough. A gap was visible between the brick veneer and the adjacent trim. Recommend repair by a qualified contractor.

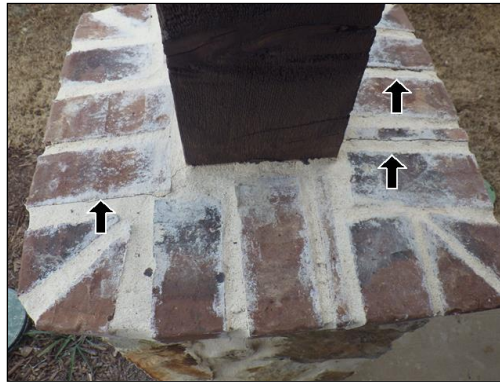
K. Photo 6

(3) There were mortar cracks along the brick veneer base of the front patio post.

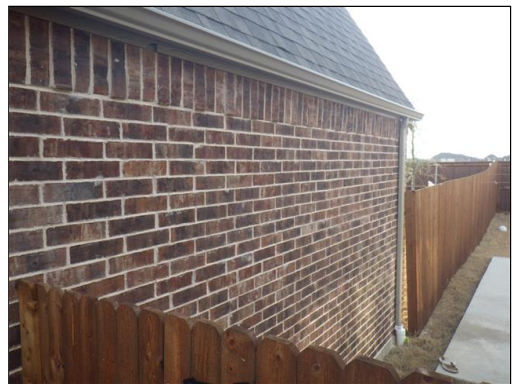
L. Photo 2

(1) The right rear corner of the structure was not accessible due to a locked gate from the adjacent residence. The wall behind the fence was not assessed.

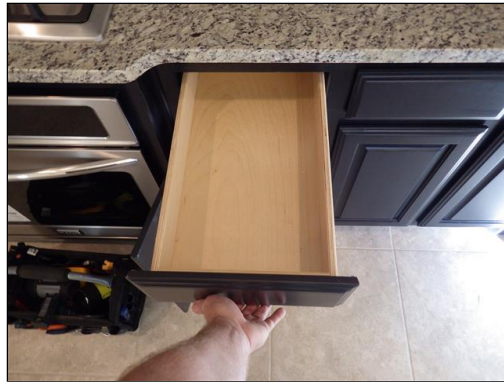
L. Photo 3

(2) There was no stopping point for a drawer to the right of the oven. The drawer could be pulled right out of the cabinet. Recommend repair/adjustment by a qualified contractor.

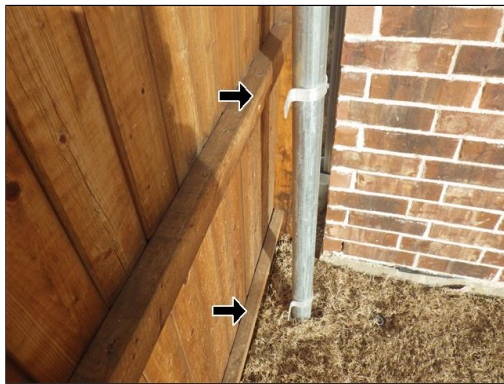
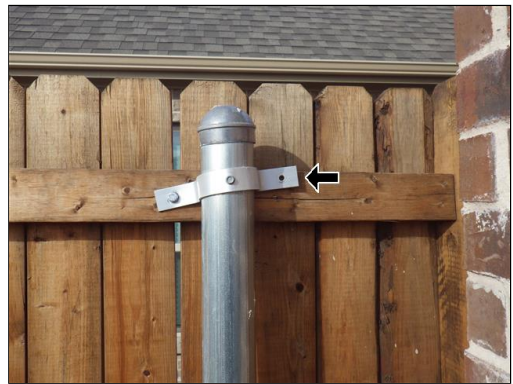
(3) At the right rear of the structure, a post was not adequately secured to support the fence. Recommend repair/adjustment by a qualified contractor.

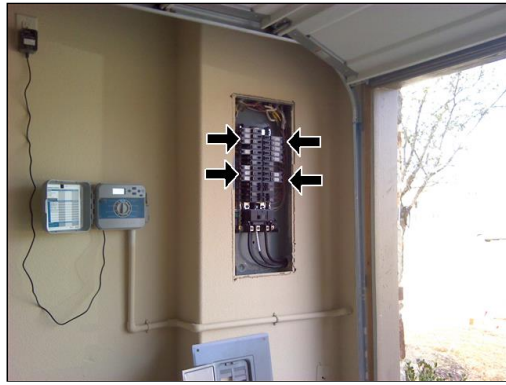
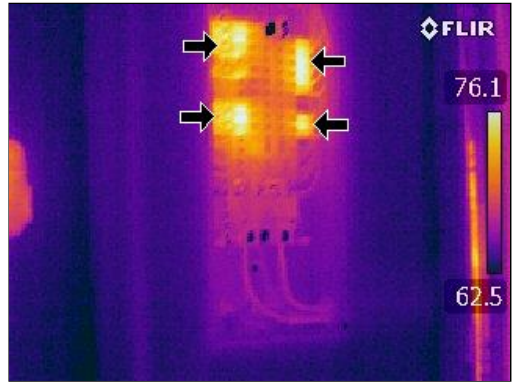
Electrical panel(s) appeared to be performing as intended at time of inspection. A thermal scan of the panel(s) showed an increase in the apparent temperature at panel components such as but not limited to: Arc Fault Circuit Interrupter (AFCI) breakers, Ground Fault Circuit Interrupter (GFCI) breakers, and/or surge protectors. Although the scan showed a higher apparent temperature in comparison to the surrounding breakers, this was considered a normal condition in that these components have integrated circuits that operate at a warmer temperature.

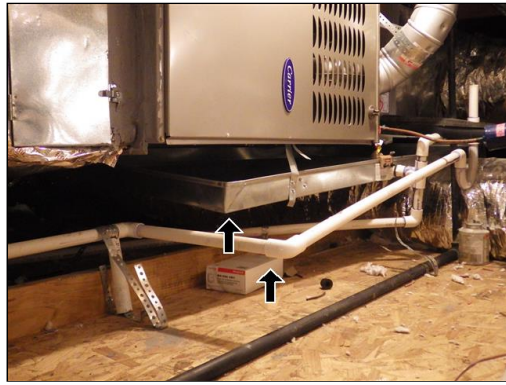
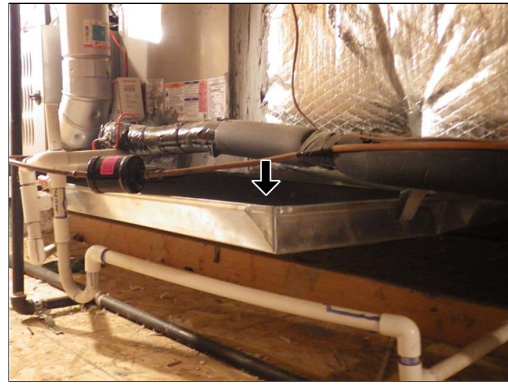
(2) At both cooling evaporator coils in the attic, the secondary condensate drain pans were not properly pitched to the drain lines. This could impede condensate drainage. Also, at the unit to the right of the attic entry, the primary condensate line was running uphill against gravity. It needed additional support. Recommend repair by a qualified HVAC contractor.

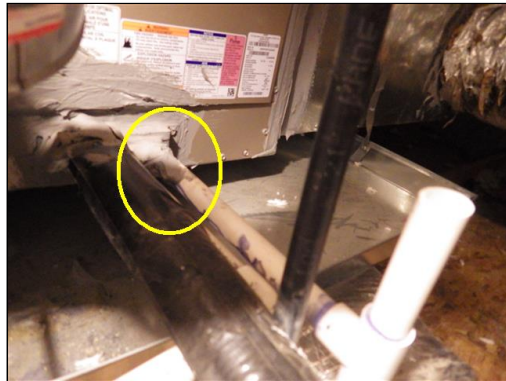
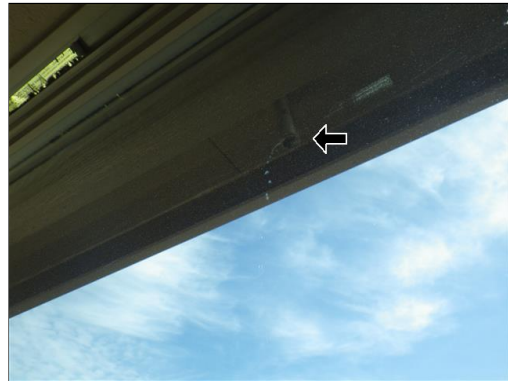
(3) During cooling equipment testing, there was condensate dripping out of a pipe at the left side eave. Further investigation in the attic found that the condensate drain lines at one of the evaporator coils were installed backwards. Recommend repair by a qualified HVAC contractor.

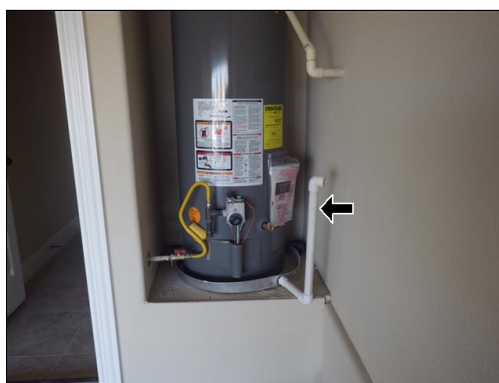
C. Photo 1

(2) The pan drain for the water heater was not yet completed. It should terminate to the exterior.

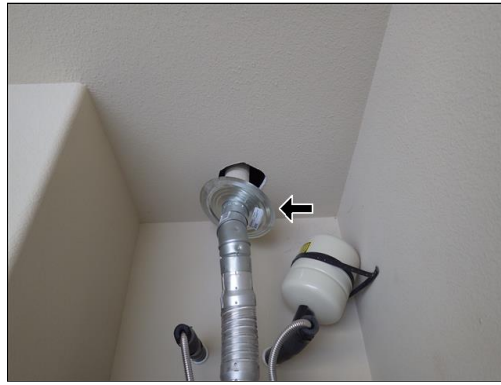
C. Photo 2

(3) The exhaust vent collar(s) had pulled away from the adjacent ceiling. Recommend collar(s) be secured to ensure an effective separation between the garage and the adjacent ceiling.

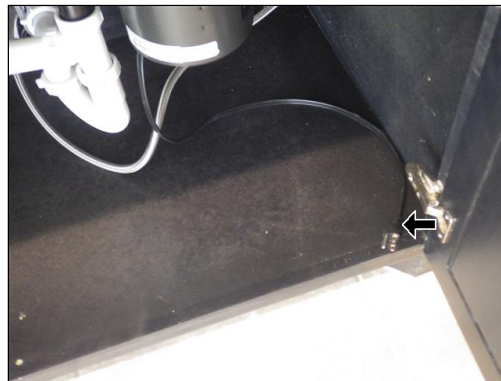
B. Photo 1

The disposer was unplugged at time of the inspection. Further investigation found that the disposer was full of debris.

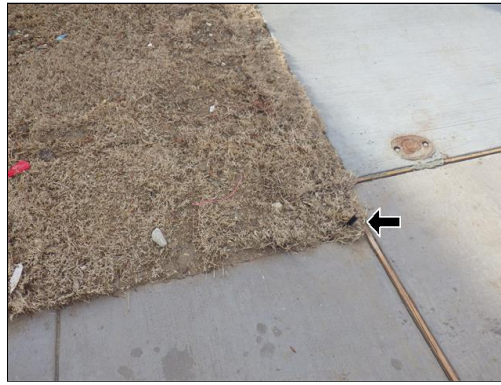
A. Photo 1

(1) There was a head at the left front corner of the driveway that did not put out any water. Recommend repair by a qualified sprinkler system contractor.

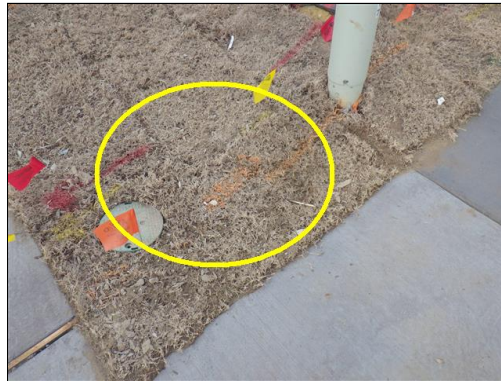
A. Photo 2

(2) To the right front corner of the driveway, the drip system in that area sounded as if it was spraying out an excessive amount of water. There could be an underground drip hose leak. Recommend further evaluation by a qualified sprinkler system contractor.
