Property Condition Report

Date Inspected: 4/5/2023

Property Address: [REDACTED]
Mukwonago, WI 53149

Prepared by: *Quality Inspections L.L.C. dba*
National Property Inspections
8330 Corporate Dr
Mt Pleasant, WI. 53406

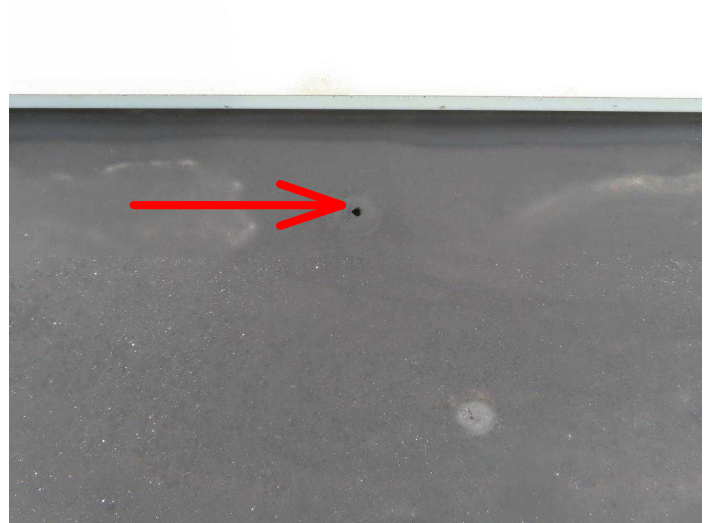
- The roof was walked on and accessed by a ladder on the West side. Not all the rubber roof was visible due to the stone ballast in place. There is evidence of dirt buildup in the field ballast which is typical due to the age of the roof.
- There are sections of thin or missing ballast near the corners.
- The roof flashing into the gutter appears to be pulled away from the edge and could be allowing water to enter behind the gutter and affect the block wall causing water staining and discoloration at interior and exterior block walls throughout the building. There is inadequate flashing present where roof meets parapet walls.
- There is evidence of leaking on the West wall visible on the interior of the shop.
- There is a puncture with a hole at the North side of the roof.

North Puncture

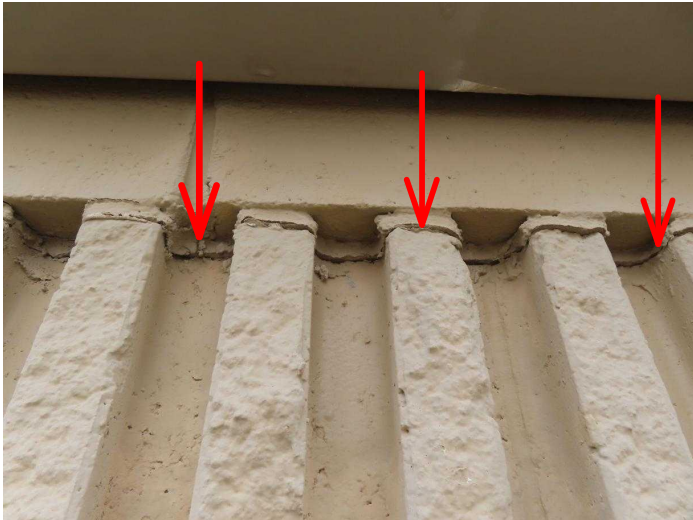
- Concrete block sections had visible active wall staining on the interior and exterior sections of the NE, SW, SE and West walls. See roofing sections for specific notes.
- There are cracked mortar joints under gutters, recommend tuck pointing.

Cracked Mortar Under Gutters

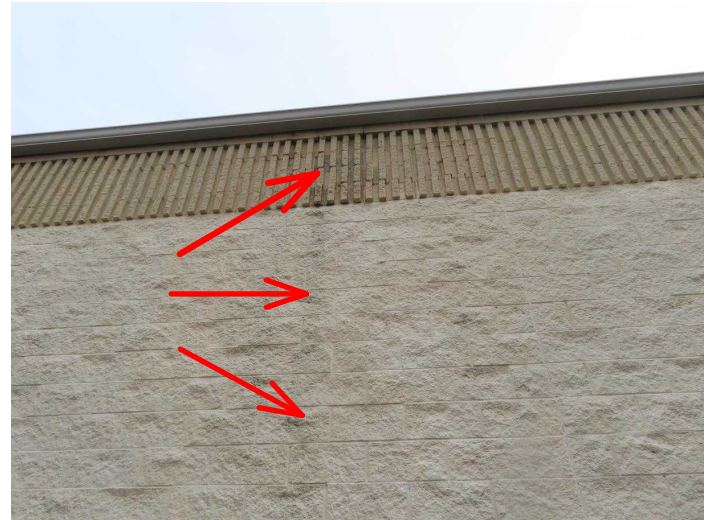
West Water Staining

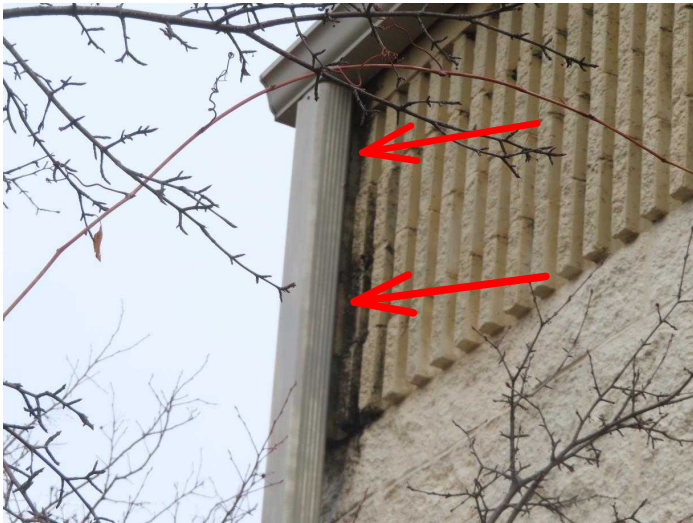
West Discoloration

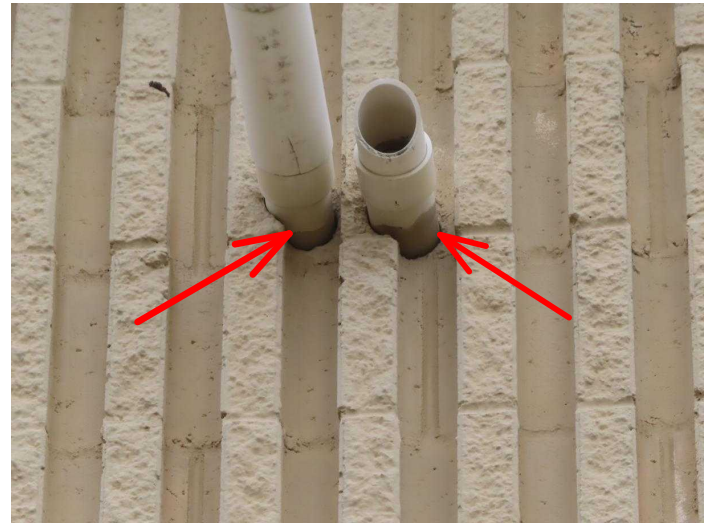
- Recommend seal exhaust vents at exterior.
- The units were not tested for function at the time of inspection.
- The three forced air furnaces appear to be original to the building. Recommend budget for replacement.
- There is PEX present for the hydronic heating under the concrete.

Exhaust Vents Not Sealed

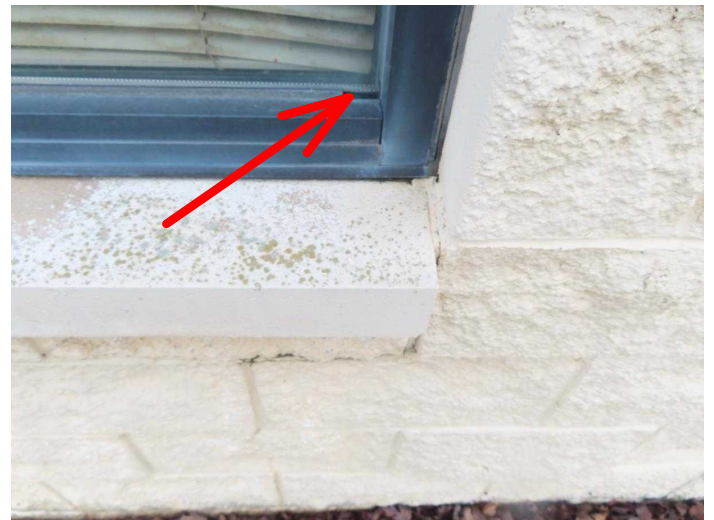
- Most windows are allowing moisture intrusion at the interior, causing discoloration and/ or efflorescence. The rubber butyl tape on the West side fixed windows did not seal the entire bottom edge and is allowing water to affect the block wall beneath the block walls at the office windows at the North side and the large windows on the East. The East wall window is dry rotted. There is a broken IG seal underneath the front awning.
- The East shop door jamb is rusted with damage present.

Gaps In Butyl Tape

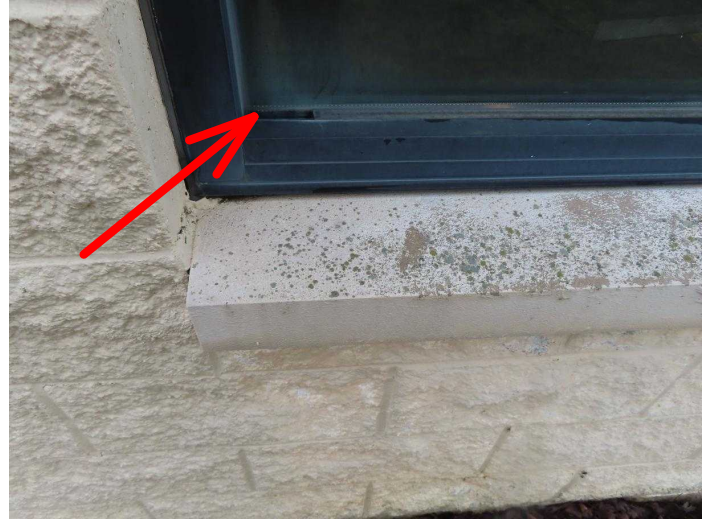
Gaps In Butyl Tape

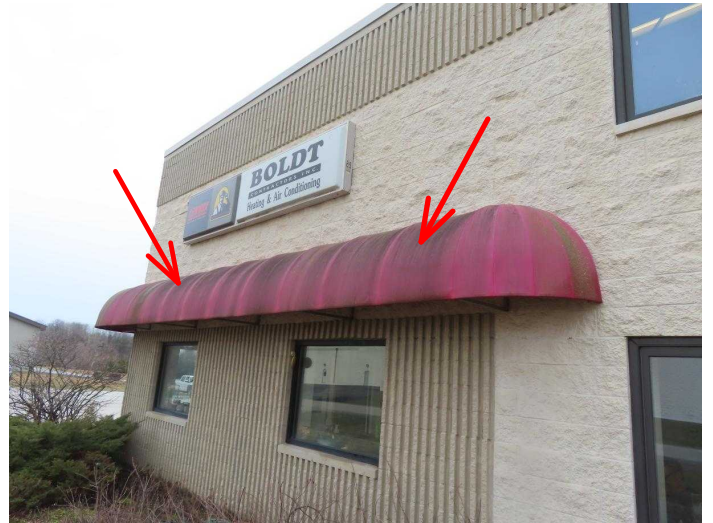
- The loading dock retaining walls are damaged, cracked, and need replacement.
- The loading dock retaining wall metal railings are rusty and deteriorated, recommend replacement.
- Recommend remove or trim back trees and bushes touching the North side of the building.
- The East awning has mildew and staining present.

Mildew and Staining on Awning

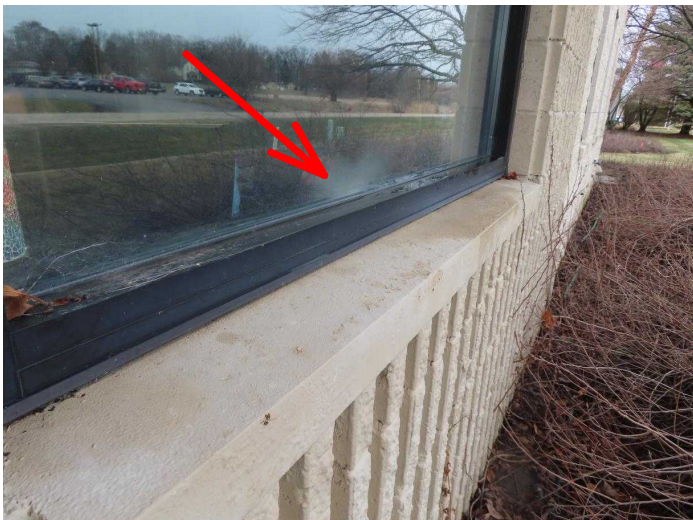
Broken IG Seal

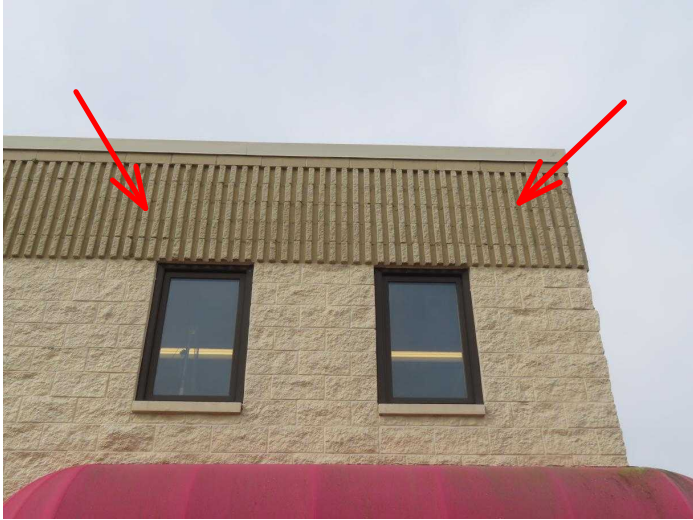
NE Wall Exterior Water Staining

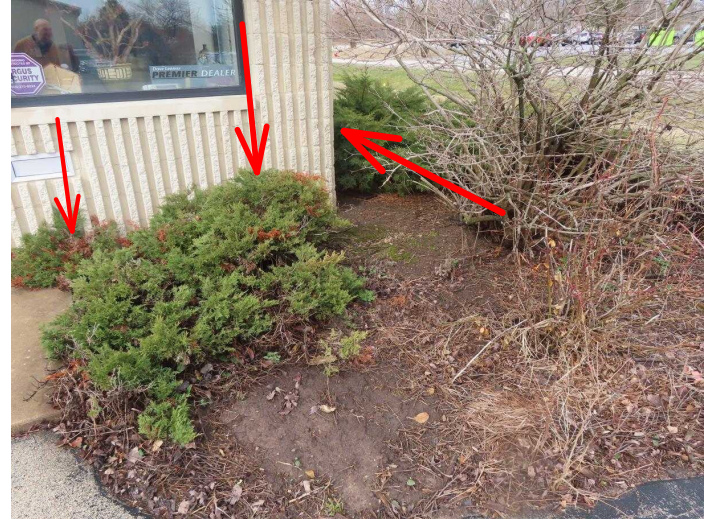
Vegetation At Building

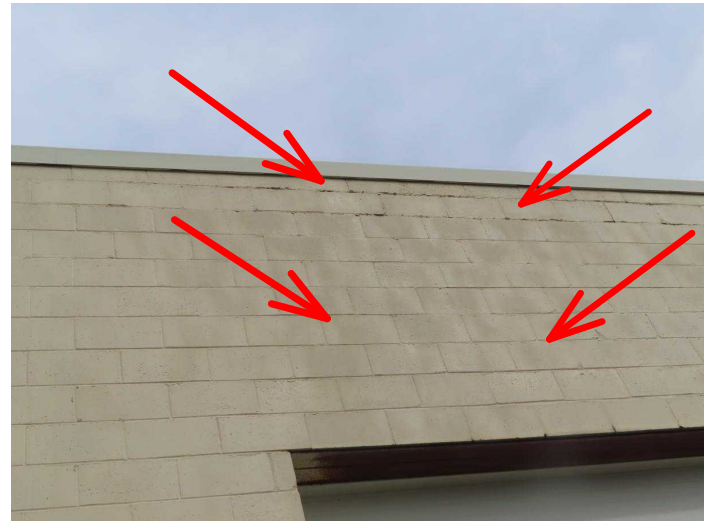
South Block Discoloration

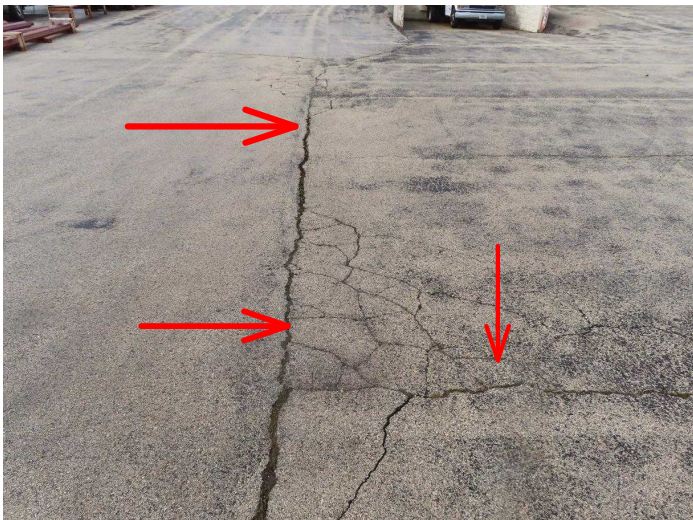
Cracks And Alligatoring

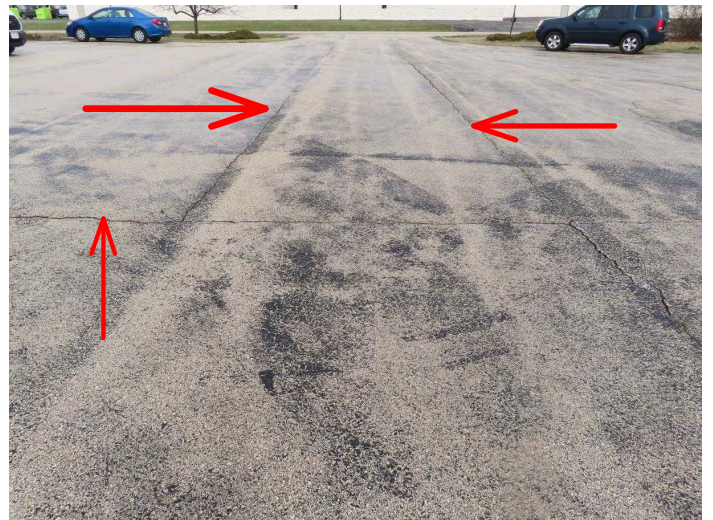
Lot Cracking

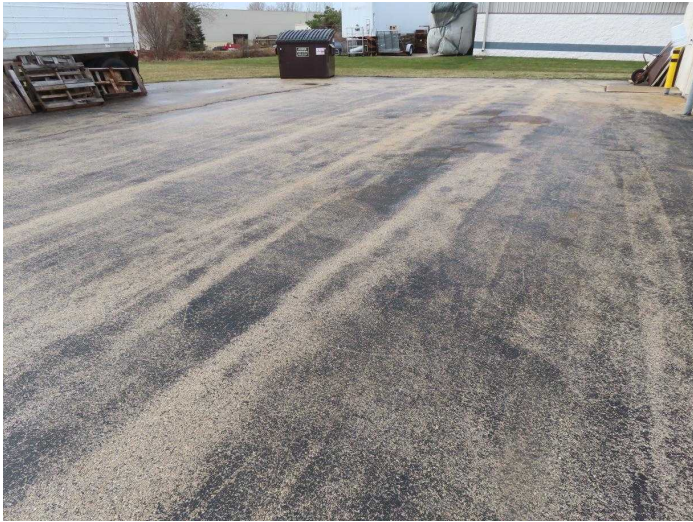
Faded South Lot

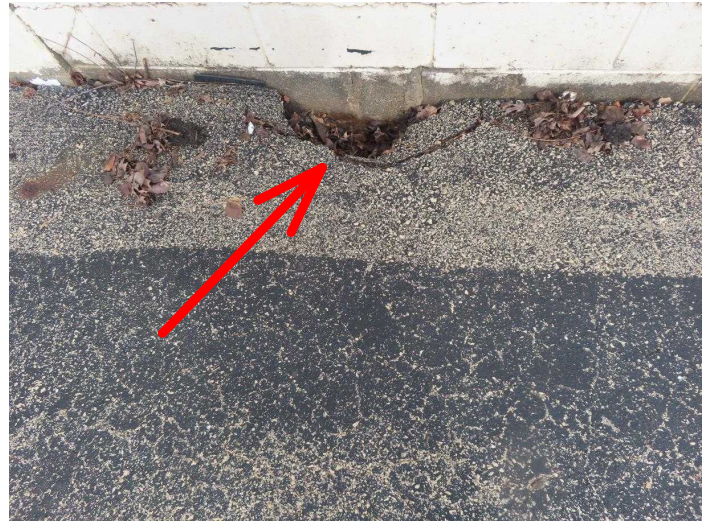
South Lot Sunken Asphalt

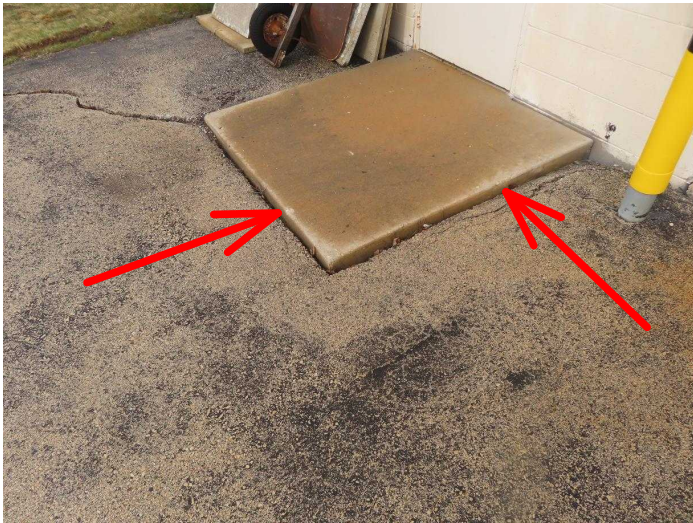
- There were materials and vehicles present. The covered lot areas were not visible for inspection.
- Recommend seal coat and re-stripe asphalt and add appropriate handicapped stalls.
- The East, and South sides of the building lot have a negative slope at the foundation and trip hazards at the concrete sidewalk transitions. There is cracking and alligatoring present which should be sealed/ repaired as needed.
- There are trip hazards at the two concrete stoops at the East entrance doors and South concrete stoop. Recommend repair asphalt to eliminate trip hazards.

South Lot Trip Hazard

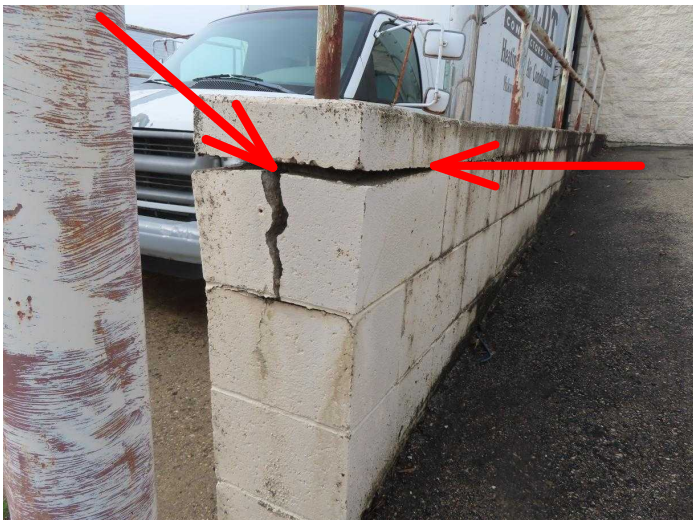
Loading Dock Wall Damage

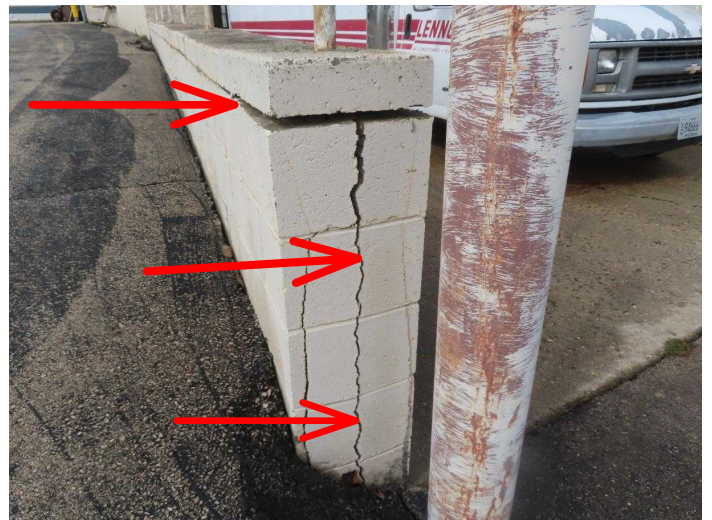
Loading Dock Wall Damage

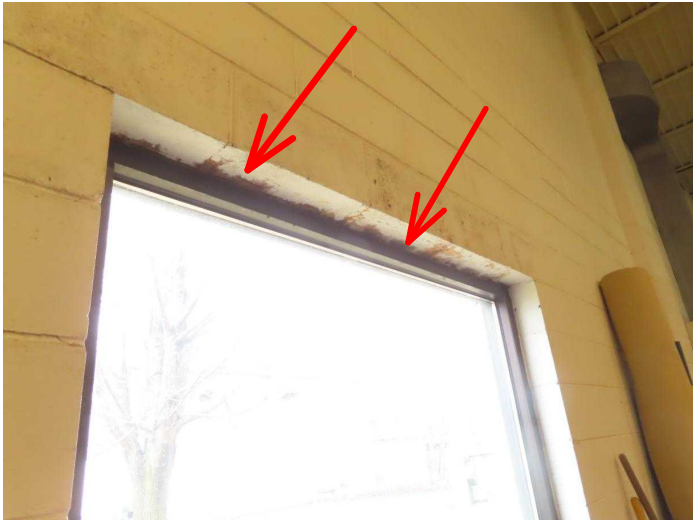
South Wall Water Staining

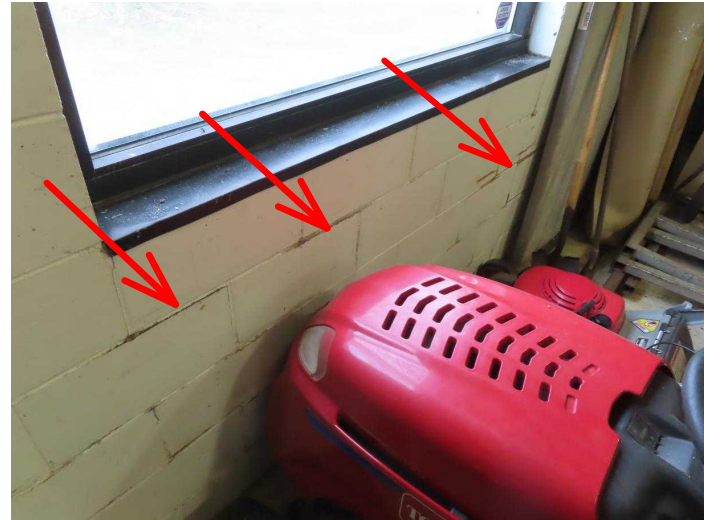
West Wall Water Staining

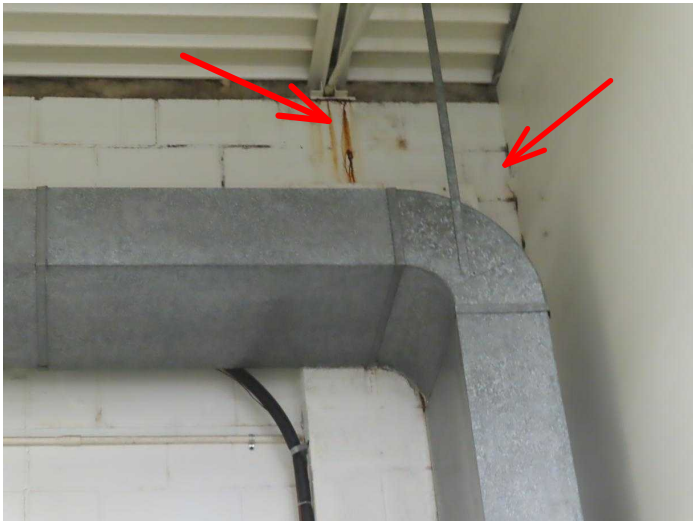
West Wall Water Staining

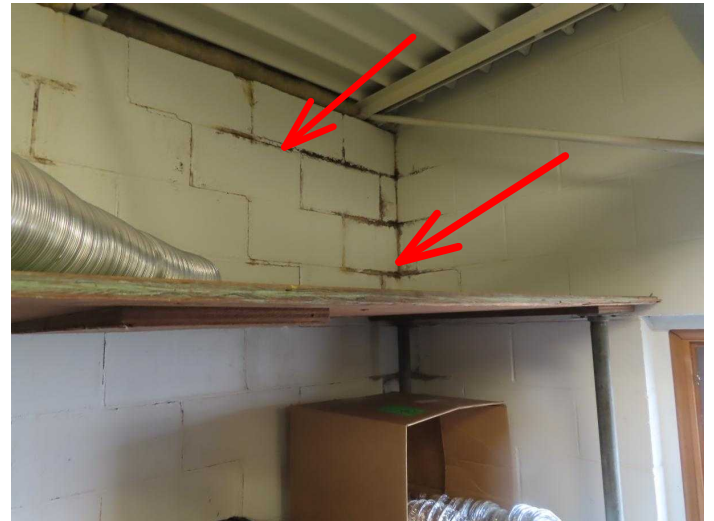
NW Wall Water Staining

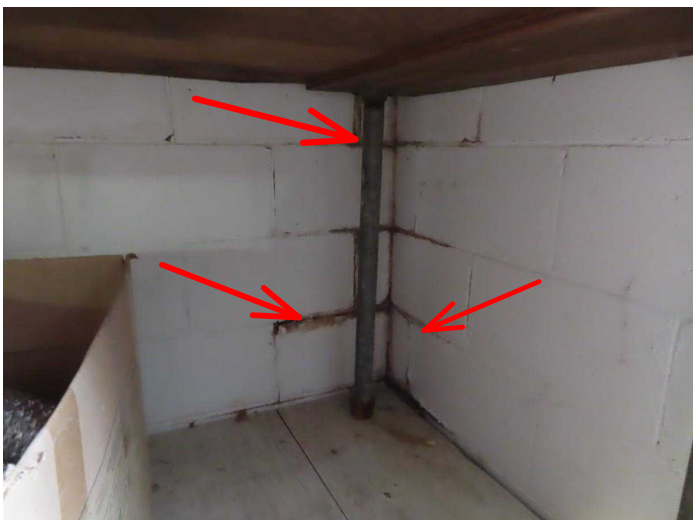
NW Wall Water Staining

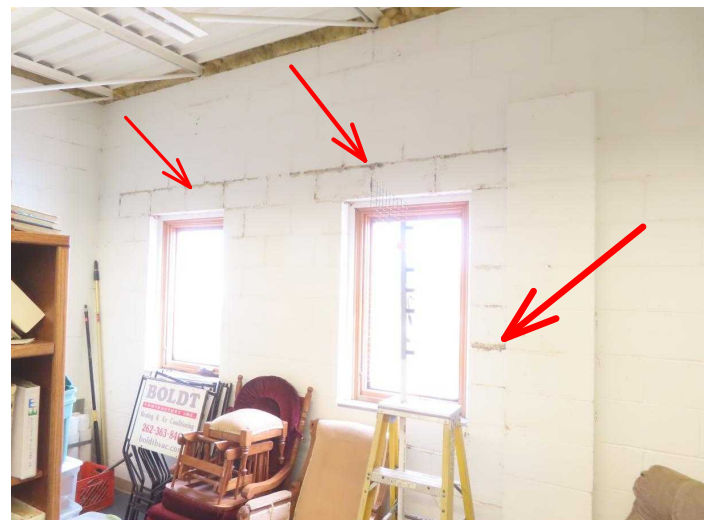
East Wall Water Staining

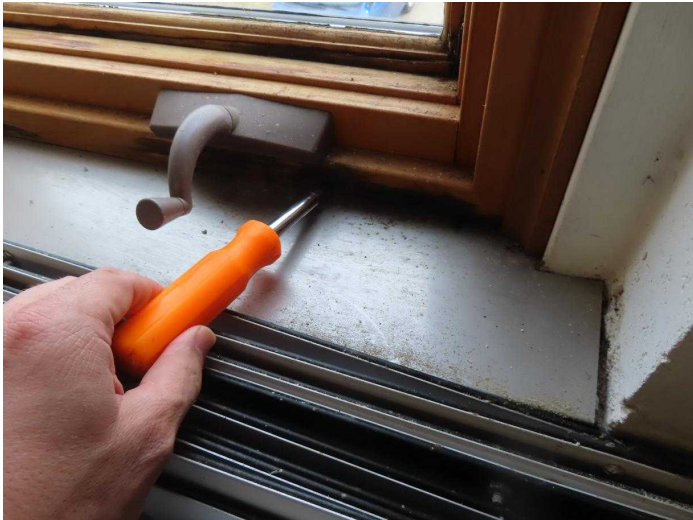
East Wall Dry Rotted Window

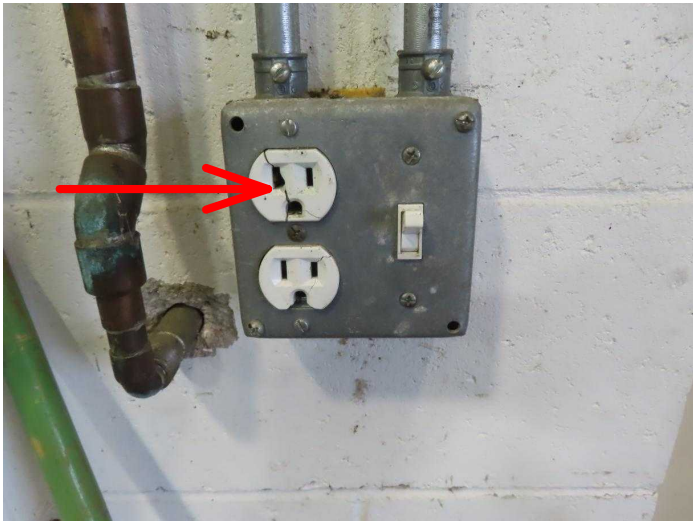
- Detailed load calculations were not performed during the observation. No electrical panel covers were removed at time of inspection.
- There is a damaged outlet on the South wall in the shop.

South Shop Damaged Outlet

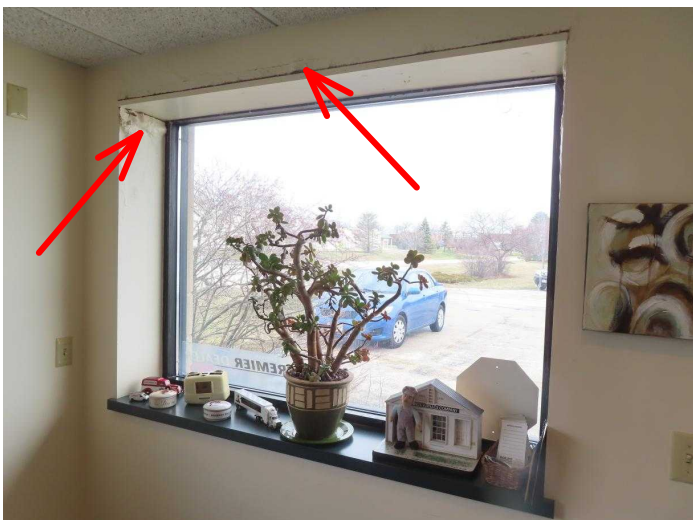
- The unfinished shops racking, tools, storage items, and contents were not inspected. Comments only pertain to the building components.
- The main office East wall surrounding the fixed window has bubbling paint, drywall damage, and active leaking present. There is drywall damage above the North wall window.
- The carpeting is stained and worn throughout the main traffic areas.

East Window Damage

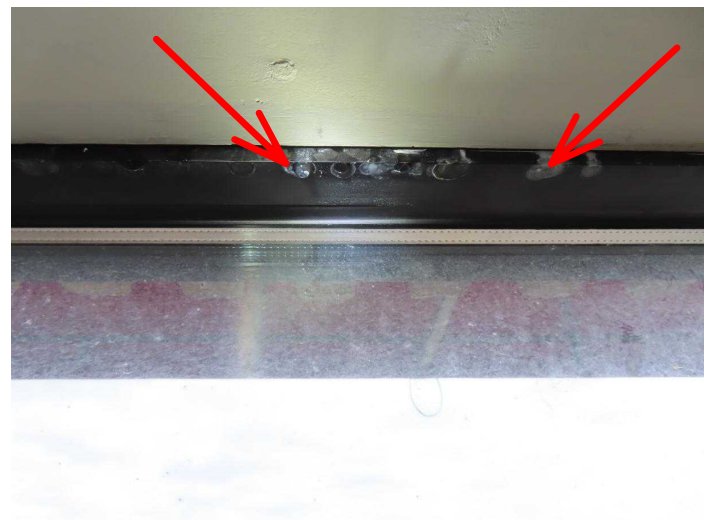
East Window Active Moisture

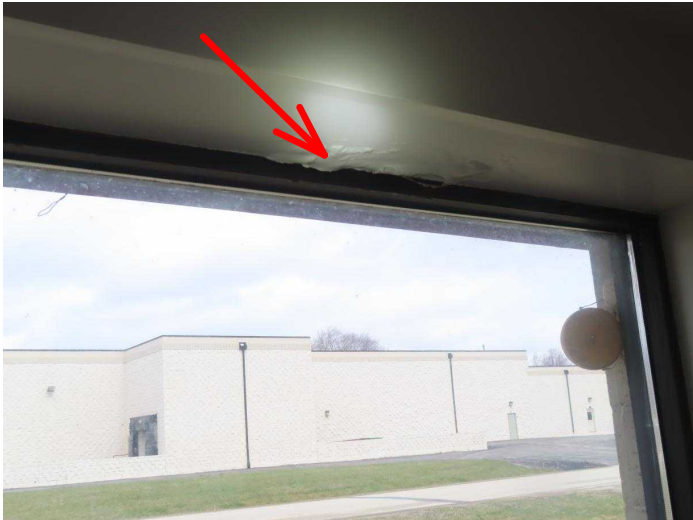
North Window Damage

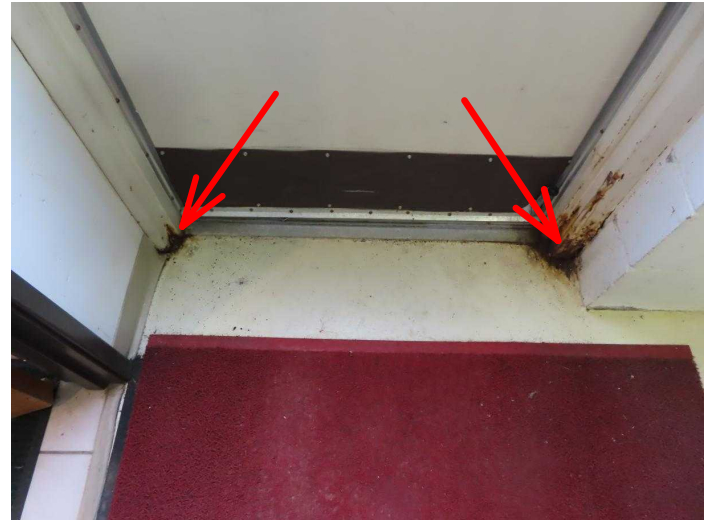
Shop Door Rusty Jamb
