**PROPERTY CONDITION REPORT**

Client(s): Client Name  
 Property Address: 123 Address St  
 Mesa, AZ 85212  
 Realtor: ,  
 Date: 05/27/2024  
 Inspector: Alex Tuia  
 Report #: A052702-24RT

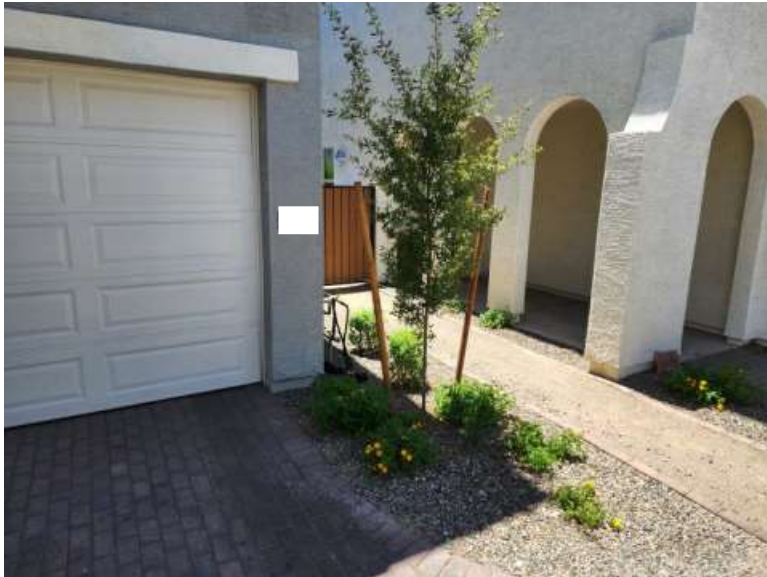
**Monitor:** There is one or more trees planted possibly too close to the stem wall in the front of the house. This is generally not recommended because the roots can possibly damage the stem wall. We recommend that you consult your local nursery (qualified individual about root systems) to determine if the tree is capable of causing any damage. There were no visual signs of any problems at the time of the inspection.

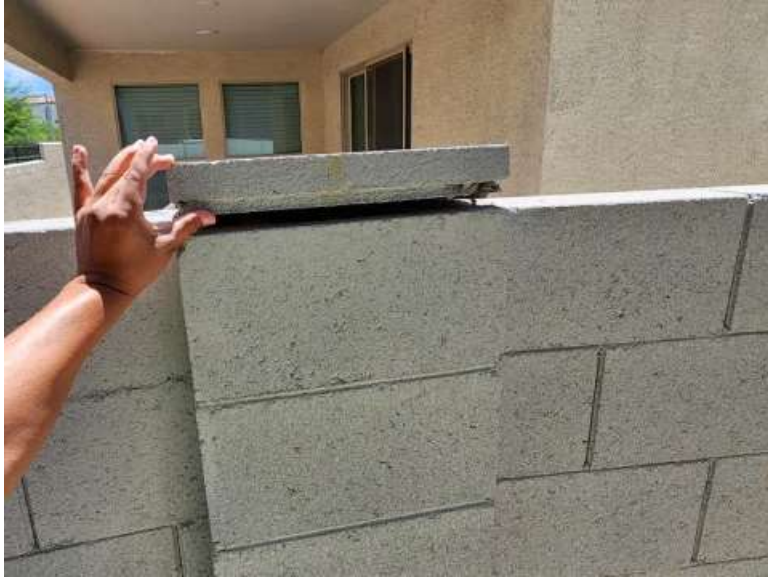
**Repair:** Several of the column caps are loose on the fence around the yard. This should be corrected for the safety of anyone playing around the fence, especially children.

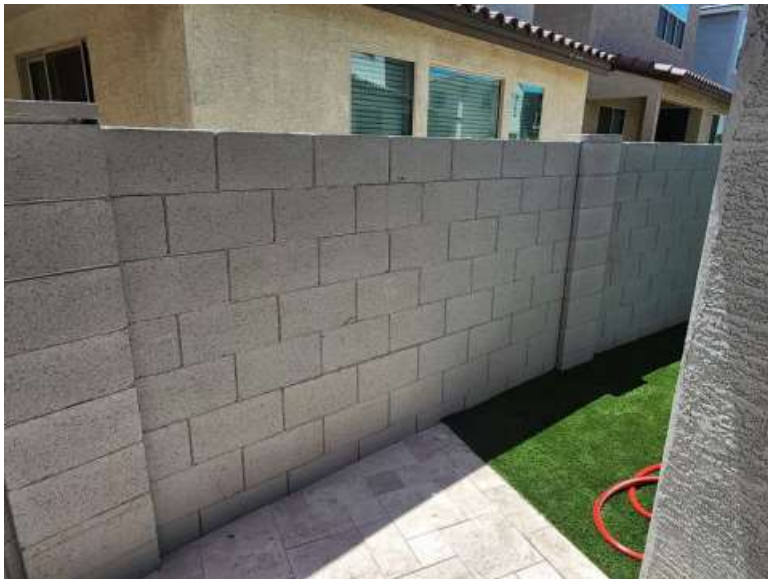
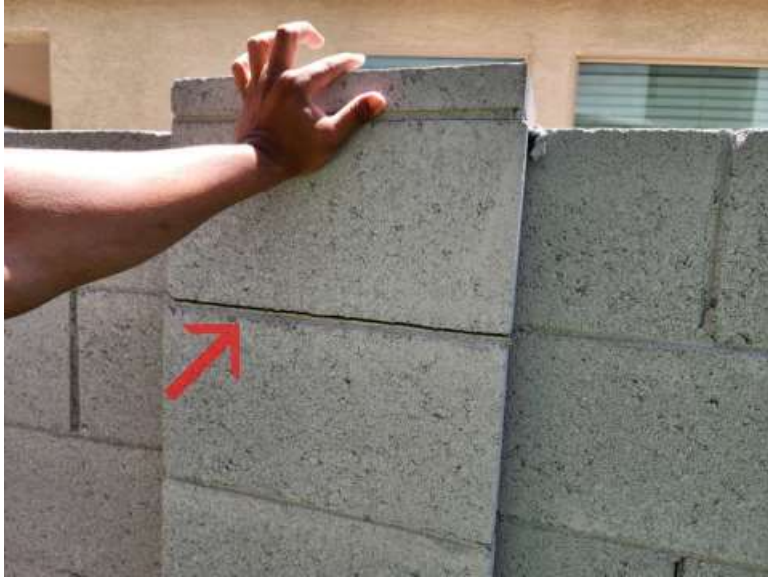
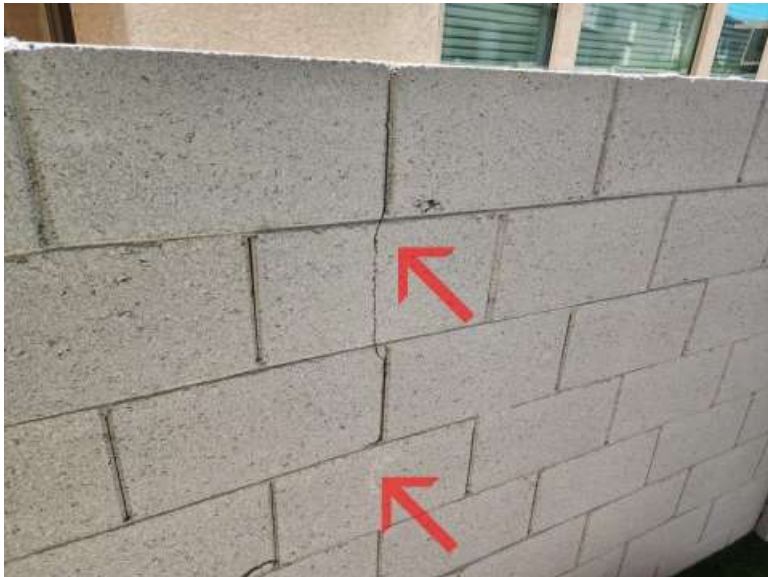
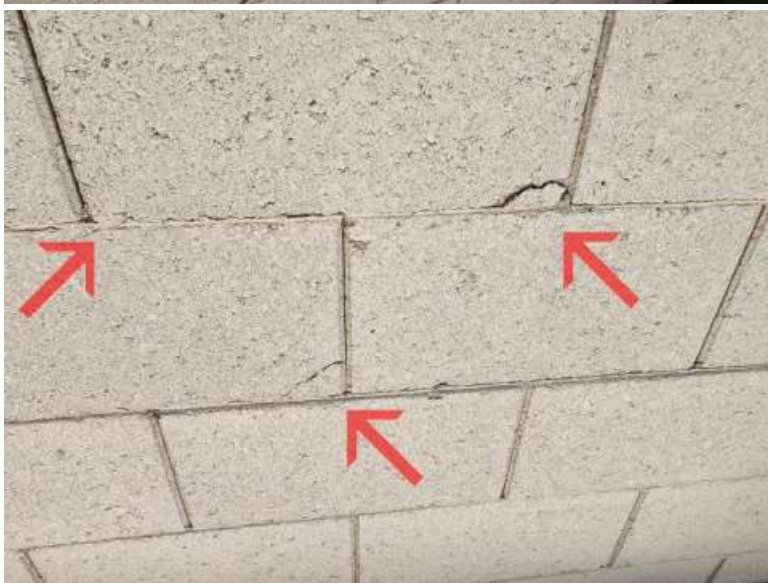
**Safety Concern:** The block wall in the backyard is severely damaged and loose. This is unsafe as it is no longer structurally sound and may fall over. Recommend the block wall be repaired immediately to help prevent any damage to property and to help avoid personal injury.

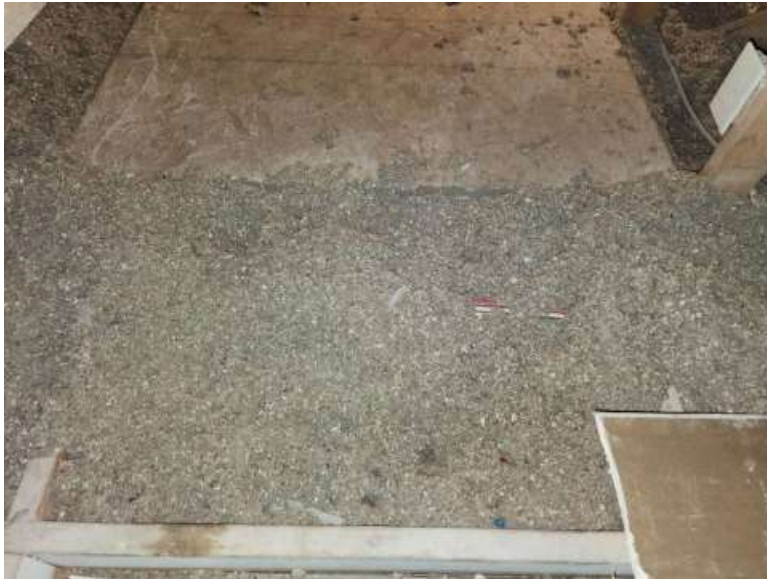
**Repair:** The service platform in the attic does not extend all the way to the access. Recommend it be extended so the furnace is easily accessible to anyone servicing the unit.

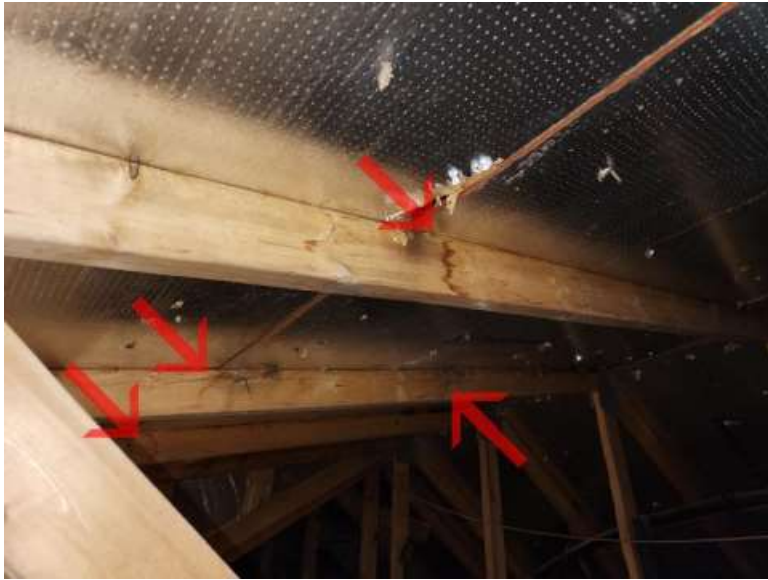
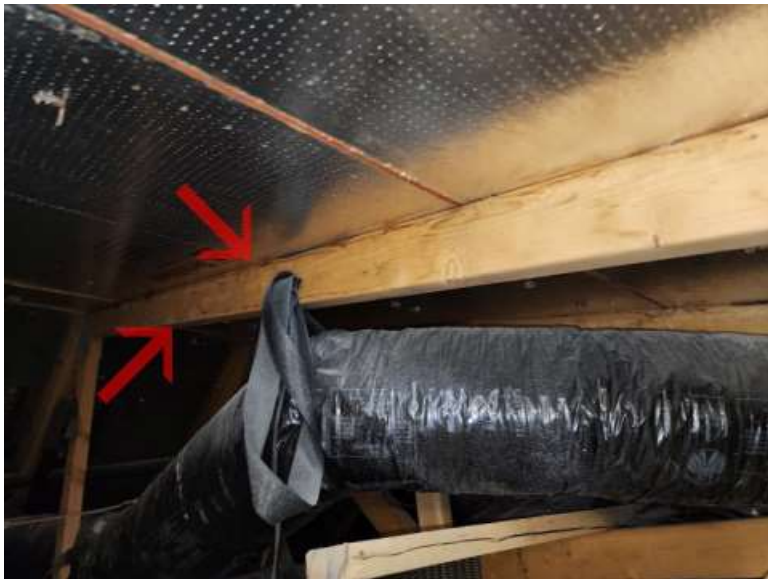
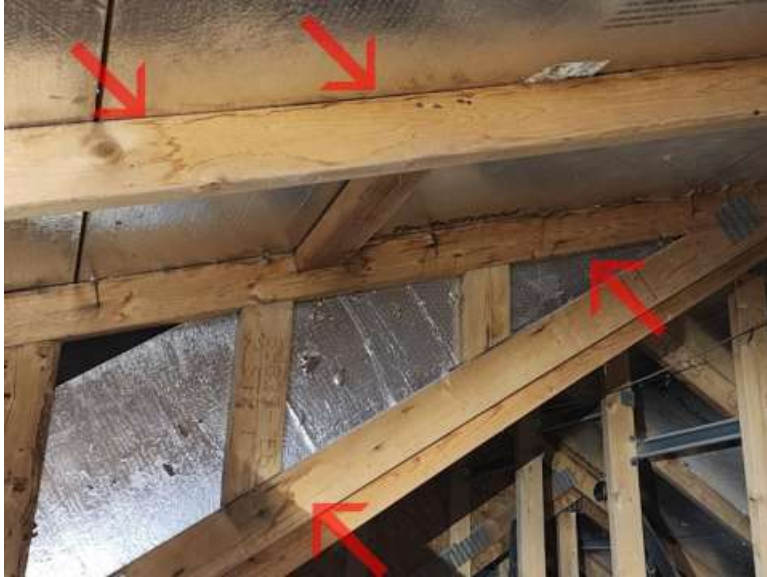
**Further Review:** There is water staining on the underside of the roof decking, trusses or rafters. The stains are not currently wet. The inspector was unable to determine if the noted leaks have been repaired.

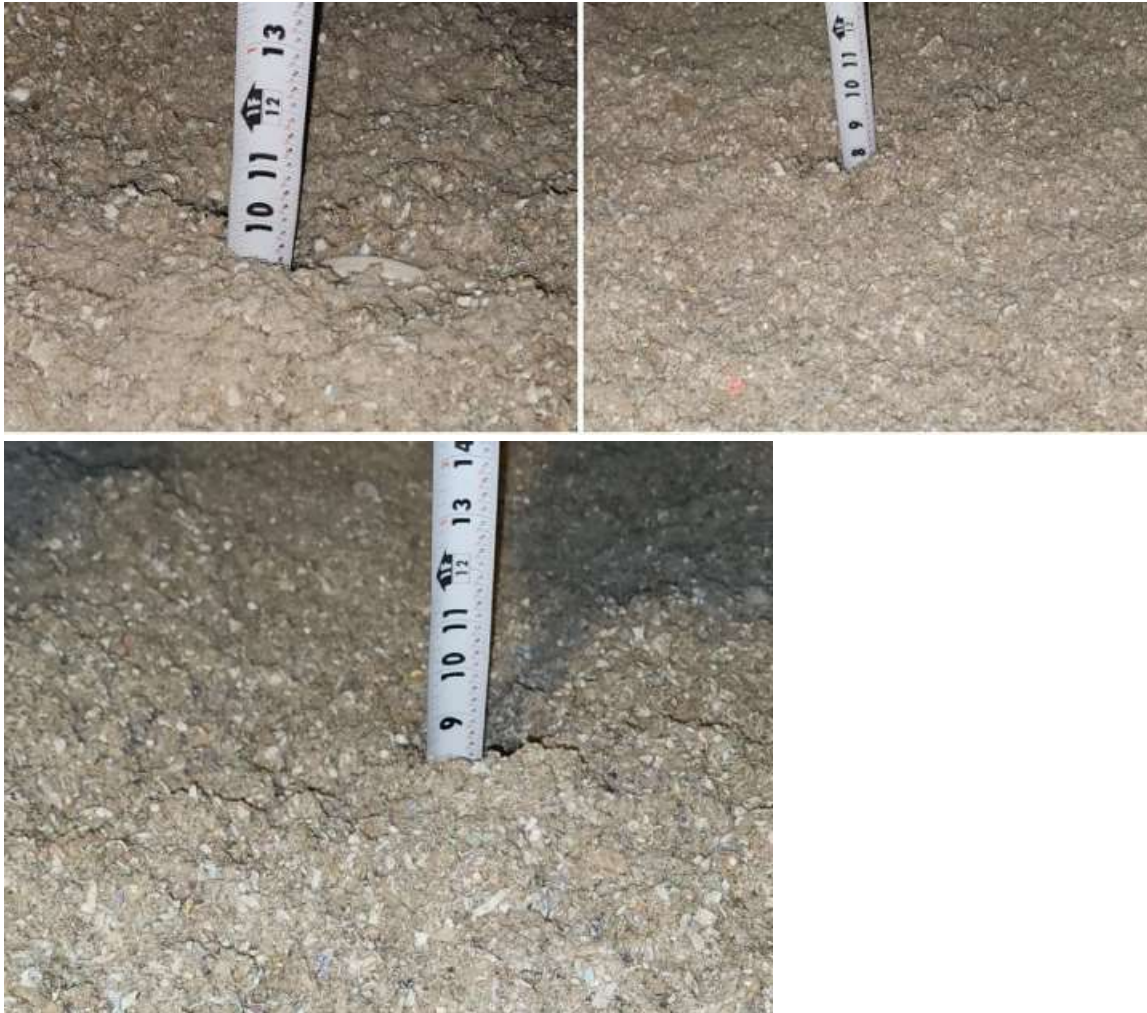
**Note:** The insulation is unevenly distributed and/or low in areas effectively reducing the coverage and R-value. This is not unusual as it gets disturbed from workers and/or was low from original construction. In some cases, the insulation is wind washed because some type of wind diverter was never installed. However, any correction will reduce thermal loss between the home and the attic.

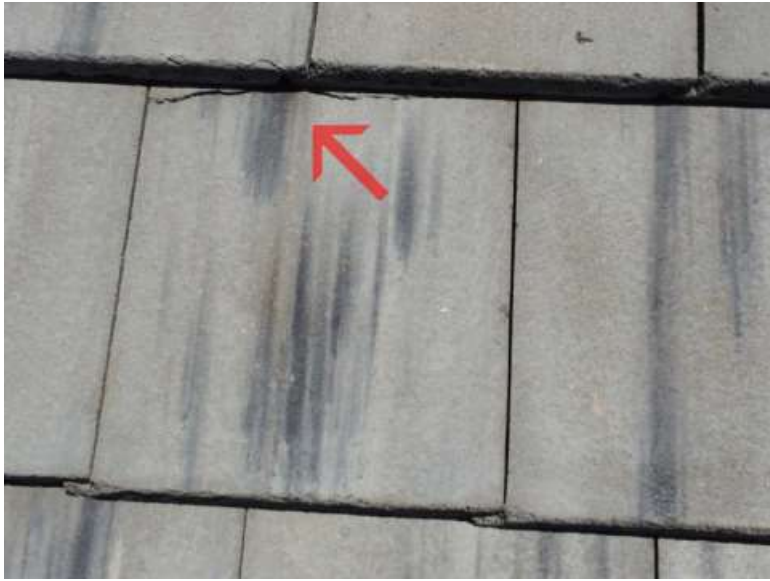
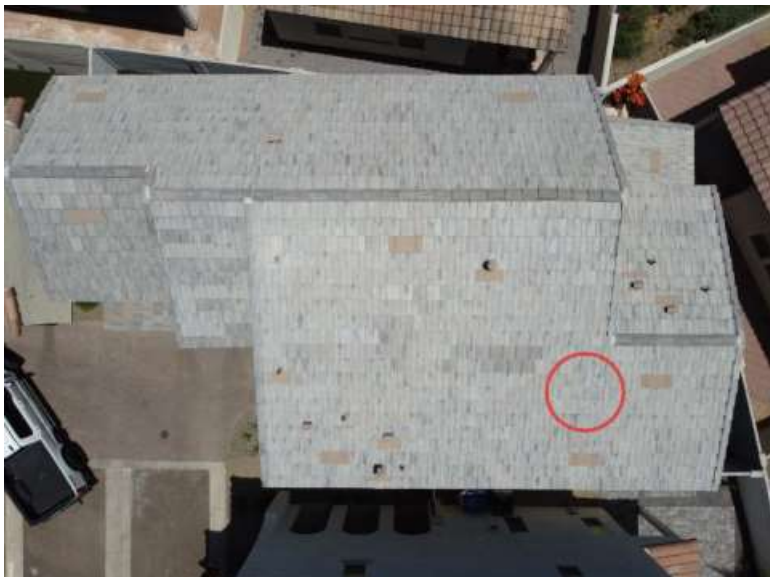
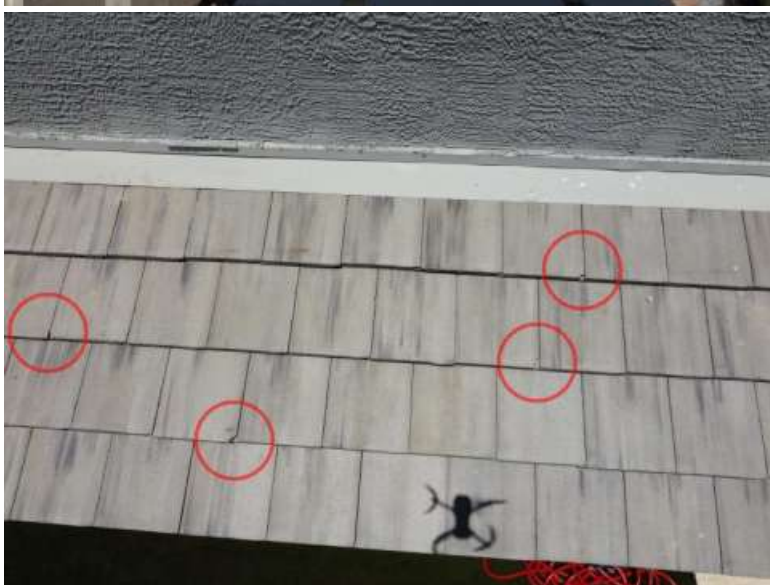
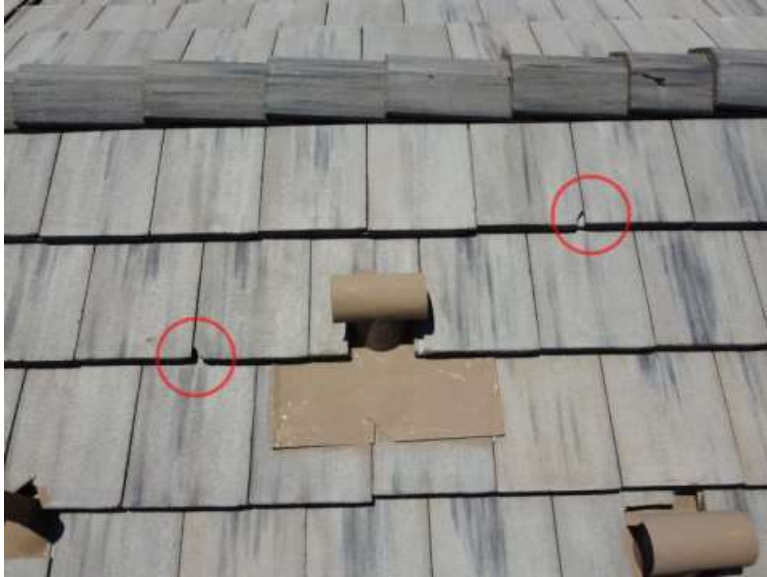
**Repair:** At least one cracked/broken field tile is noted and should be repaired and/or replaced to help prevent deterioration of the underlayment. We recommend repair by a qualified contractor.

**Further Review:** There are several chipped tiles on the roof. Recommend review by a qualified roofing contractor to determine if any repairs/replacement is necessary.

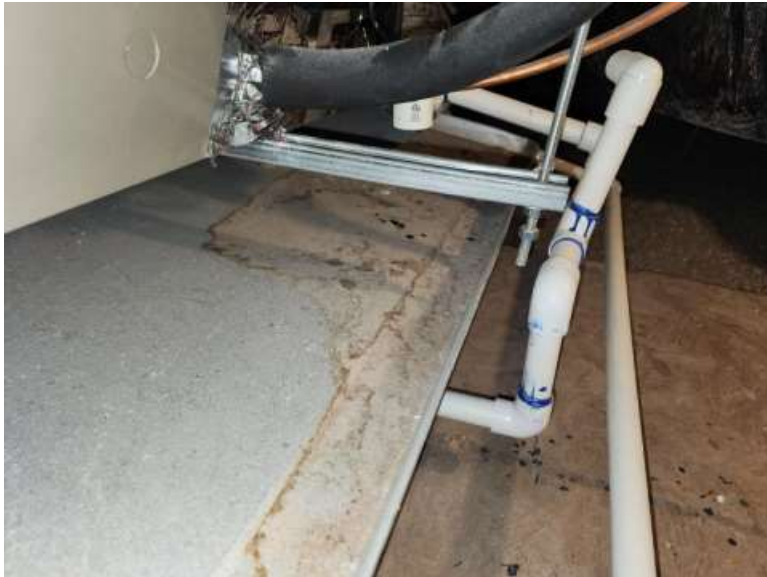
**Further Review:** The secondary drain pan that sits under the evaporative unit that is designed to catch water from the primary condensation pan if there is a problem has stains in it, indicating that the unit had been leaking. Recommend the pan be cleaned and the unit be evaluated by a qualified HVAC technician to determine if repair is needed.
