National Property Inspections

Thursday, January 11, 2018
Inspector
James Dunlap
(360)298-2155
james@gepropertyinspections.net

Pre-Inspection Agreement

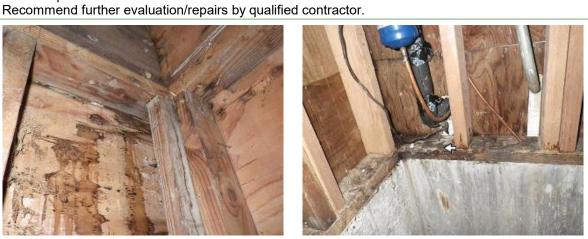
Under Floor Framing & Support: Water stains on framing and sheeting in northwest corner

Vapor barrier was deteriorated and missing in the northwest corner at time of inspection. Recommend installing vapor barrier as needed by qualified contractor. Standing water was noted in southwest crawl space at time of inspection, possibly from negative grading near A/C. Recommend further evaluation/repairs by qualified contractor. Dryer vented to crawl space and duct was damaged. Recommend further evaluation/repairs by qualified contractor. Insulation had fallen down underneath south side sun room. Recommend remove/replace insulation as needed by qualified contractor.
