NATIONAL PROPERTY INSPECTIONS | SAN DIEGO

RESIDENTIAL INSPECTION

1234 Main St.
La Jolla, ca 92037

Buyer Name
05/27/2019 9:00AM

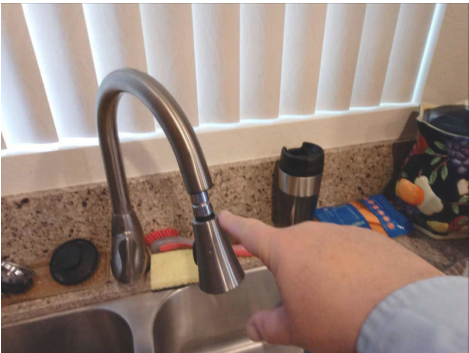
2.3.1 Sink

The faucet extension hose does not fully retract unless forced into place. This is not per design. I'd recommend that the hose weight under the sink be adjusted until it functions properly.

Contact a qualified plumbing contractor.

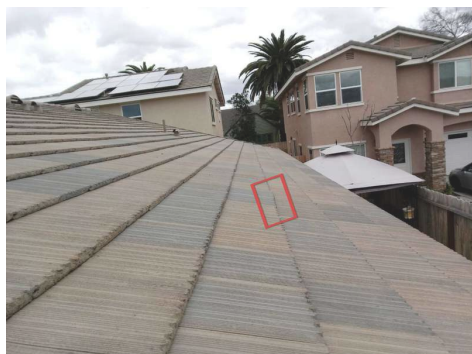
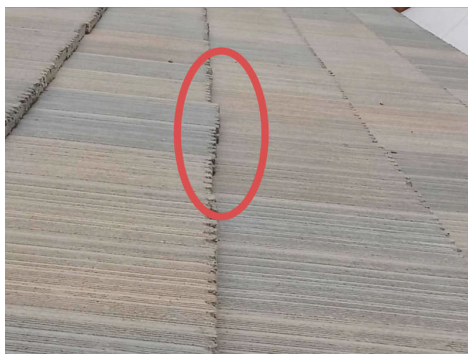
POTENTIALLY LOOSE CONCRETE TILE

Roof tile appears to have moved since installation. It may not be nailed correctly or may have come loose. I am unable to confirm situation during this visual inspection. I'd recommend further review by a qualified licensed roofing contractor.

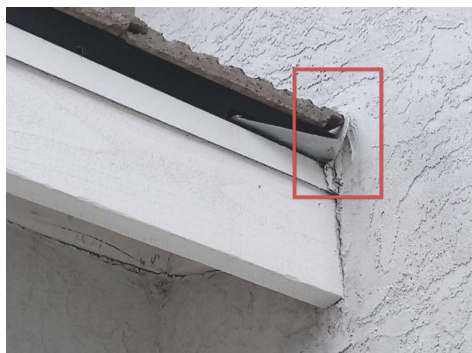
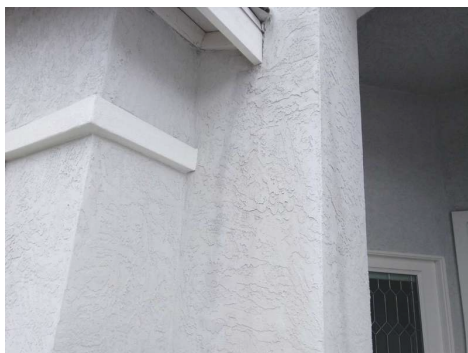
3.2.1 Roof Flashing

The kick-out flashing appears too short in places to perform as intended. The current flashing seems to terminate directly over the edge flashing. General practices recommend that a longer section of flashing be placed at the end of the roof flashing to direct the water away from the stucco as there is stucco staining present at the time of the inspection indicating water is running down the stucco. This is especially important when no gutters are present. I'd recommend a larger/longer kick-out flashing be added. Here's a great YouTube video that explains why and how to install one. [Kick-Out Flashing Video](#)

Stucco Discoloration & Staining Present

I'd also recommend the discolored stucco be either repaired or replaced so as to eliminate the caused staining.

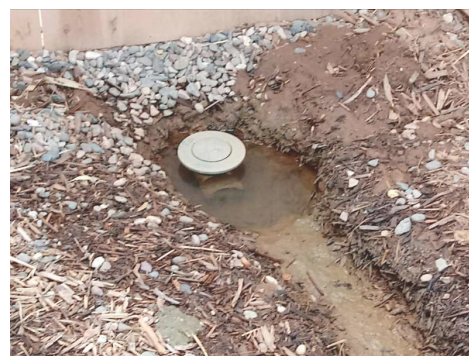
4.1.2 Topography

Standing water observed, which indicates poor drainage and/or grading. Please see the other sections herein for further information. [Here is a resource](#) on dealing with standing water in your yard.

Contact a qualified landscaping contractor

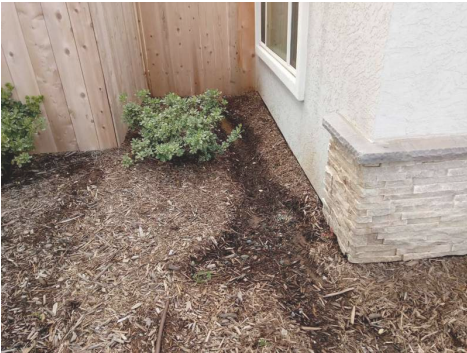
4.1.3 Topography

This has caused drainage problems during rainfall which would have caused water intrusion problems had the homeowner not dug trenches and added temporary landscape drains. I'd recommend proper repair be done by a qualified, licensed landscape contractor to insure water drains fully and quickly so as not to cause further damage and potentially permit water to invade the premises.

Homeowner's Temporary Solution to a Permanent Landscape Drainage Problem

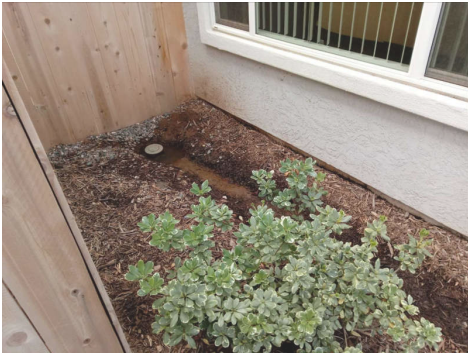
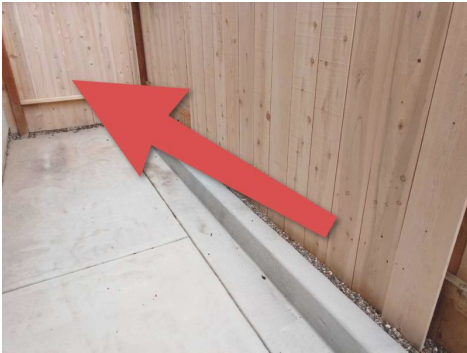
Homeowner's Solution to Major Landscape Drainage Problem was to Hardscape the Area and Install a Curb.

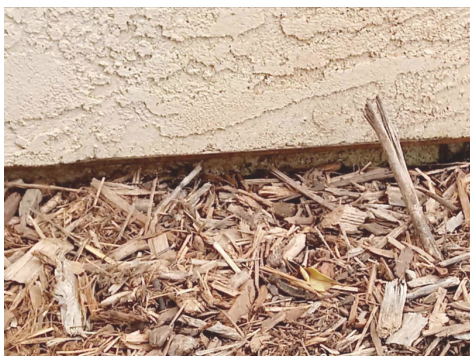
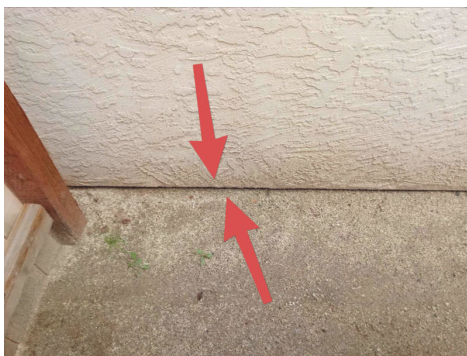
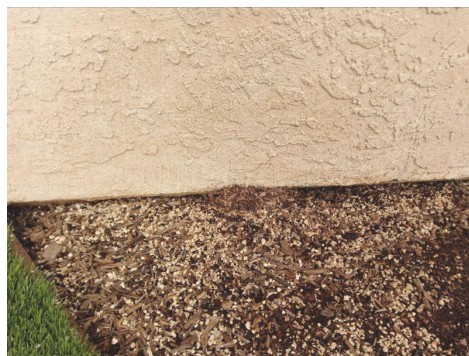
4.3.1 Siding, Flashing & Trim

Noted poor earth to siding clearance at various locations around the house. There should always be a few inches of clearance between the bottom of the stucco and top of final grade (including mulch) to help prevent moisture intrusion of the siding and permit the stucco drip screed at bottom edge of stucco siding to allow water that did penetrate the stucco to escape through the drip screed as designed. Though this IS NOT a termite inspection, this condition will most likely provide a pathway for pests to enter the home.

Typically you'd expect to see at least 2" clearance for concrete, and a minimum of 4" for soil. I'd recommend that soil be removed as much as possible to provide as much space at bottom of stucco and provide some type of drainage system to accommodate water removal from next to house. I'd also recommend consultation with a professional, licensed landscape contractor to insure this issue is correctly resolved.

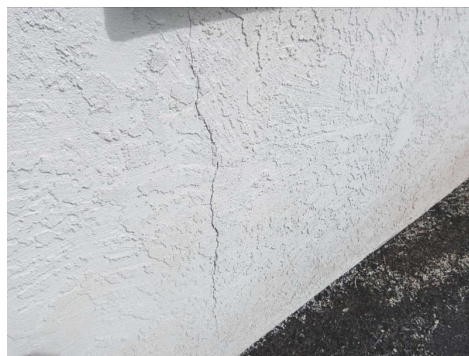
4.3.2 Siding, Flashing & Trim

Moderate cracking was observed at one or more points on the exterior. This can be the result of poor original compaction of soil at the time of construction or excess moisture in the underlying soil or just a superficial shrinkage crack. There is no way to know at this point. This may get worse over time. I'd recommend this crack be closely monitored to determine if the crack is stable or expanding. I recommend this be revisited in a year or I'd recommend consulting with a structural engineer and/or soil expert.

Recommend monitoring.

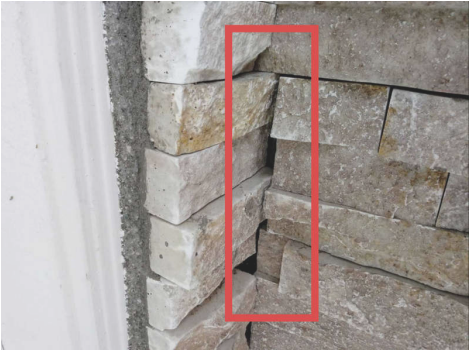
4.3.3 Siding, Flashing & Trim

Openings in Stone Veneer may allow pests and water to get behind the Veneer and cause damage. I'd recommend removal and re-installation of the the stone veneer without holes.

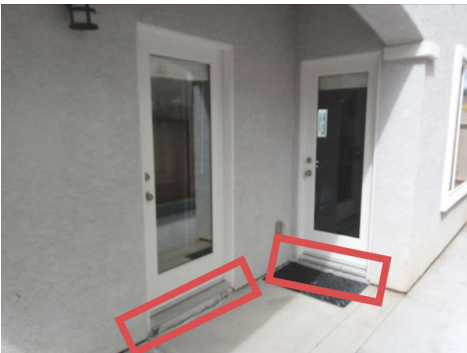
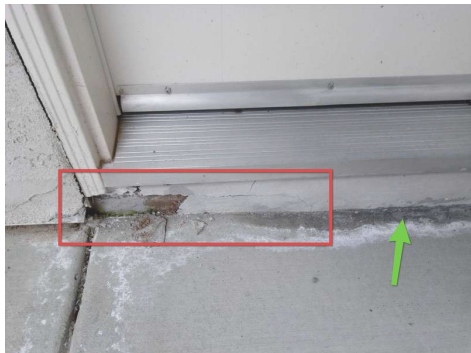
4.5.1 Exterior Doors

Both patio door sills have been compromised and require immediate attention. In one of the photos you can see exposed wood which is damp from the elements. The other door sill/threshold is flaking and discolored possibly due to poor adhesion, poor workmanship, moisture intrusion or a combination of factors. Though it doesn't appear to be structural at this time, I'd recommend repair of the sill plates of both patio doors prior to them rotting away in the near future. Close attention should be paid to the existing condition of the wood sills as they may already need replacement.

Red Rectangle shows spalling occurring of parge coat & exposing damp sill plate. Green arrow shows moisture damage from pooling water.

Contact a stucco repair contractor

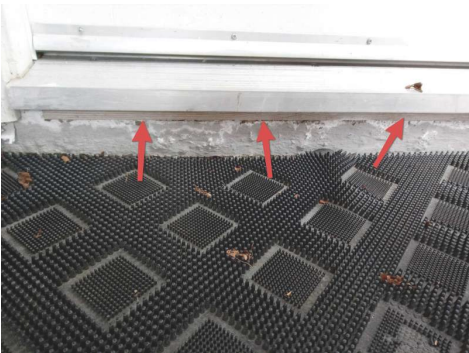
Exposed wood sill plate and messy repair.

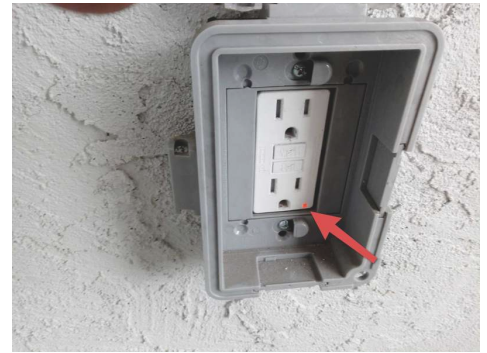
At the time of the inspection the exterior outlets were tripped or off and could not be reset. According to the homeowner this has occurred several times before, and each time the device was replaced. I'd recommend that a qualified licensed electrician inspect the connections and the wiring. If this issue occurs again, it is strongly recommended that all new wire be pulled into every exterior outlet.

Contact a qualified electrical contractor.

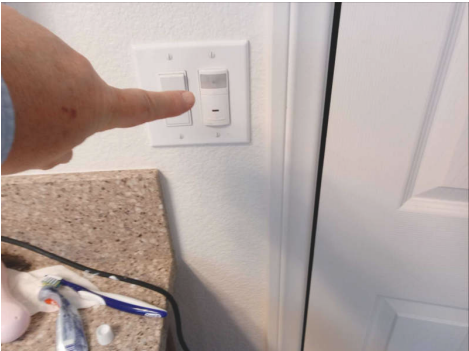
11.5.1 Lighting Fixtures, Switches & Receptacles

Photo-eye sensor light switch turns on fine but it takes over 1/2 hour to automatically turn off once all movement has ceased. This seems like it may be a malfunctioning relay/sensor and should be replaced.

Contact a qualified electrical contractor.

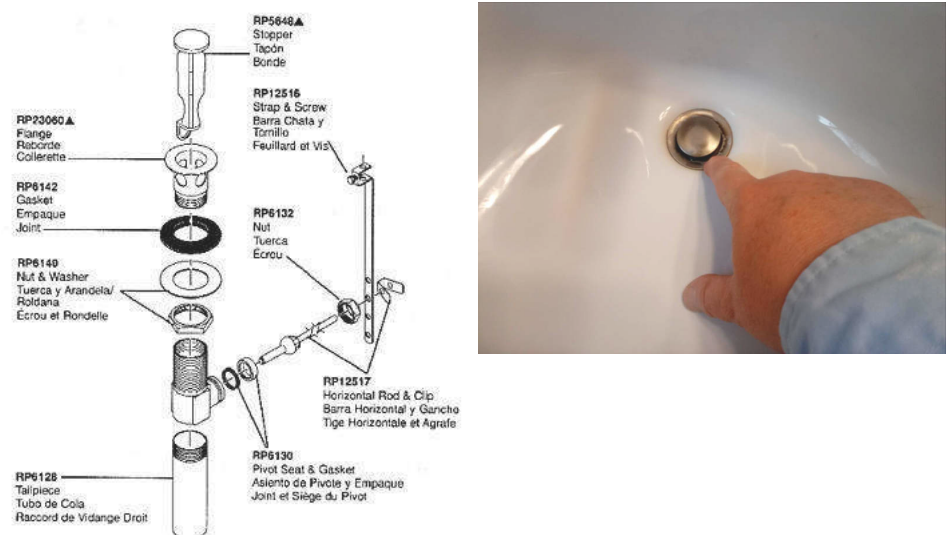
11.8.1 Vanity /Sink & Fixtures

The sink drain flange assembly between sink and underneath is not secured. It's recommend that once the flange has been removed that the missing plumbers putty be installed and then tightened back up. As it is now, water can easily drip under sink and cause damage.

Contact a qualified plumbing contractor.

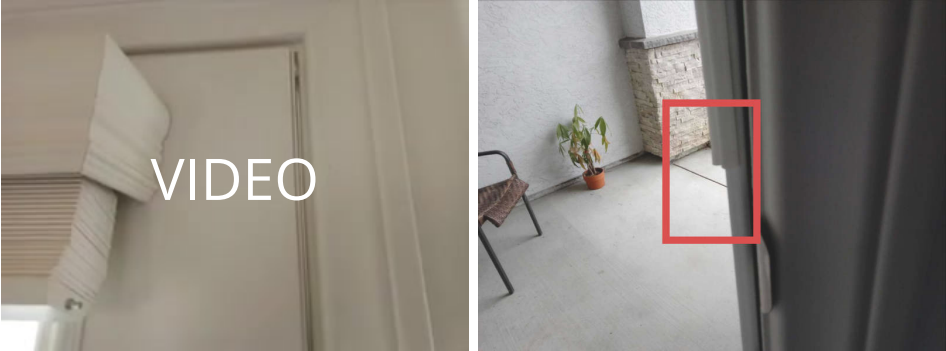
The weatherstripping at the door was not air-tight. One or more gaps could result in energy loss. The homeowner has tried to remedy the situation by adding plastic strips on top of existing stripping. Below is a video with sound where you can clearly hear the air coming thru the door opening observed when whole house fan is used to make the point of air movement.

I'd recommend a proper repair be made so a piece of paper can not be pulled from the door when it is closed. This will insure the proper tightness has been achieved.

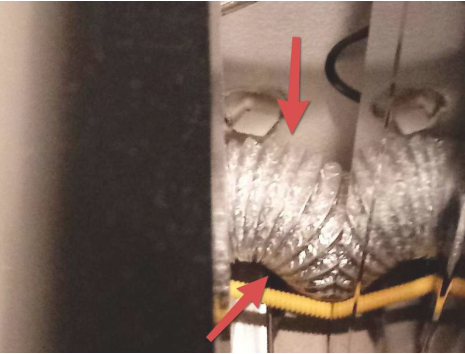
14.2.1 Dryer Vent & Exhaust Systems

Dryer vent hose is made of foil or plastic fabric wrapped around a wire spiral and is not intended nor recommended by the manufacturer to be used for this purpose. These have been known to catch lint, get hot, melt and/or catch fire. I recommend installation of the proper type of metal flex pipe as recommended by dryer manufacturer by a licensed, qualified appliance repair person.

Foil Ducting Present

Recommendation
Contact a qualified appliance repair professional.

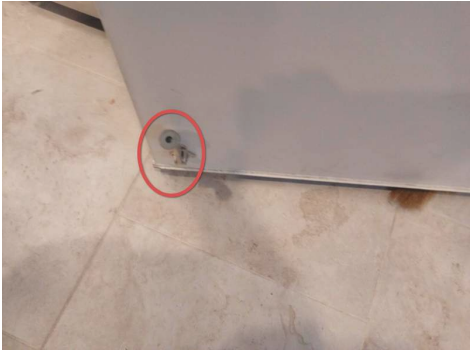
A kickstop was installed on fire door between garage and living quarters. The door should be able to fully close and latch on its own at all times without impediment. I'd recommend the doorstop be removed.

Recommendation
Recommended DIY Project
