Southwest Virginia Property Inspections, LLC DBA National Property Inspections

Inspection Date:
07/06/2018

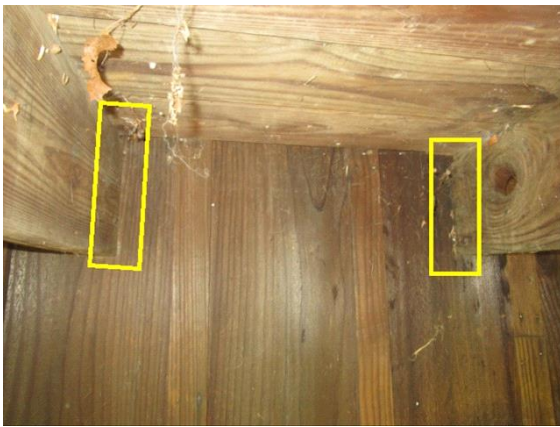
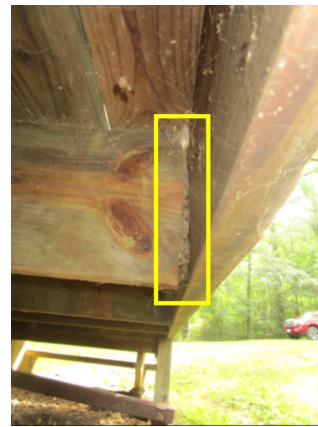
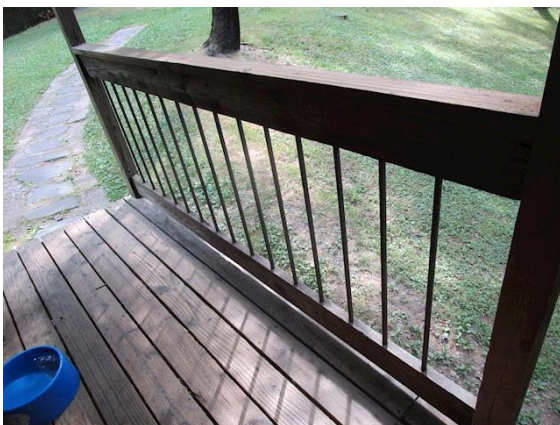
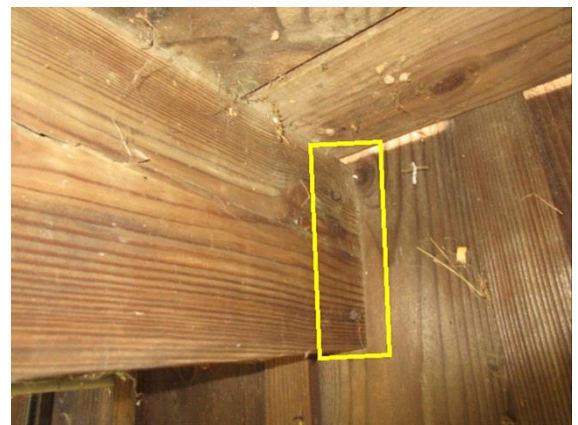
- * Although the porch appeared sturdy, the joists should be attached to the ledger board/house with joist hangers, instead of toe nailed.
- * One of the joists was pulling loose from the front ledger board. The joists are end nailed, but joist hangers would provide the joists more support.
- * Although acceptable at time of construction, the rail openings do not meet the current safety standards of being 4 inches or less apart.

Recommend further evaluation/repair by a qualified contractor.

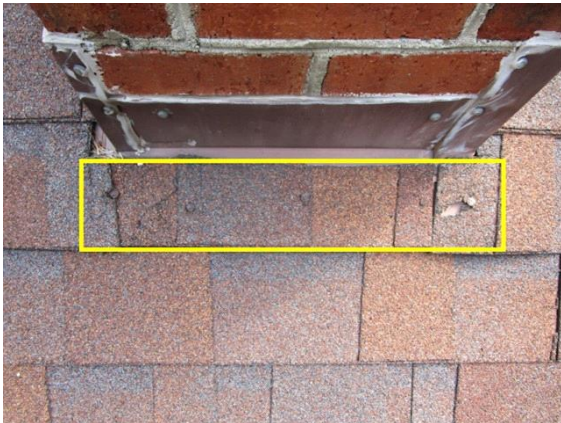
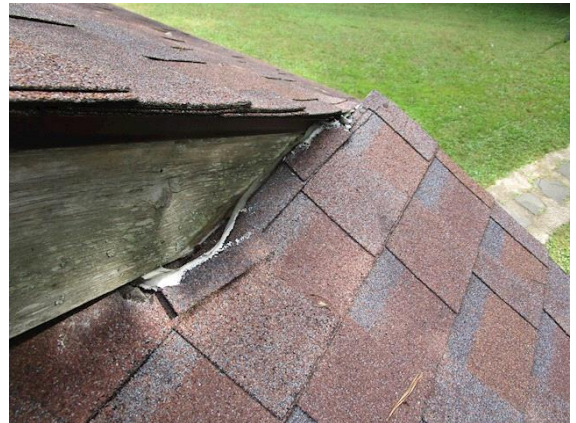
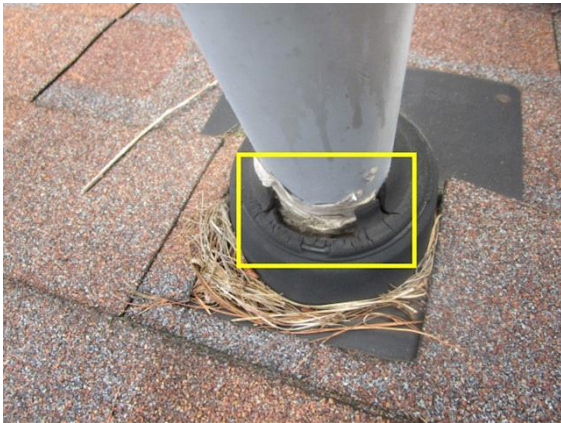
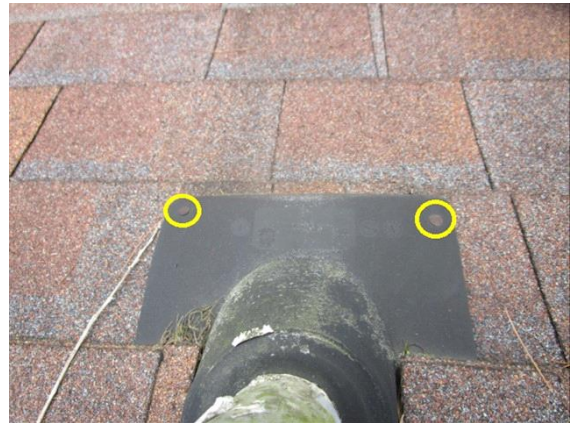
- * Exposed nail heads should be sealed over to prevent moisture intrusion.
- * The plumbing vent boot was cracked and should be repaired or replaced to prevent a leak.
- * There was no flashing where the main roof meets the front porch roof, which can cause the wood to deteriorate and rot.

Recommend further evaluation and repair by a qualified roofing contractor.

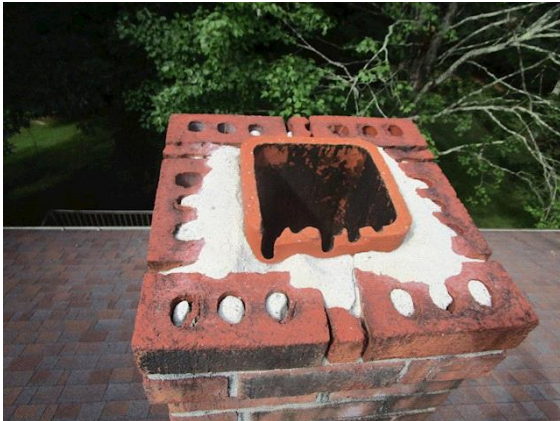
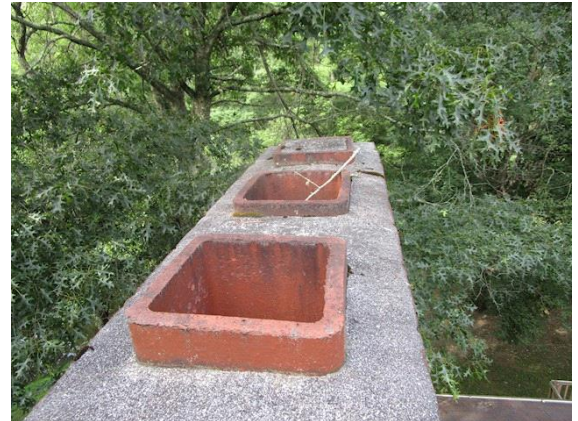
- * The mortar cap was mostly missing on the middle chimney. Recommend replacing to prevent moisture intrusion and deterioration of the chimney.
- * The top of the flue liner was broken on the middle chimney.
- * Recommend installation of caps to prevent rain and animal intrusion.

Recommend further evaluation/repair by a qualified chimney contractor.

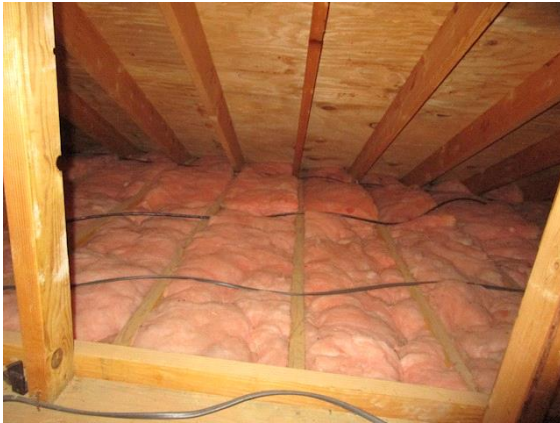
* Consider adding additional insulation to improve thermal efficiency. Current standards recommend at least ten inches. The insulation present was less than six inches.

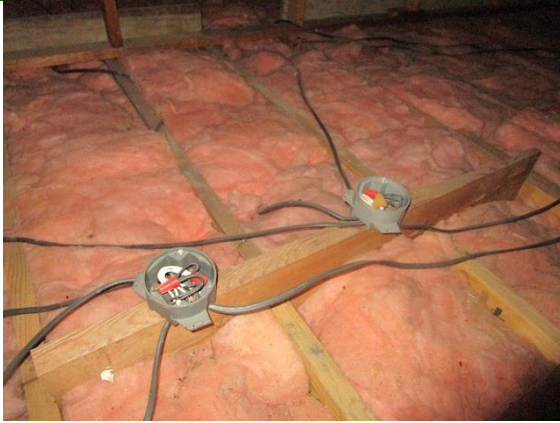
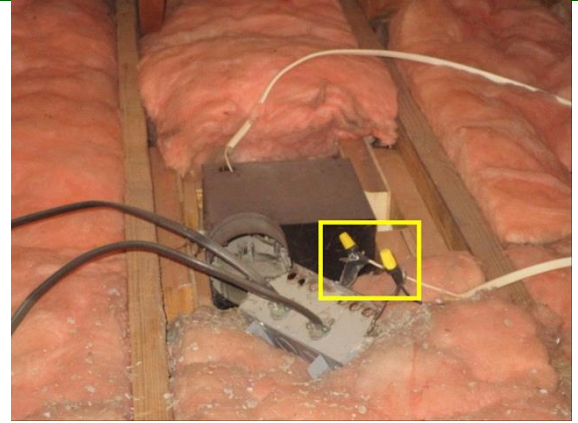
- * Wire splices in the attic need to be placed inside junction boxes.
- * Covers need to be added to the junction boxes in the attic.

Attic Electrical: Upstairs bathroom

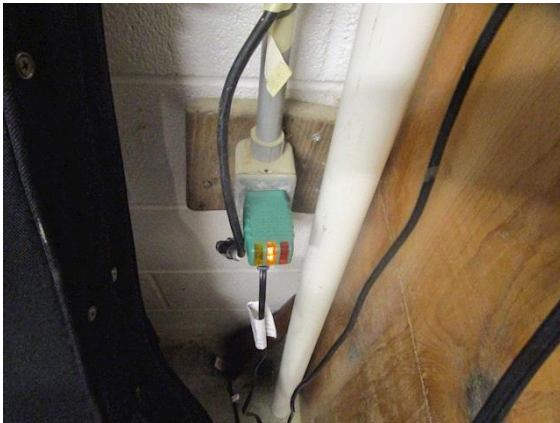
- * The receptacles on the right wall of the unfinished room in the basement and on the deck were 3-prong outlets that were not grounded. Although they functioned properly, recommend either rewiring with a ground wire or replacing the receptacles with GFCI receptacles wherever newer grounded appliances with three-prong plugs are to be used.

Electrical: Unfinished basement - ungrounded and not GFCI

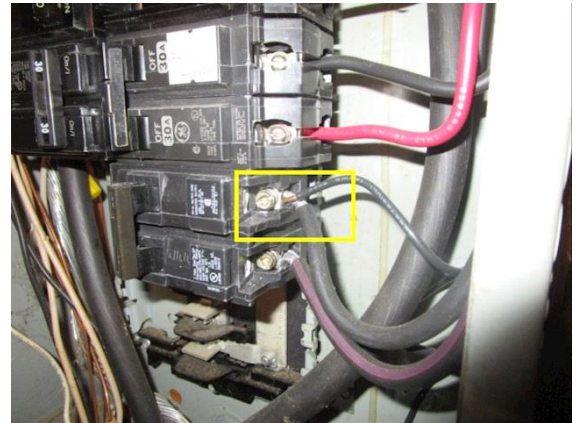
- * There were double tapped breakers in the main panel. In general, only one conductor (wire) should be connected to any breaker, fuse or panel lug unless terminals are rated for this use. Double tapping could cause one or both wires to have poor contact, creating arcing and a possible fire hazard.

Electrical: Double tapped breaker

Recommend further evaluation/repair by a licensed, certified, professional electrician.

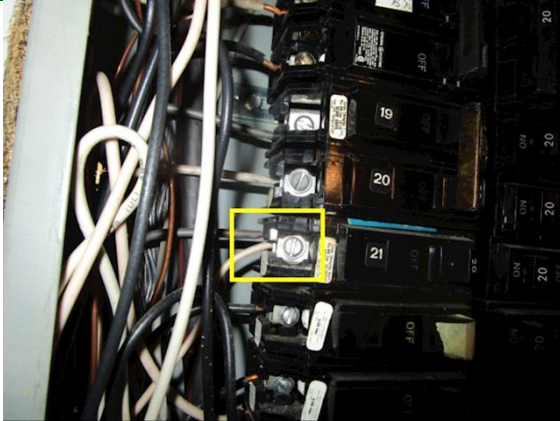
Electrical: Double tapped breaker

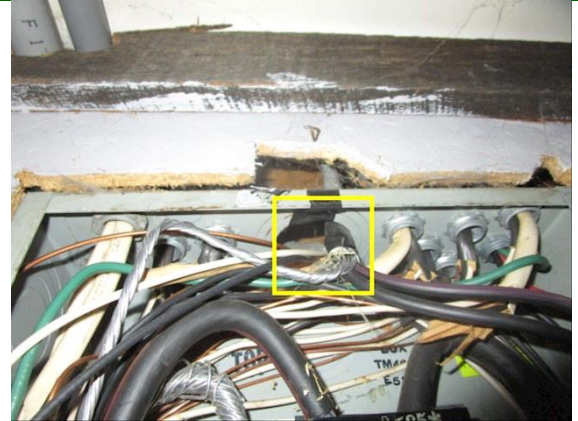
- * The top panel opening was missing a bushing or strain relief clamp to protect the wires running out.
- * Although not required when the home was built, recommend replacing the receptacles in the kitchen, hall bathroom, and exterior with GFCI receptacles. GFCI (Ground Fault Circuit Interrupter) outlets help reduce the risk of electrical shock. GFCIs detect a change in current between the "hot" and "neutral" wires and trip the circuit, shutting off power to the circuit.

Electrical: Missing bushing or strain relief clamp

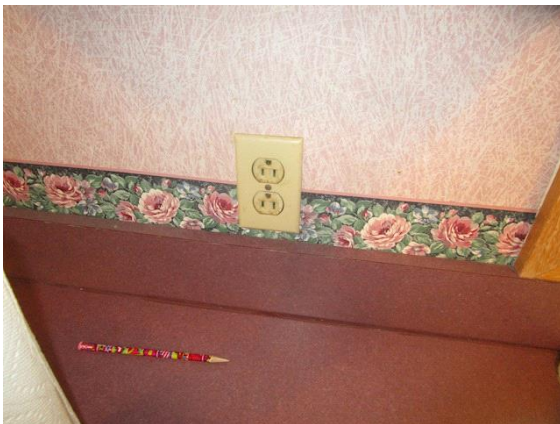
Electrical: Kitchen - not GFCI

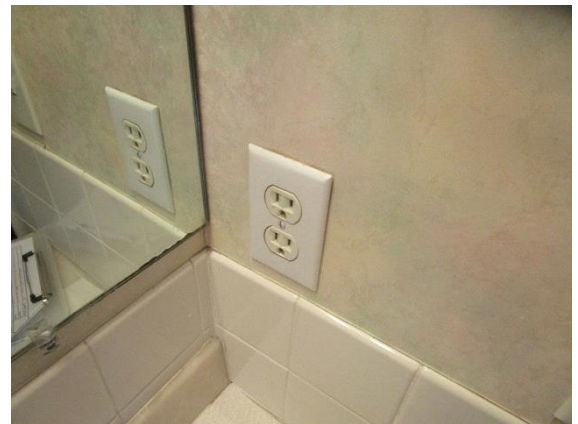
Electrical: Hall bathroom - not GFCI

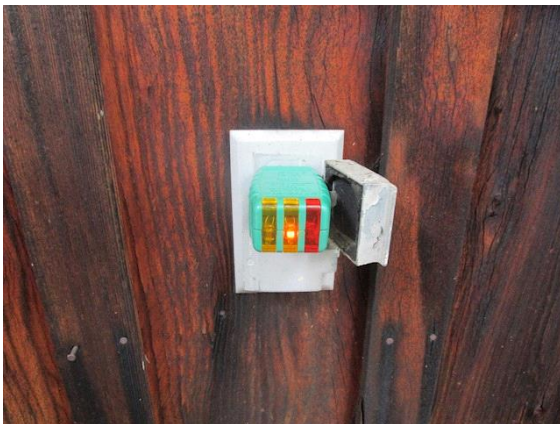
Electrical: Basement - ungrounded

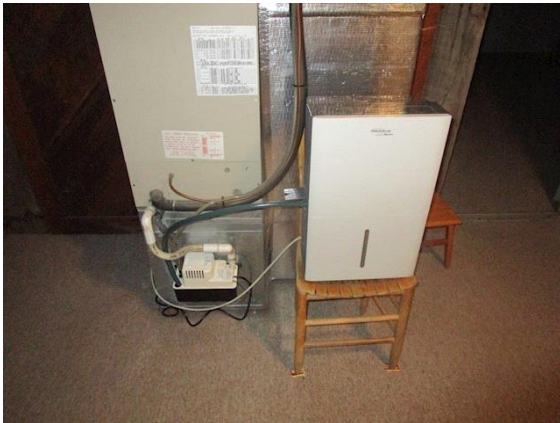
* Note that the dehumidifier is emptying into the condensation pump at the inside air handler unit. Recommend having the dehumidifier empty to the outside or into the provided pan.

* Although the cooling unit was functional at time of inspection, it was rated 'Marginal' due to the age of the system.

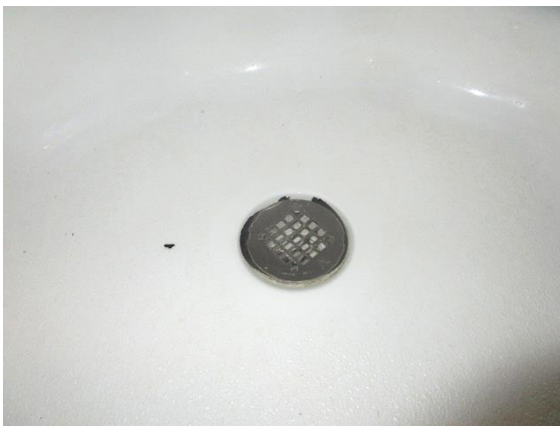
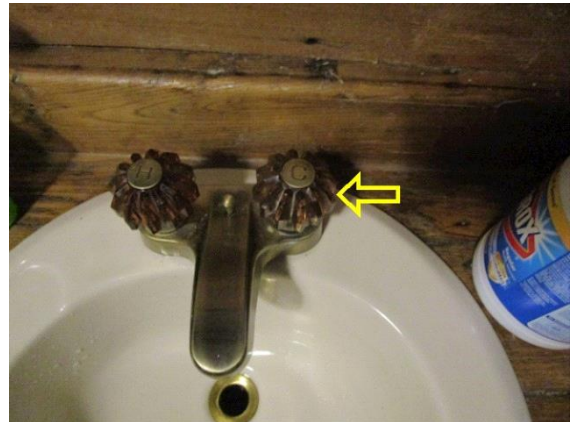
- * Although there was no evidence of leaking, recommend maintaining the caulk around the drain in the basement shower.
- * The hall bathroom exhaust fan was venting into the attic. Bathroom fans should vent to the outside to prevent moisture build up in the attic.

- * The cold water faucet handle in the basement bathroom was leaking. The owner stated they were going to replace.
- * See the 'Electrical' section for comments on the electrical receptacle in the bathroom.

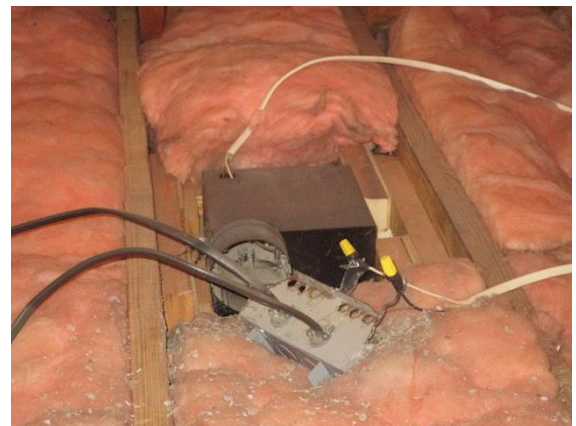
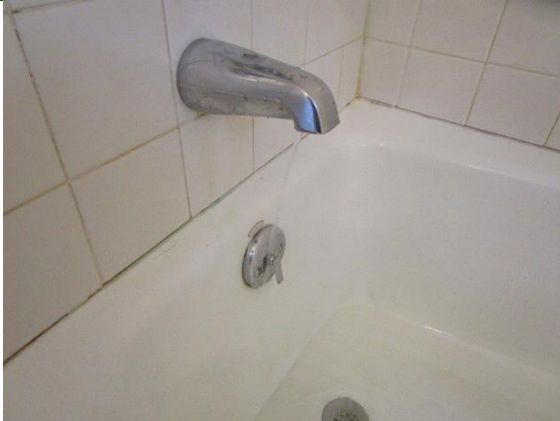
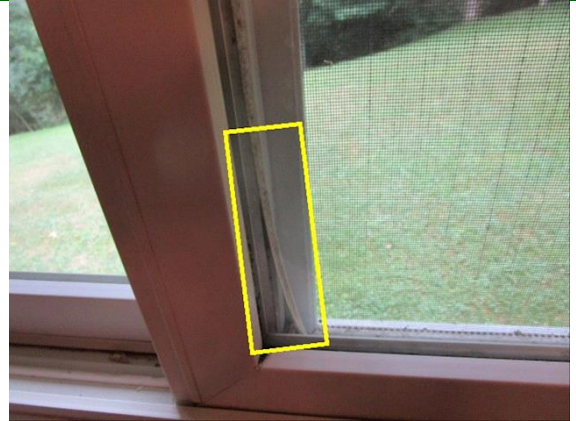
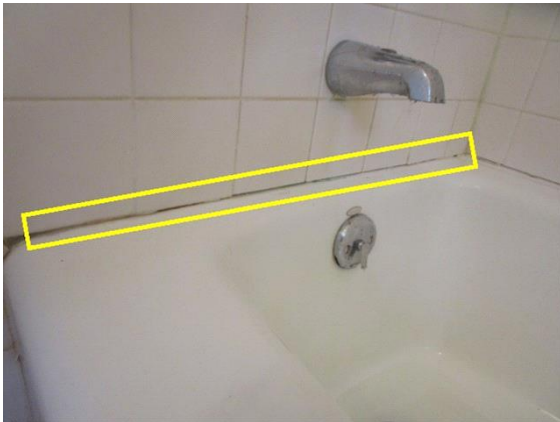
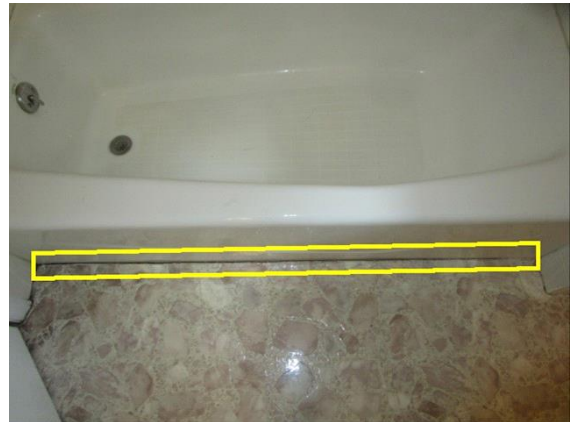
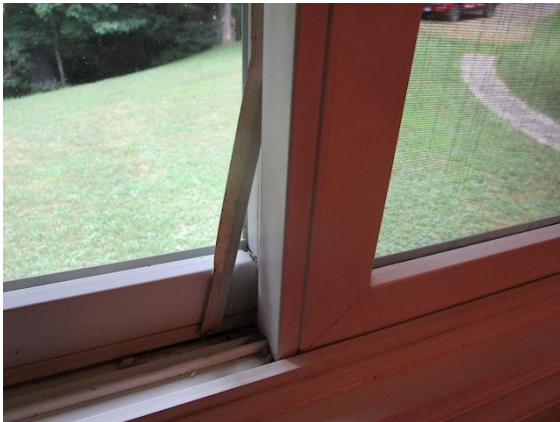
- * The shower diverter valve in the hall bathroom did not completely engage, allowing water to still flow out of the tub faucet while the shower was operating.

- * Recommend caulking around the bathtub in the hall bathroom to prevent possible moisture intrusion into the wall and floor.
- * The tub in the hall bathroom was draining slowly, suggesting there is a restriction in the drain pipe or trap located under the tub.

- * The weather stripping was damaged around the window in the hall bathroom. This should be repaired to maintain the thermal efficiency of the home. It also appears that the seal inside the window is damaged, which could diminish the energy efficiency of the window and cause permanent hazing to the glass.
