National Property Inspections

Joe Smith, 123 Main Street, Pensacola, FL, 32501

Saturday, September 21, 2019

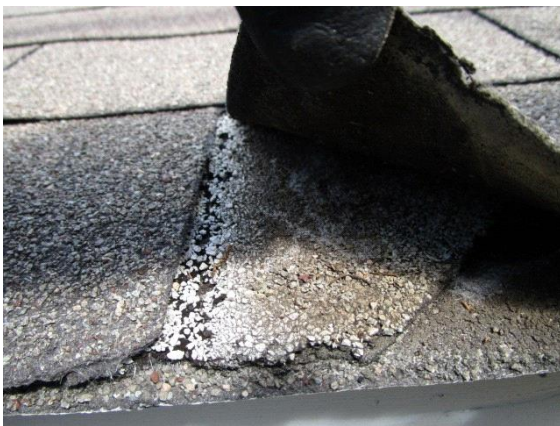
Disclaimer: Multi layer roofs are rated on exterior layer only. When an overlay is done, heat and weight are added to roof. This shortens life expectancy of roof and affects efficiency of home.

Suspected original roofing under replacement.

Recommend a qualified roofing contractor remove both layers of shingles, make any necessary repairs to sheathing before installing new roof.

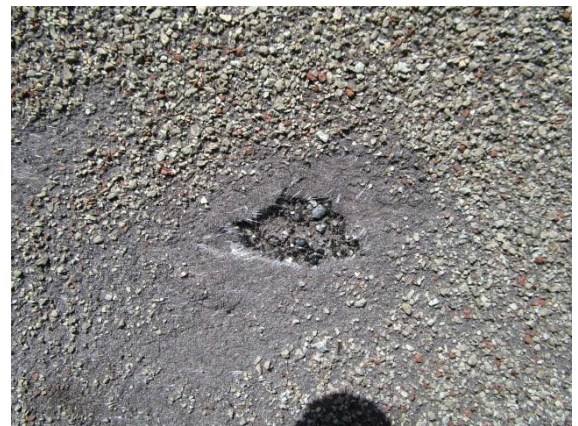
Shingles displayed various deficiencies including cracks, holes, granular loss, exposed fiber, and exposed nails.

Hole with granular loss. Possible hail damage.

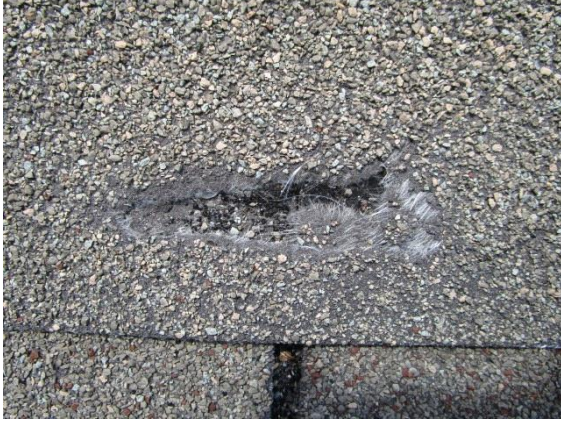
Hole with exposed fibers.

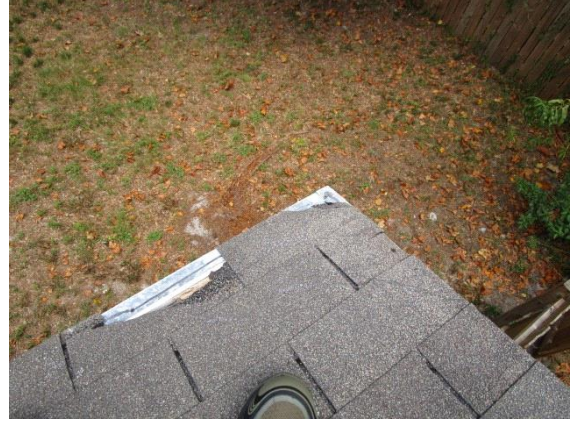
Damaged shingles; exposed sheathing.

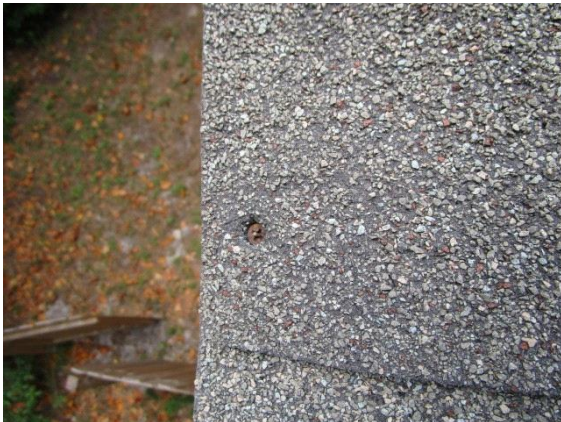
Exposed nail.

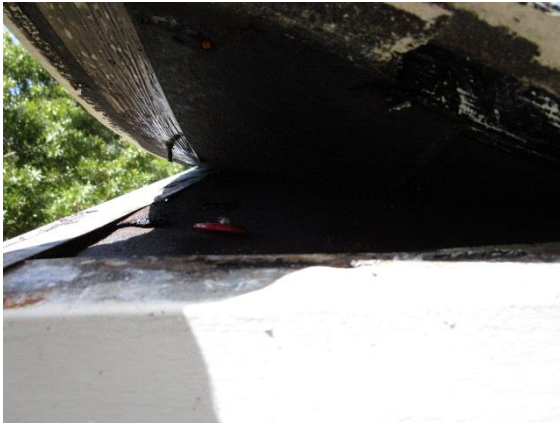
The drip edge flashing has been improperly installed. Underlayment was incorrectly installed under drip edge. Recommend repairs made by qualified contractor at time of roof replacement. Noted rusty flashing. Paint and/or seal as necessary.

Underlayment under flashing.

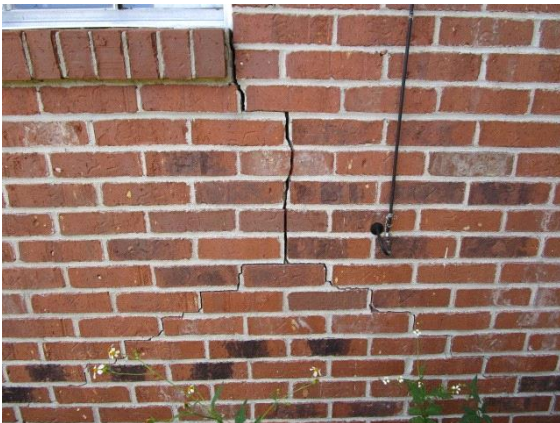
Brick wall was bowed (left side master window) or cracked (all sides). Recommend further evaluation and possible repair by qualified contractor.

Bowing and cracks.

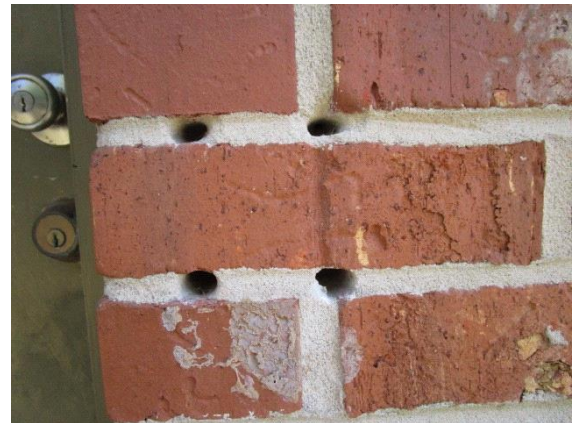
Mortar joints require re-pointing as holes were present and could allow weather or insects in.

Needed re-pointing.

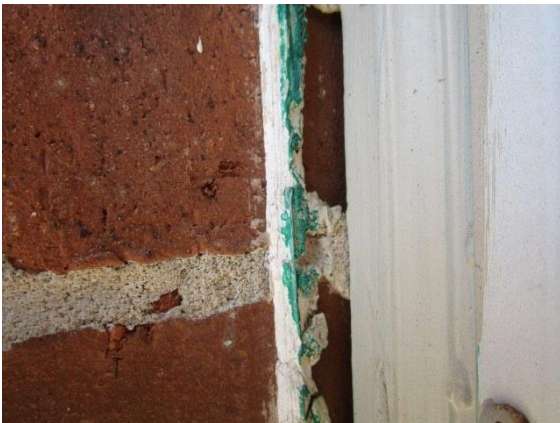
Brick/frame separation.

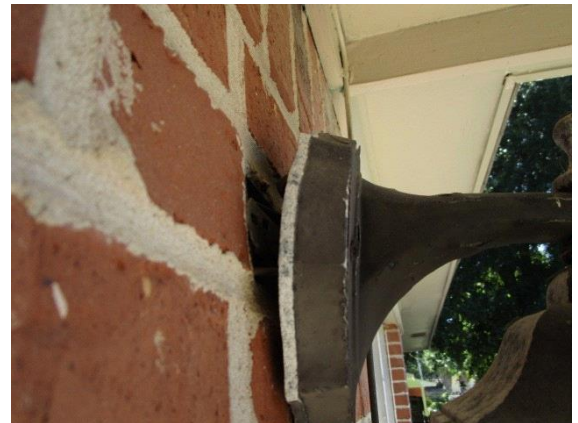
Front light did not turn on (could be bad bulb) and light fixture appeared to be separating from mount. Recommend repairs by a qualified contractor.

Light fixture separating with exposed wiring.

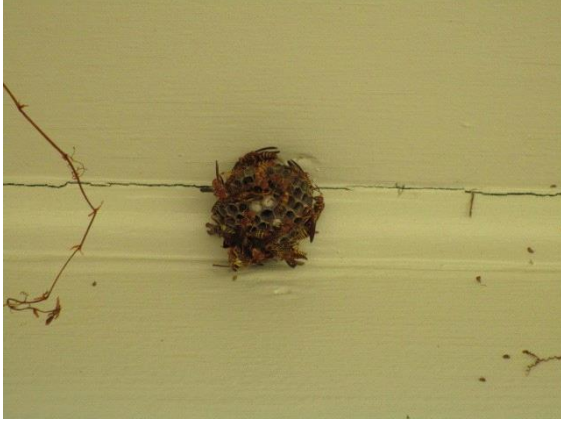
Evidence of flying pests around perimeter siding. Recommend extermination to prevent possible damage to siding as well as safety of residents.

Flying pests.

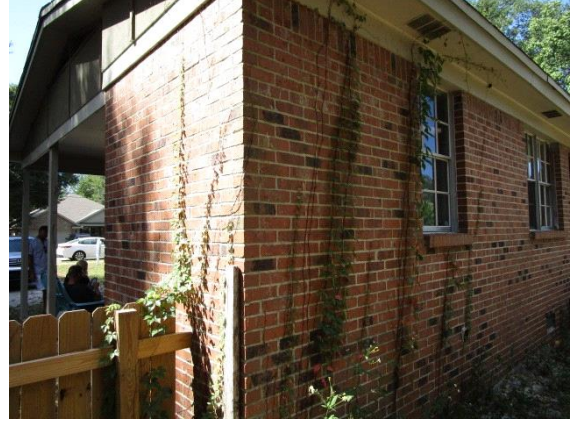
There was vegetation growing up and against the siding. Recommend trimming back growth to avoid damage to the siding.

Vegetation.

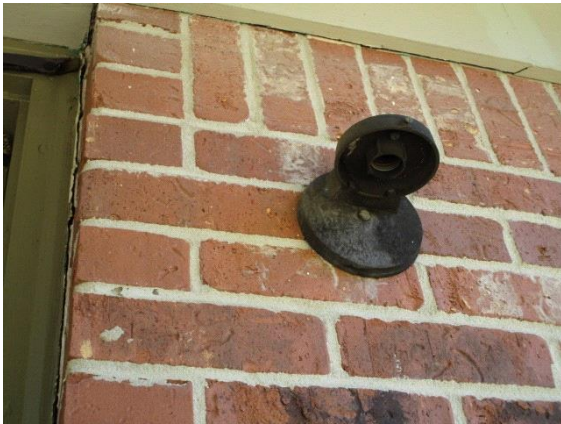
Backlight exposure, missing light/cover.

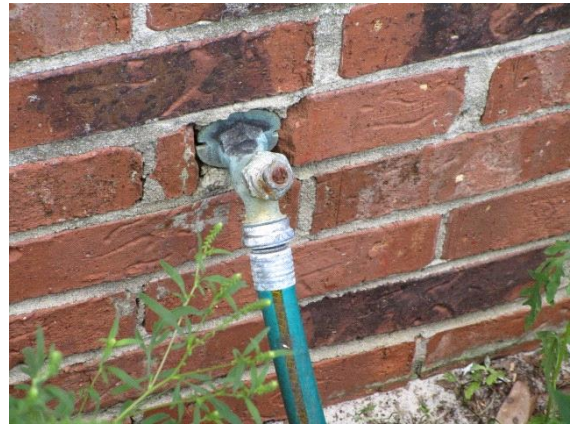
Back faucet missing handle. Unable to test. Recommend repair for proper operation.

Missing hardware. Unable to test.

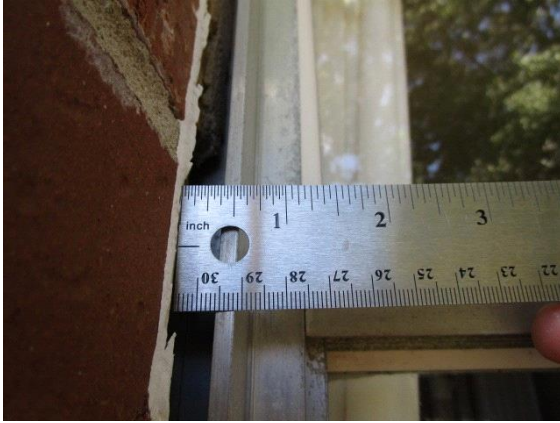
Appeared to be original windows. Brick and window intersections show signs of separation with large gaps in some areas. Possible loss of thermal efficiency and/or potential site for water intrusion. Recommend further evaluation and possible repairs by qualified contractor.

Frame/brick separation

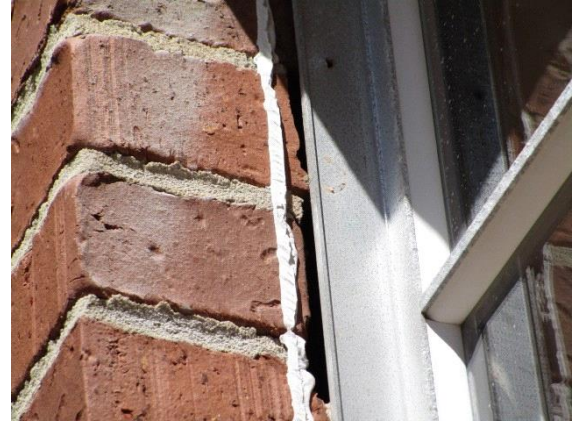
Window frame/siding separation.

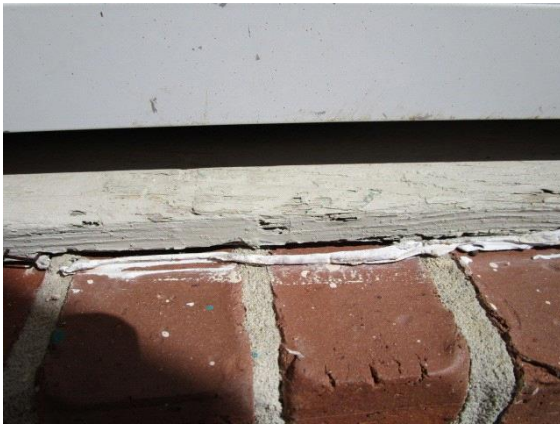
Exposed wood.

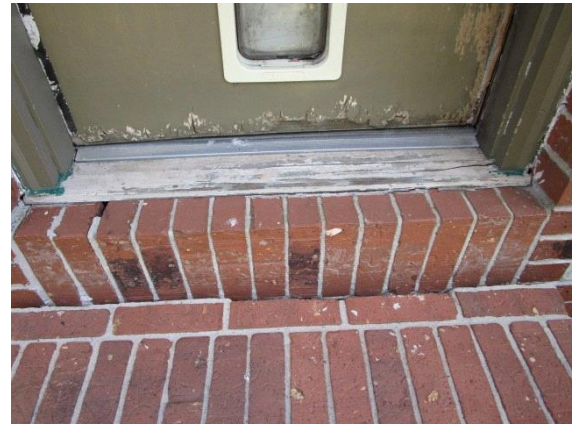
Exposed/moisture damaged wood.

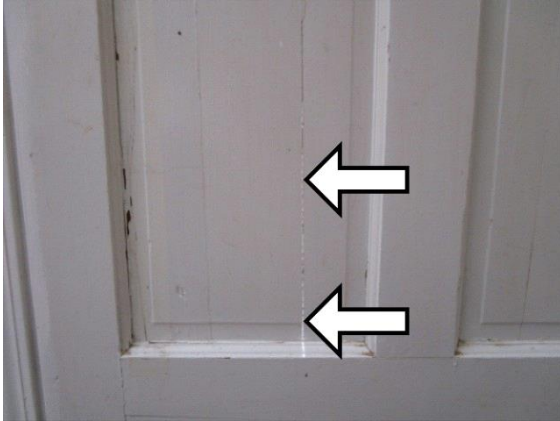
Crack down center as evidenced by sunlight shining through (when viewed from inside); may lead to thermal loss. Wood near door knob is compromised as seen when closing door from inside. Recommend a new front door installed with new seals by a qualified contractor.

Cracked front door.

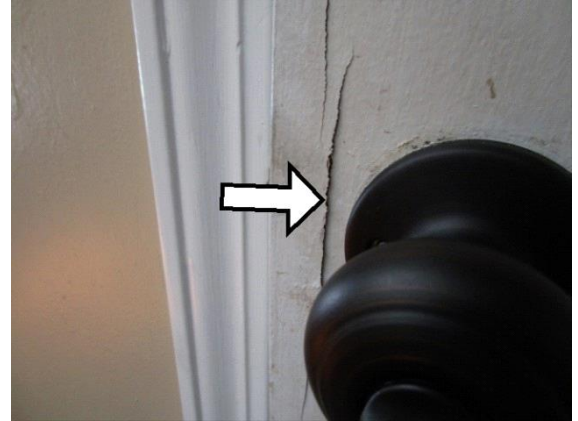
Crack.

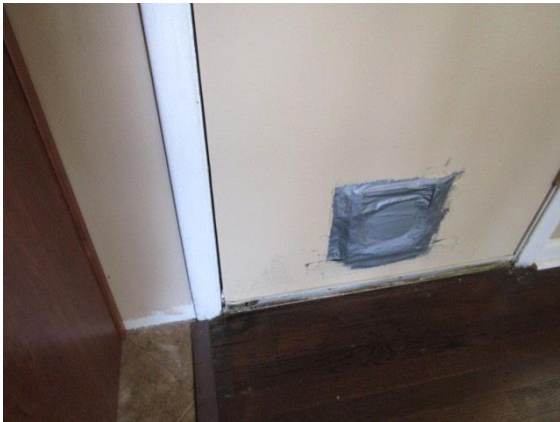
Backdoor has a hole from pet door removal, covered by duct tape. Bottom corner does not have a good seal. Recommend a new back door installed with new seals by a qualified contractor to increase thermal efficiency.

Duct tape over pet door.

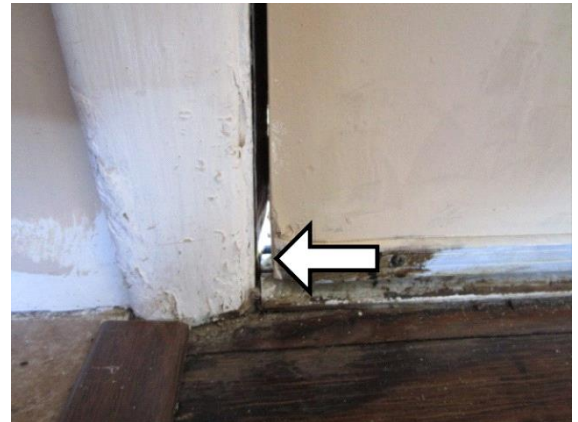
Air leak, back door.

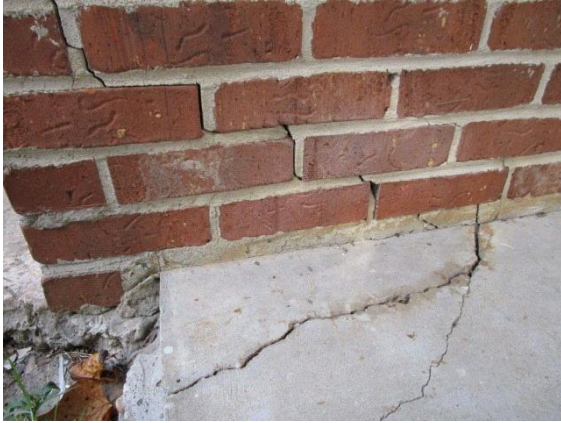
Moderate crack noted with some deflection noted at front/carport corner. Large crack noted on left side near master bedroom. Recommend further evaluation by a qualified foundation contractor for possible repair.

Cracks in concrete and brick.

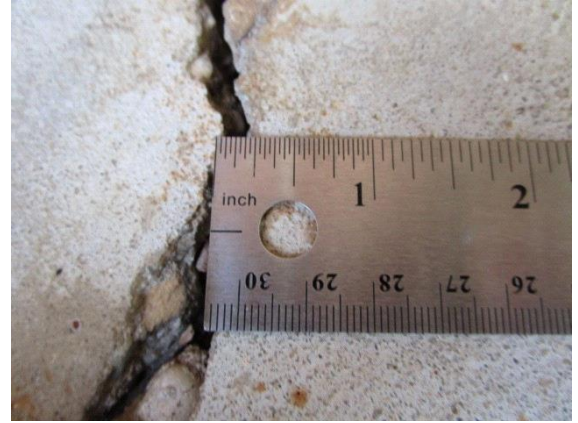
1/4" crack.

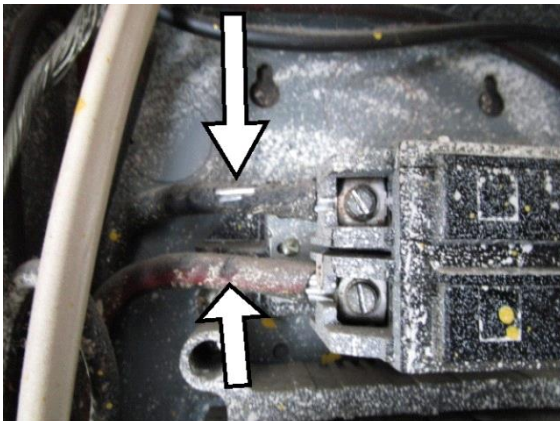
Damaged sheathing on main wires.

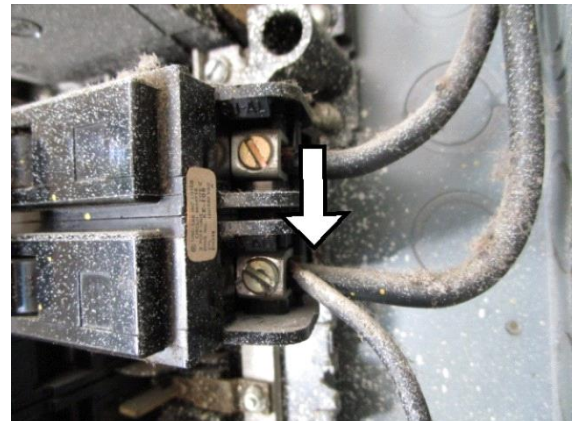
Double tap

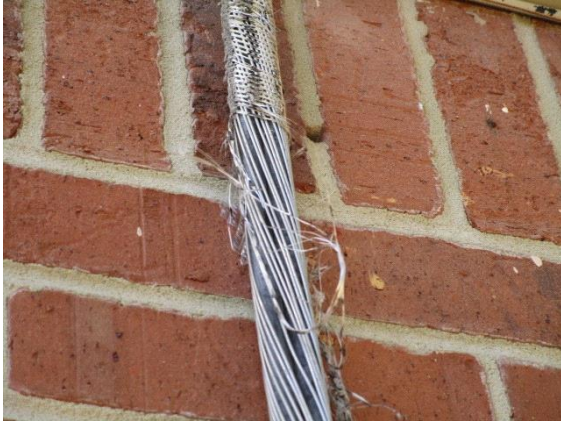
Service line sheathing heavily weathered.

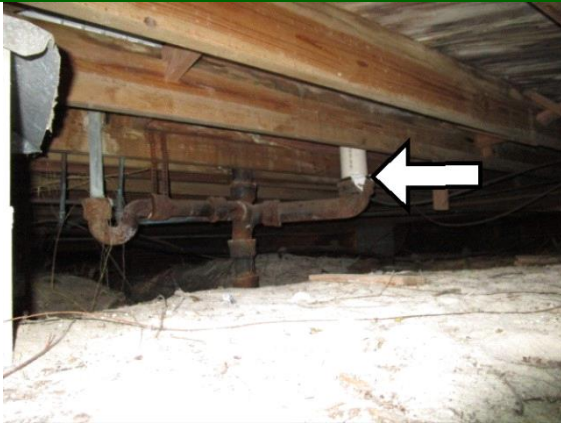
PVC/cast iron drain appear to be improperly connected. Recommend further evaluation by qualified contractor.

Improper connection.

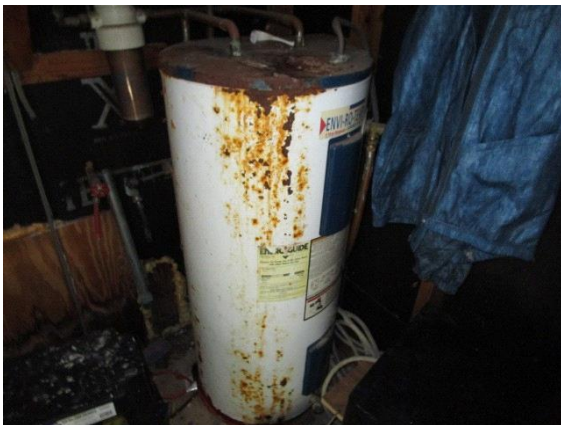
Rust on Water Heater.

The water heater was operational at time of inspection. Unit had a significant amount of rust possibly due to exposure to the elements. Monitor condition as unexpected repairs/replacement may be needed.

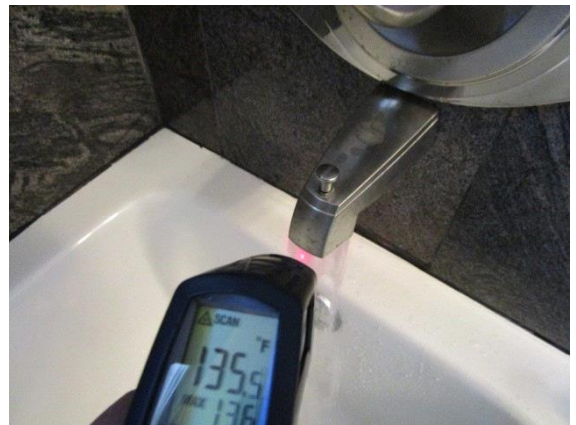
WARNING: Water temp exceedingly hot.

Max temp recorded was 136 degrees at bathtub. Recommend lowering water temperature to the industry standard of 120-125 degrees for health, sanitary and safety purposes.

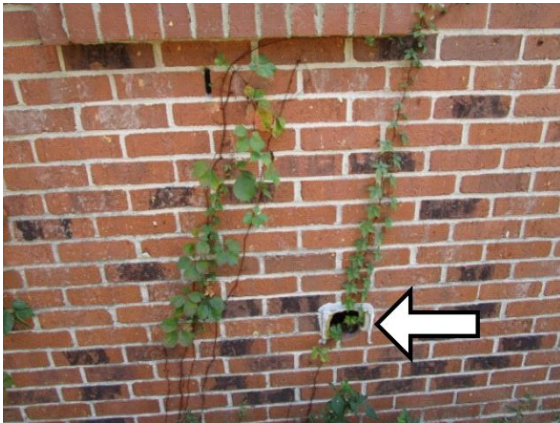
Dryer vent/screen was not installed leaving exposed hole in wall. Recommend installation to prevent possible pest and/or water intrusion.

Vegetation growing over hole for dryer vent.

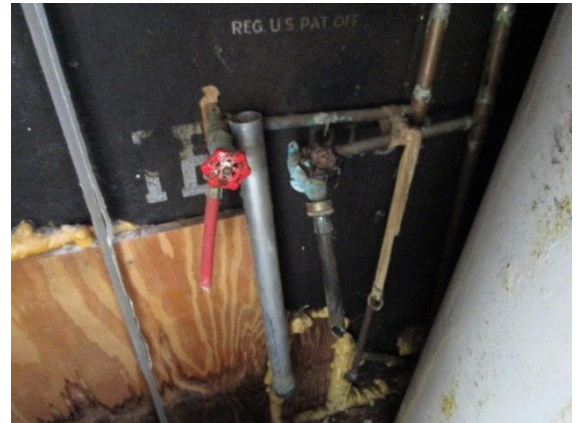
Wall behind washer hook-up appeared to have possible water damage. Recommend contacting owner to determine what, if any, repairs have been done to determine possibility of future water intrusion.

Washer hookup. Possible water damage in background.

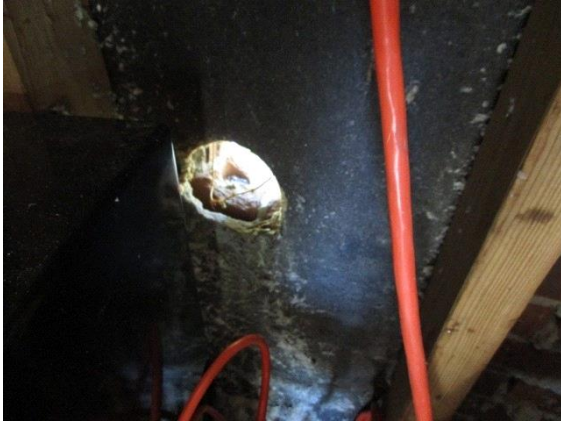
Dryer vent hole from inside.

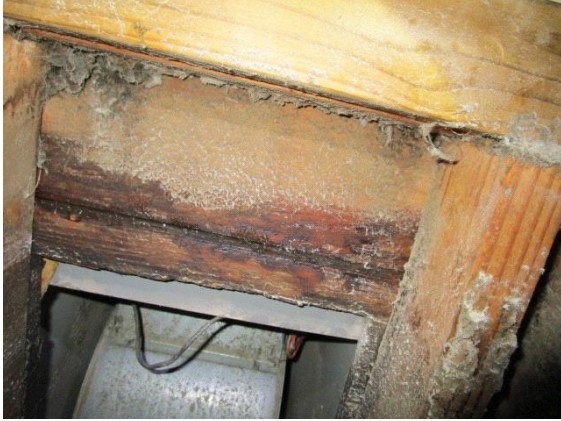
Plenum inspection revealed active leak at time of inspection. Recommend HVAC system service by a qualified HVAC contractor.

Active leak into plenum

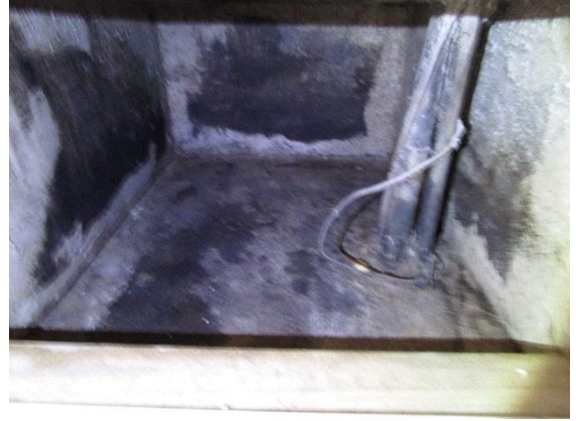
Moisture in plenum

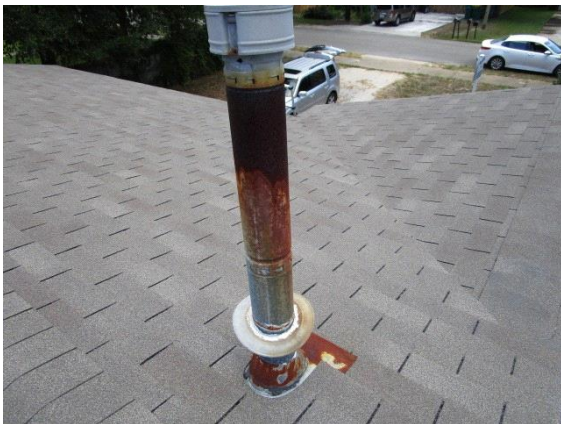
Rust was noted on the gas vent pipe. No areas appear rusted through at this time.

Failed caulk bead at base of flue could be indication of possible water entry point. Recommend repairs by qualified contractor.

Rusty flue with failed caulk bead
