National Property Inspections

Property Address, Montoursville, PA, 17754

Monday, May 2, 2022

Summary

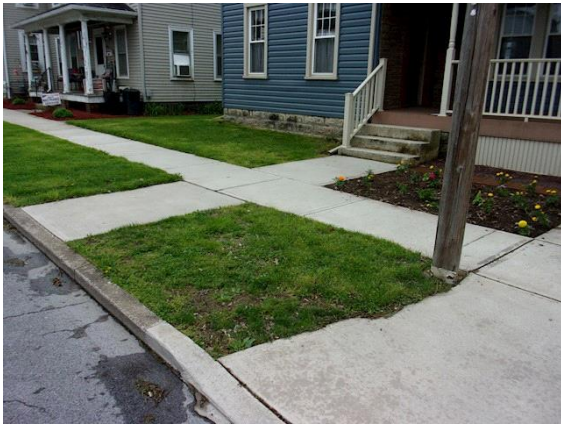
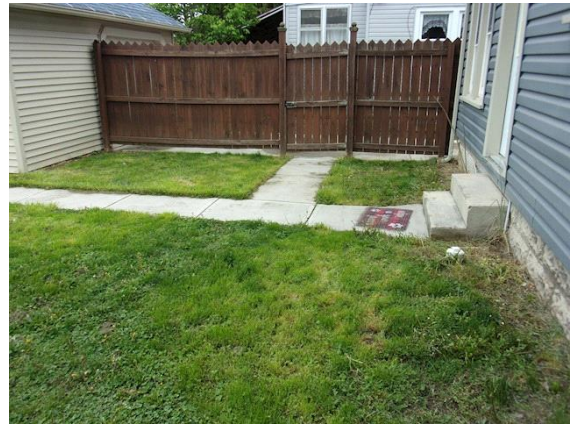
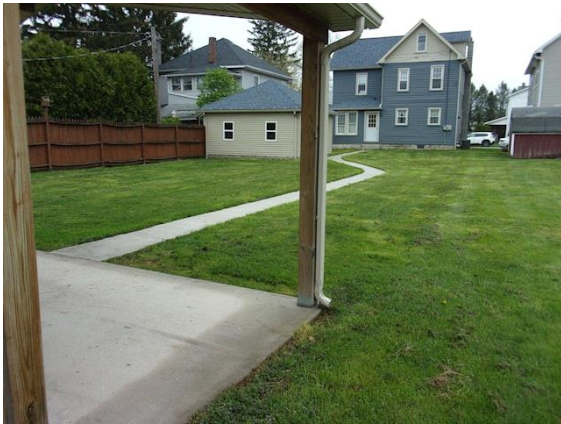
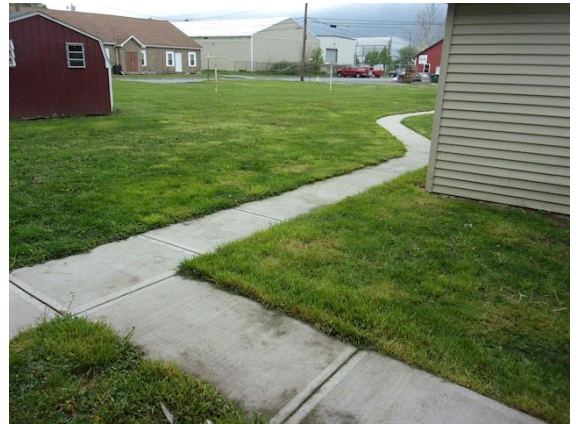
The grading around the dwelling was near level. Ideally, the grading should slope away from the house to allow water to run away from the foundation. Recommend the installation of gutters and downspouts that direct water away from the foundation.

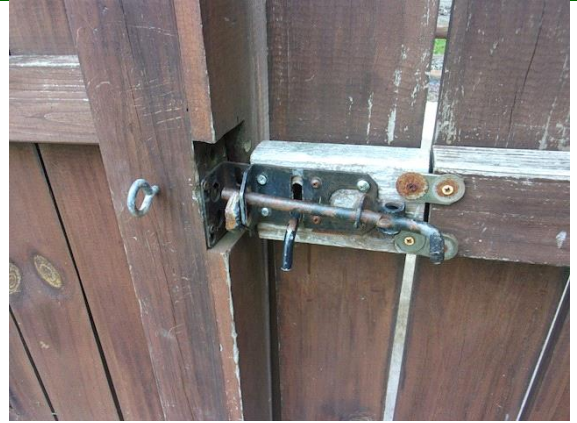
The gate lock is inoperable from the driveway side and should be replaced.

Fences / Gates: Lock can't unlock from driveway

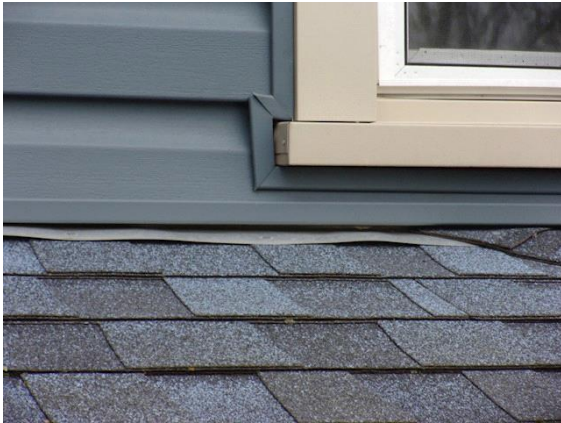
Roofing: Flashing at low roof

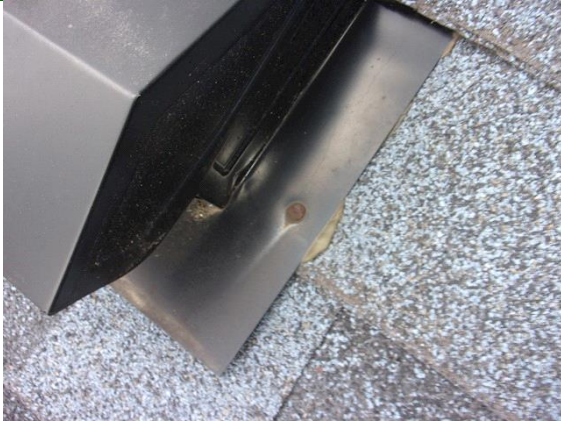
Roofing: Bath vent flange nailed and sealed

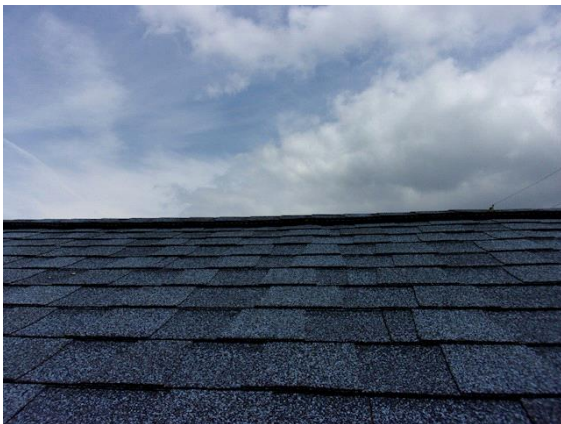
Roofing: Ridge vent installed

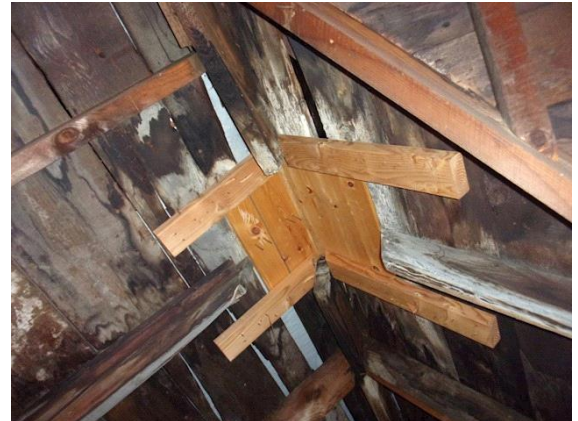
All the framing and sheathing that was visible from the attic was acceptable at time of inspection. Evidence of a roof leak around a chimney that has been removed and repaired was noted.

Attic Framing/Sheathing: previous leak and repair

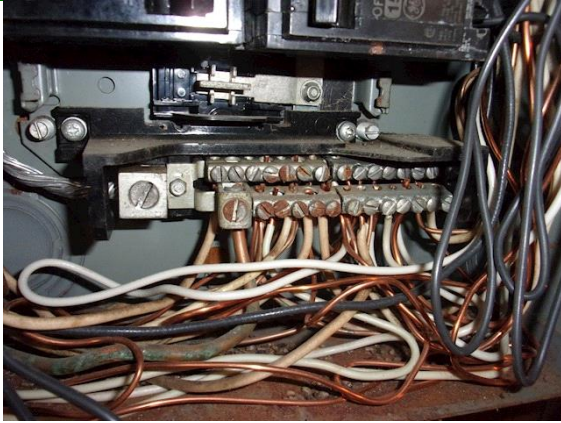
All neutral wires must be individually connected to the buss bar. Some were doubled up. Improper clearance to electric panel. Today's standards require 3 feet wide x 3 feet deep by 6 feet high for safe working clearance. Rust noted on the bottom of the electrical panel and on the screws for the neutral buss. As a result of this corrosion, hazardous conditions may be expected as the integrity of any corroded connection can become suspect.

Main House Panel: Minor rust on screws and double taps

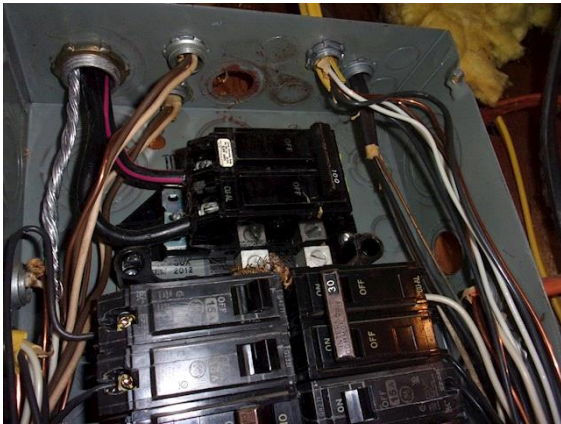
Main House Panel: open knock-outs

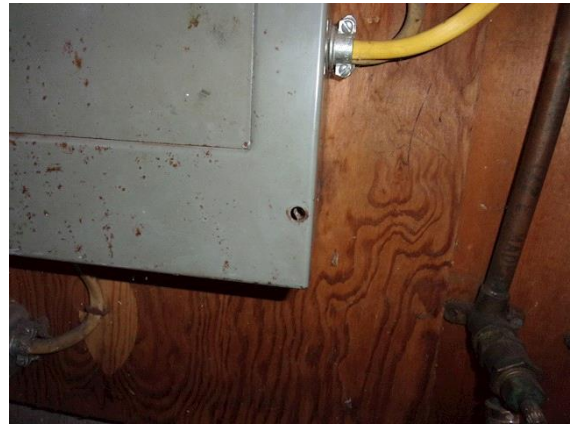
Main House Panel: one missing screw

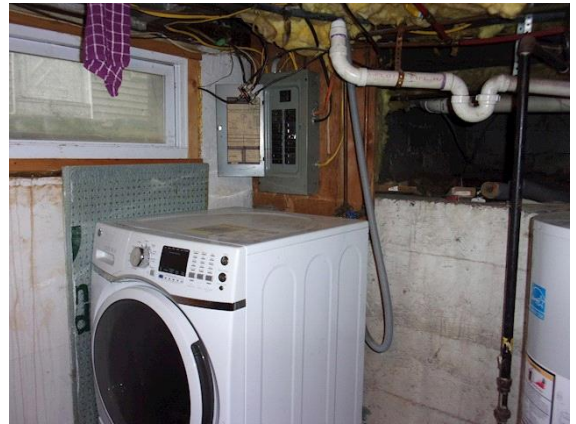
Main House Panel: the area should be clear in front of the panel
