Trinity OC LLC DBA
National Property Inspections

Client Name, Street Address, City, NJ, Zip

Inspection Date:
11/26/2022

Inspector: Don Bosco
Inspector Phone: 609-276-2377

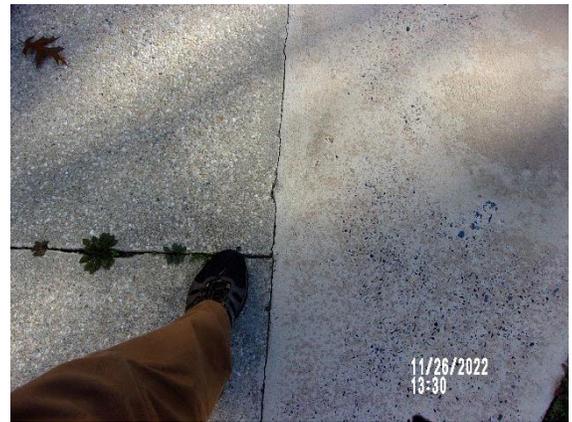
Asphalt driveway had general deterioration, settlement cracking, and pitting. Driveway was functional at time of inspection.

Driveway: Minor trip hazard, < 1".

Driveways require routine maintenance, such as sealing, crack repair, etc.

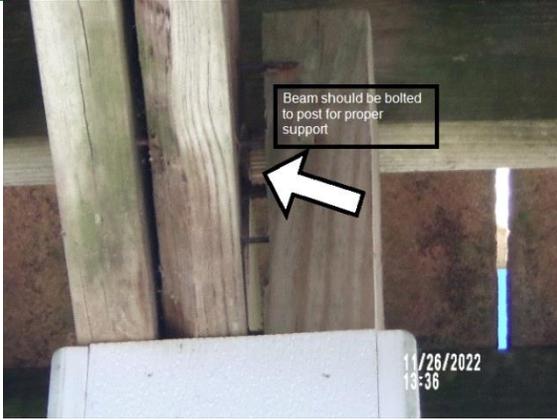
Beam on second story deck, appears to be lag bolted to support post. A gap is developing, recommend better attachment to post.

Decks / Balcony: Gap forming between beam and support post.

Recommend further evaluation/repair by qualified contractor(s).

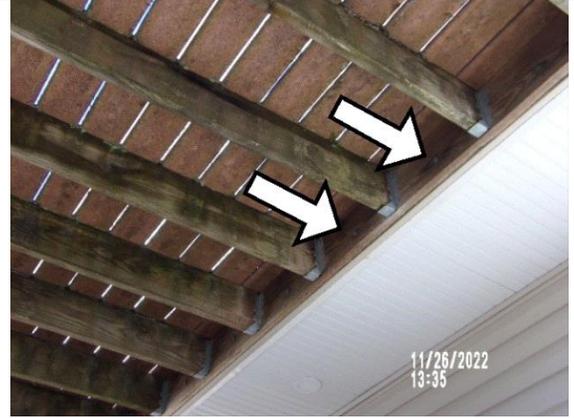
Decks / Balcony: Bolts should ideally be in a zigzag pattern on ledger board.

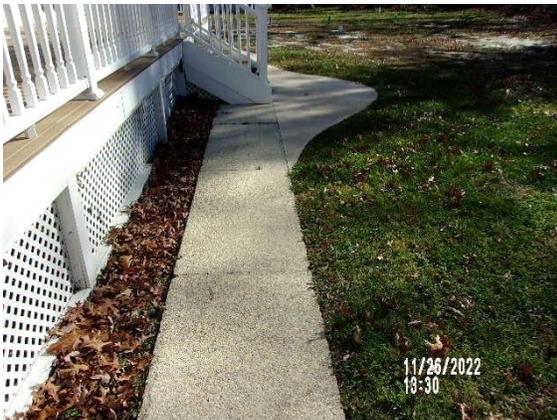
Limited access beneath deck due to low clearance and lattice work, preventing full inspection of ground level deck.

Decks / Balcony: Lattice work limiting inspection.

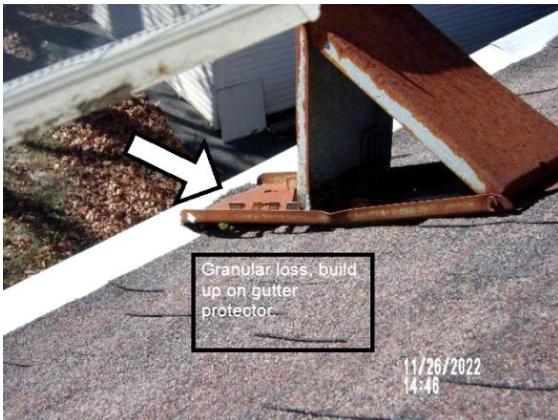
Overall the roof was in acceptable condition with no active leaks noted on day of inspection. It was rated marginal due to age. Recommend monitoring for future deterioration and repair/replace as required. Roof was not walked due to pitch, ridge vent may have some compressed areas. There was some organic growth, recommend cleaning by a qualified contractor.

Roofing: Granular loss at bottom of old bracket.

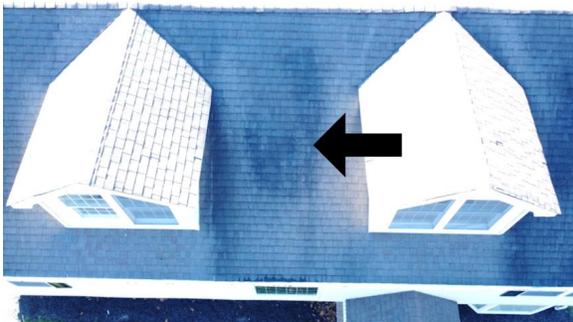
Roofing: Organic growth on roof. Front of home.

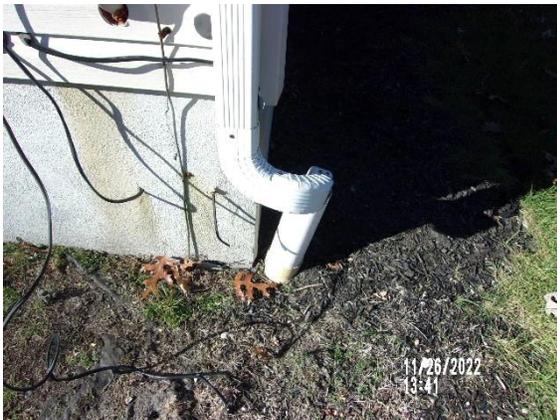
Gutters were in good condition and free of debris, with downspouts and extensions present. Even with gutter screens in place, routinely clean and maintain gutters. Could not determine if drainage of gutters was acceptable, gutters emptied into underground piping.

Gutters/Down Spouts: Emptying into underground piping.

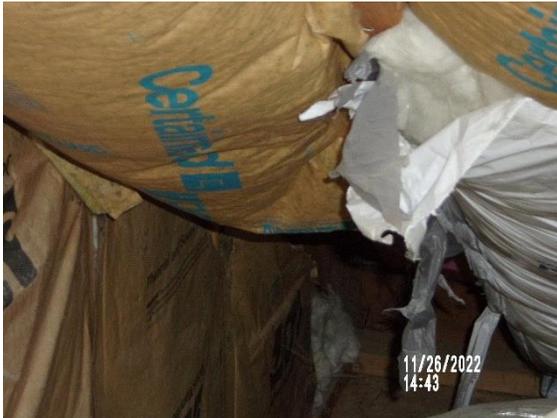
The majority of the attic structure was not inspected due to lack of access, the attic is a finished space. What was visible, was rafters construction and plywood sheathing. No visible water staining on ceiling at time of inspection.

Attic Framing/Sheathing: Small section of attic visible, no apparent evidence of leaks at time of inspection

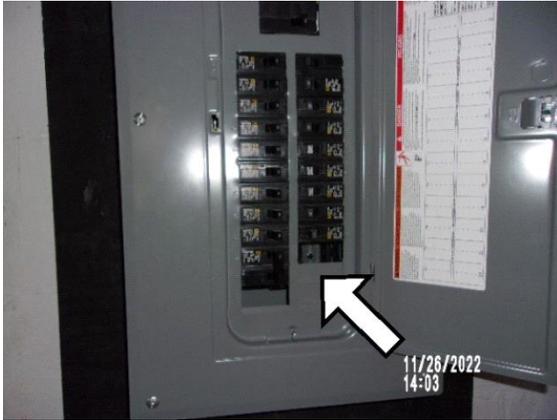
There was one or more open breaker spaces on the panel. The knockouts in the dead front (cover of the main panel) were removed. This is considered a major safety hazard as live components of the electrical system are potentially exposed.

Electrical: Open knockouts in panel.

Recommend further evaluation/repair by qualified contractor(s).

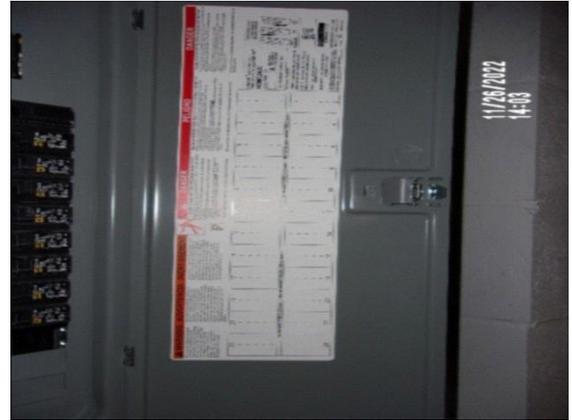
Electrical: Circuits not labeled

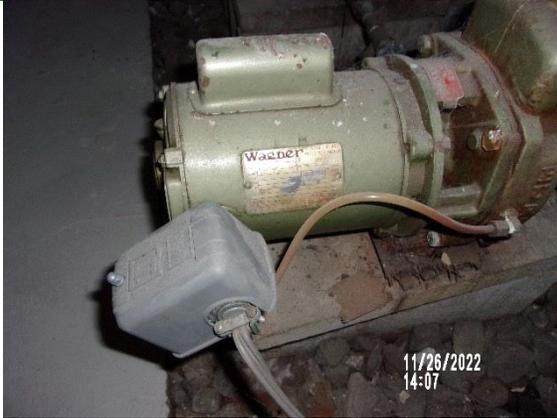
Private well and septic not inspected. Outside of scope of this inspection. Well pump appears to be original to house, in acceptable working condition, marked marginal due to age. Average life expectancy for a well pump is 15 years.

Plumbing: Well pump.

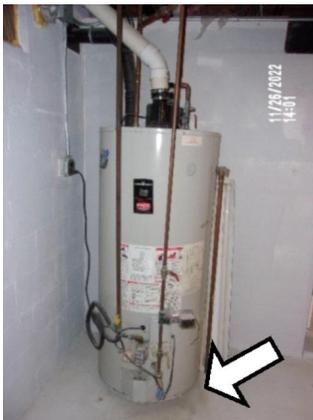
Missing overflow pan under water heater.

Water Heater: Missing drip/overflow pan.

Budget for replacement.

Recommend further evaluation/repair by qualified contractor(s).

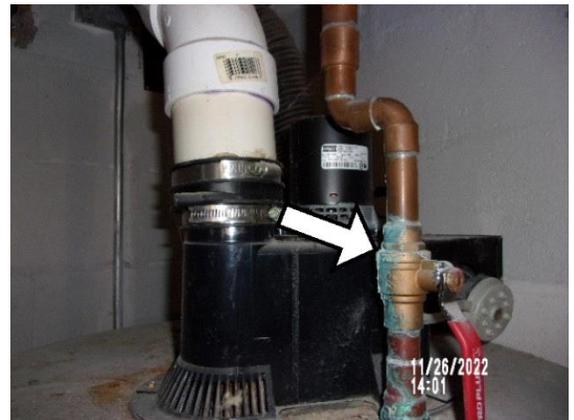
Serial number indicates a manufacture date of 2003 or 2023. Based on condition of water heater and corrosion on supply lines, I speculate manufacture in 2003.

Water Heater: Corrosion on copper supply line.

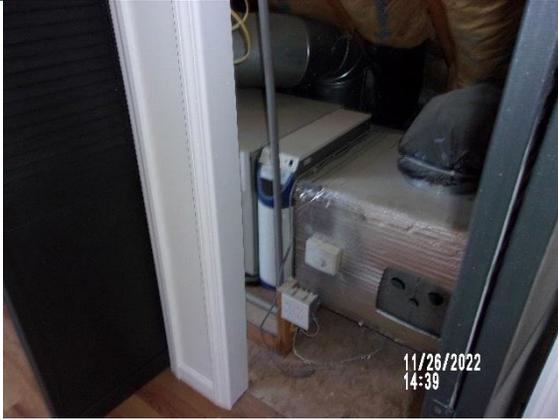
Heating: second unit.

Second unit in chase on third floor did not respond for heat when called, could not be tested. Recommend further evaluation/repair by qualified contractor(s).

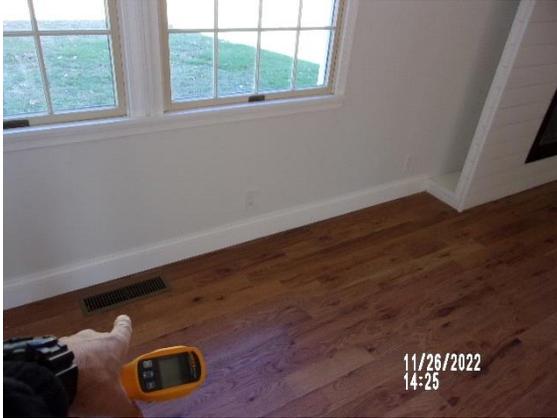
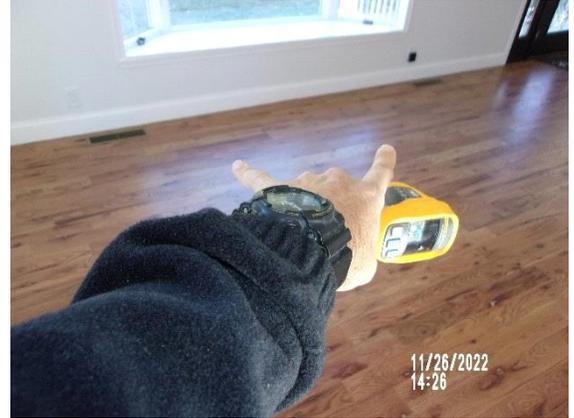
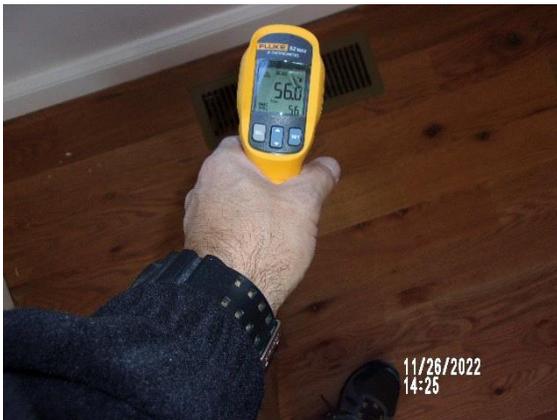
No heat detected in 3 registers on the first floor. no heat distribution to these registers. Possible damper or blockage of heated air.

Thermostats did not respond when operated.

Heating Distribution: no heat detected

Heating Distribution: no heat detected.

Recommend further evaluation/repair by qualified contractor(s).
