# INSPECTION REPORT

12345 Main St  
El Paso, TX 79938

**INSPECTION DATE**  
Wednesday, January 10, 2024

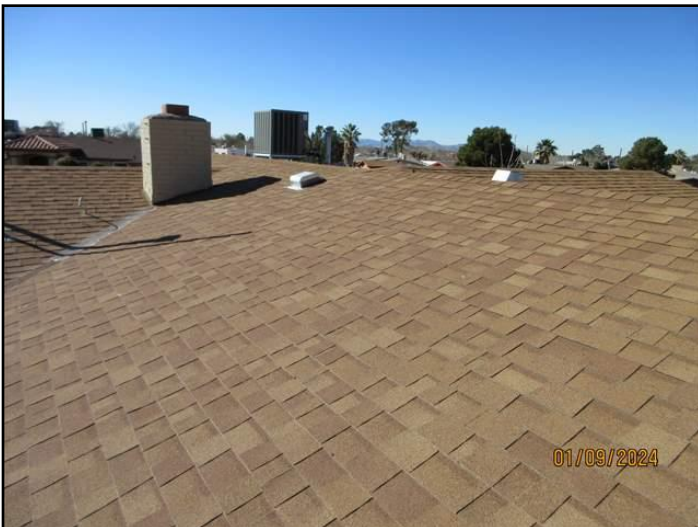
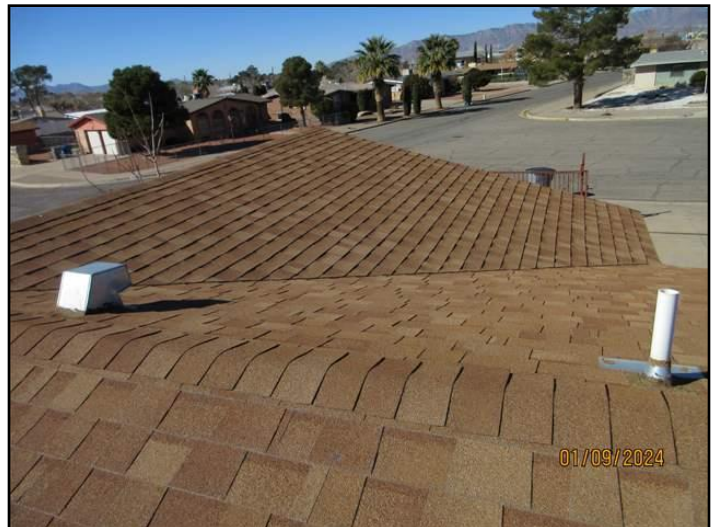
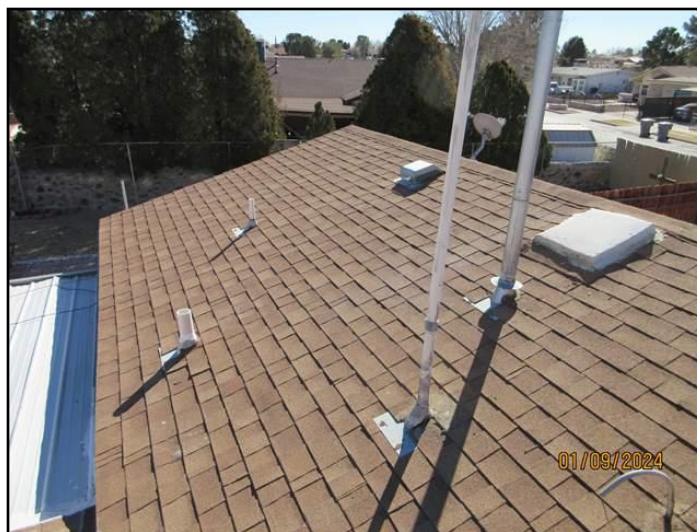
- Recommendations\General: In the opinion of the inspector the roof covering has outlived it's usefulness life.

1. **Condition:** • In the opinion of the inspector the roof covering has outlived it's usefulness life.

1. In the opinion of the inspector the roof...

2. In the opinion of the inspector the roof...

3. In the opinion of the inspector the roof...

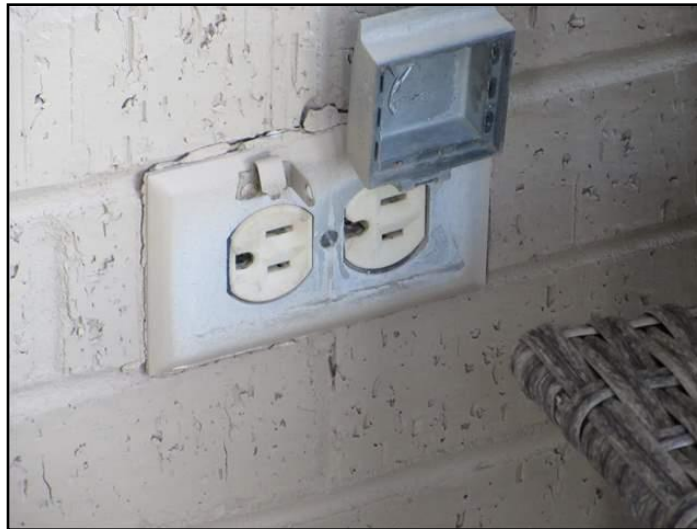
Exterior outlets are not GFCI nor are the coverings updated with bubble covers.

6. No GFCI

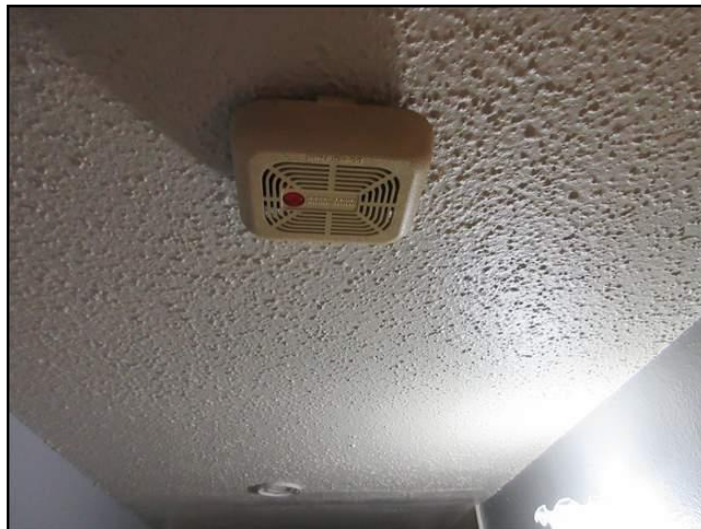
smoke alarm is 10+ years, recommend replacing.

7. Present

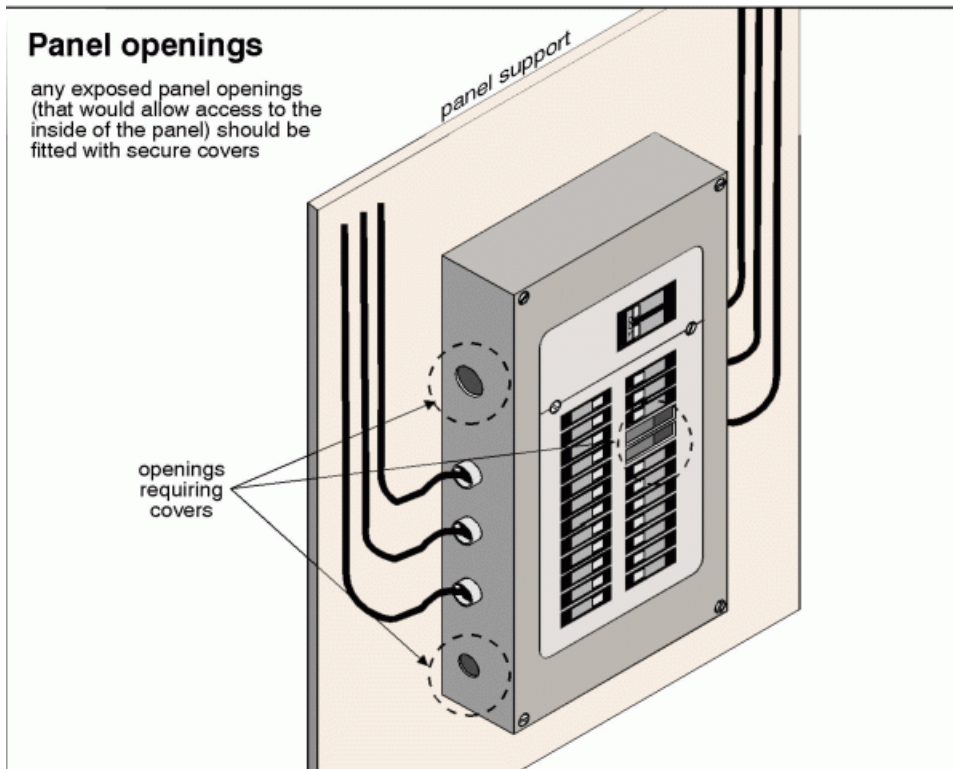
4. Condition: • [Openings in panel](#)

Implication(s): Electric shock | Fire hazard

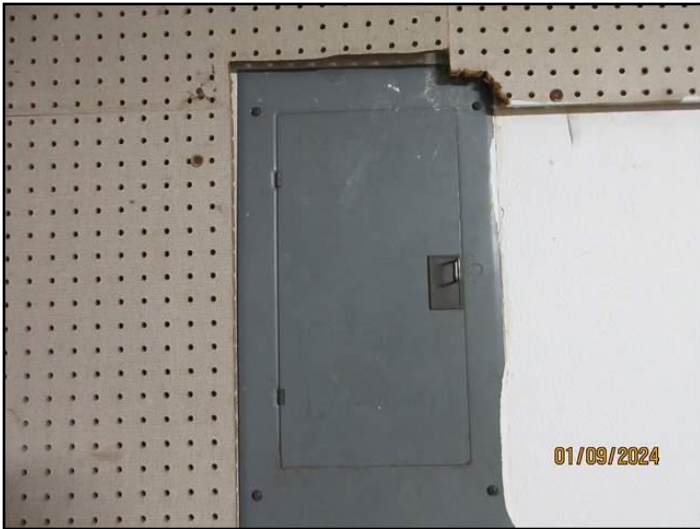
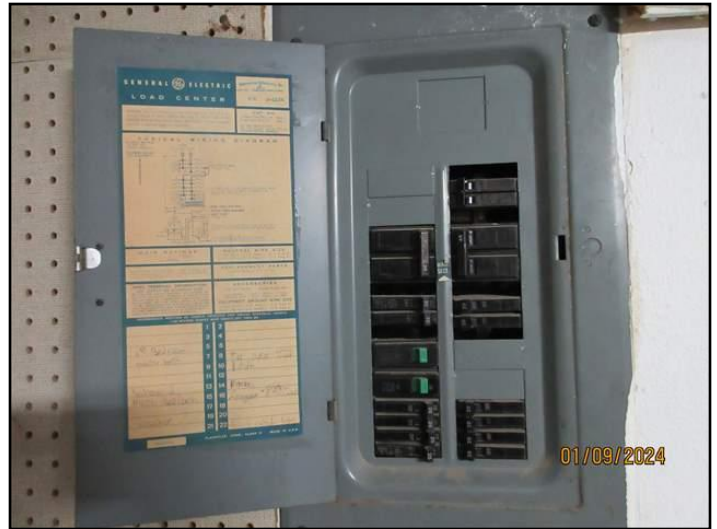
8. Unprotected openings

9. Unprotected openings

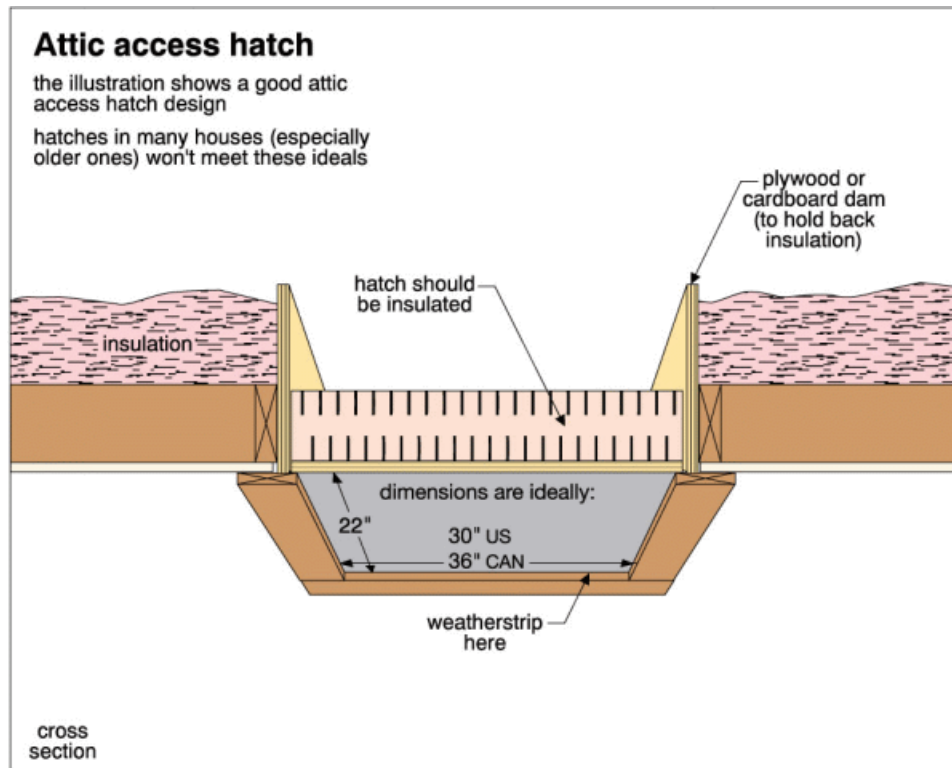
**11. Condition:** • [Not insulated](#)

Attic access panel should have a weatherstrip and insulation.

**Implication(s):** Increased heating and cooling costs | Reduced comfort
