# INSPECTION REPORT

123 ABC  
St. Louis, MO 63141

**INSPECTION DATE**  
Tuesday, April 15, 2025

Report No. 1012

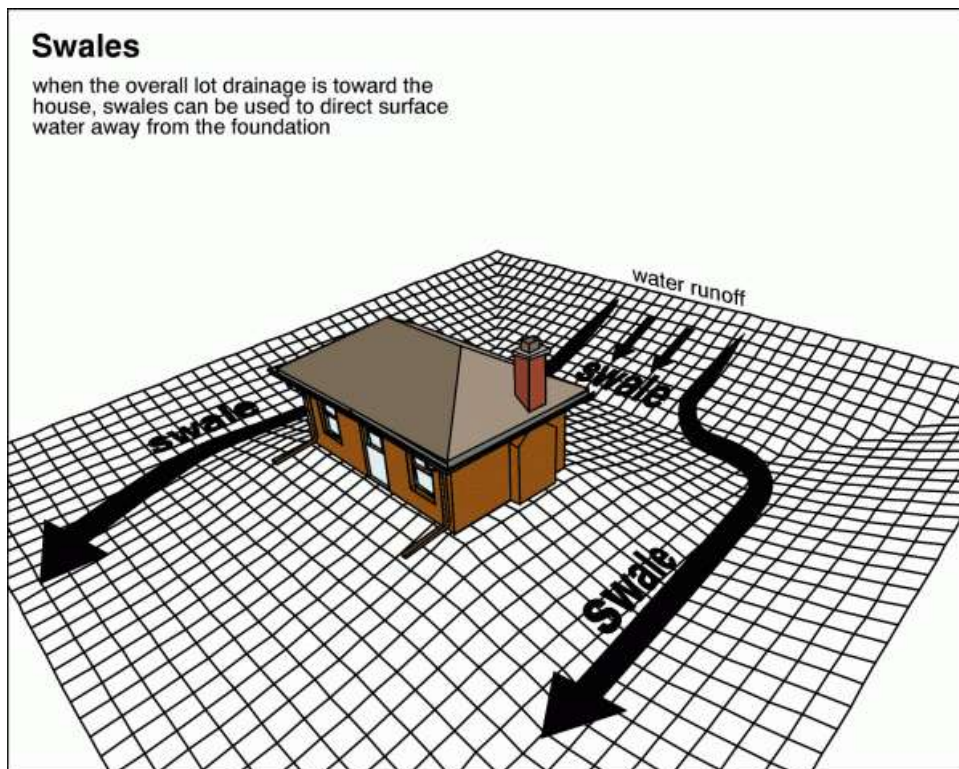
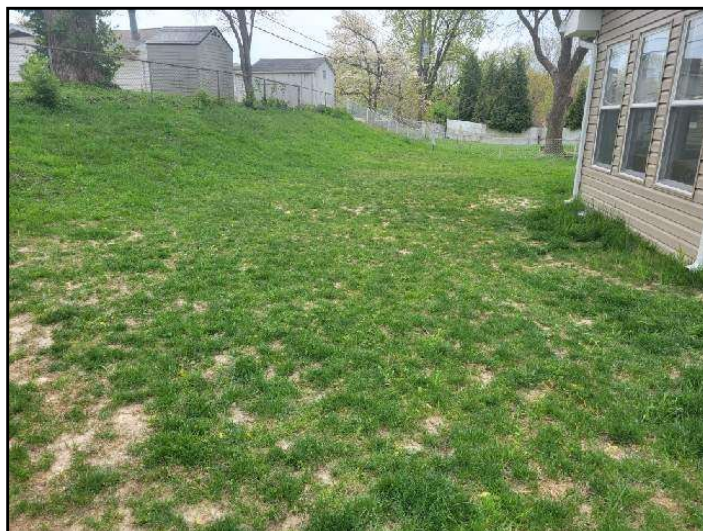
4. Condition: • [No swale](#)

Implication(s): Chance of water entering building

20. No swale

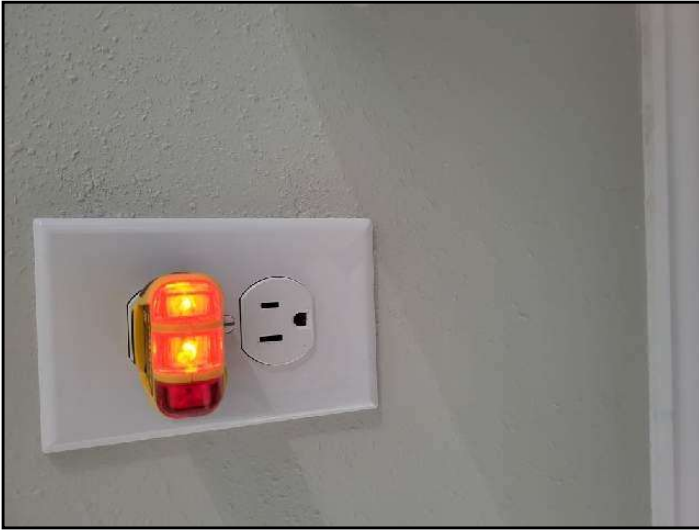
33.

**Condition:** • [Ungrounded](#)

**Implication(s):** Electric shock

- [Ungrounded - typical](#)

**Task:** Upgrade

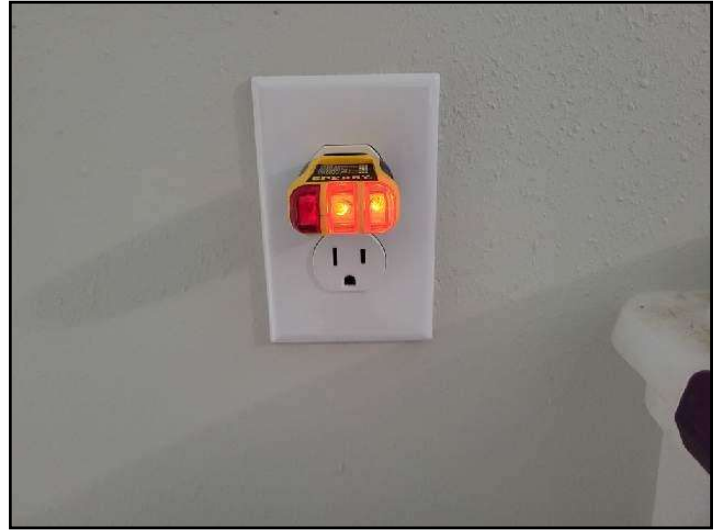
34. *Grounded - typical*

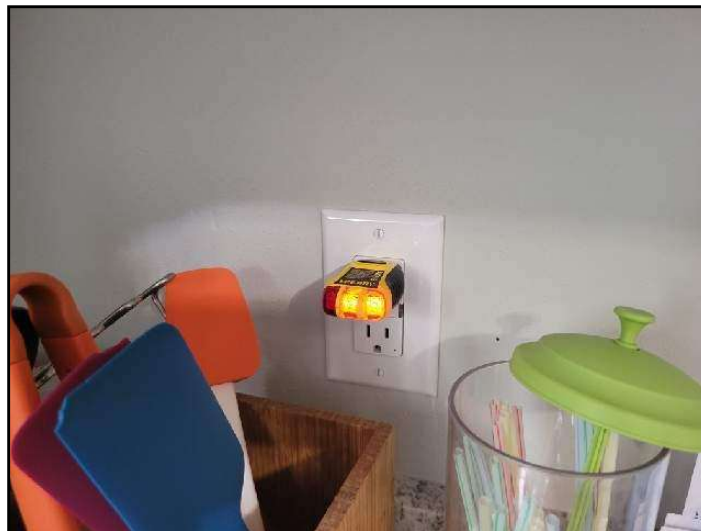
35. *GFCI - kitchen*

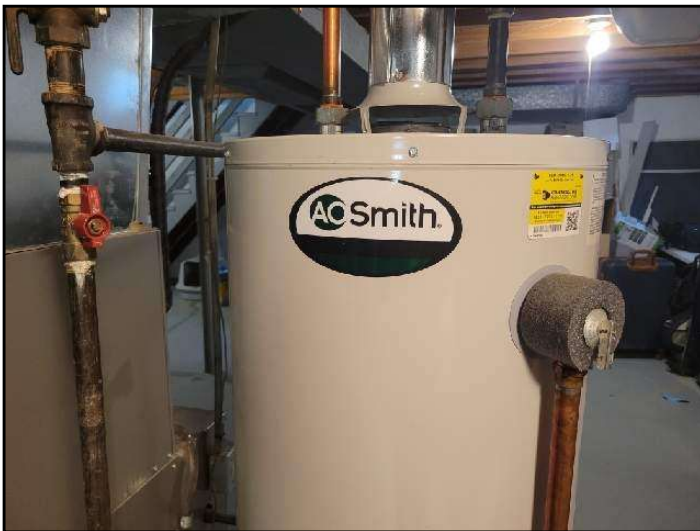
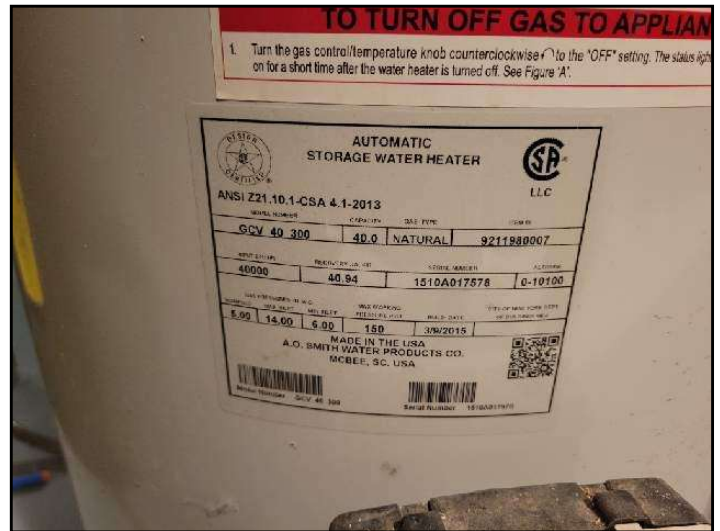
56. A.O. Smith

11. Condition: • [Near end of life expectancy](#)

Implication(s): No hot water

12. Condition: • [Rust](#)

Implication(s): System inoperative | No hot water

Task: Monitor Upgrade

Task: Monitor Service Clean
