NATIONAL
PROPERTY
INSPECTION
HEADQUARTERS

INSPECTION REPORT

123 Main st
Crossville, TN 38572

Date of Inspection: 11/18/2021
Year Built: 2015 Size: 9217 sq.ft.

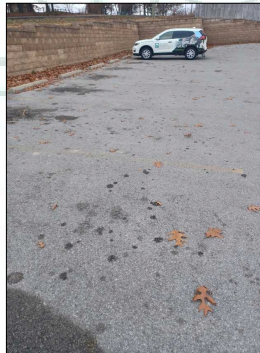
- 31 Total parking spots observed. 2 of which were handicapped.
- Parking lot striping was faded. Recommend restriping.

Parking lot lines faded

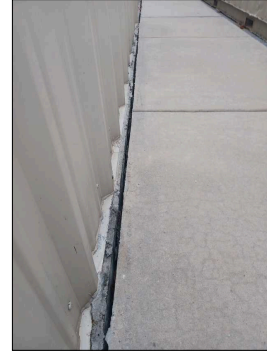
- Gap present between sidewalk and building. Recommend sealing gap to prevent moisture intrusion.

Gap between sidewalk and building

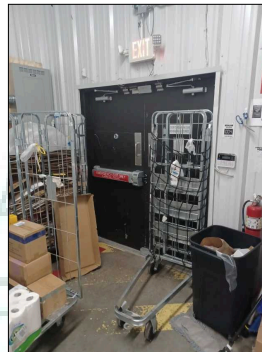
- Items were blocking rear emergency exit. This is a fire hazard. Recommend keeping all emergency exits clear at all times for safety.

Rear emergency exit blocked

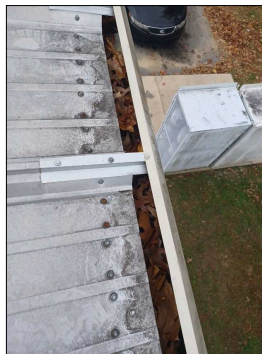
- Gutters were full of debris. Recommend routine cleaning for proper operation and to prevent moisture related issues at the foundation.

Debris in gutters

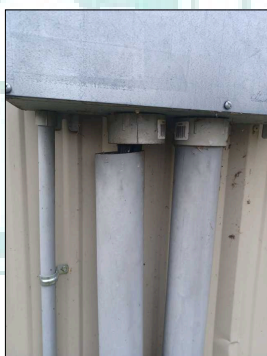
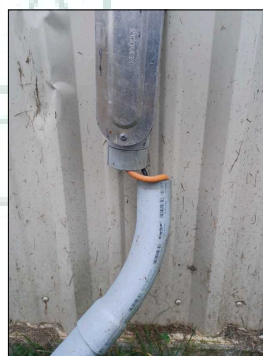
Observations: Multiple conduits at electrical entrance were loose. Recommend properly securing.

Conduit loose

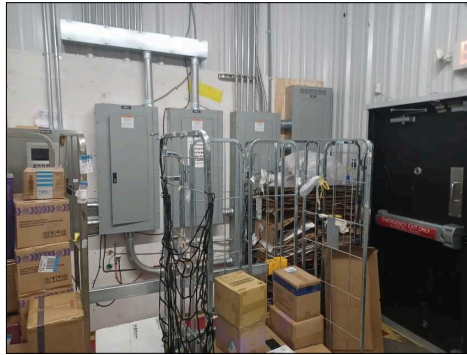
- Boxes, carts, and other items were being stored in front of breaker panels. Recommend removing these items to allow easier access to breaker panels for safety.

Breaker panels blocked

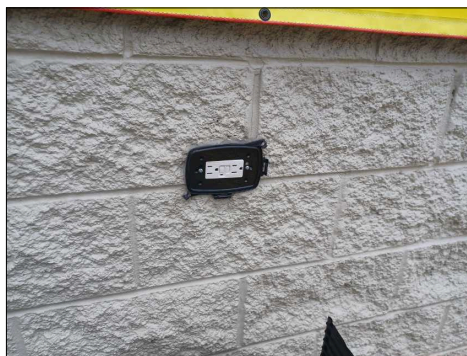
Outlet missing cover

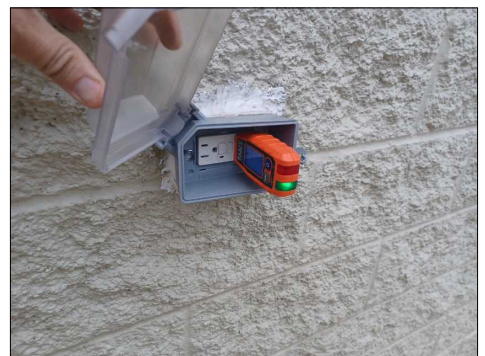
GFCI did not trip

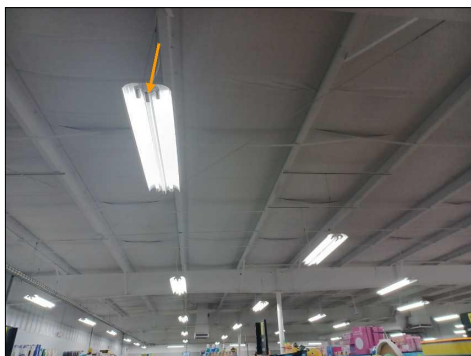
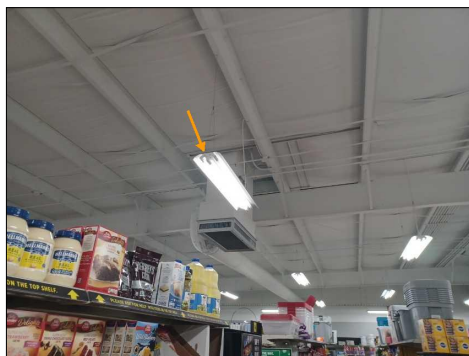
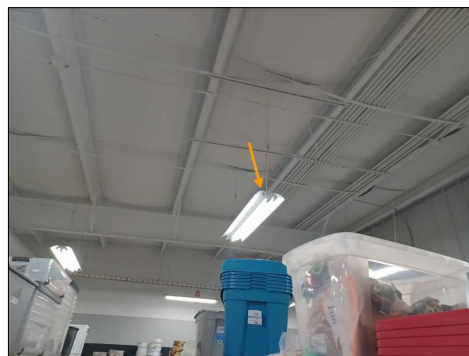
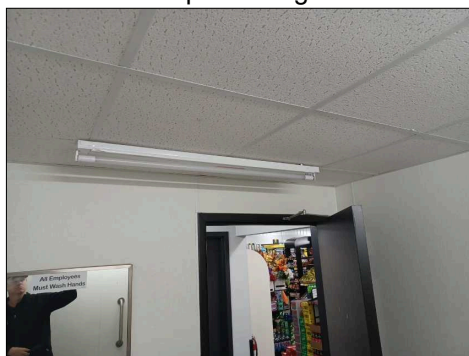
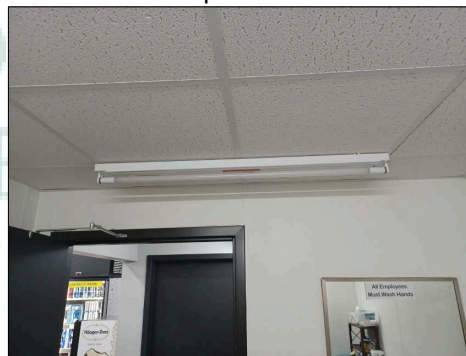
- Multiple inoperable light fixtures. Many times this is due to a bad bulb. Recommend changing bulbs to ensure proper operation and have qualified electrical contractor further evaluate if necessary.
- 9 exterior security lights observed
- 8 interior emergency lights observed
- GFCI (Ground Fault Circuit Interrupter) circuitry was inoperable in on exterior of building. Industry standards since approximately 1987 indicate all exterior electrical outlets have GFCI protection for additional safety.
- Bathroom exhaust fans were inoperable. Recommend qualified contractor repair/replace.

Inoperable light

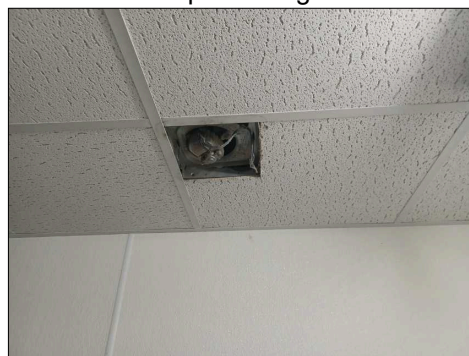
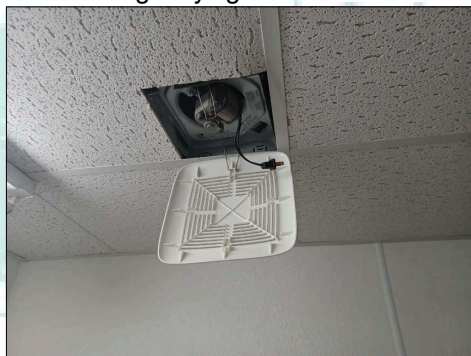
Inoperable bathroom exhaust fan

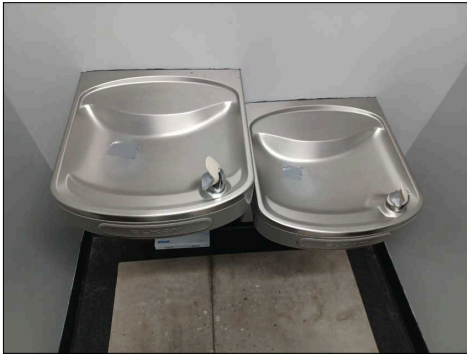
Water fountains disabled

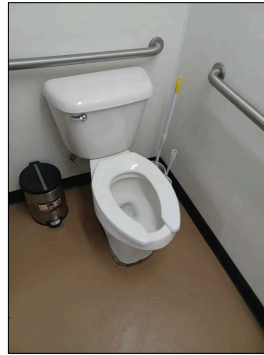
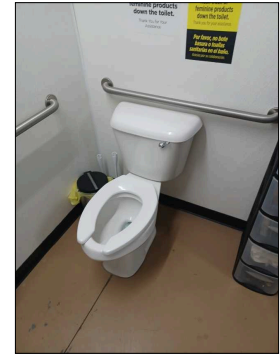
- Water fountains were taken out of service.
- Multiple toilets were loose at the base. Recommend securely attaching to the floor to prevent leaks.

Toilet loose at base
