NATIONAL PROPERTY INSPECTIONS®

Inspection Report

1234 Street
Montgomery TX

Date: 2/18/2022	Time:	Report ID: NPINHO21822
Property: Street Address Montgomery TX	Customer: Client Name	Real Estate Professional:

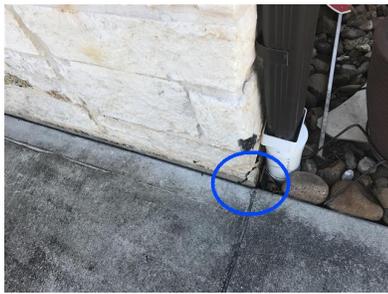
A. Item 6 (Picture)
east elevation; front, by gas shutoff

(2) Typical corner pops were observed. It was noted that the house had corner pops on one or more corners of the foundation. Corner pops are not structural in most cases and should be patched as needed. Corner pops generally occur in areas of the foundation where it is difficult to add reinforcements into the concrete foundation forms and the lack of reinforcement allow corners to crack and sometimes pop loose. I recommend patching the concrete to prevent further deterioration

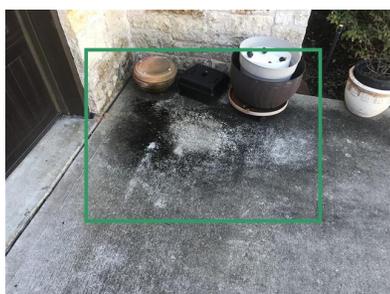
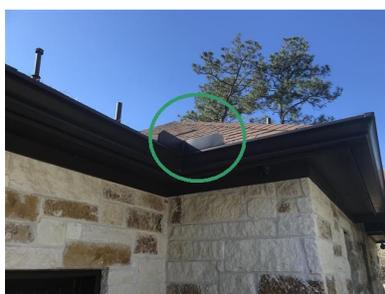
(3) Evidence of moisture accumulation was observed near the garage. The gutter directly above was clogged and could be the source of excess standing water. I would recommend cleaning the gutters of debris, and cleaning the microbial growth off concrete and monitor area for water accumulation. If continues, i would recommend consulting a drainage contractor to discuss installing a drain in this location.

3. (3) Evidence of moisture accumulation was observed near the garage. The gutter directly above was clogged and could be the source of excess standing water. I would recommend cleaning the gutters of debris, and cleaning the microbial growth off concrete and monitor area for water accumulation. If continues, i would recommend consulting a drainage contractor to discuss installing a drain in this location.

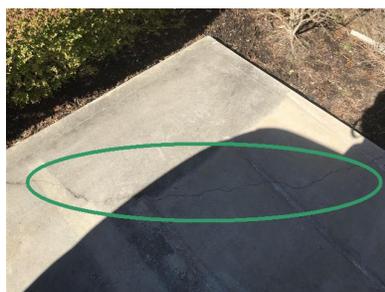
The driveway was concrete and had the proper expansion joints to help prevent cracking. The concrete driveway had some noticeable cracking in various places. The cracks observed at the time of inspection seemed to be typical concrete cracking, there was minimal horizontal and vertical displacement observed at this time to cause concern. Not a big safety concern at this moment, but if these separate further or show any signs of vertical displacement I would recommend repairing these areas.

C. Item 2 (Picture)
cracked corner

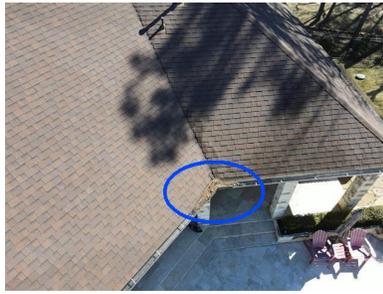
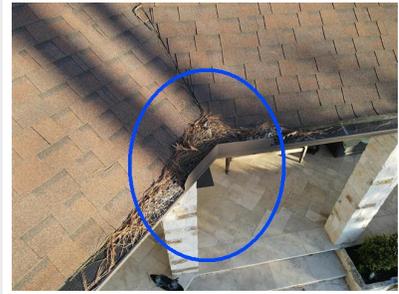
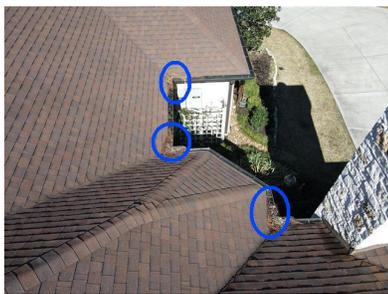
(2) Piles of pine needles and debris were observed sitting in several locations on the roof. I recommend clearing these areas to prevent moisture being trapped on shingles and causing shingles to deteriorate at a quicker rate than the surrounding roof covering. All debris should be cleared from roof covering and gutter system to make sure runoff is directed off and away from the home.

D. Item 9 (Picture)
debris

4. (2) Piles of pine needles and debris were observed sitting in several locations on the roof. I recommend clearing these areas to prevent moisture being trapped on shingles and causing shingles to deteriorate at a quicker rate than the surrounding roof covering. All debris should be cleared from roof covering and gutter system to make sure runoff is directed off and away from the home.

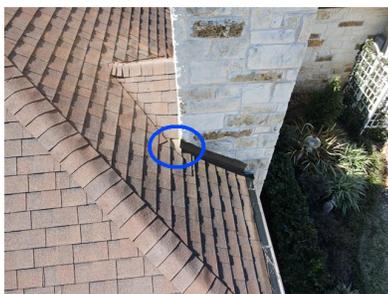
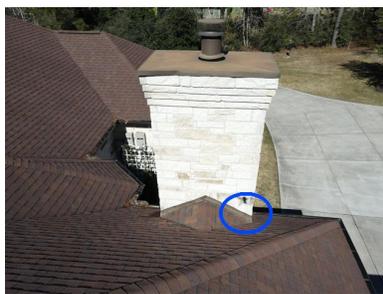
(3) Damaged or missing shingles were noted on the cricket for the dining room chimney. This is a vulnerable location for water penetration and needs to be corrected, I recommend further investigation and repair if necessary by a qualified roofing contractor.

D. Item 13 (Picture)
dining chimney

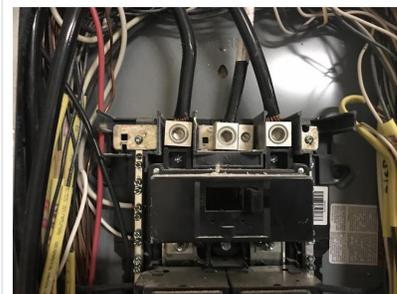
B. Item 6 (Picture)
garage panel

(1) There are two 200amp circuit panels located in the garage manufactured by Square D. Wiring from main panel appears to be 2/0 awg copper wiring as well and seems to be sufficiently sized for this application. The branch circuit wiring system appeared to be in good working condition at the time of inspection. All accessible receptacles were tested for polarity and GFCI protection where applicable. All branch wiring leaving the circuit panel were properly protected with bushings.
