Inspection Report

Property Address:
1313 Mockinbird Ln
Anytown, TX 77433

PROPERTY INSPECTION REPORT

2-15-2018

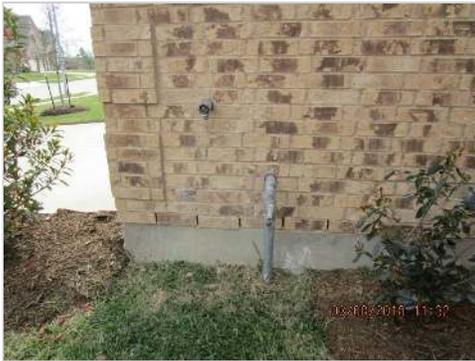
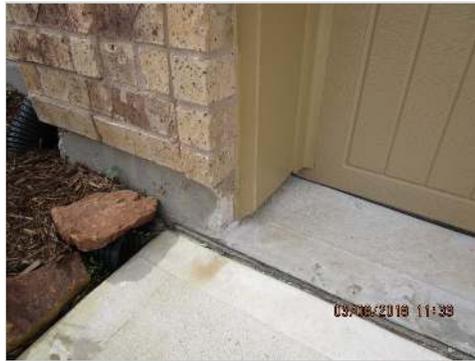
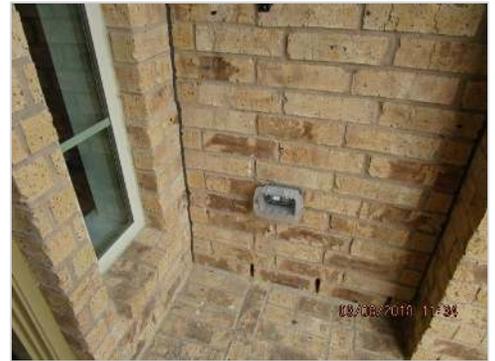
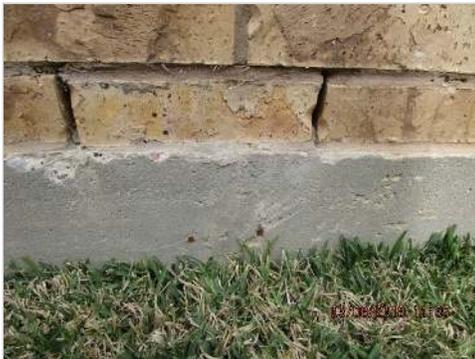
Three corners of the foundation had corner cracks. Corner cracks are diagonal, wedge shaped cracks isolated to the extreme corners of the foundation. While this is typical on concrete foundations and not considered to be a structural concern, it should be repaired, where possible to prevent further spreading. Foundation cracks require routine maintenance and may need to be caulked and/or sealed from time to time to prevent water seepage.

3.20.2018 Reinspection comment: Corner Cracks were repaired / covered with cement. this should aid in prevent further movement. This area should be monitored to ensure it does not move in the future.

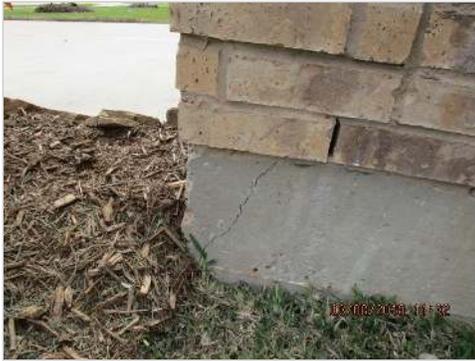
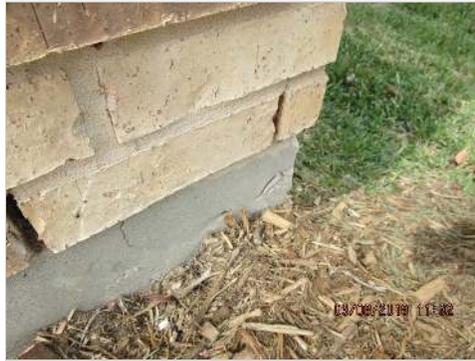
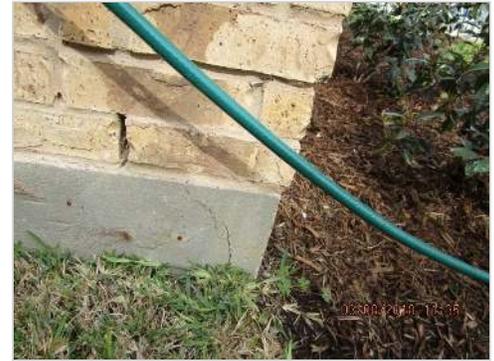
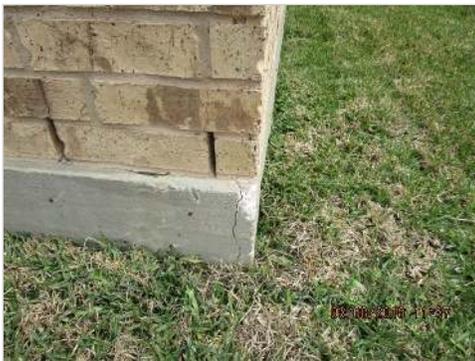
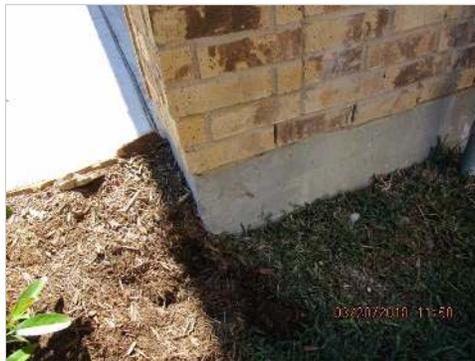
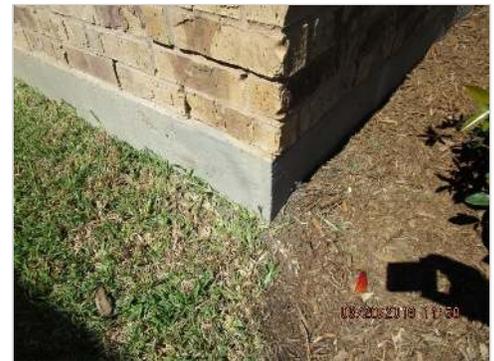
Photo of repair

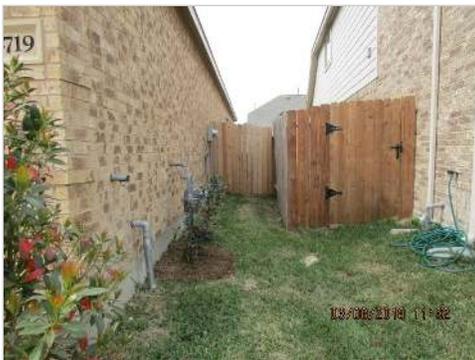
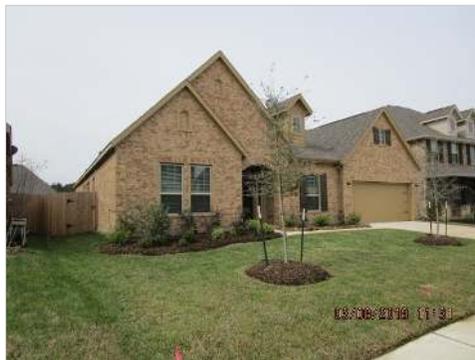
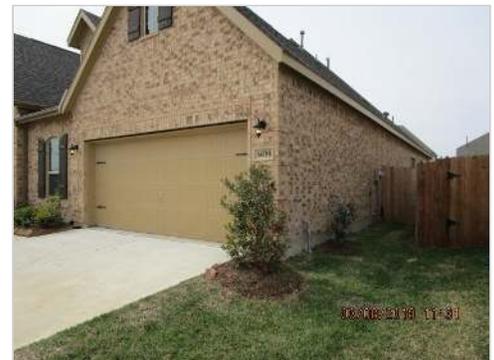
Overall the grading around the home maintained a positive slope away from the building. However, the grading in the rear of the house did not meet the required 6" over 10' slope (5%). While there is a swale in the backyard, it appeared that 70% of the drainage would be directed towards the house, and not properly diverted to the sides. This condition may allow water to flow towards the house during rains and has the potential to allow water to enter the dwelling. Reccomend improvements in grading/drainage.

3.20.2018 Reinspection comment: Builder attempted to improve the drainage by digging the swale a little deeper. Inspector was not able to confirm if this effort will have the desired effect.

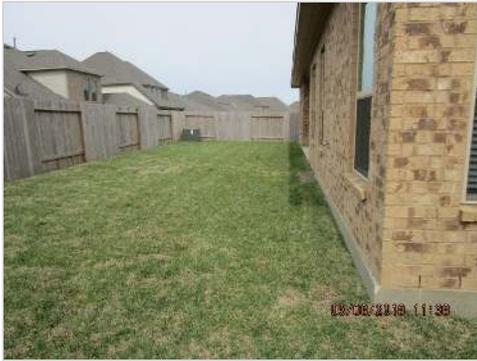
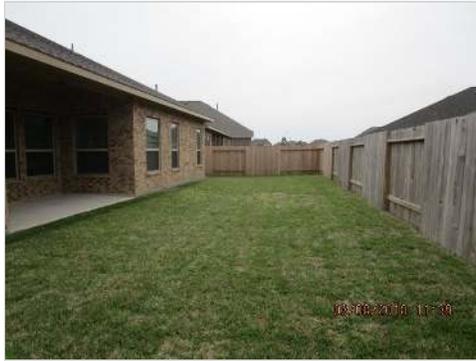
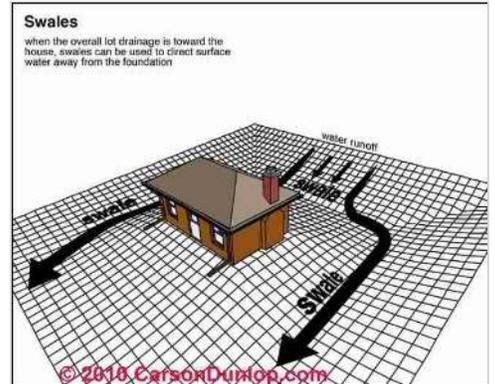
Typical rear Grading / Swale

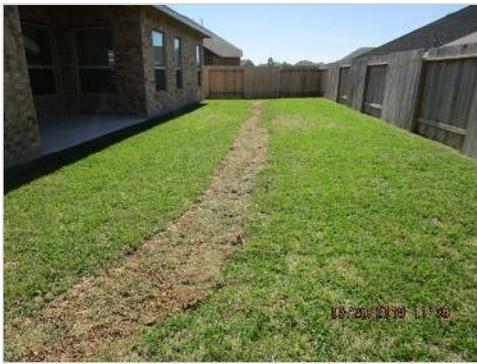
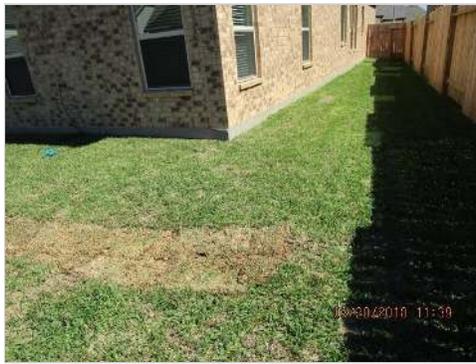
Photo of repair

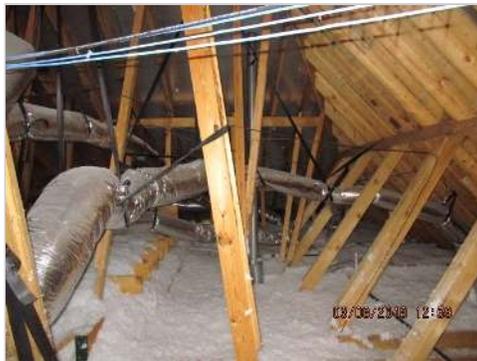
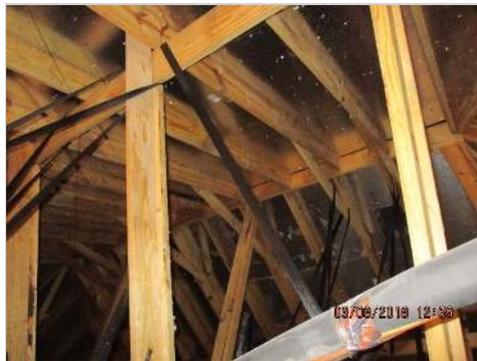
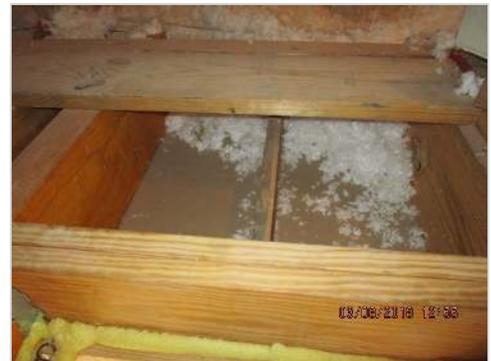
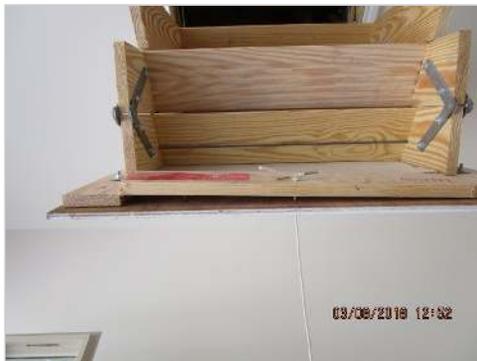
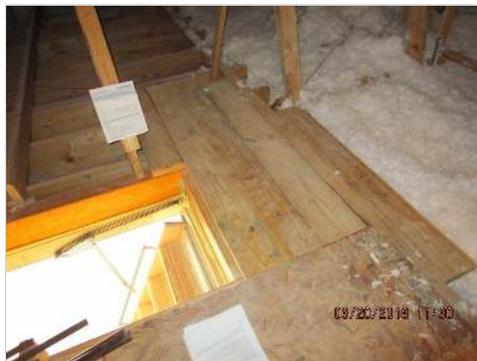
All the framing and sheathing that was visible from the attic was acceptable at time of inspection. The landing at the top of the attic access stairs is not decked at the first step. this small section should be decked in order to prevent trips.

The pull down ladder was beginning to separate where the pull cord is attached. This should be repaired.

3.20.2018 Reinspection comment: Landing at top of attic stairs has been corrected.

Photo of repair

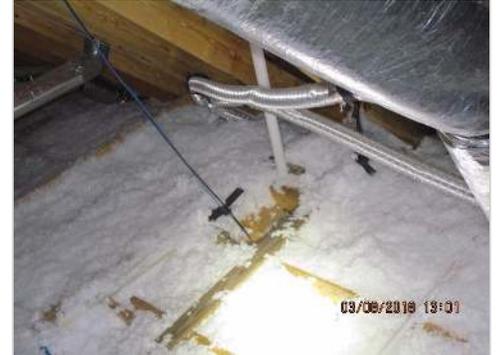
There were a few areas in the attic where the insulation appears to have been pushed aside or removed where the low voltage / communication cables are penetrating wall caps. The insulation should be replaced back in these areas to ensure the intended function is maintained.

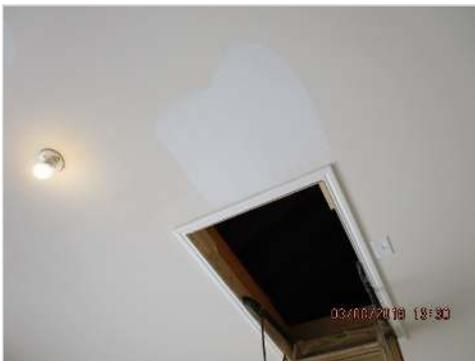
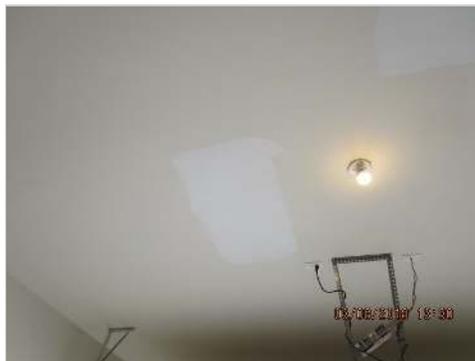
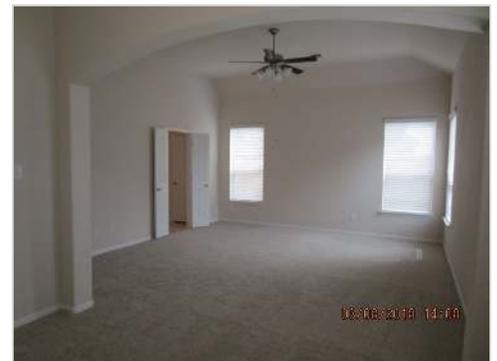
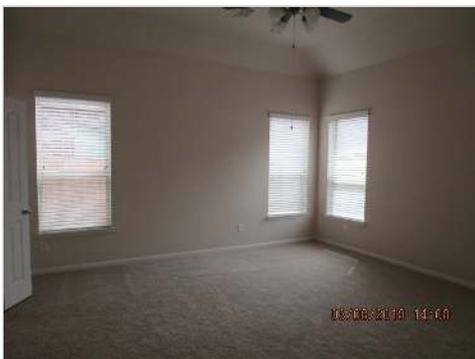
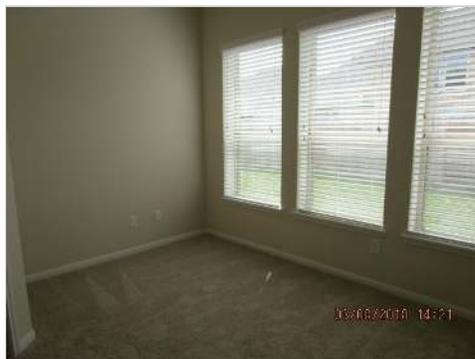
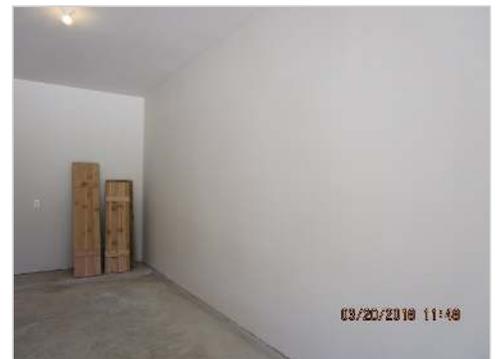
Some areas in the garage were touched up and painted with a different shade. As a matter on convenience to etc homeowner, these areas should be repainted with a matching color.

3.20.2018 Reinspection comment: Walls were repainted at time of re-inspection visit.

Photo of repair

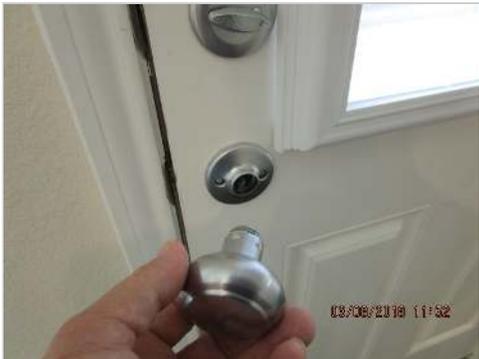
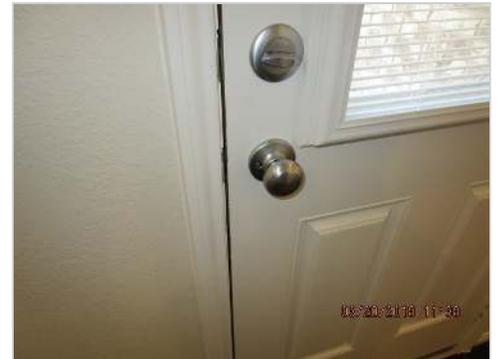
Doors appear to be functioning properly and seal properly when closed, but the rear door knob was not properly installed and fell off when attempting to open the door.

3.20.2018 Reinspection comment: Door knob was repaired.

Photo of repair

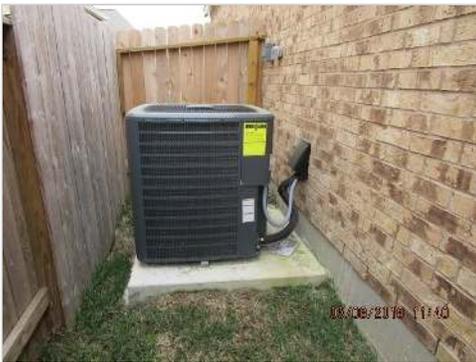
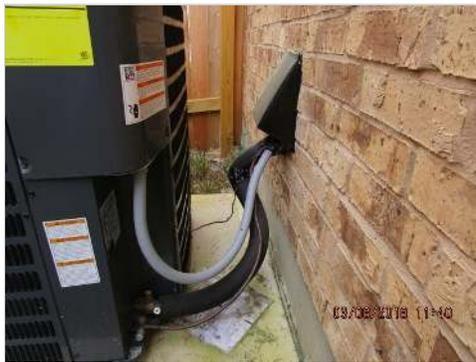
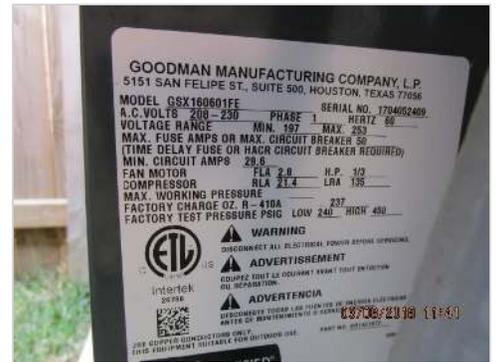
A/C Compressor access area is very restricted, which will create difficulty for service / maintenance. Additionally, the required 120volt receptacle and service disconnect are on the opposite side of the A/C from access point. Recommend adding a gate in front of A/C

3.20.2018 Reinspection comment: Builder added gate in front of A/C to improve access.

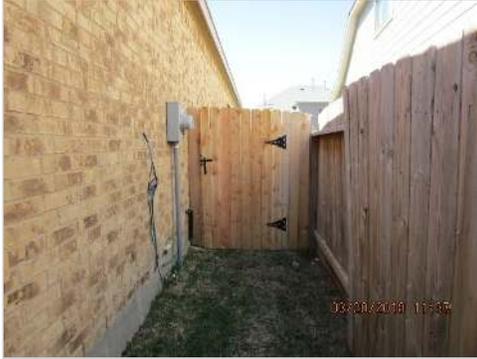
Photo of repair

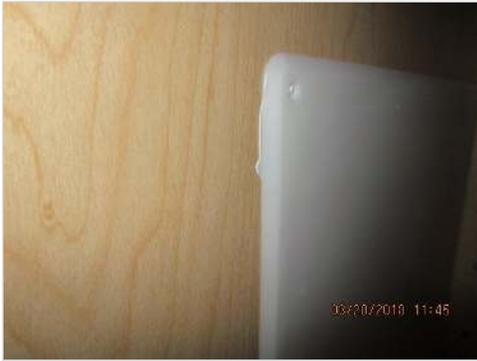
Photo of repair

3.20.2018 Reinspection comment: Access Covers were placed in the two adjacent cabinets at the Jetted Tub. Inspector could not confirm if there was an actual cutout.

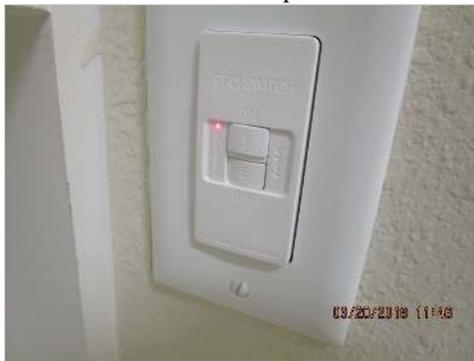
Photo of GFCI Reset

3.20.2018 Reinspection comment: GFCI was able to be reset during re-inspection

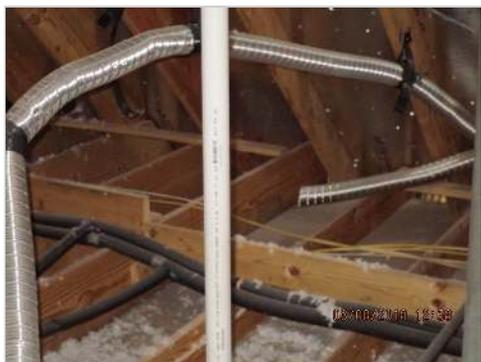
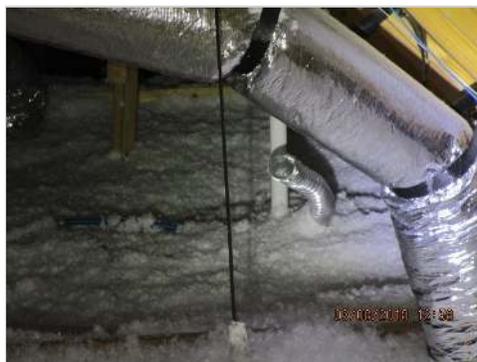
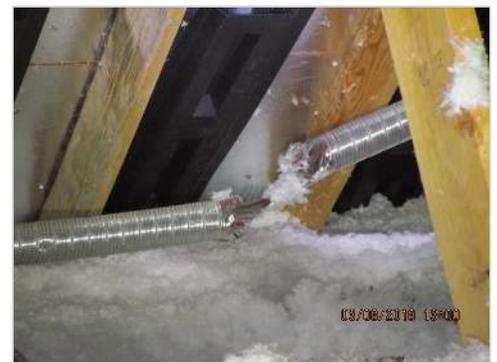
Bathroom exhaust fans were connected to ductwork that was broken in the attic space. These areas should be repaired to avoid blowing humid air from etc bathrooms into the attic.

3.20.2018 Reinspection comment: Bathroom exhaust duct work was found to have been repaired during re-inspection.
