Thoreyon Enterprises LLC DBA
National Property Inspections

Inspection Date:
03/11/2025

GENERAL INFORMATION

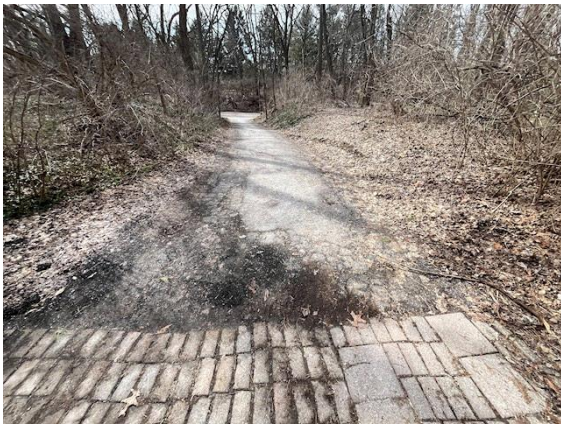
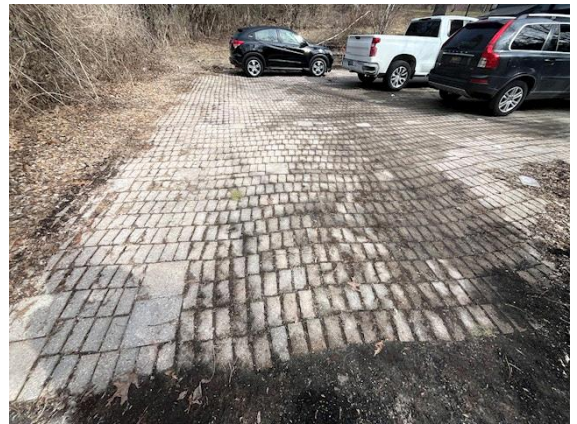
Brick driveway was an acceptable condition at the time of the inspection bricks had some Moss growth and some of the bricks had come up recommend relaying the bricks and cleaning the surface

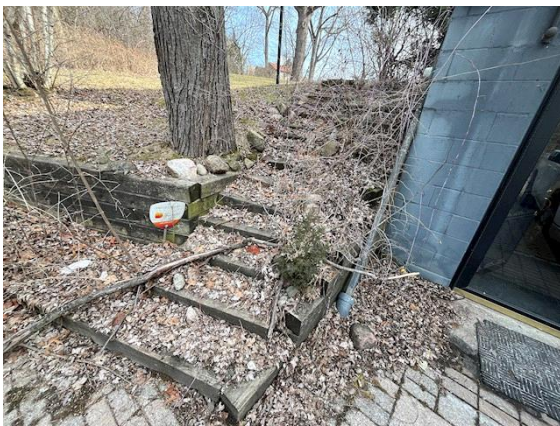
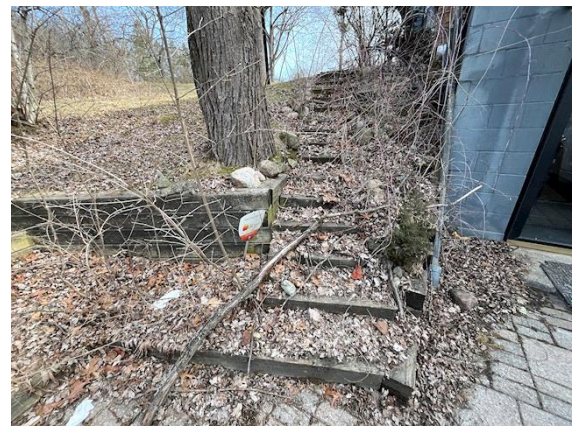
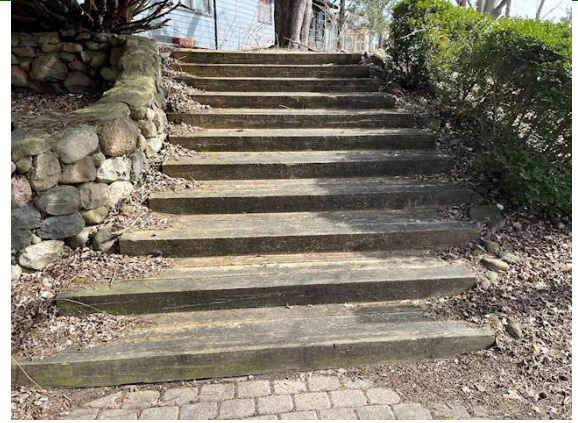
Wood steps leading from the driveway to the front and rear of the property were deteriorating and overgrown with vegetation recommend clearing out the vegetation and re laying the steps

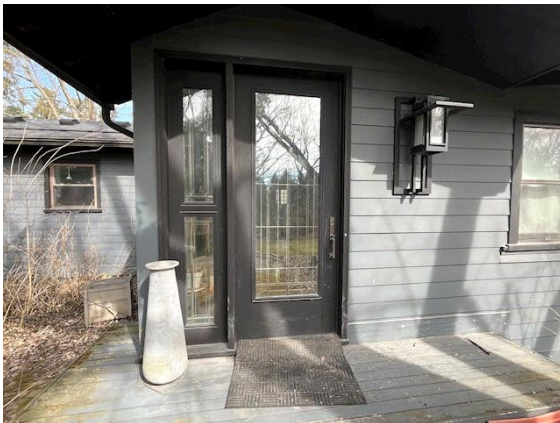
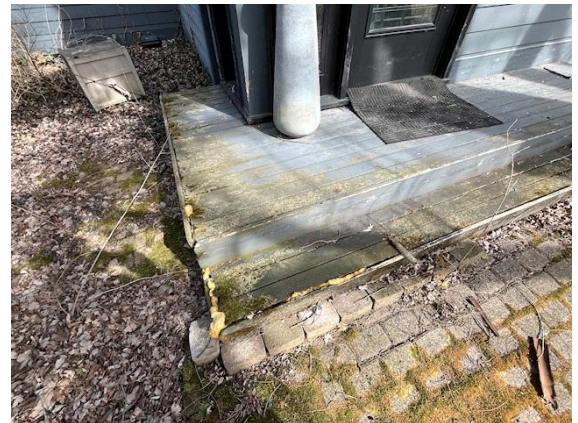
Deterioration was observed at some of the floor boards.

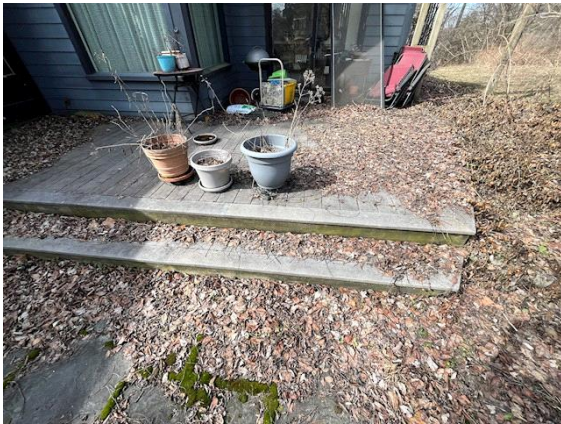
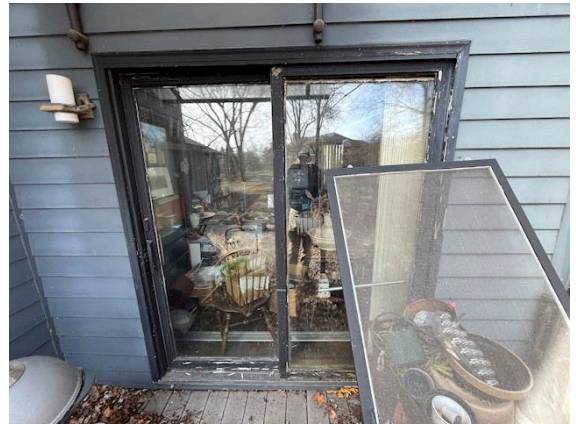
Rear deck showed some deterioration of the wood. There were holes present and deck was covered in vegetation recommend repairing the wood and clearing the deck and resealing. Sliding doors to sun room were deteriorated and glass has slipped down due to degradation of the wood frame leaving a gap in the top of the door.

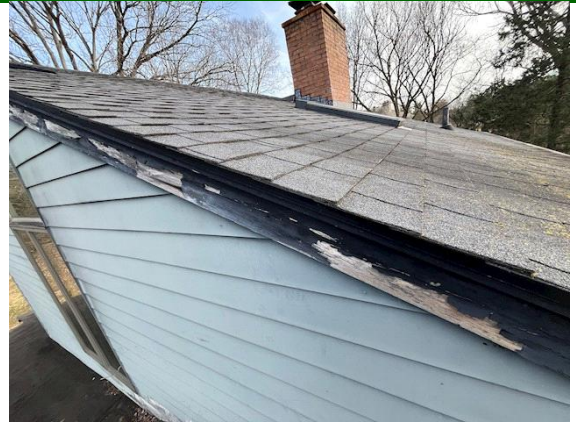
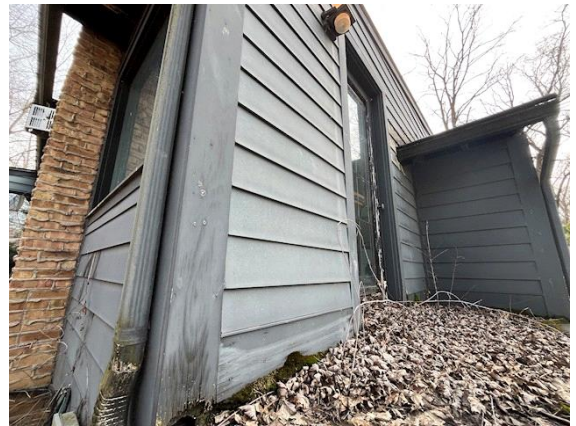
There were many areas where the flashing had deteriorated and there were holes present that could be a conducive condition for water intrusion and rodent and pest entry. There were areas where the wood Ridge board and fascia had deteriorated. Recommend repair to prevent further damage and intrusion

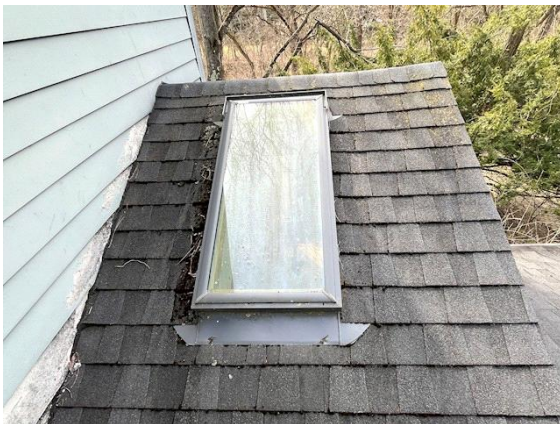
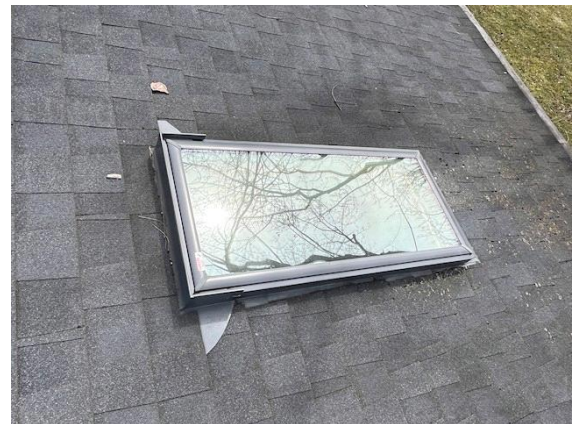
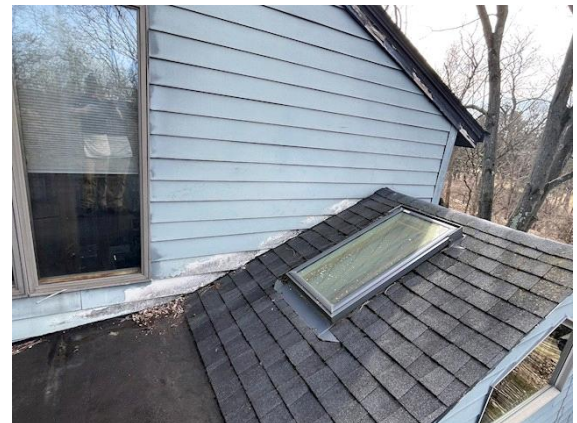
Flashing around the skylights could be causing some water intrusion. Recommend resealing and caulking to prevent further intrusion. Thermal Imaging shows possible moisture intrusion. This could be due to loose flashing or leak in the skylight.

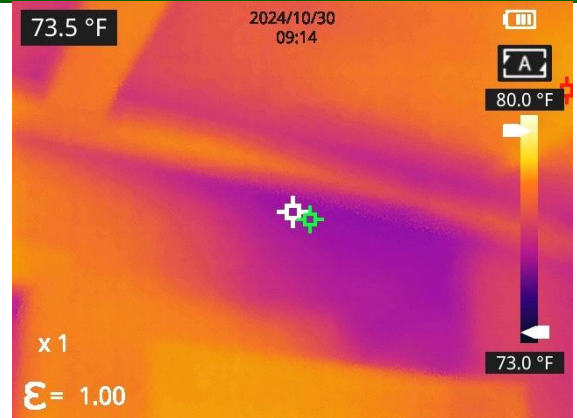
Skylights: Thermal Imaging shows possible moisture intrusion in Ceiling in Living Room.

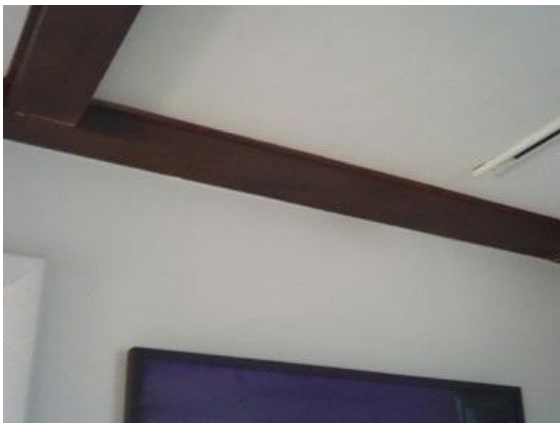
Skylights: Area in Living Room of possible moisture intrusion.

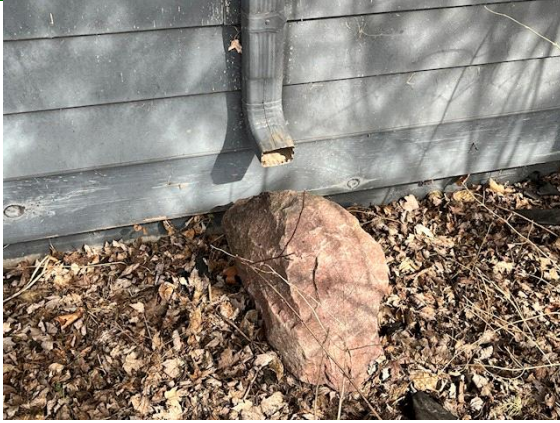
Gutters/Down Spouts: Missing Downspout extension to divert water away from the foundation.

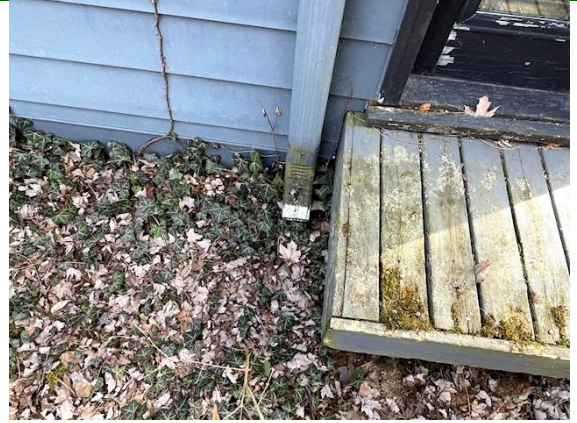
Gutters/Down Spouts: Missing Downspout extension to divert water away from the foundation.

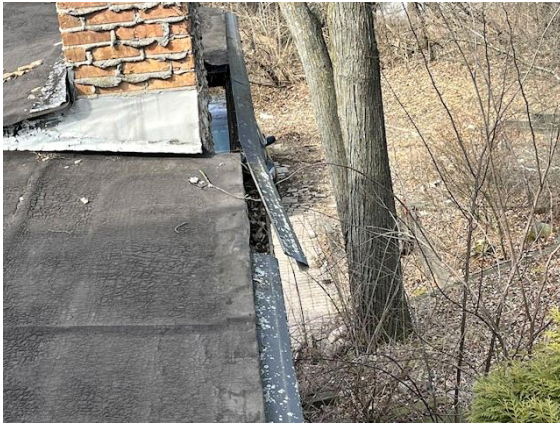
Gutters/Down Spouts: Gutter has become detached from fascia.

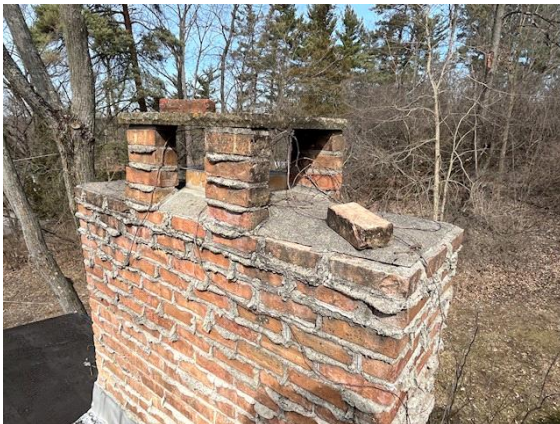
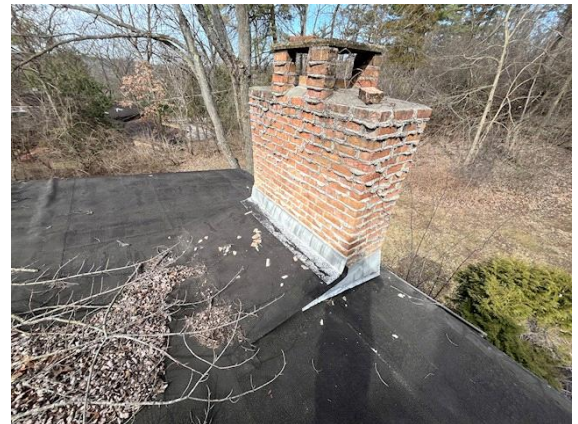
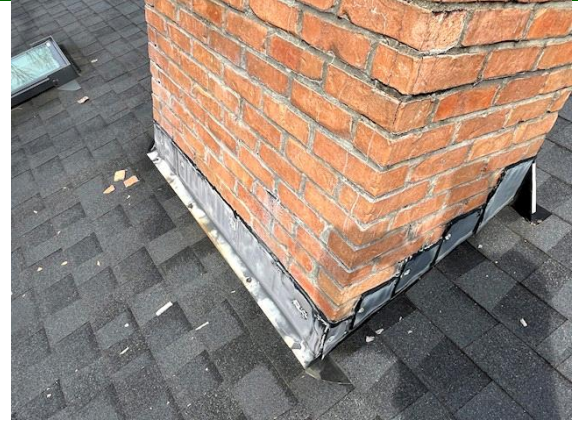
There are two chimneys. The chimney off the dining room appears to have been sealed off and was in acceptable condition at the time of the inspection. The chimney connected to the living room showed some signs of deterioration. Recommend repointing and tucking the mortar in the chimney

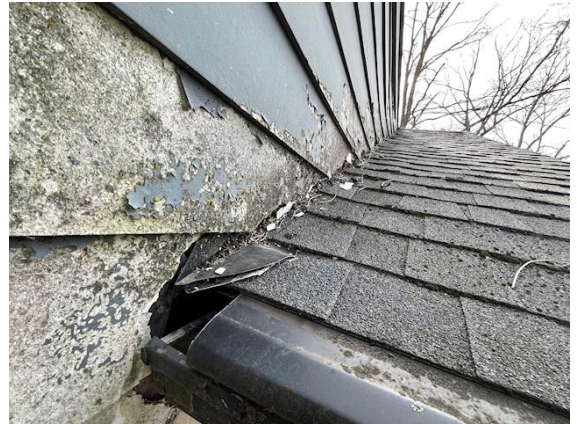
There were areas of the siding that had become deteriorated and degraded. This condition could lead to water intrusion and pest intrusion. Recommend repairing damaged siding to prevent further degradation.

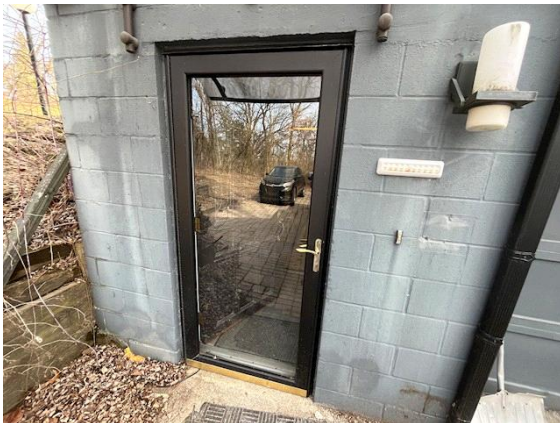
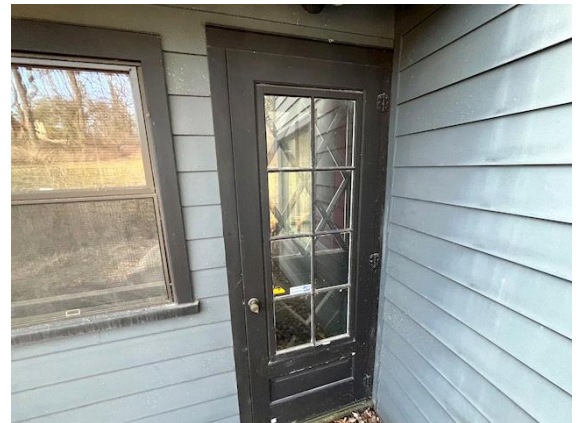
Sliding doors off the rear deck in the sunroom word degraded and deteriorated glass had slid down allowing for a gap in the top of the door. Balcony door off the dining room also had a deteriorated frame which has caused the glass to slide down as well allowing for a gap in the top of the window. Front door and rear laundry room door were in acceptable condition at the time of the inspection.

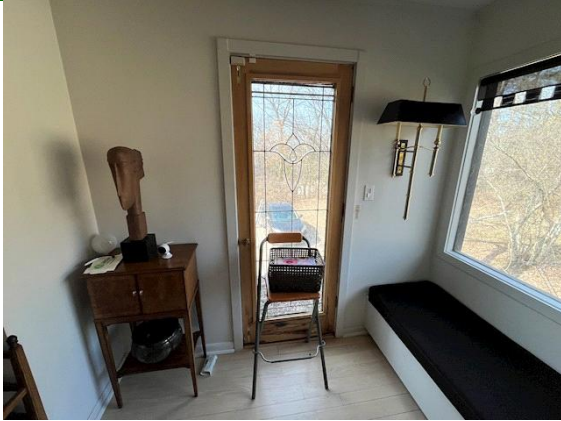
Exterior Doors: Balcony Door off Dining Room. Wood Frame is deteriorated and there is a Gap in the door between the Glass and the top of the frame.

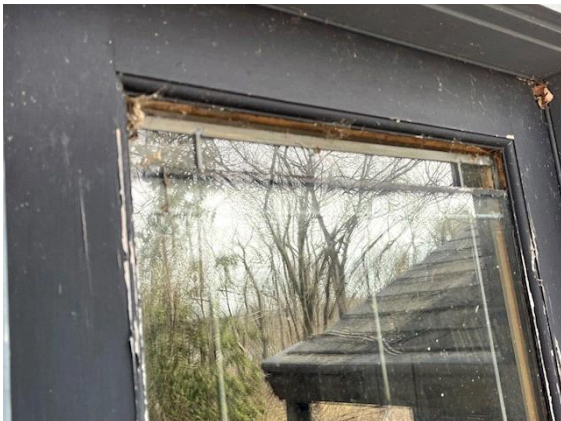
Exterior Doors: Balcony Door off Dining Room. Wood Frame is deteriorated and there is a Gap in the door between the Glass and the top of the frame.

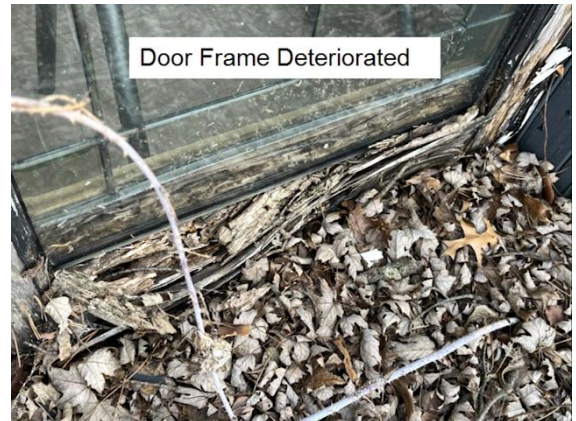
Exterior Doors: Balcony Door off Dining Room. Wood Frame is deteriorated and there is a Gap in the door between the Glass and the top of the frame.

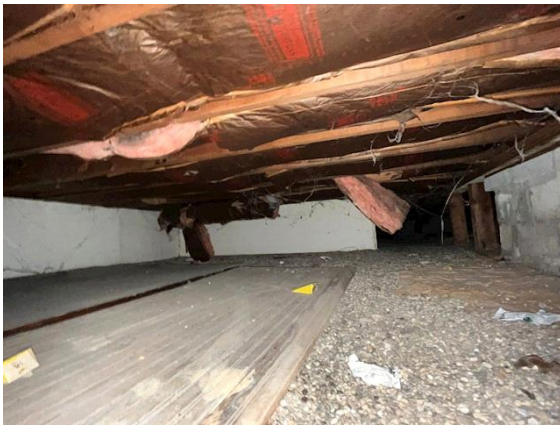
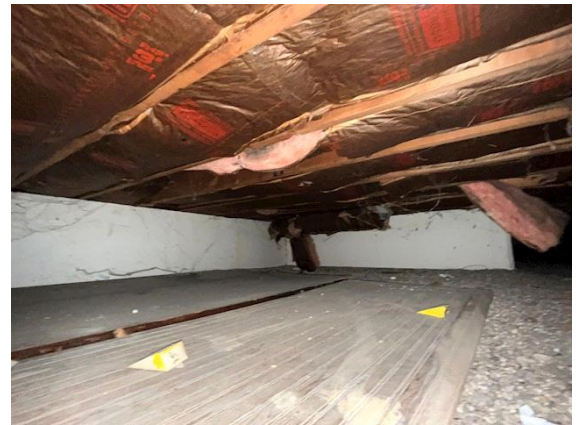
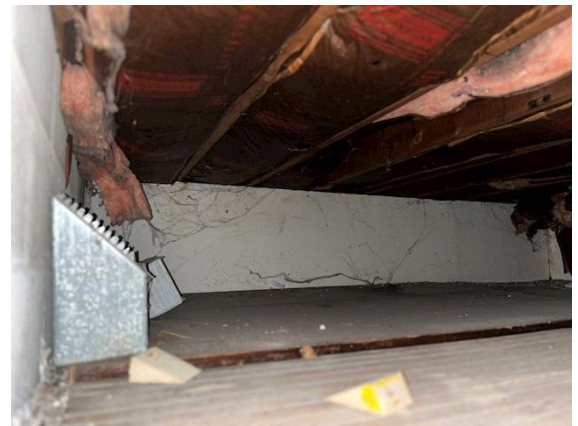
Crawl space was not entered due to rodent activity. Space was observed from the opening. Recommend continued treatment to prevent further activity.

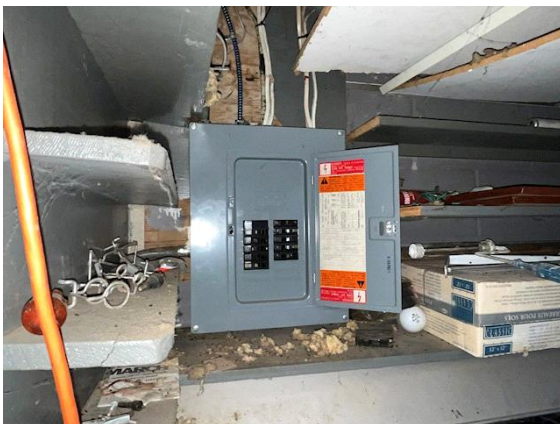
There were three electrical panels observed during the inspection. Electrical panel in the garage showed signs of rodent activity in the panel and a dead mouse on top of the panel. This is a potential fire hazard. Electrical panel in the kitchen was in acceptable condition at the time of the inspection. Electrical panel in the laundry room was painted shut and unable to be inspected for the wiring. There were no GFI protected outlets in the home. GFI outlets were not standard at the time of construction but recommend adding GFI protected outlets in kitchen and bathrooms. Smoke detectors were present in the home but not tested due to the homeowner being present and sleeping.

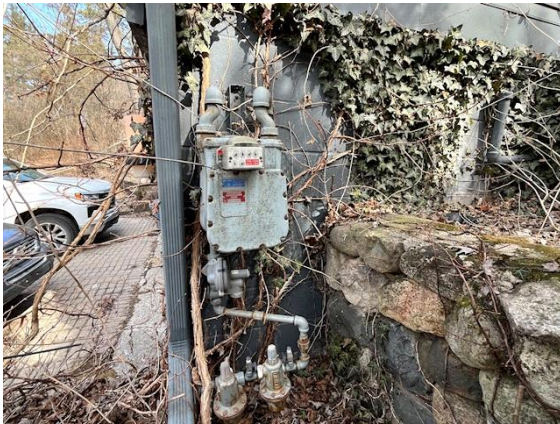
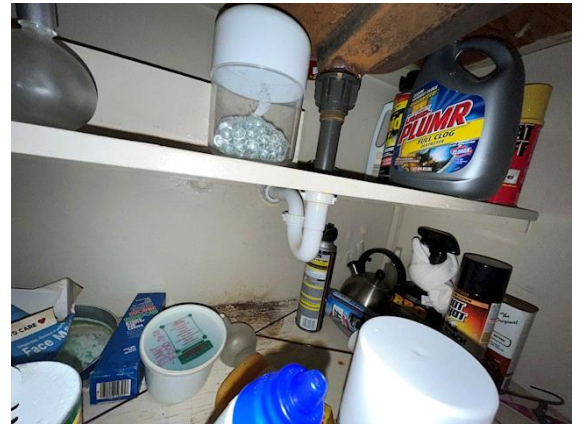
Plumbing appeared to be an acceptable condition at the time of the inspection. Some galvanized piping was observed which is known to degrade and cause leaks. Recommend replacing with PVC pipe as needed.

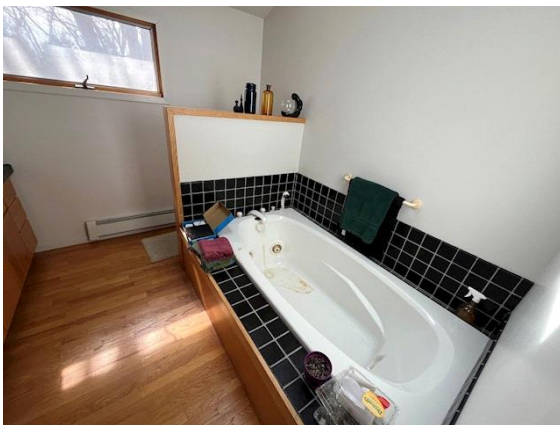
Toilet flush handle was not connected. Water to bathtub was not turned on. Sink was functional. Door handle was loose.

Bathroom - 2nd Floor: Water turned off in tub

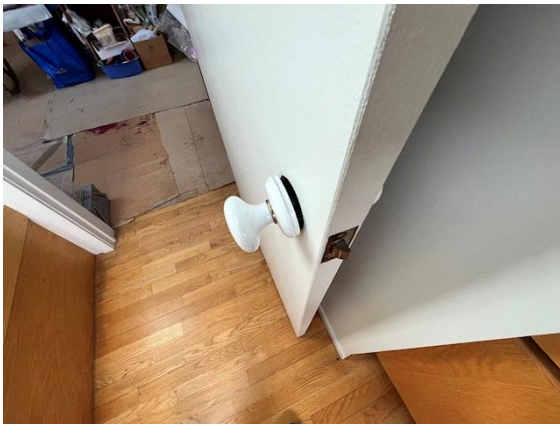
Bathroom - 2nd Floor: Door Handle Loose

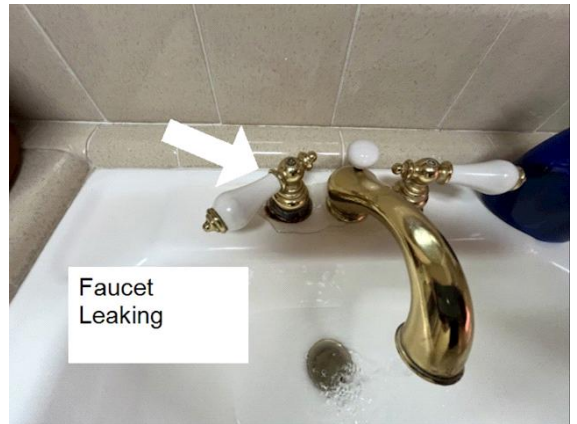
Faucets on the right hand sink were leaking when turned on. All other components were acceptable at the time of the inspection

Bathroom - Full Guest Bathroom: Faucet Leaking

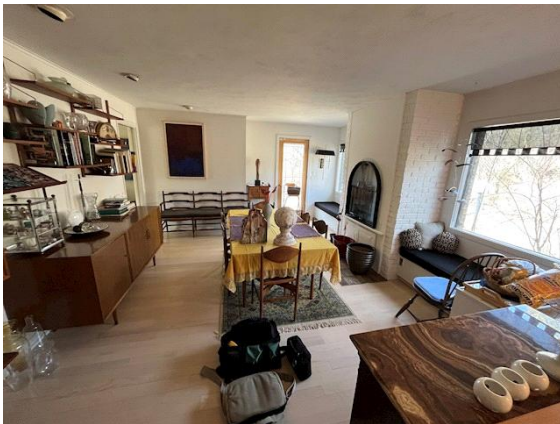
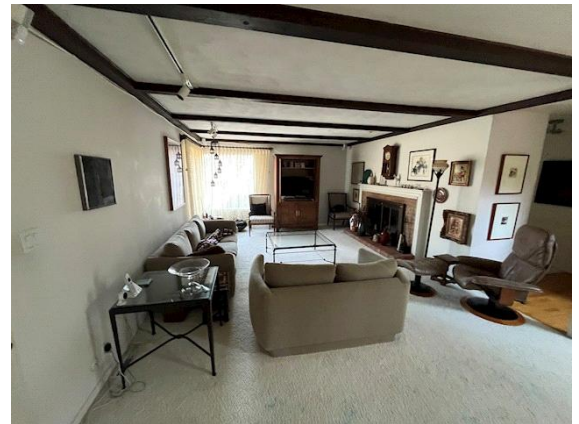
There was evidence of previous damage/leak to the ceiling of the Living Room. Walls were free of cracks. Window(s) functioned properly and seals were acceptable. Receptacles and lights appeared to be wired correctly.

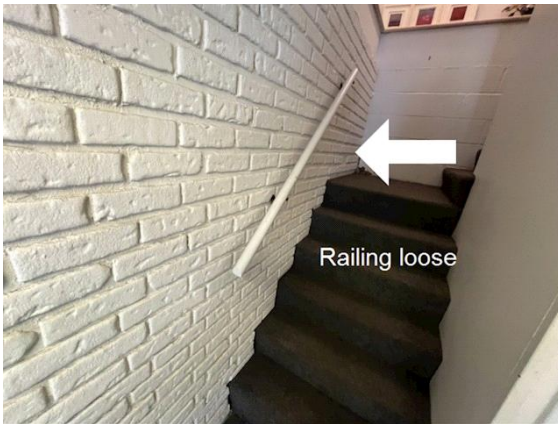
Basement Staircase Railing was loose.

Stairs / Railings: Railing Loose
