INSPECTION REPORT

123 Sample Drive
Sometown, AR

INSPECTION DATE
Tuesday, April 8, 2025

Report No. 1139

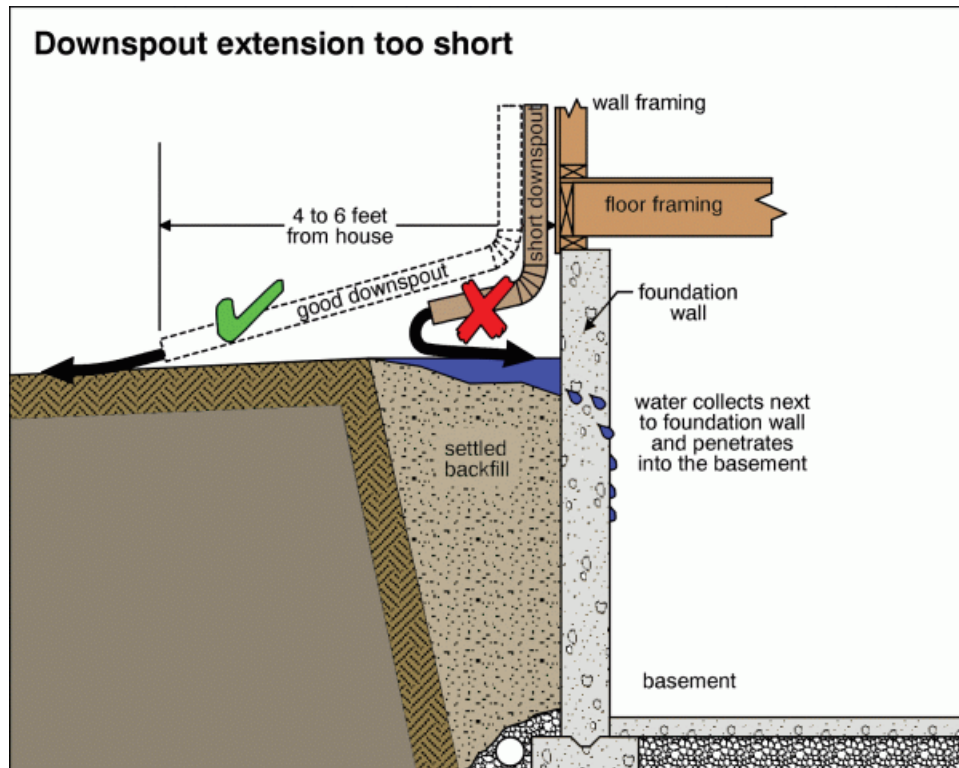
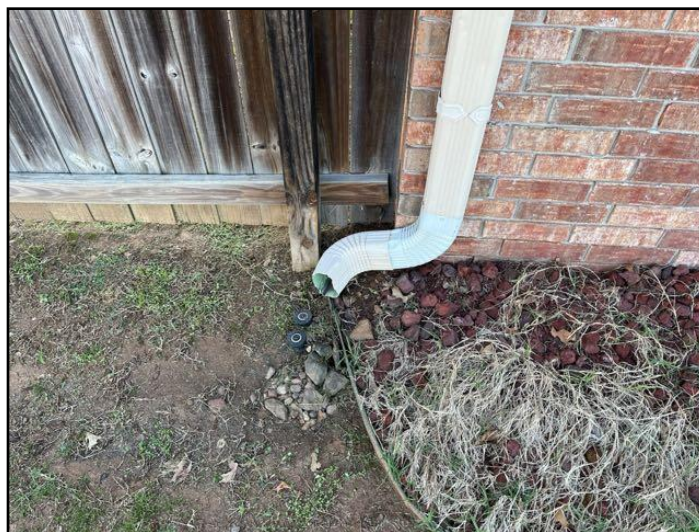
2. Condition: • Discharge too close to building

Downspout discharges too close to building. This can erosion and damage foundation. Recommend splash blocks or extensions.

Location: West by fence

8. Discharge too close to building

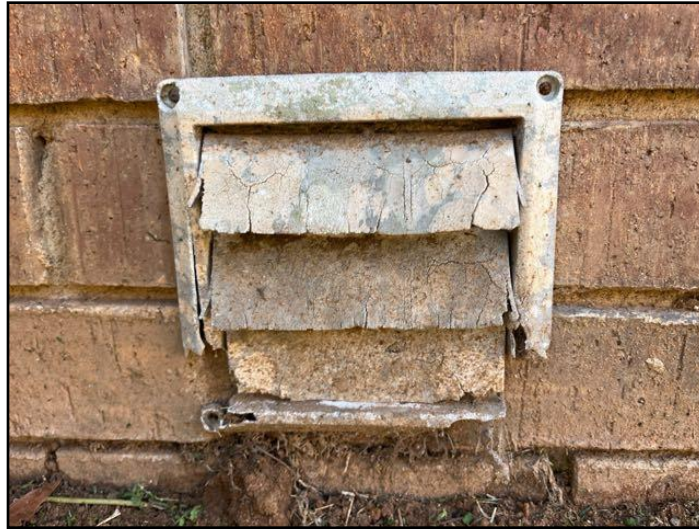
3. Condition: • Cover damaged

Cover damaged/brittle and doesn't close properly. This can allow pest intrusion. Recommend cover be replaced by a qualified contractor.

Location: NW by electric meter

9. Cover damaged

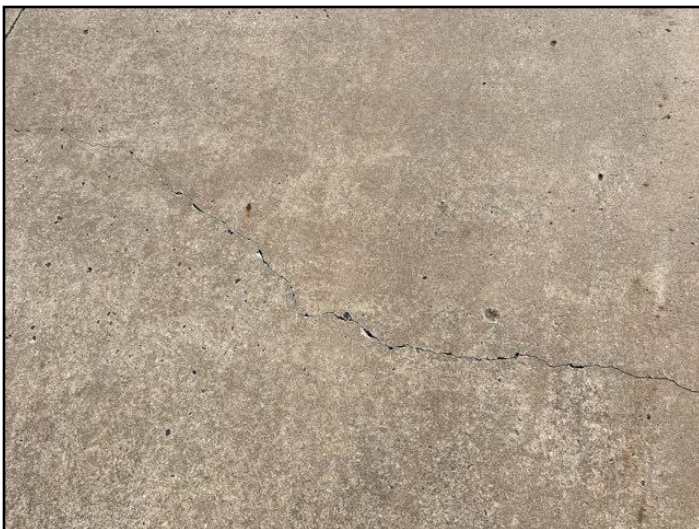
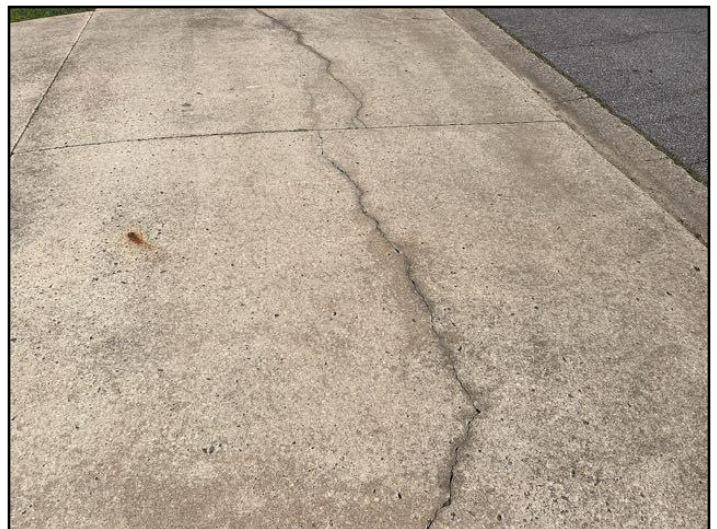
4. Condition: • Cracked or damaged surfaces

Typical cracking noted in the driveway. Recommend sealing the cracks to help prevent moisture and intrusion and future separation.

10. Cracked or damaged surfaces

11. Cracked or damaged surfaces

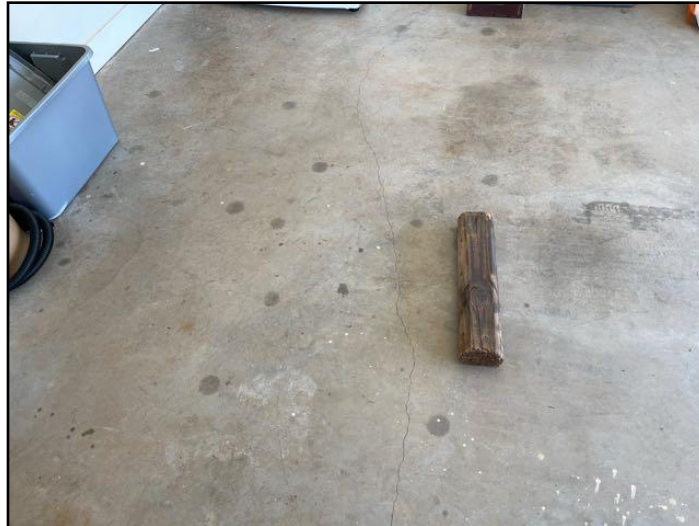
5. Condition: • Cracked

Typical concrete cracking noted in the garage floor. Recommend sealing the cracks to avoid moisture intrusion, settling and separation of the concrete.

12. Cracked

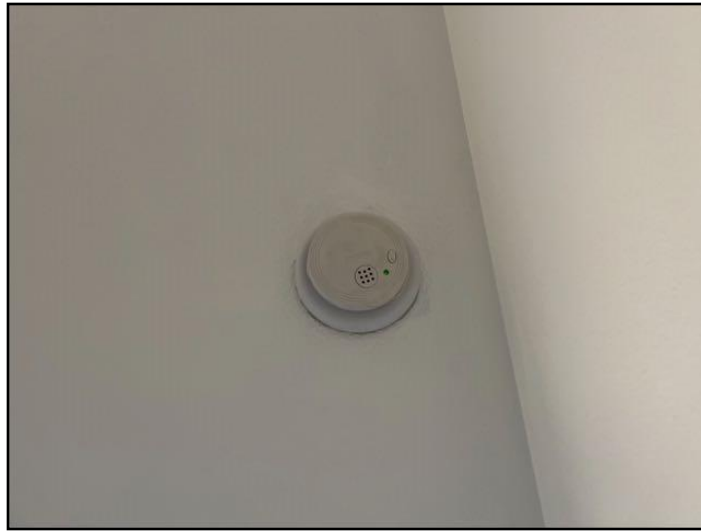
Smoke alarm present.. NFPA recommends interconnected smoke alarms in every sleeping room and outside each sleeping area (hallways leading to bedrooms). They also recommend smoke alarms be replaced every 10 years and tested monthly.

30. *Smoke alarm*

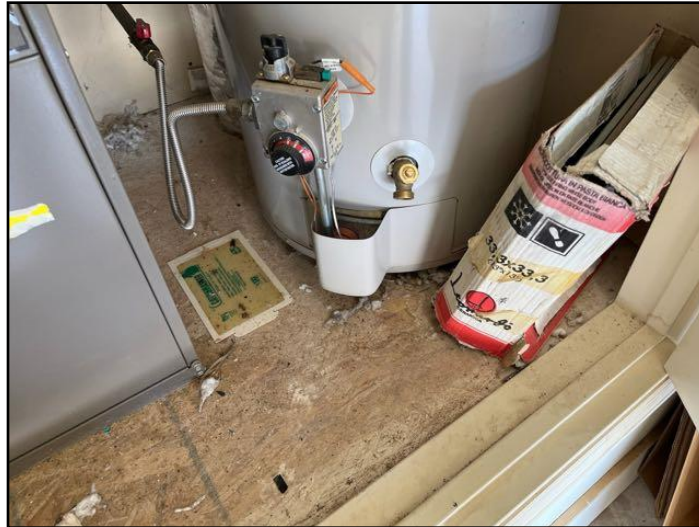
11. Condition: • Safety pan and drain missing

No safety pan/drain noted under water heater. This can lead to water damage. Recommend further evaluation by a licensed plumber and repair/replace as needed.

42. *Safety pan and drain missing*

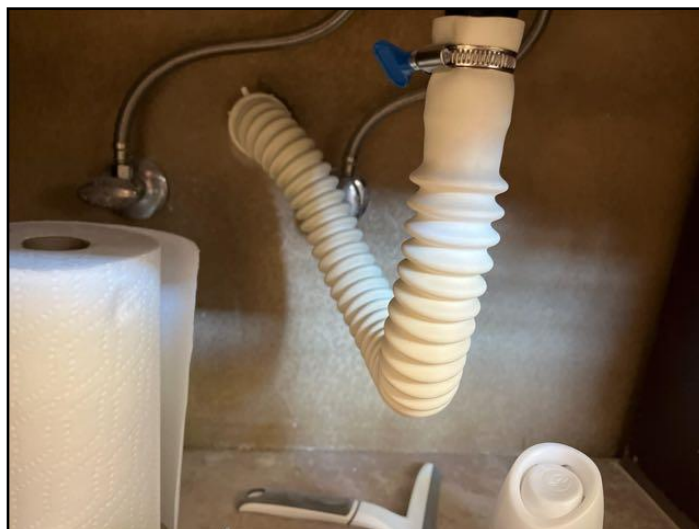
12. Condition: • Nonstandard materials and patches

The drain line under the master sink was missing a P-trap and was flex pipe. Lack of P-trap can allow sewer gases to enter the structure. Flex lines used in drains can catch debris and clog. Recommend further evaluation by a licensed plumber and repair/replace as needed.

Location: Master sink

43. *Nonstandard materials and patches*

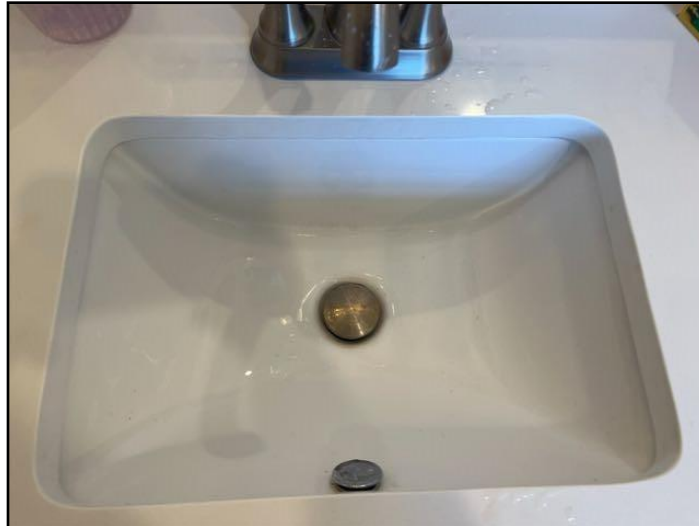
13. Condition: • Drain stop ineffective

Drain stop does not open properly on the master sink. Recommend further evaluation by a licensed plumber and repair/replace as needed.

Location: Master sink

44. *Drain stop ineffective*

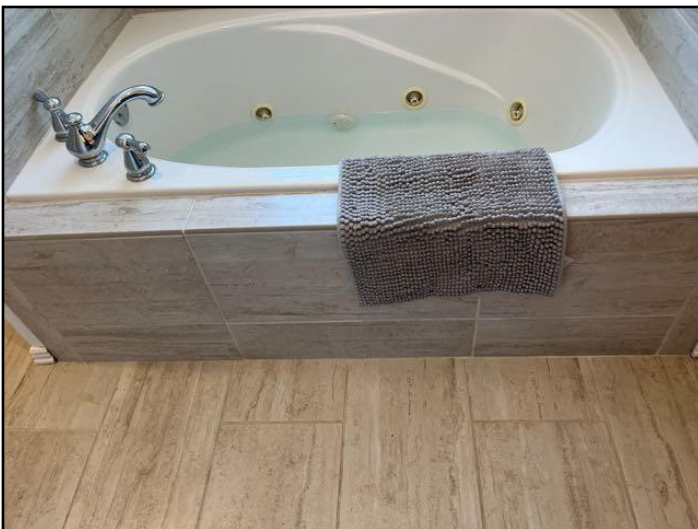
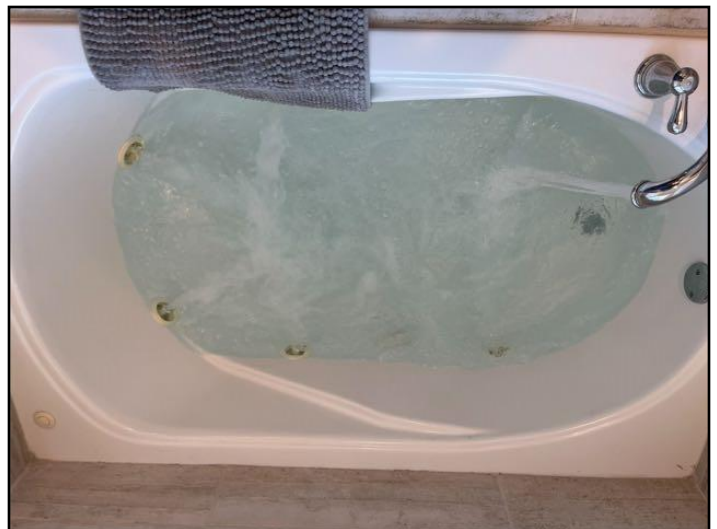
14. Condition: • There was no service panel on the jetted tub in the master bathroom. This can make servicing the unit and detecting leaks difficult. Recommend service panel be installed by a qualified contractor and the tub be checked for leaks. The jets were operating properly at the time of inspection.
