INSPECTION REPORT

1234 Sample Rd
Sometown, AR

INSPECTION DATE
Tuesday, March 25, 2025

INSPECTED BY
Micah Talley, AR License #2568 OK License #70002960

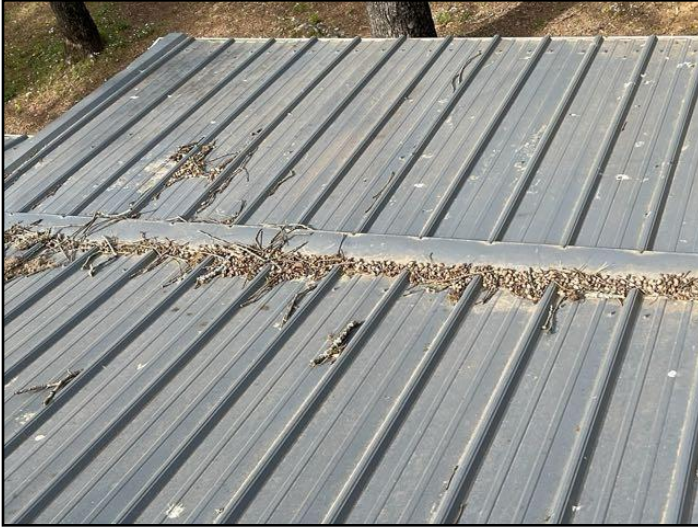
1. Condition: • Debris/leaves noted on the roof. Leaves/debris can hold water and shorten the life expectancy of roofing materials. Recommend cleaning debris from the roof as part of routine maintenance.

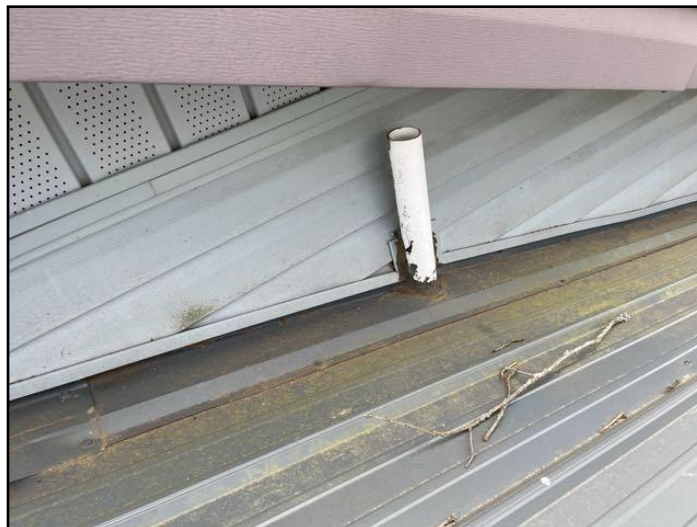
3.

2. Condition: • Plumbing vent was located under the overhang. While there was no soffit vent above the plumbing vent. There was ventilation for the attic space near by. Recommend further evaluation by a qualified contractor and repair/replace as needed.

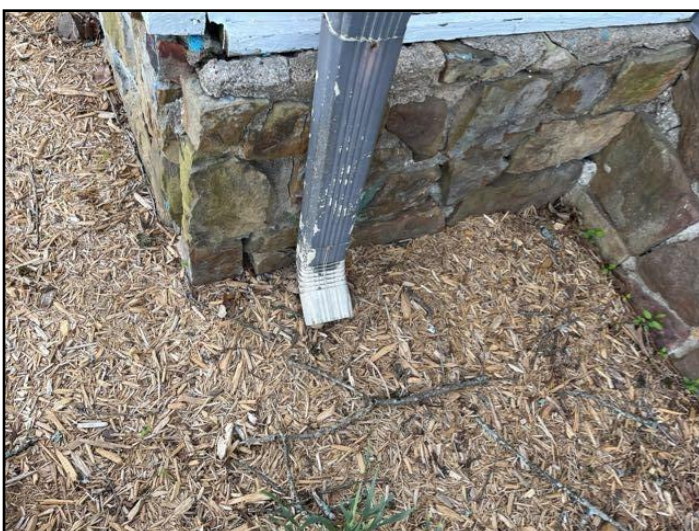
3. Condition: • Discharge too close to building

Downspout discharges too close to the building. This can lead to soil erosion and water damage. Recommend downspout extension or splash blocks be installed.

10. Discharge too close to building

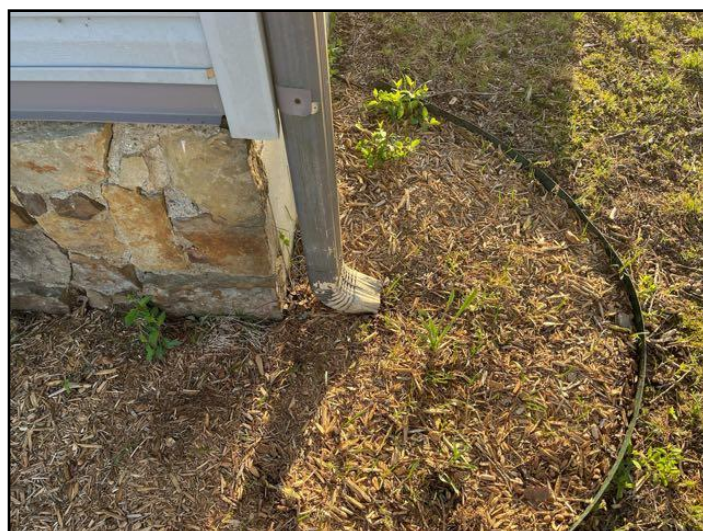
11. Discharge too close to building

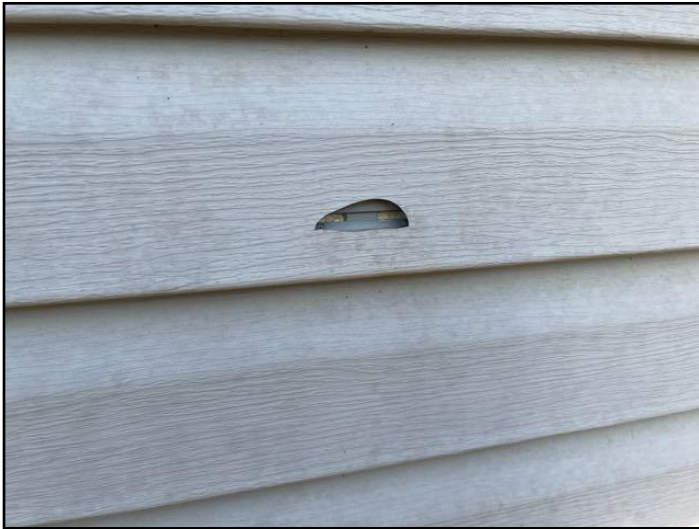
4. Condition: • Mechanical damage

Mechanical damage to siding can lead to moisture intrusion. Recommend repair or replace siding as needed.

12. Mechanical damage

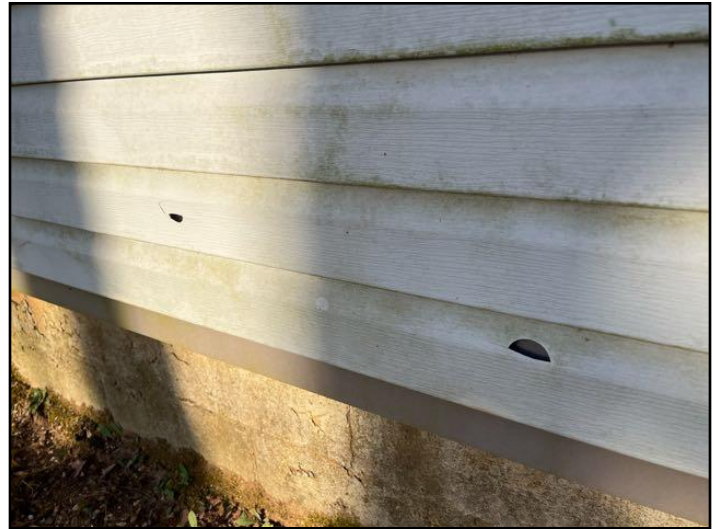
13. Mechanical damage

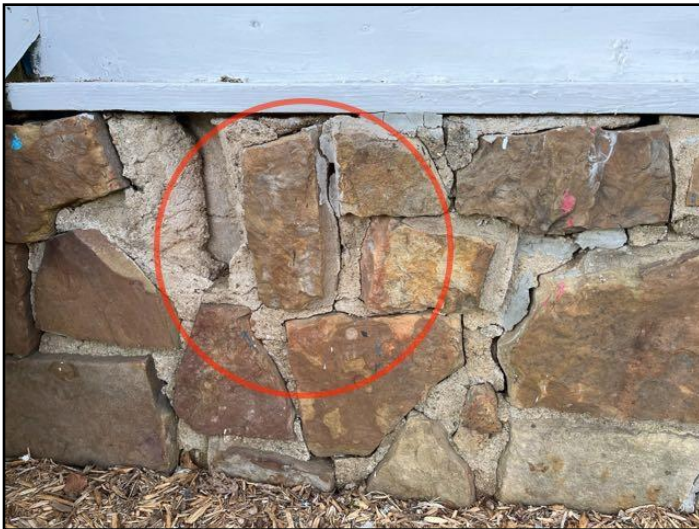
14.

5. Condition: • Cracked mortar and loose stones noted in multiple places on the front wainscoting. This stone appears to be cosmetic only as there is masonry block behind it. Recommend repair by a qualified contractor.

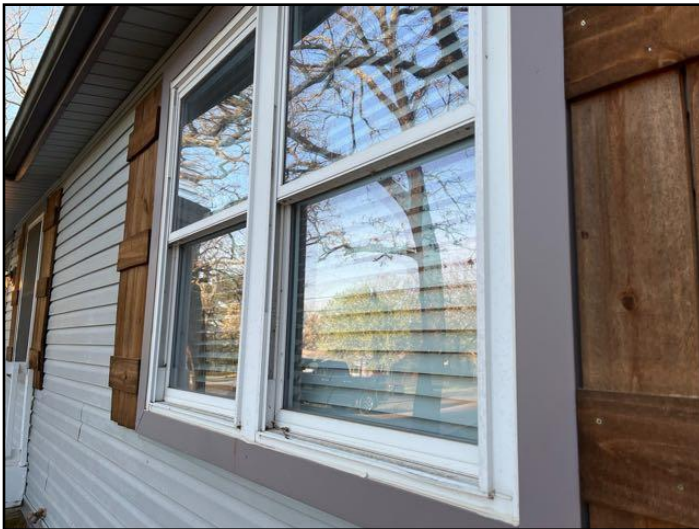
Several missing screens noted throughout. Recommend replacing the screens.

17. Missing

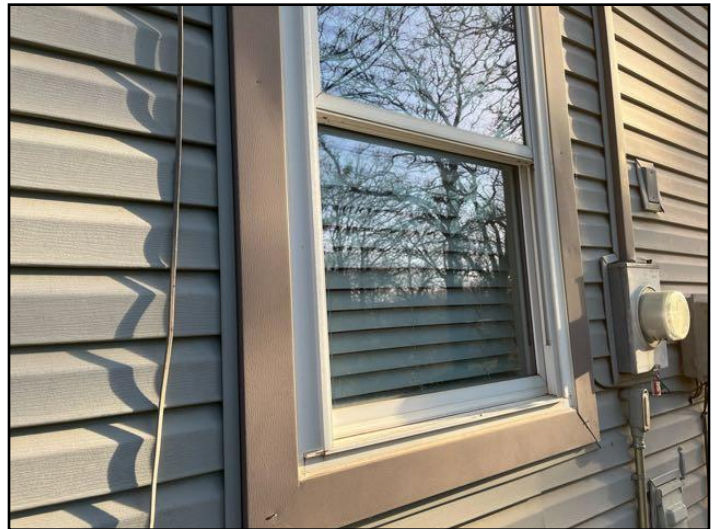
18. Missing

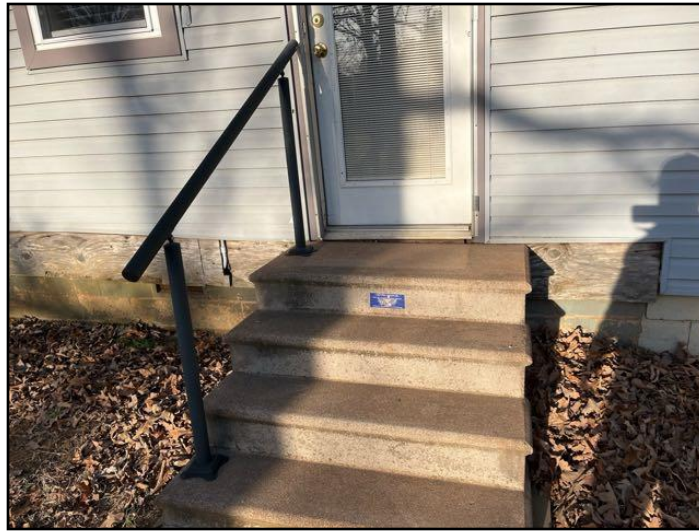
Loose handrail on the back steps could be a safety hazard. Recommend further evaluation by a licensed contractor and repair/replace as needed.

19. Loose

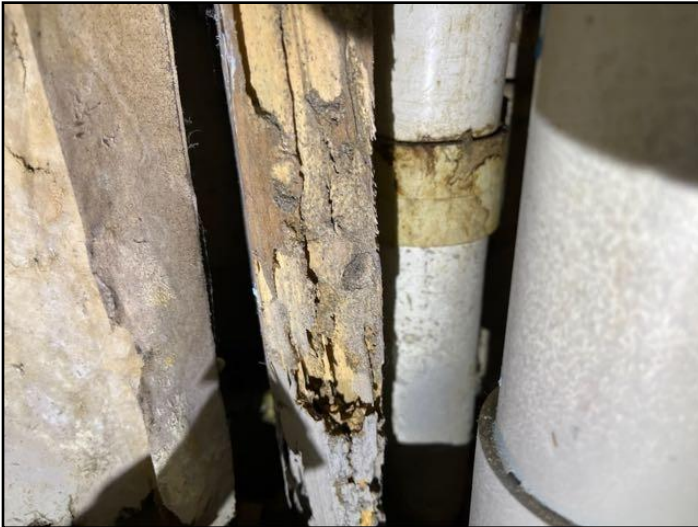
Deteriorated wall stud noted under master sink. Recommend further evaluation by a qualified contractor and repair/replace as needed.

22. Rot, insect or fire damage

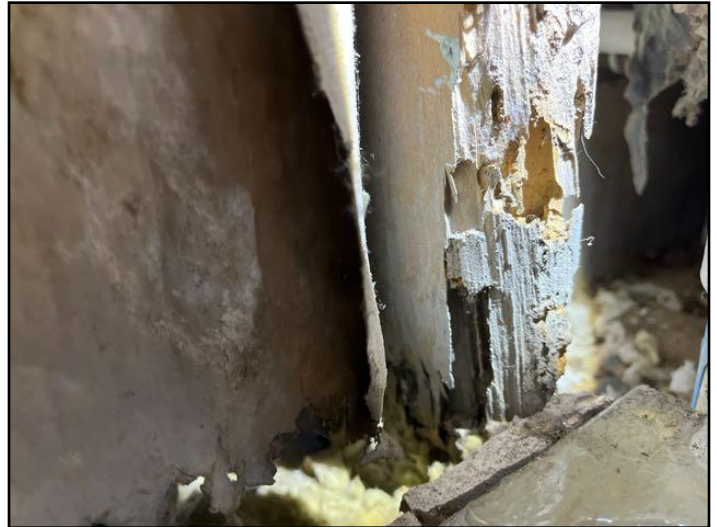
23. Rot, insect or fire damage

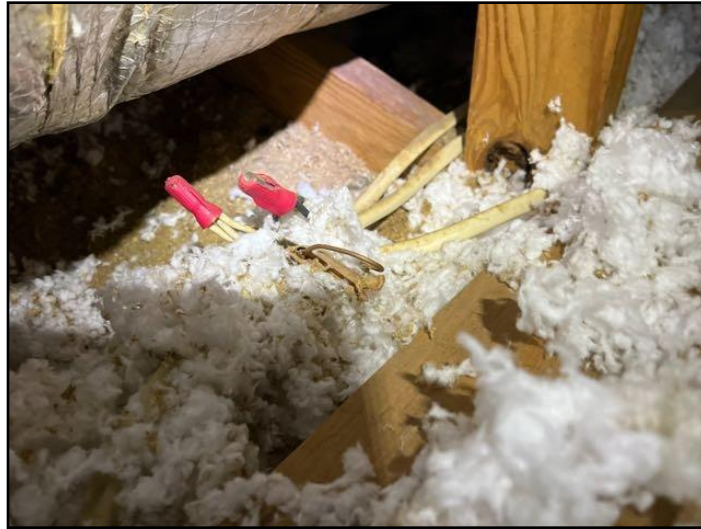
Wires spliced together with wire nut/tape missing junction box. This could be a shock/fire hazard. Recommend further evaluation by a licensed electrician and repair/replace as needed.

37. Missing

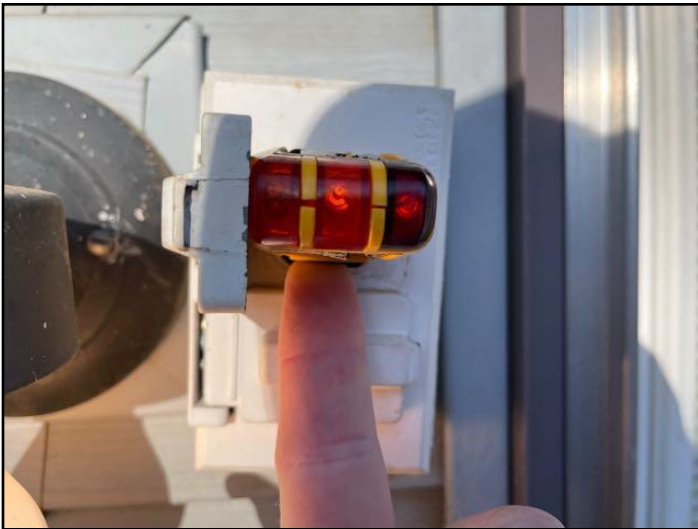
Several outlets with open grounds noted in the downstairs area as well as the outdoor outlet near the back door. This can be a shock hazard. Recommend further evaluation by a licensed electrician and repair/replace as needed.

38. Ungrounded & No GFCI

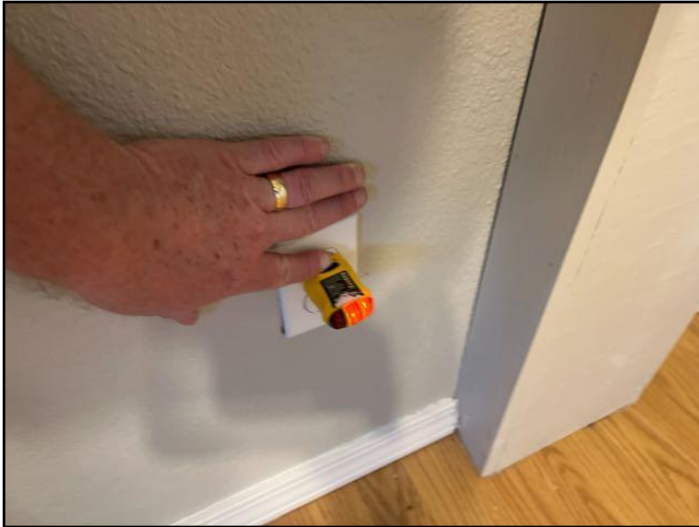
41. Laundry area

12. Condition: • There was no GFCI protection throughout the house. This can be a shock hazard. Recommend further evaluation by a licensed electrician and repair/replace as needed.

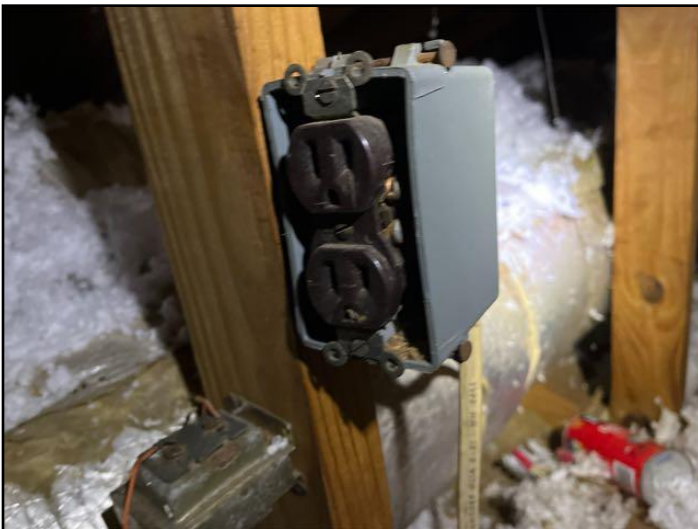
Two outlets in the attic were missing cover plates. This can be a fire/shock hazard. Recommend further evaluation by a licensed electrician and repair/replace as needed.

45. Missing

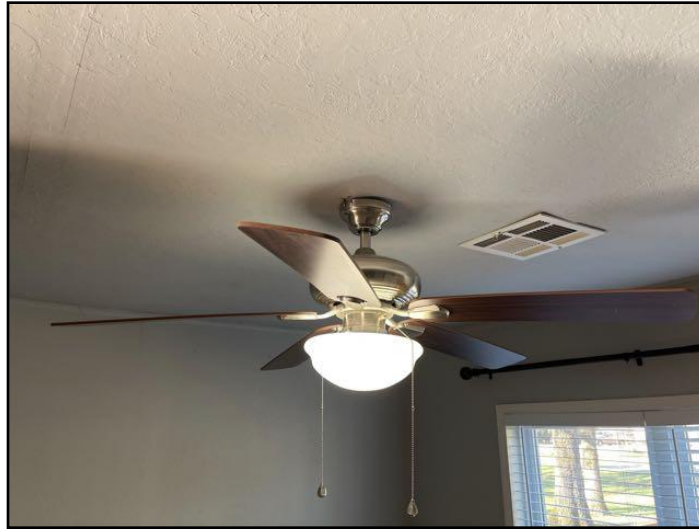
The fan in the master bedroom was loose. Recommend further evaluation by a licensed electrician and repair/replace as needed.

47. Loose

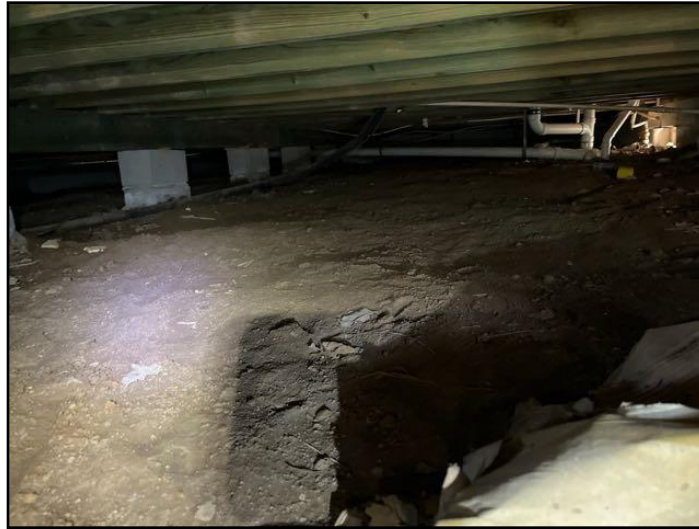
No vapor barrier in the crawlspace can lead to condensation causing moisture damage to structure and/or finishes as well as create conditions conducive for microbial growth. Recommend vapor barrier be installed by a qualified contractor.

60. No vapor barrier

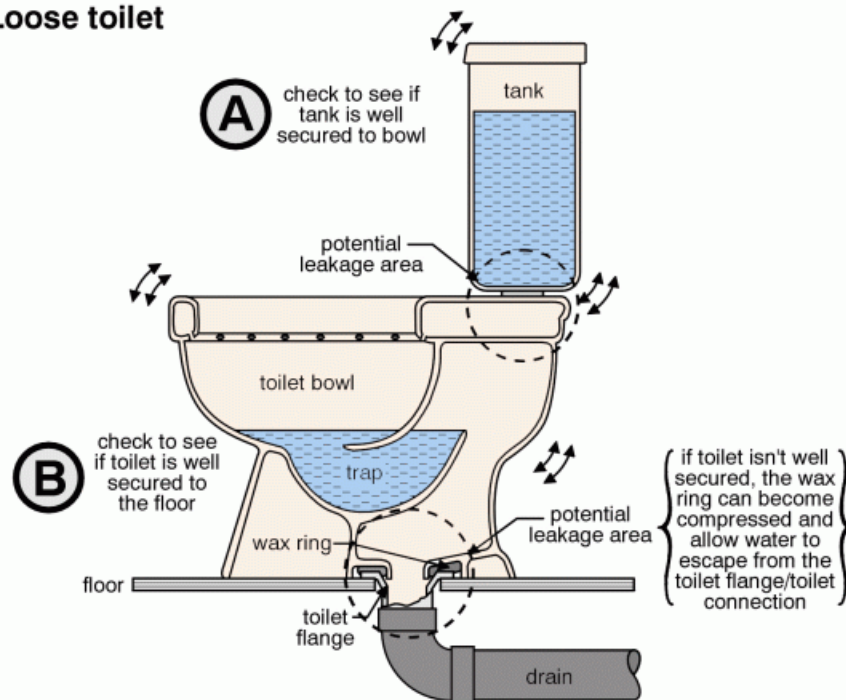
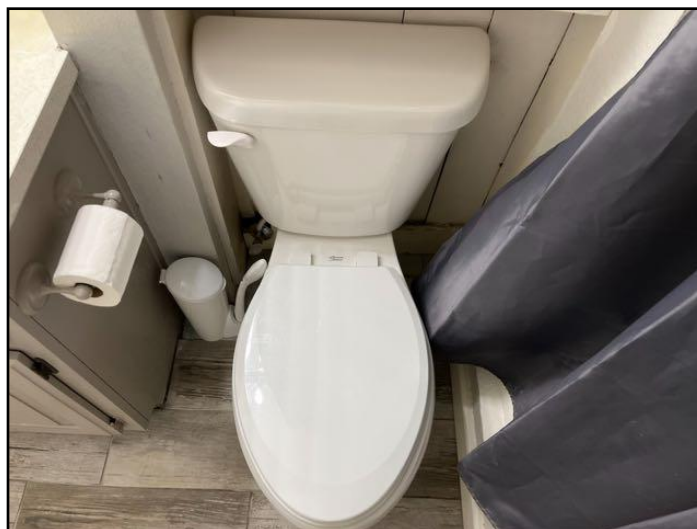
Loose toilet noted in the master bathroom. This can allow water/sewage damage. Recommend further evaluation by a licensed plumber and repair/replace as needed.

Loose toilet

68. Loose

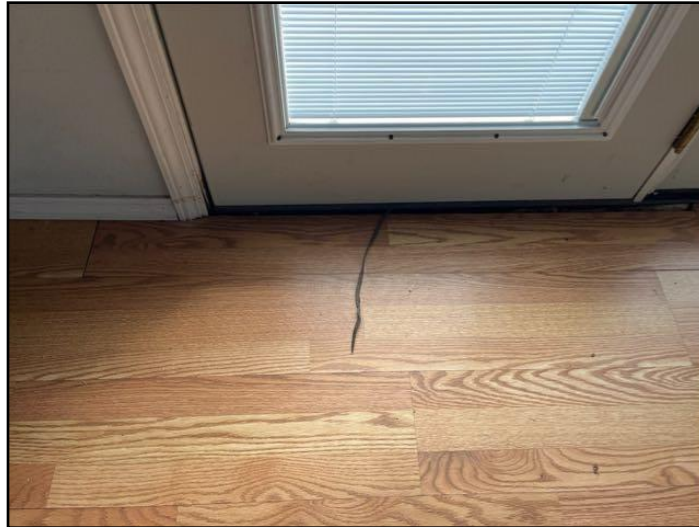
Loose weather stripping noted at the back door in the downstairs area. This can lead to increased heating/cooling cost and water intrusion. Recommend repair by a qualified contractor.

78. Loose

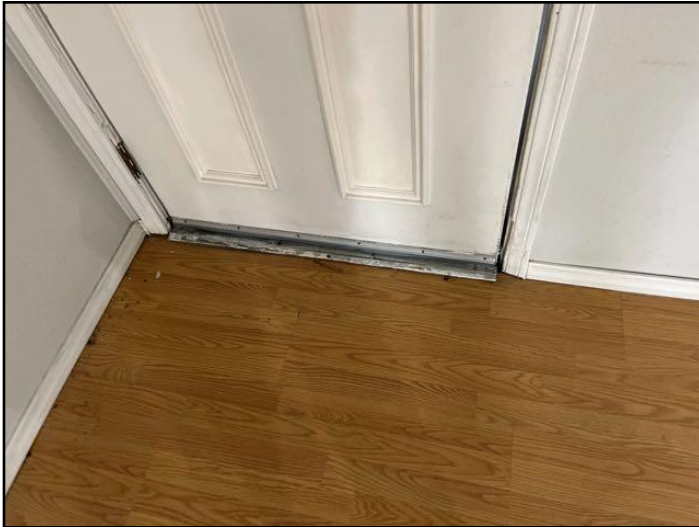
79.

21. Condition: • Door rubs floor and has light visible on the side. The can lead to increased heating/cooling costs and damage the flooring. Recommend repair by a qualified contractor.
