National Property Inspections

Address, Dixon, Ca, 95620

Inspection Date:
08/02/2024

GENERAL INFORMATION

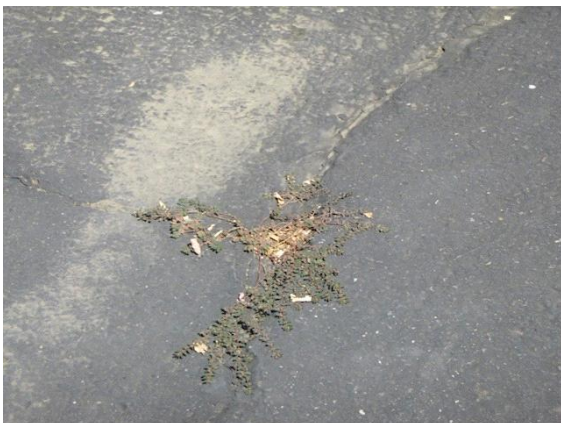
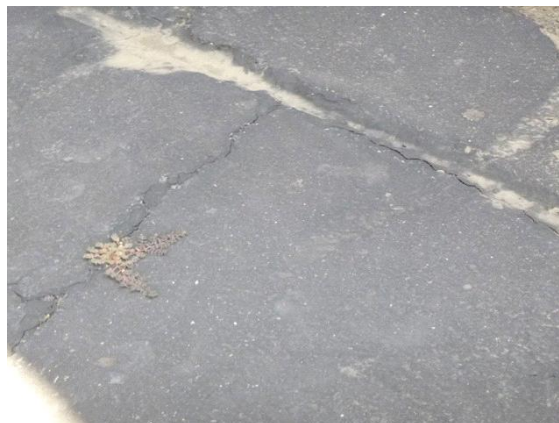
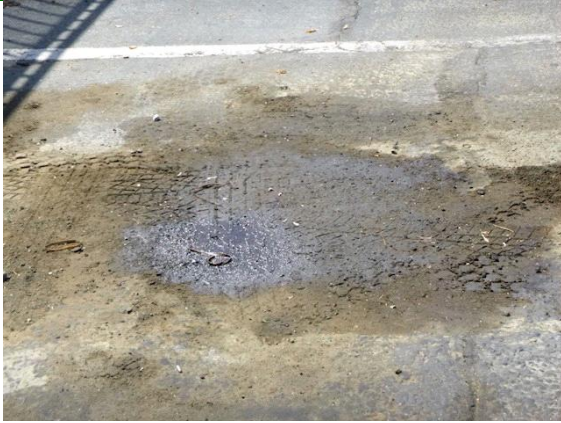
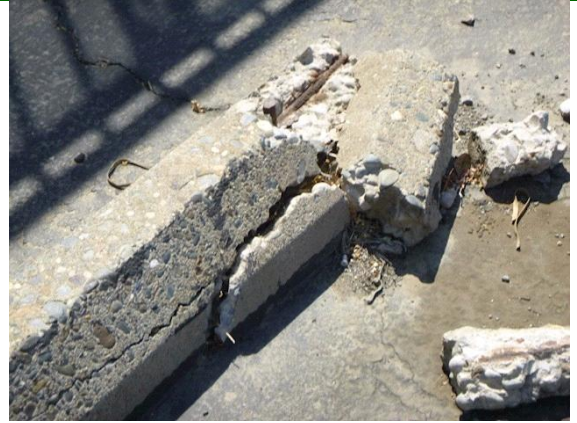
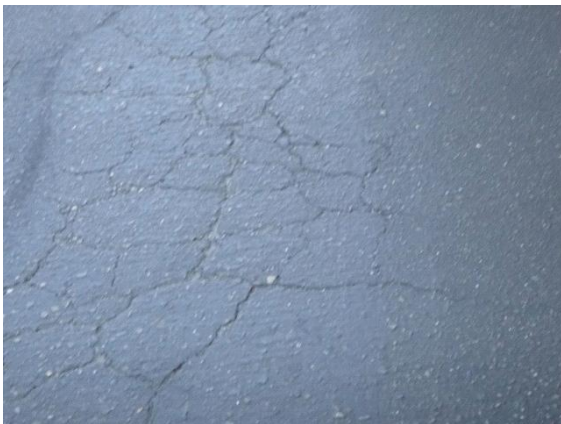
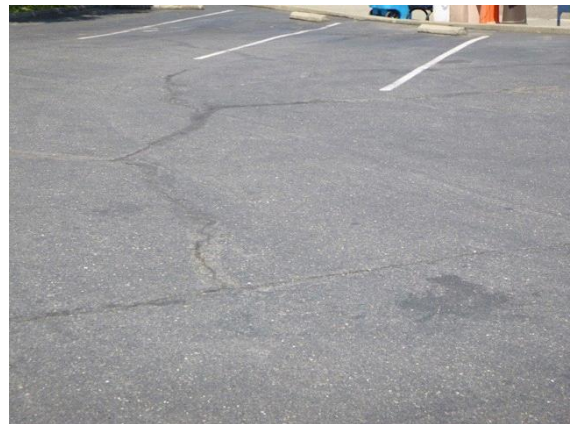
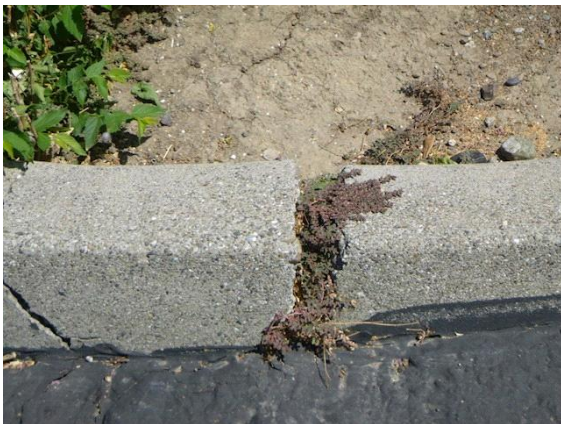
Multiple areas of staining at the head of the parking stalls.

Area of cracking, recommend further evaluation and repair. Possible slip coat by a license contractor.

Multiple parking stops and curbs are crack or broken. Recommend further evaluation and repairs by a licensed contractor.

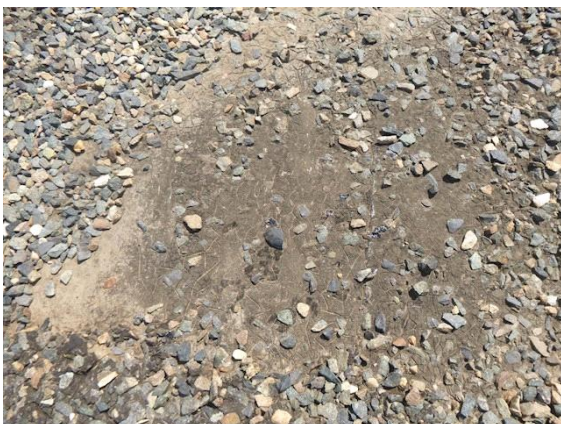
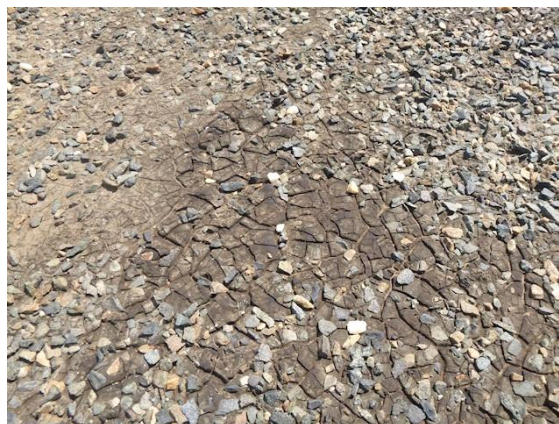
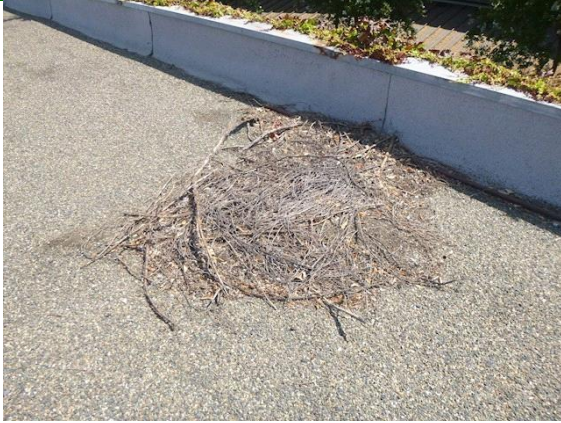
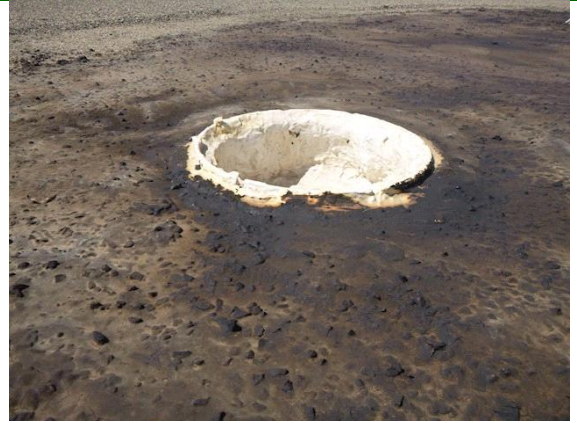
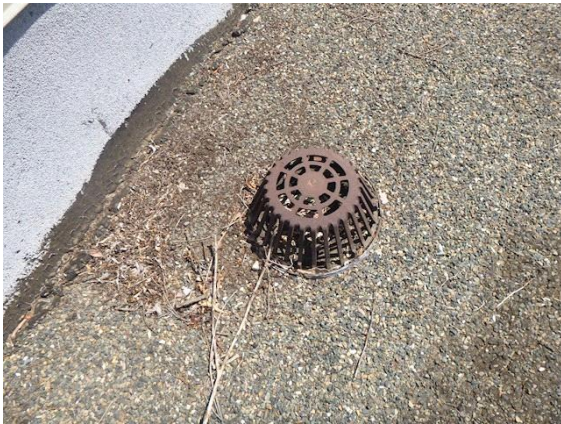
Areas of the tar and gravel roof has worn away exposing the tar. The tar is bubbled and damaged in one or more locations.

Signs of previous leaks on the interior of the building. Recommend further evaluation and repairs by a licensed roofing contractor.

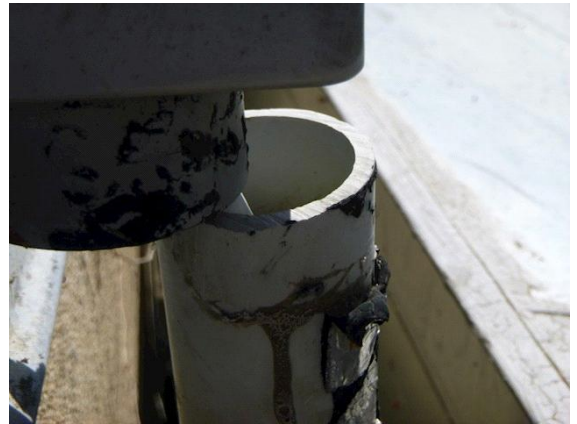
There is conduit damaged on the roof near the Rooftop HVAC unit. Recommend further evaluation and repairs by a licensed contractor.

Roofing: Area of conduit damaged on the roof near rooftop AC unit.

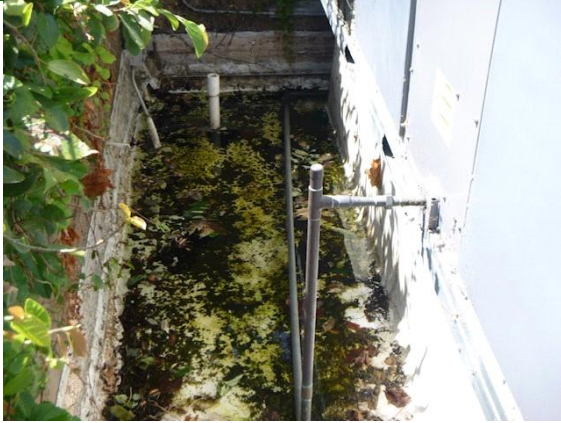
Standing water on the roof near the HVAC unit. Recommend further evaluation and repairs by a licensed roofing contractor.

Roofing: Standing water on the roof near rooftop HVAC unit.

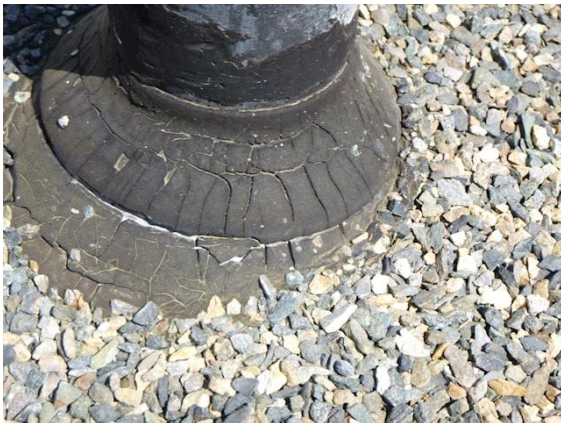
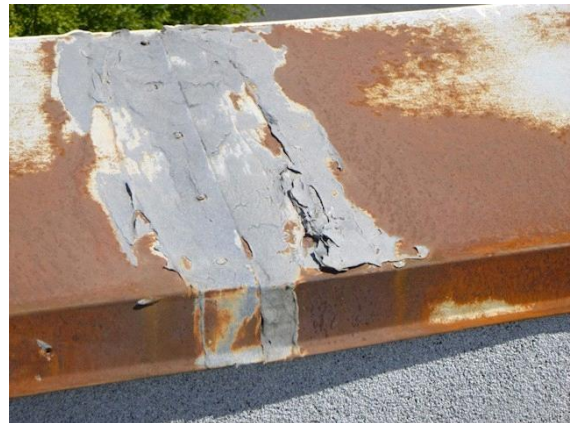
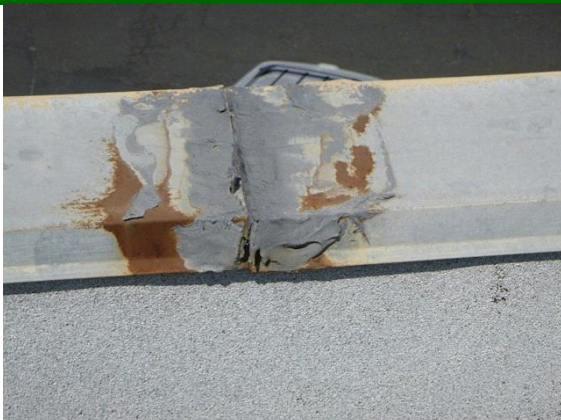
The rubber boots at the base of multiple plumbing jacks around the roof are cracking/deteriorated and could lead to moisture damage in the future. Recommend further evaluation and possible repair/replacement by a licensed contractor.

Parapet wall needs to be sealed to prevent future damage.

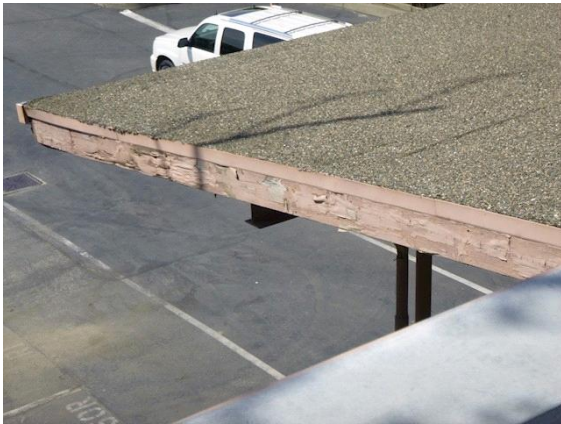
Signs of moisture damage present in wood trim and wood cover at the loading dock. Recommend further evaluation and possible repair/replacement by a licensed contractor.

Exterior Surface: Loading dock has sign of moisture damage.

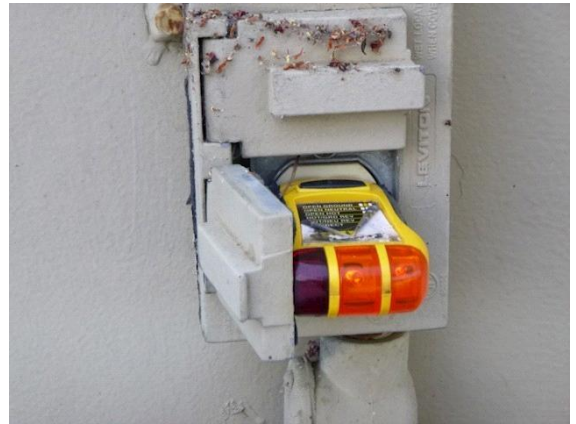
One or more exterior outlets not GFCI type, nor protected by a GFCI circuit. Recommend GFCI outlets be installed by a licensed electrician for safety.

Exterior Surface: No power exterior electrical outlet.

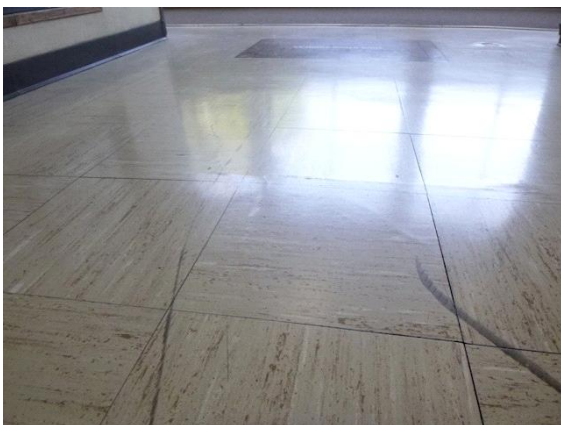
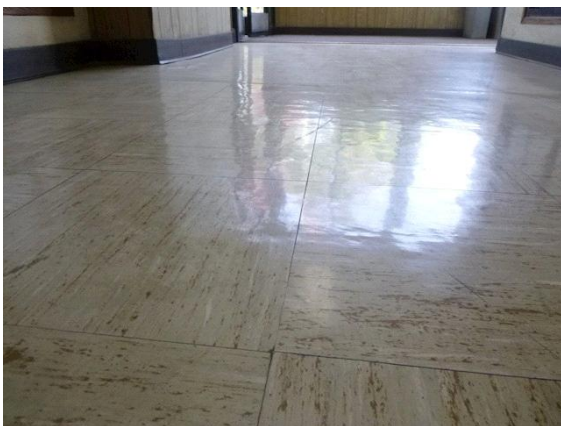
Areas of the floor near the PO boxes has several areas of crowning, indicating possible cracking and damage. Recommend further evaluation and repairs by a licensed structural contractor.

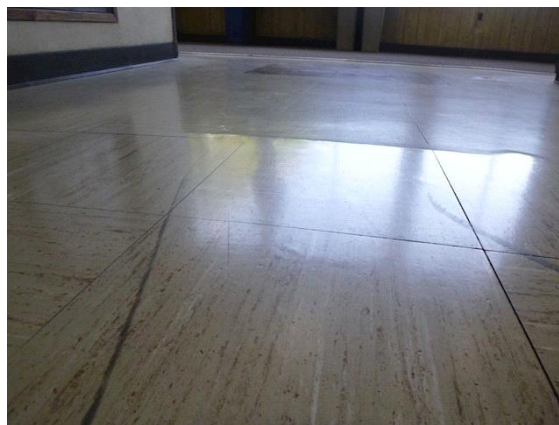
Floor/Slab: Areas of the floor in the PO box section has signs that the slab may be cracked and crowning in multiple locations

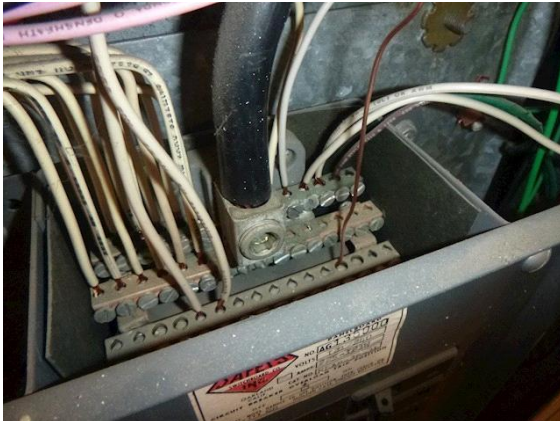
Left sub panel has a mixed bus bar, where the neutral and grounds are together, which is not allowed. Recommend repairs by a licensed electricians.

Electrical: Sub panel on the left has a mixed bus bar.

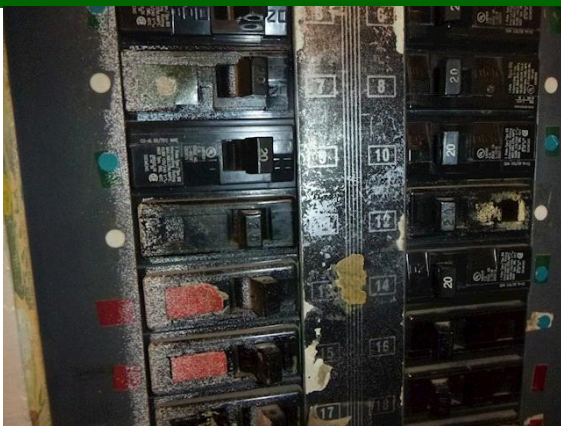
The right sub panel has a breaker that was tripped and not reset. Recommend further evaluation and repairs by a licensed electrician.

Electrical: Sub panel on the right hand side has a breaker that has been tripped and not reset.

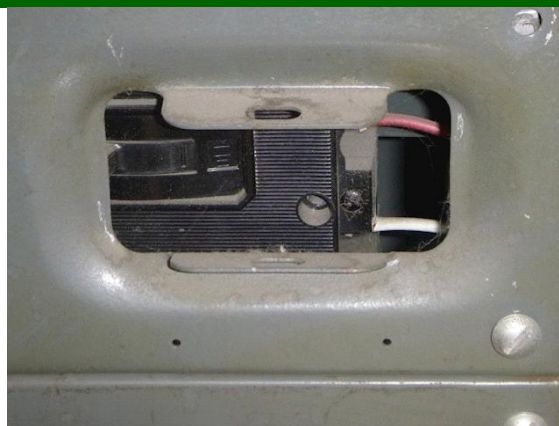
The main electrical panel has an open knockout due to a misaligned breaker. Recommend further evaluation and repairs by a licensed electrician.

Electrical: At the main electrical panel there is a breaker that is misaligned and creates an open knockout in the dead front cover.

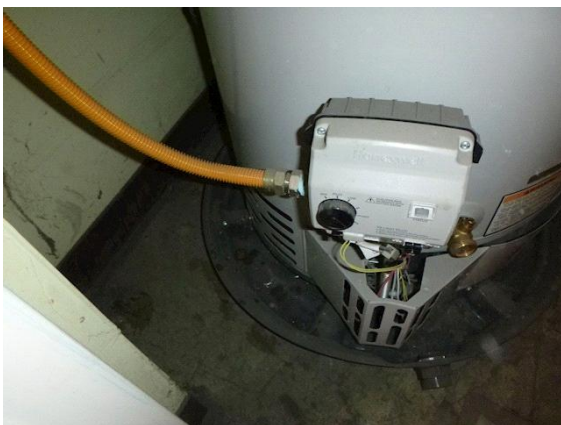
The gas supply line is missing the "drip leg" or "sediment trap" that collects moisture and debris at the valve to the unit. While this may not have been required when the unit was installed, we recommend upgrading to current standards by a licensed plumber.

Water Heater: Missing drip pan.

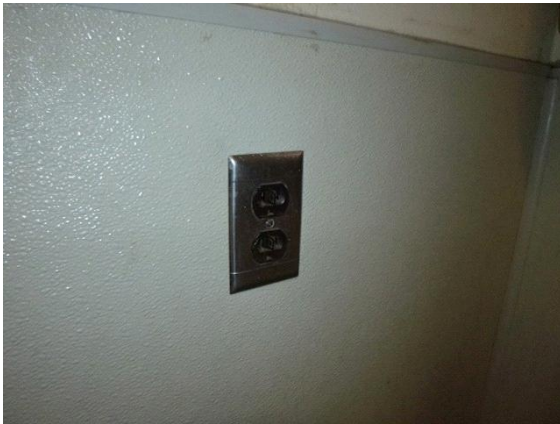
Electrical outlets not GFCI protected or not functioning. Recommend installation of GFCI protected outlets, by a licensed electrician, for safety.

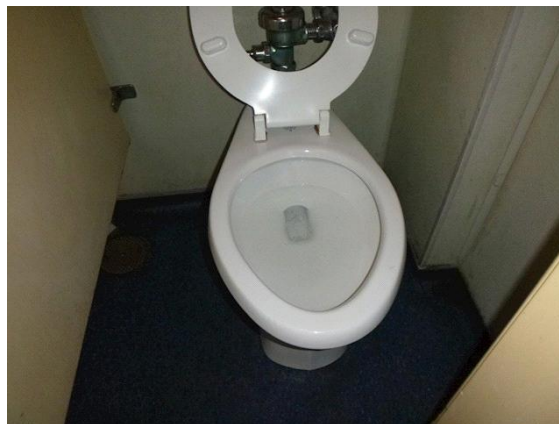
The toilet at the right in this room is difficult to flush and may need a new tank kit. Recommend repairs by a licensed contractor.

BATHROOM MENS: The right hand toilet is difficult to flush and may need a flush and fill kit.

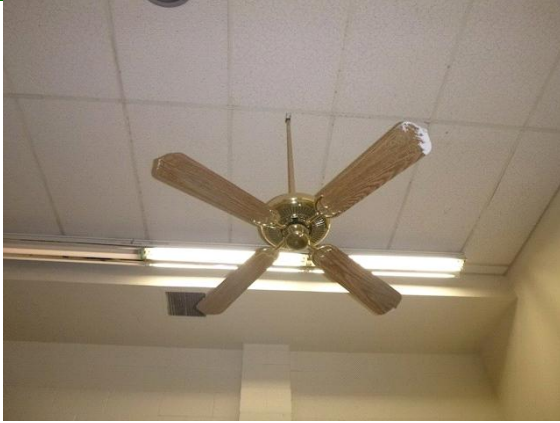
There is a ceiling fan in the main room at the back of the house that is wobbling excessively. Recommend further evaluation and repairs by a licensed contractor.

OFFICES/BACK OF HOUSE: Ceiling fan wobbles excessively.

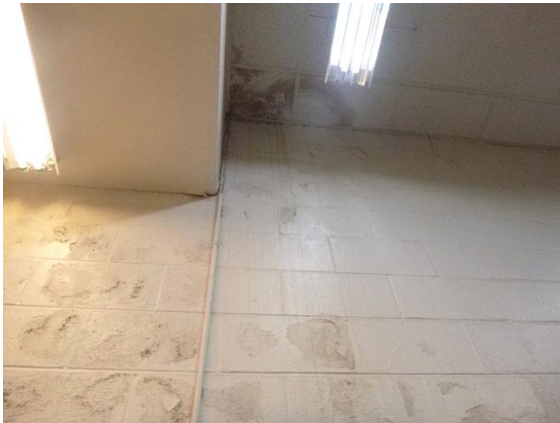
There are areas at the block wall with moisture damage and efflorescence. Recommend further evaluation and repairs by a licensed contractor.

OFFICES/BACK OF HOUSE: Moisture stains on ceiling and walls.

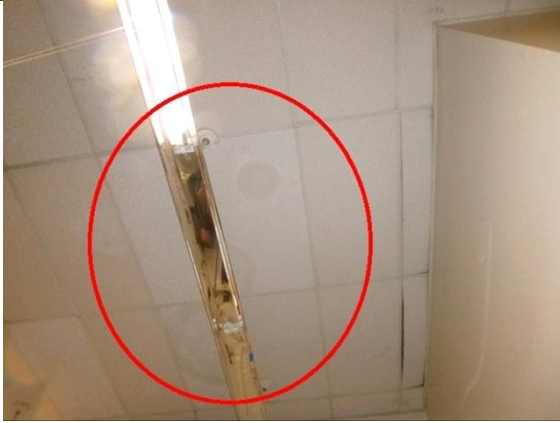
Multiple ceiling tiles have signs of moisture damage.

OFFICES/BACK OF HOUSE: Moisture stains on ceiling tiles.

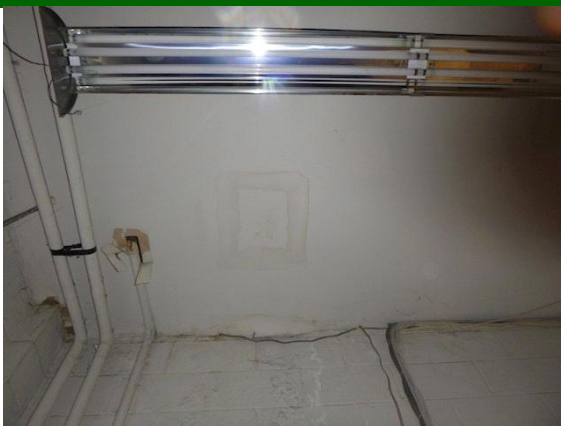
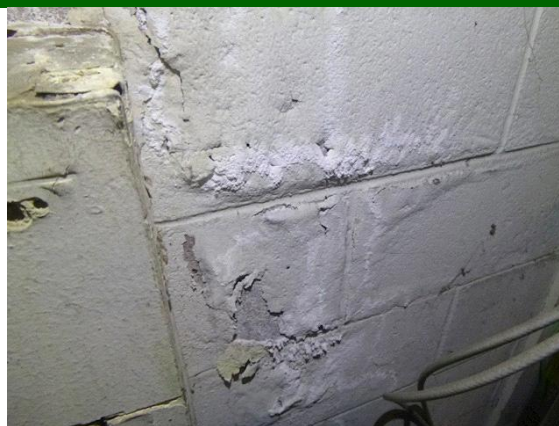
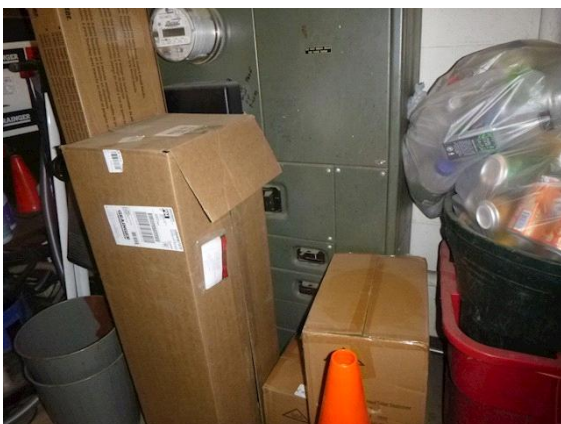
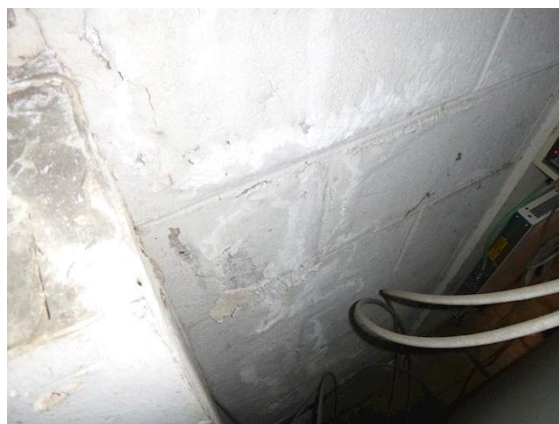
Moisture stain around a previous repair on the ceiling. Recommend further evaluation and repairs by a licensed contractor.

The block wall has signs of moisture damage and efflorescence. Recommend further evaluation and repairs by a licensed contractor.

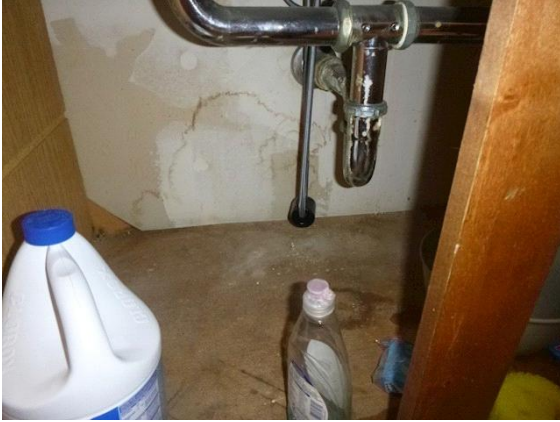
Moisture staining noted under the sink in the break room, recommend monitoring.

BREAKROOM/ STORAGE ROOM: Previous moisture under the sink in the break room.

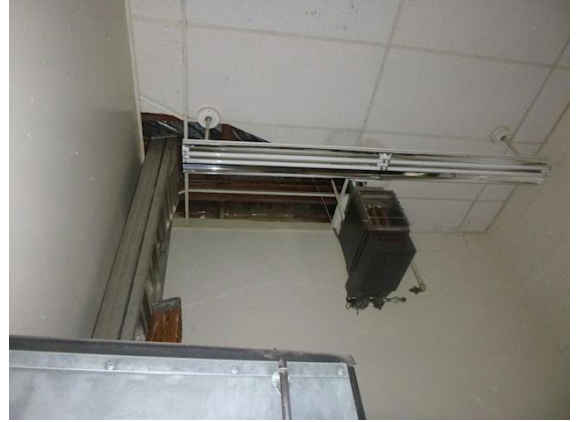
The area heading to the loading dock has a heater that has been disconnected. Recommend capping the gas line for safety.

BREAKROOM/ STORAGE ROOM: The area heading to the loading dock has a heater that has been disconnected. Recommend capping the gas line.
