Inspection Report

National Property Inspections

11 Month Warranty Inspection

123 Anystreet
Any town TX

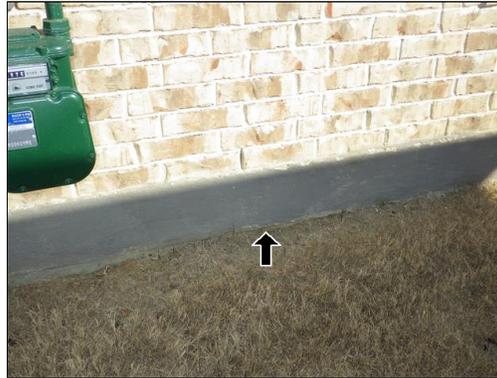
A. Photo 1

(2) A form board was still in place at the right side along the foundation perimeter grade beam. This is considered a conducive condition for wood destroying insects/termites. Recommend board be removed.

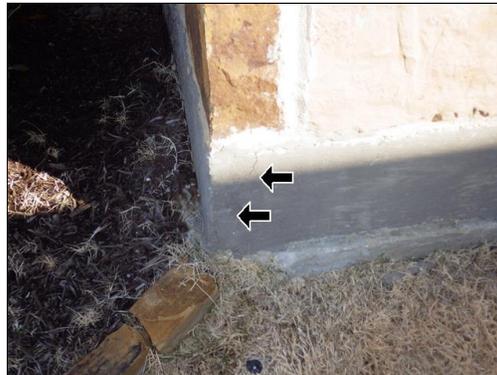
A. Photo 2

(3) Noted cracks at one or more corners of the foundation grade beam. Corner cracks are not structural in nature but cosmetic and caused primarily by expansion of the adjacent veneer when heated by the sun. Although cracks such as these are common and not structurally significant, the client may want to repair a corner crack as the foundation in this area does provide some support for the adjacent wall.

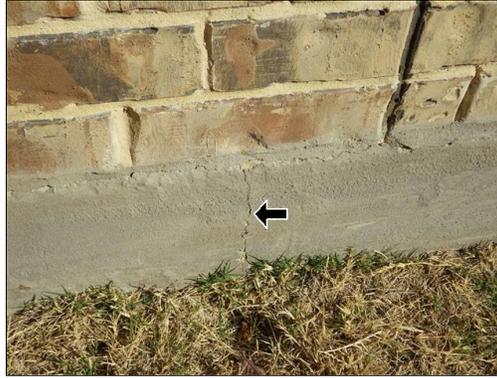
A. Photo 3

(4) There was a vertical hairline crack along the foundation about half way back on the right side of the structure. Although the crack did not appear to be structurally significant,

recommend homeowner continue to monitor the crack for any changes. If crack were to widen, recommend further evaluation by a professional engineer licensed with the State of Texas.

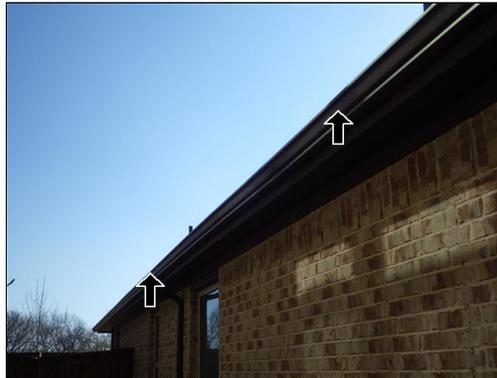
B. Photo 1

- (1) The grading appeared to be positively sloped away from the structure to promote drainage.
- (2) There were two dents to the left side gutter that due to their location, could retain rainwater. Recommend gutter be repaired to ensure proper flow of water to the downspouts.

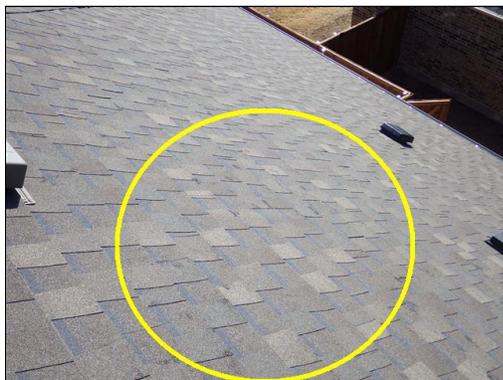
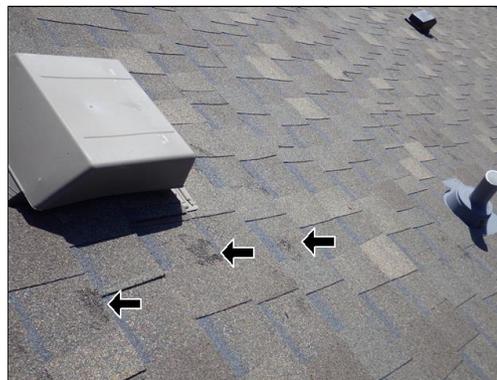
- (1) Roof covering appeared to be performing as intended at time of inspection, however, one or more deficiencies were observed with examples within this subsection.
- (2) Observed scuffs at several points along the roof that most likely occurred from a contractor walking the roof. In these areas, the granules along the shingles had been removed exposing the tar below the granule layer. This condition can shorten the expected life of the shingles in that granules provide ultra-violet ray protection and impact resistance. Recommend affected shingles be replaced by a qualified roofing contractor.

C. Photo 1 Right side

C. Photo 2 Right side

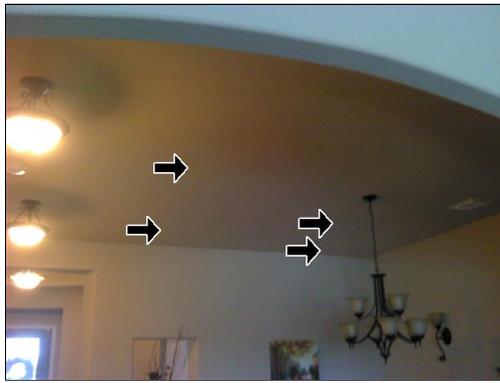
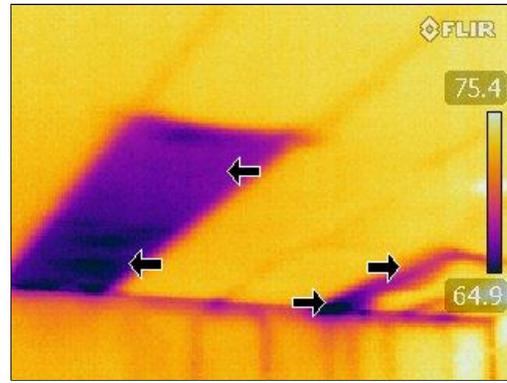
(1) During a thermal imaging scan, the inspector observed decreases in the apparent temperature of the formal dining room ceiling. Further evaluation in the attic found that a section of insulation was dislodged and that a section of the attic floor below a walkway was missing insulation. This condition can affect energy efficiency. All ceiling areas must be insulated. Recommend repair by a qualified contractor.

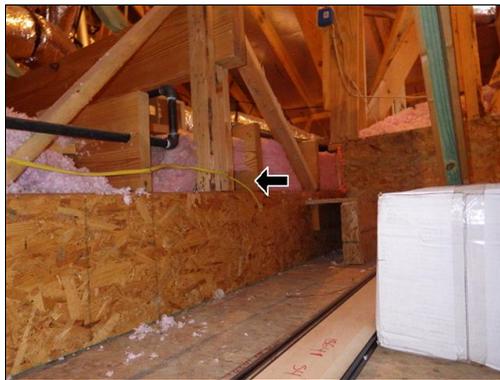
F. Photo 3 Dislodged insulation

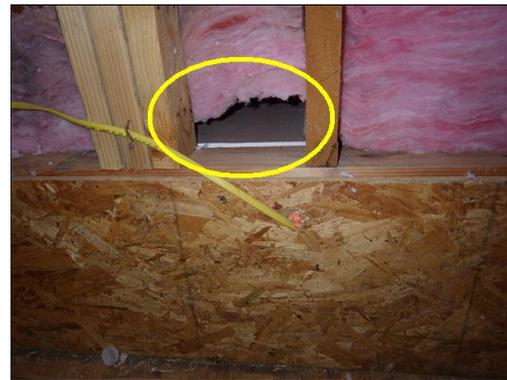
F. Photo 4 Dislodged insulation (close up view)

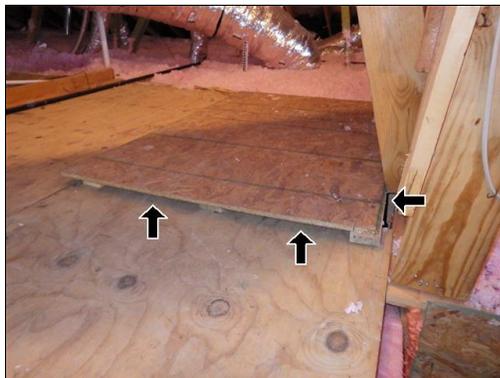
F. Photo 5 Attic view

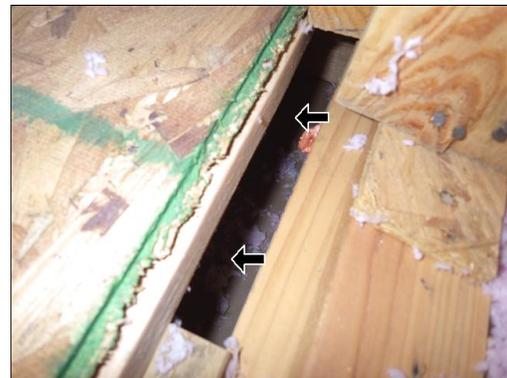
F. Photo 6 Attic close up view (no insulation)

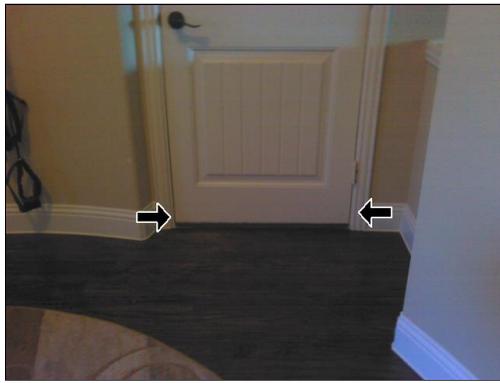
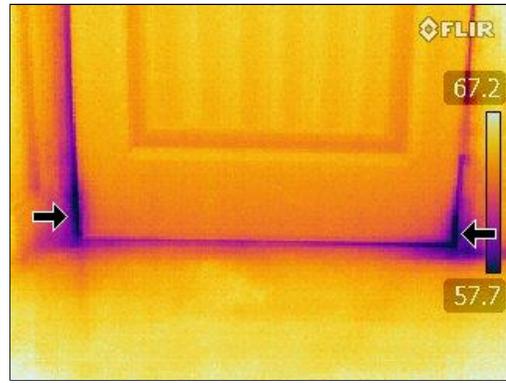
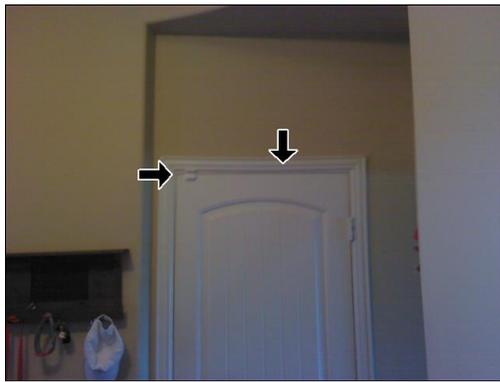
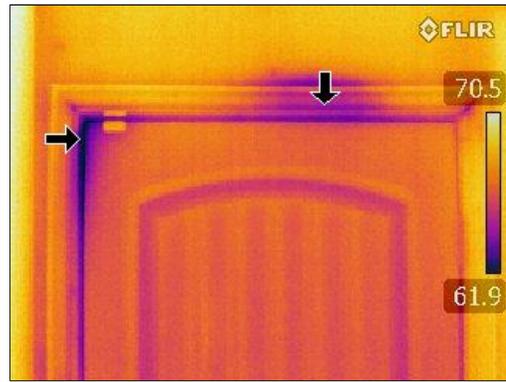
(1) During a thermal imaging scan, the inspector observed a decrease in the apparent temperature along the perimeter of the door leading into the garage. This can affect energy efficiency and is typically due to the door not fully compressing the weatherstrip. Recommend repair/adjustment by a qualified contractor.

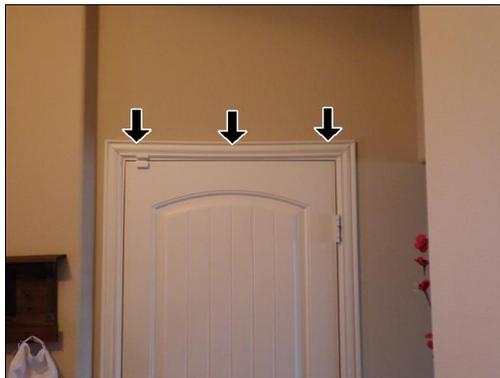
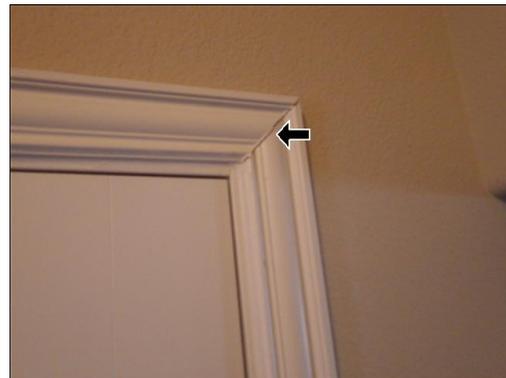
(2) At the door leading to the garage, the trim at the upper portion of the opening was bowed with sealant separation observed. The trim should be level with the opening. Recommend repair by a qualified contractor.

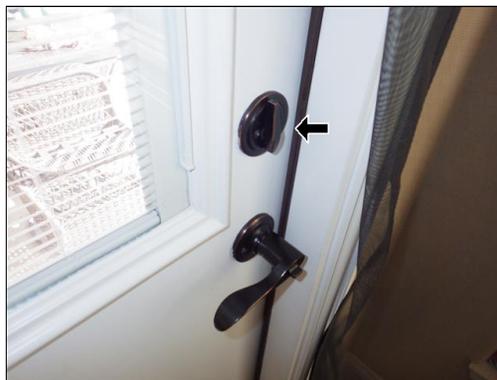
G. Photo 7

(3) When the rear exterior door was fully closed, the deadbolt lock would not fully engage. The door had to be slightly ajar for the lock to engage which is improper. Recommend repair/adjustment by a qualified contractor.

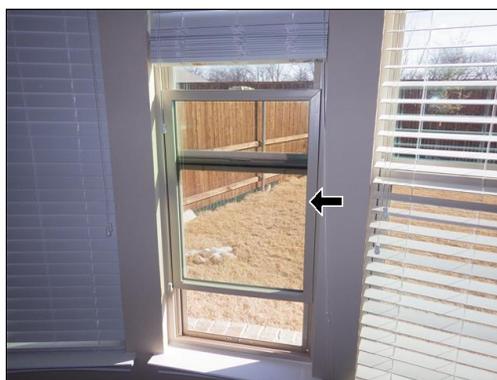
H. Photo 1

- (1) Windows were tested in a random sampling and appeared to be operating as intended.
- (2) One of the windows in the master bedroom made a squeaking sound when the lower sash was opened. This is not a normal condition for a home of this age. Recommend repair/adjustment by a qualified window contractor.

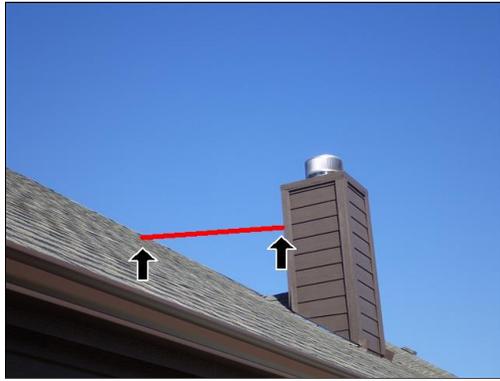
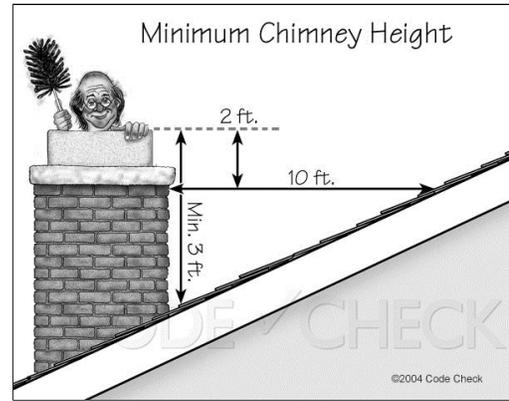
- (1) The fireplace flue was relatively clean but not fully visible by design. In following the Texas Real Estate Commission's (TREC) Standards of Practice, only the visible portion of the fireplace flue was inspected. To fully inspect the flue for safety, recommend it be further evaluated by a qualified fireplace specialist and/or chimney sweep.
- (2) Chimney was not built high enough above the roof plane for proper drafting. The chimney should extend a minimum of three feet above the point passing through the roof and a minimum of two feet above any part of the building within ten feet. The inspector measured that the adjacent roof was less than five feet from the area of the chimney that was two feet below the opening. Recommend repair by a qualified chimney/fireplace specialist.

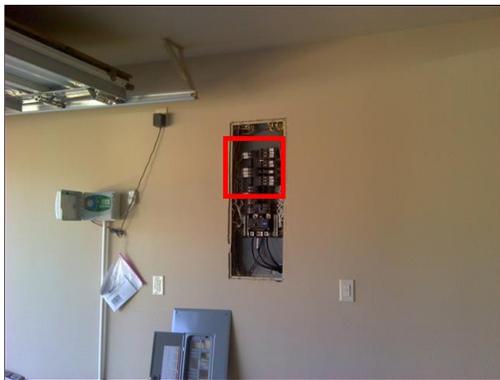
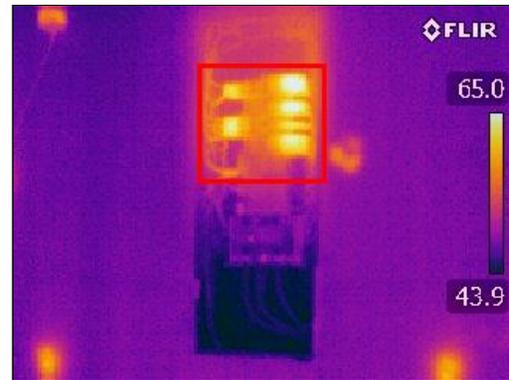
(1) Electrical panel(s) appeared to be performing as intended at time of inspection. A thermal scan of the panel(s) showed an increase in the apparent temperature at panel components such as but not limited to: Arc Fault Circuit Interrupter (AFCI) breakers, Ground Fault Circuit Interrupter (GFCI) breakers, and/or surge protectors. Although the scan showed a higher apparent temperature in comparison to the surrounding breakers, this was considered a normal condition in that these components have integrated circuits that operate at a warmer temperature.

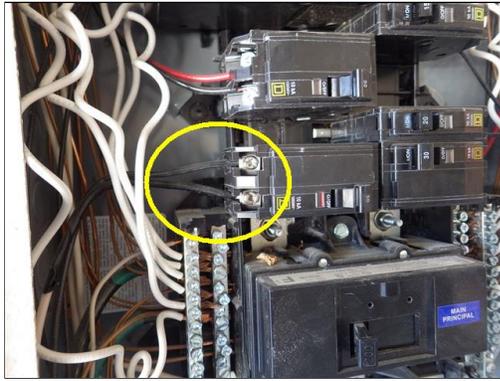
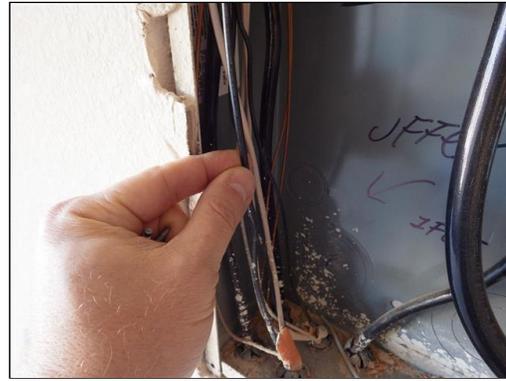
(2) At the electrical circuit for the air conditioning condenser, the wiring used was too small to be protected by a 50 amp breaker. This is a safety issue. In a high current event, the wiring could overheat before the breaker were to trip. The wire size for this branch circuit should be a minimum of 8 gauge, not 10 gauge. Recommend repair by a licensed electrician.

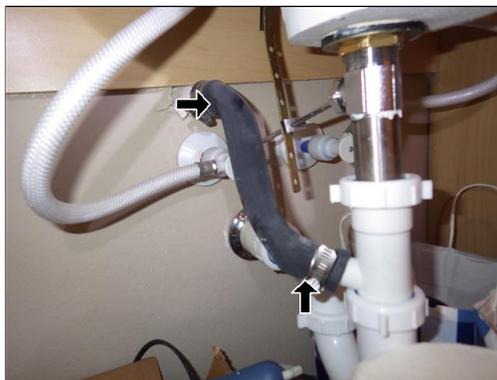
B. Photo 1

(2) The hose in the guest bathroom used for the cooling equipment condensate line was narrowed due to two kinks in the hose. Kinks in the hose can contribute to a backup of condensate over time. Recommend repair by a qualified contractor.

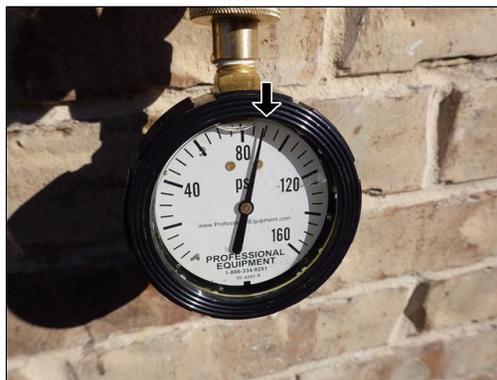
A. Photo 1

(2) The water pressure was measured to be over 85 PSI. This amount of water pressure is too high by today's plumbing standards and is typically due to a lack of a water pressure

reducing valve (regulator) or from a misadjusted regulator. No regulator was found. High water pressure can cause premature failure of plumbing pipe connections and fixture seals. Recommend further evaluation by a licensed plumber.

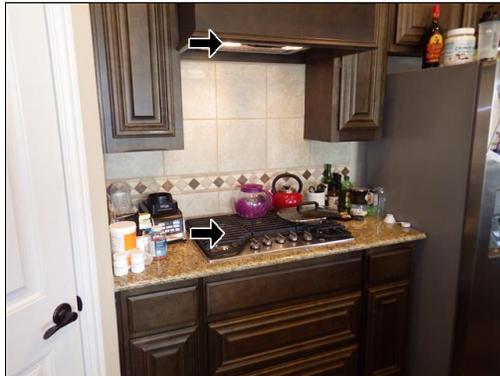
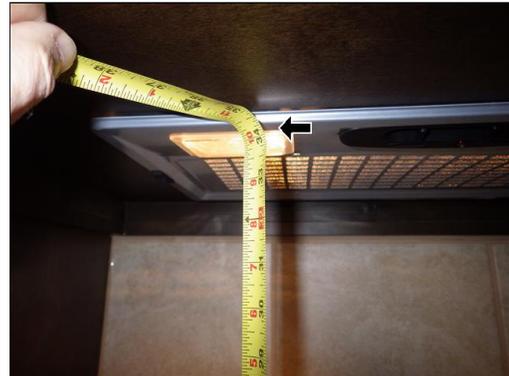
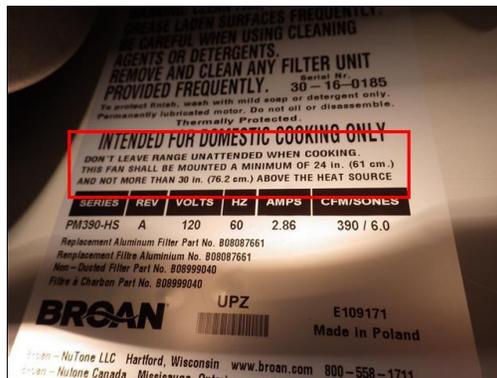
The range exhaust vent was improperly positioned in relation to the cooktop. The manufacturer instructions viewed on the vent assembly stated that the "fan shall be mounted a minimum of 24 inches and not more than 30 inches from the heat source". At present, the vent was approximately 34 1/2 inches above the heat source. This condition can affect vent performance. Recommend repair by a qualified contractor.

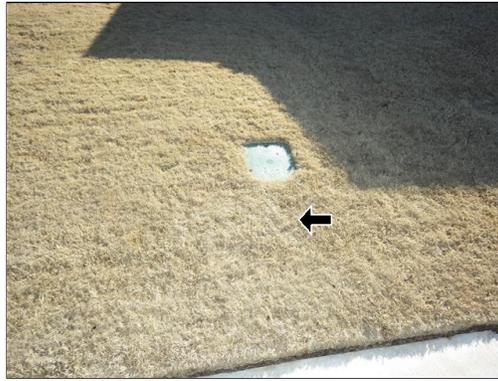
A. Photo 1

(1) The inspector did not find the presence of an isolation valve for the lawn sprinkler system water supply. Today's irrigation standards require that an isolation valve be installed between the water meter and the backflow prevention device. This is so the water supply to the lawn sprinkler system can be shut off independently of the main water supply for servicing of the system and/or of the backflow prevention device.

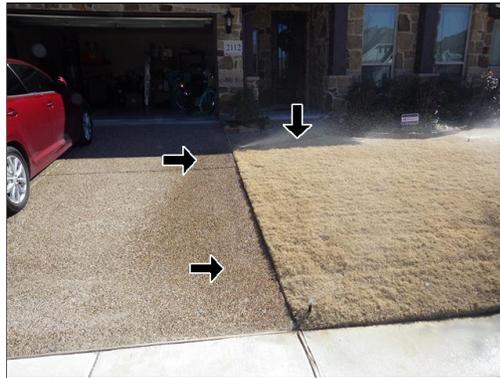
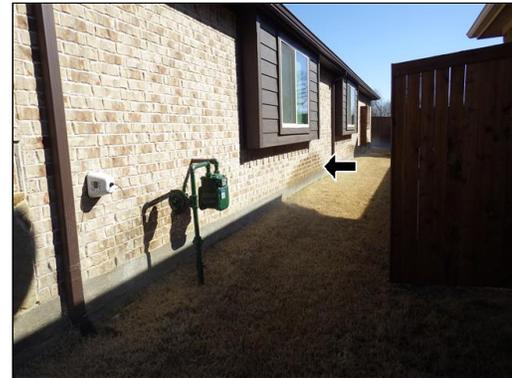
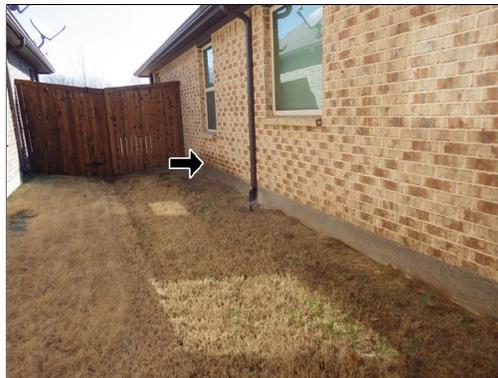
(2) Noted one or more sprinkler heads on the property that were adjusted incorrectly and spraying on areas such as but not limited to: the structure, the flatwork (e.g. sidewalk, driveway, decks), street, cooling equipment, gutters, fencing. Recommend head adjustment by a qualified lawn sprinkler contractor.
