National Property Inspections of Middle Tennessee DBA
National Property Inspections

Your Street, Middle, TN

Sunday, July 1, 2018
Inspector
Jason Lee
(931) 398-8477
jason.lee@npiinspect.com

Summary

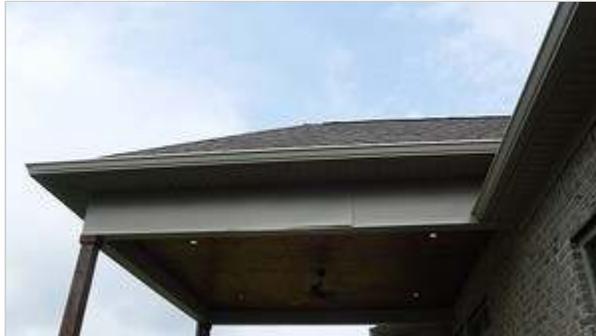
Recommend repair/replace of the siding at the east facing of the patio roof as it appeared to be loose at time of inspection.

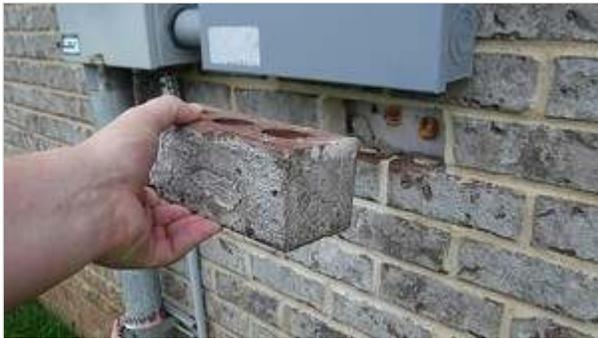
Loose brick

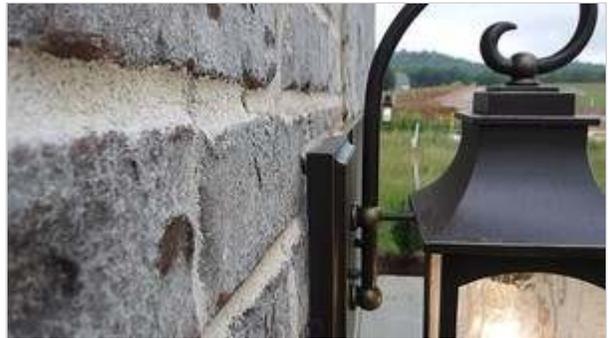
Driveway lights, gapped caulking

Recommend caulking around trim windows, doors, service entrances, and electrical outlets as gaps were visible between the brick and metal trim.

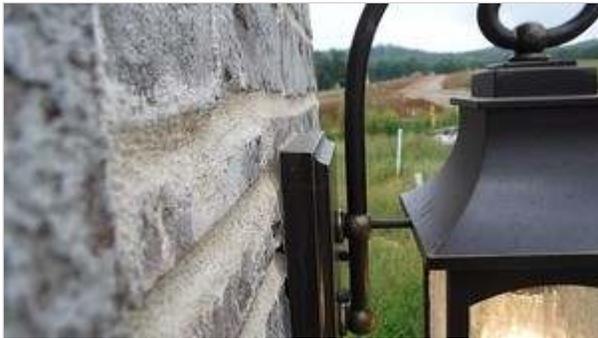
Driveway lights, gapped caulking

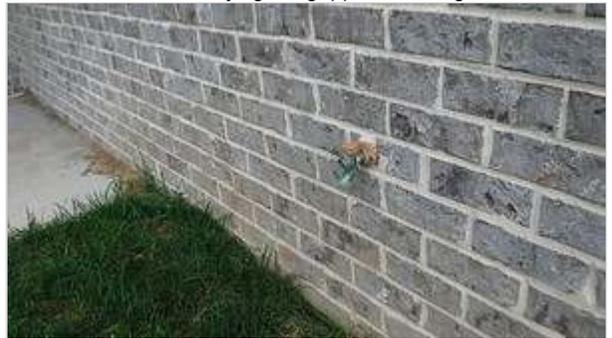
Missing spigot handle

Recommend repair/replace of the exterior water faucets as they did not have handles and could not be tested.

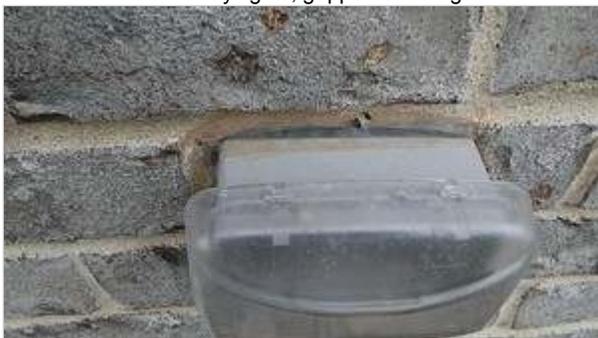
Rear electrical outlet, gapped caulk

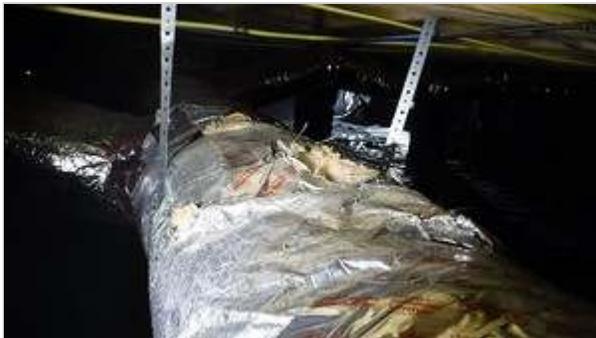
Damaged HVAC insulation under kitchen

Recommend repair of insulation at an area of HVAC ducting that was showing signs of damage at time of inspection,

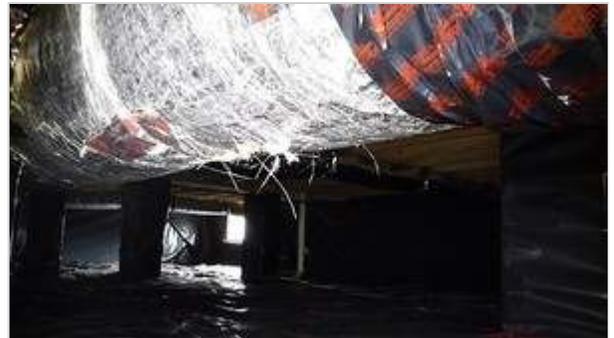
Damaged HVAC insulation under kitchen
