National Property Inspections of Middle Tennessee DBA  
**National Property Inspections**

Thursday, July 17, 2025  
**Inspector**  
Jason Lee  
(931) 398-8477  
jason.lee@npiinspect.com

<b>Type of Property:</b> Office Building <b>Primary Construction:</b> ISO - I Wood Frame <b>Property Occupied:</b> No <b>Property Faces:</b> Southeast	<b>Temperature:</b> 90's, 80's F <b>Weather:</b> Sunny <b>Soil Conditions:</b> Dry
---	--

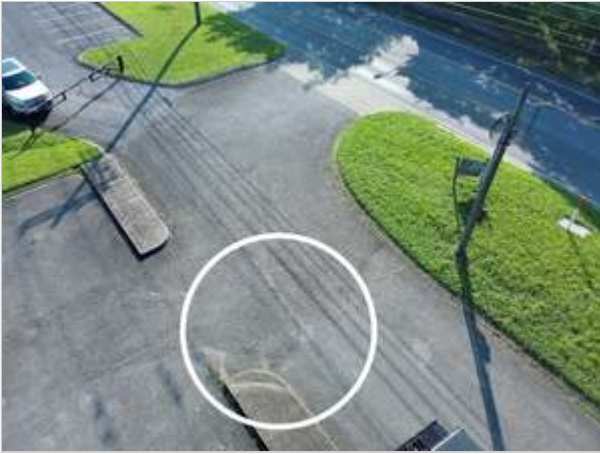
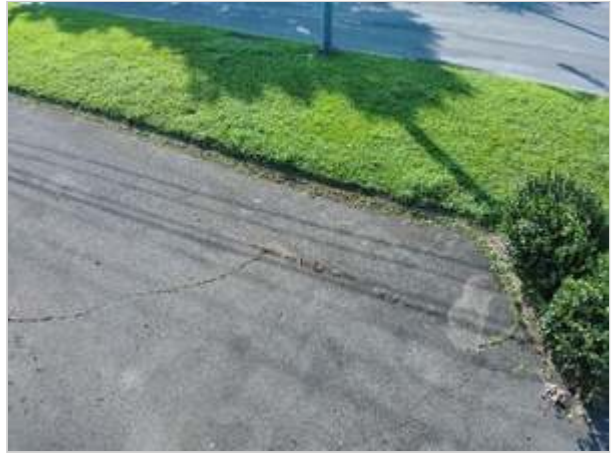
1. Surface deterioration of the paved surface was present at various locations. The areas should be repaired to prevent further damage.
2. The paved surface was cracked at various locations and vegetation was growing between the cracks. Vegetation should be removed, and the cracks sealed.
3. The surface sealant and striping were worn at many locations. The surface should be sealed to prevent further deterioration and the lot striping and decals repainted.
4. Evidence of ponding was present at the north parking lot.

Recommend repair/replace by a qualified contractor for the following:

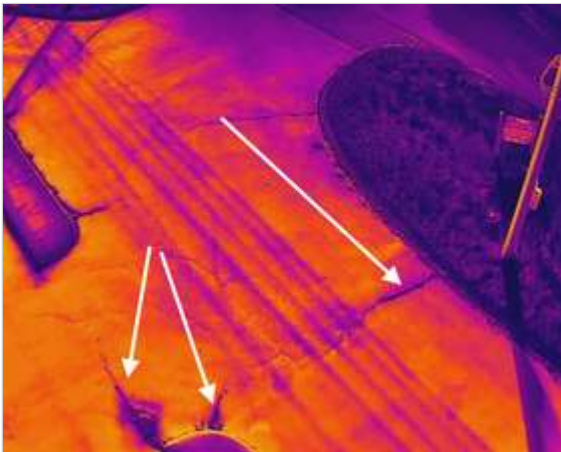
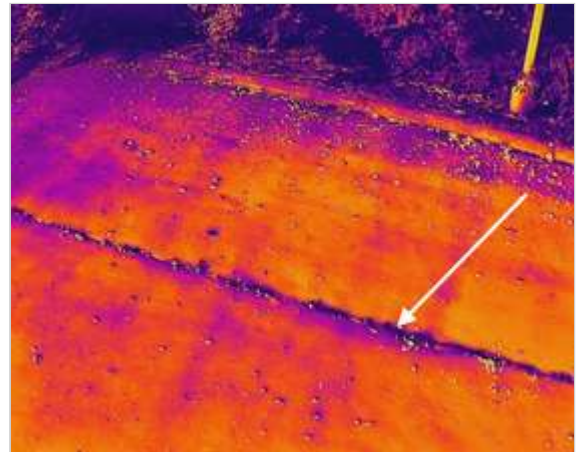
2. Infrared shows moisture within pavement cracks

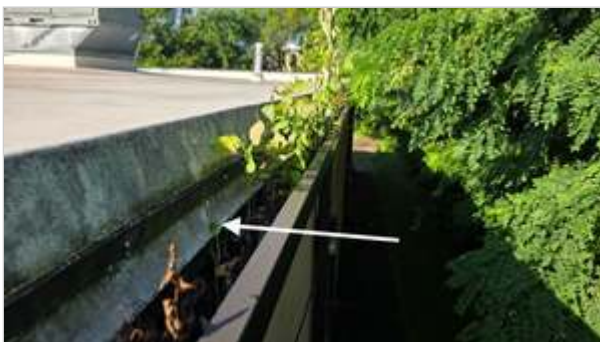
Membrane gutter overlap is loose at the flashing

Recommend repair/replace by a qualified contractor as the parapet walls and rear roof flashing was not sealed and allowing water intrusion into the interior wall structure. Signs of early water intrusion beneath the membrane surface was evident with thermal infrared imaging.

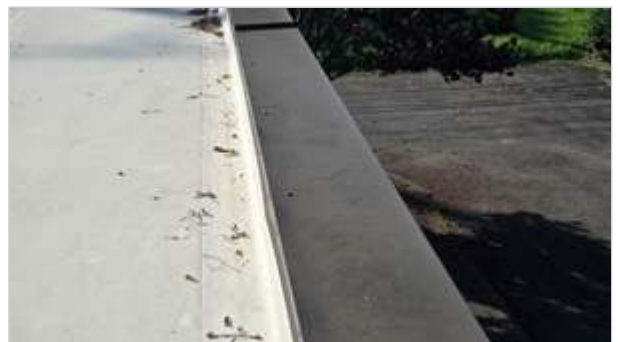
Parapet walls

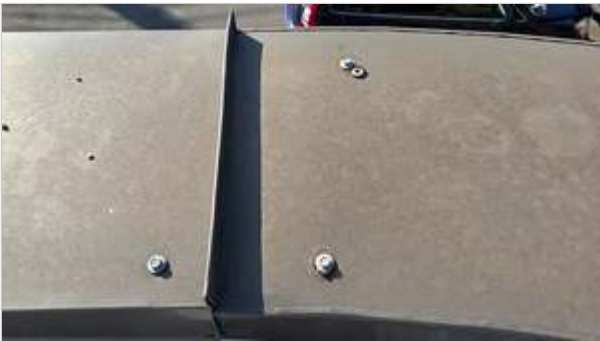
Loose screws

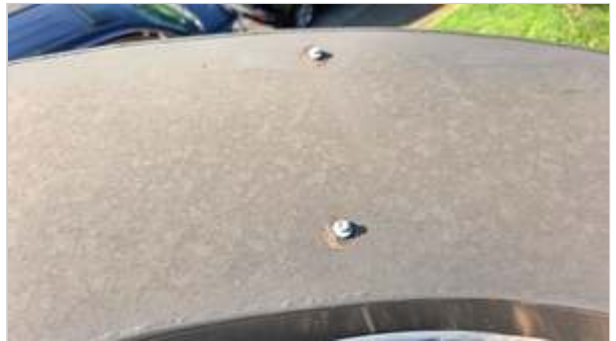
Deteriorated sealant

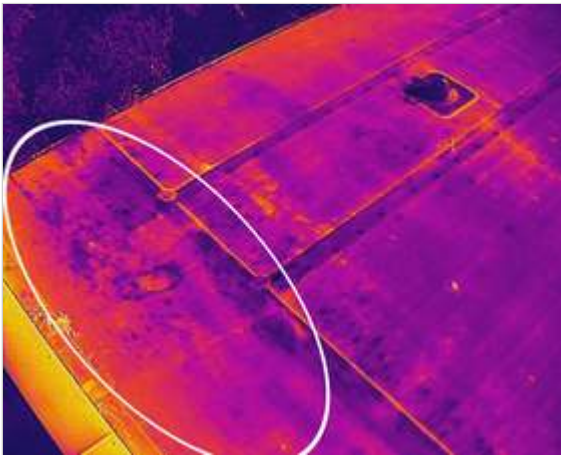
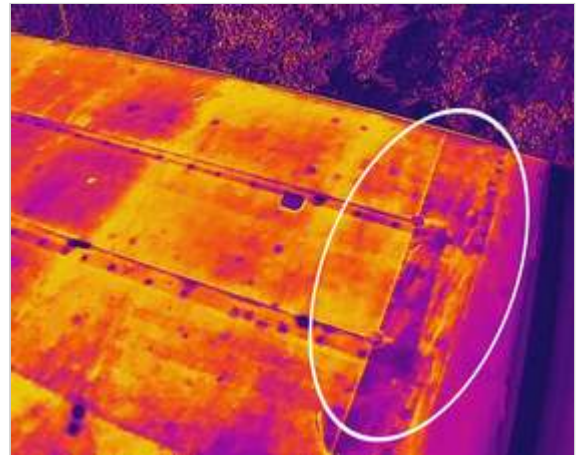
Signs of water intrusion beneath the membrane surface

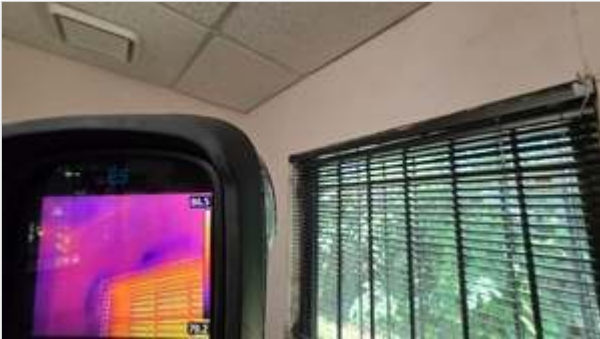
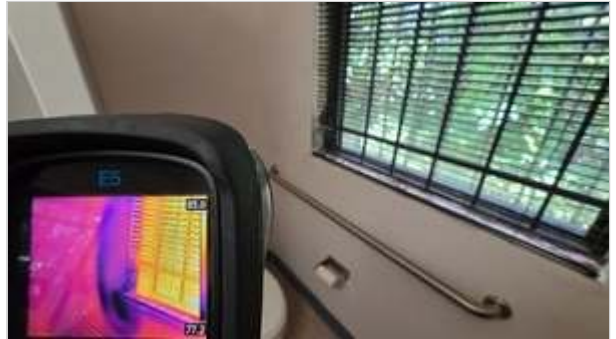
Current water detected at the south bathroom wall

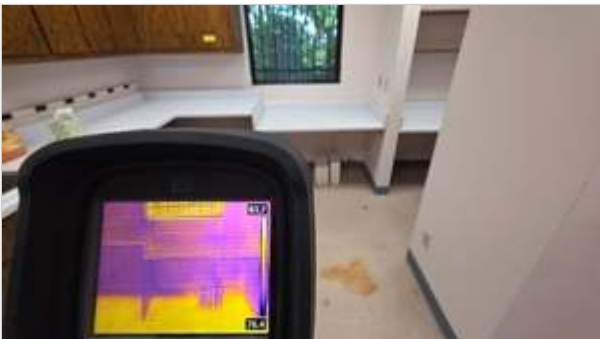
Current water detected at the laboratory wall

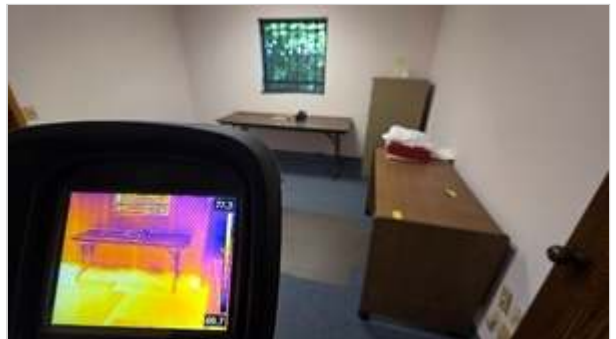
Current water detected at the south office wall

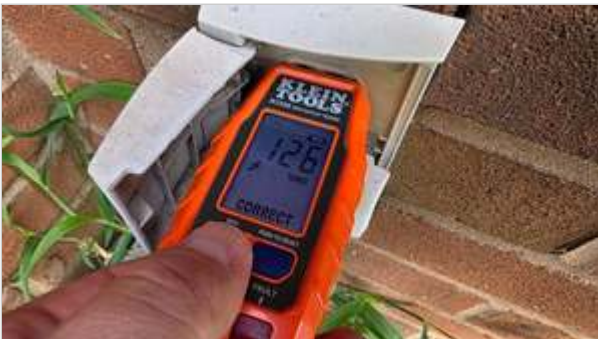
- Recommend further evaluation and repair/replace by a licensed electrician for the following:
  1. Further evaluation as a bonding clamp was not observed at the main gas service. Current standards of practice call for bonding clamps to be installed on the customer side of the gas meter.
  2. Installation of GFCI protection for all bathroom and exterior outlets.
  3. An outlet was testing as being incorrectly wired within the north prep room.
  4. Wire nut terminations were exposed within the attic and should be enclosed into electrical junction boxes.
  5. Some outlets were loose at the wall.
  6. The interior cover was missing at the HVAC disconnect panel.

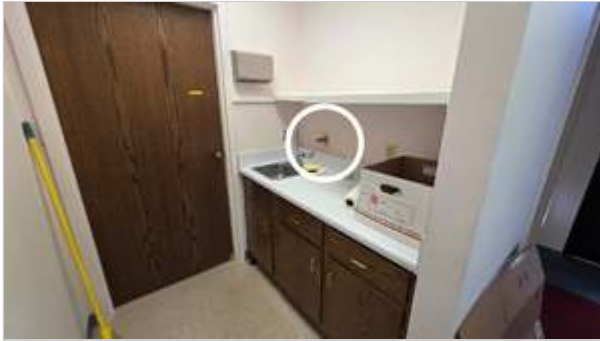
3. Reversed hot & neutral
