National Property Inspections of Middle Tennessee DBA
National Property Inspections

Tuesday, July 15, 2025
Inspector
Jason Lee
(931) 398-8477
jason.lee@npiinspect.com

GENERAL INFORMATION

Type of Property: Single-Family Home	Temperature: 80's F
Primary Construction: Crawl Space, Wood Framing	Weather: Sunny
Property Occupied: Yes	Soil Conditions: Dry
Estimated Age of Property: Two Year(s)	Persons Present: Buyer, Owner(s), Inspector
Property Faces: East

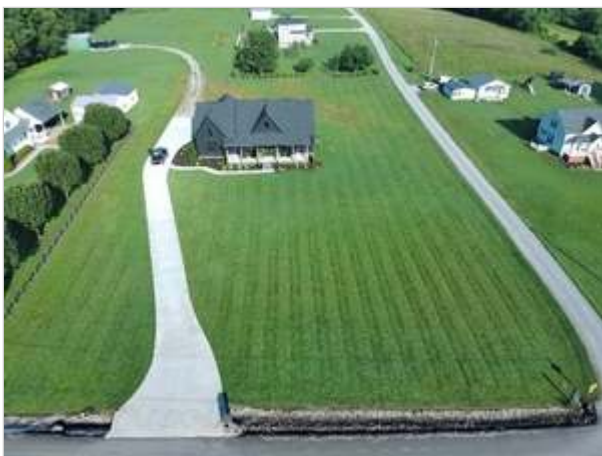
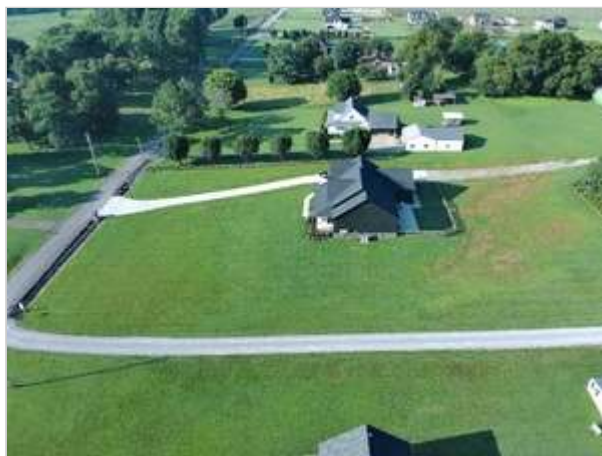
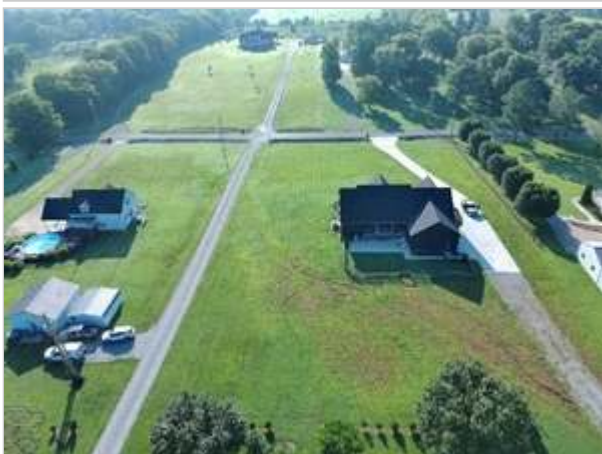
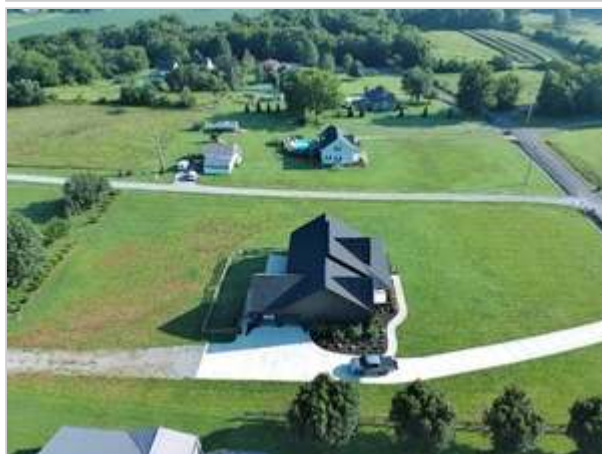
The lot within four-to-six feet of the house was inspected for elevations, apparent drainage patterns and drainage landscaping. Recommend monitoring conditions during heavy rain.

Recommend installation of landscaping, or other system to help divert water away from the house foundation.

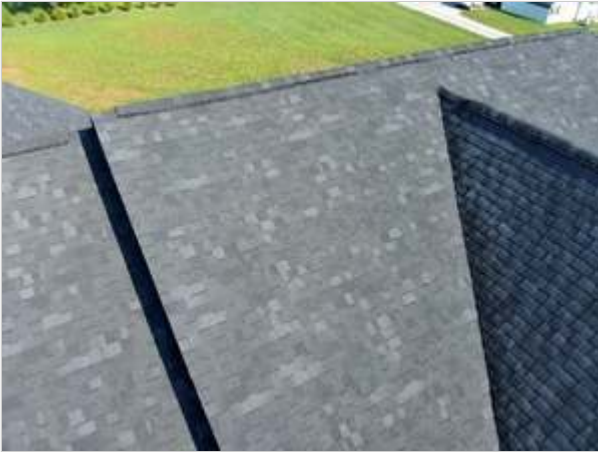
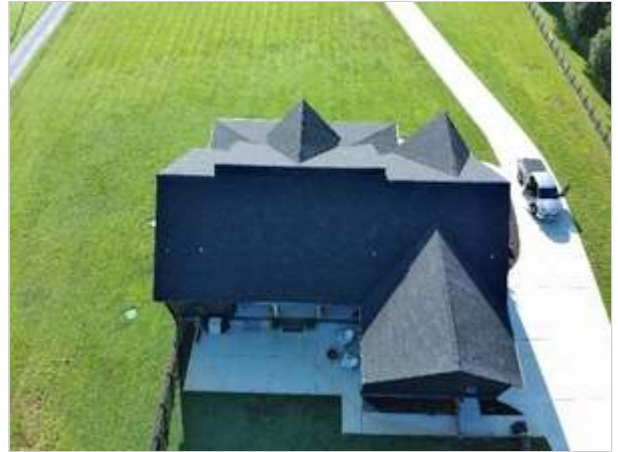
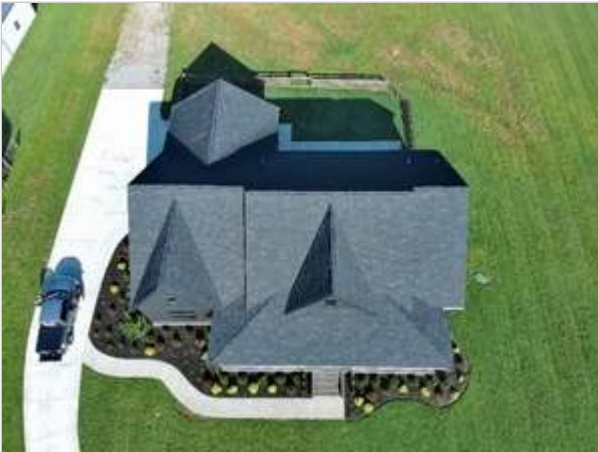
Recommend further evaluation by a qualified contractor as the apparent underlayment of the roof was secured beneath the drip edge at the lower edge of the roof. The lower edge of the underlayment of the roof should be installed on top of the drip edge to allow for full drainage of any water which may be beneath the layer of shingles.

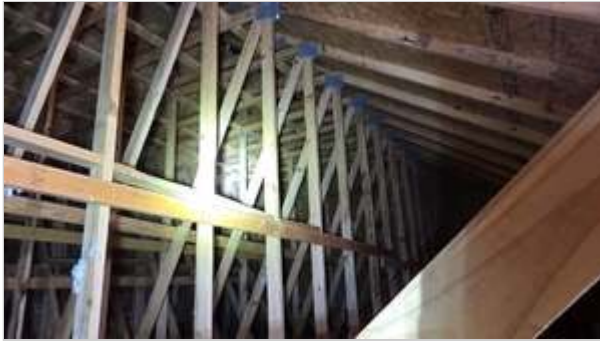
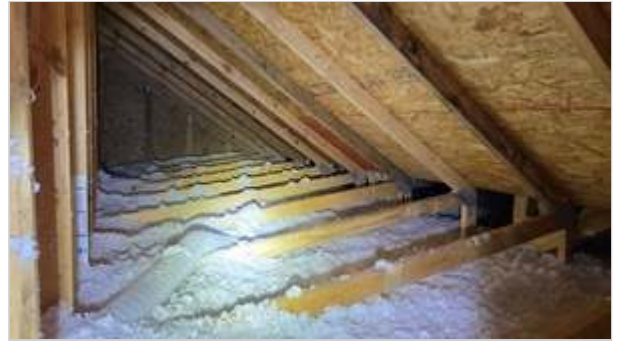
Recommend repair as a bracing member above the living room was observed as being loose at time of inspection.

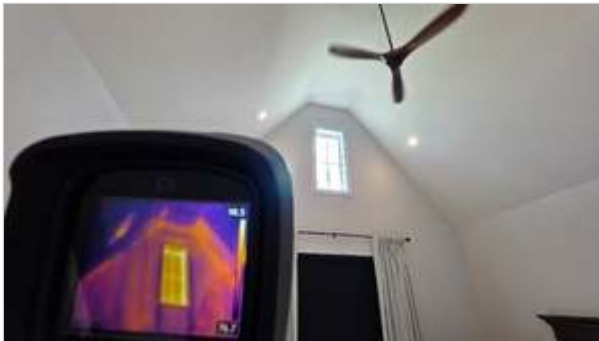
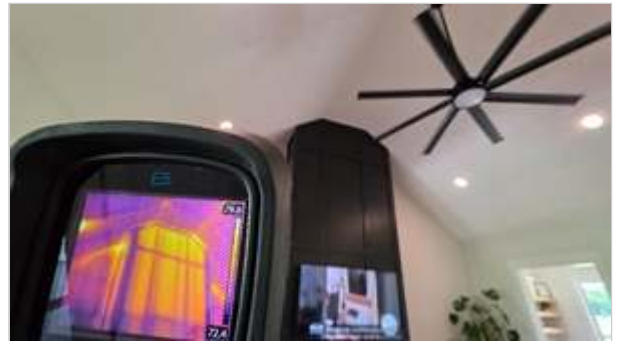
Recommend repair as some areas of insulation was showing signs of displacement.

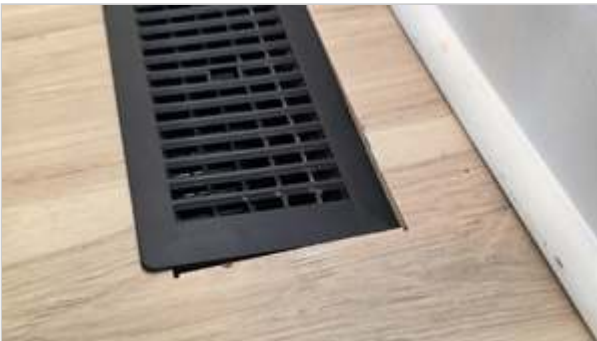
Dining room register

Recommend further evaluation and repair/replace by a qualified HVAC contractor for maintenance and service for cleaning, refrigerant pressure check and evaluation of exhaust systems.
