Jason Young, TN Lic. #1690 Jason.Young@npiinspect.com 865-523-6200

Scope of Inspection

Report Summary

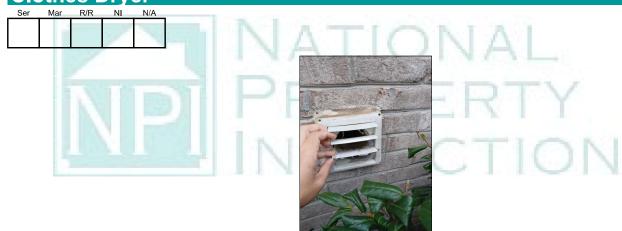
Dirty dryer vent
