SEWER INSPECTION

Street Address

MAY 5, 2023

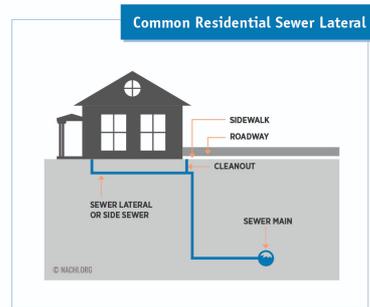
Drain System: Materials Identified from Access Point

PVC

All sewer line materials are not always identifiable.
