**Southshore/Manatee Property Inspections DBA
National Property Inspections**

Christian Brothers Automotive Corp, 128 Harbor Village Lane, Apollo Beach, FL, 33572

Friday, January 8, 2021
Inspector
Greg Suhre
941.254.1583
greg.suhre@npiinspect.com
HI12972

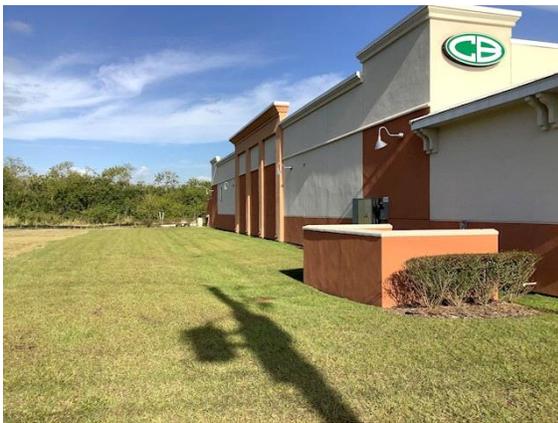
- Drainage in swale in rear is covered with a substance and blocked in the bottom. Repair is recommended for proper drainage.

Grading / Drainage: Swale in rear

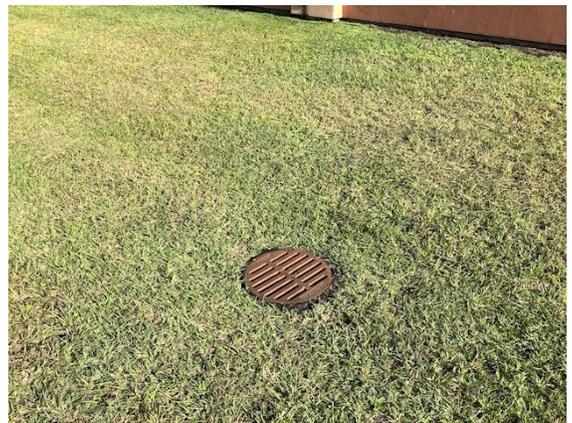
Grading / Drainage: Drainage in swale

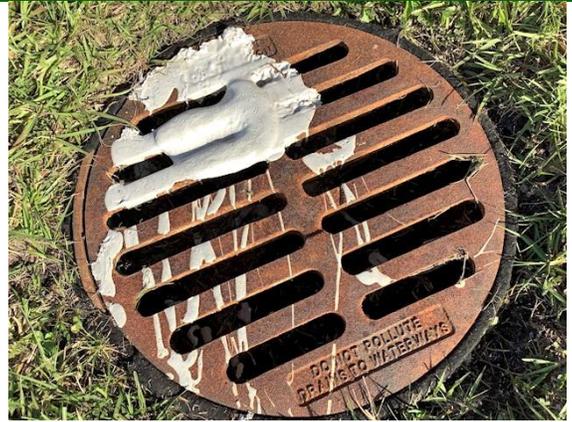
Grading / Drainage: Blockage

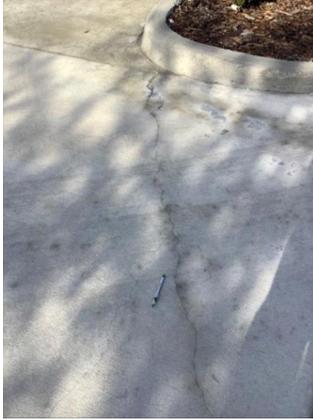
The asphalt driveway at the front of the property connects to the concrete parking lot with concrete curbing. The driveway and parking lot are in new condition with no signs of notable deterioration or settlement. There is minor cracking on the parking lot and curbing - monitor going forward. Lot markings are present and in good overall condition.

Parking Lot: Minor cracking

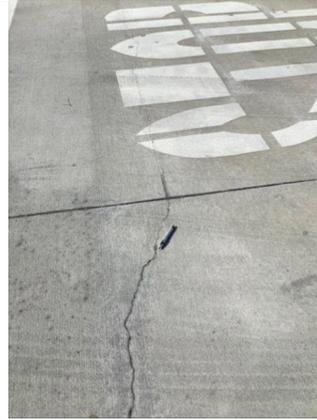
Parking Lot: Minor cracking

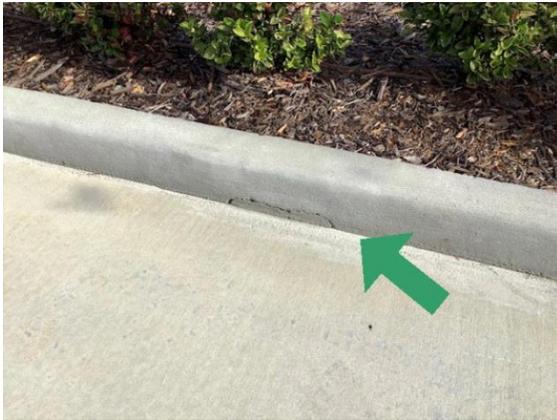
Parking Lot: Minor curb cracking

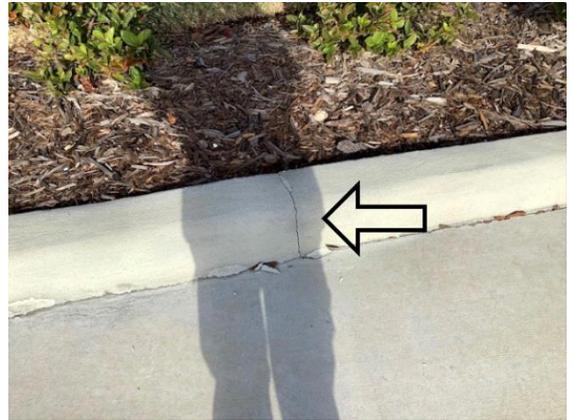
Parking Lot: Minor curb cracking

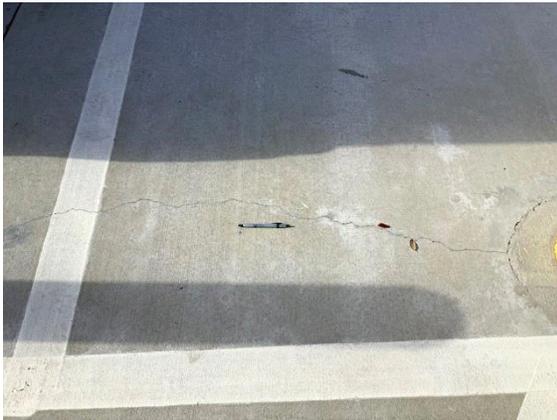
Parking Lot: Minor cracking

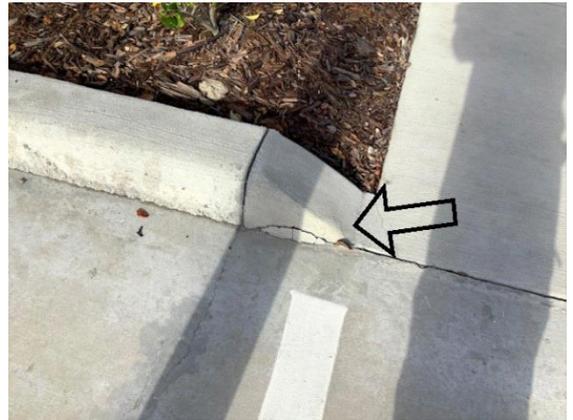
Parking Lot: Minor curb cracking

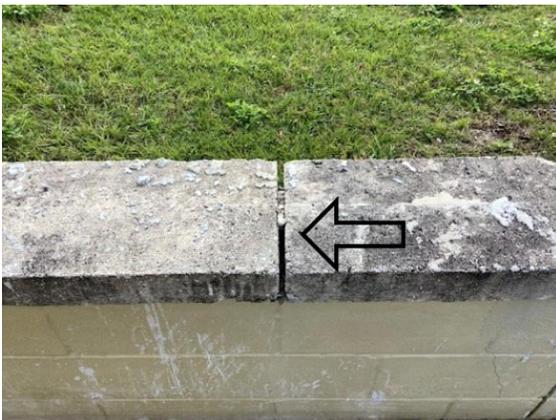
- There is damage to the wall that fronts the strip mall. Not sure who is responsible for it's upkeep; most likely the owner of the strip mall. The pictures are provided as a courtesy as the aesthetics of the front of the property is compromised.

Lots & Grounds Misc Item: Missing mortar

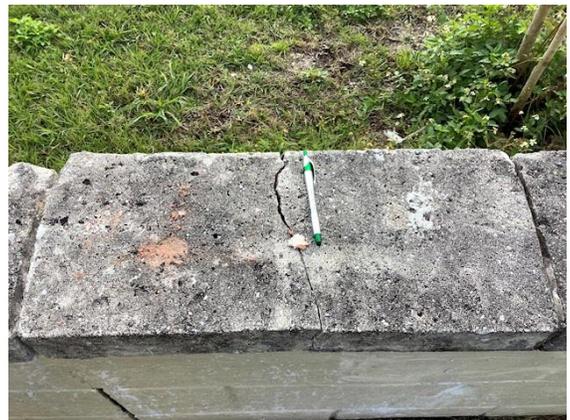
Lots & Grounds Misc Item: Cracking

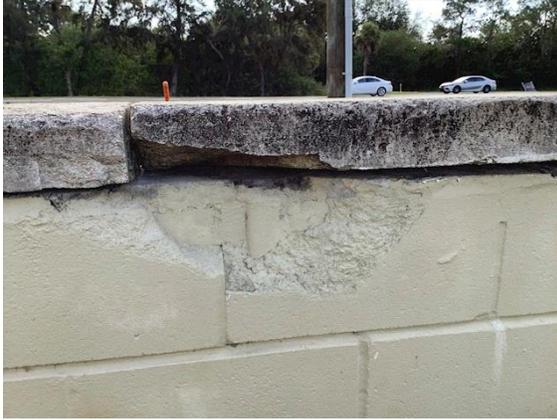
Lots & Grounds Misc Item: Deteriorated CMU

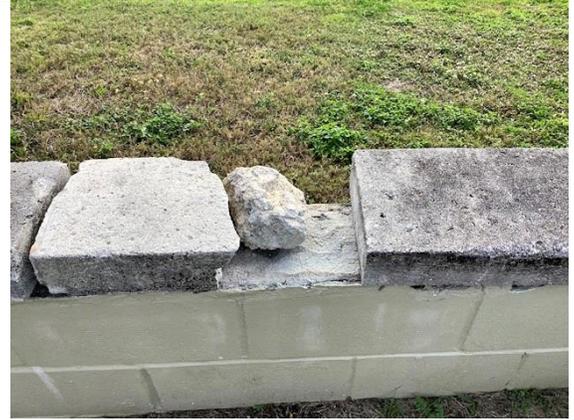
Lots & Grounds Misc Item: Damaged top

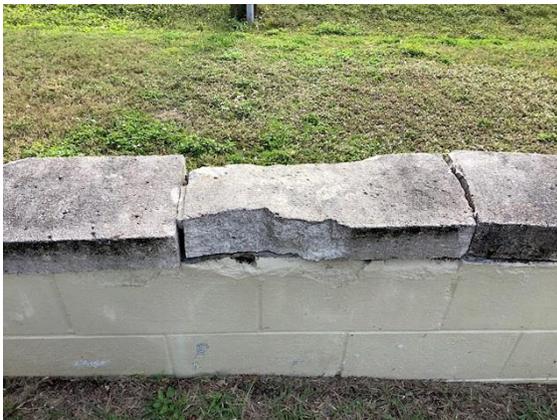
Lots & Grounds Misc Item: Damaged top and CMU

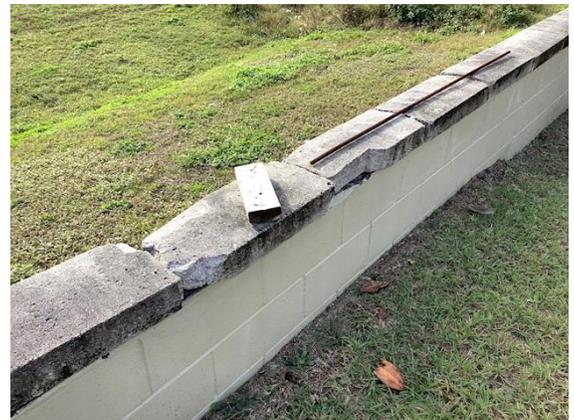
Lots & Grounds Misc Item: Damaged top and CMU

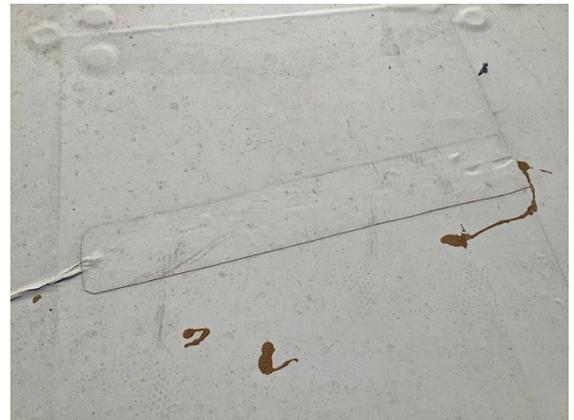
Roofing: Possible previous repairs

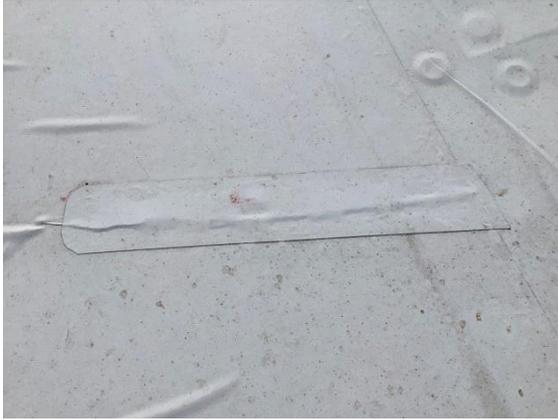
Roofing: Possible previous repairs

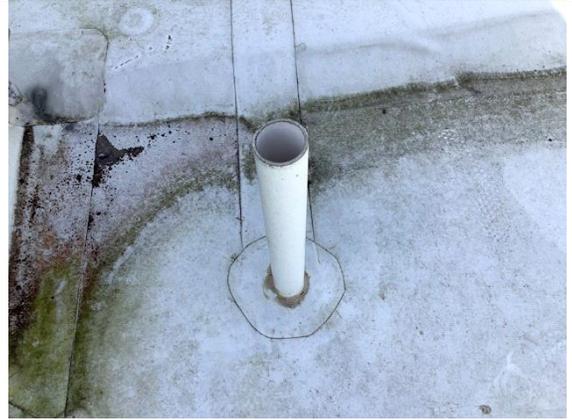
- One or more of the roof vents are missing the screen or flapper. This can allow bugs, insects, small animals/rodents to enter the vents. It is recommended to have a certified roofing contractor install the necessary screen or flap.
- There is some deterioration to the parapet walls that could allow moisture/pest intrusion. It is recommended to have a certified roofing contractor repair as necessary.
- Appears there was previous repairs to the flat roof. Monitor going forward for any moisture intrusion.

Roofing: Plumbing vent - missing screen

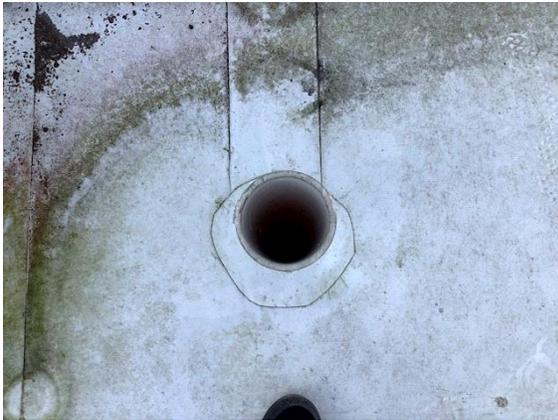
Roofing: Plumbing vent - missing screen

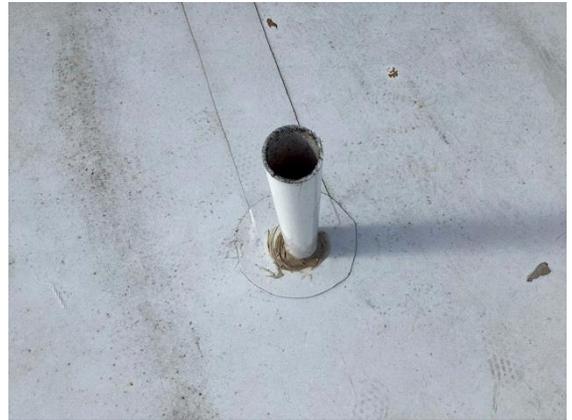
Roofing: Plumbing vent - missing screen

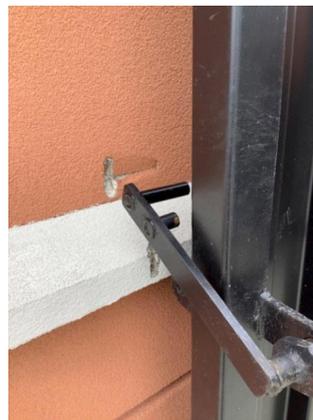
- The dumpster enclosure door was striking the siding damaging it. Recommend rubber stopper or similar be installed to prevent further damage.
- The concrete parking lot surface near the front do not provide appropriate clearance below stucco siding. Over time, this lack of clearance could be conducive to moisture intrusion and damage to building materials.

Exterior Surface: Wall damage from dumpster enclosure door

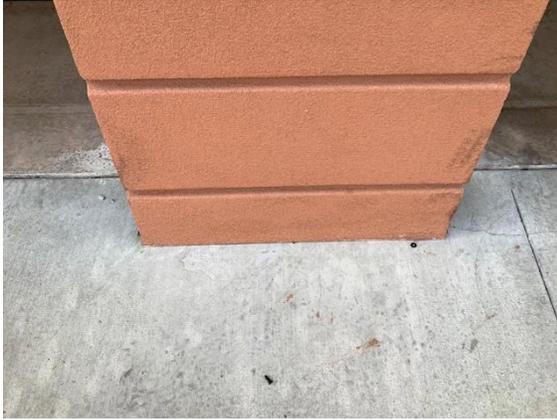
Exterior Surface: Inadequate clearance observed between the siding and exterior surfaces at the front bay areas.

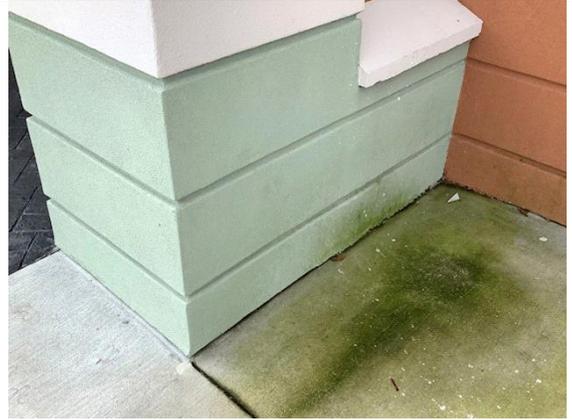
Exterior Surface: Pressure wash for mildew from drainage from metal roof. Also low clearance.

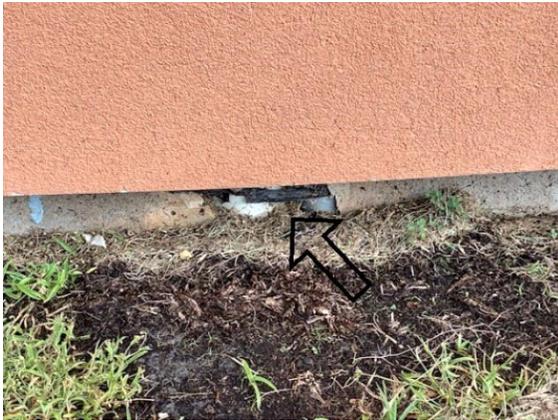
- Foundation wall(s) have damage in rear that require repair to prevent water/pest entry.

Foundation: Foundation damage

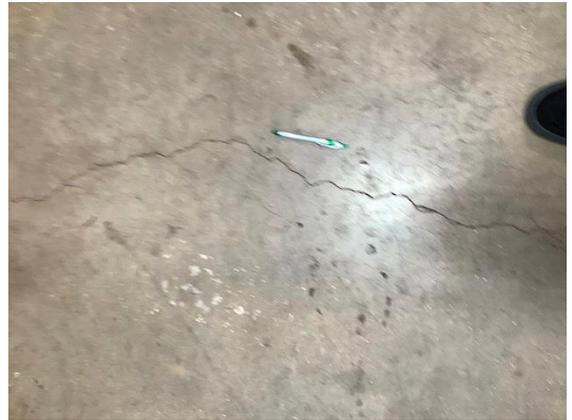
Typical minor cracking was observed in the vehicle bays.

Foundation: Minor cracks in garage

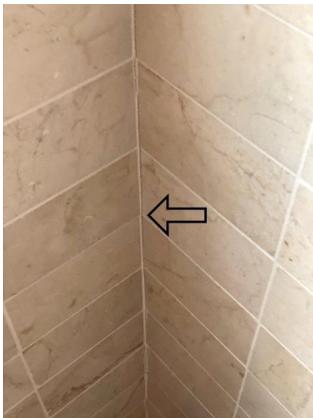
Bathroom: Minor cracks in office bathroom

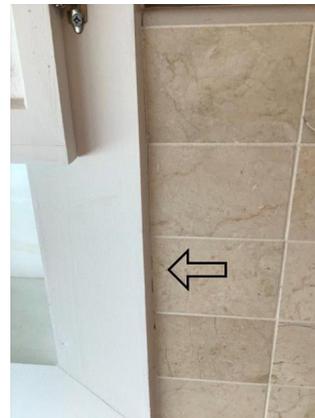
Bathroom: Minor cracks in office bathroom

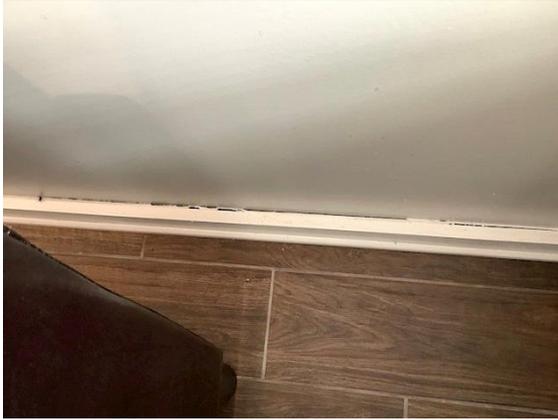
Minor cracking along baseboard.

Interior Room: Minor cracking in lobby along baseboard

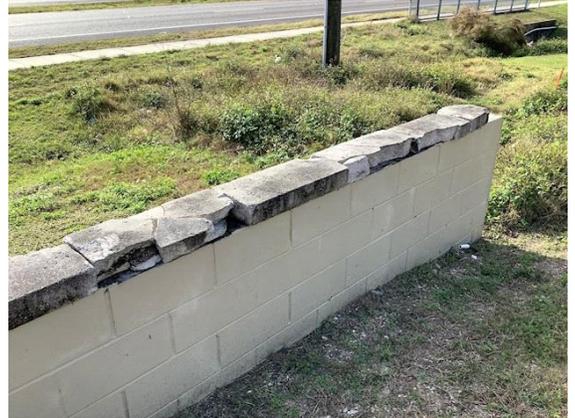
Damaged top

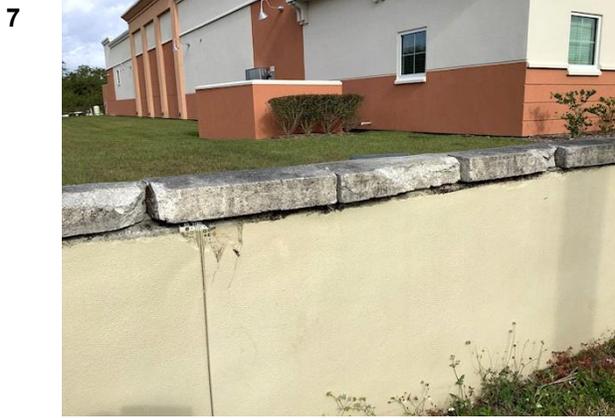
Damaged top and CMU

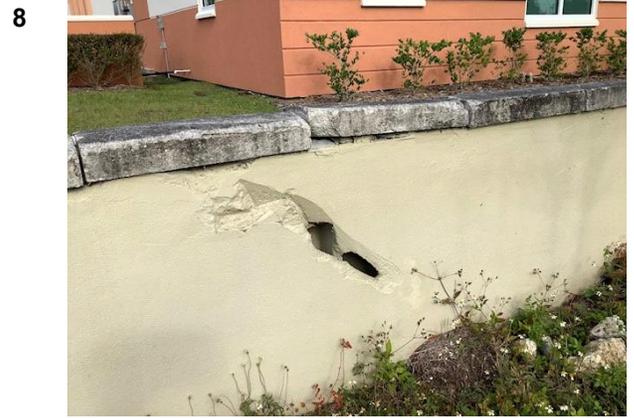
Top and front damage

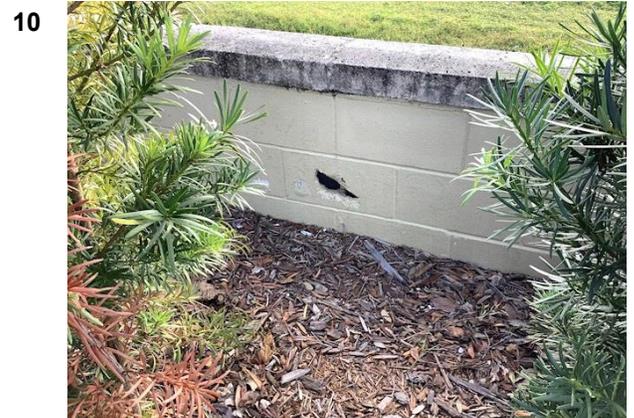
Damaged CMU

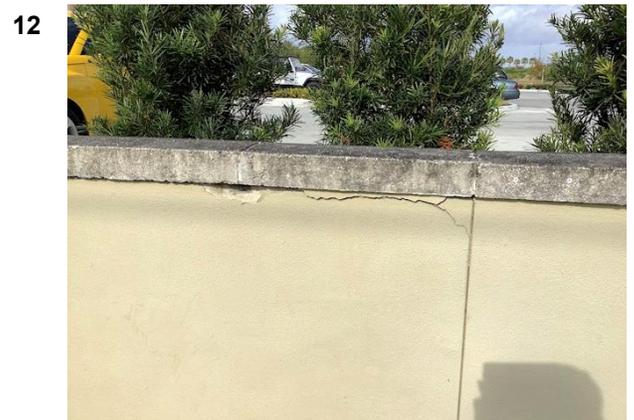
Damage to front wall

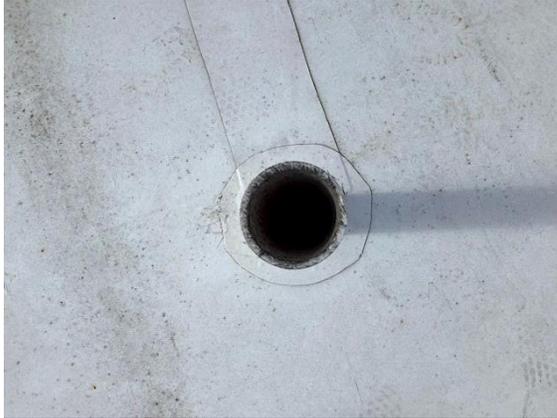
13

Plumbing vent - missing screen

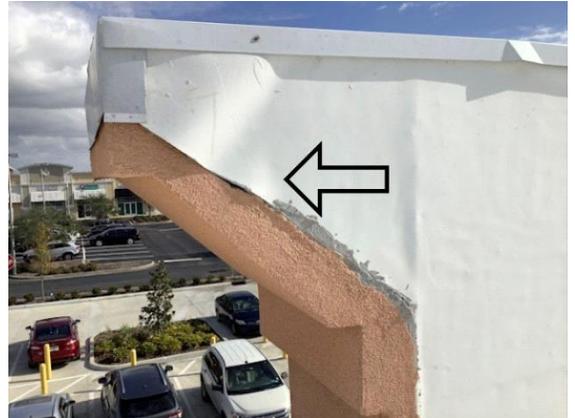
16

Parapet wall deterioration

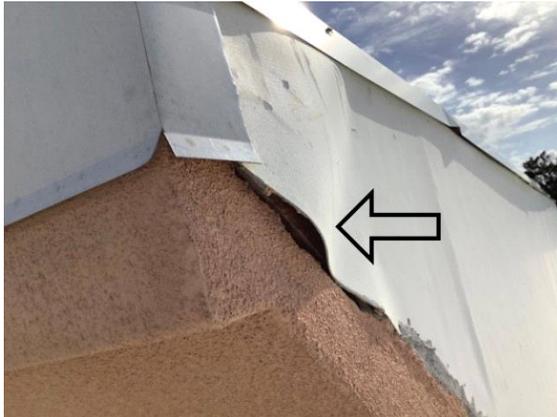
17

Parapet wall deterioration

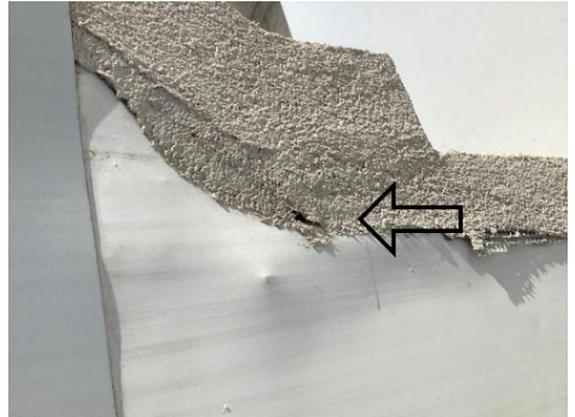
18

Parapet wall deterioration

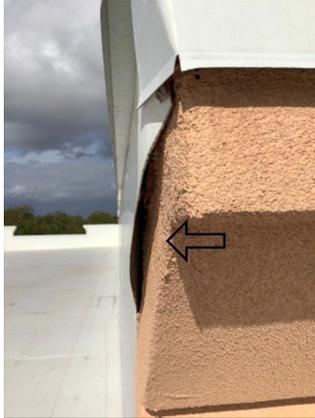
19

Parapet wall deterioration

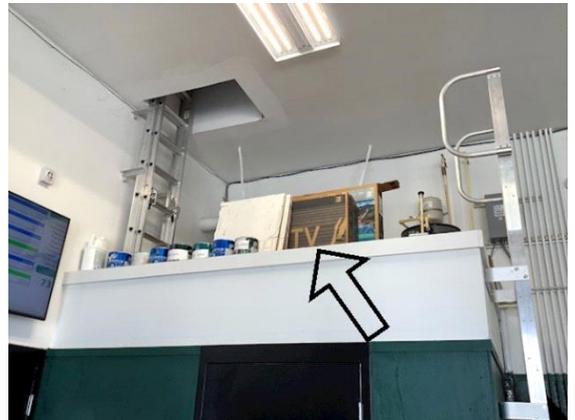
22

Loft area where the water heater is installed does not contain a guardrail.

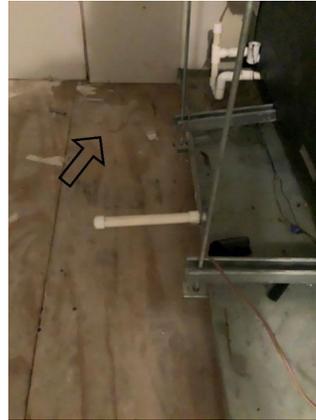
48

Water stains

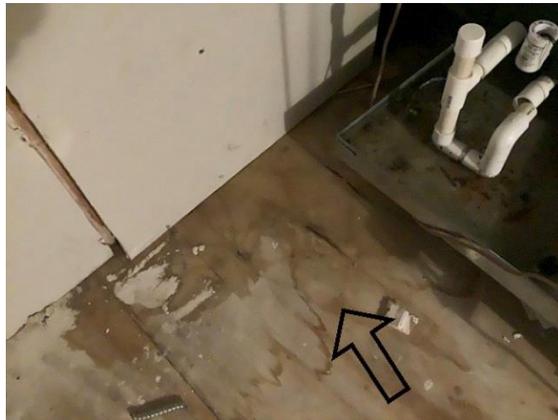
49

Water stains

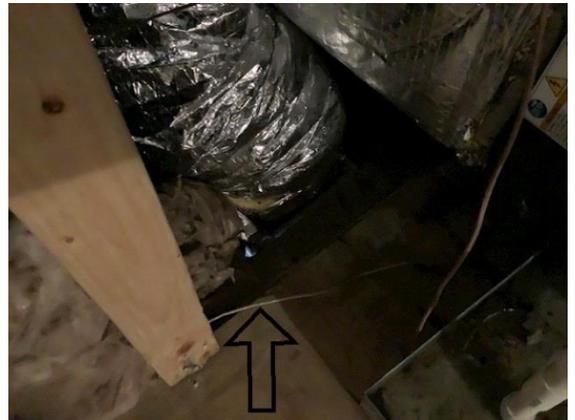
50

- Emergency catch pan under unit was full of water. Unit was not draining condensation properly. Water has overflow previously, saturating the floor, and flowing behind the drywall down into and around the supply vent above the office. The picture shows what appears to be microbial growth around the supply vent as well as ceiling stains and sagging. A qualified heating and cooling contractor should evaluate and repair as necessary.

Water flowed behind drywall into and around vent

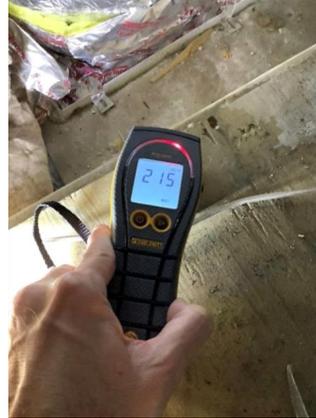
53

Positive elevated moisture reading

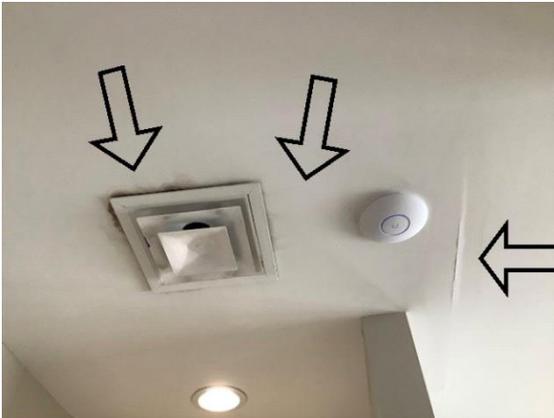
54

What appears to be microbial growth, water stains, and sagging in office ceiling from overfilled air handler pan above
