12345

Des Moines IA 50311

Prepared for:  
Client Name

Chris Meade  
npiguydsm@gmail.com

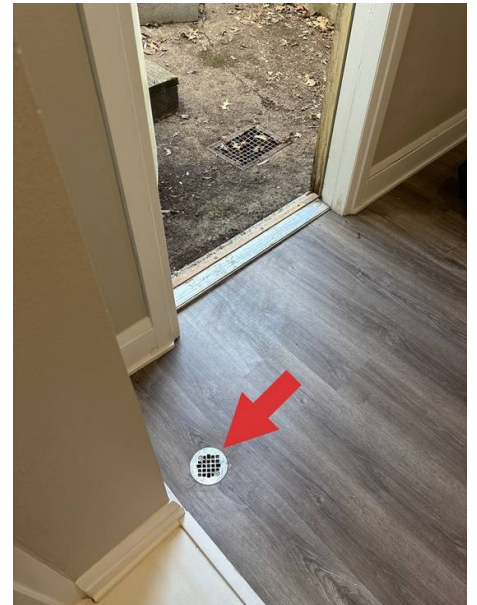
Rear entrance to east basement room

Insufficient drainage observed in the rear entrance to the east basement room stairwell, evidenced by dirt nearly level with the threshold and in contact with the siding despite the presence of a drain, as well as an interior drain on the other side of the door suggesting potential water management issues, recommend a comprehensive evaluation by a qualified contractor to ensure the drain is functioning, the grading prevents water accumulation and contact with the siding, and the threshold is protected from moisture intrusion.

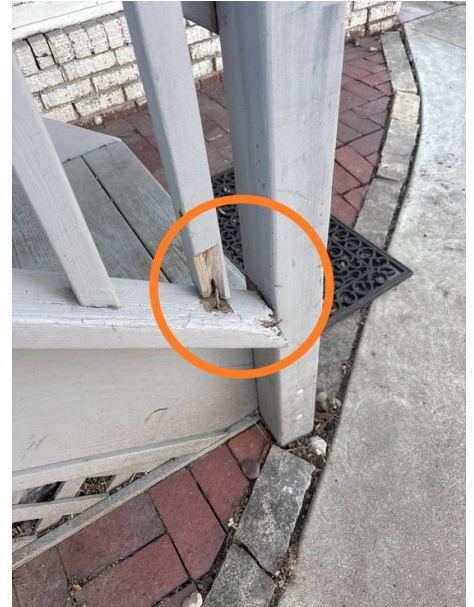
Handrails observed as loose and deteriorated, posing a safety concern, with general deterioration noted on the deck and stairs. Deck is at or near life expectancy. Recommend further evaluation by a qualified contractor for any or all repair or replacement needs.

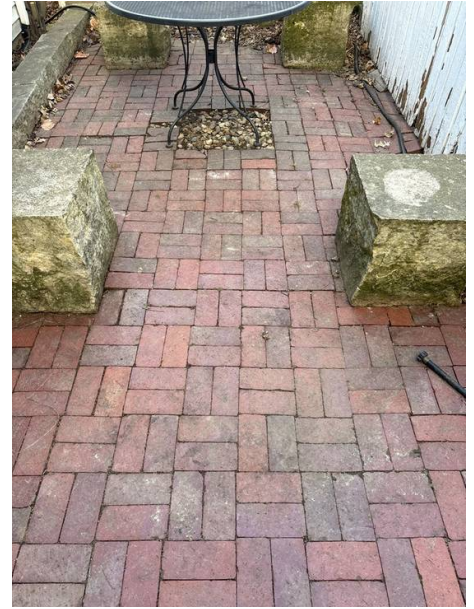
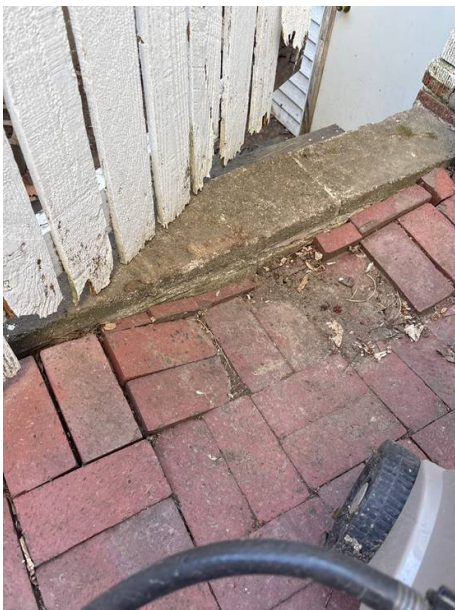
Loose bricks observed in the brick patio near the stairs leading to the northeast rear entrance, with the patio noted as wavy, recommend further evaluation by a qualified contractor to ensure stability and safety.

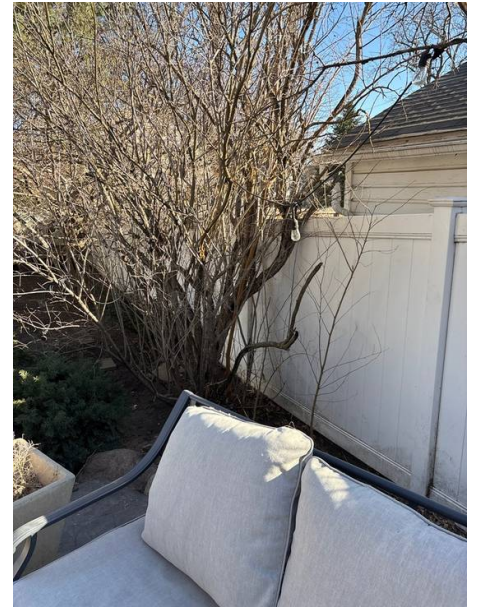
Vegetation is observed in contact with the fence, potentially causing structural damage and promoting rot or insect

activity. Recommend vegetation be trimmed back.

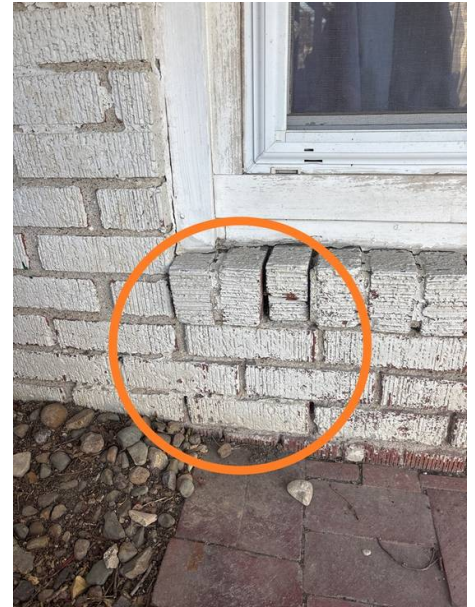
Gap observed between the foundation and the northeast basement window, with an uneven foundation noted along the gap, potentially allowing moisture infiltration and structural stress, recommend further evaluation and repair by a qualified contractor to ensure structural stability and protection from moisture damage.

Minor gaps observed throughout the rest of the painted brick foundation wall with no significant cracking or movement noted. Recommend monitoring the area for signs of moisture infiltration or further deterioration, and suggest minor repairs to the gaps in the brick foundation as needed to maintain protection against weathering. Further evaluation by a qualified contractor is advised if moisture or worsening conditions become evident.

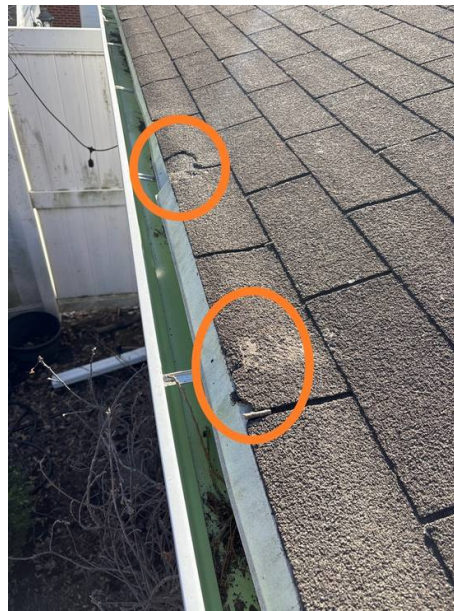
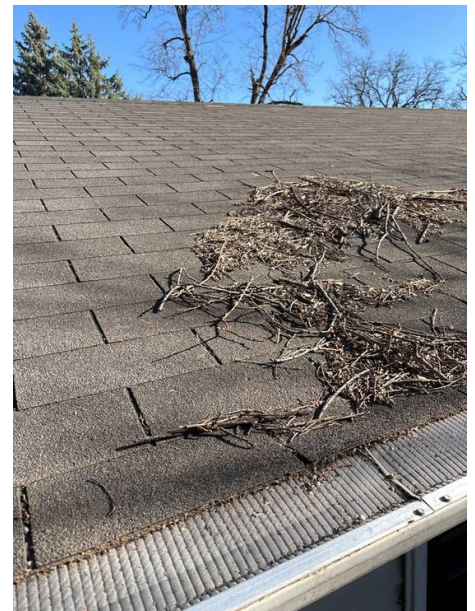
Damage observed on the rear of the garage roof, where 3-tab shingles (with an average lifespan of 20-25 years) are missing/deteriorating, exposing the underlying roof surface. Multiple layers observed, potentially allowing moisture infiltration and complicating repairs. Recommend further evaluation by a qualified roofing contractor to assess the overall roof condition and remaining lifespan.

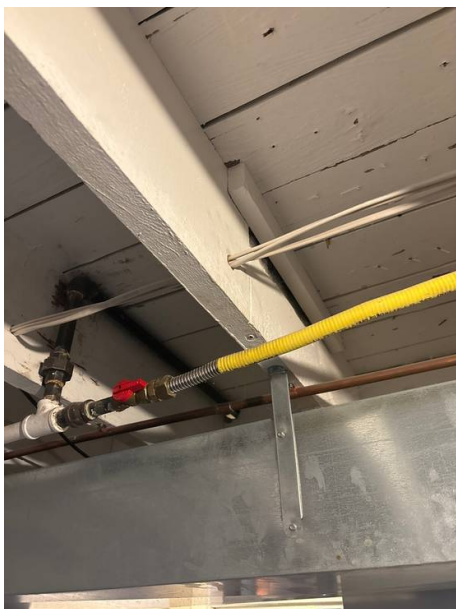
Corrugated Stainless Steel Tubing (CSST) was observed and does not appear to be properly bonded, posing a potential safety risk. Recommend further evaluation/repair by a qualified contractor.

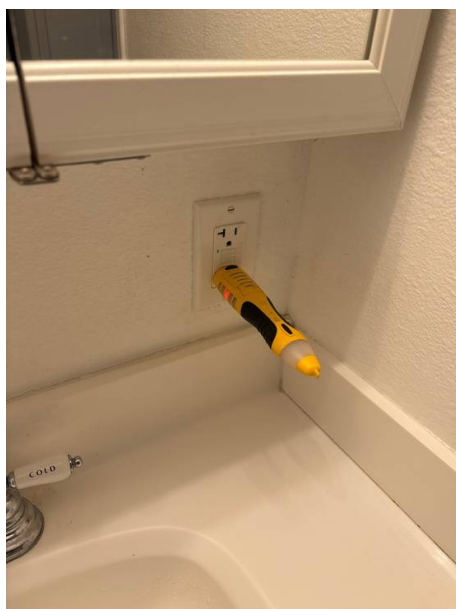
Outlet in the basement bathroom next to the sink observed to be wired incorrectly with a hot/neutral reverse as indicated by tester readings, posing a potential electrical hazard. Recommend further evaluation by a qualified contractor to ensure safety and proper function.

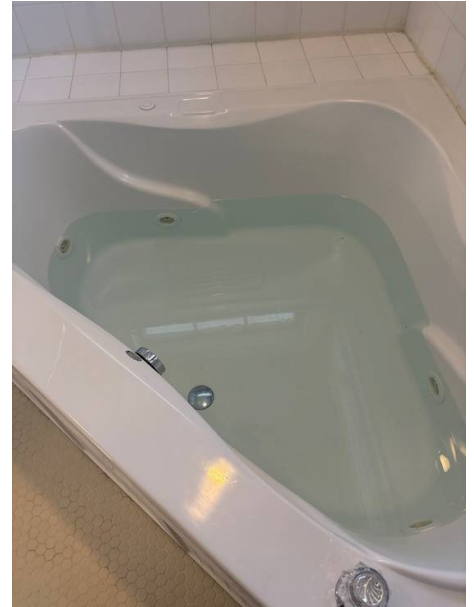
Chip observed in the jacuzzi tub, potentially allowing moisture to penetrate the underlying material. Jacuzzi tub jets appeared underpowered during operation, indicating a possible mechanical or electrical issue. No dedicated GFCI (Ground Fault Circuit Interrupter) protection observed for the unit, posing a safety hazard. Deteriorated caulk observed between the tiles in the bathroom, potentially allowing moisture infiltration behind the walls. Recommend further evaluation/repair of jacuzzi tub and surrounding area by a qualified contractor.

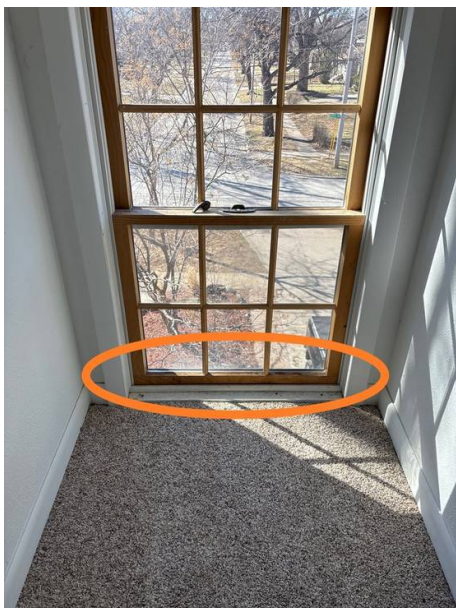
Damaged screen was observed, potentially allowing pests or debris to enter and reducing security or ventilation effectiveness.

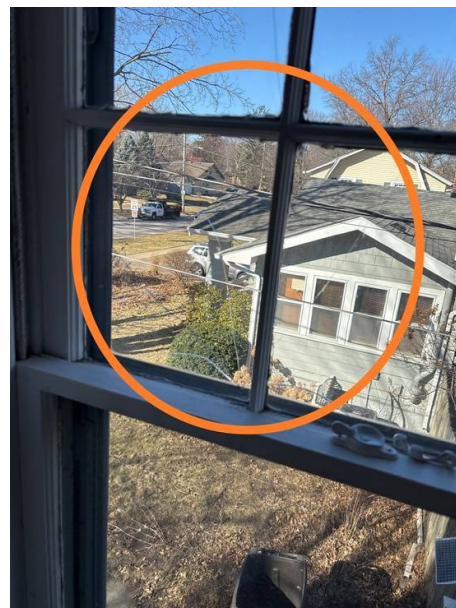
Windows in the finished attic space on the third floor observed to not meet the minimum sill height requirements of 24 inches for fall protection. This poses a fall hazard for children given the significant height above the exterior grade. Recommend installing window guards and/or further evaluation by a qualified contractor to ensure compliance with safety standards and prevent potential falls.

3rd floor window does not meet minimum height requirements and has broken locking hardware

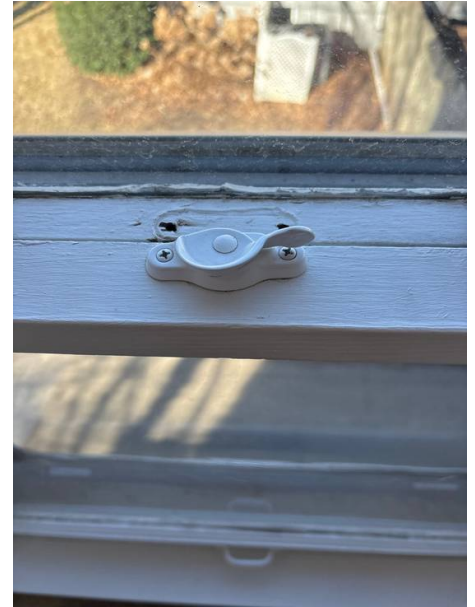
Window right of the fireplace in the living room observed with a missing sash lock, compromising the ability to secure or operate the window properly. Additionally, the primary bedroom closet window in the primary bedroom observed with a loose sash lock. Recommend replacing the missing sash lock in the living room window and tightening or replacing the loose sash lock on the closet window to restore proper function and security. Suggest further evaluation by a qualified contractor to ensure both windows operate safely and effectively.

Primary bedroom closet window hardware

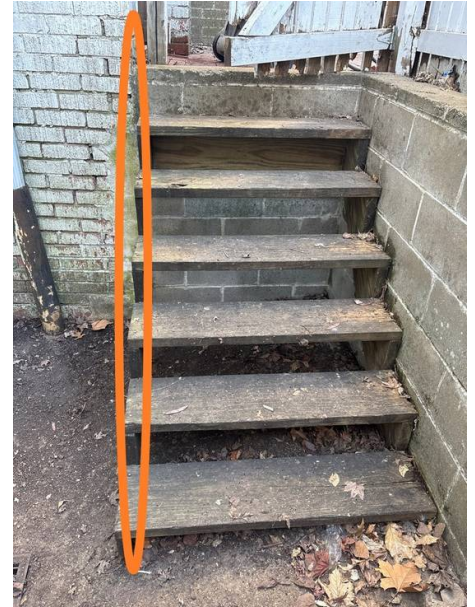
Top step leading to front door exceeds maximum height requirements

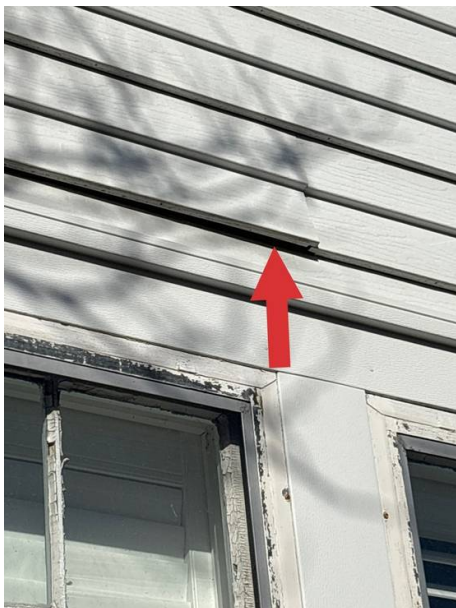
Gap observed between siding panels above the second-floor window on the east side of the house. Recommend further evaluation/repair by a qualified contractor.

Vegetation observed to be in contact with the siding on the east side of the house, potentially trapping moisture and promoting deterioration, recommend trimming back the vegetation to maintain a clear gap between the siding and plants.

Gap in siding panels above the second-floor window on the east side

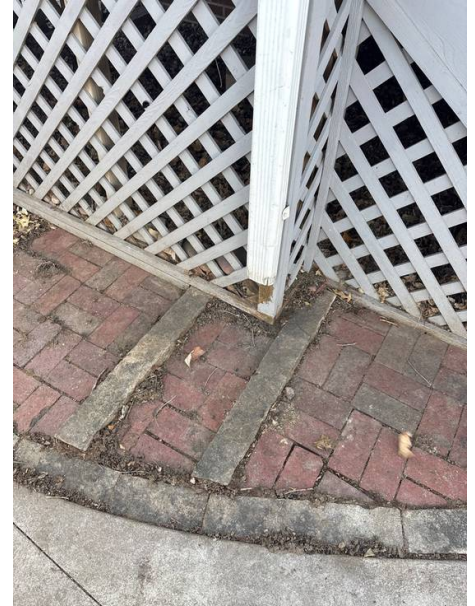
Multiple gutter downspout extensions observed to be missing, potentially allowing water to pool near the foundation and cause damage or erosion. Recommend replacing missing downspout extension.

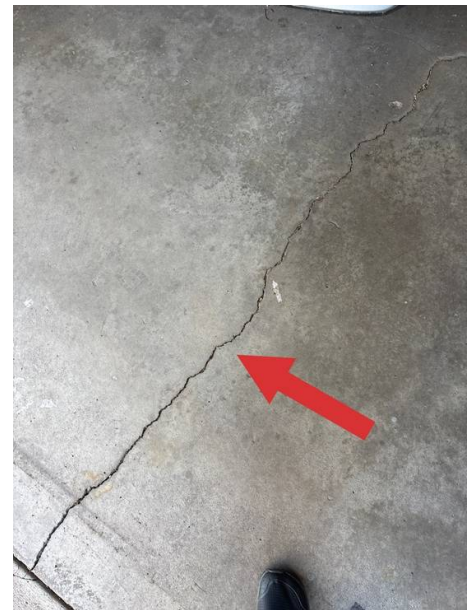
Deteriorated section of garage slab

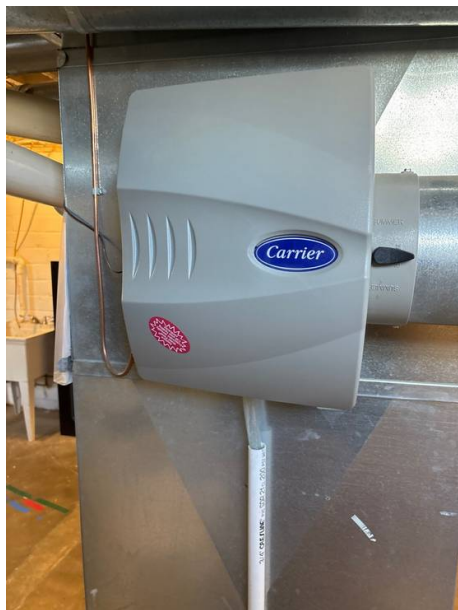
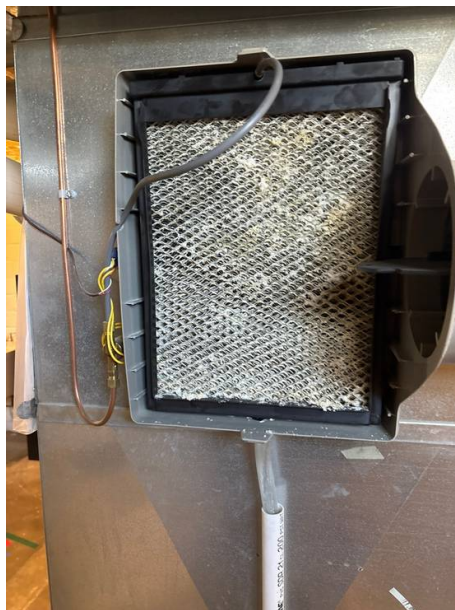
Humidifier filter observed to be very dirty and controlled at the thermostat, recommend inspection by a qualified contractor prior to use and replacing the filter to ensure proper function and air quality.

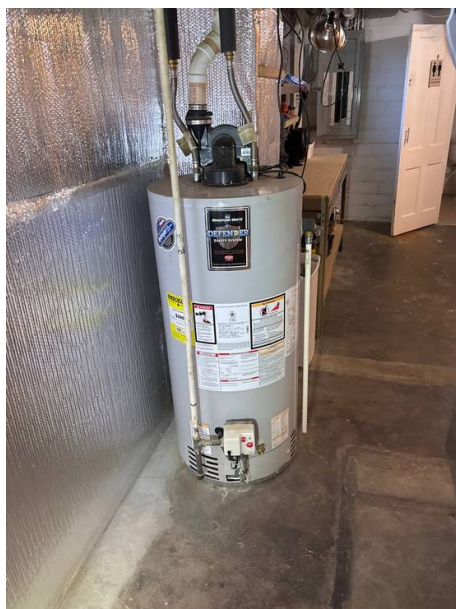
Water heater may observed to have exceeded its manufacturer's intended lifespan, suggesting potential declines in efficiency, reliability, or safety due to age-related deterioration. Recommend ongoing monitoring for performance issues and consulting a plumber or technician to evaluate its condition, with consideration for potential replacement in the upcoming years.

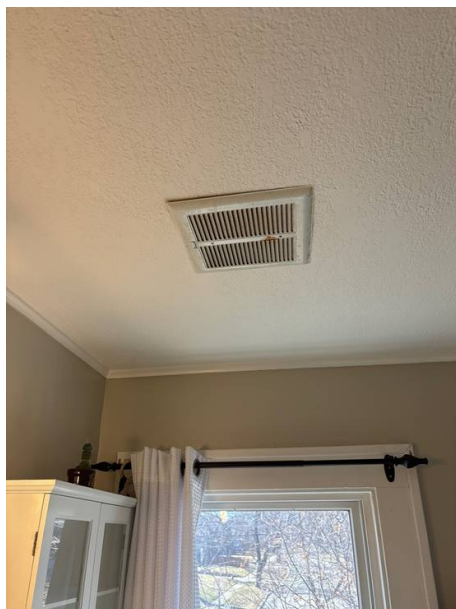
The exhaust fan is loud, which may result in a deficiency indicating potential mechanical wear or imbalance affecting performance. Recommend further evaluation/repair by a qualified contractor to correct the deficiency and ensure proper fan operation.

Upstairs exhaust fan is loud

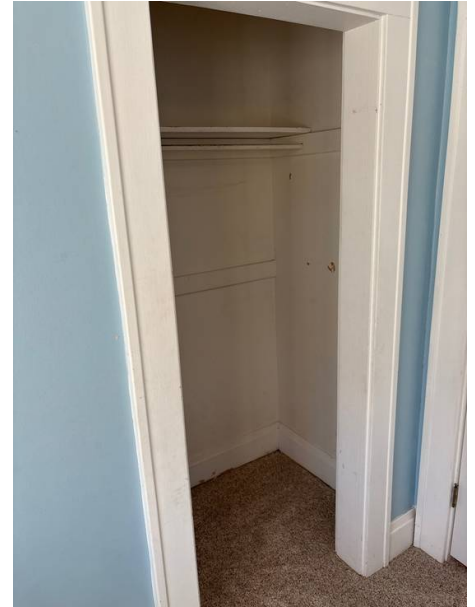
Northeast bedroom

Missing closet door. Recommend missing closet door be replaced.

Missing closet door in northeast bedroom

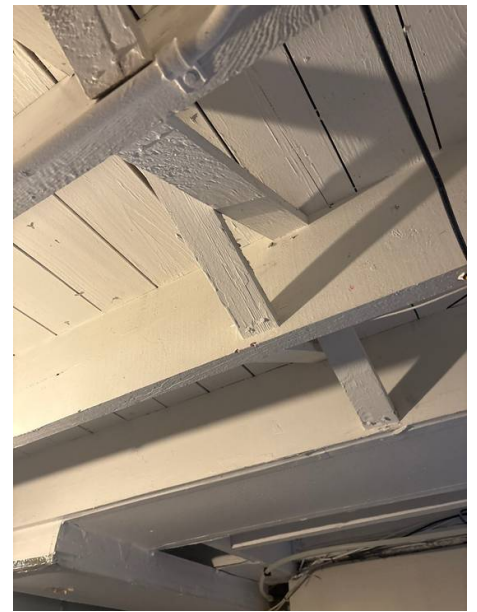
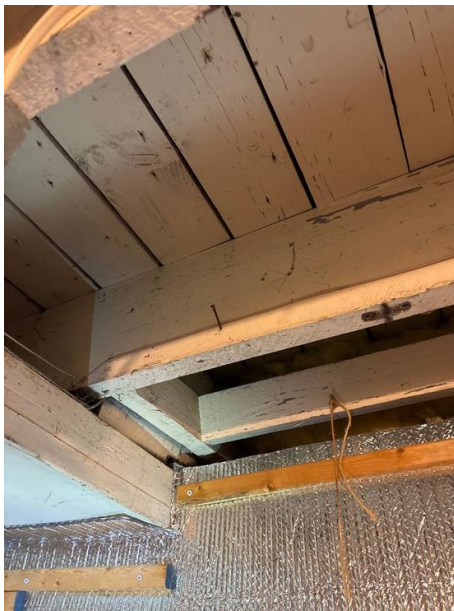
Staining and deterioration noted on the basement ceiling near the electrical panel, with the area dry at the time of inspection, and the painted ceiling limiting a full assessment of the extent of damage or potential moisture issues. This may indicate past or ongoing water infiltration.

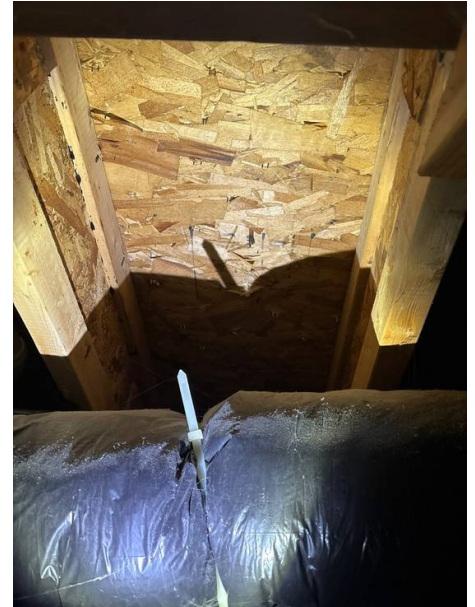
Small crawlspace area observed with a missing access panel, resulting in an exposed opening, and no vapor barrier on the floor or insulation on the ceiling, potentially allowing moisture infiltration, pest entry, and energy loss. Recommend installing an access panel to cover the opening, adding a vapor barrier to the floor, and installing insulation on the ceiling to improve moisture control and energy efficiency.

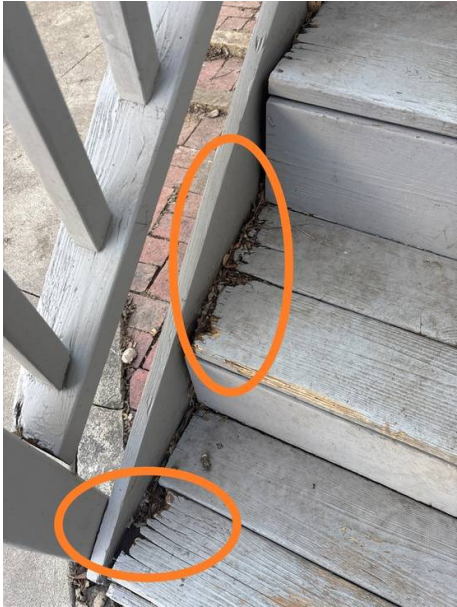
Handrails observed as loose and deteriorated, posing a safety concern, with general deterioration noted on the deck and stairs. Deck is at or near life expectancy. Recommend further evaluation by a qualified contractor for any or all

repair or replacement needs.

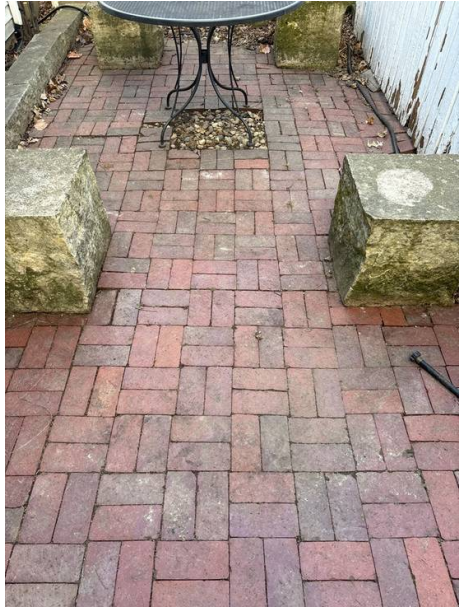
Loose bricks observed in the brick patio near the stairs leading to the northeast rear entrance, with the patio noted as wavy, recommend further evaluation by a qualified contractor to ensure stability and safety.

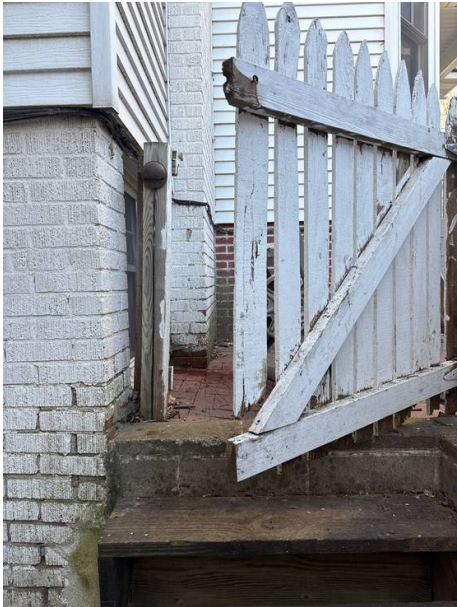
Deterioration observed on the wood fence around the rear northeast entrance, recommend replacement by a qualified contractor to ensure stability and proper function.

Location: East.  
Vegetation is observed in contact with the fence, potentially causing structural damage and promoting rot or insect activity. Recommend vegetation be trimmed back.

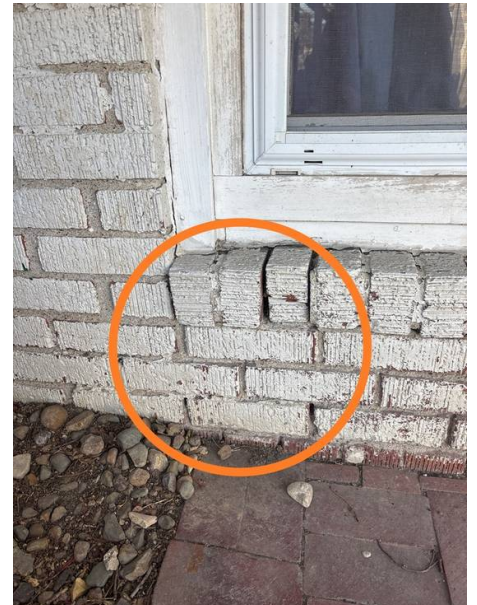
Gap observed between the foundation and the northeast basement window, with an uneven foundation noted along the gap, potentially allowing moisture infiltration and structural stress, recommend further evaluation and repair by a qualified contractor to ensure structural stability and protection from moisture damage.

Minor gaps observed throughout the rest of the painted brick foundation wall with no significant cracking or movement noted. Recommend monitoring the area for signs of moisture infiltration or further deterioration, and suggest minor repairs to the gaps in the brick foundation as needed to maintain protection against weathering. Further evaluation by a qualified contractor is advised if moisture or worsening conditions become evident.

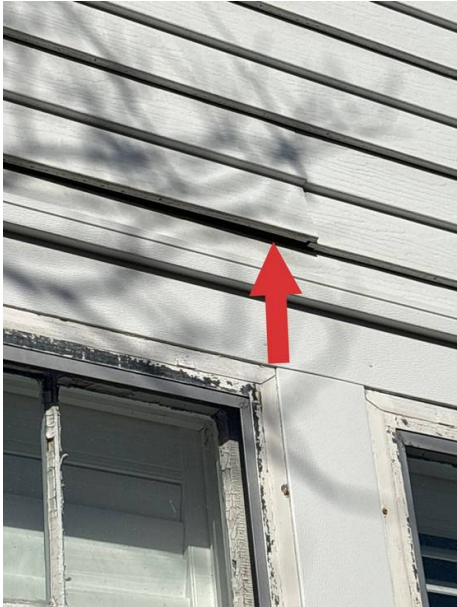
Location: East.  
Gap observed between siding panels above the second-floor window on the east side of the house. Recommend further evaluation/repair by a qualified contractor.

Vegetation observed to be in contact with the siding on the east side of the house, potentially trapping moisture and promoting deterioration, recommend trimming back the vegetation to maintain a clear gap between the siding and plants.

Gap in siding panels above the second-floor window on the east side

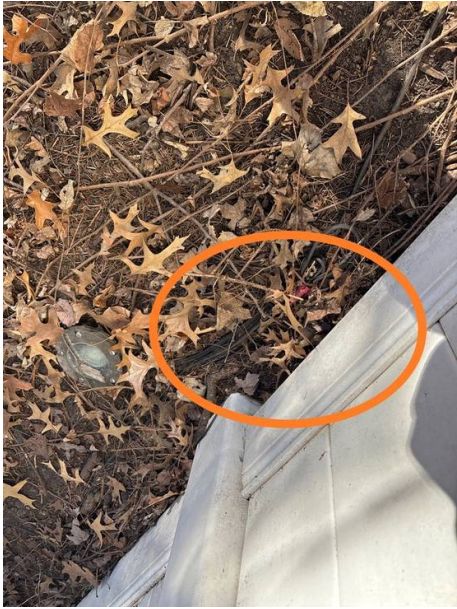
Wires for the yard light observed lying on top of the ground along the fence with visible wire nuts, posing a potential electrical hazard and exposure to moisture.

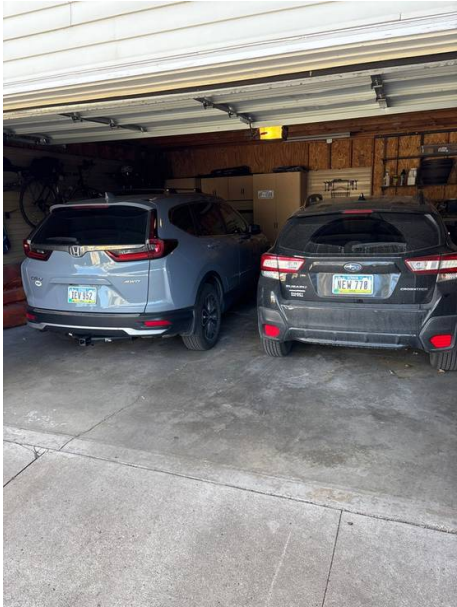
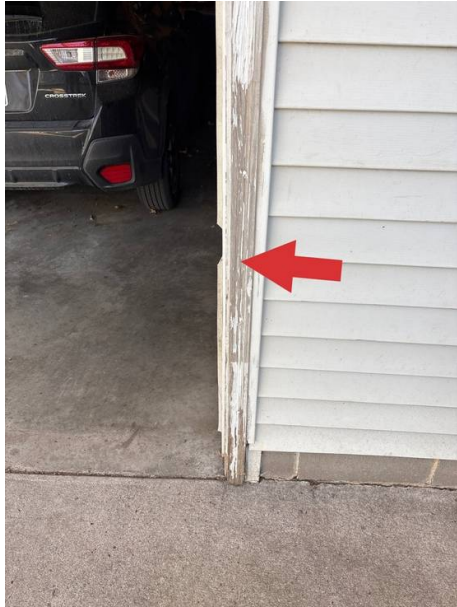
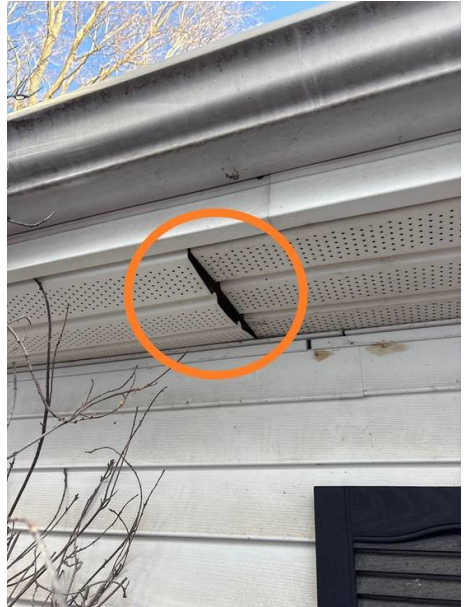
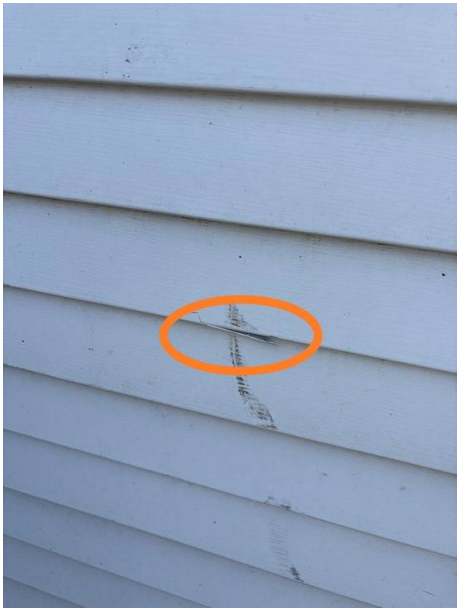
Cracks were observed in the garage floor during the inspection. These appear to be standard and typical; however, they should be monitored for excessive movement or worsening over time.

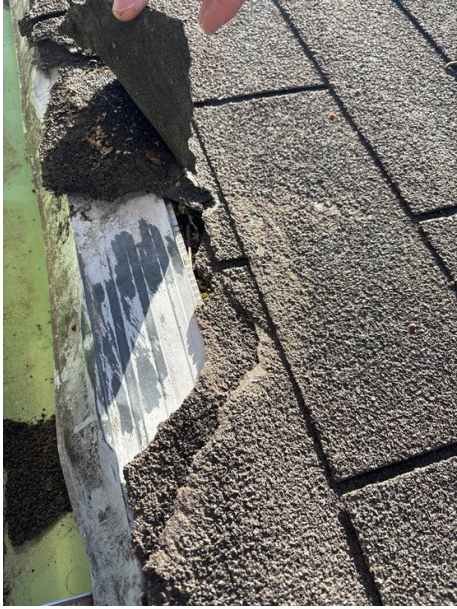
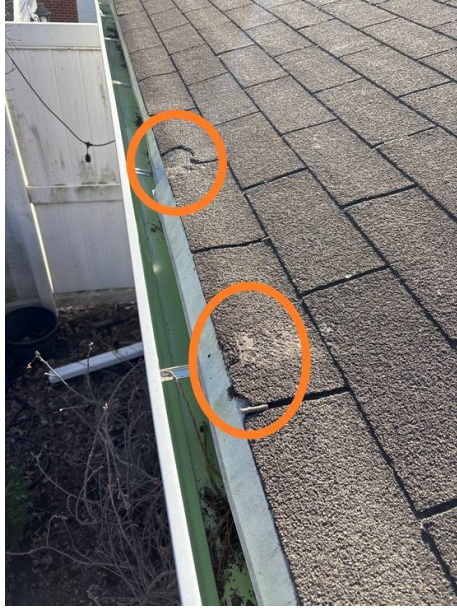
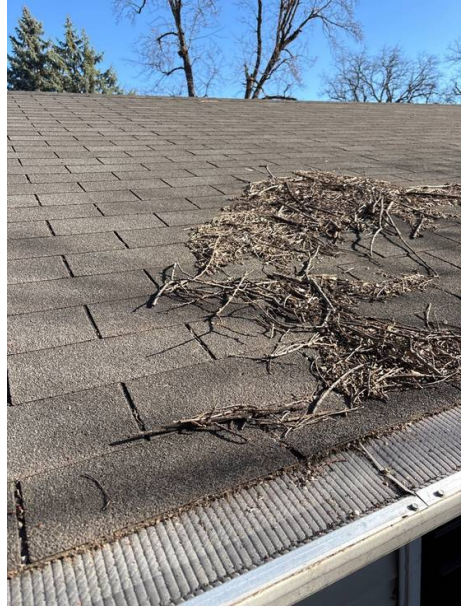
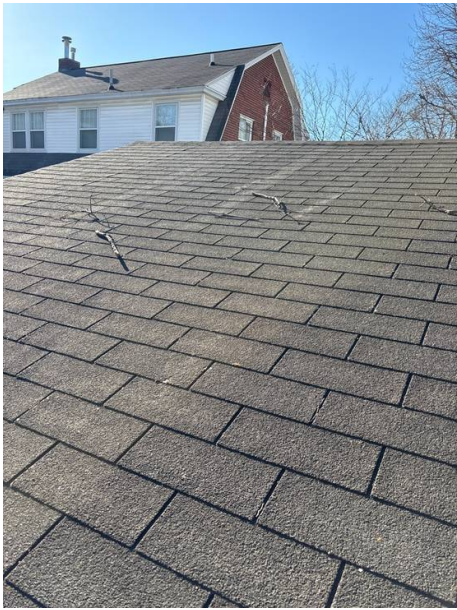
Damage observed on the rear of the garage roof, where 3-tab shingles (with an average lifespan of 20-25 years) are missing/deteriorating, exposing the underlying roof surface. Multiple layers observed, potentially allowing moisture infiltration and complicating repairs. Recommend further evaluation by a qualified roofing contractor to assess the overall roof condition and remaining lifespan.

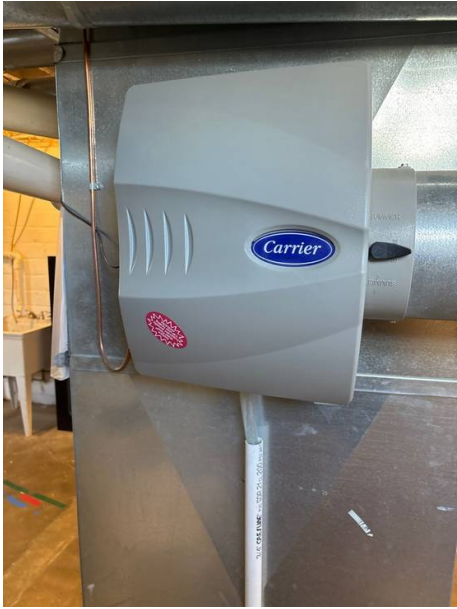
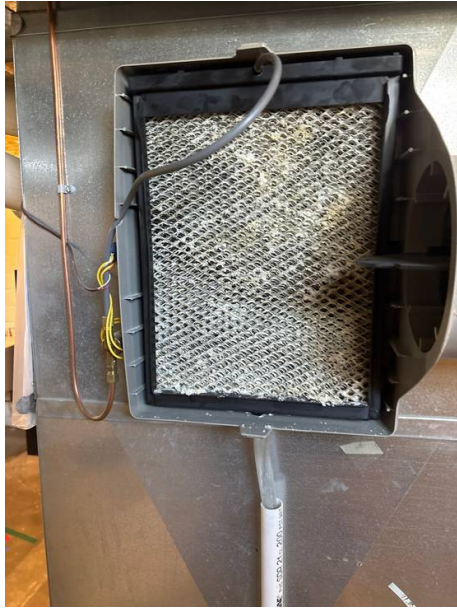
Humidifier filter observed to be very dirty and controlled at the thermostat, recommend inspection by a qualified contractor prior to use and replacing the filter to ensure proper function and air quality.

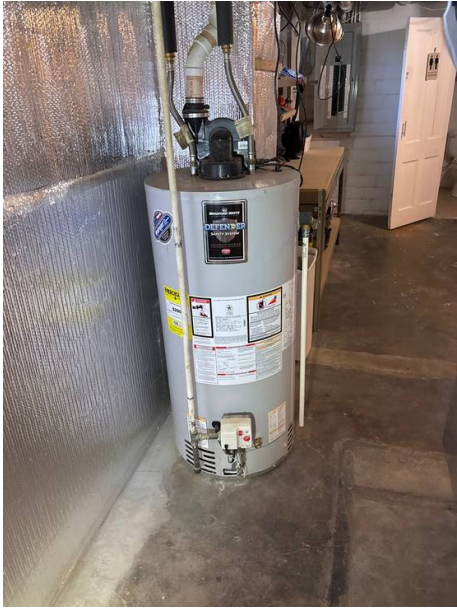
Water heater may observed to have exceeded its manufacturer's intended lifespan, suggesting potential declines in efficiency, reliability, or safety due to age-related deterioration. Recommend ongoing monitoring for performance issues and consulting a plumber or technician to evaluate its condition, with consideration for potential replacement in the upcoming years.

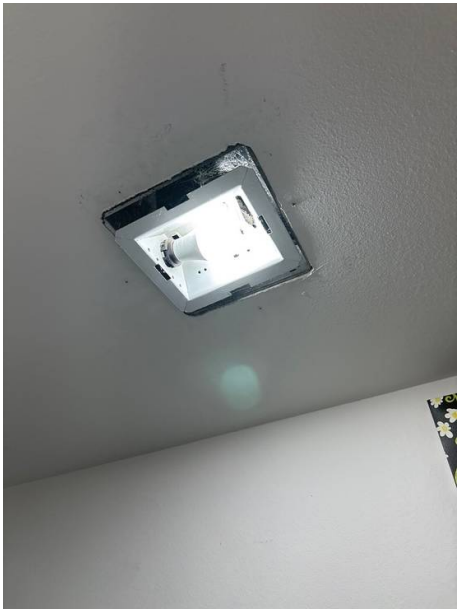
Exhaust fan is missing its cover. Recommend replacing missing cover.

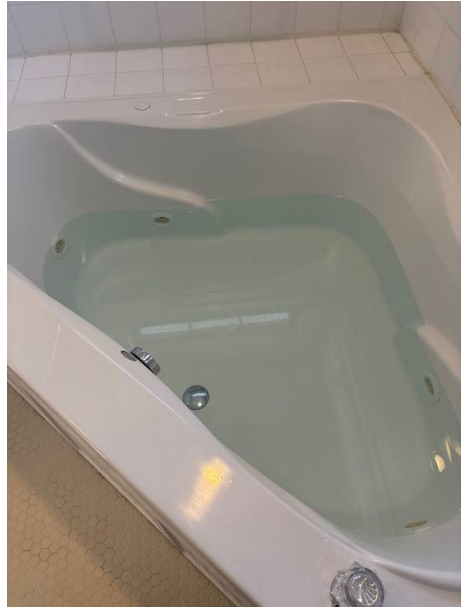
Chip observed in the jacuzzi tub, potentially allowing moisture to penetrate the underlying material. Jacuzzi tub jets appeared underpowered during operation, indicating a possible mechanical or electrical issue. No dedicated GFCI (Ground Fault Circuit Interrupter) protection observed for the unit, posing a safety hazard. Deteriorated caulk observed between the tiles in the bathroom, potentially allowing moisture infiltration behind the walls. Recommend further evaluation/repair of jacuzzi tub and surrounding area by a qualified contractor.

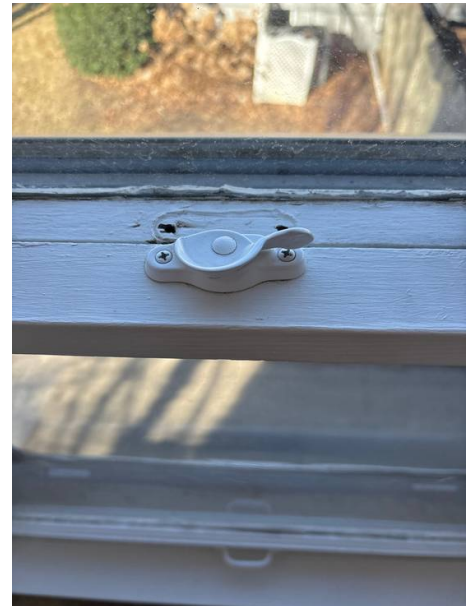
Primary bedroom closet window hardware

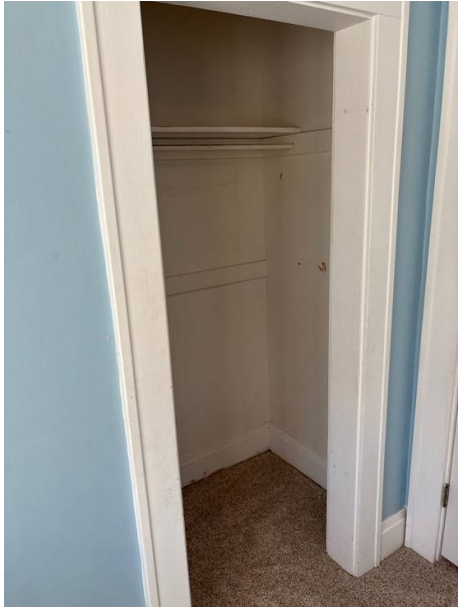
Northeast bedroom

Missing closet door in northeast bedroom

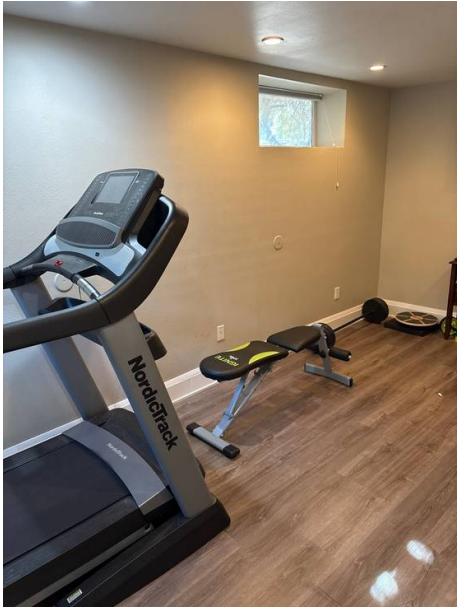
East basement room

No vents observed in the east basement room, a finished area within a larger unfinished basement, currently used as a gym, potentially leading to poor air circulation and increased risk of moisture or air quality issues in this section. Recommend installing proper ventilation, such as a supply and return vent, to improve air circulation in the finished area. Suggest further evaluation by a qualified HVAC contractor to ensure adequate ventilation and air quality for the space.

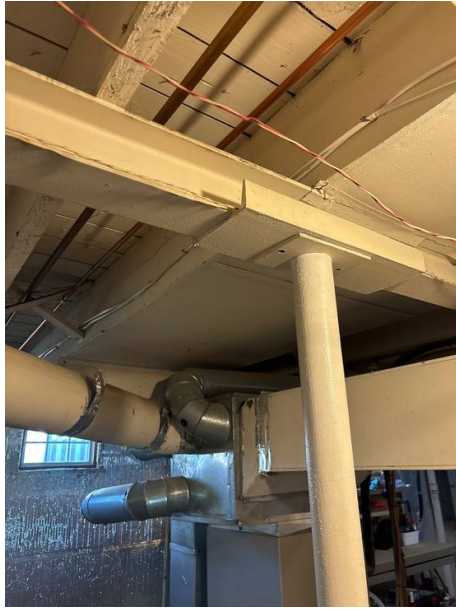
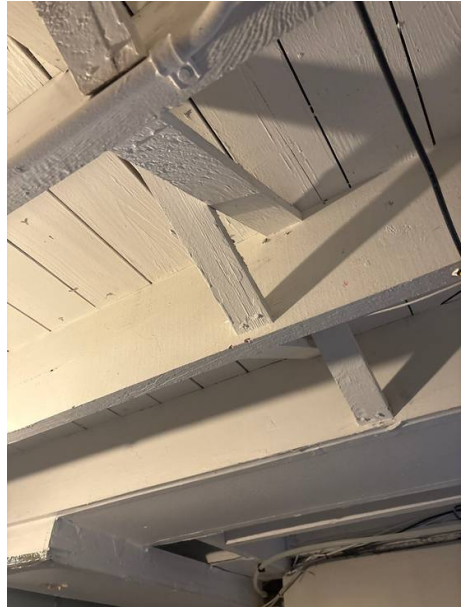
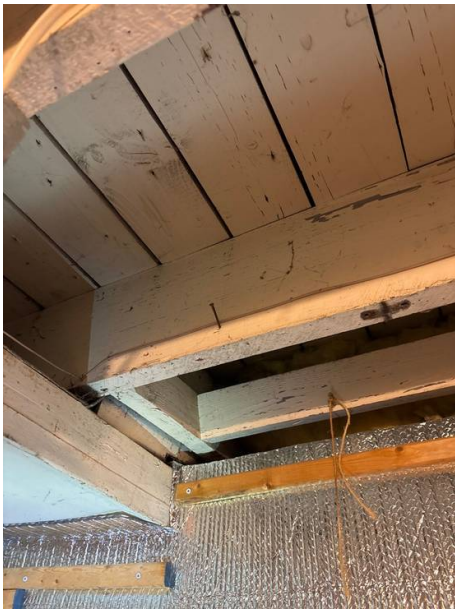
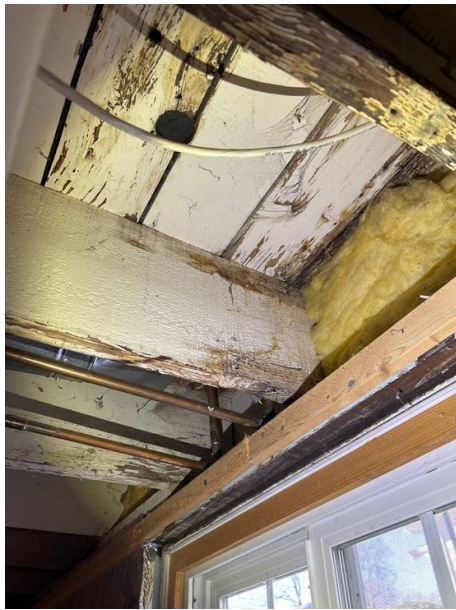
Staining and deterioration noted on the basement ceiling near the electrical panel, with the area dry at the time of inspection, and the painted ceiling limiting a full assessment of the extent of damage or potential moisture issues. This may indicate past or ongoing water infiltration.

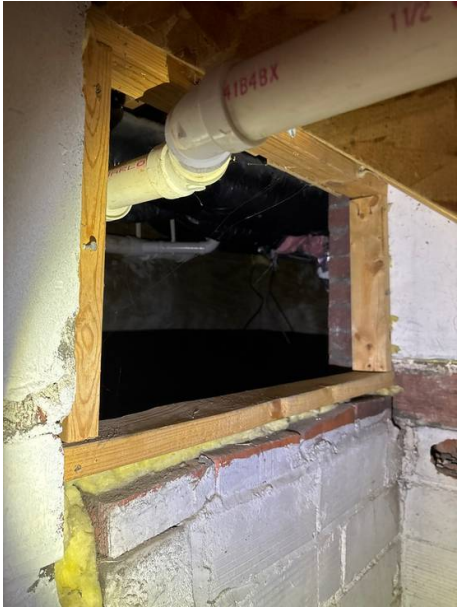
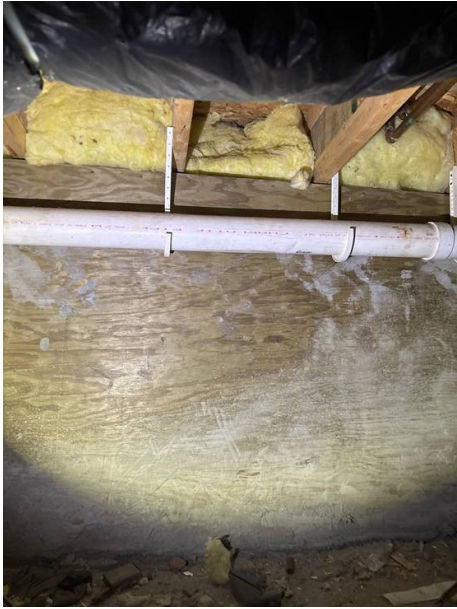
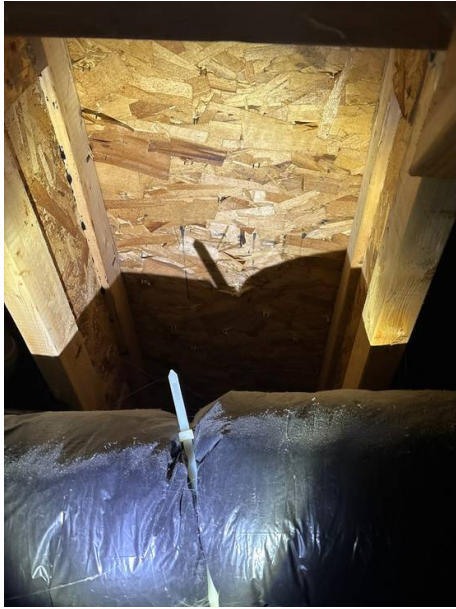
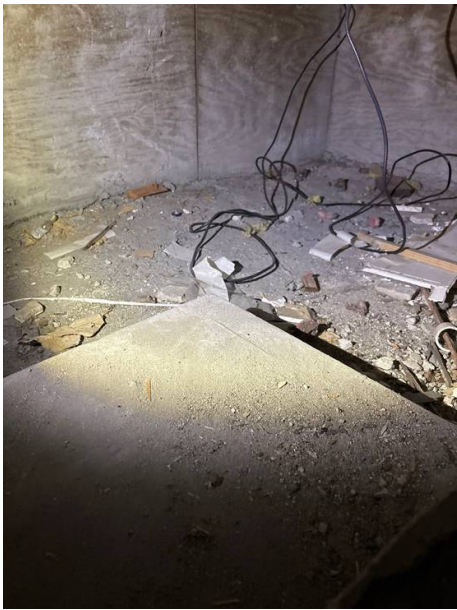
Small crawlspace area observed with a missing access panel, resulting in an exposed opening, and no vapor barrier on the floor or insulation on the ceiling, potentially allowing moisture infiltration, pest entry, and energy loss. Recommend installing an access panel to cover the opening, adding a vapor barrier to the floor, and installing insulation on the ceiling to improve moisture control and energy efficiency.
