# National Property Inspections

705 Sample Report, Key Largo, Fl, 33037

Thursday, March 27, 2025

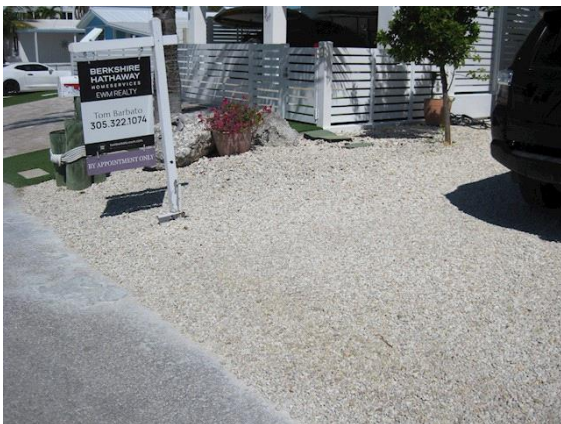
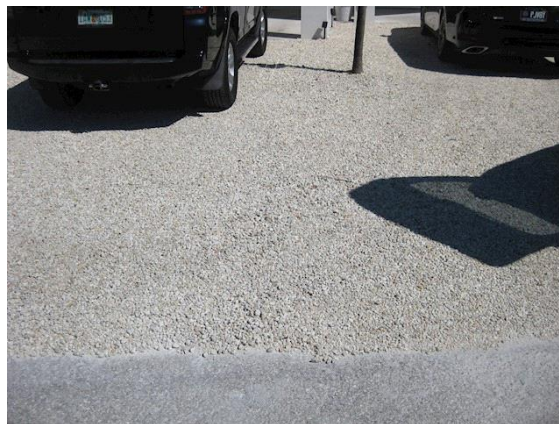
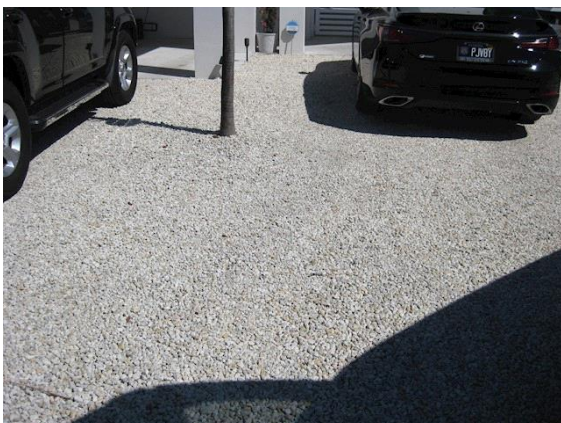
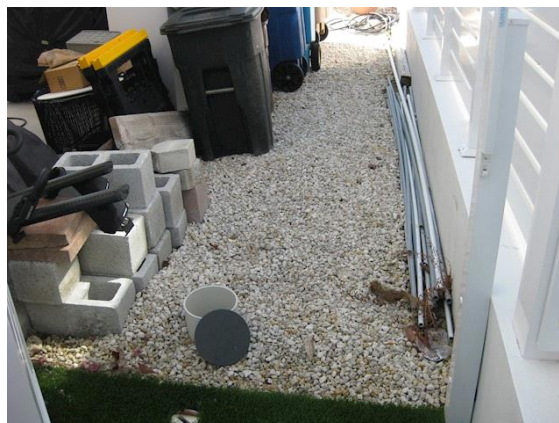
Gravel driveways may erode from heavy rains. Recommend monitoring the condition and repair as necessary.

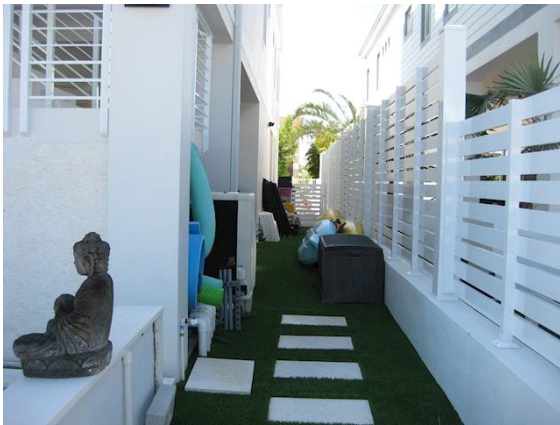
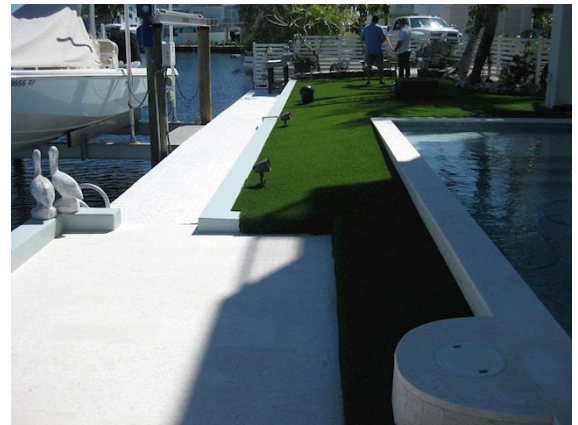
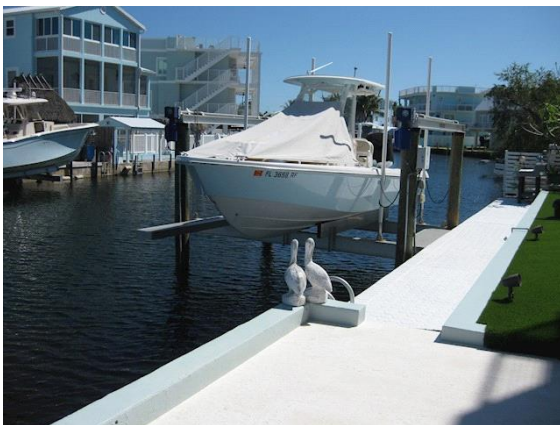
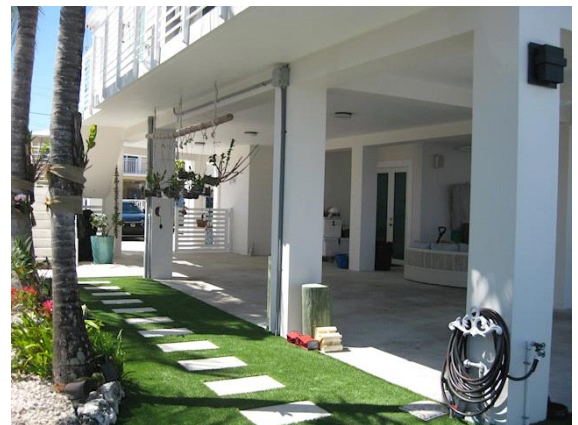
Walkways/steps to the house and around the property were in good condition at time of the inspection.

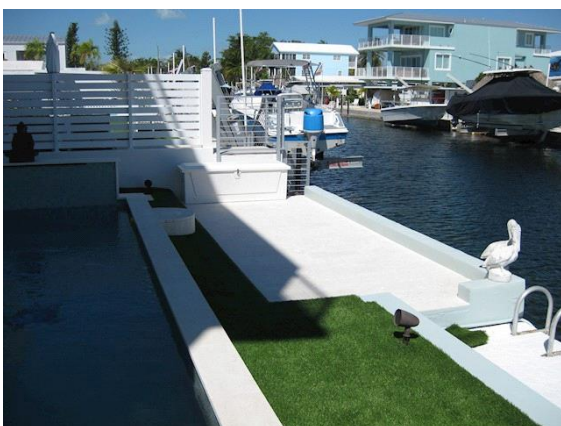
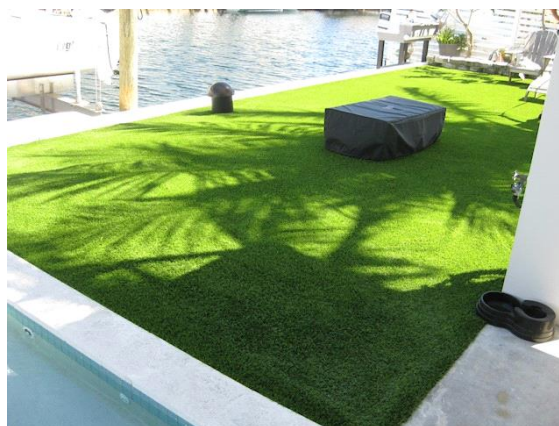
Backyard area was in acceptable condition  
Area was functional at time of inspection.

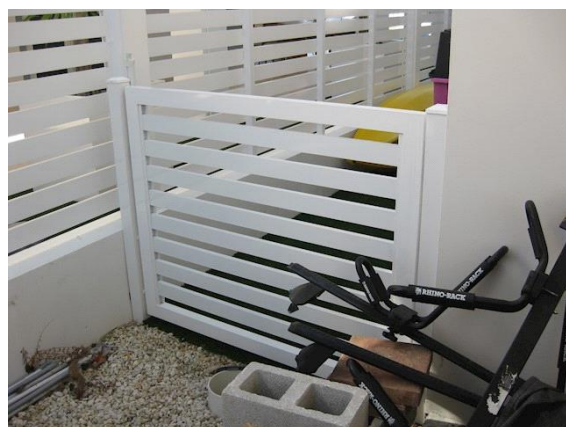
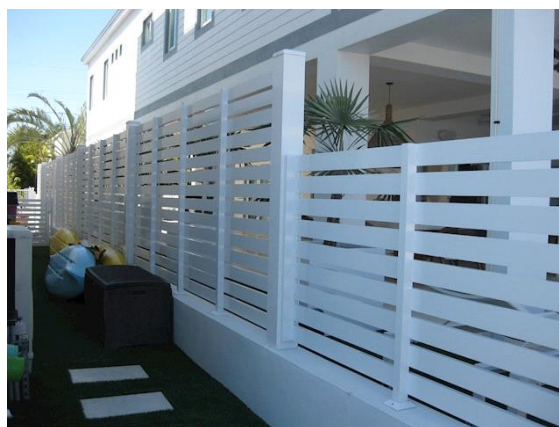
Metal fence was in generally good condition with operational gate(s).

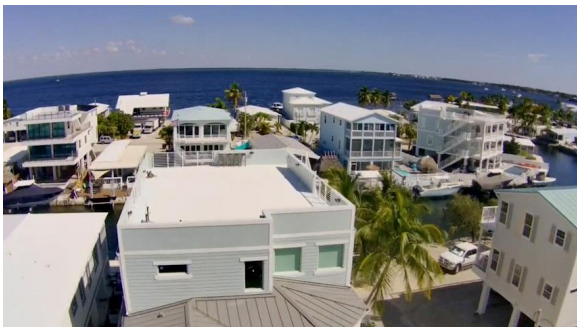
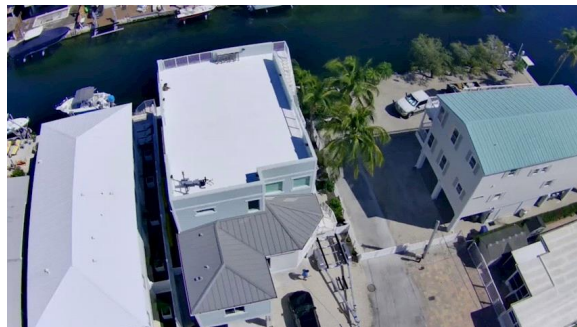
The flat roof appeared to be in acceptable condition for its age. Recommend an annual inspection and tune-up to minimize the risk of leakage and to maximize the life of the roof.

A metal roof was present. Metal roofs require routine maintenance such as painting. Monitor condition and paint as necessary.

Overall the roof was in acceptable condition with no active leaks noted on day of inspection.

Metal roofs should be coated periodically.

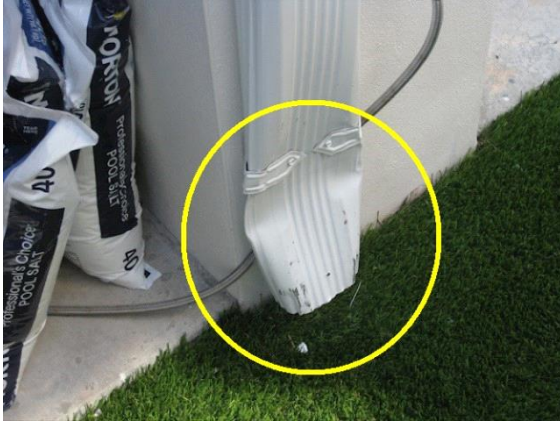
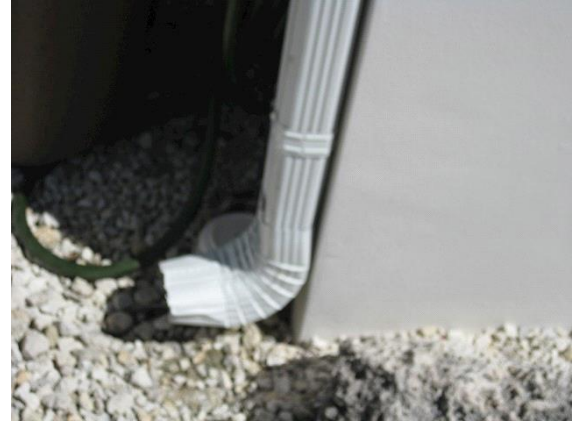
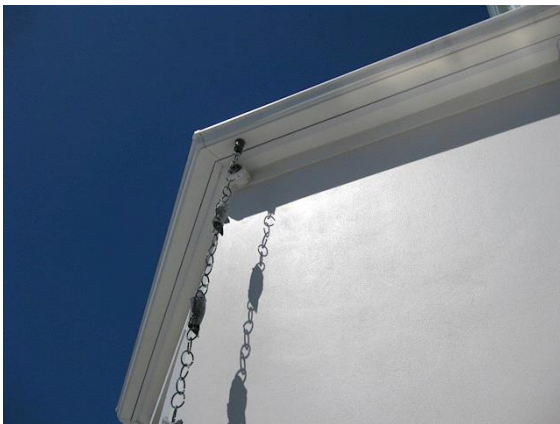
Gutter downspouts were crushed, recommend repair to allow proper water flow

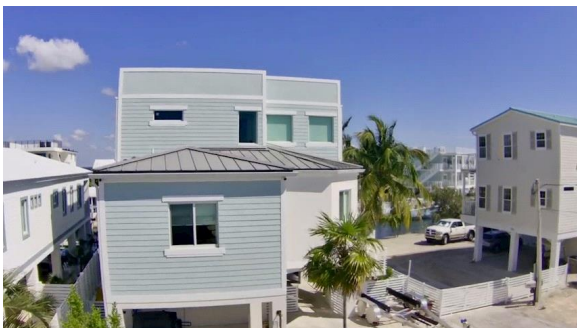
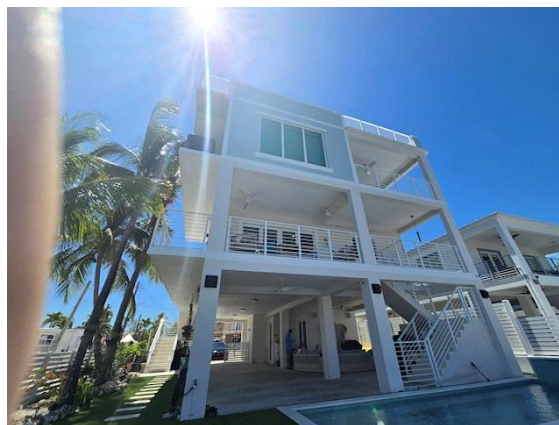
Exterior of the house and the components listed were acceptable at time of inspection.

All exterior siding/surface appeared in good state of repair at time of inspection with no major defects noted.

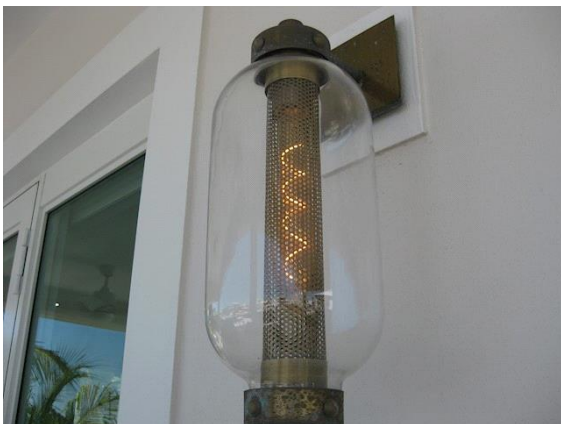
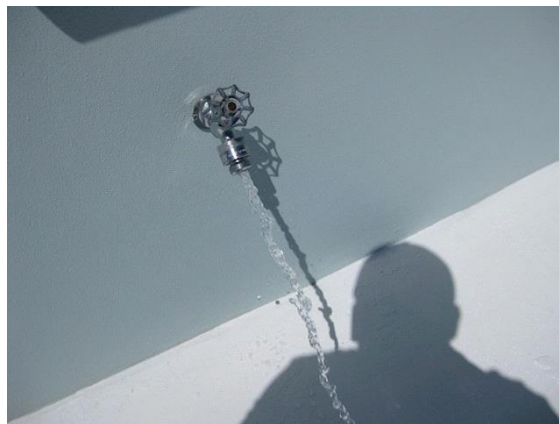
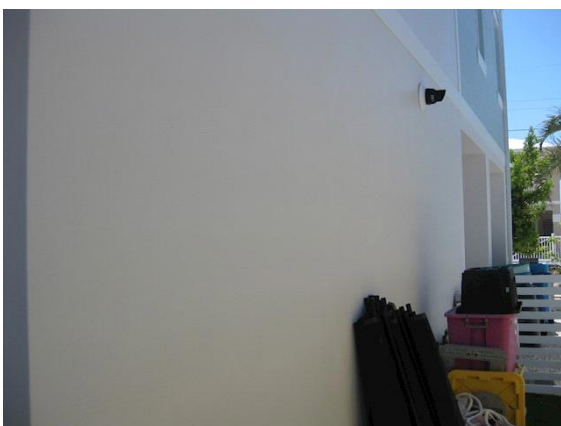
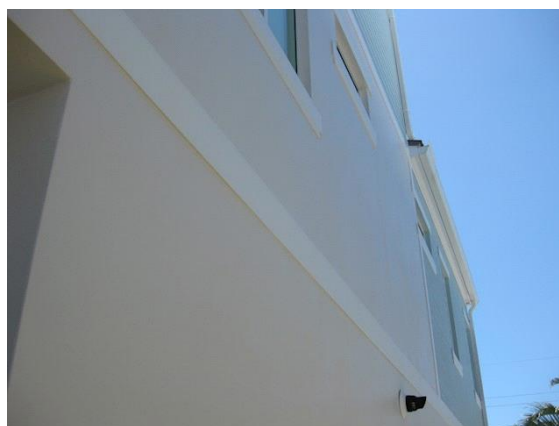
Exterior of the house and the components listed were acceptable at time of inspection.

All exterior siding/surface appeared in good state of repair at time of inspection with no major defects noted.

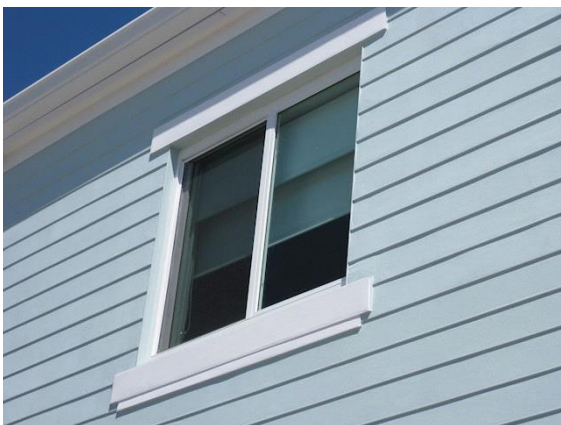
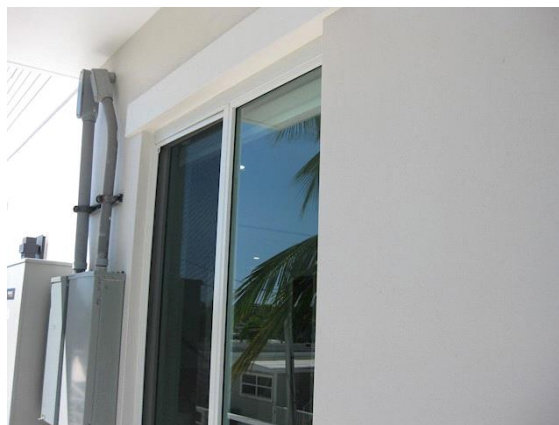
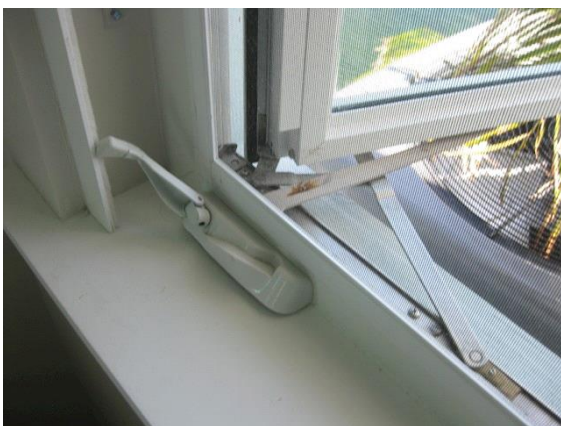
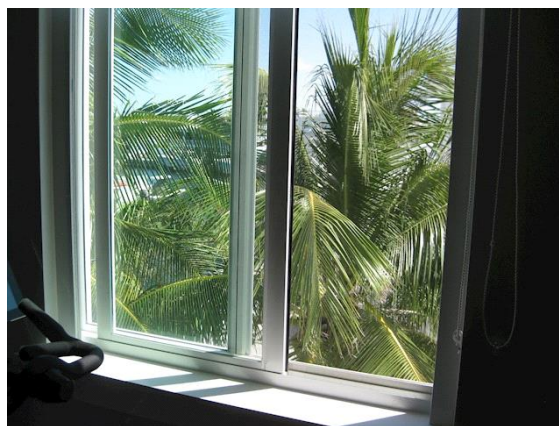
All accessible windows were checked for leaks and operation. No leaks or water stains were observed and windows were operating properly.

All windows appeared to be in good repair at time of inspection from the exterior.

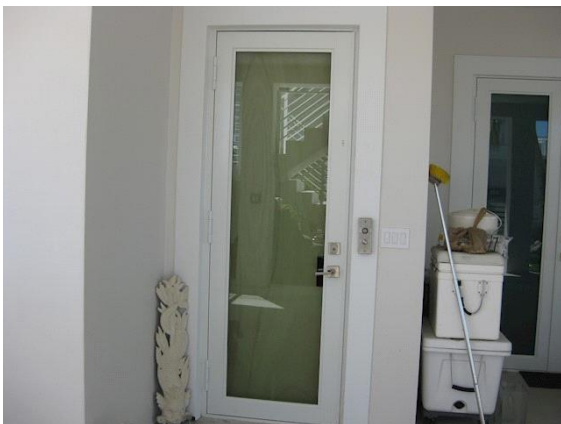
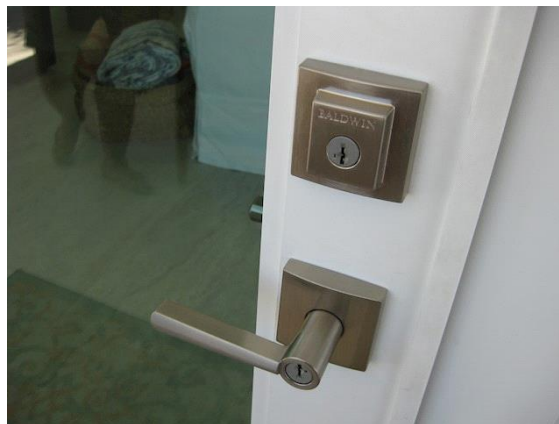
Entry doors and the associated hardware were tested and operated as intended. The exterior doors are in acceptable condition with no visual flaws or defects.

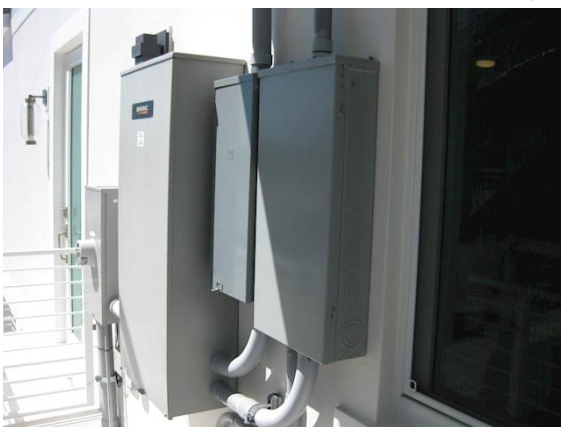
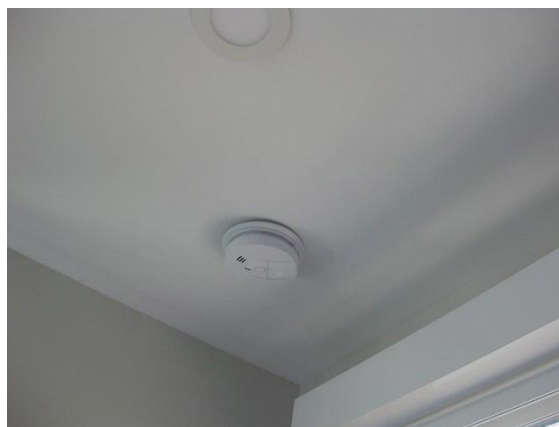
The electrical service entrance and panel are in good condition and appear to be performing as intended.

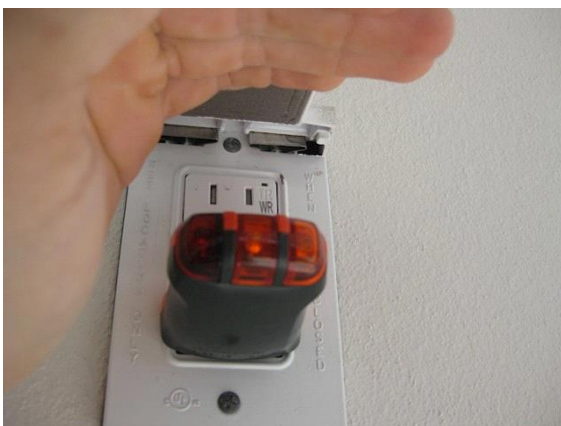
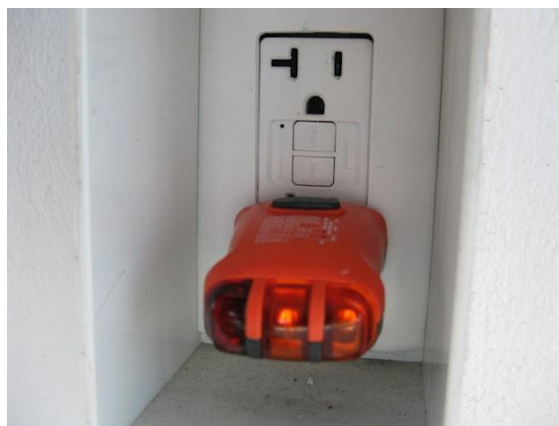
Electrical outlets were tested at random, all tested outlets were found to be acceptable at time of inspection

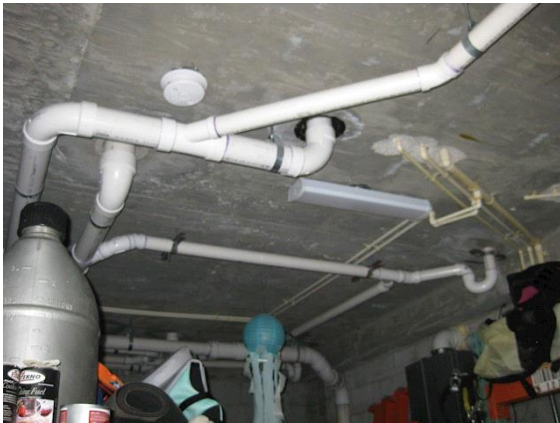
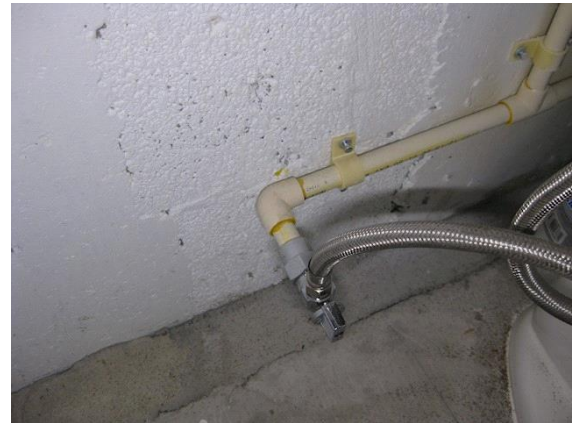
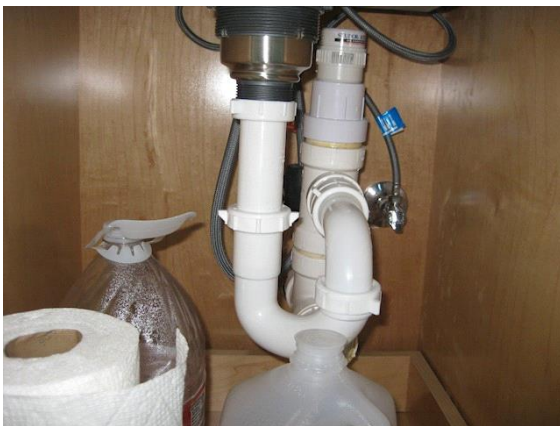
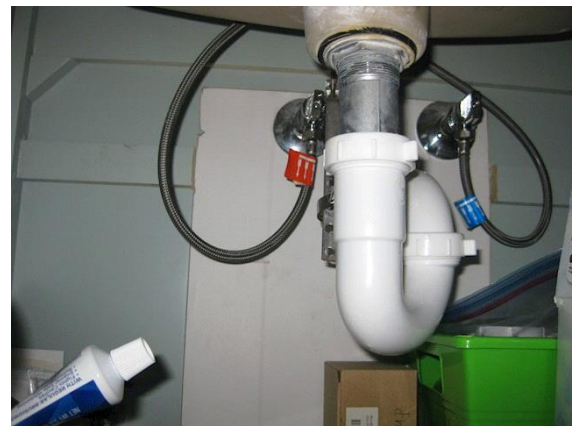
No defects were found pertaining to the main plumbing system at time of inspection.

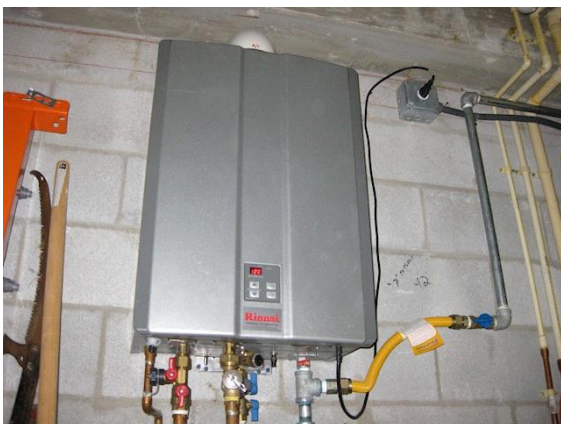
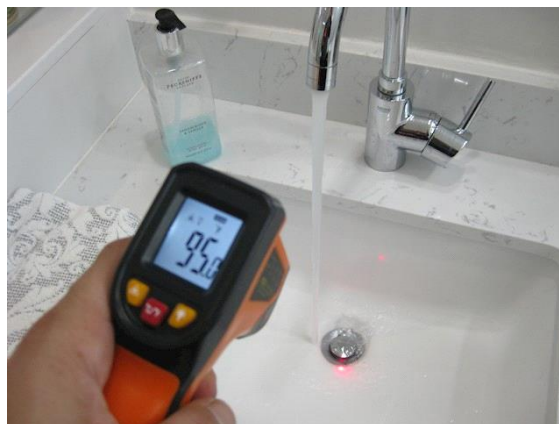
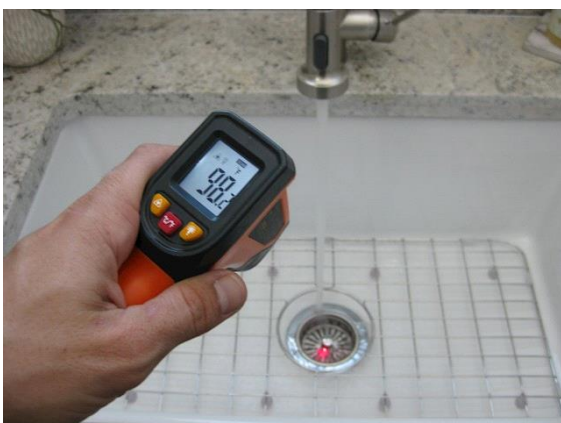
The tankless water heater was acceptable at time of inspection.

Gas-fired tankless water heater installed and appeared to be in acceptable condition and supplied hot water upon demand at the time of the inspection.

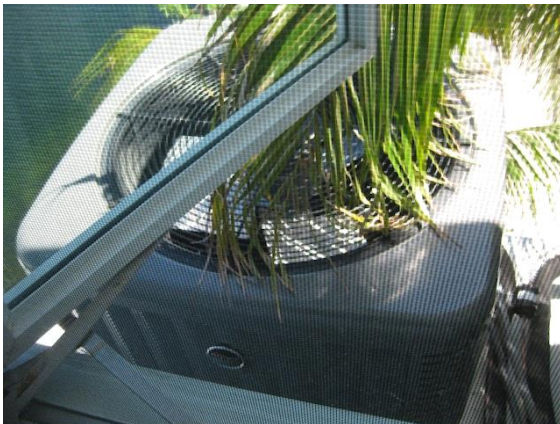
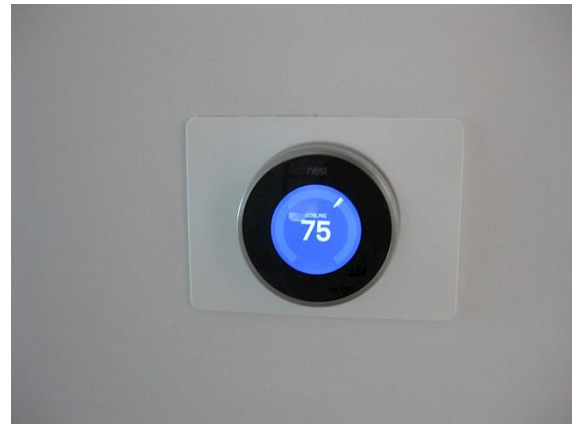
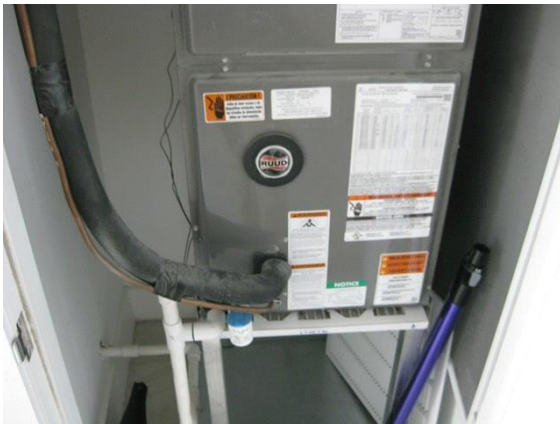
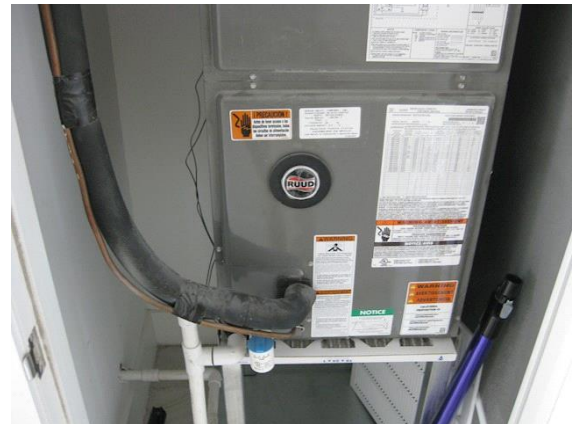
The air conditioning system responded to the controls and appeared to operate in a satisfactory manner. All visible components of the air-conditioning system appeared to be in serviceable condition at the time of the inspection. Adequate air flow was present. Recommend bi-annual cleaning of ductwork in order to maintain proper operation and to extend life expectancy of unit.

Recommend repair/regular service to maintain peak performance.

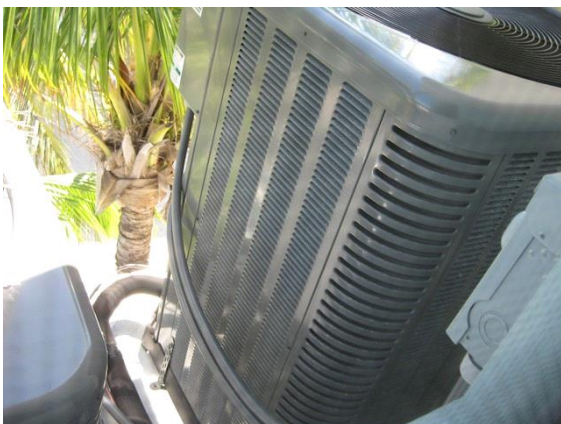
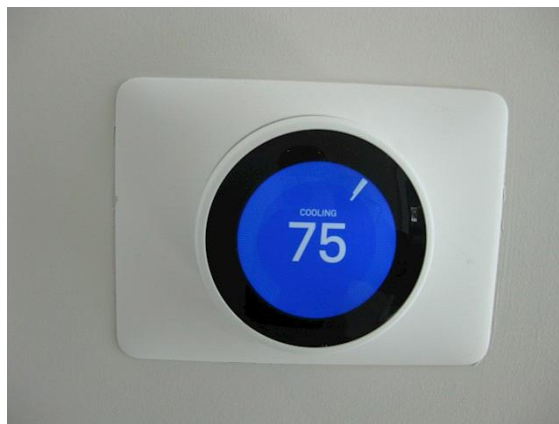
The air conditioning system responded to the controls and appeared to operate in a satisfactory manner. All visible components of the air-conditioning system appeared to be in serviceable condition at the time of the inspection. The air conditioning system responded to the controls and appeared to operate in a satisfactory manner. Adequate air flow was present. Recommend bi-annual cleaning of ductwork in order to maintain proper operation and to extend life expectancy of unit.

Recommend repair/regular service to maintain peak performance.

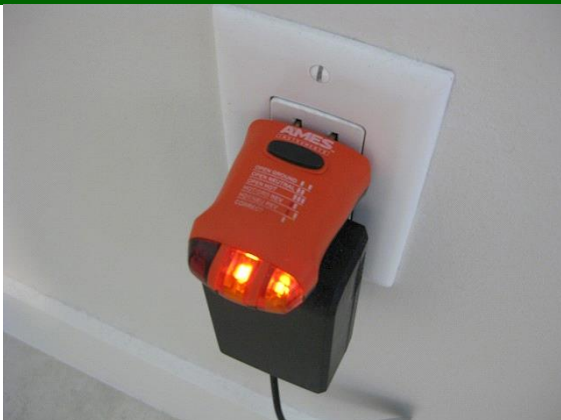
Proper wiring noted along electrical outlets in area

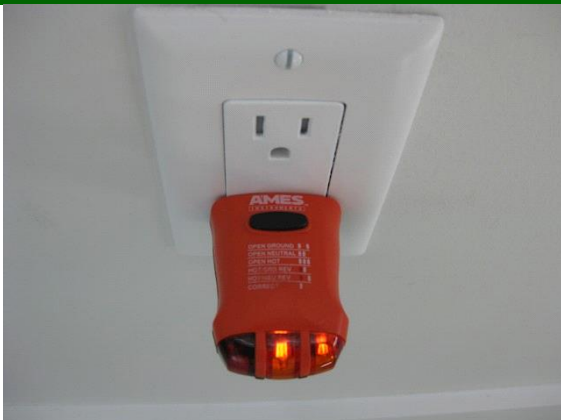
Proper wiring noted along electrical outlets in area

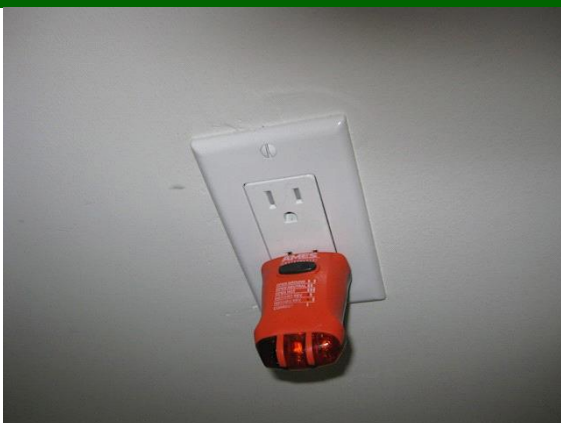
Proper wiring noted along electrical outlets in area

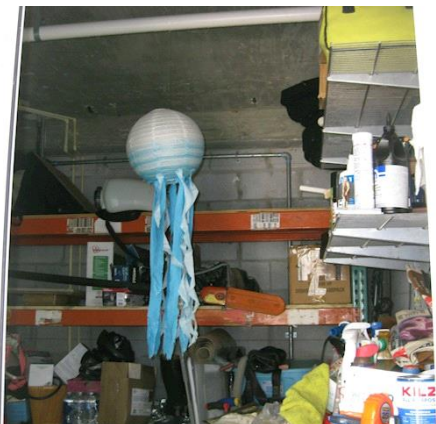
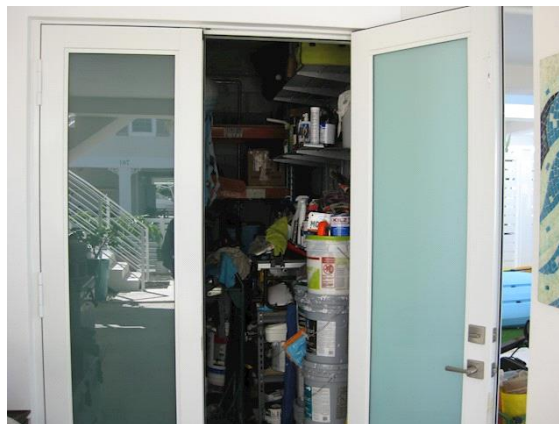
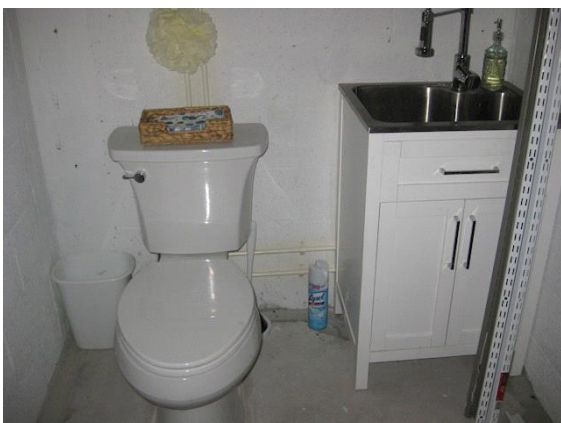
Storage room functional at time of inspection, no evidence of damage noted to structures

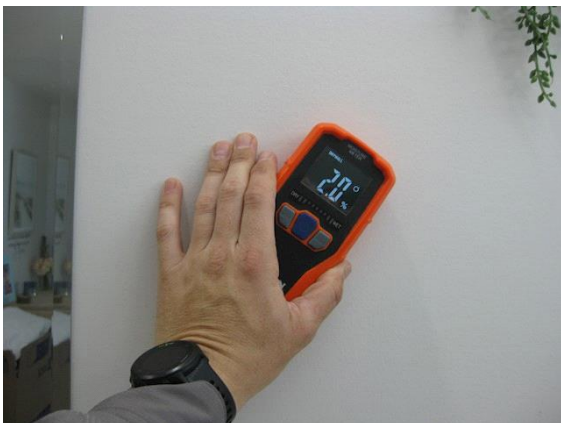
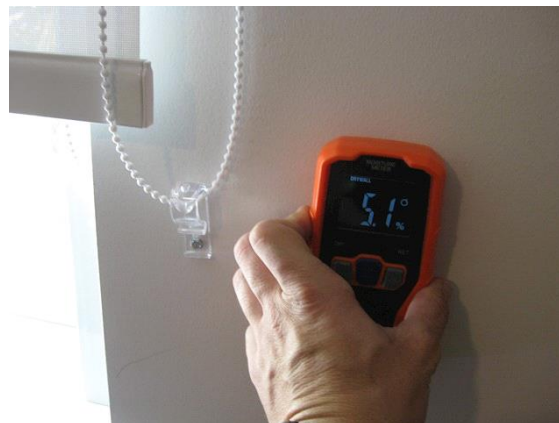
Overall no damaging levels of humidity were detected throughout property upon random sampling with a noninvasive moisture meter.

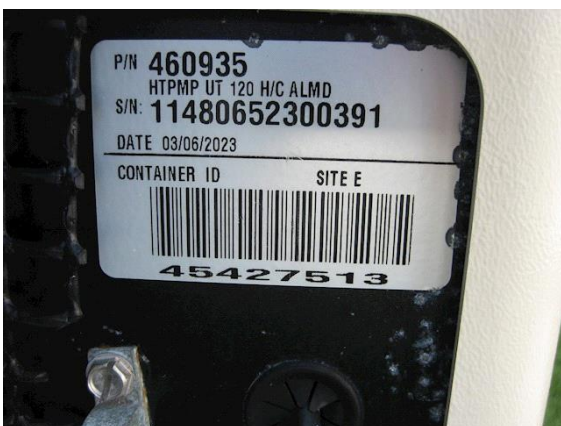
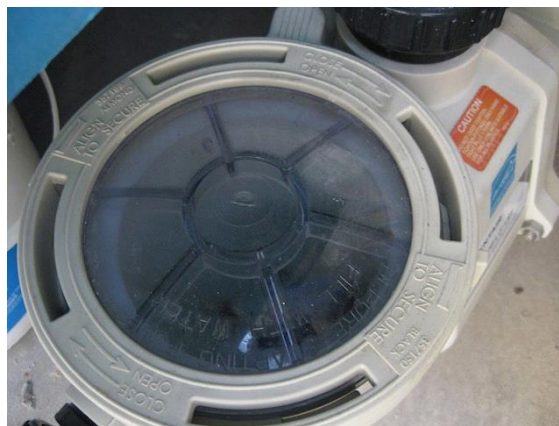
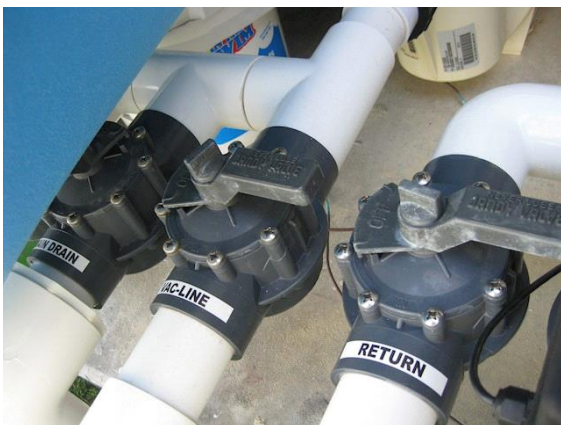
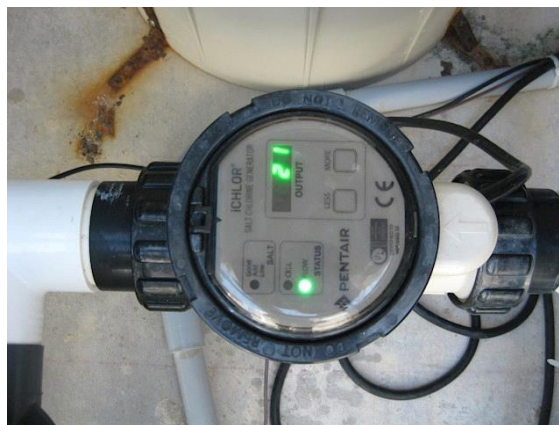
All components of the pool system appeared to be acceptable at time of inspection.

Pool heater was turned on remotely and was observed to be working at time of inspection

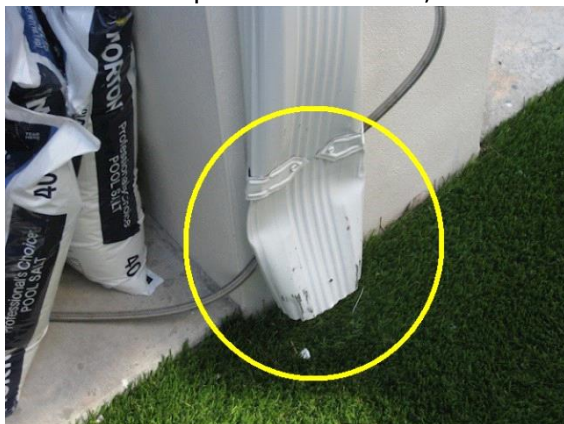
Gutter downspouts were crushed, recommend repair to allow proper water flow
