National Property Inspections

Sample Report, 151 Sample Report, Miami Beach, Fl, 33139

Wednesday, April 9, 2025

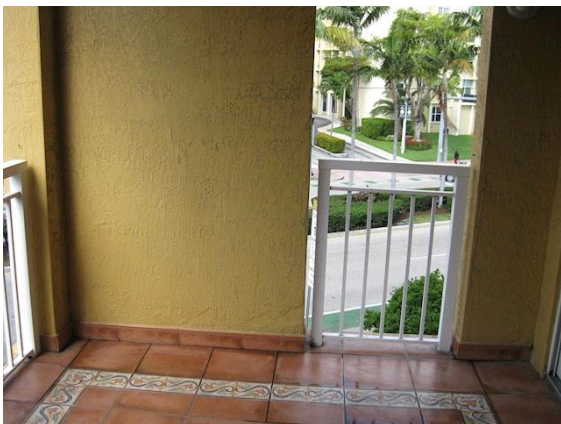
Balcony fan did not turn on at time of inspection, recommend repair

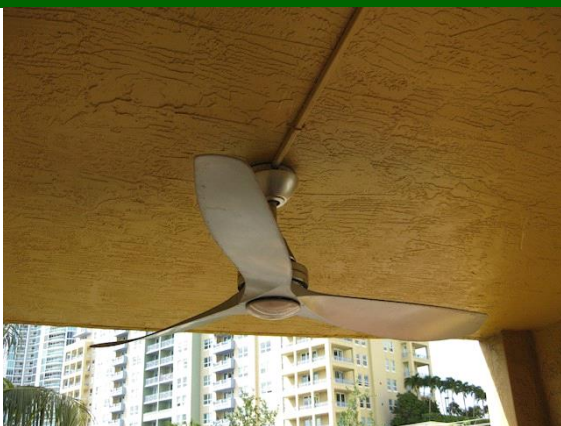
Fan did not turn on at time of inspection,
recommend repair

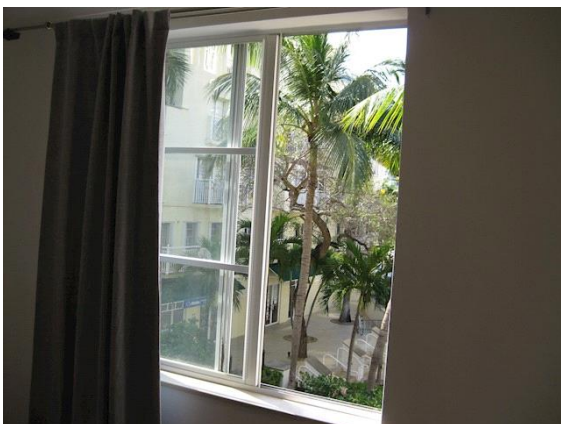
Window in bedroom 2 showed signs of deterioration, recommend repair for ease of use

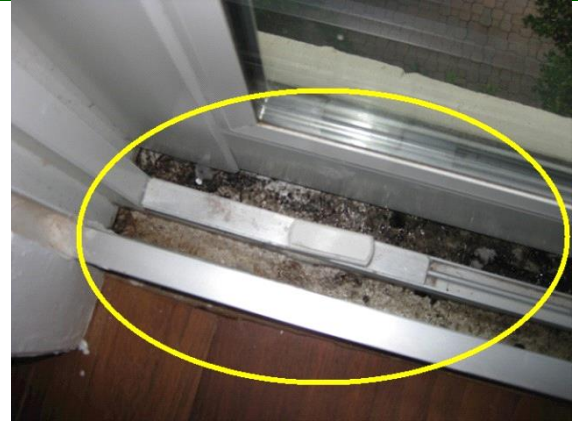
Sliding glass door did not have weather strip present, stagnated water was observed in sliding glass door track area, recommend repair to prevent additional moisture from entering apartment

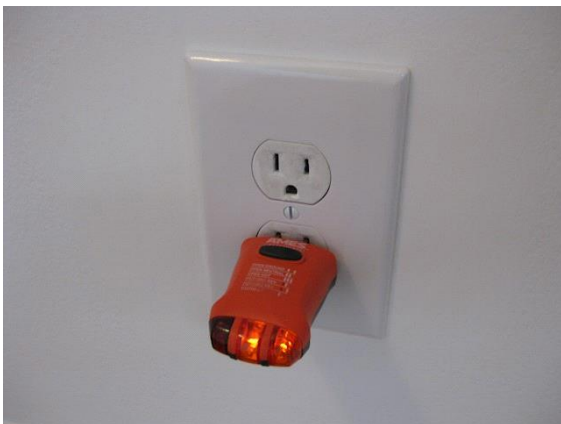
Electrical outlet in main bedroom was acceptable at time of inspection

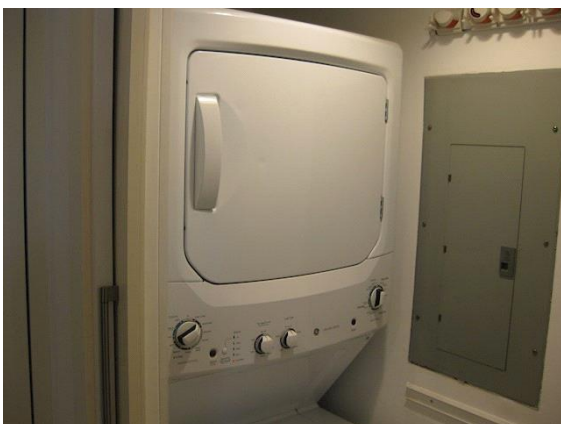
Light switch in laundry area was missing cover, recommend replacement to prevent any damage to electrical fixture

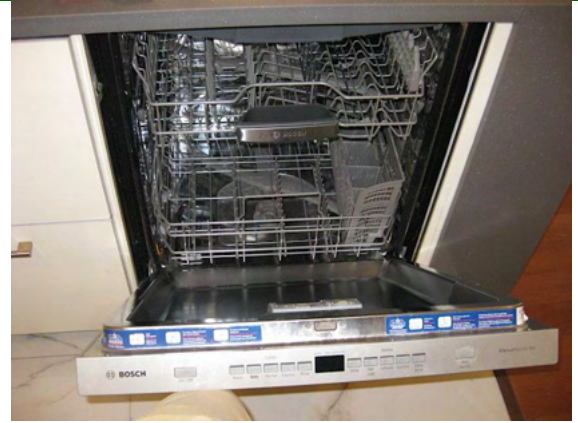
Maintenance recommended on door of dishwasher as the door was missing its slow-open function, this may cause advanced deterioration

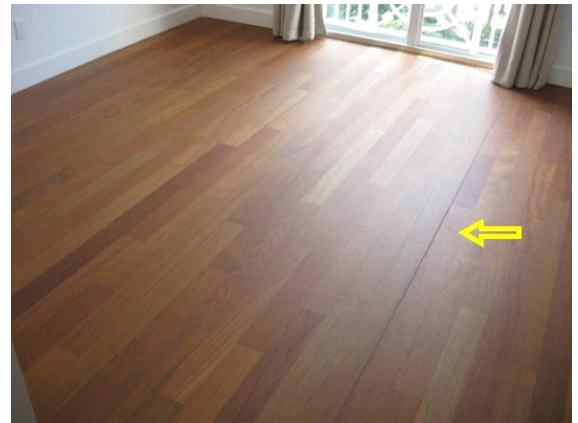
Vinyl flooring showed signs of separation at time of inspection, recommend repair

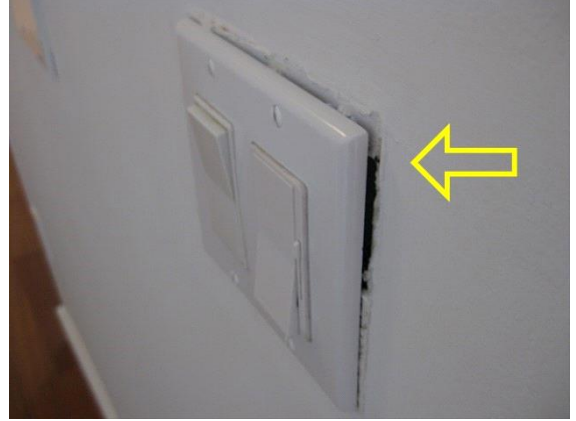
Electrical switch trim showed signs of damage, recommend repair

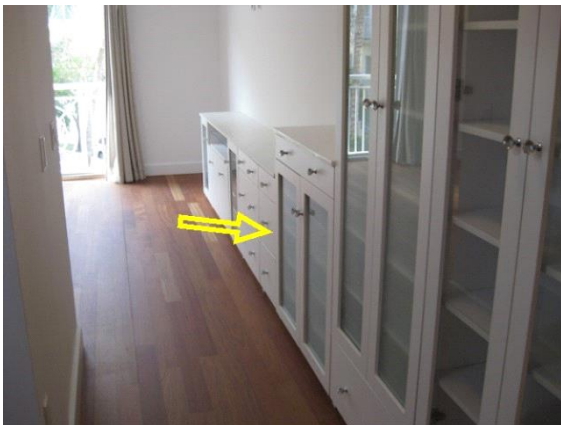
Some cabinets and closet doors did not have the slow-close function, recommend repair to prevent damage on cabinet fixtures

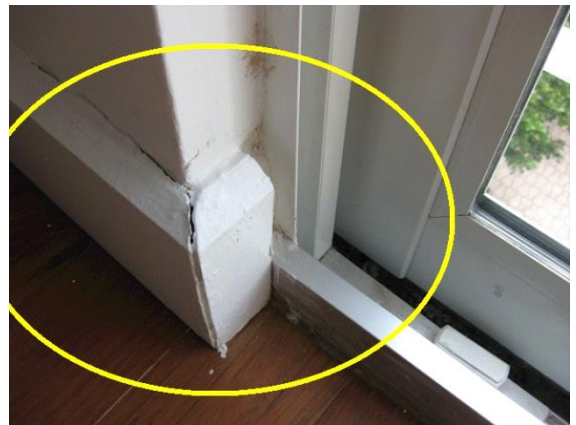
Area was seen to have evidence of moisture intrusion, area was tested with contact humidity meter and no elevated levels of humidity were noted at time of inspection, monitor area

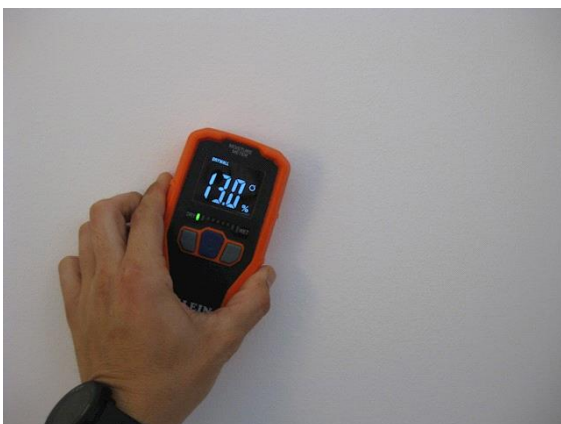
Humidity reading taken in main bedroom along west facing wall

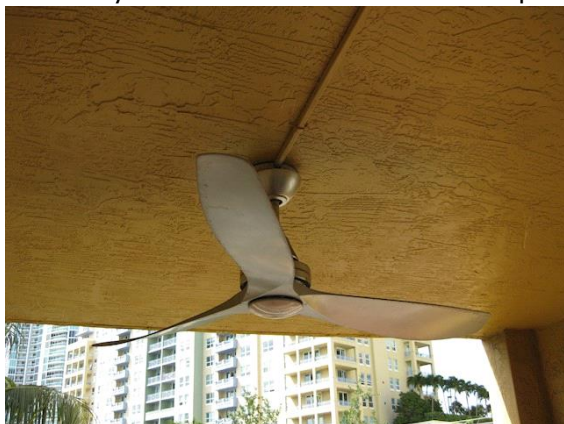
Fan did not turn on at time of inspection, recommend repair

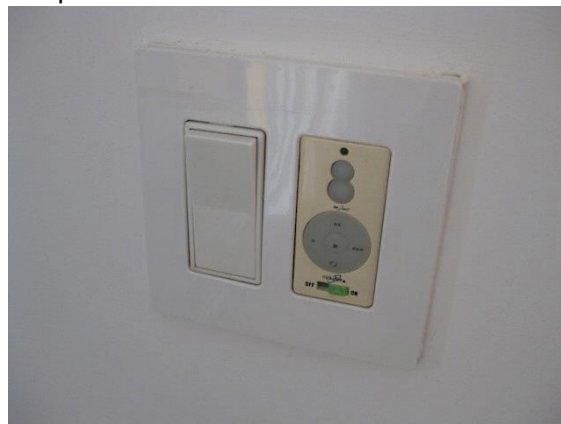
Fan controller turned on and off however the fan itself did not move at all, recommend repair

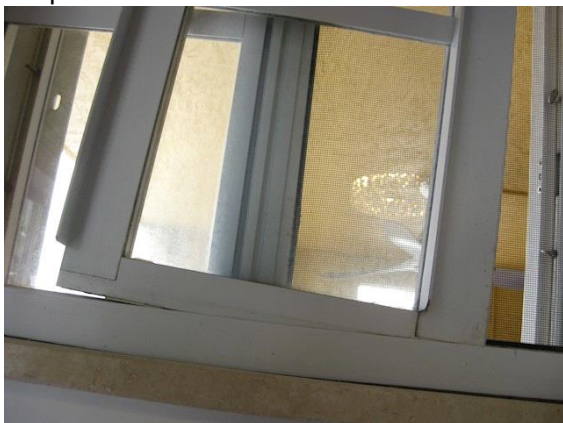
Window in bedroom 2 showed signs of deterioration, recommend repair for ease of use

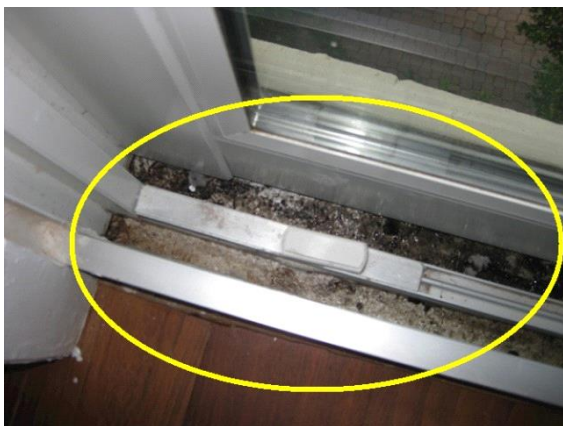
Sliding glass door did not have weather strip present, stagnated water was observed in sliding glass door track area, recommend repair to prevent additional moisture from entering apartment

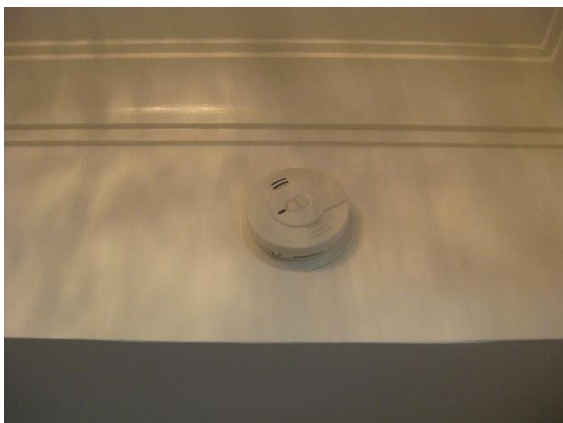
Smoke detector had a constant beeping observed,
recommend repair

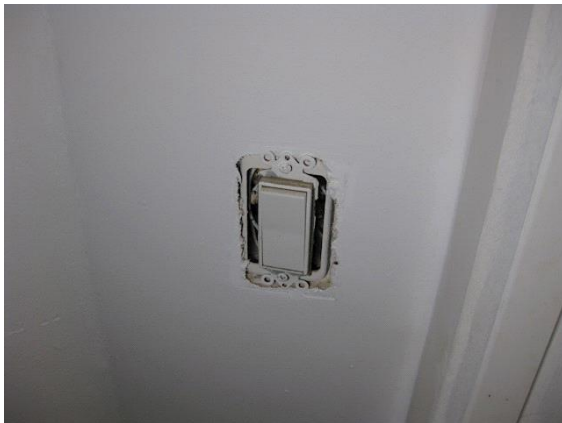
Light switch in laundry area was missing cover, recommend replacement to prevent any damage to electrical fixture

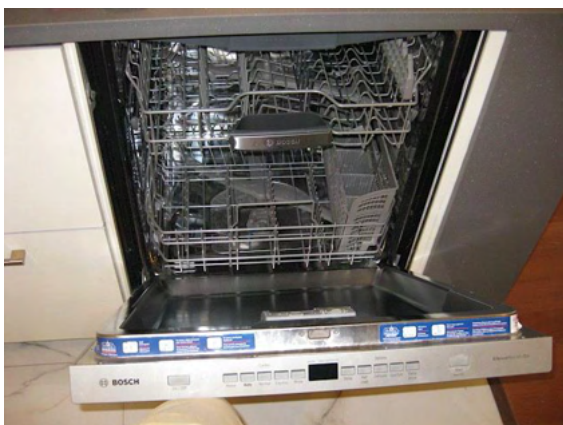
Maintenance recommended on door of dishwasher as the door was missing its slow-open function, this may cause advanced deterioration

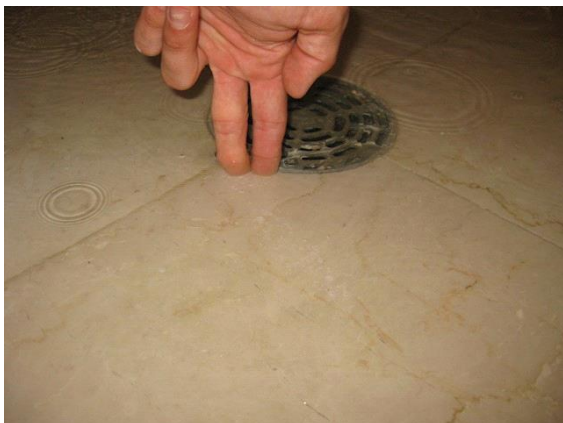
Shower area did not drain at time of inspection, recommend repair

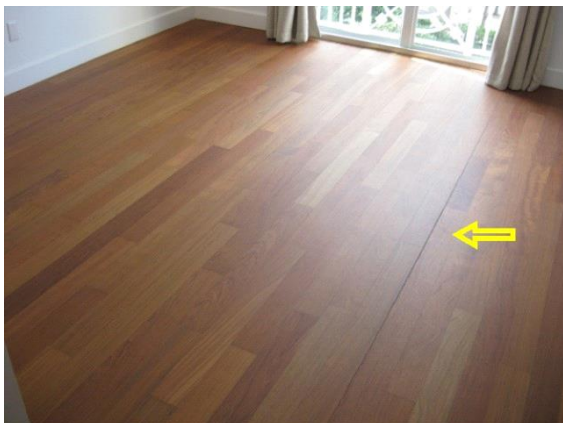
Vinyl flooring showed signs of separation at time of inspection, recommend repair

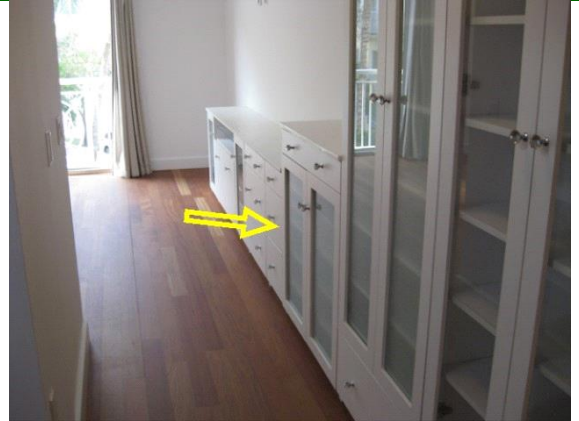
Some cabinets and closet doors did not have the slow-close function, recommend repair to prevent damage on cabinet fixtures

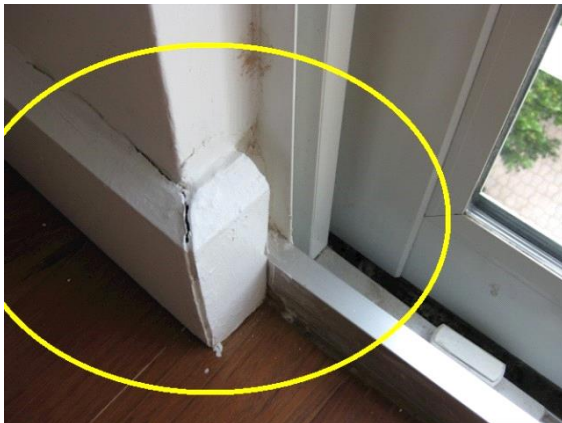
Area was seen to have evidence of moisture intrusion, area was tested with contact humidity meter and no elevated levels of humidity were noted at time of inspection, monitor area

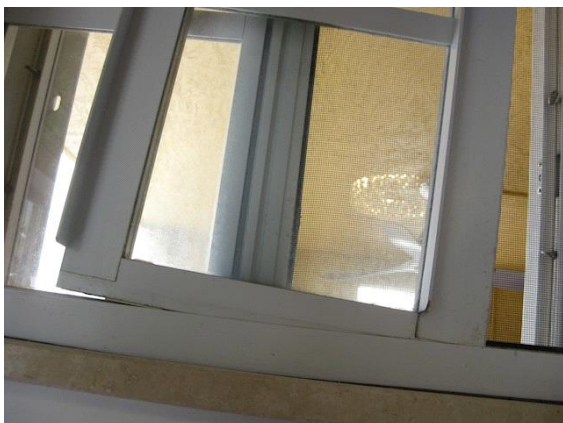
Window in bedroom 2 showed signs of deterioration, recommend repair for ease of use

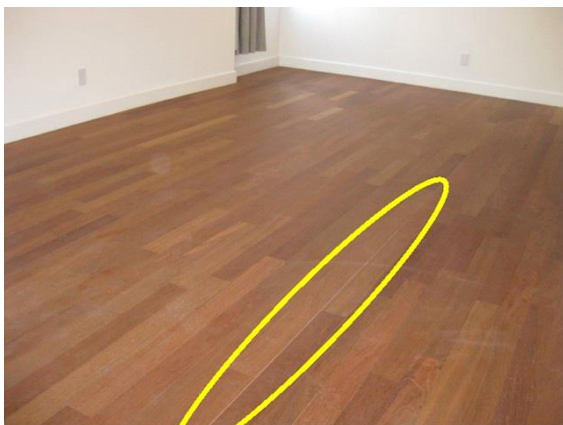
Vinyl flooring showed signs of separation at time of inspection, recommend repair
