Benny Paneto DBA
National Property Inspections

Jane Smith, 10961 Fawn Rd, Cali, CA, 92250

Inspection Date:
05/15/2023

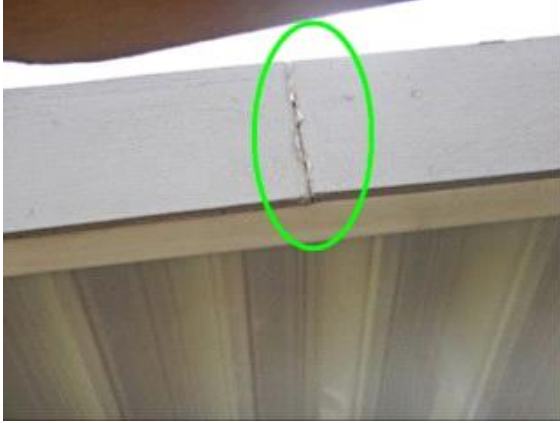
The metal patio side molding has evidence of cracked sealant on the seam. Recommend further evaluation/repair by qualified contractor(s).

Patio: metal patio molding has evidence of cracked sealant on the seam

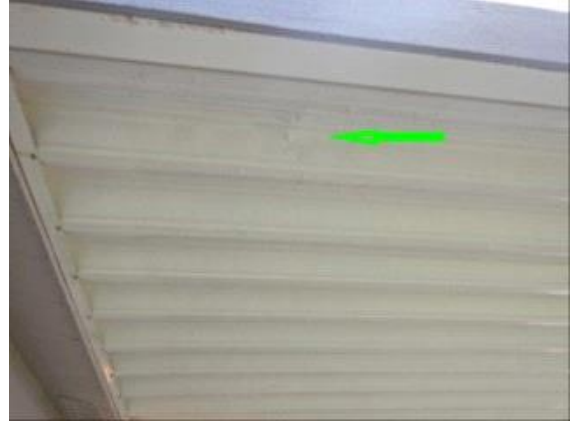
Patio: noted dent on the patio metal roof

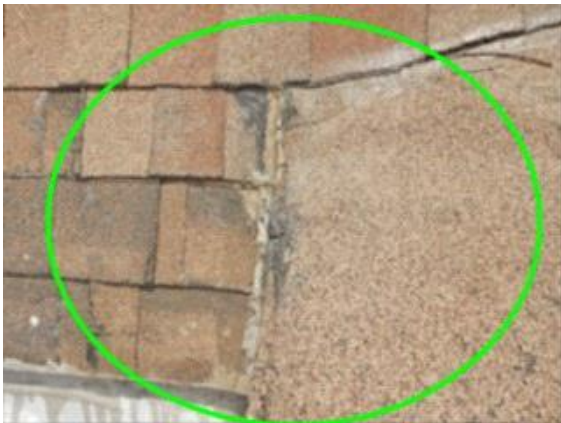
Roofing 1: cracked sealant

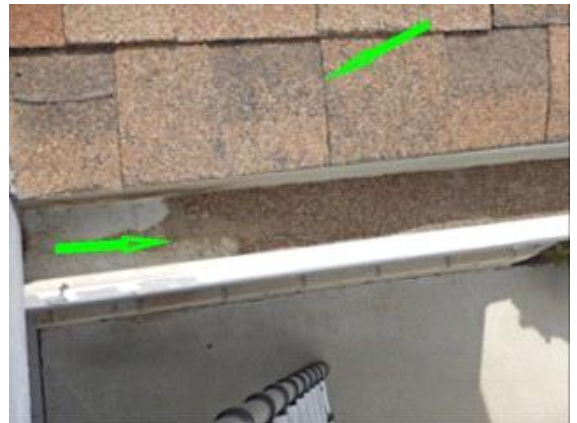
Observed multiple areas on the roof with evidence of missing granules. Noted evidence of pooling water on the main roof valley. Recommend further evaluation/repair by qualified roofing contractor(s).

Roofing 1: noted roof granules in the gutters and dark areas on the asphalt shingles show evidence of missing granules

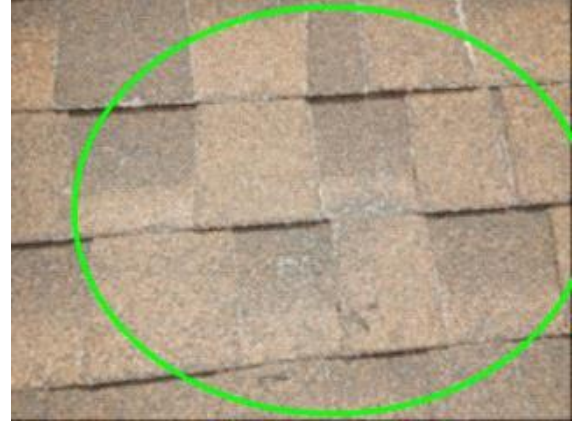
Roofing 1: missing granules

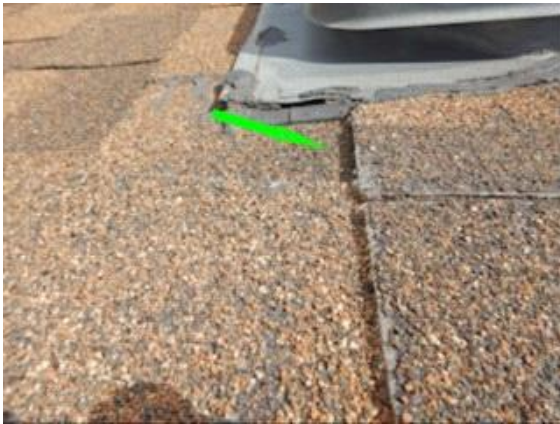
Roofing 1: missing granules on the asphalt shingles

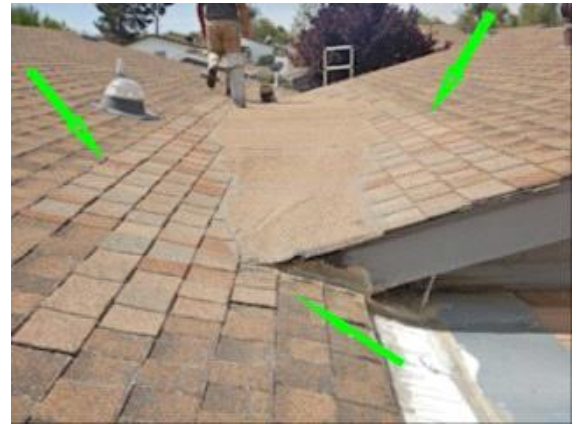
Roofing 1: observed previous roof repairs around the valley

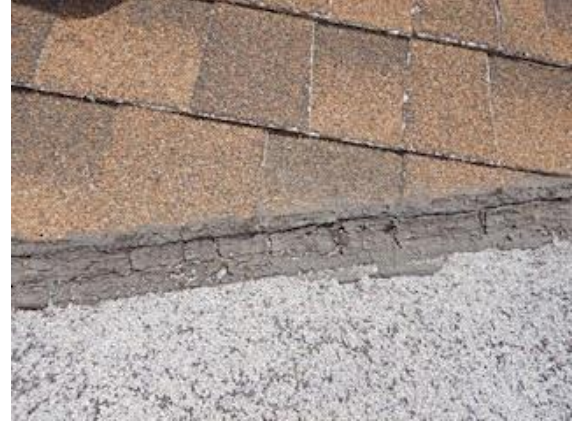
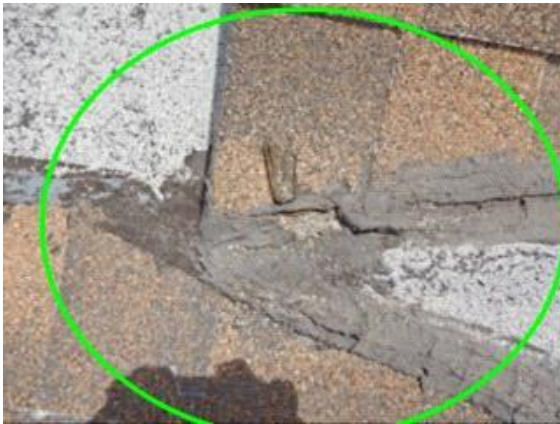
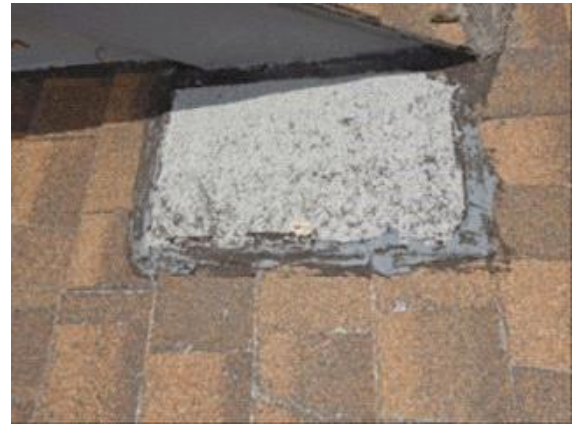
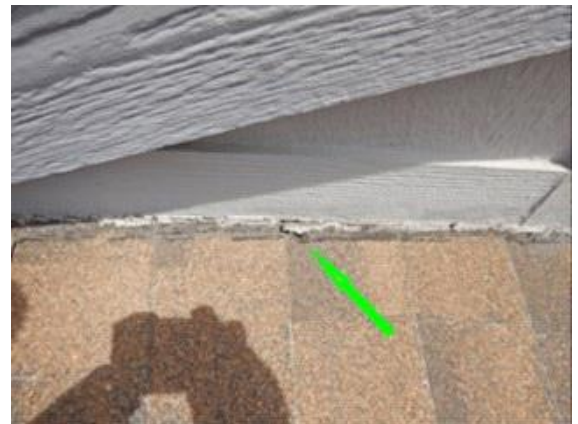
The roof dormer had cracked sealant in several areas. Recommend further evaluation/repair by qualified roofing contractor(s).

Roofing Dormer over the living room: cracked sealant

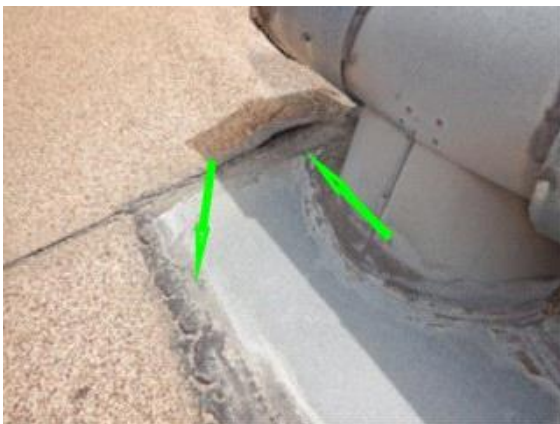
Observed several metal flashings with cracked sealant around the base. Recommend further evaluation/repair by qualified contractor(s).

Flashing/Valleys: noted lifting roofing material and cracked sealant

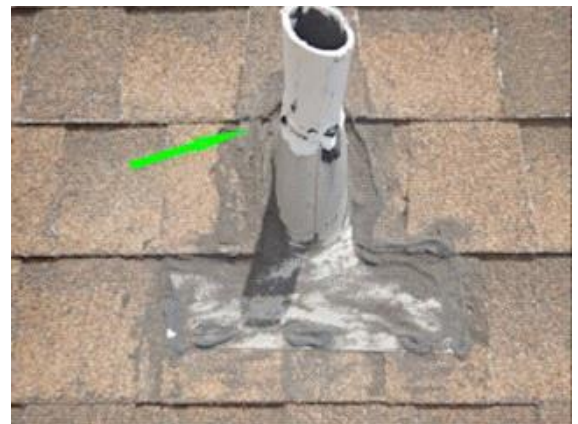
Flashing/Valleys: cracked sealant

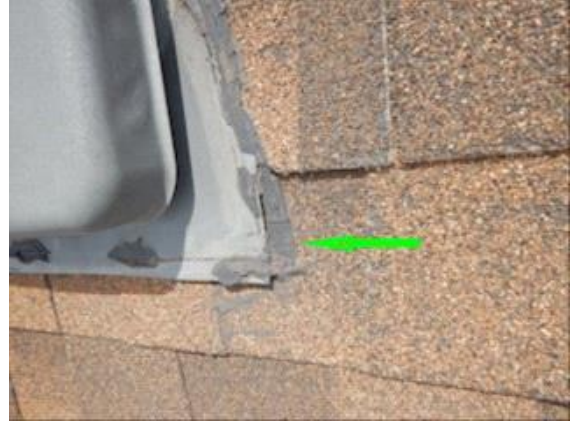
Flashing/Valleys: cracked sealant

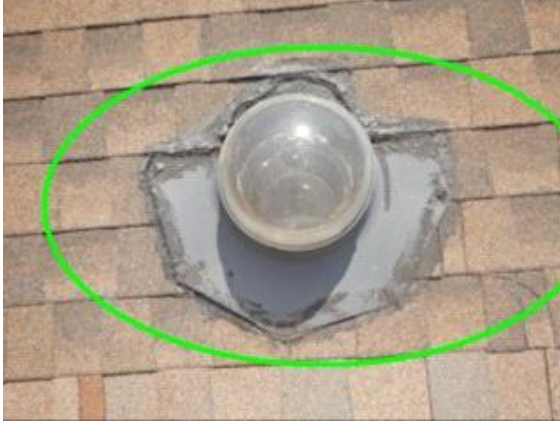
Both skylights show evidence of cracked sealant around the base. Recommend further evaluation/repair by qualified roofing contractor(s).

Skylights: noted cracked sealant around the skylight

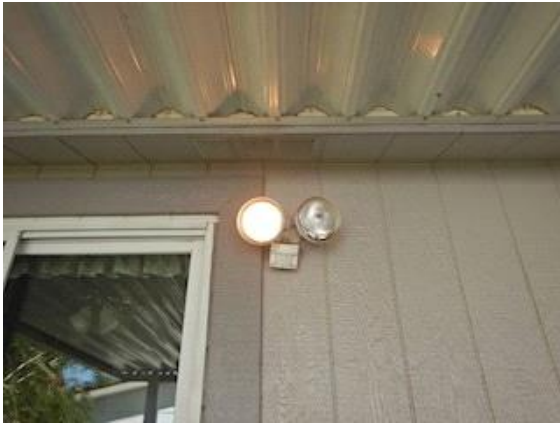
Exterior Surface: right side bulb is out

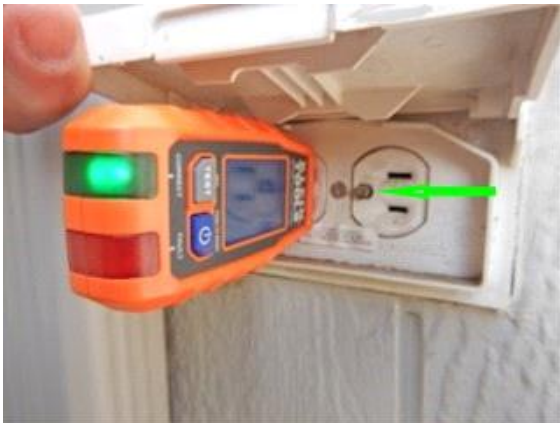
The outdoor outlet close to the porch is functioning as designed but noted a ground prong stuck inside an opening. Recommend further evaluation/repair by a licensed electrician.

Exterior Surface: noted a ground prong stuck inside opening

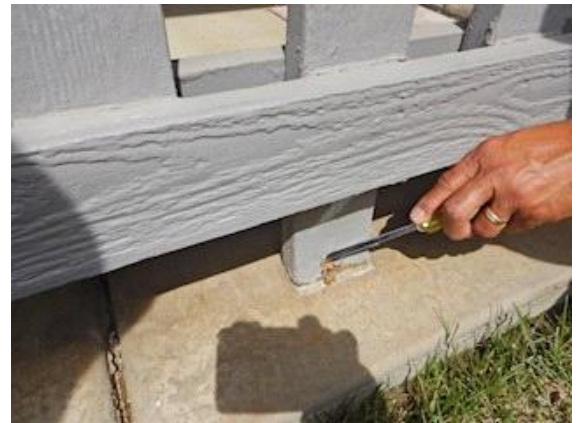
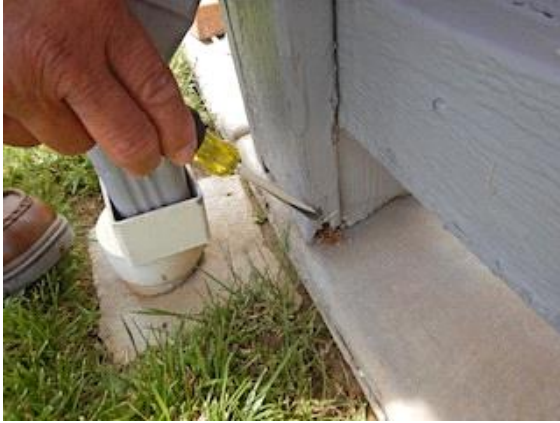
Noted wood rot on the porch on several areas of the composite trim. Recommend further evaluation/repair by qualified contractor(s).

Exterior Surface: noted wood rot on the porch composite trim

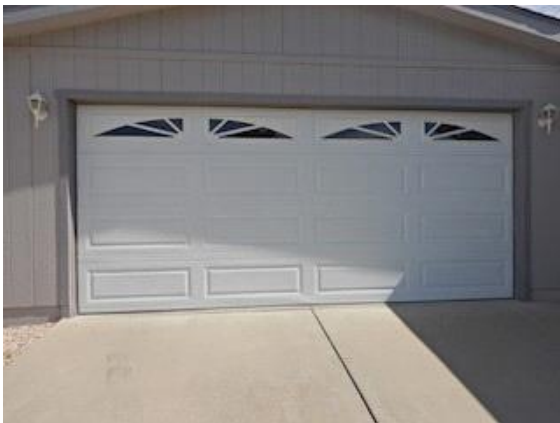
Overhead Garage Doors:

The upper right garage door molding is not attached. The automatic garage door opener had an inoperable or out of adjustment automatic-reverse feature. Auto reverse is a safety feature that stops the door from closing when it hits an object. Recommend a garage door technician review the operation of the garage door and make repairs/adjustments needed for the door to operate in a safe manner.

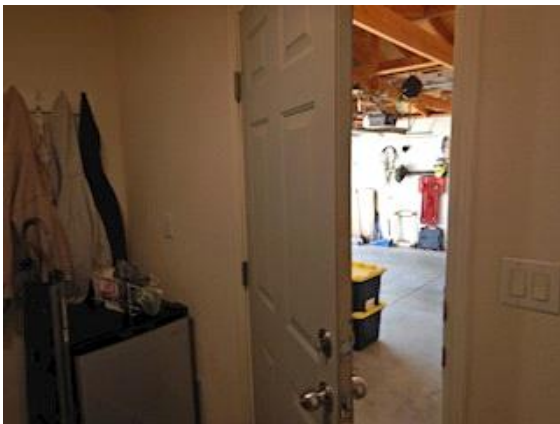
Any door between the house and the garage should have an automatic door closer that is tight fitting and weather-stripped for fire safety and to reduce the chance of gasoline or exhaust fumes entering the home. Recommend installation of auto-closure unit.

Garage Pedestrian Door into House: the house/ pedestrian door is not self closing

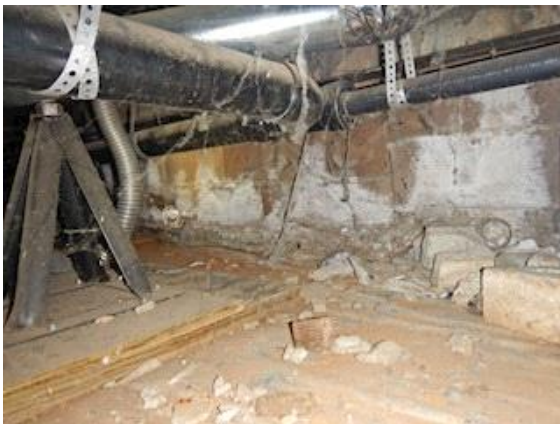
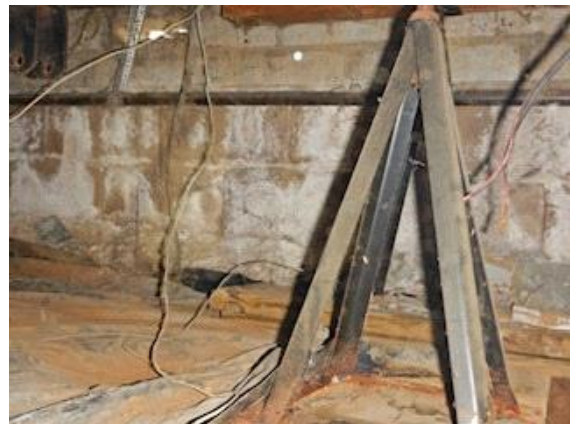
Interior Foundation:

Efflorescence along foundation wall. Efflorescence is a powdery deposit of salts which forms on the surface of bricks and mortar. It is usually caused by water intrusion. Recommend further evaluation/repair by qualified contractor(s).

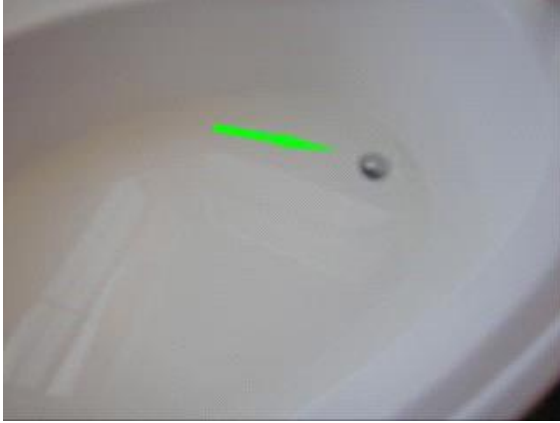
Noted a slow drain in the tub.Recommend further evaluation/repair by qualified contractor(s).

Bathroom 3: noted a slow drain in the tub

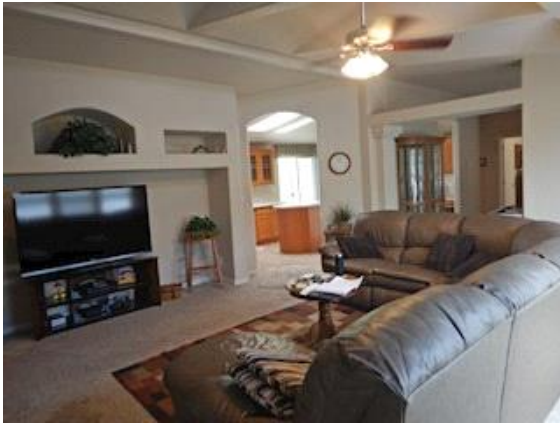
Living room:

The outlet is showing an open hot. The ceiling fan is wobbling, needs adjustment. Recommend further evaluation/repair by a licensed electrician.
