Benny Paneto DBA
National Property Inspections

Dan Blanco, 2661 W Daw Ct, Ranger, CA, 92699

Friday, March 31, 2023

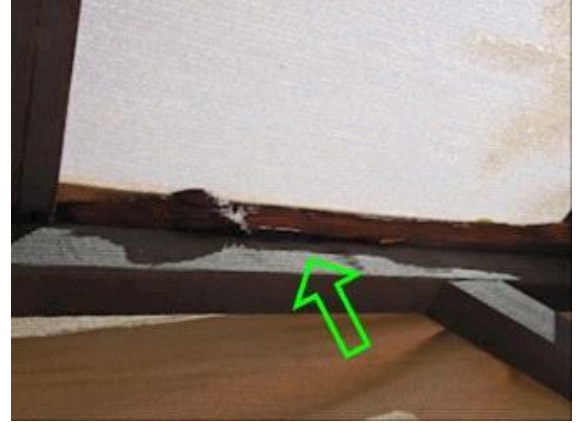
Observed wood rot on several areas of the patio wood trim. Recommend further evaluation/repair by qualified contractor(s).

Patio: observed wood rot on the patio upper wood trim

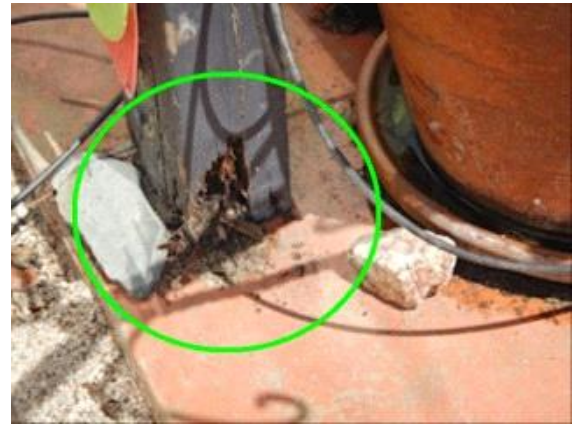
Patio: wood rot patio post

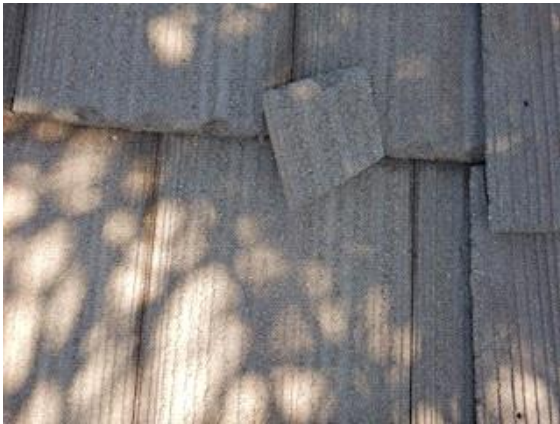
Roofing: noted a piece of roof tile on the rear side

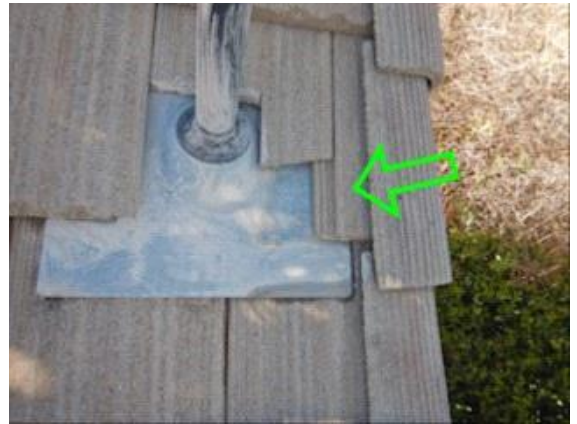
Observed a missing piece of a roof tile located on a rear metal flashing cover, the piece is still on the roof. Recommend further evaluation/repair by qualified roofing contractor(s).

Roofing: noted a piece of roof tile missing, the loose piece is still on the roof

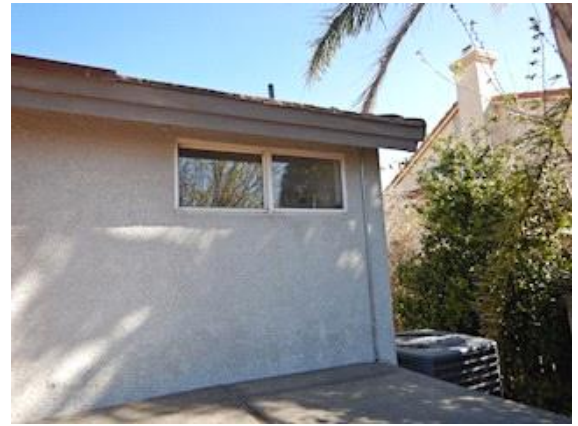
Two windows are missing their screen. Recommend further evaluation/repair by qualified contractor(s).

Windows: window is missing the screen

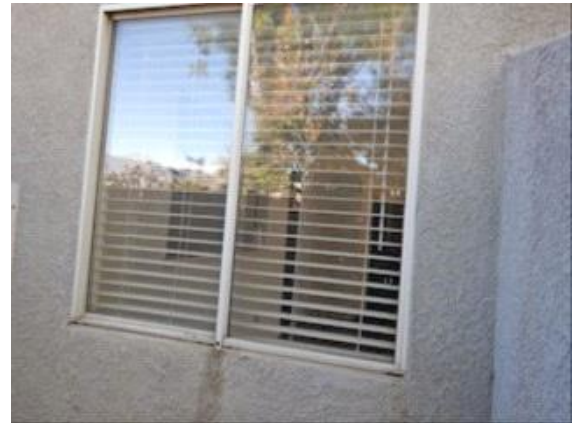
Windows: window is missing the screen

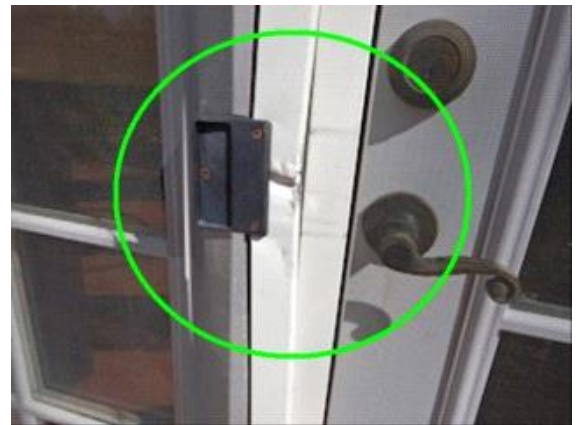
Noted a damaged French door screen door. Recommend further evaluation/repair by qualified contractor(s).

Exterior Doors: damaged French door screen door

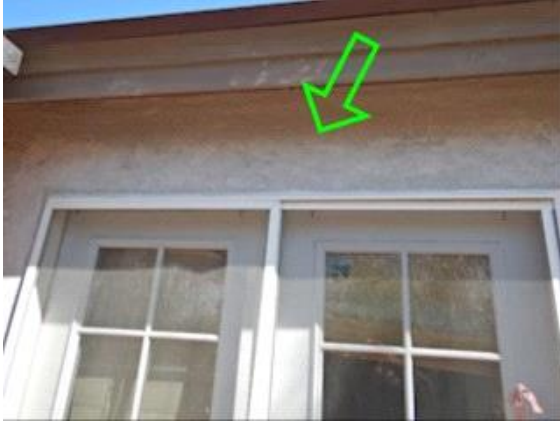
Exterior Doors: observed previous repairs on the patio French door frame

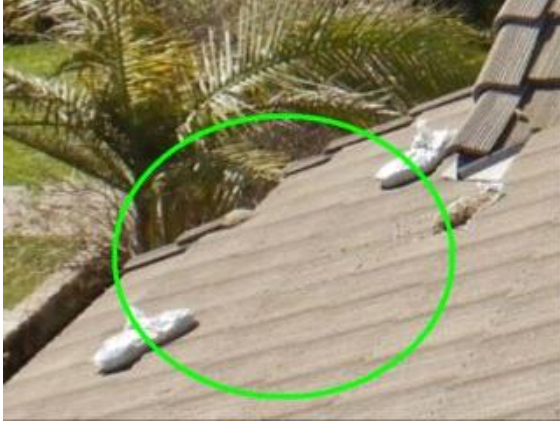
Garage/Carport: roof area of the garage where water is leaking from

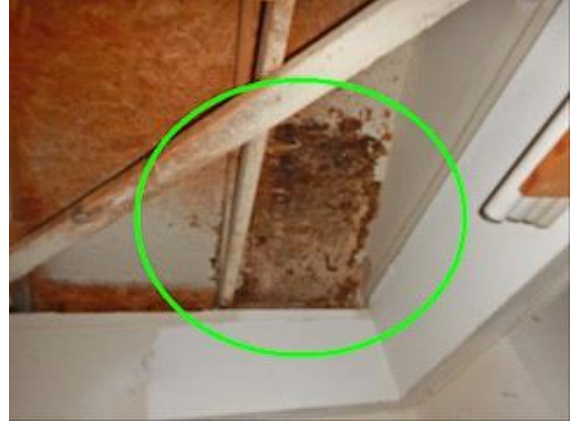
Observed wet roof sheathing on the left side ceiling. Recommend to have a qualified roofer further evaluate the roofing system and make the necessary repairs.

Garage/Carport: observed wet roof sheathing on the garage ceiling

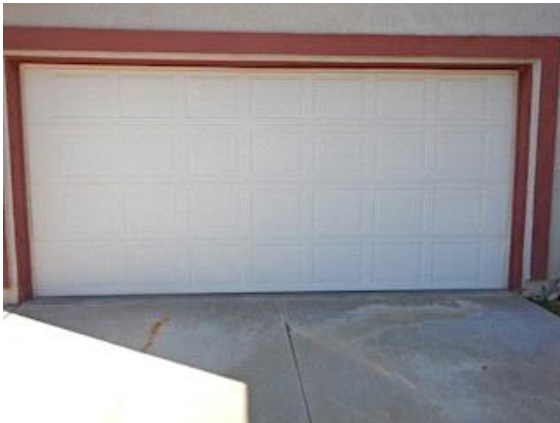
Overhead Garage Doors:

The automatic garage door opener had a inoperable or out of adjustment automatic-reverse feature. Auto reverse is a safety feature that stops the door from closing when it hits a object. Recommend a garage door technician review the operation of garage door and make repairs/adjustments needed for door to operate in a safe manor.

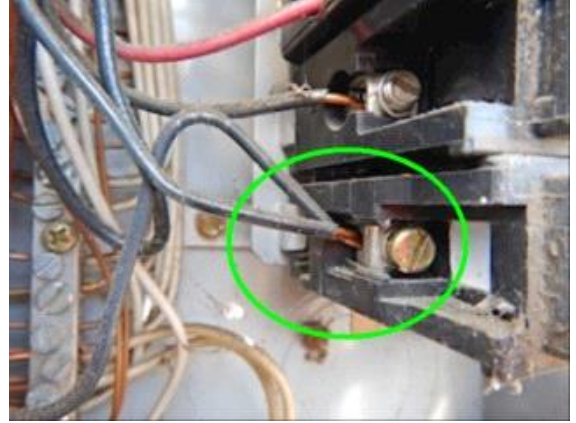
The electrical panel has a breaker with double tapping. A double tapped breaker is when two wires connect to one breaker. The problem is that it can cause loose connections, arcing. Recommend to have a licensed electrician further evaluate this concern.

Electrical: noted a breaker with double tap wires

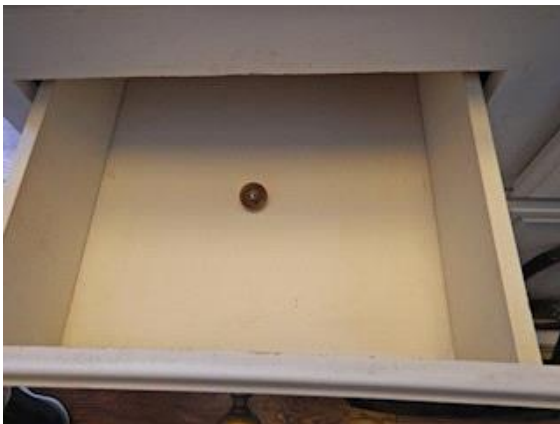
A drawer in the kitchen island has a loose roller. Recommend further evaluation/repair by qualified contractor(s).

Kitchen: drawer in the kitchen island has a loose roller

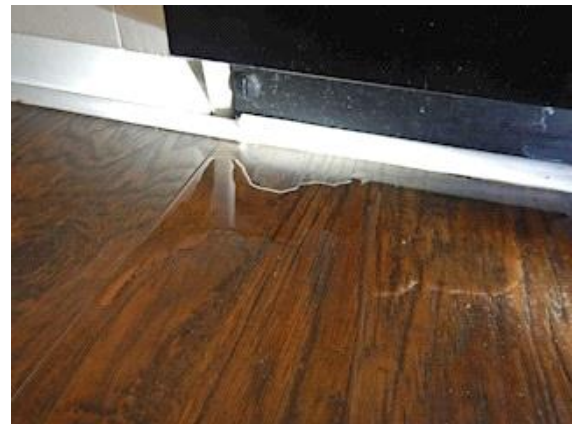
The dishwasher is leaking water on the front side under the door. Recommend further evaluation/repair by qualified appliance contractor(s).

Kitchen: the dishwasher is leaking water

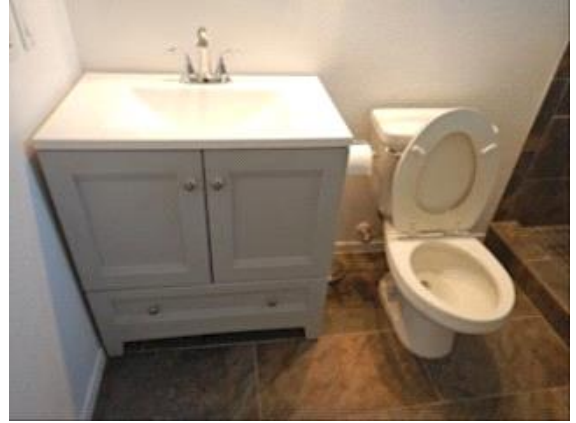
The sink is missing the splash guard. Recommend further evaluation/repair by qualified contractor(s).

Bathroom 1: the sink is missing the splash guard

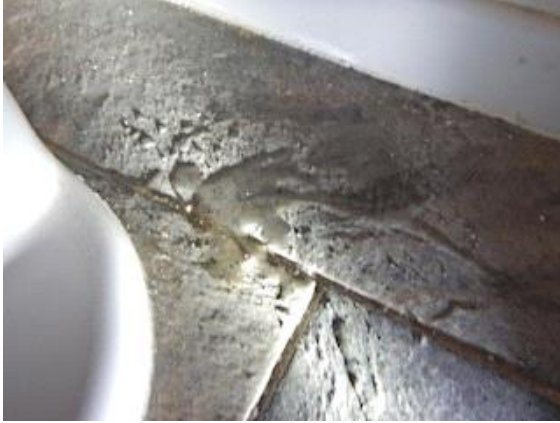
Observed a water leak under the toilet tank. Recommend further evaluation/repair by qualified plumbing contractor(s).

Bathroom 1: observed a water leak under the toilet tank

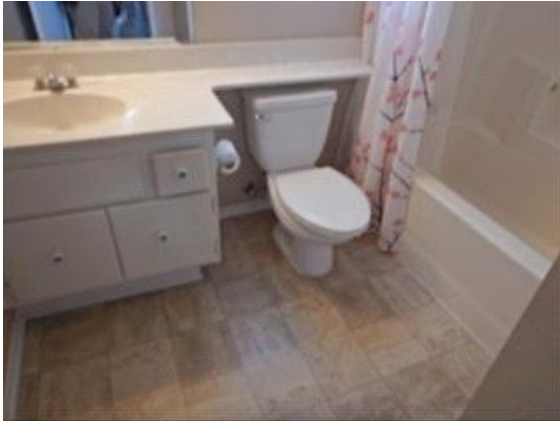
Noted small cracks on the sink. Recommend further evaluation/repair by qualified contractor(s).

Bathroom 2: noted small cracks on the sink

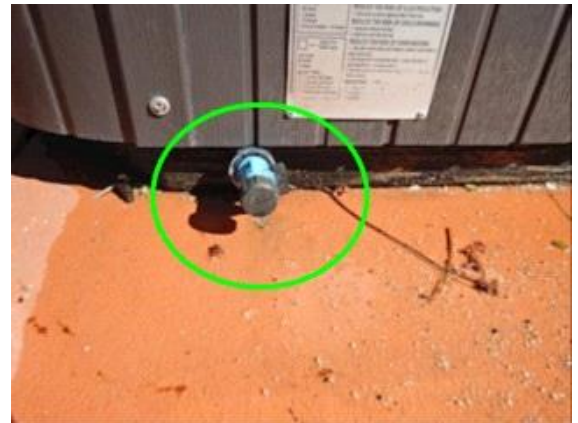
Observed a water leak on a front fitting. Recommend further evaluation/repair by qualified contractor(s).

Hot Tub / Spa: observed a water leak
