# Fixing Air Leakage in Connecticut Town Houses

*After energy improvements were made to some town houses, a second look revealed big opportunities for energy and money savings.*

Mill Pond Village is a 360-unit affordable housing development built in 1975 and located in Broad Brook, Connecticut. Owned and managed by Winn Companies, this property has undergone many improvements over the past few years, but energy

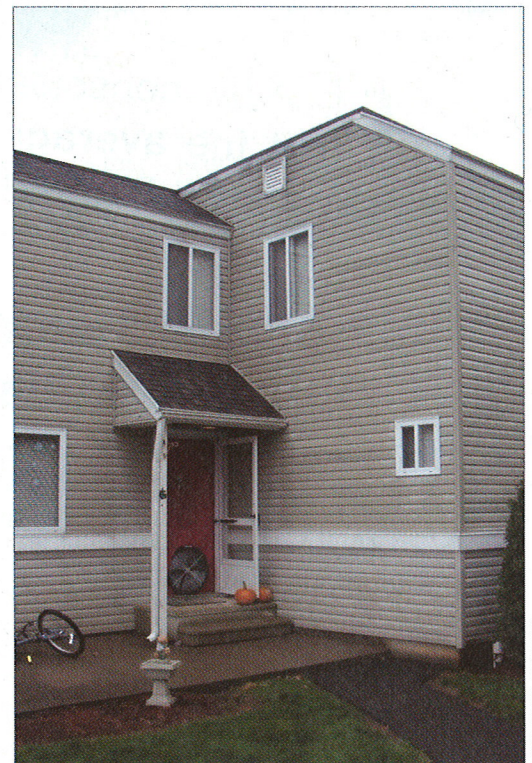
A blower door was set up in this typical townhouse unit. Testing indicated substantial leakage under the porch roof.

Blower door tests were conducted on a sample of these units. They were found to have an average air leakage rate of 1,700 CFM<sub>50</sub>. Based on the size of the units, the target CFM<sub>50</sub> for these apartments without adding mechanical ventilation is approximately 1,000. An air leakage rate of 1,700 CFM<sub>50</sub> is

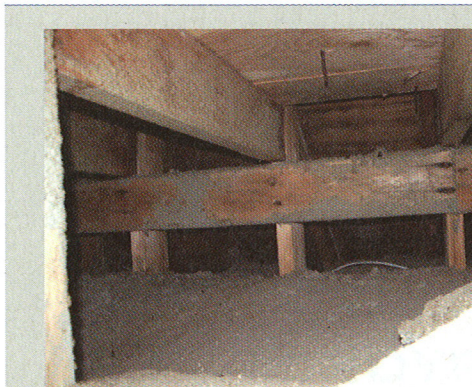
There is not much space to access the existing attic.

in an unoccupied unit. The attic space was very tight, with approximately 20 inches of clearance between the top of the ceiling joists and the bottom of the roof rafters. Additional cellulose insulation had been blown over the original insulation, making it more difficult to move through the attics. The observable air leakage paths in the attic were minimal. The top plates were already covered in a manner similar to that used in modular construction. There was a gap of approximately 2–3 inches around the plumbing vent stack that could be sealed, but SWA determined that to access the gap for sealing would be more trouble than it was worth. At this point, it looked as if not much air sealing could be done in the town house attics.

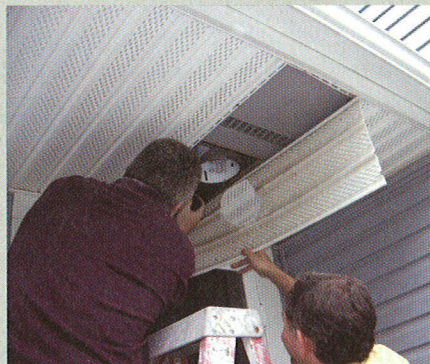
Workers open the porch roof for inspection.

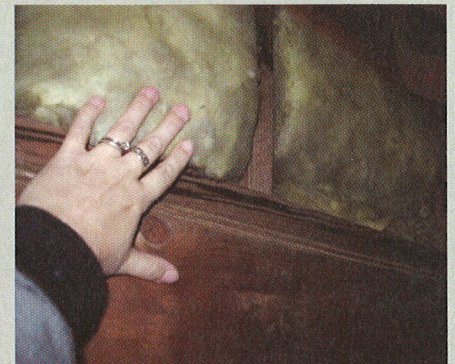
The porch roof connection has a gap in the wall sheathing.

The main entrance to the town house unit has a small porch roof above it. This porch roof is located directly below the hallway window seen in the infrared photo. When the perforated-vinyl soffit panel was removed to access the area above this porch roof, it was found that entire sections of sheathing, some as large as 3–4 square feet, were missing, leaving the fiberglass insulation in the walls directly exposed to outside air (see photos, p. 28). As the photos show, the insulation in these areas is discolored with dirt from years of air passing through it. This windwashing reduces the effective R-value of the insulation in the wall in addition to being a source of air leakage.

To seal the leaks, each porch roof had to be opened up for access. A carpenter was hired to make temporary openings, and to close them up after the air sealing crew had done its work. The crew used rigid foam insulation and expandable foam sealant to seal each area. Blower door test results indicate that this work alone reduced envelope leakage by over 200 CFM<sub>50</sub> per unit. In addition, this work will protect the existing fiberglass wall insulation from windwashing, so it will now perform at its rated R-value.

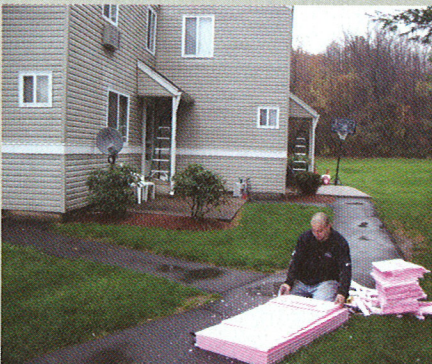
Hundreds of pieces of insulation are cut for air sealing.

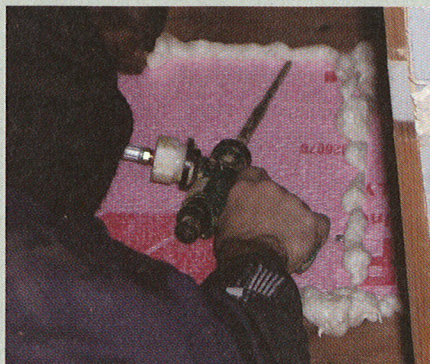
The sheathing is being sealed with rigid insulation and spray foam.

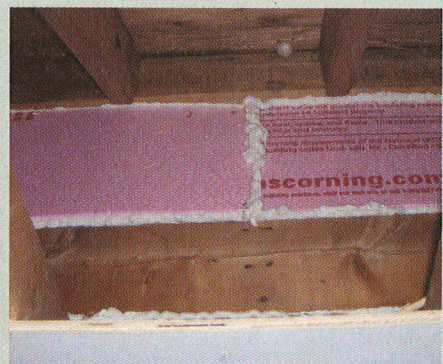
The finished product—the gap in the sheathing after sealing.

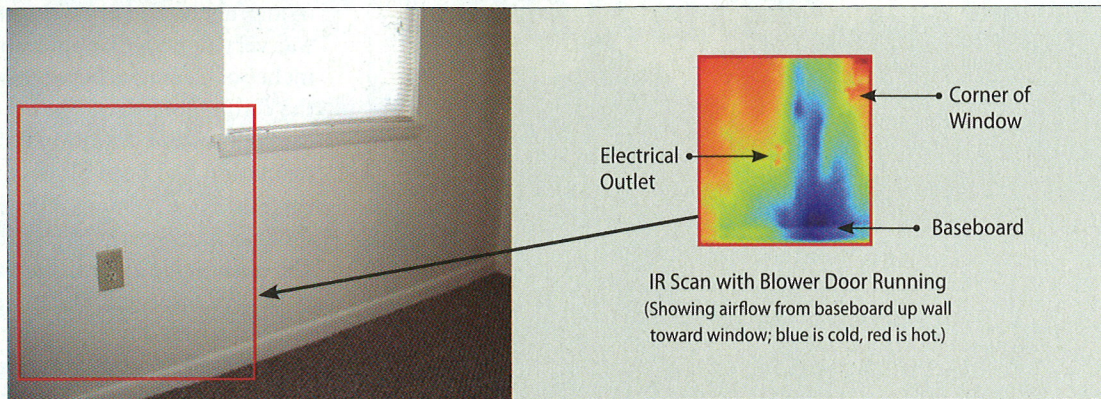
As part of the diagnostic testing, an infrared scan was conducted to verify the existence and proper performance of insulation in the ceilings and walls. With the blower door running, a second infrared scan allows the diagnostician to locate air leakage paths through the building envelope (see "Infrared Thermography: (Nearly) A Daily Tool," *HE* Mar/Apr '08, p. 31). Some typical air leakage paths were noted, including air movement around plumbing pipe chases. However, our team was surprised to find a large leakage path in the exterior wall under the hallway window on the second floor (see photos, p. 30). The blue area in the infrared photograph shows where cold air is being drawn into the building and up the wall cavity through an opening near the baseboard. To determine

A leakage path was discovered (above) in the interior wall (left).
